# Connection Details and Field Implementation of UHPC Piles – Phase II

**Final Report**  
**September 2019**

**Sponsored by**  
Iowa Highway Research Board  
(IHRB Project TR-615)  
Iowa Department of Transportation  
(InTrans Project 09-363)

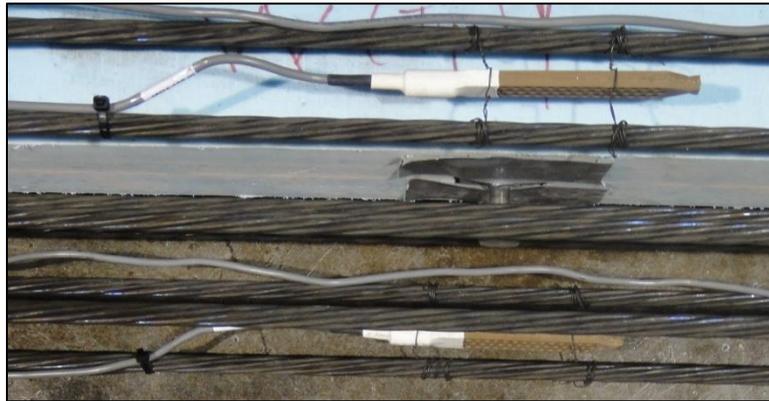
**Figure D-3. Strung embedded concrete strain gage**

1. Twist wire around the bottom of the strain gage, which is nearest to the attached cable, leaving excess wire on both sides
2. Twist wire around the top of the strain gages, leaving excess wire on both sides
3. Align the strain gages with the transition end pointing toward the head of the pile
4. Twist the excess wire from steps 1 and 2 around the adjacent prestressing strands (see Figure D-3)
5. String the cables along the prestressing strands using zip ties, until at the pile head. Make sure to spread the cables out so a weak point does not develop in the cross-section of the pile
