Beam End Repair for Prestressed Concrete Beams

tech transfer summary

September 2020

Iowa Highway Research Board
(IHRB Project TR-715)
Iowa Department of Transportation
(InTrans Project 17-598)

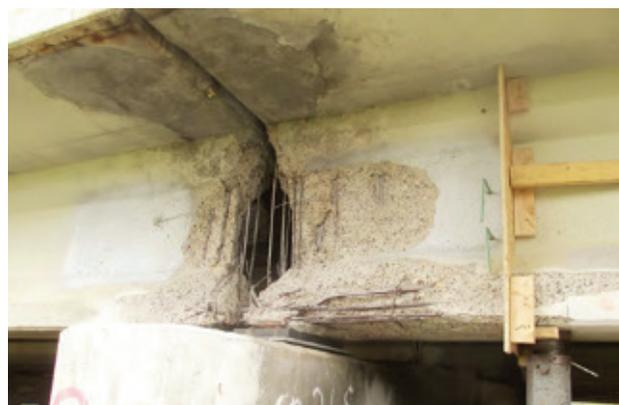
Severely deteriorated prestressed concrete beam ends in Minnesota

A primary concern with the use of precast prestressed concrete beam (PPCB) bridges is the frequent occurrence of cracking and spalling of the concrete towards the ends of the prestressed concrete beams.

This deterioration allows water and chlorides to penetrate into the beam ends, causing exposure and corrosion of the beams' steel reinforcement and prestressing strands. Chloride ingress is particularly problematic in areas with colder climates, such as Iowa, where deicing salts are used on roadways.

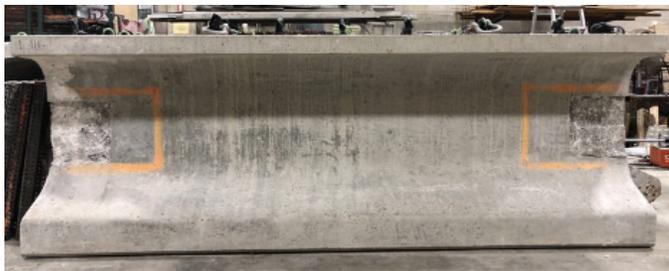
Beam specimen with artificial damage on both ends

Full-scale laboratory testing was conducted to determine the properties and performance of UHPC and HESC as beam patching materials. Six prestressed concrete beams 11 ft in length were cut from a full-size bulb-tee C-shaped beam and artificially damaged at the ends. Two segments were left unrepaired, two were repaired with UHPC, and two were repaired with HESC.
