# Experimental Validation of a Rapid Assessment Tool for Pile Capacity and Stability in Response to Scour Situations

**Final Report**  
**October 2021**

**Sponsored by**  
Iowa Department of Transportation  
(InTrans Project 19-692)

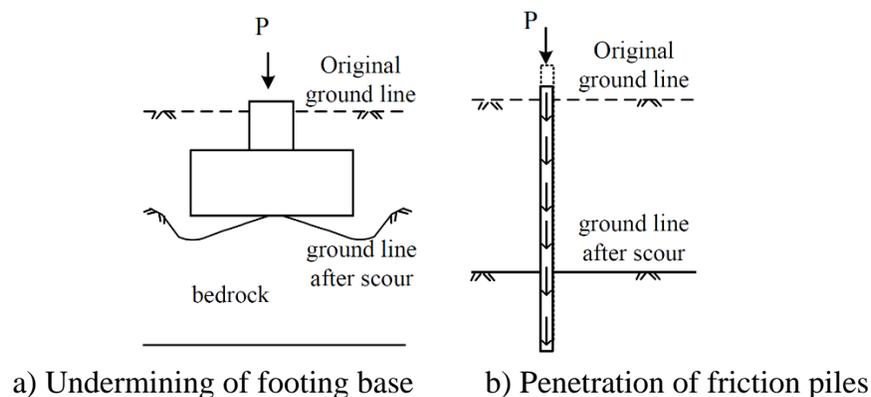
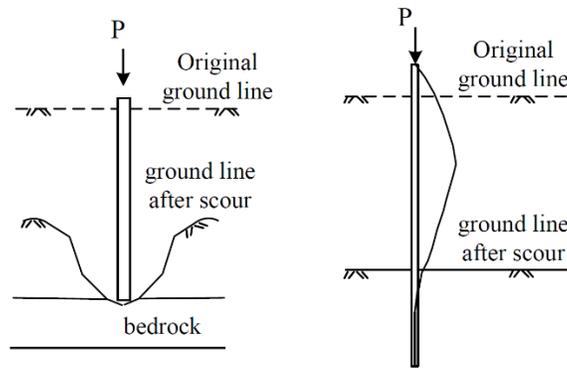
### Figure 1. Vertical failure modes of bridge foundations

Lin et al. (2014) considered the combination of four main factors attributing to vertical failure of bridges under scour conditions. As illustrated in Figure 1, these factors include inadequate bearing capacity of soil (shallow foundations), penetration of friction piles, undermining of the pile toe, and pile buckling.

c) Undermining of pile tip      d) Buckling of piles  
Lin et al. 2014

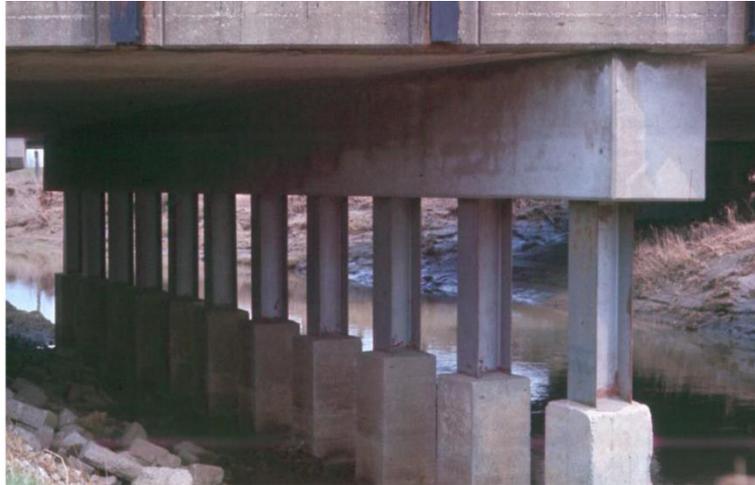
**Figure 2. Steel H-pile concrete encasement for rehabilitation purposes used in Ohio**

In some states, the concrete encasement is not considered on the entire length of the exposed pile. With this method, only some specific length of the pile that is more prone to corrosion or the length that is already corroded is encased in the concrete, as shown in Figure 2.

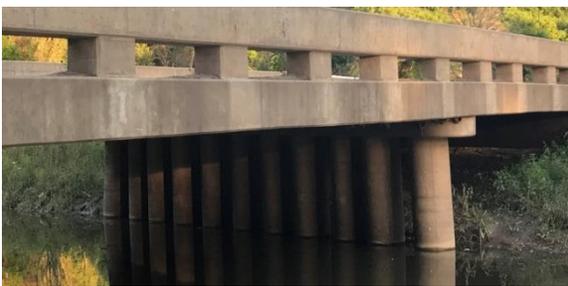
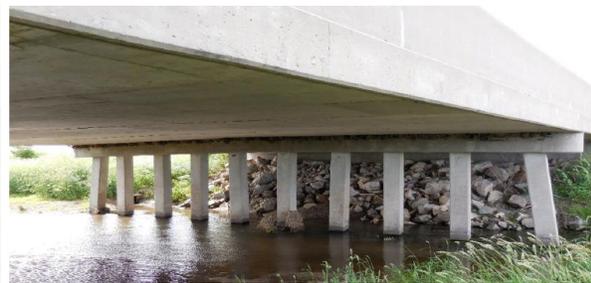
**Figure 3. Steel H-piles with concrete encasement used in Iowa**

However, the Iowa DOT uses continuous concrete encasement along the piles in square or circular cross-sections, as shown in Figure 3.

a) Circular encasements

b) Square encasements

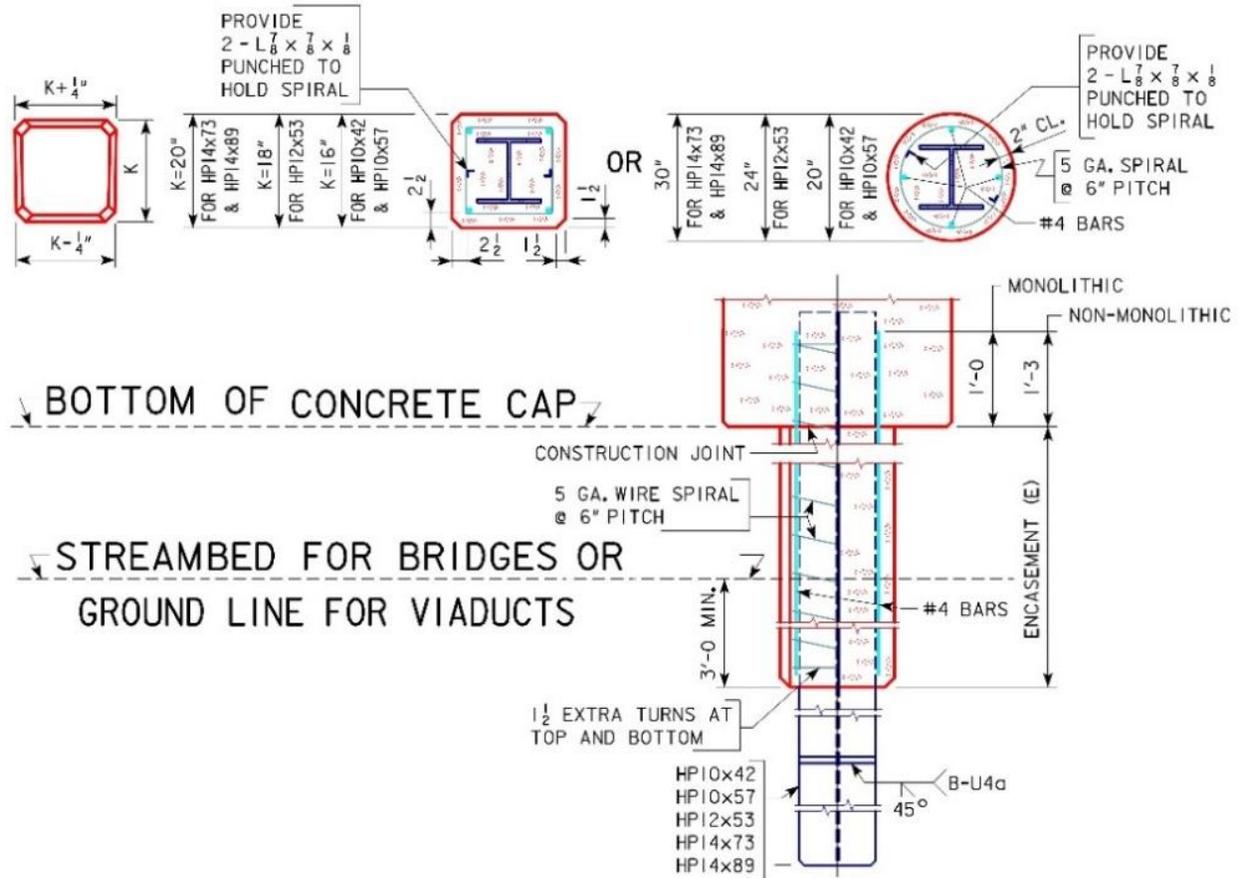
**Figure 4. Iowa DOT concrete encasement standard for H-piles**

A specific standard for concrete encasements of steel H-piles was developed by the Iowa DOT, as shown in Figure 4.

Based on this standard, concrete encasement begins at the pile cap and extends at least 3 ft below the ground surface. The encasement can be a circular or square cross-section, and the dimension depends on the length of the pile above the ground.

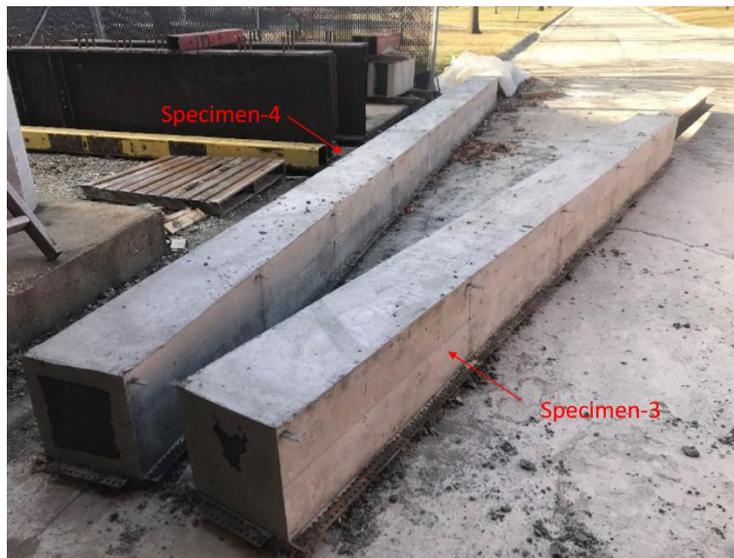
**Figure 5. Specimen-3 and Specimen-4**

The specimens were constructed in the Structural Laboratory at Iowa State University. According to the P10L standard from the Iowa DOT, the square spirals with 6 in. pitch were placed around the piles. A steel plate was welded to the end of the pile to distribute the axial load evenly across the cross-section of each pile. After preparing the formwork for all three specimens, the concrete was poured for all of them at once. Figure 5 shows the prepared piles with concrete encasements for the third and fourth specimens.

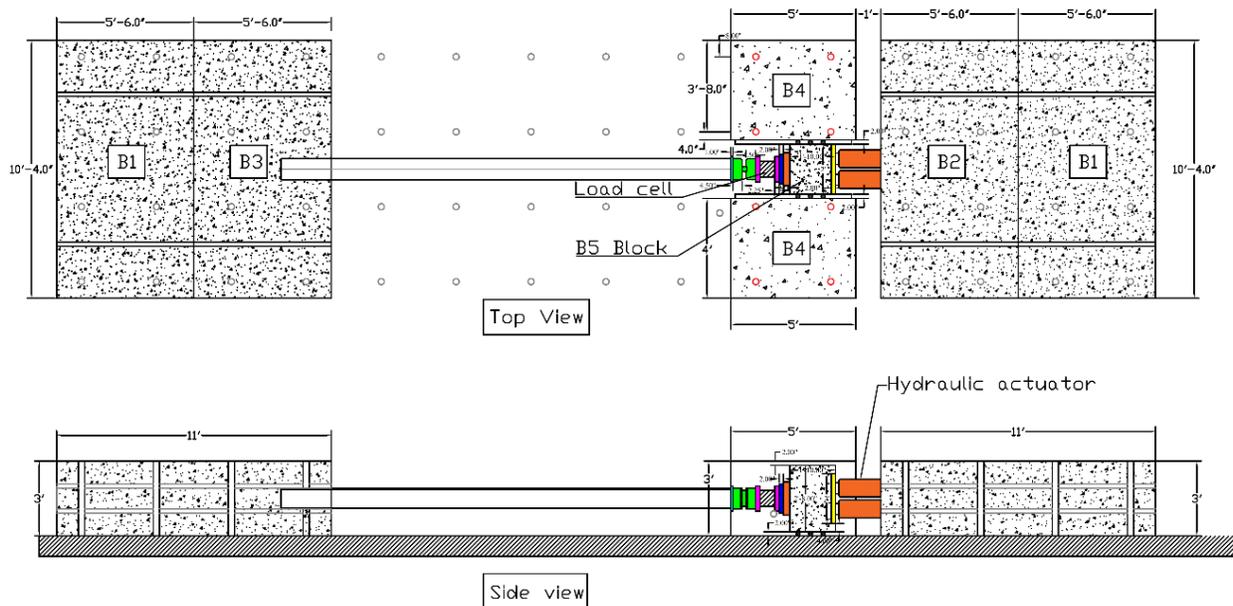
**Figure 6. Test setup**

The results of the numerical simulations in the first phase of this research revealed that a large axial load of about 600 kips was needed to make a 16 ft long encased H10×42 pile buckle. This axial load needs reasonable supports to transfer the load to the ground by friction forces. As a result, to provide adequate friction forces between the floor and supports, large concrete blocks were constructed. Figure 6 shows the schematic view of this test setup for all specimens.

The maximum capacity of the available crane in the laboratory was a limiting factor; thus, the concrete blocks at each side of each pile were built in two smaller blocks (B1, B2, and B3) and then post-tensioned in the horizontal direction. Finally, all the concrete blocks on both sides were post-tensioned to the laboratory floor to add enough vertical load to result in more friction counteracting forces.

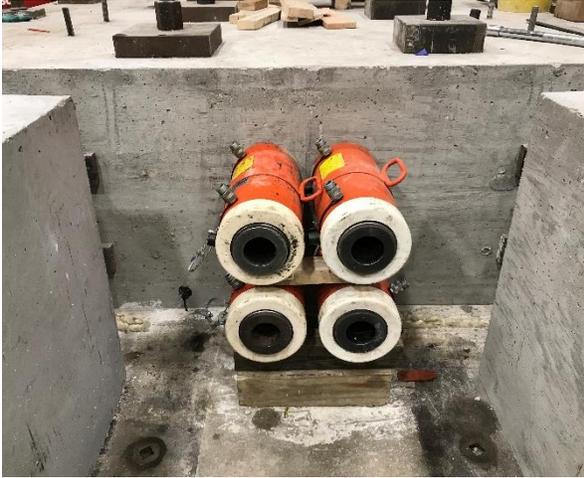
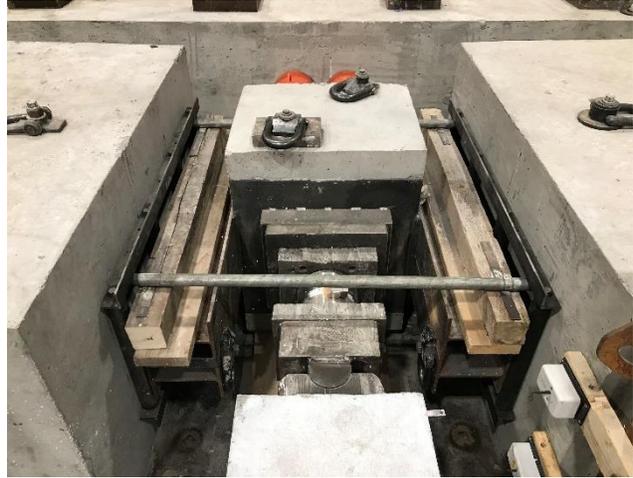
**Figure 7. Pile pin-end setup**

In this setup, four hydraulic actuators (Figure 7-a), with 200 kips capacity on each, were mounted horizontally on the support concrete block to apply the axial load to the pile pin-end.

a) Hydraulic actuators.

b) B5 block and two B4 blocks and side rollers.

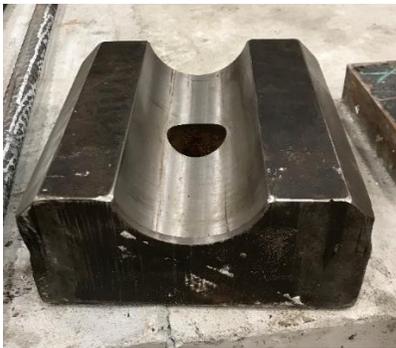
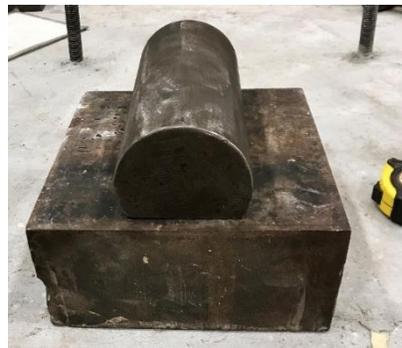
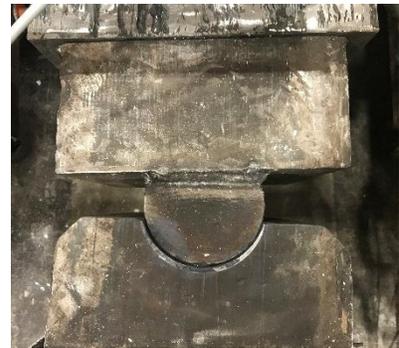
**Figure 8. Pin connection details**

To achieve a pin-end condition at the end of the pile, two thick plates with a dimension of 10×10×4.5 in. were used. On one of these plates, a cylindrical concaved shape was constructed, and a corresponding cylindrical part was welded to the other plate. Figure 8 shows the pin connection at the end of the pile.

a) Cylindrical concaved shape

b) Cylindrical part

c) Pin connection

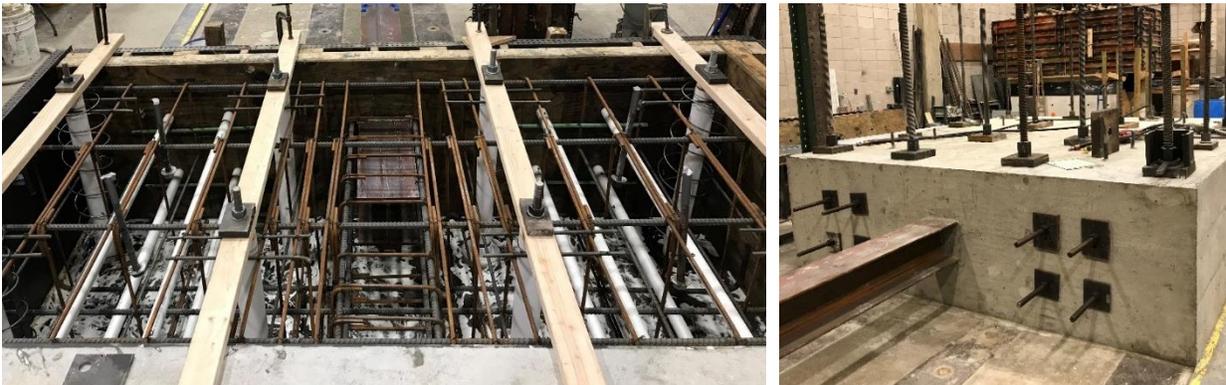
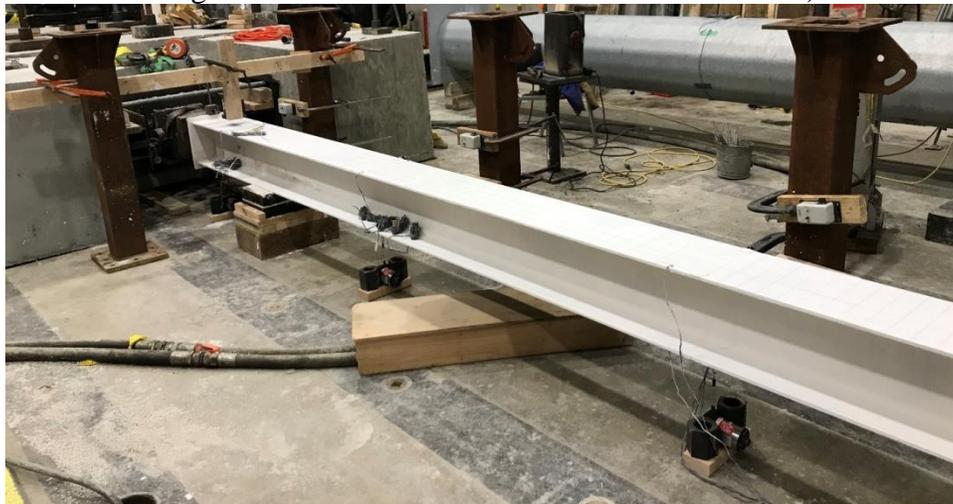
**Figure 9. Pile fixity inside the concrete block**

The other end of the pile, which is assumed to be in the soil, was constructed with a fixed-end condition. The fixity was achieved by embedding 2 ft of pile into the concrete block. Previous studies confirmed that this length of embedment can provide complete fixity at the end of the

member (Castilla et al. 1984). Figure 9-a shows the pile embedment inside the concrete block before pouring the concrete.

a) Reinforcement arrangement in the concrete block B3

b) Fixed end

c) Pin support end

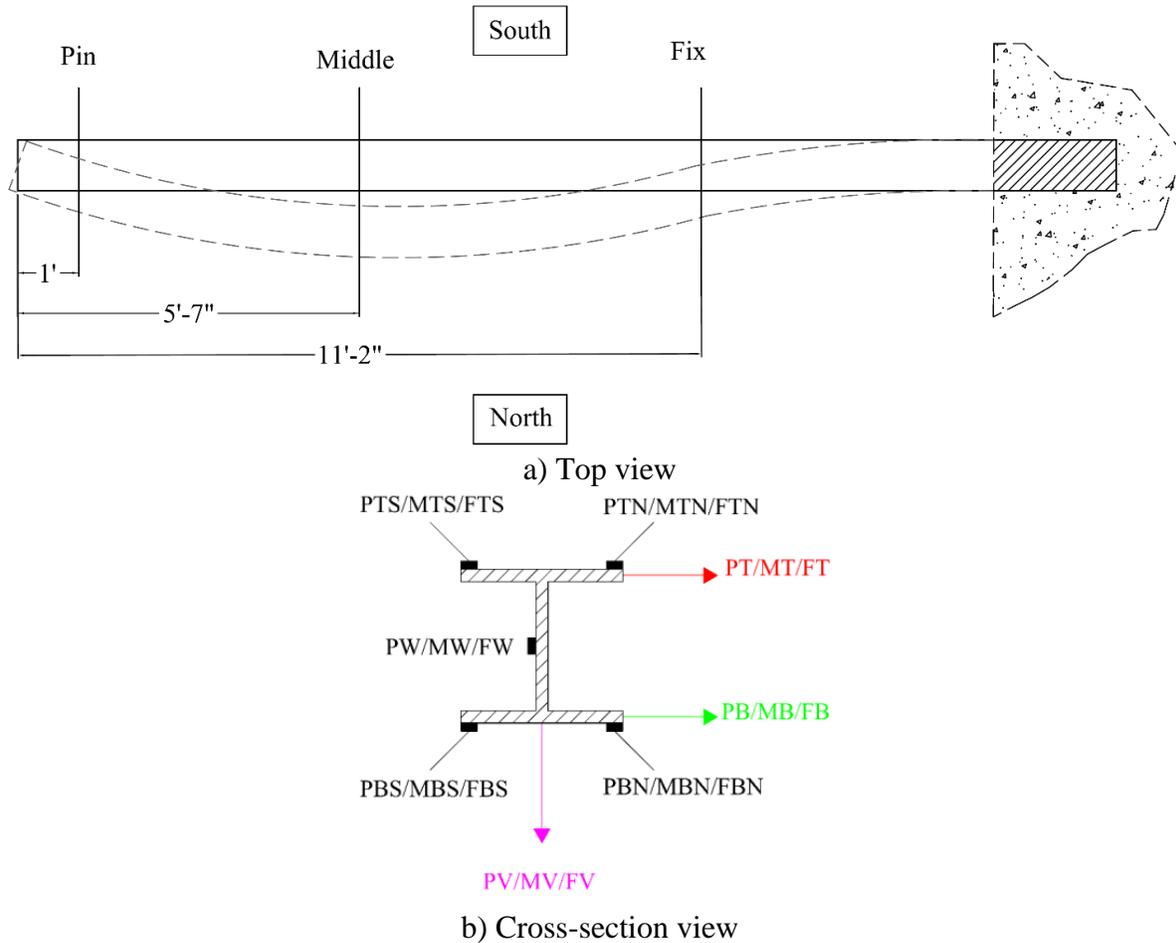
**Figure 10. Instrumentation on Specimen-1**

Specimen-1 was 16 ft long without any concrete encasement. The instrumentation plan for Specimen-1 is shown in Figure 10.

The gauges were installed in three instrumentation sections labeled as pin (P), middle (M), and fix (F). The P section was 1 ft from the pinned end of the pile. The M section was 5 ft 7 in. from the pinned end (0.35L). The F section was close to the fixed end of the pile and was 11 ft 2 in. from the pinned end (0.7L)

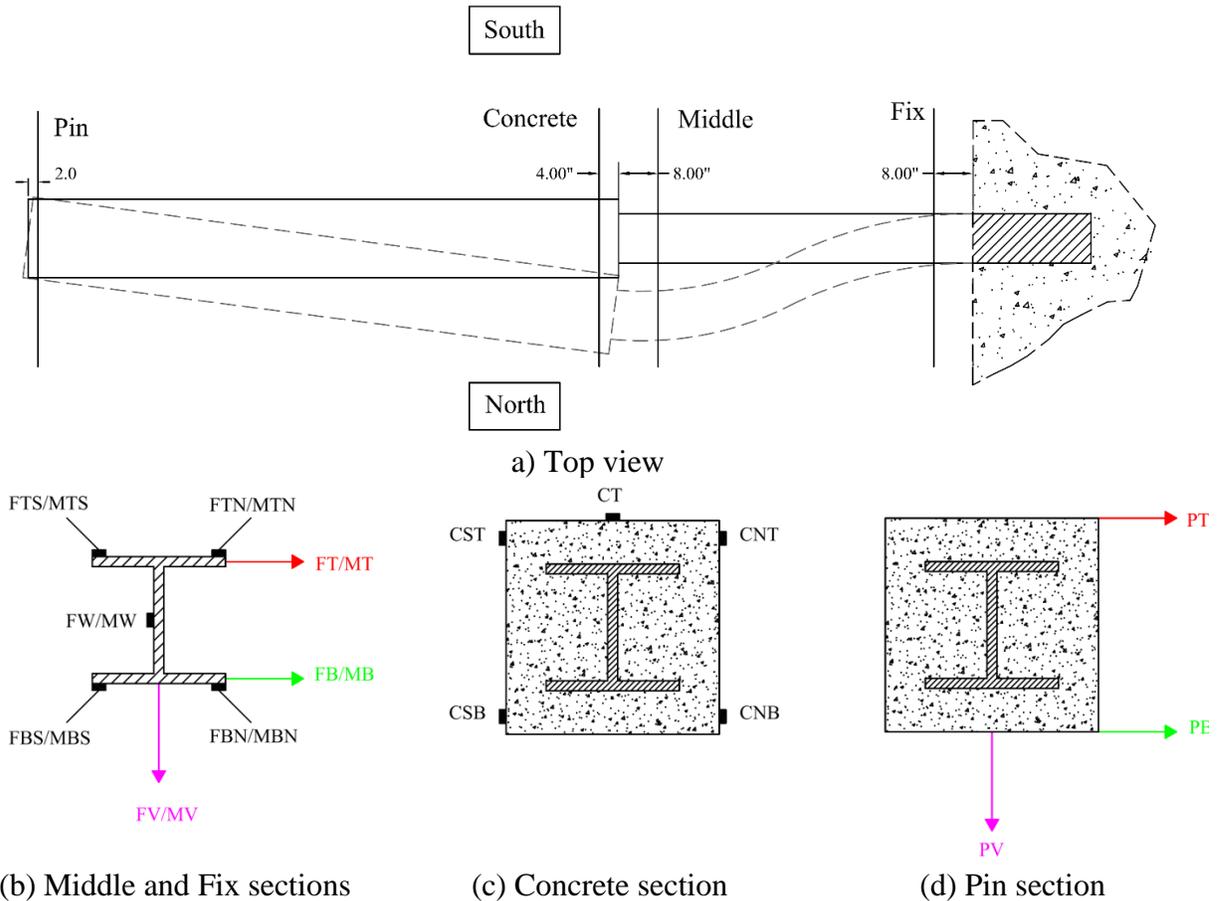
**Figure 11. Instrumentation on Specimen-2**

Specimen-2 was 16 ft long and had a 10 ft long concrete encasement. For this specimen, the data were recorded in four main instrumentation sections named pin (P), concrete (C), middle (M), and fix (F), as shown in Figure 11-a.

The P section was 2 in. from the pin end of the pile. The C section was 4 in. from the end of the concrete encasement, and the M section was 8 in. from the end of the concrete encasement. The F section was 8 in. from the concrete block at the fixed end of the pile.

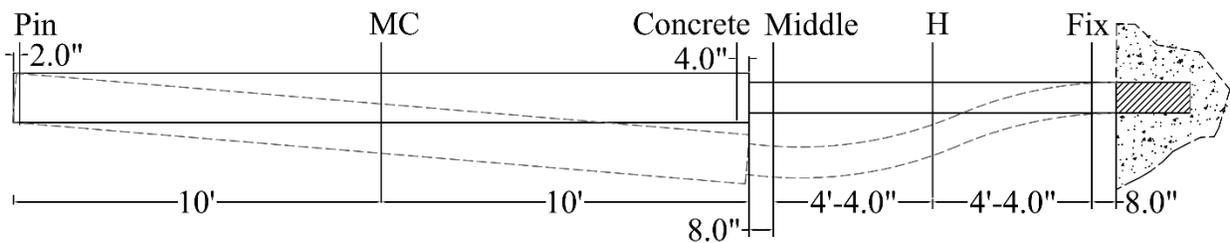
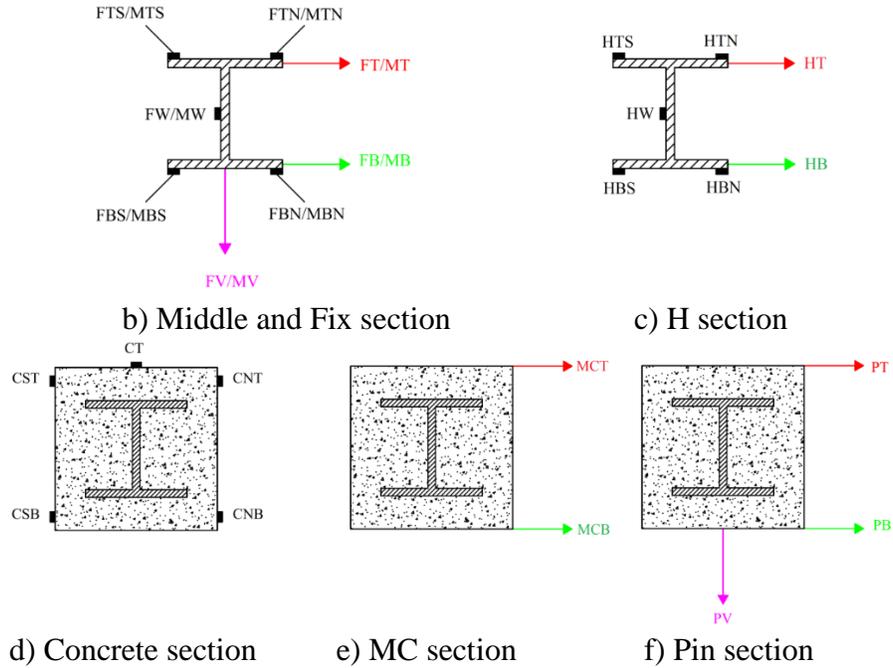
**Figure 12. Instrumentation on Specimen-3**

Specimen-3 was 30 ft long with a 20 ft long concrete encasement. The instrumentation plan for Specimen-3 is shown in Figure 12.

a) Top view

Similar to Specimen-2, data were recorded in sections P, C, M, and F. However, given that the pile and concrete encasement were longer than those for Specimen-2, two additional sections were evaluated along the pile: one in the middle of the concrete encasement, labeled MC in Figure 12-a, and the other in the middle of the steel section, labeled H.

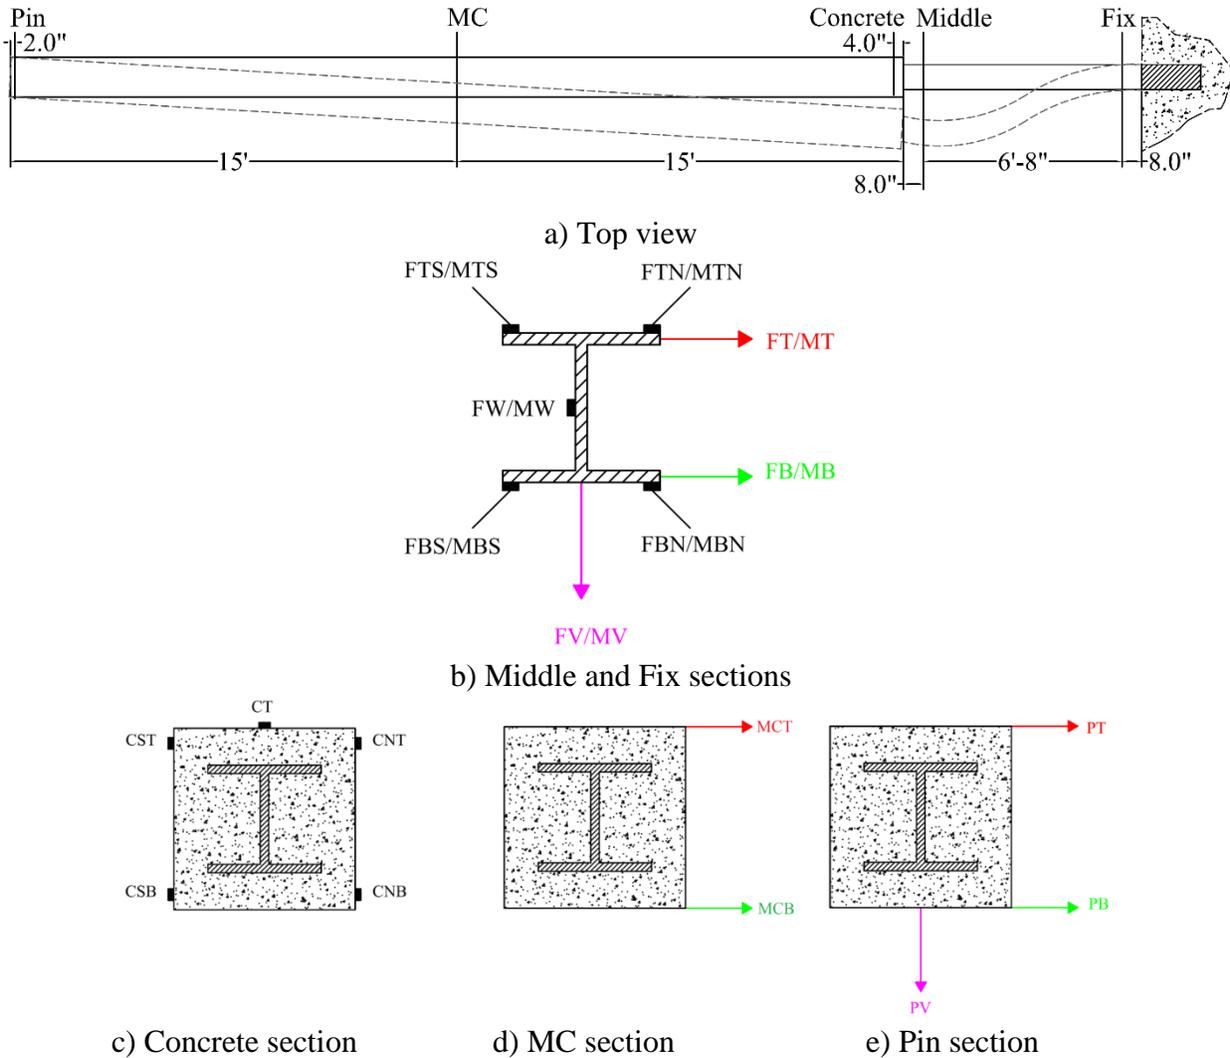
**Figure 13. Instrumentation on Specimen-4**

Specimen-4 was 38 ft long with a 30 ft long concrete encasement. The instrumentation plan for Specimen-4 is shown in Figure 13.

Similar to the other specimens, data were recorded in the P, C, M, and F sections (Figure 13-a). Also, in order to detect probable bending in the middle of the concrete encased section, similar to the Specimen-3, one additional section was evaluated in the middle of the concrete encasement, called MC. Strain gauges and displacement transducers were installed and labeled in the same way as with Specimen-3. Figure 13-b through -e show the details for each instrumentation section. Table 6 presents the detailed information for all of the measurements obtained from Specimen-4.

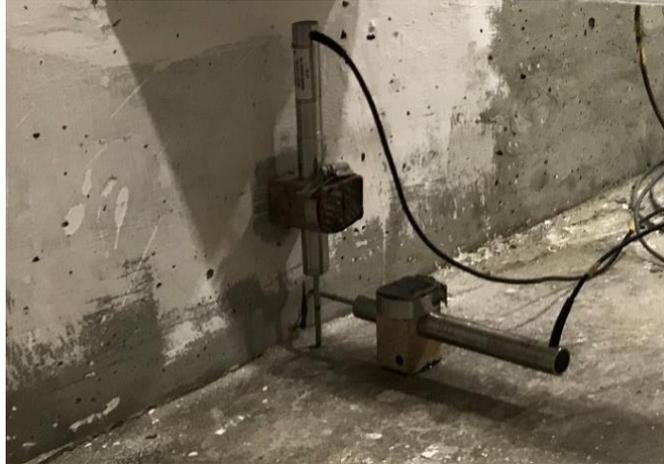
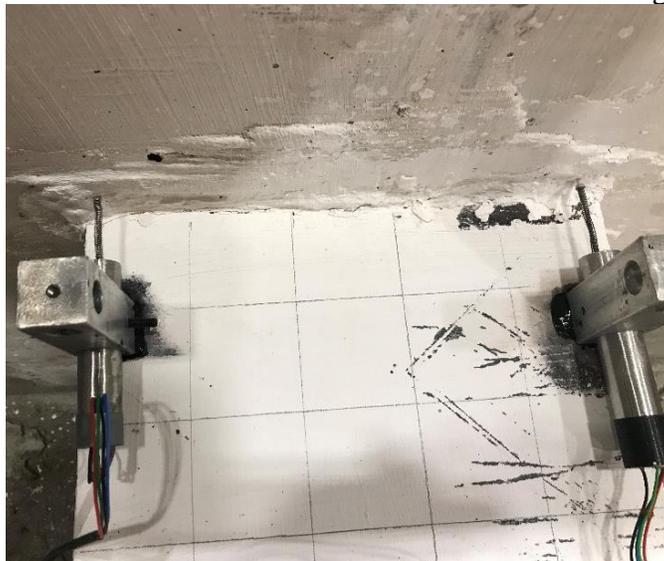
#### **Figure 14. Additional instrumentation**

One of the challenges in these tests was providing enough friction between the concrete blocks (B1, B2, and B3) and the ground to resist the horizontal load applied to the ends of the piles. To detect any movement of the blocks during testing, additional instrumentation was implemented. Two displacement transducers were mounted to each concrete block to measure any potential movement of the block in the horizontal or vertical direction, as shown Figure 14-a.

a) Transducers to check the movement of the blocks during the test

b) Transducers to check the fixity at the end of the piles

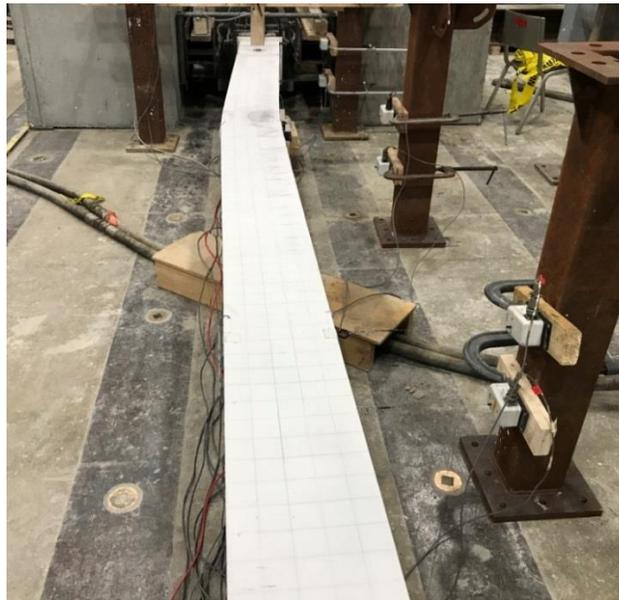
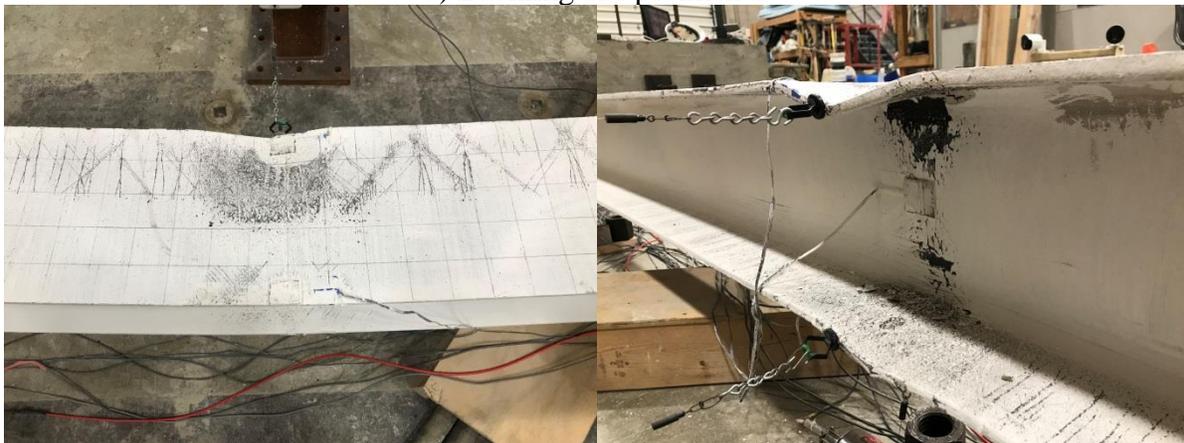
Specimen-1 was 16 ft long with no concrete encasement. Figure 15-a shows the deformed shape of the member after the global buckling occurred.

a) Buckling of Specimen-1

b) Local failure on flange (top)

c) Local failure on flange (side)

The pile reached its maximum axial capacity and experienced bending toward the north side along its weak axis. The maximum displacement occurred at the middle section (5 ft 7 in. from the pin end). Figure 15-b and -c show the deformation of the failure on both the top and bottom flanges at the M section. Before the load application, the specimen was painted white; the black color shown on the steel indicates significant strain occurring during the load application. Figure 16 shows the axial load-displacement curve.

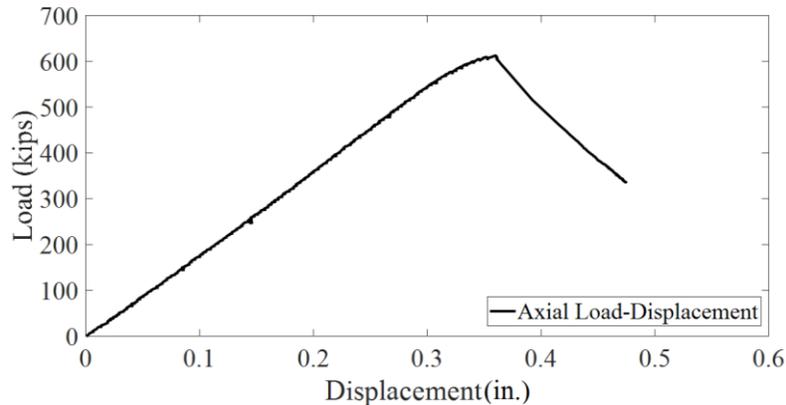
**Figure 16. Axial load-displacement of Specimen-1**

As the load increased, the axial displacement increased linearly until it reached 612.25 kips. At this point, the pile experienced an axial displacement of 0.4031 in. Beyond this point, the pile suddenly buckled, and the load-resisting capacity was lost. Assuming the yield strength of the pile steel is exactly 50 ksi, the yield strength of the full cross-section (with an area of 12.4 in.<sup>2</sup>) will be about 620 kips. This indicated that the Specimen-1 buckled right before the yielding of the full cross-section.

Unlike Specimen-1 (as shown in the previous Figure 16), the load displacement curve for Specimen-2 was not perfectly linear prior to the critical load. The slope of the axial load-displacement curve changed when loading reached about 350 kips. This is because cracking occurred in the concrete encasement and reduced the cross-sectional stiffness.

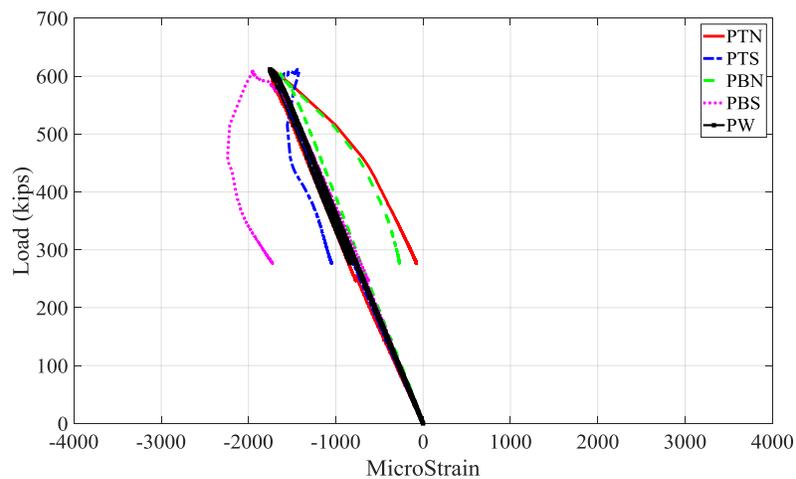
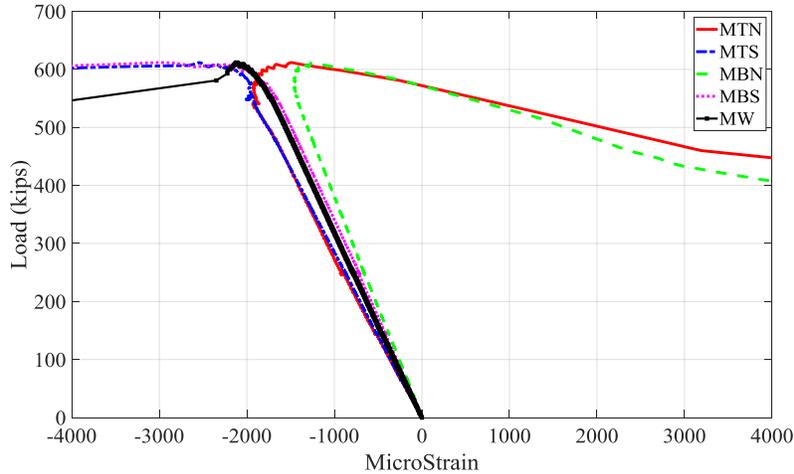
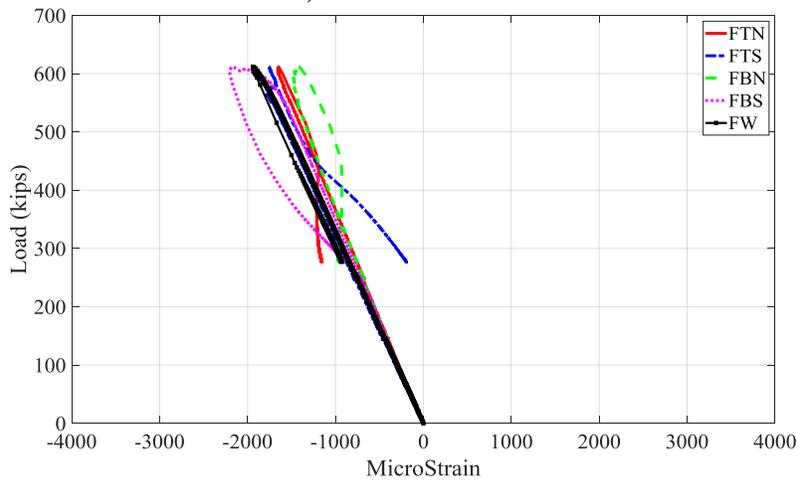
**Figure 17. Strain data from Specimen-1**

Figure 17-a shows the strain results collected from Section P (2 ft from the pinned end).

According to this diagram, the strain values increase linearly while the axial load increased. Except for PBS, other strain values in this section remained less than the yielding strain of about 0.0021 (2,100 microstrain), and the specimen remained in the elastic region. Since the deflection of the pile was toward the north side, this made the flanges on the north side experience tensile strain and the flanges on the south side experience compressive strain. After buckling, the compressive strain values in PTN and PBN decreased, while the strain in PTS and PBS increased and experienced more compressive strain. Based on Figure 17-a, the strain in the web (PW) decreased linearly after buckling occurred.

Figure 17-c shows the strain in section F (11 ft 2 in. from the pinned end). The strain values increased linearly while the axial load increased. Similar to the pin section, except for FBS, other strain values in this section remained less than the yielding strain of about 0.0021 (2,100 microstrain), and the specimen remained in elastic region.

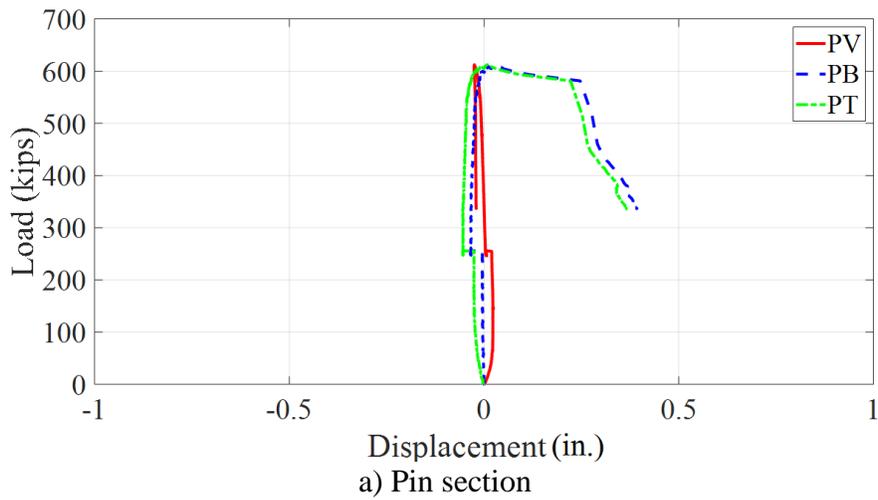
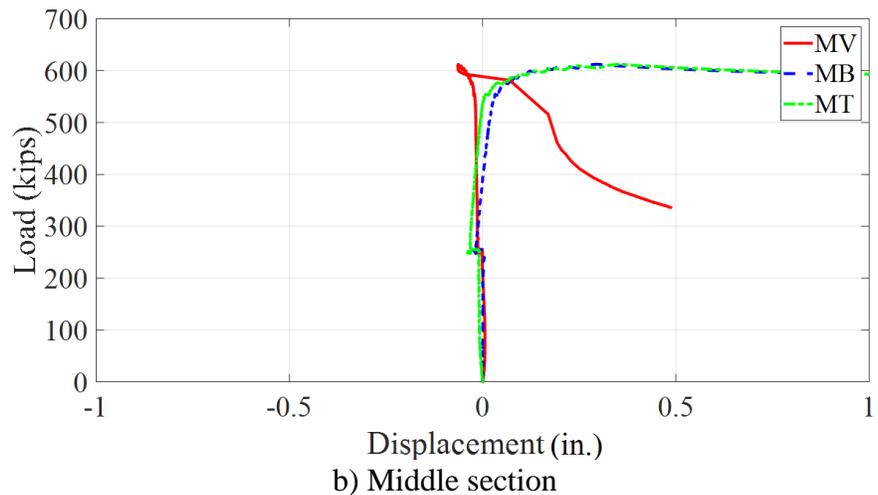
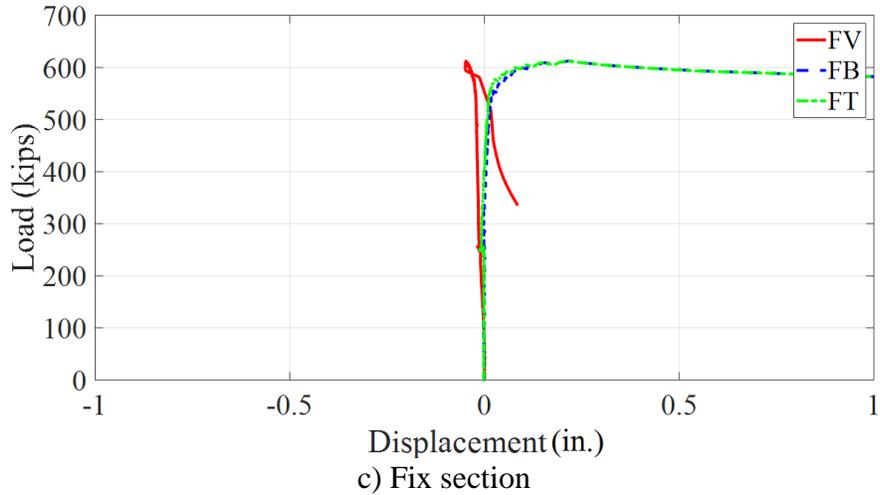
**Figure 18. Displacement data from Specimen-1**

Figure 18 shows the axial load versus transverse and vertical displacement of the pile in sections P, M, and F.

As the load increased, there was almost no significant transverse or vertical displacement prior to the buckling point. When the load approached the maximum, the transverse displacement gradually increased, and when the load reached its maximum value, buckling occurred and transverse displacement rapidly increased. Given that the transverse displacement on the top and bottom flanges (MT and MB) were similar, the pile did not experience significant torsion.

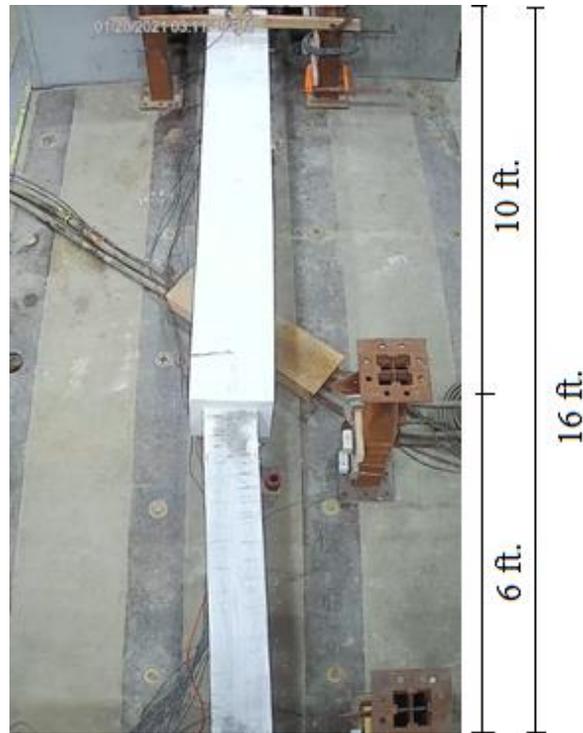
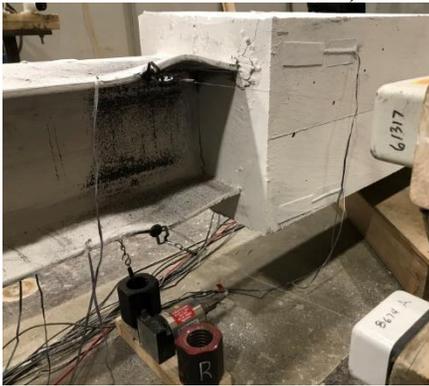
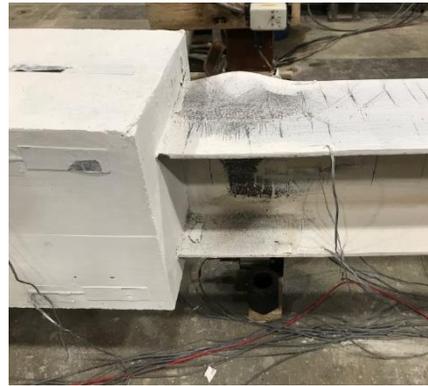
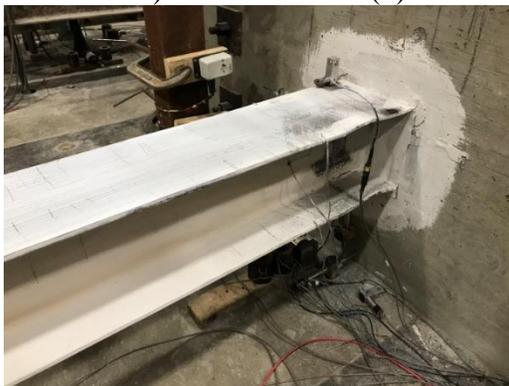
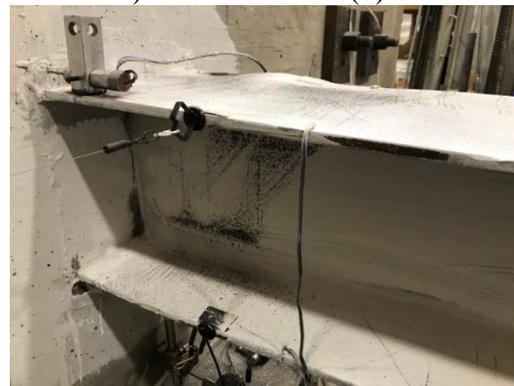
**Figure 19. Deformed shape of Specimen-2**

Specimen-2 was 16 ft long with a 10 ft long concrete encasement. Figure 19-a shows the deformed shape of this specimen after global buckling occurred.

a) Buckling of Specimen-2

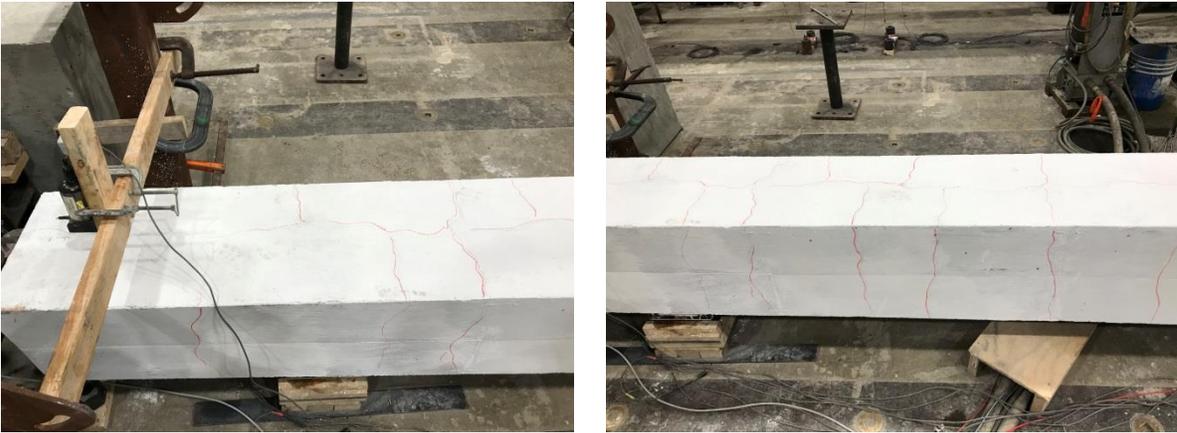
**Figure 20. Crack pattern in the concrete encasement of Specimen-2**

Buckling also caused longitudinal and transverse cracks in the encasement. As shown in Figure 20, longitudinal cracking occurred along the pile, and transverse cracks occurred on all sides of the concrete encasement perpendicular to the pile axis.

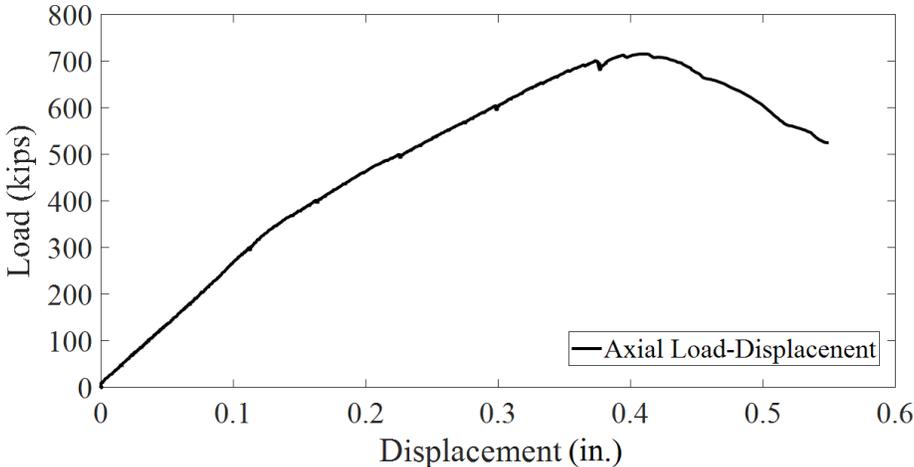
**Figure 21. Axial load-displacement of Specimen-2**

Figure 21 shows the axial load-displacement curve for Specimen-2.

As the load increased, the axial displacement increased until it reached the critical load of 715 kips, which is about 103 kips higher than Specimen-1. At this point, the pile experienced 0.4087 in. axial displacement, which is similar to the axial displacement at buckling for Specimen-1

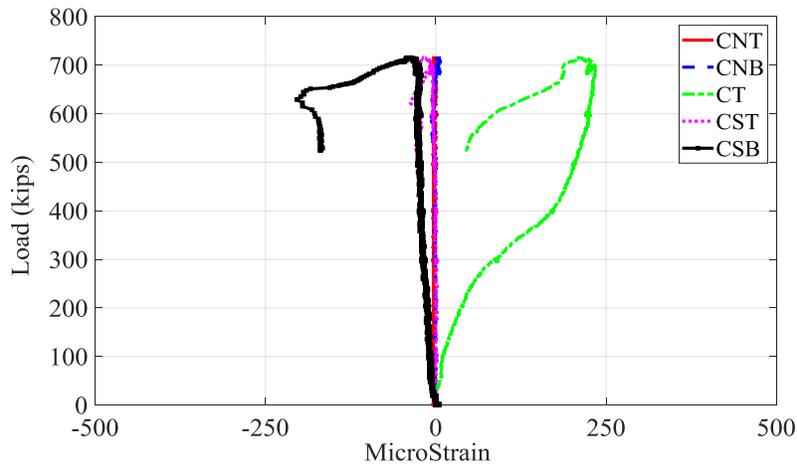
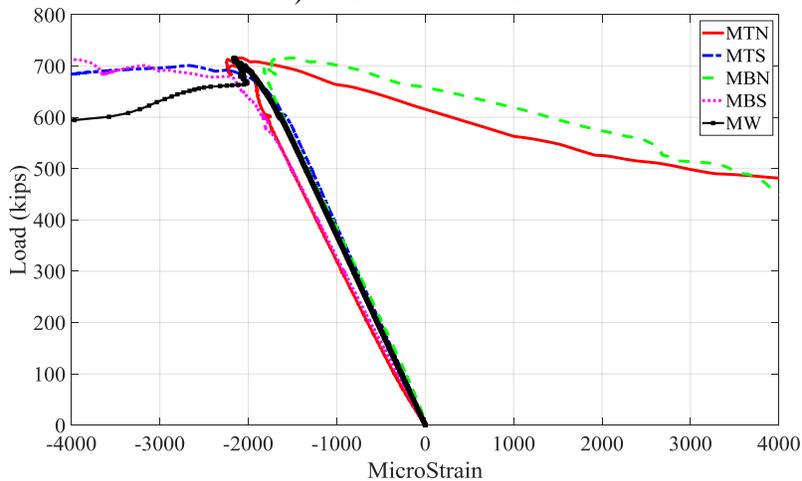
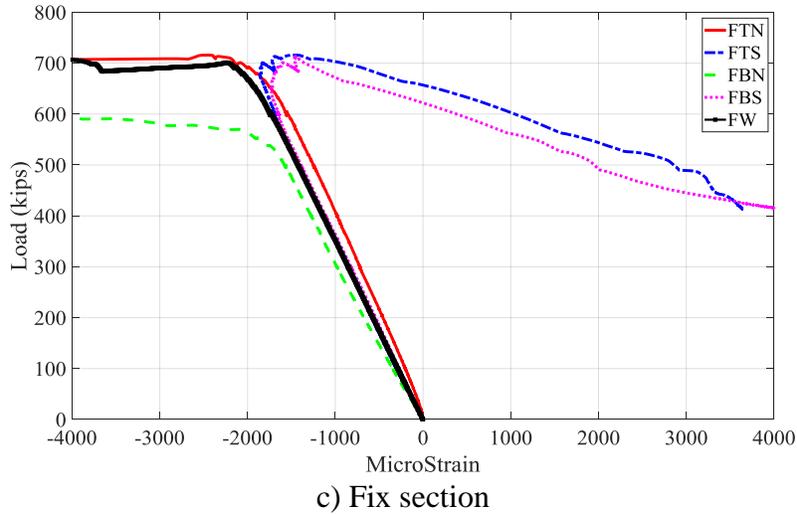
**Figure 22. Strain data from Specimen-2**

Figure 22-a shows the strain data collected from the concrete section (4 in. from the end of the concrete encasement).

The results indicated that, except for CT, the strain values increased linearly with the axial load. The results also indicated that a tensile crack occurred near the CT strain gauge when the load reached 320 kips. The other strain gauges recorded compressive strain values in this section, and their values remained less than the ultimate compression strain of the concrete, which is considered as 0.003 based on ACI-318 code.

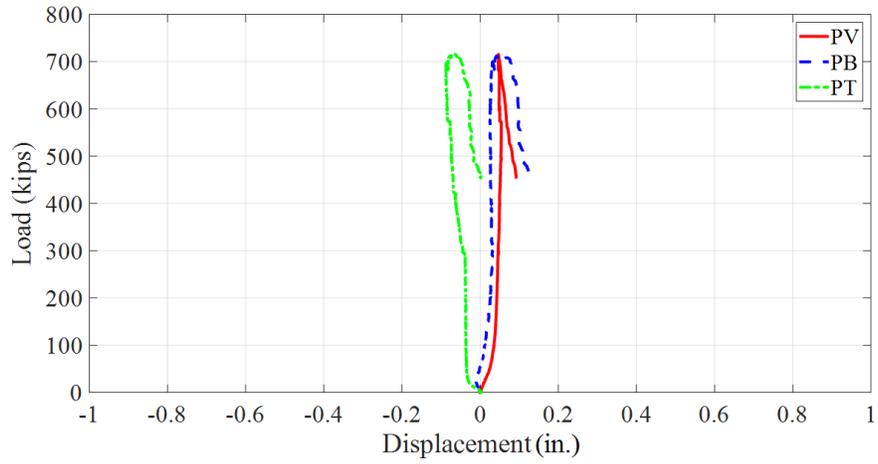
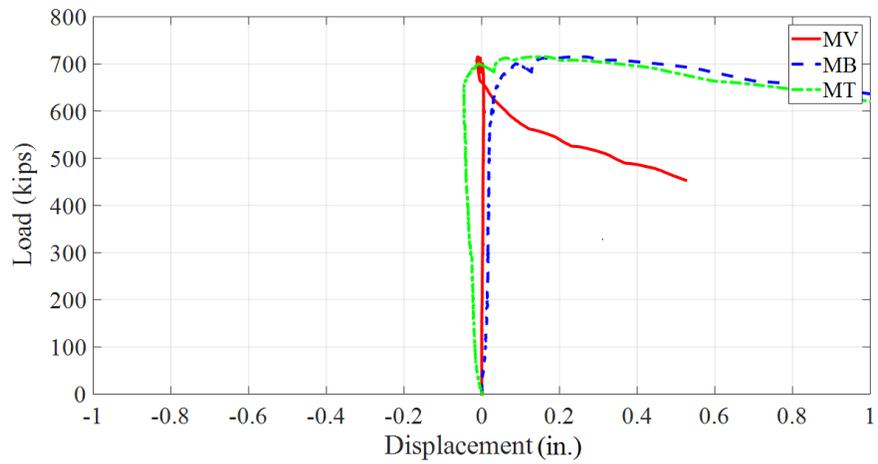
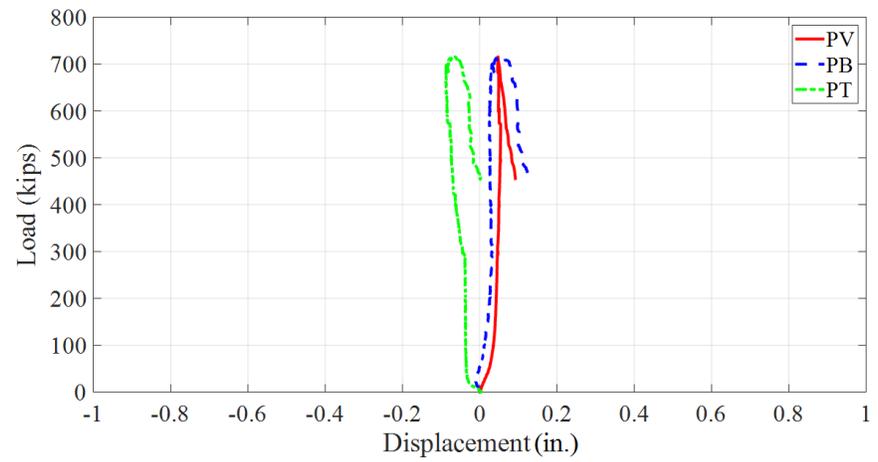
**Figure 23. Displacement data from Specimen-2**

Figure 23 shows the axial load versus transverse and vertical displacement of the pile in sections P, M, and F.
