# Experimental Validation of a Rapid Assessment Tool for Pile Capacity and Stability in Response to Scour Situations

**Final Report**  
**October 2021**

**Sponsored by**  
Iowa Department of Transportation  
(InTrans Project 19-692)

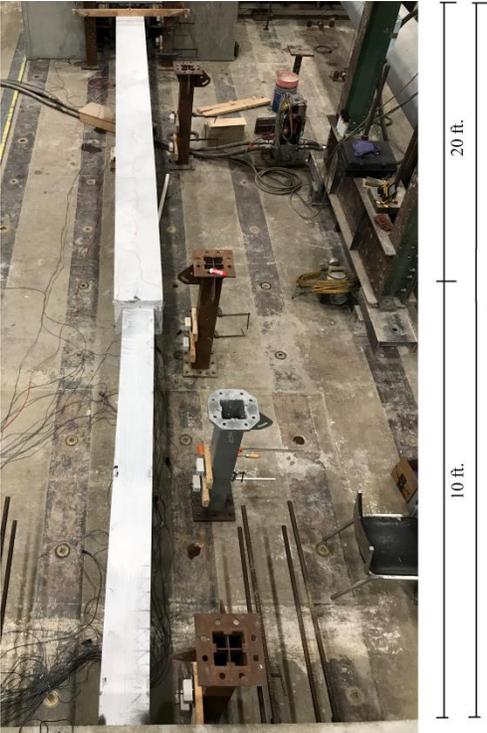
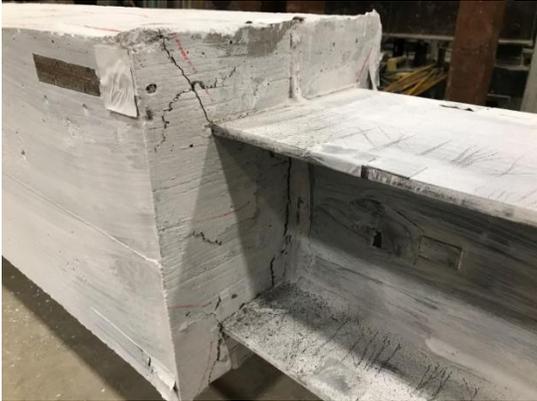
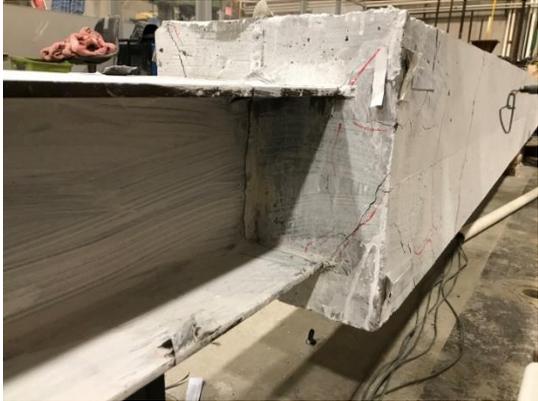
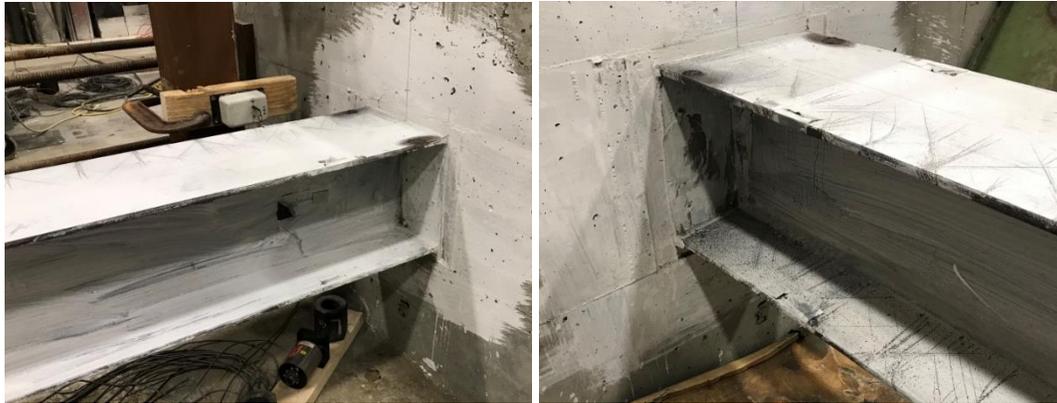
Specimen-3 was 30 ft long with a 20 ft long concrete encasement. Figure 24-a shows the deformed shape of this specimen after buckling occurred.

a) Buckling of Specimen-3

The maximum displacement occurred at the middle section, which was 20 ft 8in. from the pinned end of the pile. Similar to Specimen-2, longitudinal and transverse cracking were observed during the application of the load. Figure 24-b through -e show the deformed shape in sections M and F. As shown in Figure 24-b and -c, concrete crushing was observed at the end of the encasement near section M. Figure 24-d and -e show the condition of the pile at the fixed end. Based on this figure, no significant local buckling occurred at this location.

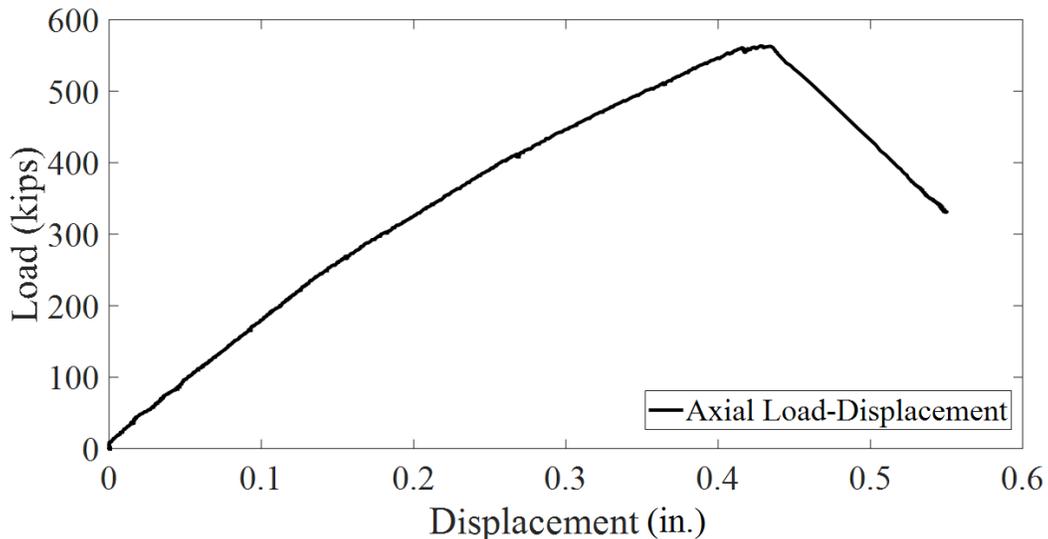
**Figure 25. Axial load-displacement of Specimen-3**

Figure 25 shows the axial load-displacement curve for Specimen-3. In this chart, by increasing the axial load, the axial displacement increased linearly until it reached the maximum load of 563 kips (620 kips for full cross-section yielding).

At this point, the pile experienced 0.4283 in. axial displacement. Similar to Specimen-2, the load displacement curve was not perfectly linear, again due to the cracking that occurred in the concrete encasement and the accompanying stiffness reduction.

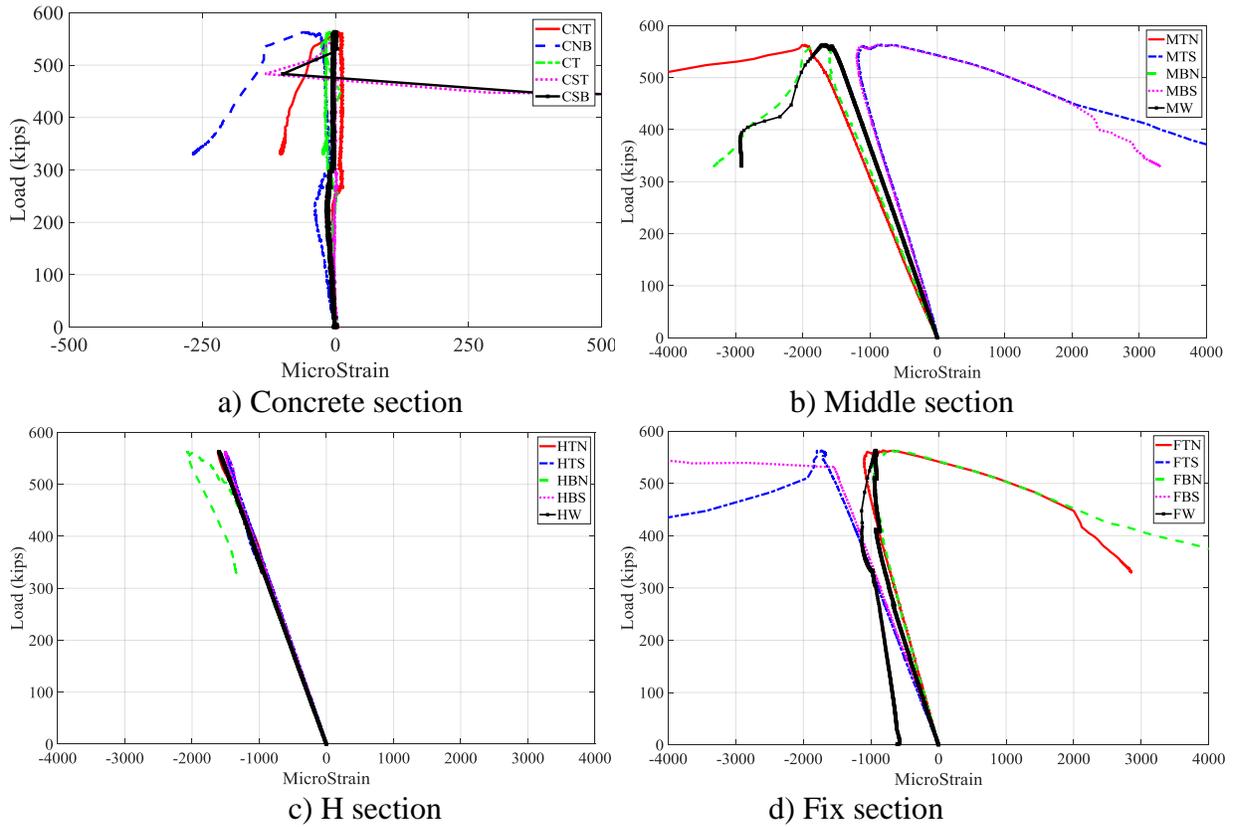
**Figure 26. Strain data from Specimen-3**

Figure 26 and Figure 27 show the strain and displacement data, respectively, for Specimen-3.

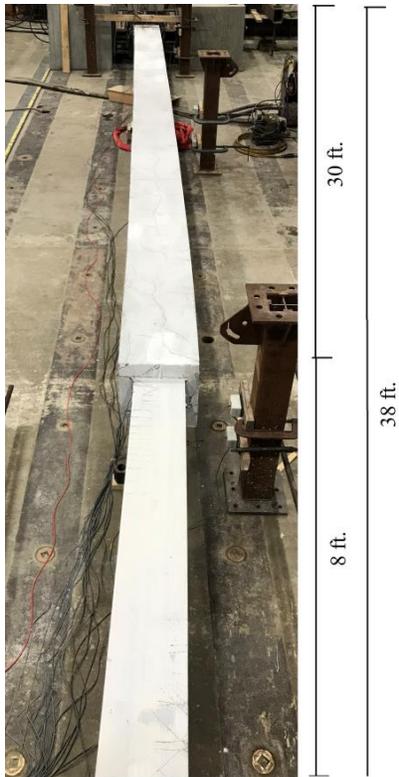
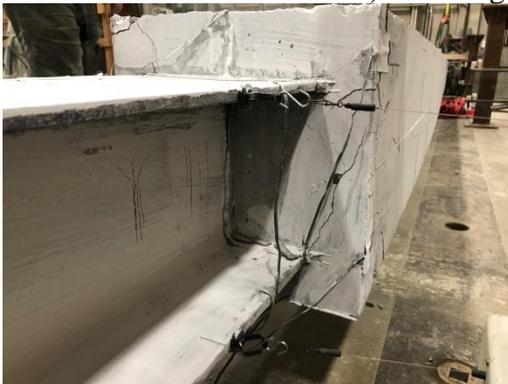
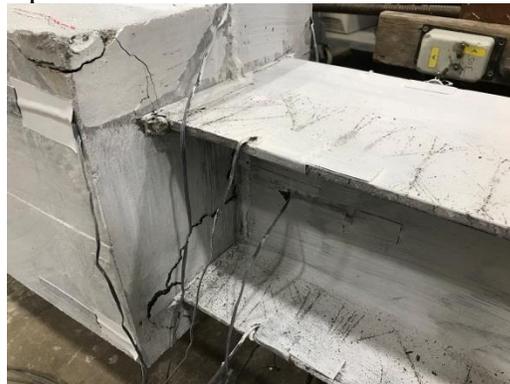
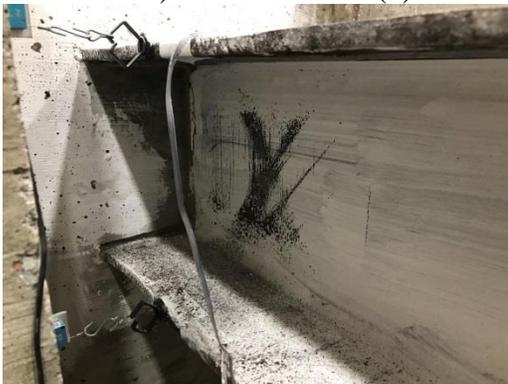
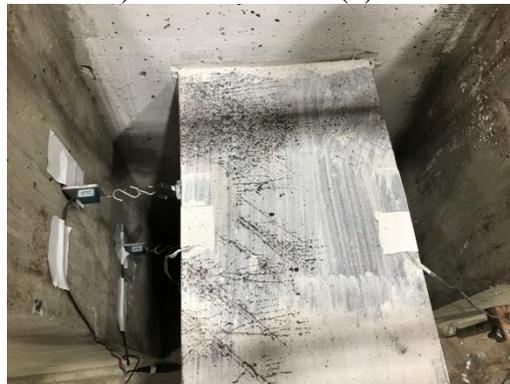
**Figure 28. Deformed shape of Specimen-4**

Specimen-4 was 38 ft long with a 30 ft long concrete encasement. Figure 28 shows the deformed shape of this specimen after buckling occurred.

When the pile reached its maximum axial capacity, similar to the other specimens with encasements, it experienced bending toward the south side along its weak axis. The maximum displacement occurred at the middle section (30 ft 8 in. from the pinned end). Figure 28-b through -e show the deformation of the pile in the middle and fix sections. Similar to Specimen-2 and Specimen-3, longitudinal and transverse cracking were observed during the application of the load. In addition, concrete crushing occurred at the end of the encasement near the concrete section. On both sections M and F, the steel pile experienced significant strain.

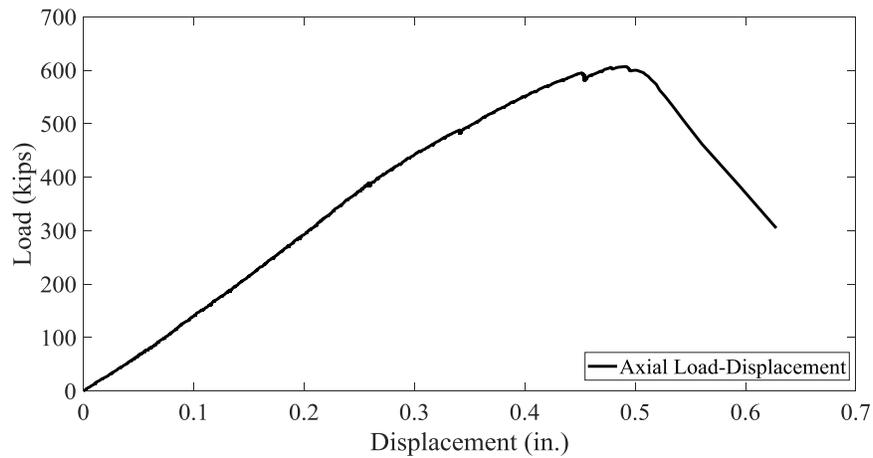
**Figure 29. Axial load-displacement of Specimen-4**

Figure 29 shows the axial load-displacement curve for Specimen-4.

As the load increased, the axial displacement increased until it reached the maximum load of 606 kips (620 kips for full cross-section yielding). At this point, the pile experienced 0.4913 in. axial displacement. Similar to Specimen-2 and Specimen-3, the load displacement curve was not perfectly linear, again due to the cracking that occurred in the concrete encasement.

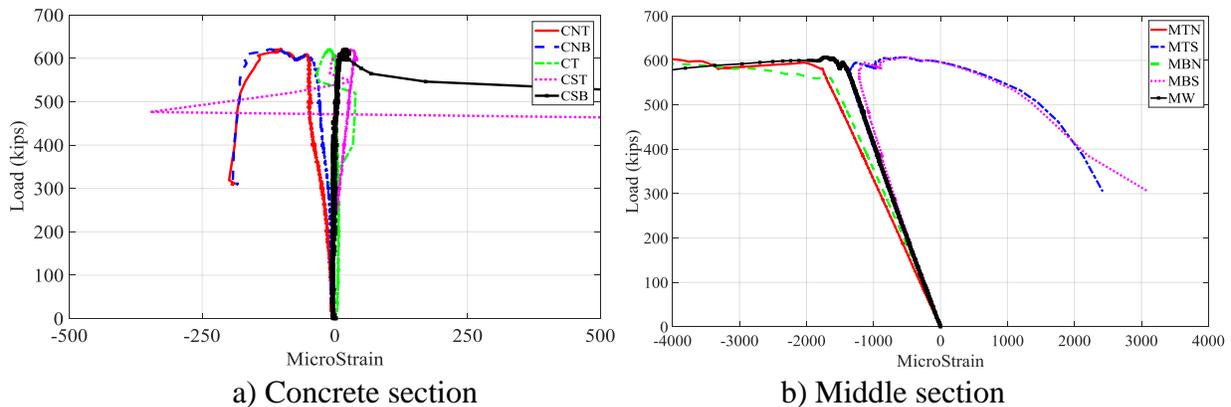
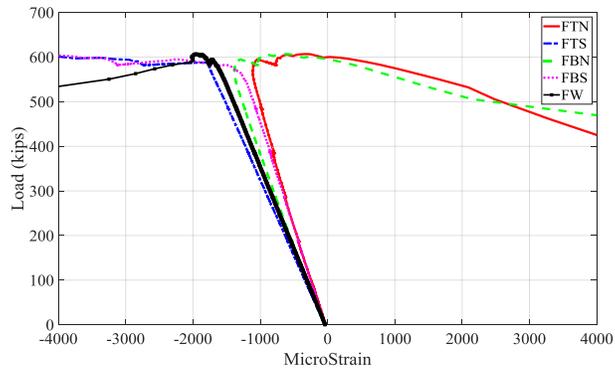
**Figure 30. Strain data from Specimen-4**

Figure 30 and Figure 31 show the strain and displacement data, respectively, for Specimen-4.

The data showed similar findings to those for Specimen-3. The strain results indicated that plasticity occurred in both sections M and F after the load reached its maximum.

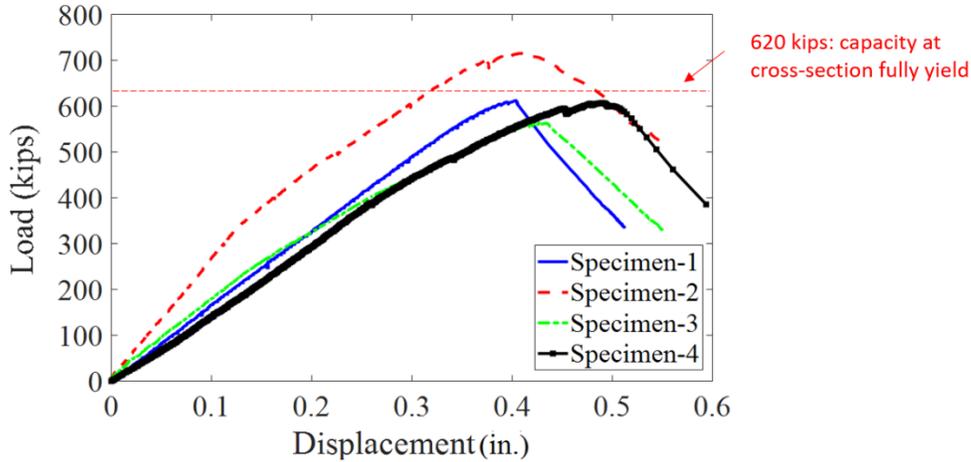
**Figure 32. Comparison of load-displacement from all specimens**

Figure 32 compares the axial load-displacements of the four specimens.

Comparing the results from Specimen-1 and Specimen-2, the chart shows that the concrete encasement increased the initial stiffness and maximum axial capacity of the pile. For Specimen-1 with no concrete encasement, the load-displacement was completely linear until it reached the critical buckling load. In the other three specimens, with encasements, the displacement curves were not perfectly linear. As mentioned previously, this was because cracking occurred in the concrete encasement and reduced the cross-sectional stiffness.
