An Integral Abutment Bridge with Precast Concrete Piles

Final Report
May 2007

Sponsored by
the Iowa Highway Research Board
(IHRB Project TR-438)
and
the Iowa Department of Transportation
(CTRE Project 99-48)

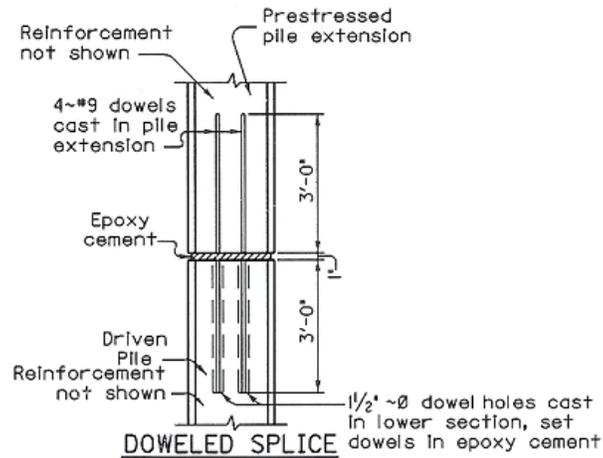
Figure 2.2. Pile splice detail (courtesy of Kentucky DOT)

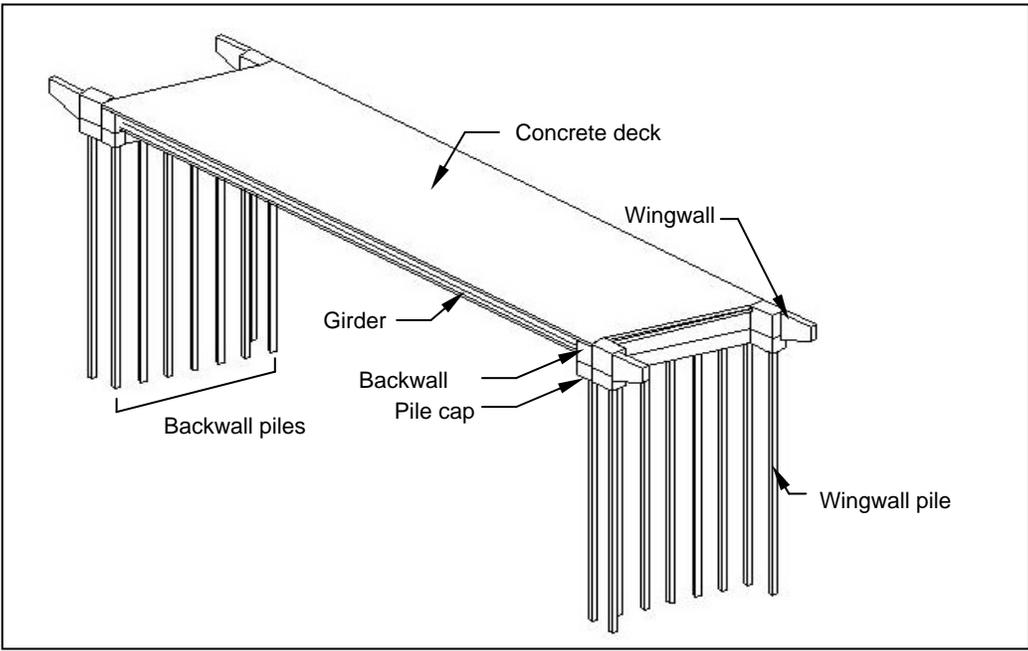
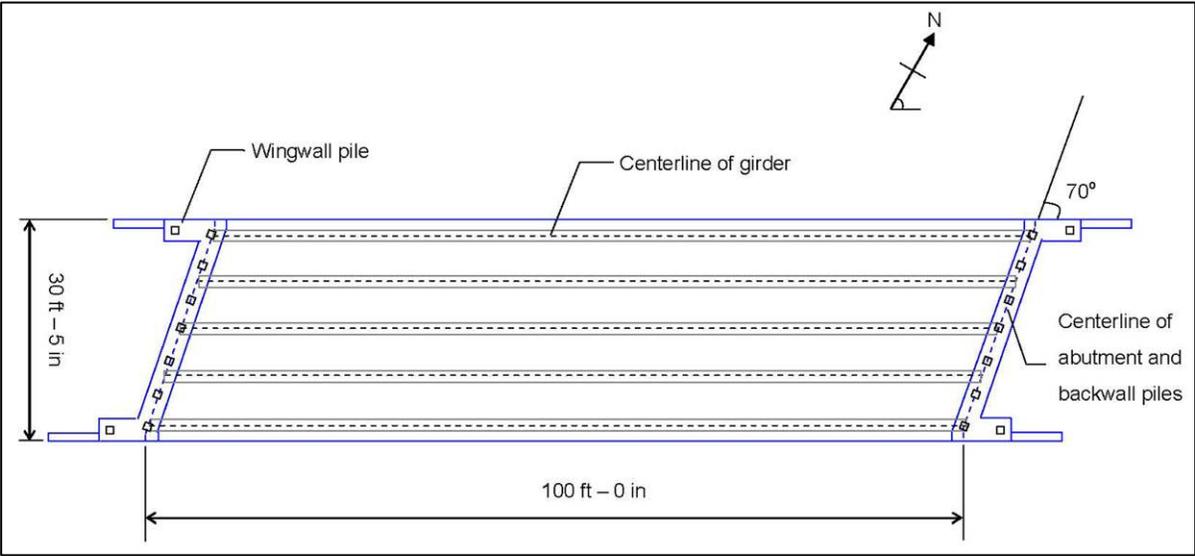
(a) Isometric view

(b) Plan view

Figure 3.1. Isometric and plan views of the Tama County Bridge

The Tama County Bridge, which had a December 1, 1998, letting date, replaced an existing bridge on the farm-to-market system. Design drawings for this bridge do not specify the use of prebored holes for the abutment piles. When HP-shaped steel piles support the abutments for an integral abutment bridge, the Iowa DOT specifies the use of prebored holes at each abutment pile. After the steel piles are driven, these holes are filled with a non-stiff material, such as bentonite, which provides flexibility for the abutment piles along the upper portion of their lengths when the bridge superstructure experiences thermal expansion and contraction. For the Tama County Bridge, Sheet No. 6 of 15 states that the top 3 ft. of the pile lengths were to be wrapped with a double thickness of rug padding that was to be attached to the piles using galvanized roofing nails and #14 gage galvanized wire that was wrapped at a 4 in. pitch around the piles. This rug padding was to be either a hair and jute padding rubberized on both sides and weighing not less than 47 oz./yd.² or a bonded urethane or bonded poly-foam padding with a density of at least 5 lb./ft.³ and a thickness of at least 1/2 in. This padding was used to minimize bending moment continuity between the PC piles and the RC abutment. After the padding was attached to the abutment piles, the top two ft. of the piles were encased by the abutment concrete.

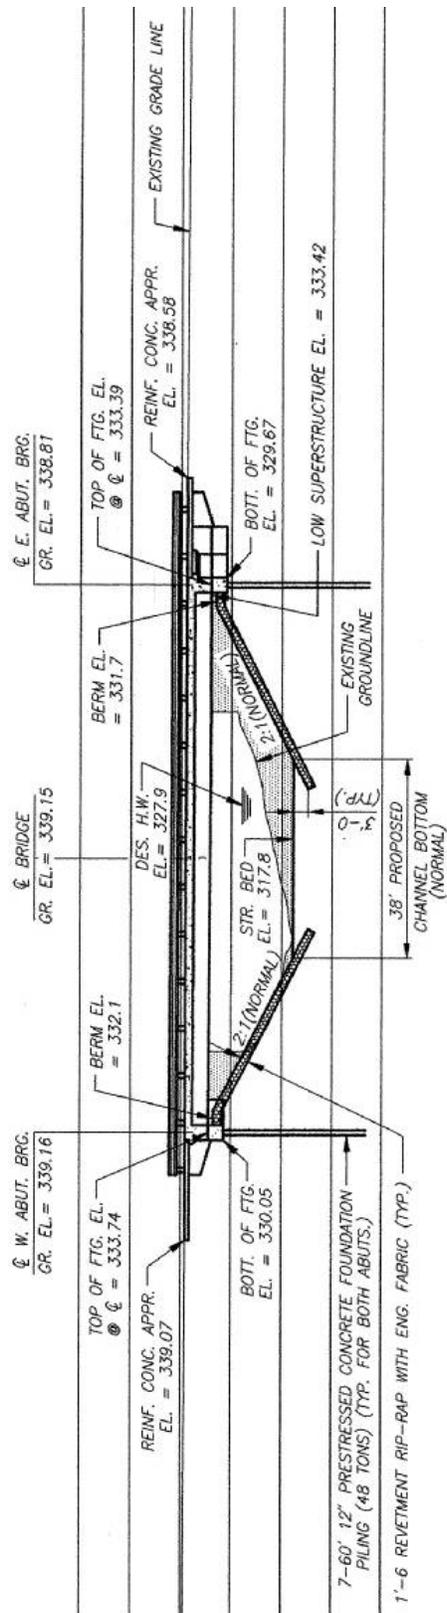
(a) Longitudinal section along roadway

Figure 3.2. Design drawing for the Tama County Bridge (courtesy of Iowa DOT)

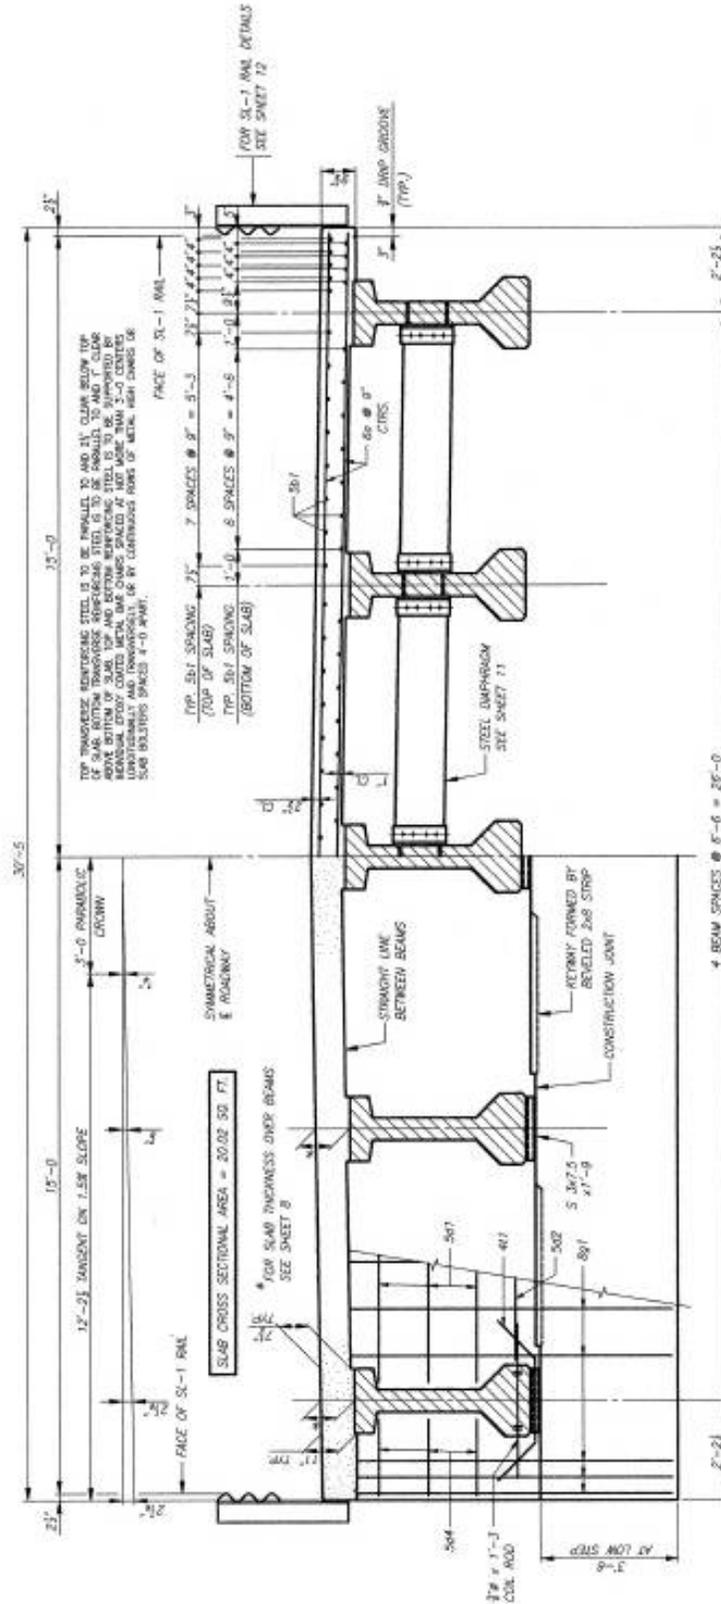
(b) Transverse cross sections

Figure 3.2. Design drawing for the Tama County Bridge (courtesy of Iowa DOT)

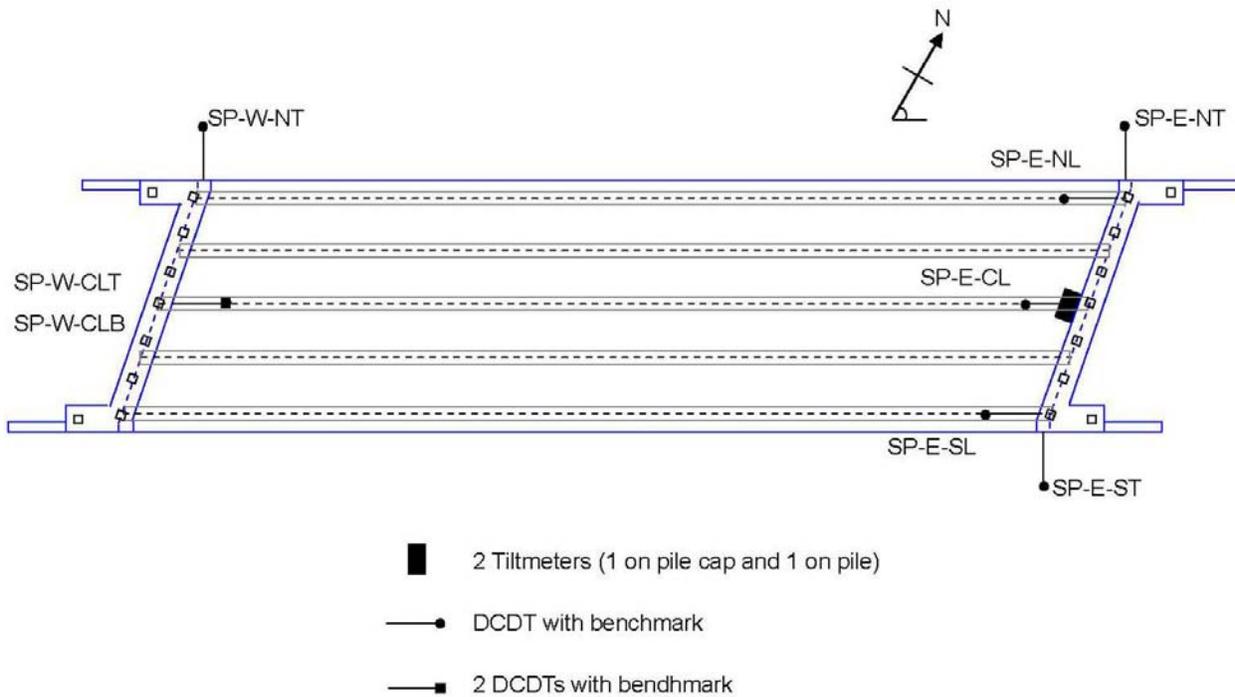
Figure 3.3. Location of transducers on the Tama County Bridge

Instrument code	Location	Measurement
SP-E-NL	East abutment at north end	Longitudinal movement of pile cap
SP-E-CL	East abutment at center of width	Longitudinal movement of pile cap
SP-E-SL	East abutment at south end	Longitudinal movement of pile cap
SP-E-NT	East abutment at north edge	Transverse movement of pile cap
SP-E-ST	East abutment at south edge	Transverse movement of pile cap
SP-W-CLT	West abutment at center of width	Longitudinal movement at top of pile cap
SP-W-CLB	West abutment at center of width	Longitudinal movement at bottom of pile cap
SP-W-NT	West abutment at the north edge	Transverse movement of pile cap

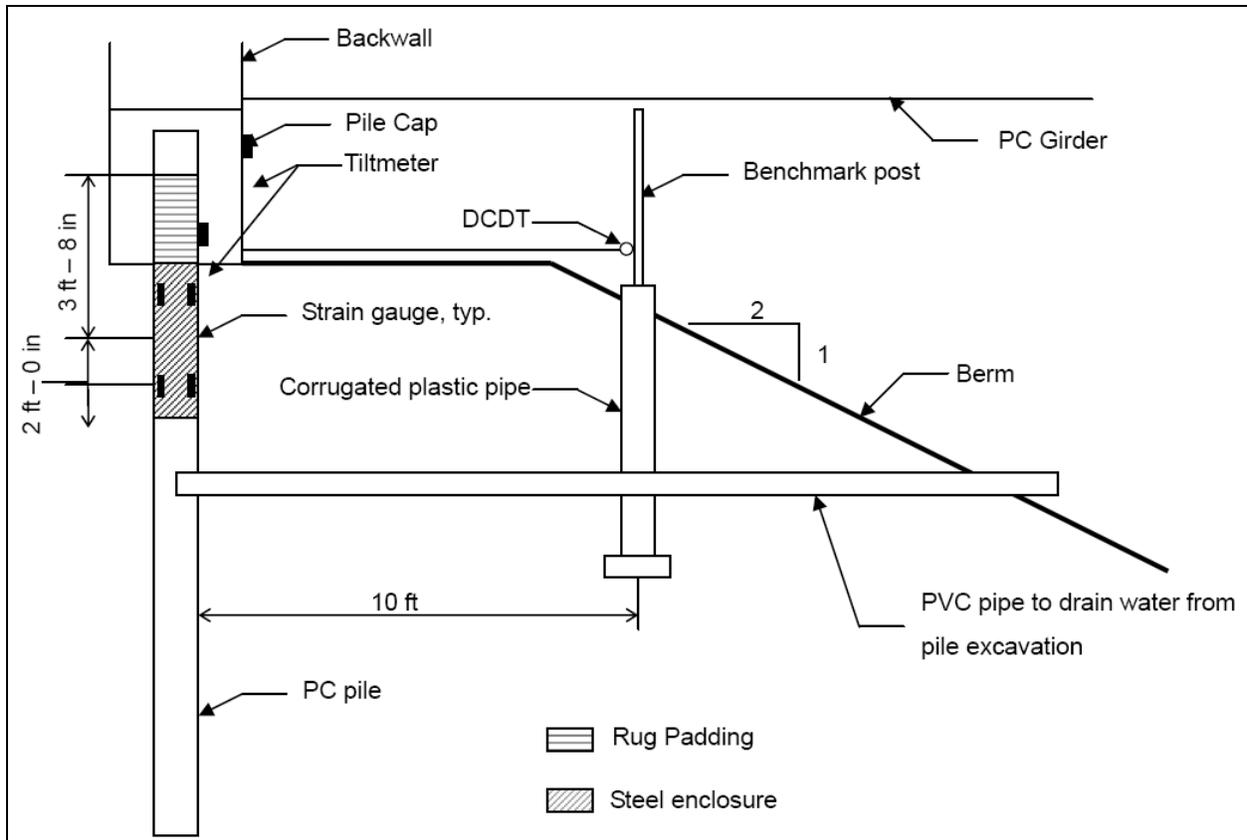
Figure 3.4. Instrumentation at mid-width of east abutment for the Tama County Bridge

All displacement transducers were mounted on benchmark posts installed approximately 10 ft. from the face of a bridge abutment, as shown in Figure 3.4. Each post-mounted transducer was firmly bolted to a benchmark post, and its sensor cable was attached to the monitored abutment utilizing a steel wire with a known coefficient of thermal expansion and contraction. The thermally induced expansion and contraction of the bridge superstructure produced movements of the abutments that were measured relative to a benchmark post.

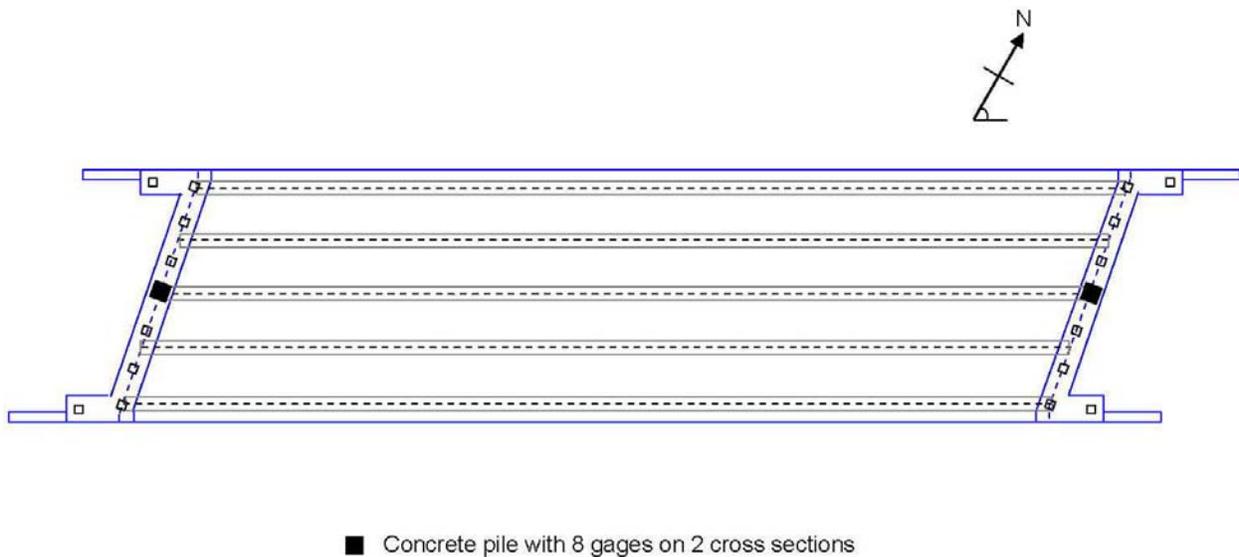
Figure 3.5. Vibrating wire strain gage locations for the Tama County Bridge

As shown in Figure 3.5, the strain in the center pile was monitored at each abutment. Each of these piles was instrumented with eight vibrating wire strain gages that were mounted to the exterior surface of the pile on the bridge. Table 3.4 lists the instrumentation code, member, and location for each of the vibrating strain gages. As shown in Figure 3.6, an array of four strain gages was installed to measure the longitudinal strains at a cross section for a pile. Each of the monitored piles was instrumented at two cross sections. The upper and the lower cross sections were located at 8 in. and at 32 in., respectively, below the bottom of the pile cap. If four longitudinal strains at a specific cross section for a pile are known, the x-axis bending, y-axis bending, axial, and torsional warpage strains can be calculated for that monitored cross section. Strain gages were used at two pile cross sections in an attempt to determine strain gradients along the pile length.

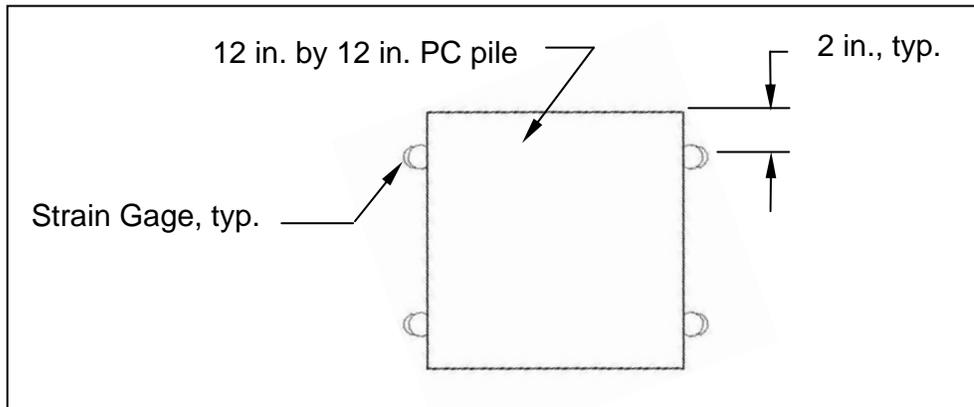
Figure 3.6. PC pile with vibrating wire strain gages

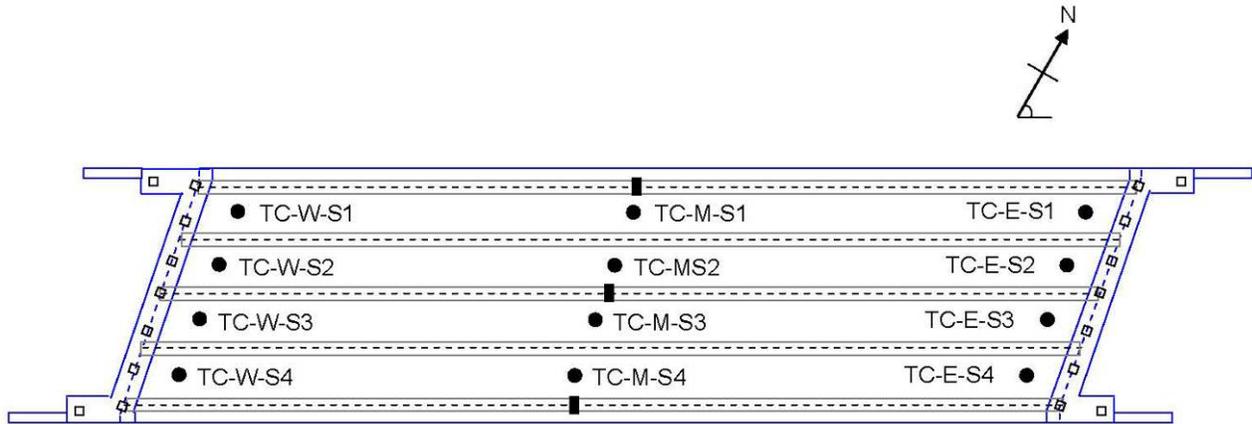
● 1 Thermocouple (within the slab midway between girders)

■ 3 Thermocouples (within girder at midspan)

Figure 3.7. Thermocouples locations for the bridge superstructure

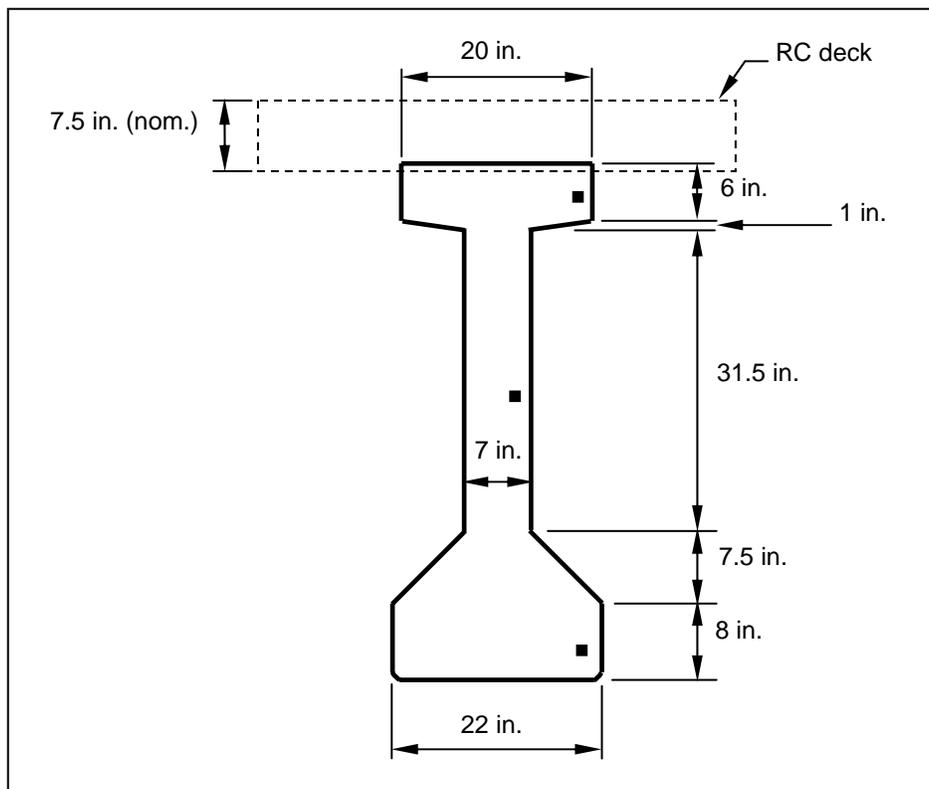
Figure 3.8. Thermocouples locations within a PC girder

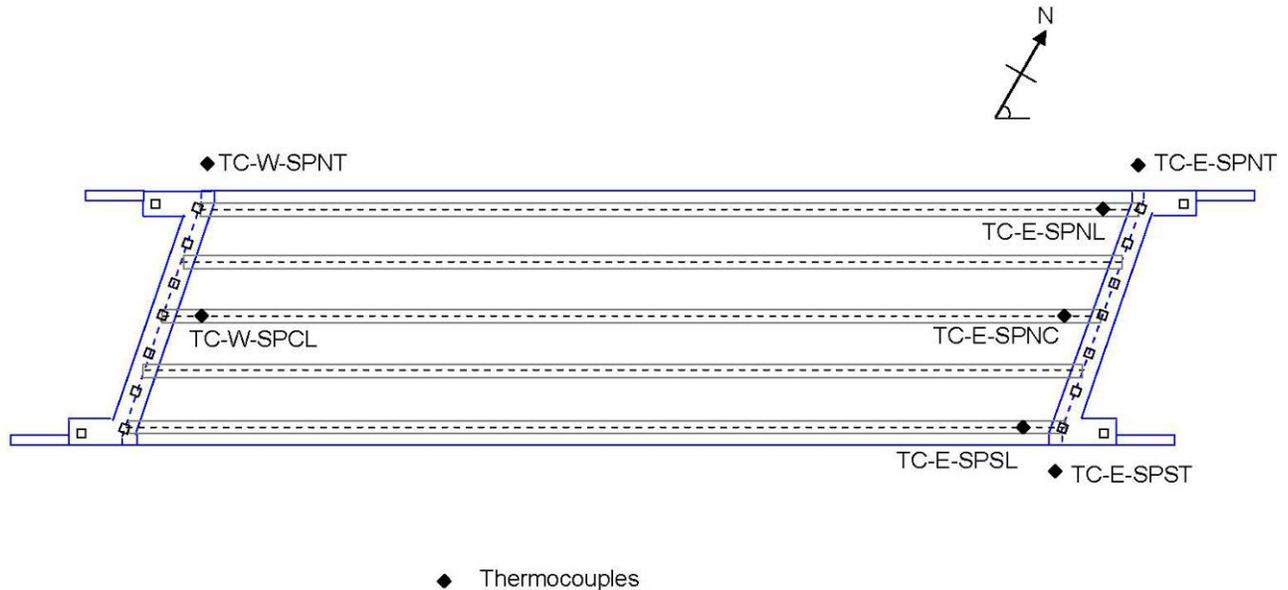
Figure 3.9. Thermocouples locations inside wooden boxes to monitor the steel wire of the displacement transducers

To monitor the air temperatures adjacent to and at the mid-length of the displacement transducers' steel extension wires, 8 of the 28 thermocouples (gages TC-E-SPNL, TC-E-SPCL, TC-E-SPSL, TC-E-SPNT, TC-E-SPST, TC-W-SPCLT, TC-W-SPCLB, and TC-W-SPNT), whose locations are shown in Figure 3.9, were installed within the wooden boxes that enclosed the displacement transducers. The temperature changes for these extension wires were used to correct the abutment displacements for temperature effects, as described in Section 3.6.

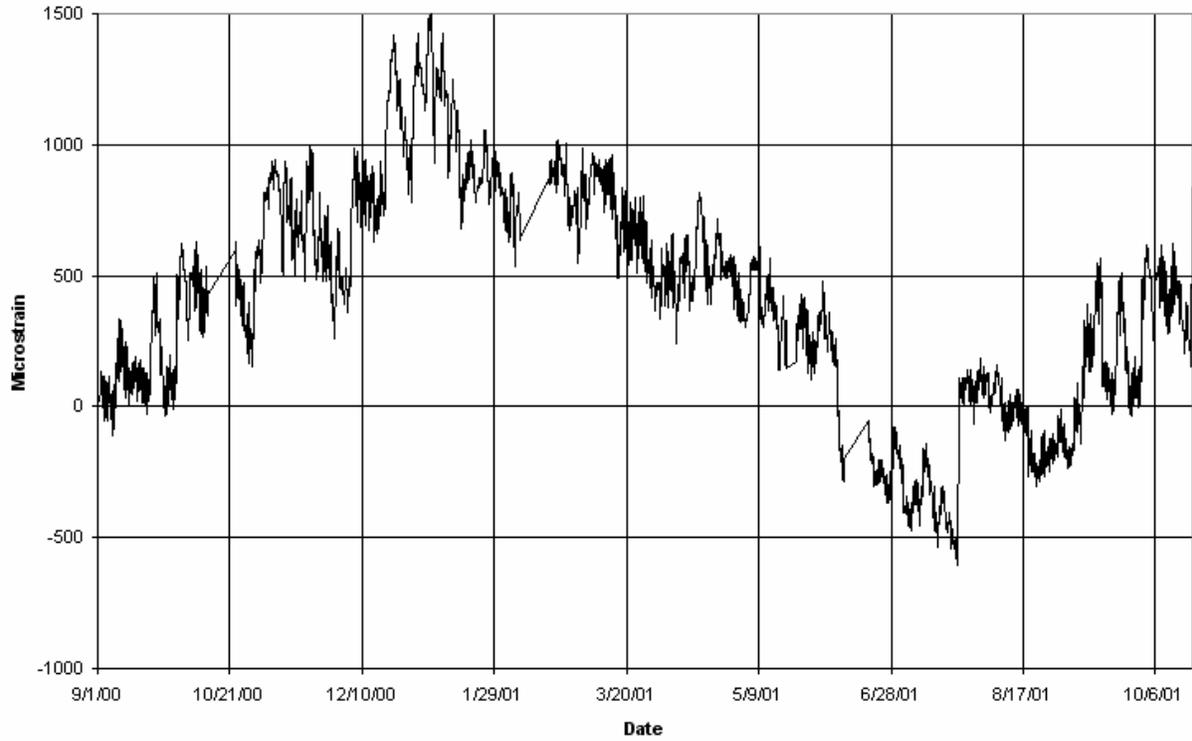
Figure 4.1. Pile strain record for gage VW-E-NWT

Problems that were encountered with a significant number of the strain gages for the piles included abrupt changes in the strain magnitudes and gradual changes in strain magnitude over time that were not attributed to any behavioral response from the bridge. The ISU researchers were unable to determine the cause of the compromised or corrupted strain measurements. An example of one of the reliable strain data records was for gage VW-E-NWT, which is shown in Figure 4.1. For this gage, the measured strain data exhibits nearly a continuous trace from September 2000 to October 2001. Only a slight offset in the strain data occurred in June 2001 and in July 2001. In contrast, an example of one of the unreliable strain gage records was for gage VW-E-SWT, which is shown in Figure 4.2. The data record for this gage is not reliable for even a brief period of time. When the ISU researchers determined that a particular strain gage record was not accurate, that particular data were not used in evaluating the performance of the abutment piles. However, in a few cases where a pile strain record was not reliable for the entire monitoring period, some conclusions regarding the performance of an abutment pile were made for those isolated periods of time when the strain data appeared to be reasonable. The dark and light shaded cells shown in Table 4.3 indicate the months during which all (dark shading) and some (light shading) of the data were considered to be reliable for each of the strain gages that were used to measure pile strains for the Tama County Bridge. The unshaded cells shown in Table 4.3 indicate the months during which all of the data were considered to be unreliable for each of the pile strain gages.

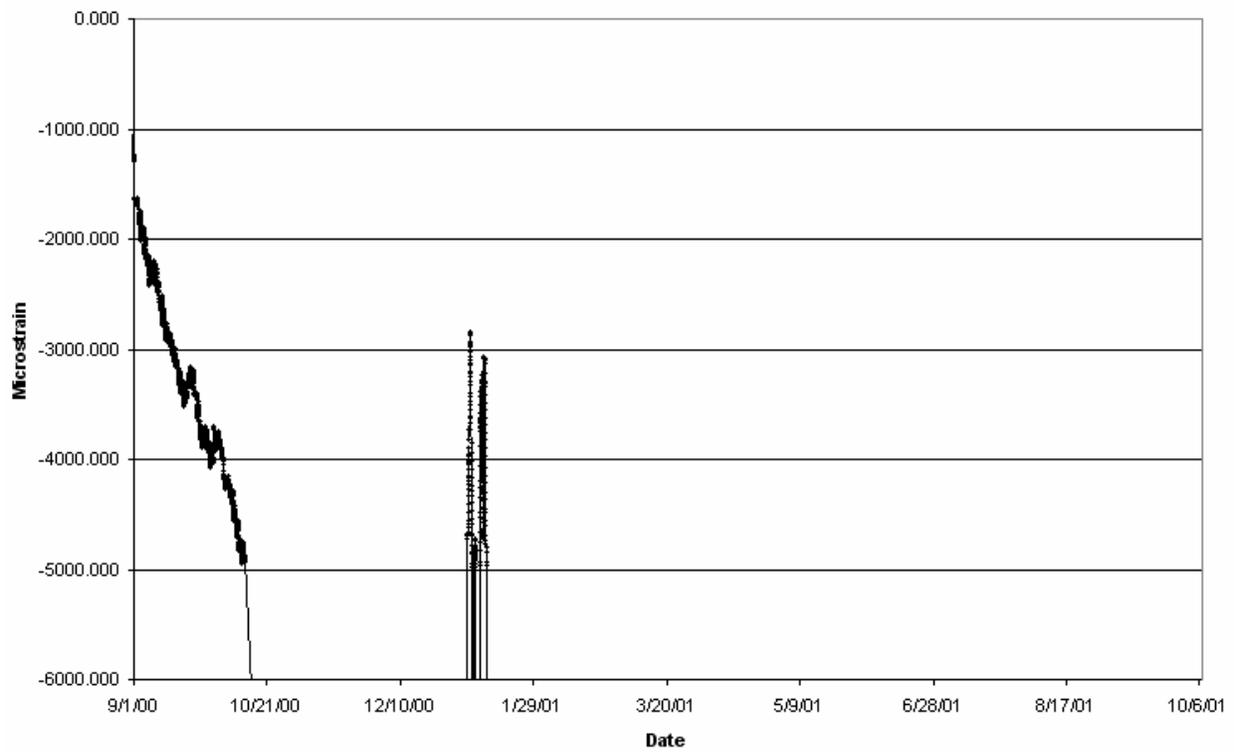
Figure 4.2. Pile strain record for gage VW-E-SWT

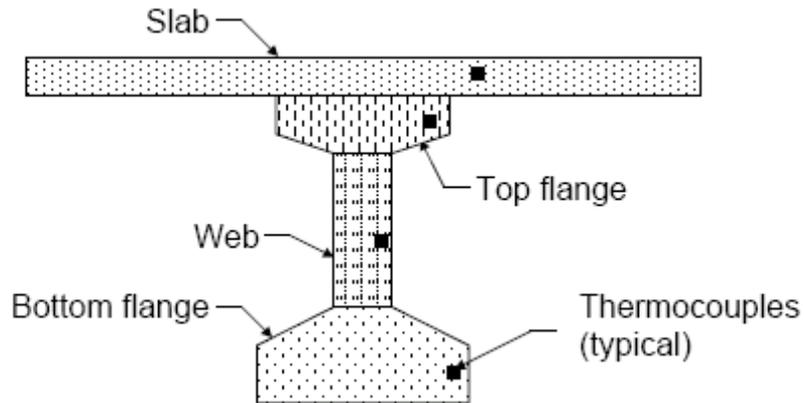
Figure 4.3. Temperature regions for a partial cross section of a bridge (not to scale)

An average temperature for the superstructure of the Tama County Bridge was calculated as a weighted average of the temperatures that were measured by the embedded thermocouples located at the mid-span of the bridge. Figure 4.3 shows a partial cross section of a bridge superstructure that has one bridge girder and a portion of the bridge slab. Each of the three temperature-monitored PC girders was divided into three regions that included the top flange, web, and bottom flange. The width of the RC deck was divided into four regions. Each of the exterior deck regions were monitored by thermocouples TC-M-S1 and TC-M-S4, and each of the interior deck regions were monitored by thermocouples TC-M-S2 and TC-M-S3. A uniform temperature was assumed to exist within each of the temperature-monitored regions at the mid-span of the superstructure.

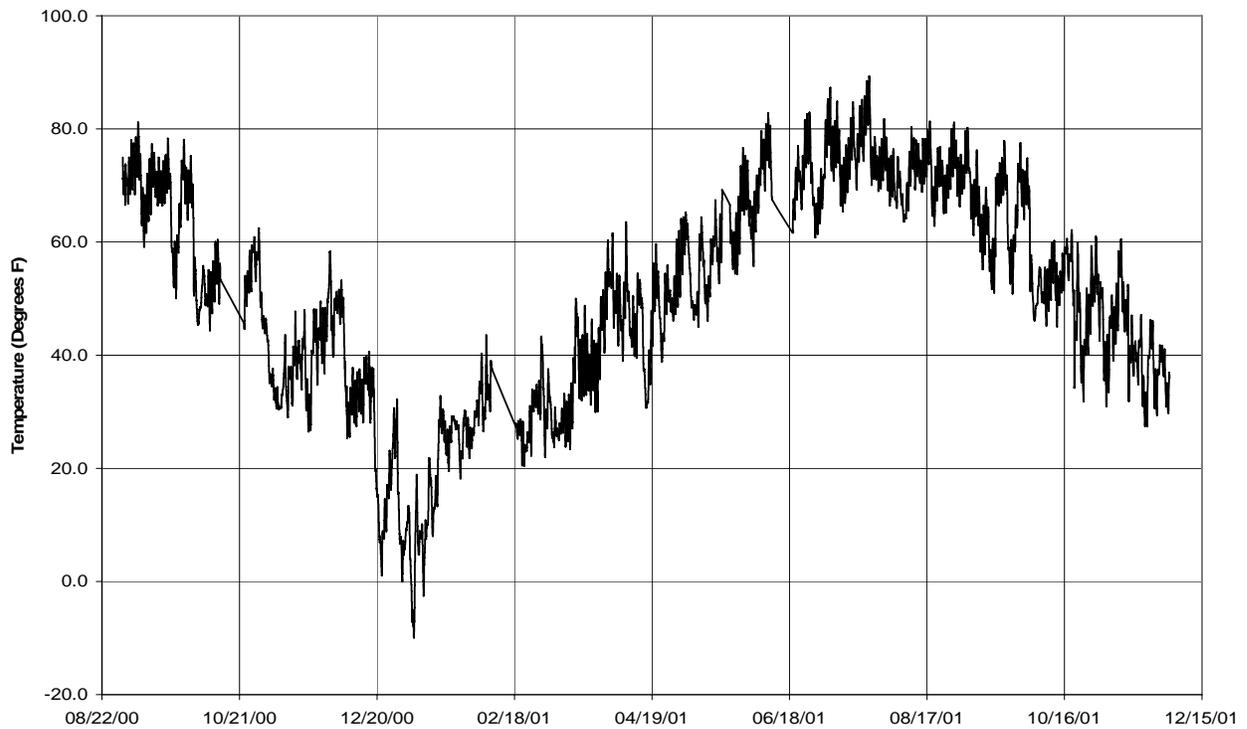
Figure 4.4. Average superstructure temperature for the Tama County Bridge

where, T_j is the temperature that was measured by a thermocouple in the j^{th} region of the mid-span cross section for the bridge superstructure, A_j is the area of that particular region, and n is the number of regions in the mid-span cross section for the bridge superstructure. (For the Tama County Bridge, n was equal to 13.) A plot of the average bridge temperature versus time for the Tama County Bridge is presented in Figure 4.4. An absolute maximum and minimum bridge temperature of about -10°F and 89°F , respectively, were recorded during the monitoring period. The maximum average bridge temperature of about 89°F occurred in the early evening hours of July 22, 2001. The minimum average bridge temperature of about -10°F occurred at 2:30 a.m. on January 8, 2001.

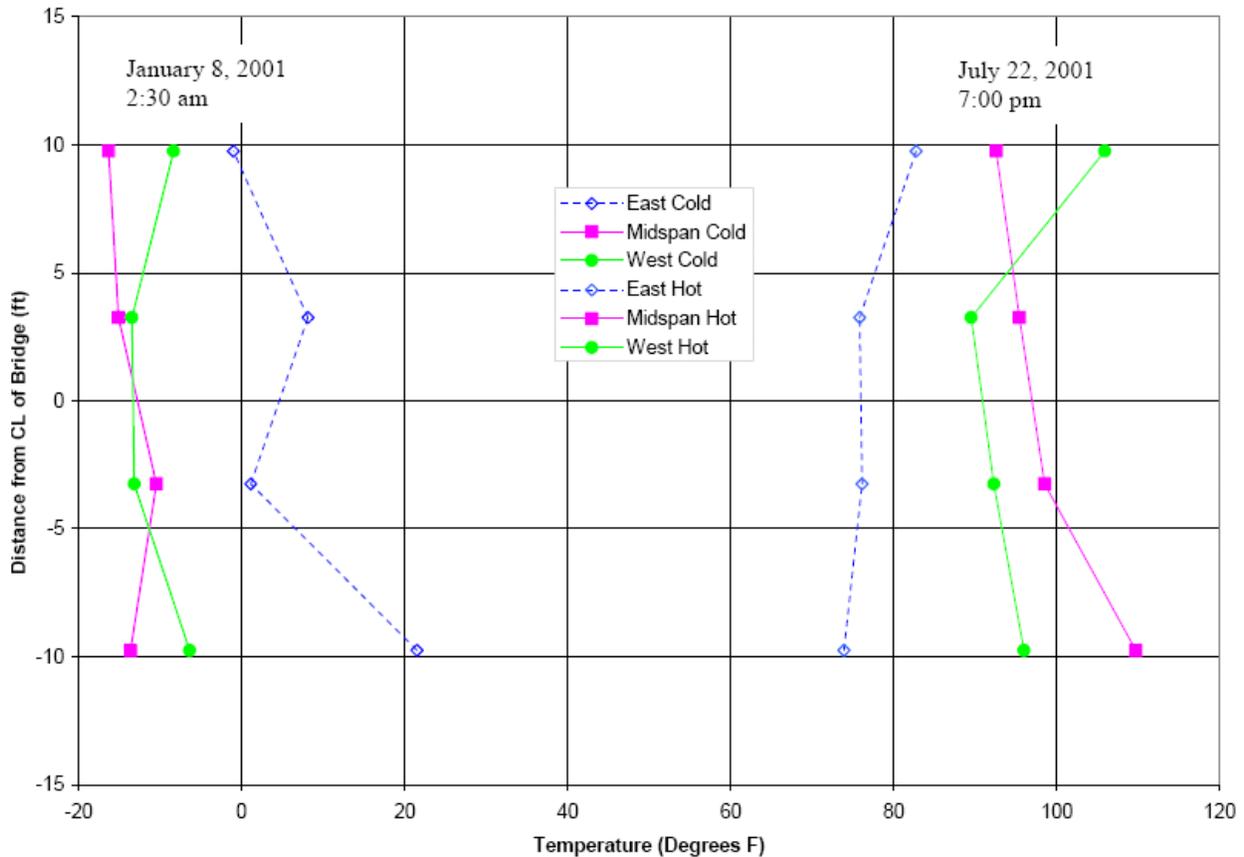
Figure 4.5. Transverse slab temperature distribution at times of maximum and minimum average bridge temperature

Figure 4.5 presents the transverse slab temperature distribution at the times of both the maximum and minimum average bridge temperatures. Temperatures varied by as much as about 20°F across the transverse bridge cross section. The thermocouples located near the west end of the bridge and at the mid-span recorded nearly the same temperatures during both hot and cold ambient temperature conditions. However, the thermocouples near the east end of the bridge recorded temperatures about 10°F to 12°F warmer at the time of the minimum average bridge temperature and 18°F to 20°F cooler during the time of the maximum average bridge temperature. A few possible explanations can be offered for this temperature differential. The most likely explanation for this condition is the method of installation used for the thermocouples. Each thermocouple was installed by drilling a small-diameter hole from the bottom of the deck, inserting the thermocouple, and filling the hole with grout. A slight difference in the depth of the thermocouple within the deck can have a significant impact on the recorded temperature. A second possible explanation for this temperature difference is the presence of an undocumented source of groundwater near the east abutment. Groundwater, which remains near 60°F year-round, would tend to reduce bridge temperature extremes during both hot and cold weather conditions.

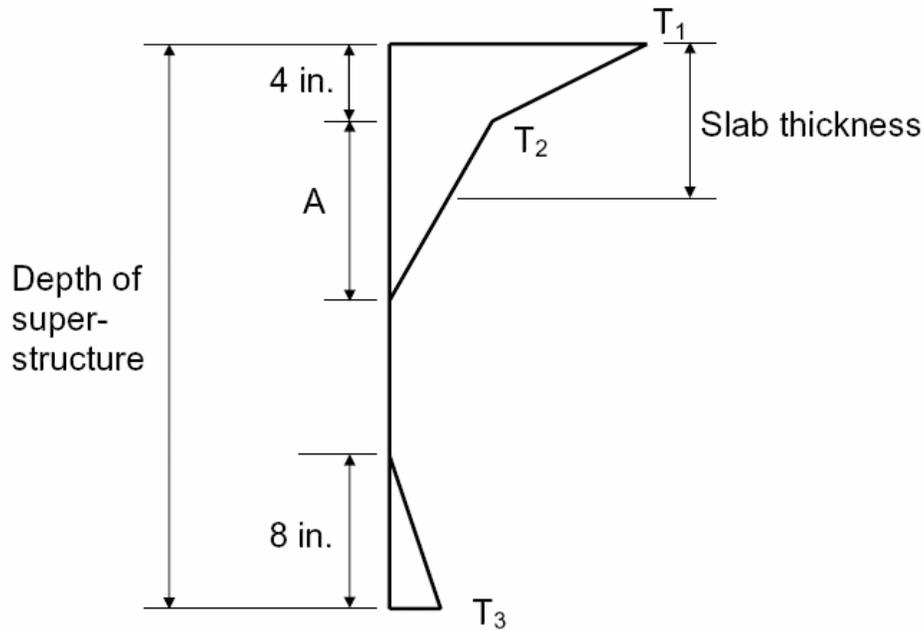
Figure 4.6. Thermal gradient through depth of bridge superstructure (adapted from AASHTO-LRFD 2004)

Article 3.12.3 in the AASHTO LRFD Specifications (2004) provides a method for establishing the temperature gradients through the depth of a PC-girder bridge superstructure, as shown in Figure 4.6. This process defines relative temperatures, T_1 , T_2 , and T_3 at three points within the depth of the superstructure. These values have been established for four solar radiation zones in the United States; however, only those values applicable to Iowa bridges are presented herein. For warm weather conditions, temperature T_1 , which occurs at the top of the slab, shall be taken as 46°F and temperature T_2 , which occurs 4 in. below the top surface of the slab, shall be taken as 12°F. Temperature T_3 , which occurs at the bottom surface of the PC bridge girders, shall be equal to zero, unless a site-specific study is performed, and in any case shall not exceed not exceed 5°F. In accordance with the AASHTO specifications, dimension A may be set equal to 12 in. for typical PC girder bridges similar to the Tama County Bridge. For cold weather conditions, the AASHTO specification states that the temperatures for T_1 and T_2 shall be taken as -14°F and -4°F, respectively. These temperatures given by the AASHTO specifications are not absolute temperatures, but rather differential temperatures between elements of the bridge superstructure.

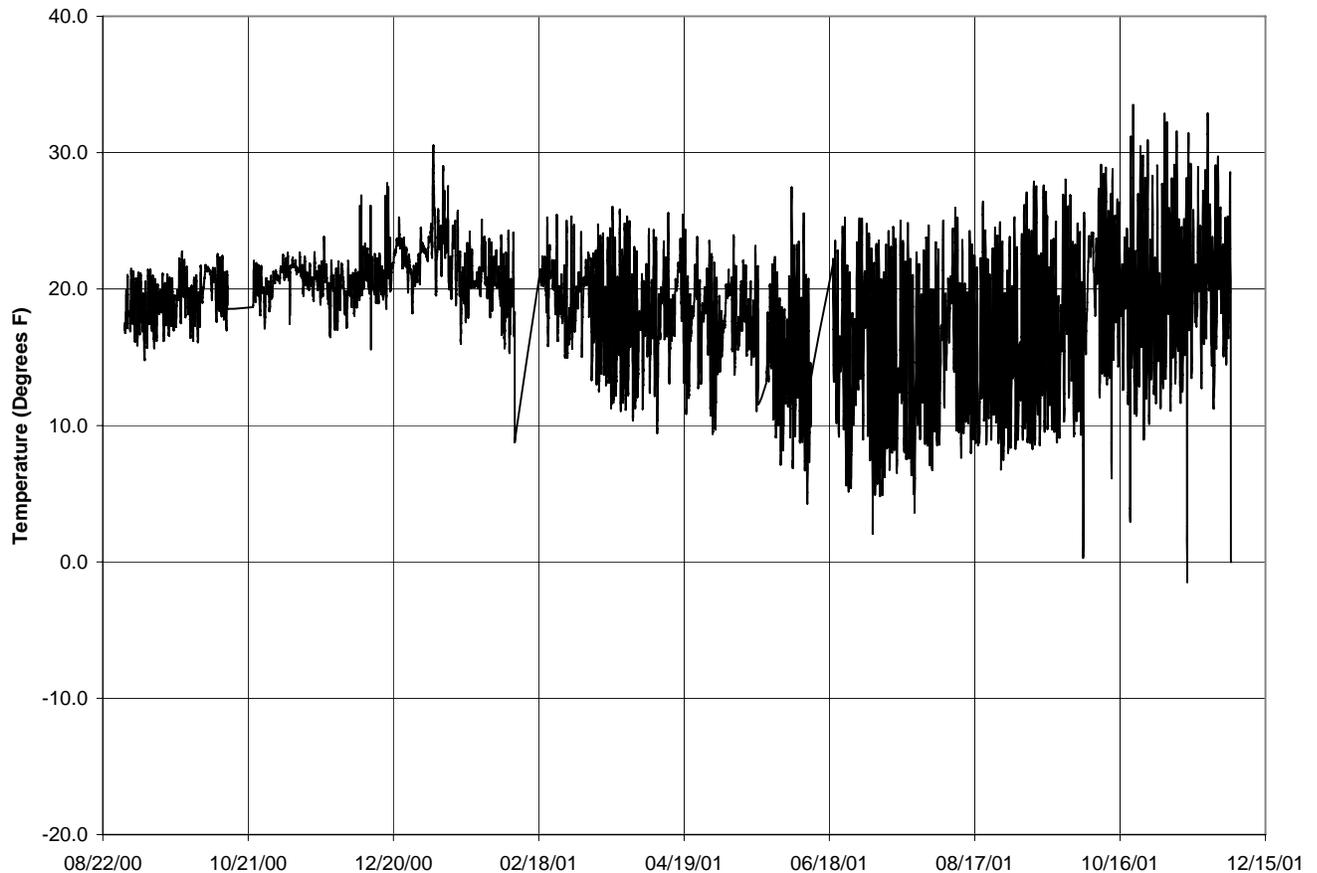
Figure 4.7. Difference between average temperature in the RC bridge deck and in the PC girder bottom flange

Figure 4.7 illustrates the difference between the average temperature in the RC bridge deck and the average temperature in the bottom flange of the PC girders. The thermal gradient varies seasonally as well as daily. The magnitude of the maximum vertical temperature gradient is much larger during the summer, due to the increased exposure of the bridge to solar radiation, than during the winter. Negative temperature gradients through the depth of the superstructure occur more frequently in the winter months.

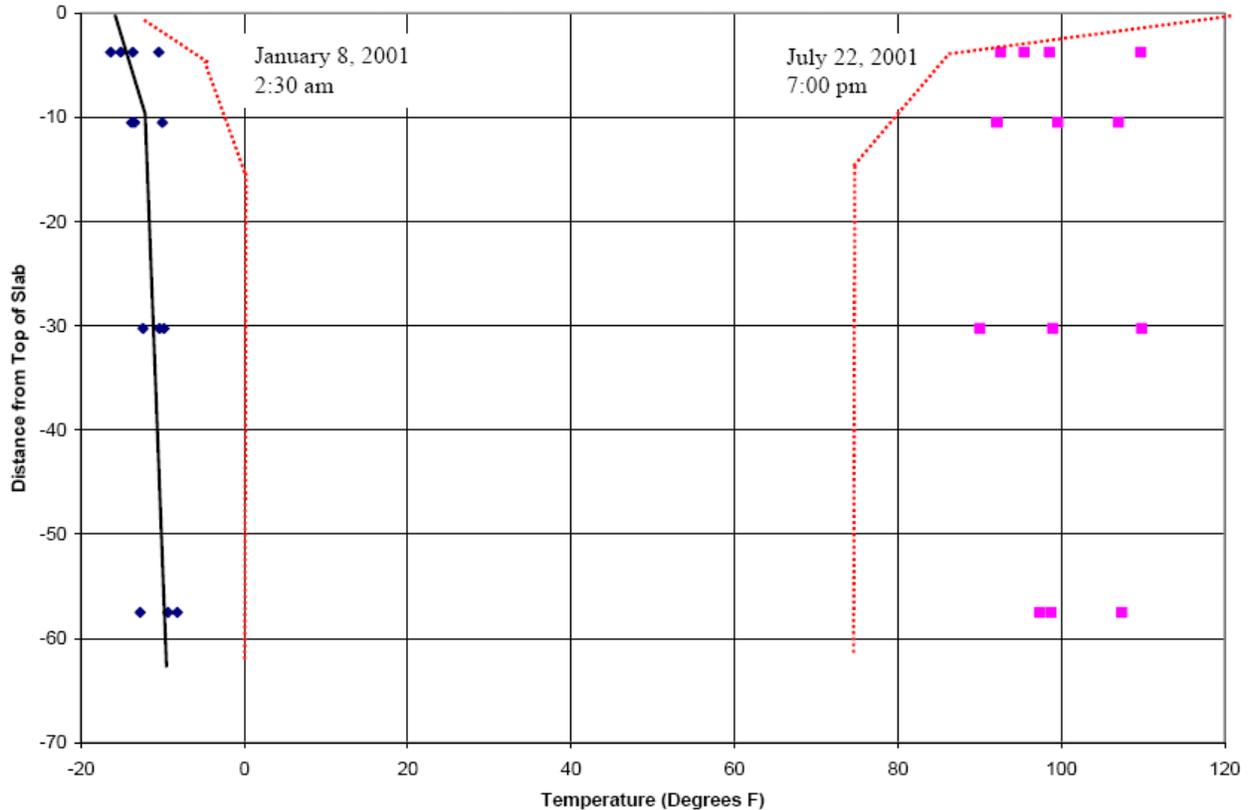
Figure 4.8. Vertical temperature distribution of the superstructure at times of minimum and maximum average bridge temperature

Figure 4.8 presents the experimentally based vertical temperature gradients for both the coldest day and hottest day at the Tama County Bridge, as well as those temperature gradients given in the AASHTO Specifications (2004). The AASHTO temperature gradients are shown as the dotted tri-linear lines in the figure. The experimentally based vertical temperature gradient recorded for the coldest day is similar to that recommended by the AASHTO Specifications (2004).

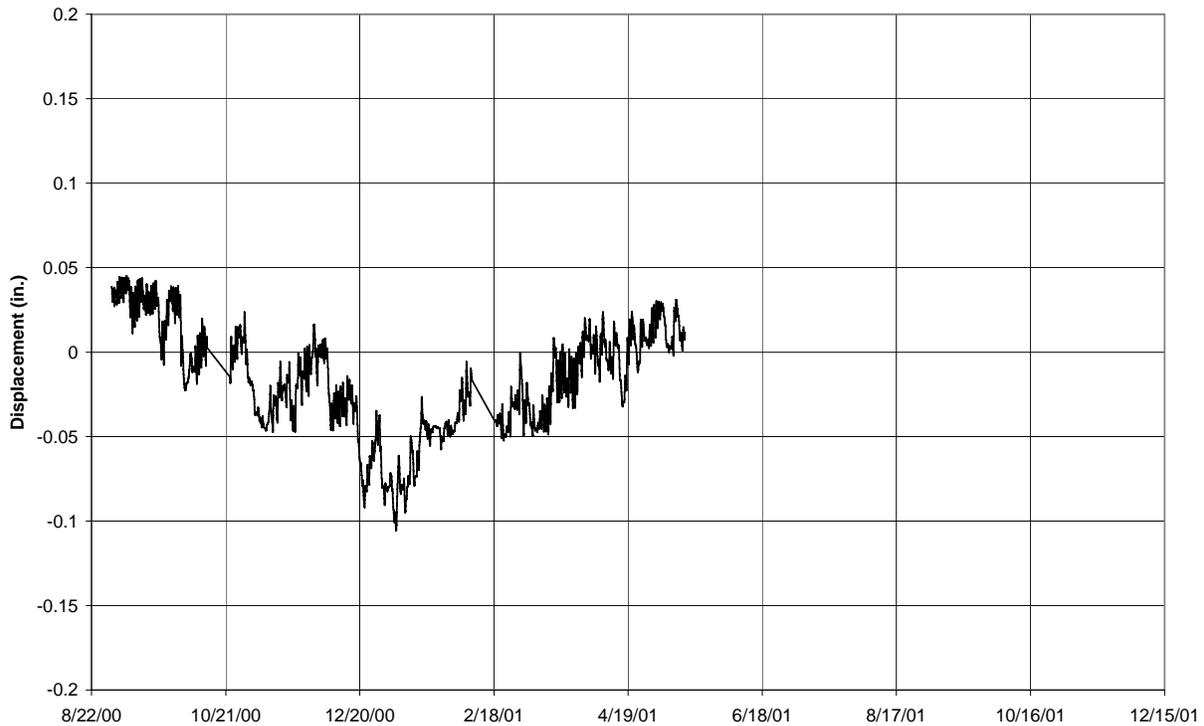
Figure 4.9. Average east abutment displacement

abutment in a horizontal plane. Figure 4.9 shows the average of the three measured displacements along the longitudinal direction of the bridge during the monitoring period. The longitudinal displacements that were measured at the west abutment were very small in comparison to those displacements that were measured at the east abutment. Essentially, all of the longitudinal displacements for the bridge superstructure occurred at the east abutment.

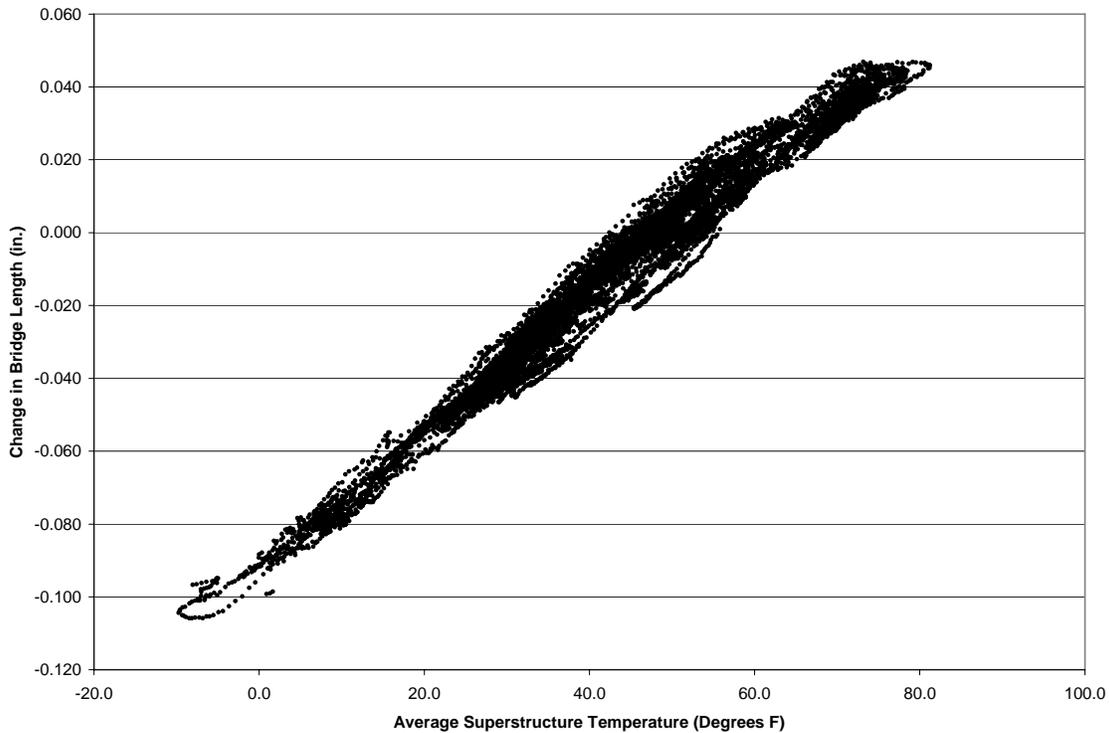
Figure 4.10. Change in bridge length versus average superstructure temperature

The longitudinal displacements that were measured at each abutment and at the mid-width of the bridge were used to calculate the change in length of the bridge. The change in the bridge length was calculated as the algebraic sum of the measured longitudinal displacements at the mid-width of the abutment pile cap at each end of the bridge. The experimentally based range for the change in the length of the Tama County Bridge was 0.153 in. The maximum change in average bridge temperature and the corresponding maximum change in the bridge length occurred during the time period between August 31, 2001, and May 14, 2001. Figure 4.10 shows the change in the bridge length versus the average bridge temperature for the Tama County Bridge. As this figure shows, reasonable correlation occurred between the change in the bridge length and the average temperature of the bridge superstructure. A positive displacement indicates an expansion of the bridge superstructure, while a negative displacement indicates a contraction of the bridge superstructure. Equal abutment displacements in the longitudinal direction of the bridge did not occur at each end of the Tama County Bridge.

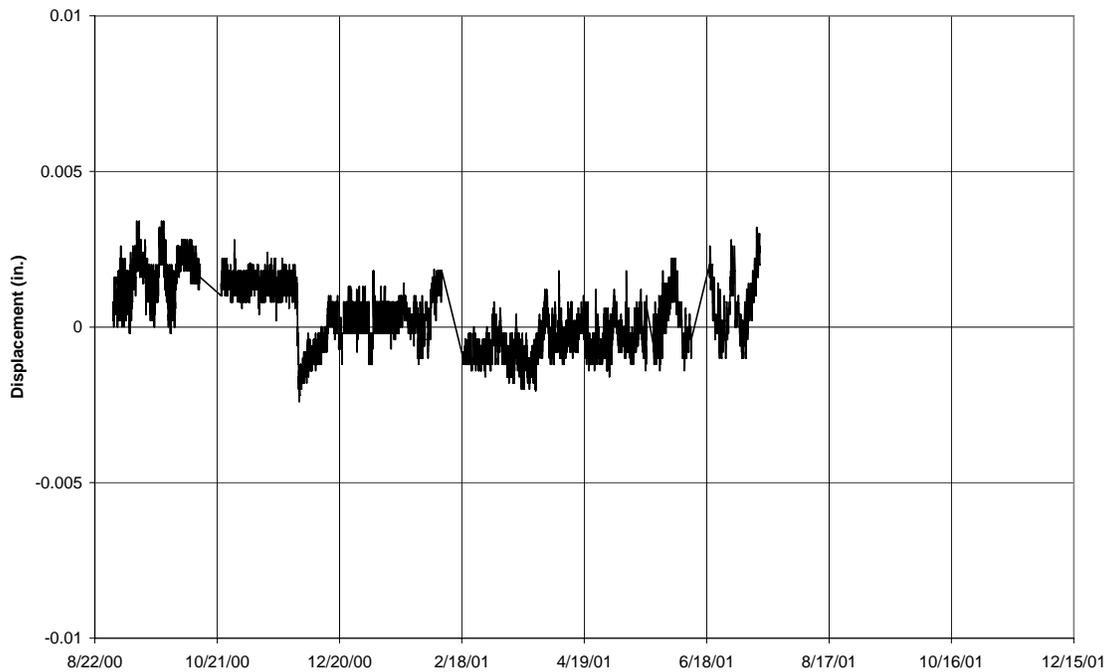
Figure 4.11. Differential longitudinal displacement, top and bottom of west abutment

vertical plane that was parallel to the longitudinal axis of the bridge. A measured displacement at the top transducer that is greater than that recorded by the bottom transducer at the same instant indicates an abutment rotation “away” from the bridge span. If the measured displacements are equal, the abutment is horizontally translating, without any rotation in a vertical plane. Figure 4.11 presents the differential longitudinal displacement (the top transducer displacement [SP-W-CLT] minus the bottom transducer displacement [SP-W-CLB]) for the west abutment of the Tama County Bridge.
