An Integral Abutment Bridge with Precast Concrete Piles

Final Report
May 2007

Sponsored by
the Iowa Highway Research Board
(IHRB Project TR-438)
and
the Iowa Department of Transportation
(CTRE Project 99-48)

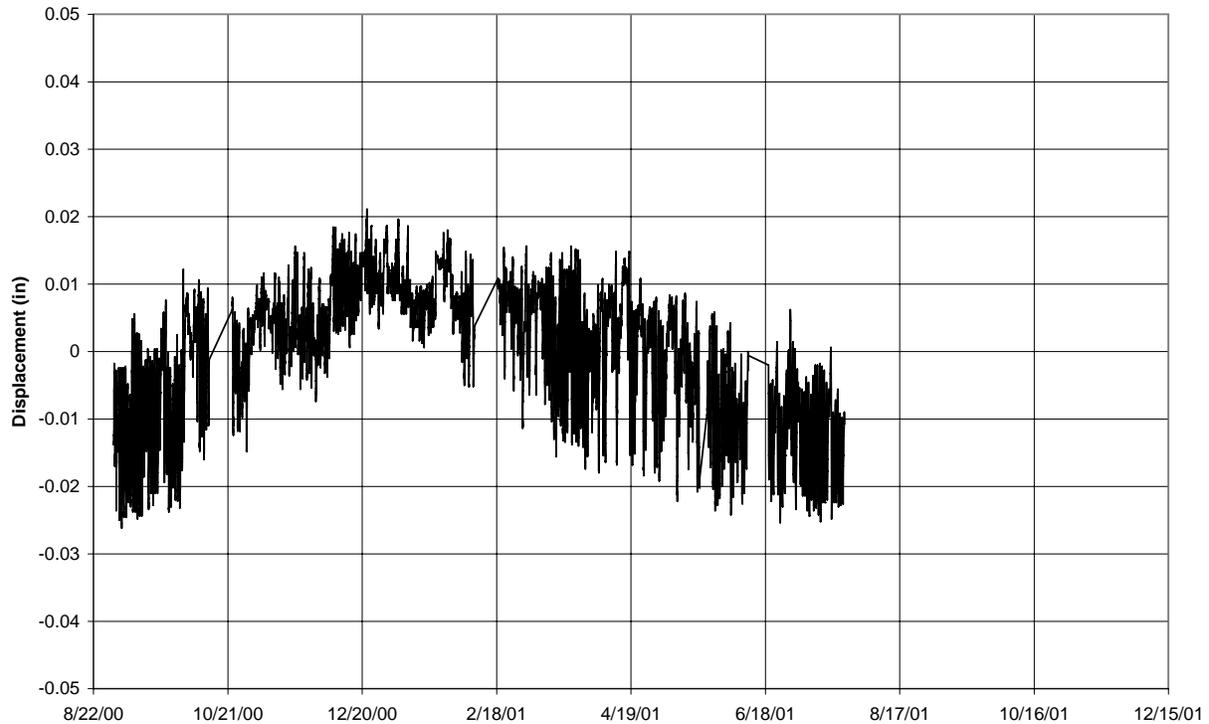
Figure 4.12. Measured transverse displacement, center of the east abutment

algebraic sum of the horizontal displacements measured at each end of the abutment. The horizontal displacement in the transverse direction of the bridge for the center of gravity of the east abutment pile cap was calculated as one-half of the algebraic difference in these measured horizontal displacements at each end of the abutment. Figure 4.12 shows the transverse displacements over time for the center of gravity for the east abutment pile cap for the Tama County Bridge. Positive displacements are directed towards the north, and negative displacements are directed towards the south. Between the end of August 2000 and the middle of May 2001, the range in the transverse displacement for this abutment was only about 0.04 in.

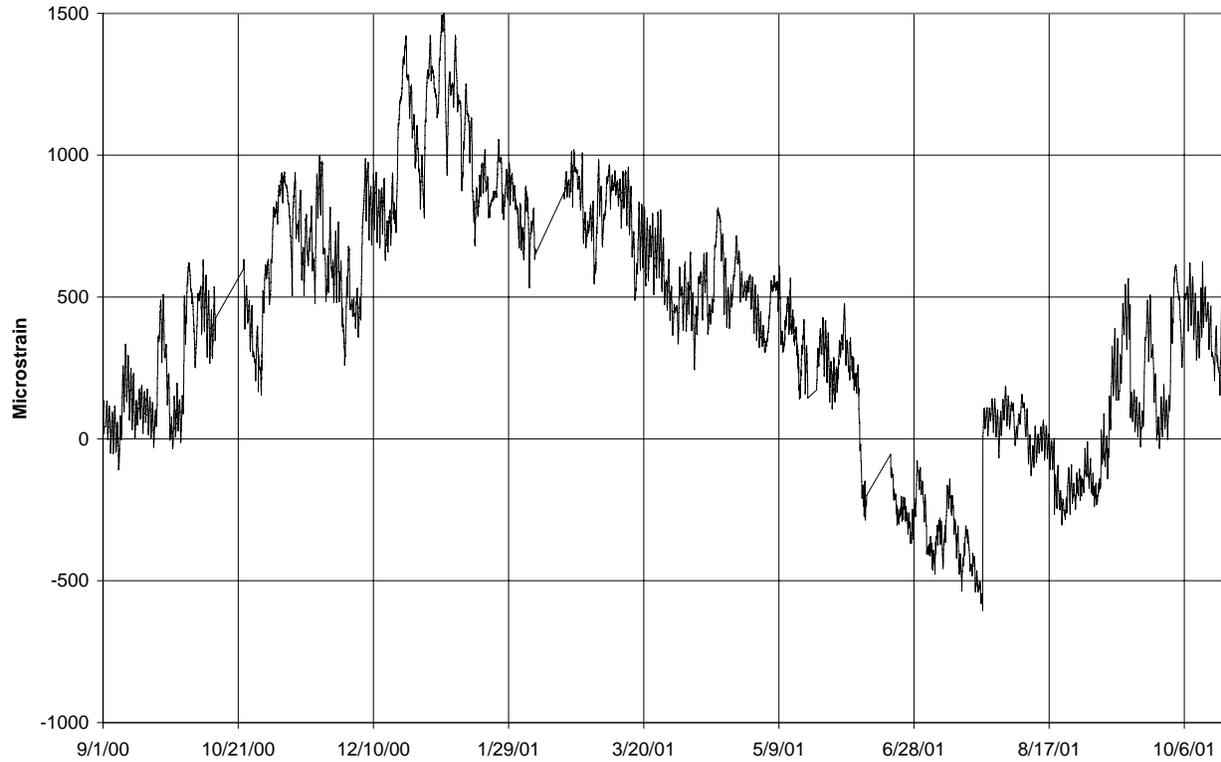
Figure 4.13. Strain record for gage VW-E-NWT

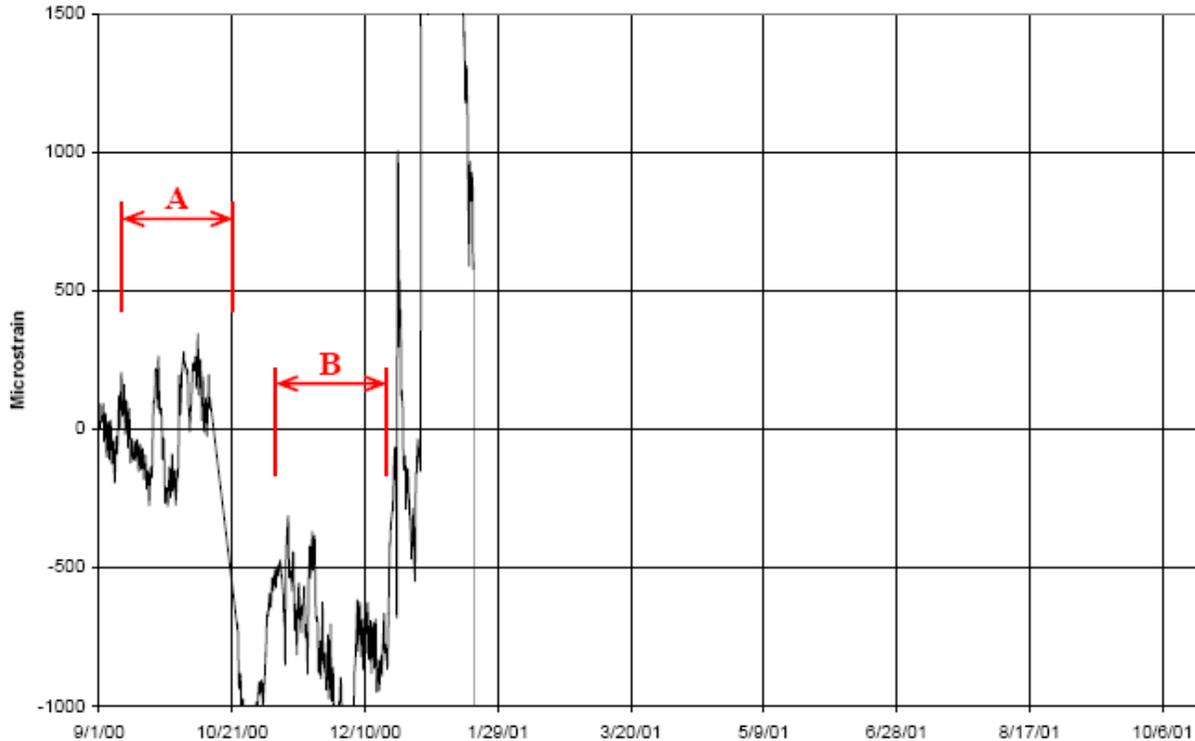
Figure 4.14. Strain record for gage VW-E-NWB

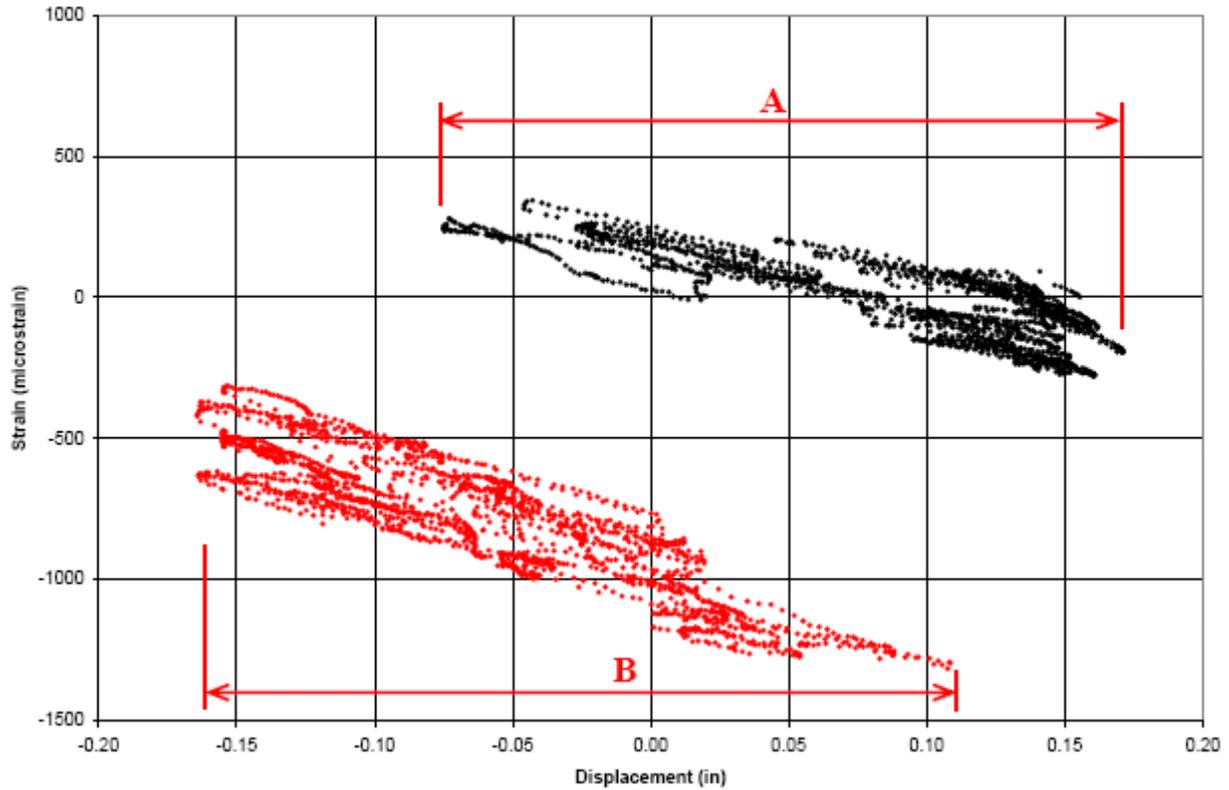
Figure 4.15. Strain gage VW-E-NWB vs. longitudinal displacement SP-E-SL

Similar piecewise continuity can be observed when the same strain record is plotted with respect to the east abutment longitudinal displacement, as in Figure 4.15. For this figure, the pile strain at gage VW-E-NWB is plotted versus the longitudinal displacement that was measured by the transducer SP-E-SL. During the time periods from September 1 to October 12, 2000, and from October 29 to December 12, 2000, the pile strain versus the displacement record can be plotted in very regular bands that occur along the regions labeled by the dimensions A and B in the figure. Clearly, during the region A and B time periods, the pile strain is linearly related to longitudinal displacement.

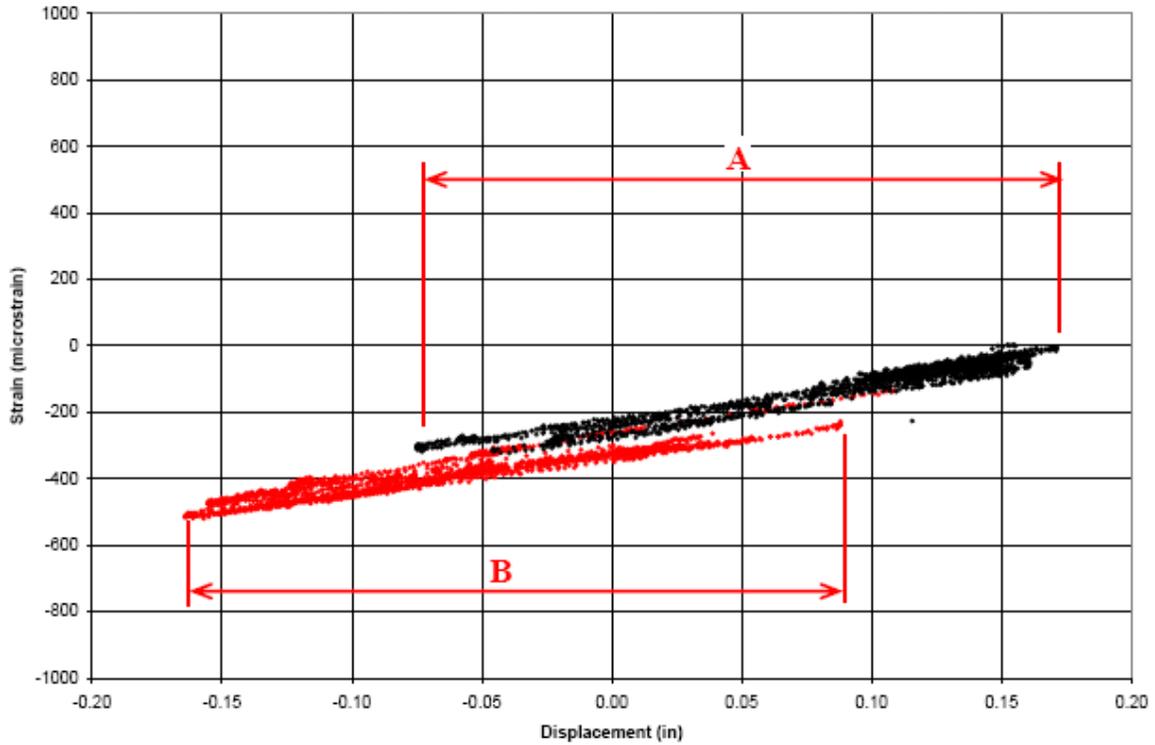
Figure 4.16. Flexural strain for gages VW-E-SET minus VW-E-NWT versus longitudinal displacement for SP-E-SL

Further evidence of the discontinuity between the region A and B time periods is illustrated in Figures 4.16 and 4.17, in which the bending strains in the east abutment center pile are plotted for the top and bottom set of gages, respectively (i.e., the strain in gage VW-E-SET minus the strain in gage VW-E-NWT, and the strain in gage VW-E-SEB minus the strain in gage VW-E-NWB, respectively). Both figures clearly show the discontinuity. Arguably, Figure 4.17 could indicate that region B could be further divided into time regions. Again, the discontinuity between the strain regions is probably caused by cracking of the PC pile or an instrument malfunction.

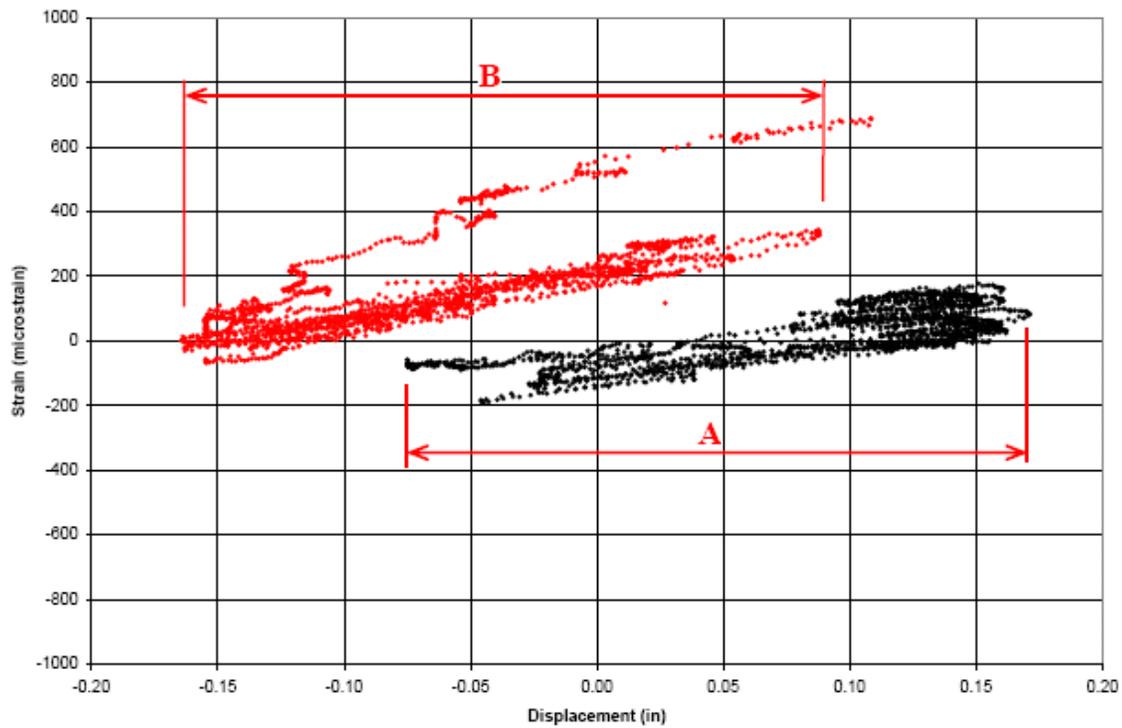
Figure 4.17. Flexural strain for gages VW-E-SEB minus VW-E-NWB versus longitudinal displacement for SP-E-SL

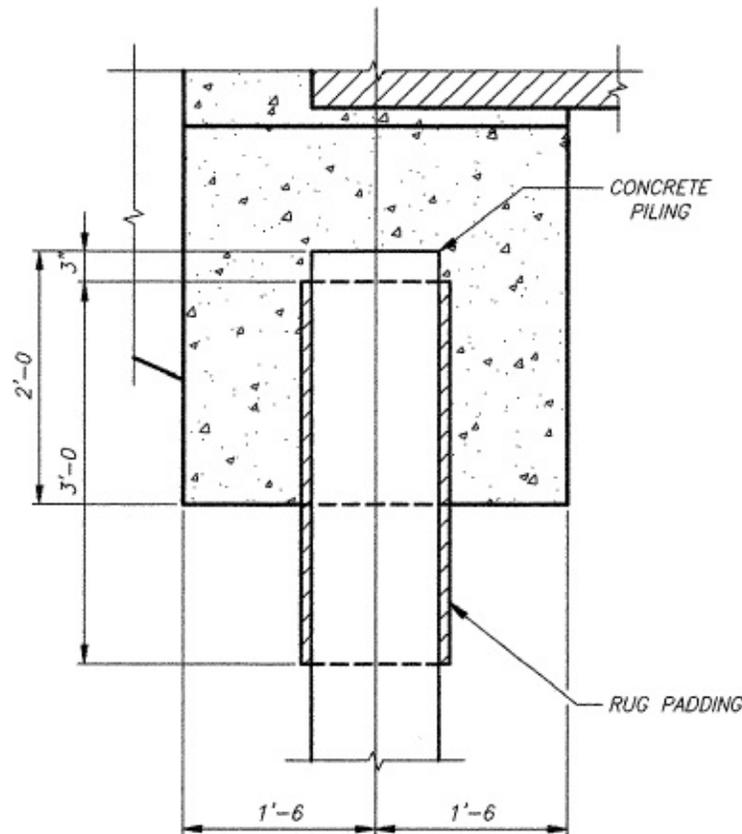
Figure 4.18. Excerpt from bridge contract plans showing pile wrapping detail

To permit rotation to occur in a vertical plane between the top of the abutment piles and the abutment pile cap that would produce a pinned-end condition at the top of the abutment piles, the designer for the Tama County Bridge specified in the bridge contract drawings that the tops of the abutment piles be wrapped with “a double thickness of rug padding.” An excerpt from the bridge plan drawings that presented this detail is shown in Figure 4.18.

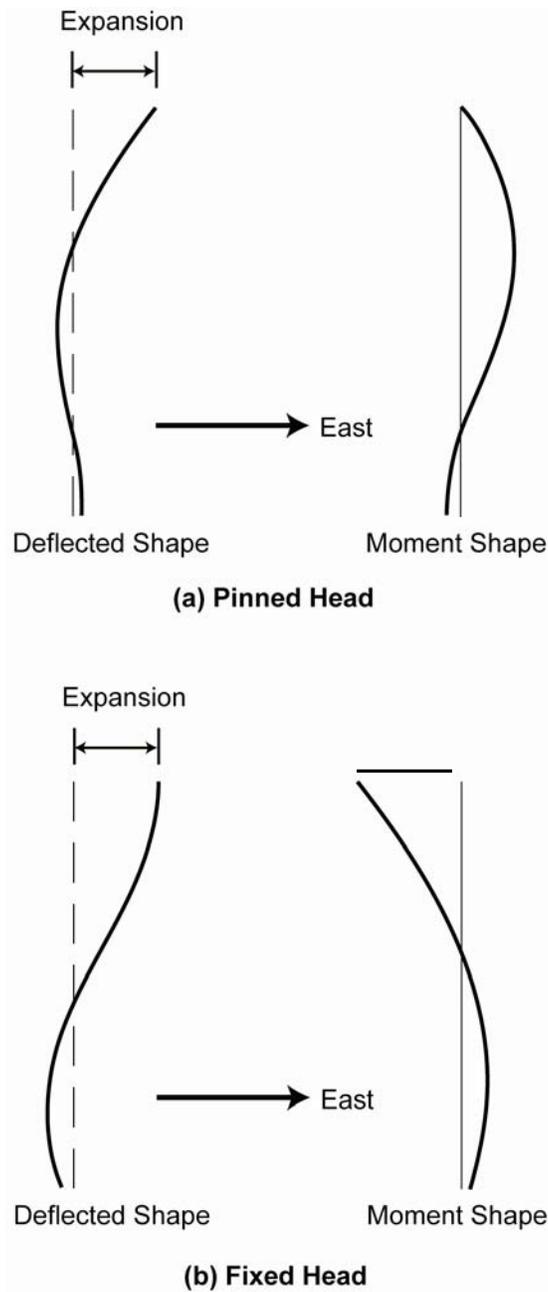
Figure 4.19. Deflected shape and moment diagram for theoretical pile top conditions, east pile

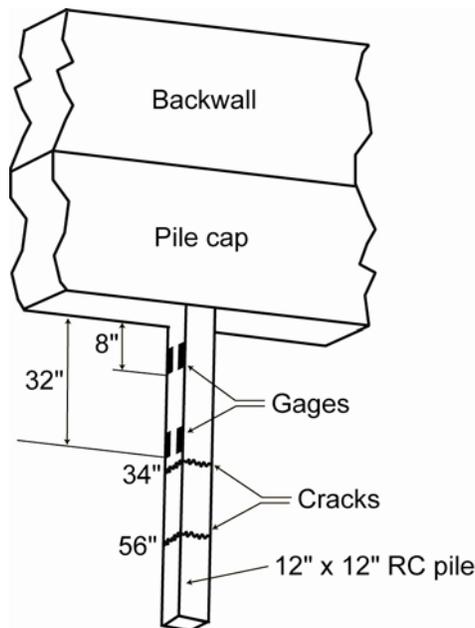
Figure 4.20. Pile crack locations observed following monitoring period

After excavating the soil in front of the pile, the pile was carefully cleaned. Two significant horizontal cracks were observed in the front face of the pile. These cracks, which are described as upper and lower cracks, were located at 2 ft. 10 in. and 4 ft. 8 in., respectively, below the bottom of the pile cap for the east abutment. The location of these cracks are shown in Figure 4.20. The upper crack is located very near the bottom strain gages on the pile. Since these vibrating wire strain gages have a 6 in. long gage length between the monitoring brackets for the gages, the bottom strain gages may have straddled the crack.

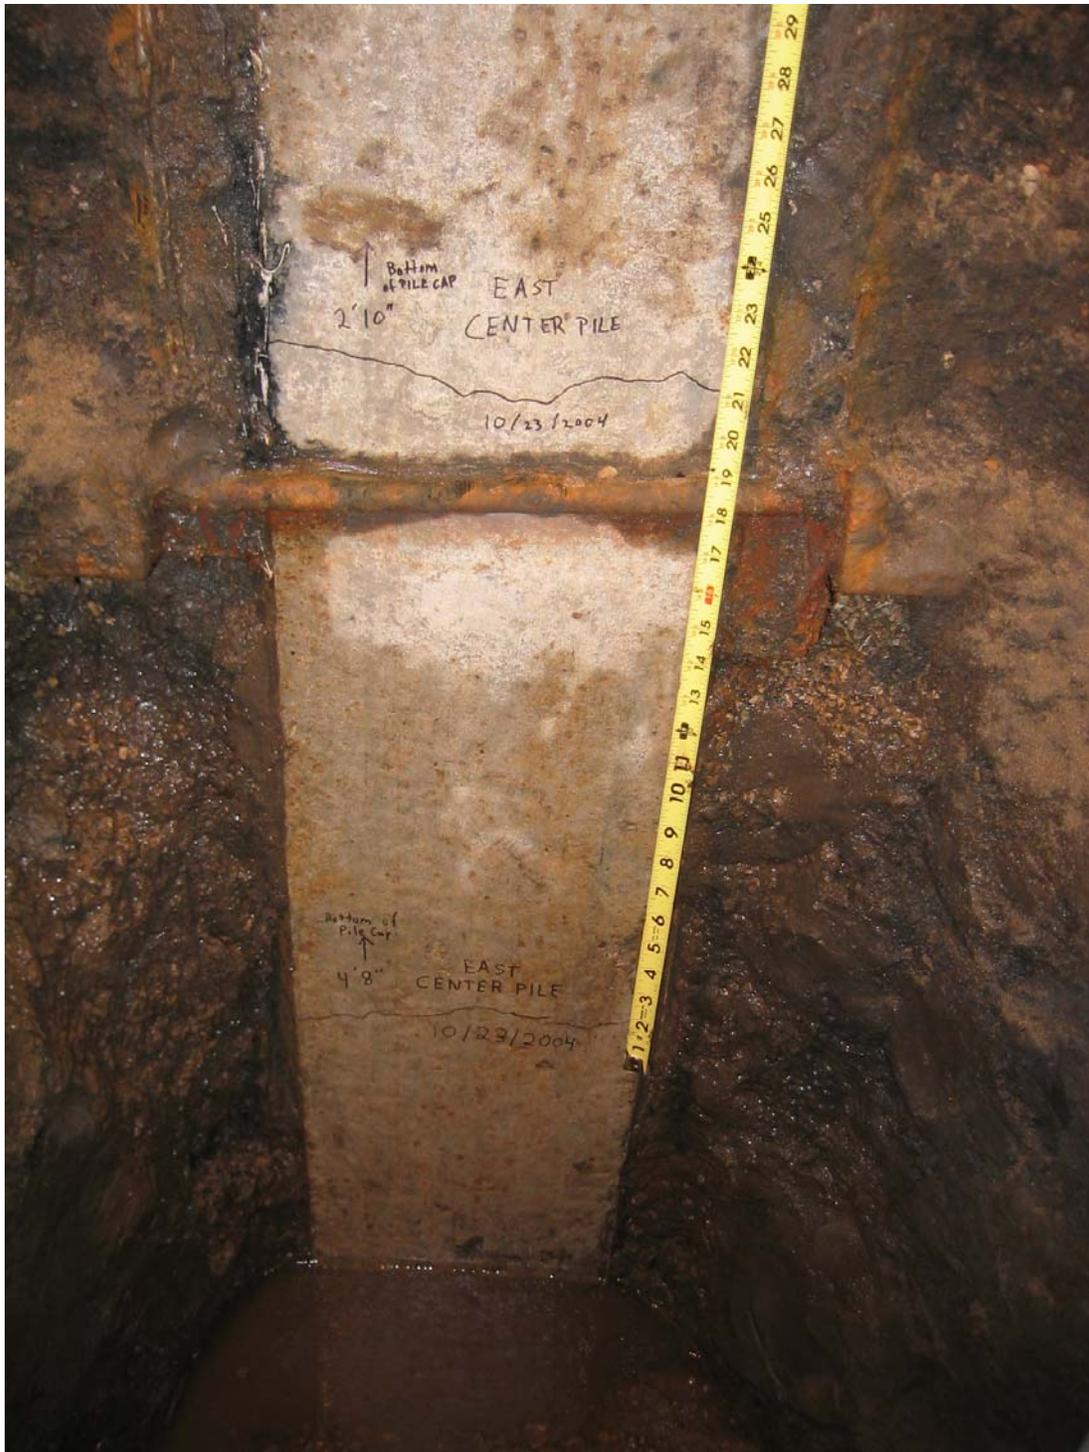
Figure 4.21. East abutment center pile excavated for crack exploration

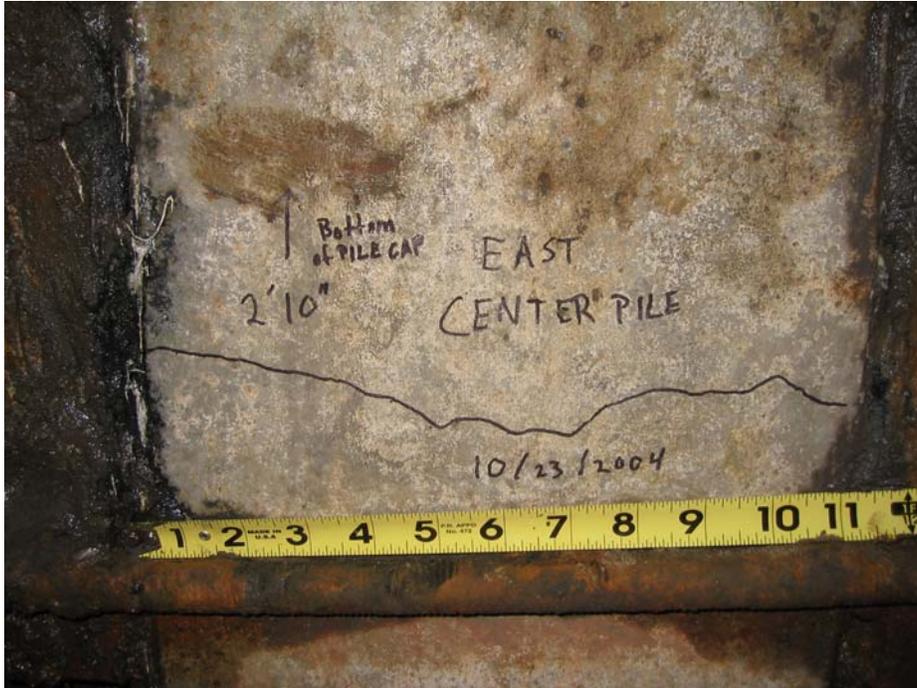
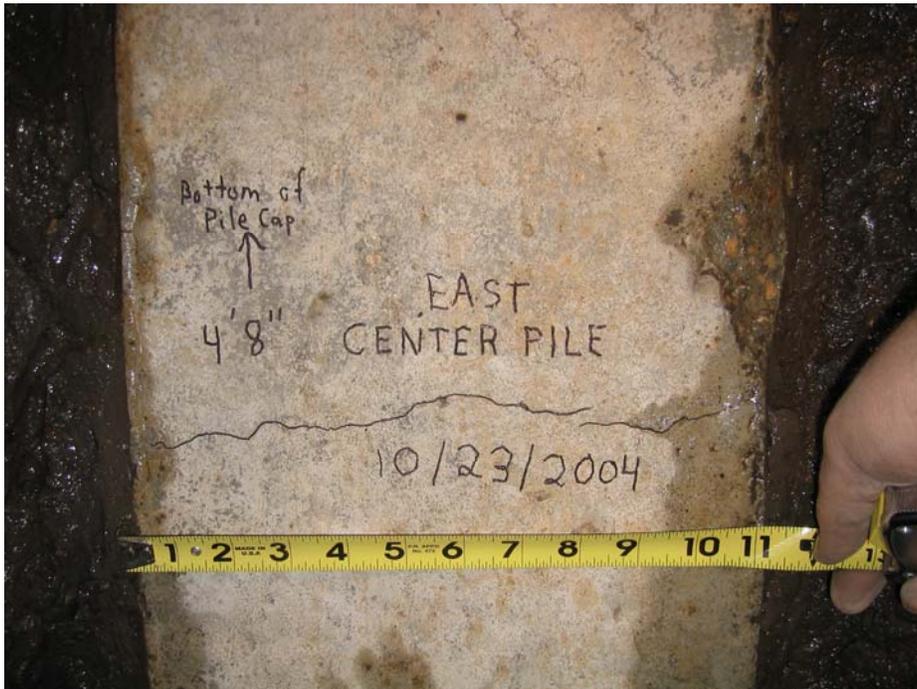
(a) Upper crack, located 2 ft. 10 in. below abutment

(b) Lower crack, located 4 ft. 8 in. below abutment

Figure 4.22. East abutment center pile cracking

These photographs of the cracks are documented evidence of the cracking of this pile. This cracking is most likely the cause of the discontinuity between time regions A and B in the pile strain plots, which were illustrated in previous figures in this report.

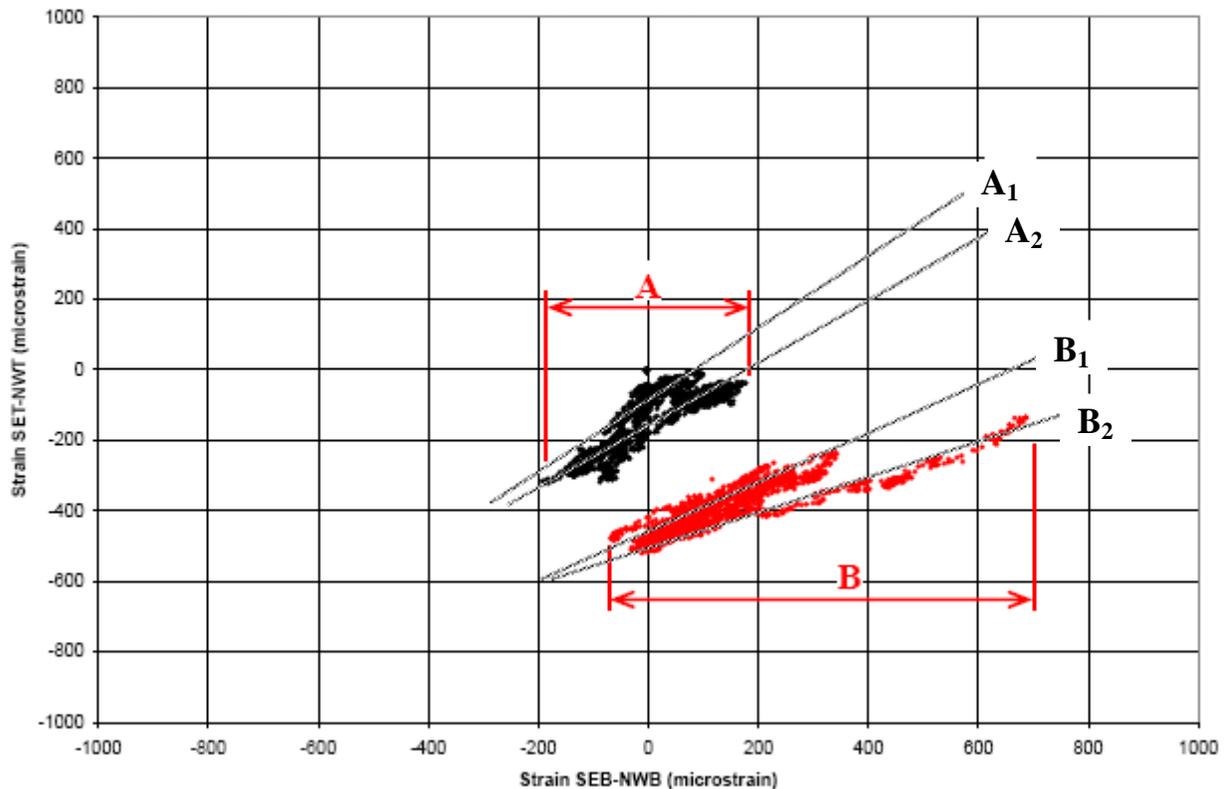
Figure 4.23. Flexural strain for VW-E-SET minus VW-E-NWT versus flexural strain for VW-E-SEB minus VW-E-NWB

Figure 4.23 graphs the bending strains at the top set of gages (from Figure 4.16) versus the bending strains at the bottom set of gages (from Figure 4.17). The abscission scale for the graph is strain measured by gage VW-E-SEB minus the strain measured by gage VW-E-NWB. The ordinate for the graph is the strain measured by gage VW-E-SET minus the strain measured by gage VW-E-NWT. Again, two time period regions of pile strain, indicated by dimensions A and B in Figure 4.23, are clearly evident. Further, one could identify two trend lines for the differences in the measured strains within both Regions A and B. These trend lines are labeled A₁ and A₂ and then B₁ and B₂, respectively. For trend line A₁, the pile may be uncracked and the bending strain range at the top set of strain gages exceeds that at the bottom set of strain gages, which would be consistent with a rotationally restrained head, as shown in Figure 4.19(b). As the pile progresses through the various stages of cracking to result in the strain differences indicated by the trend in B₂, the strain range at the bottom set of strain gages exceeds that at the top set of strain gages. An appropriate deflected shape and the shape of the curvature diagram (not moment) that corresponds with this observation are sketched in Figure 4.24. The curvature (and, hence, bending strains) would be higher in the cracked region.

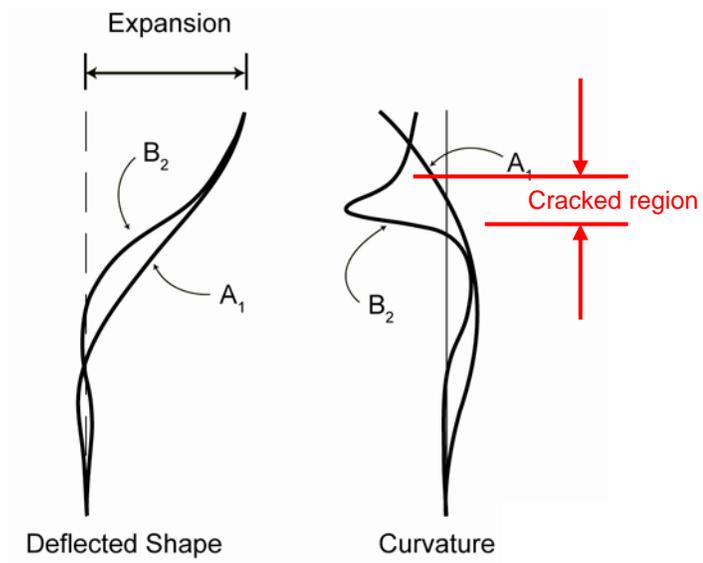
Figure 4.24. Deflected shape and curvature diagram for partially restrained pile head
