Effective Shoulder Design and Maintenance

tech transfer summary

June 2007

Iowa Highway Research Board (TR-531)
Iowa Department of Transportation
(CTRE Project 05-198)

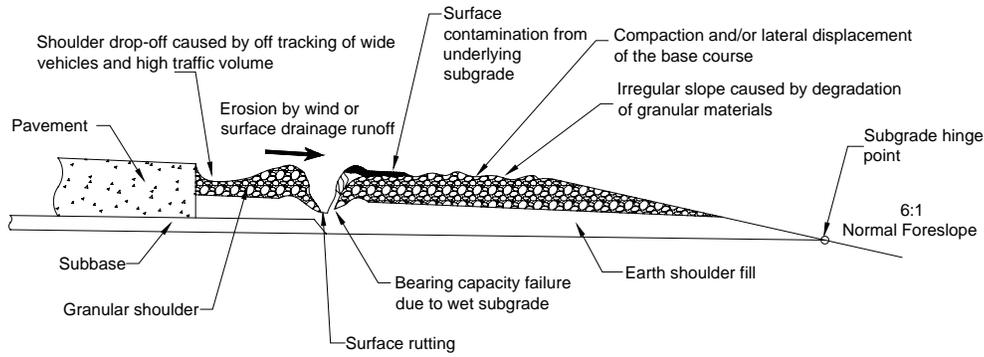
Common granular shoulder problems

Granular shoulders are a commonly used shoulder option. Although the construction of granular shoulders is initially less expensive than that of paved shoulders (by up to 70%), granular shoulders often add expense later because they require more frequent maintenance and have performance problems. Common granular shoulder problems include edge drop-off, shoulder rutting, erosion by water or wind, irregular slope, and settlement of the subgrade soil.

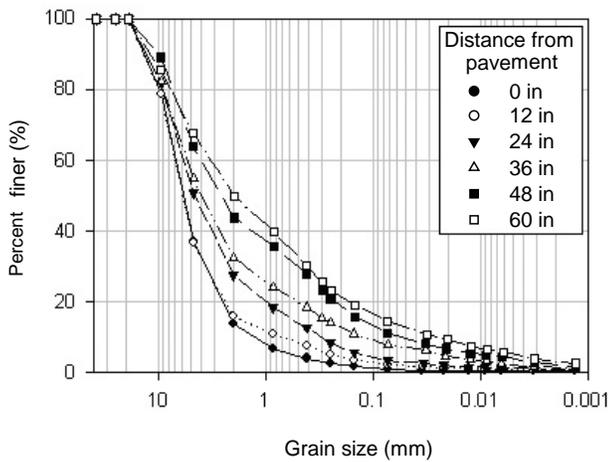
Change in granular material graduation by wind erosion

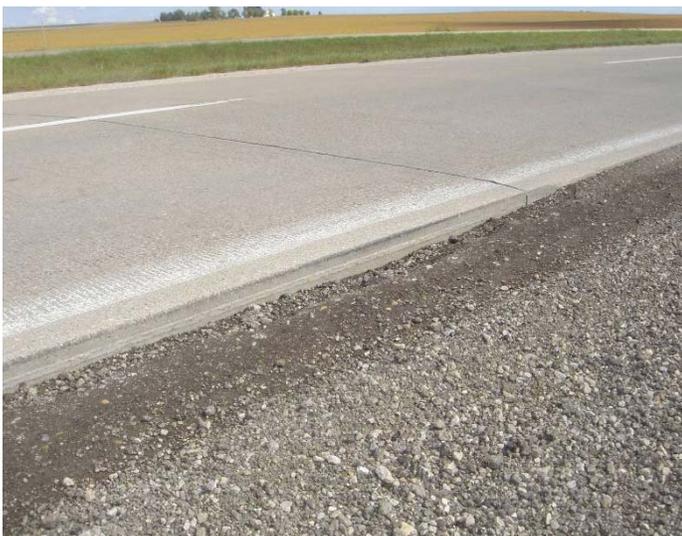
Edge drop-off along the outside shoulder caused by vehicle off-tracking

- The two major problems observed were edge drop-off and soft subgrade layer.
- Approximately 60% of the inspected sites had an edge drop-off greater than 1.5 in., and 40% had a slope higher than the 4% slope grade specified by the Iowa DOT.
- About 50% of the shoulder sections had a soft subgrade layer (CBR values less than 10 at depths between 8 and 10 in.).
- Wind induced by high-profile vehicles removes the fines and changes the granular material gradation, contributing to edge drop-off formation.
- Granular shoulders are maintained by adding virgin or recycled material, such as hot mixed asphalt (HMA) or recycled concrete.

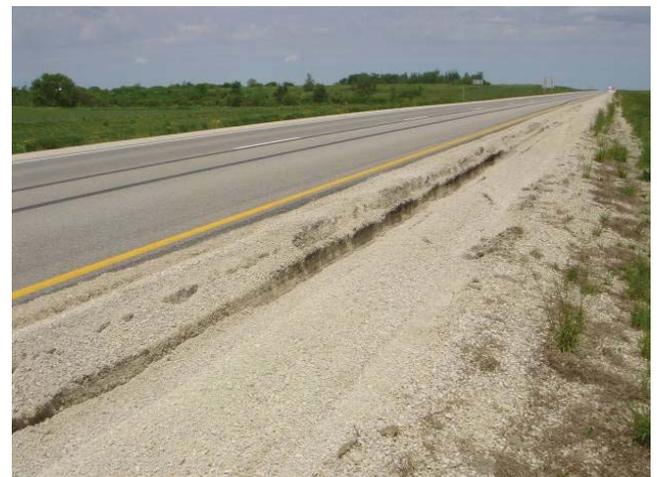
Severe shoulder rutting caused by bearing capacity failure of the soft underlying subgrade

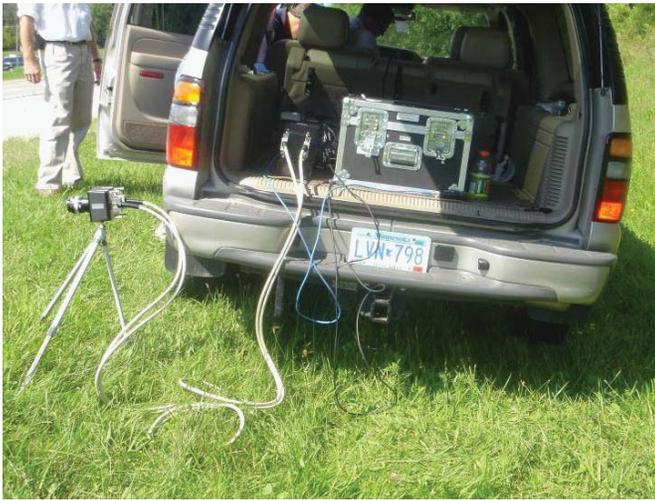
Monitoring tire-aggregate interaction using stationary high-speed camera

Vehicle off-tracking is a prime contributor to the development of edge drop-off. An approach was therefore conceived to study vehicle tire-aggregate interaction for unpaved shoulders using high-speed cameras. To capture the vehicle tire-aggregate behavior, a pickup truck was driven on an unpaved shoulder at 40 mph while the high-speed camera captured the aggregate trajectories. The results show that aggregates are elevated upward and pushed in the opposite direction of vehicle travel.

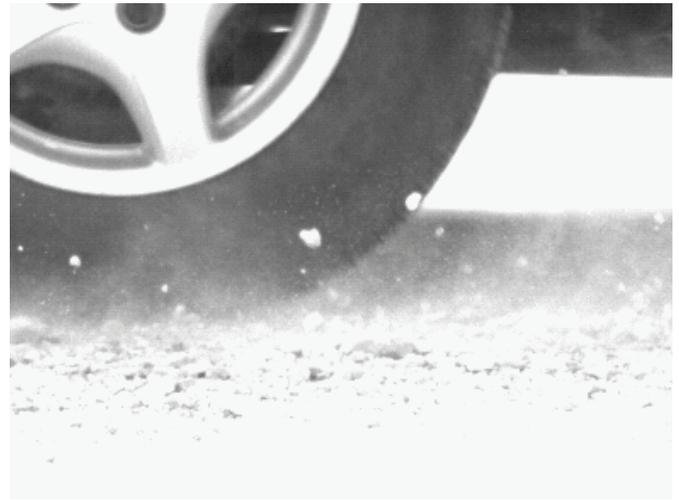
Digital images captured by camera showing elevated aggregate particles

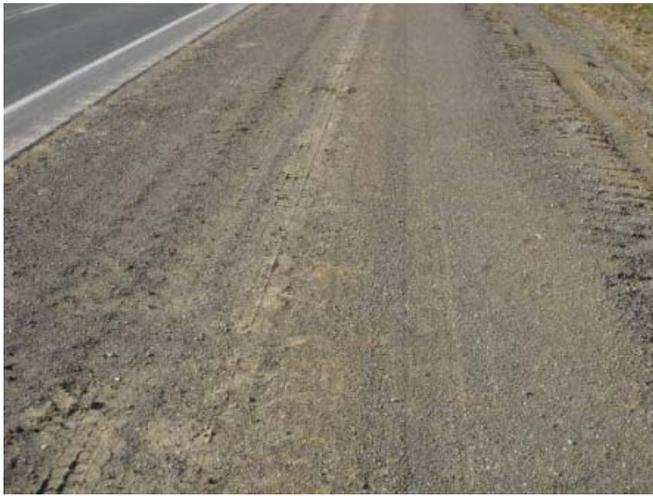
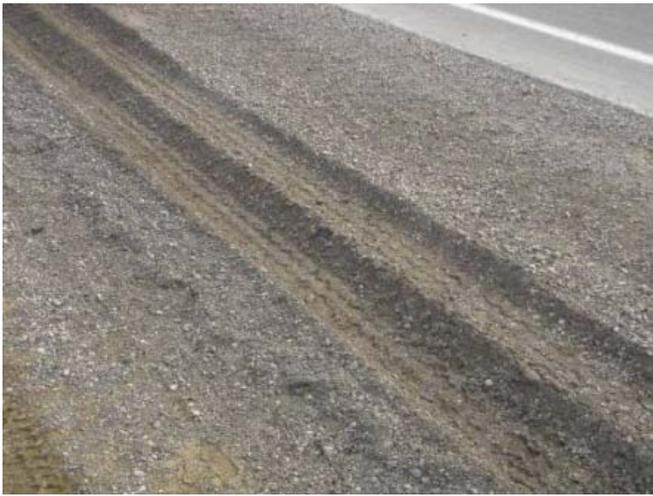
Performance of the fly ash–stabilized shoulder section after seven months: stabilized section (top) and control section (bottom)

For the fly ash stabilization techniques, shoulder sections located on Highway 34 near Batavia, Iowa, were undergoing severe rutting due to soft subgrade layers. The upper 12 in. of the subgrade were stabilized with 15% to 20% class C fly ash. The section was monitored for 19 months. Fly ash stabilization was successful in eliminating shoulder rutting and improving the overall long-term performance of the shoulder section.

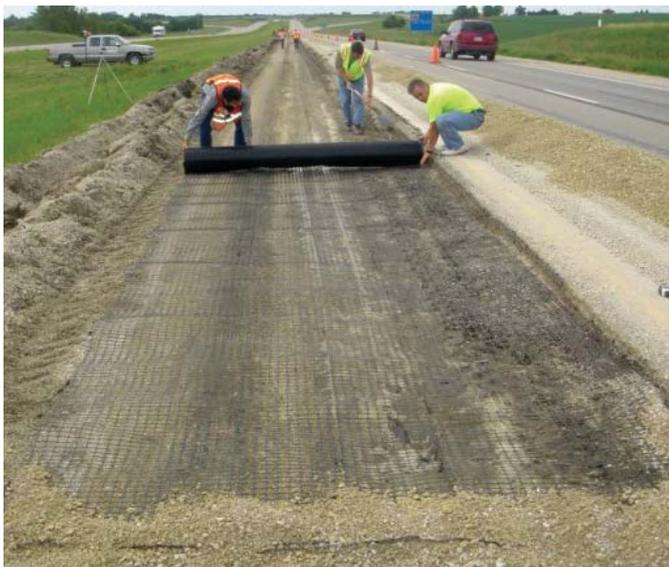
Rolling the geogrid over the soft subgrade layer near Nashua, Iowa

For the geogrid stabilization techniques, the inside granular shoulder on Highway 218 near Nashua, Iowa, was experiencing severe rutting due to soft subgrade conditions. The section was stabilized by placing various types of geogrid at the interface between the granular and subgrade layers, and the test section was monitored for 10 months. Four different geogrids were evaluated, and all considerably improved the performance of the shoulder test section and eliminated shoulder rutting.

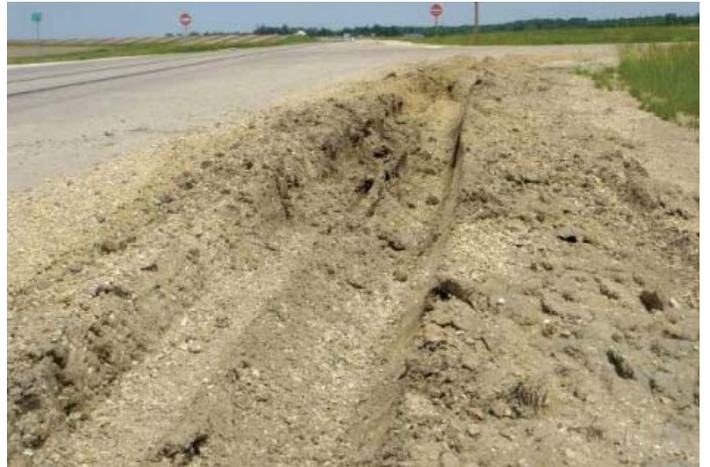
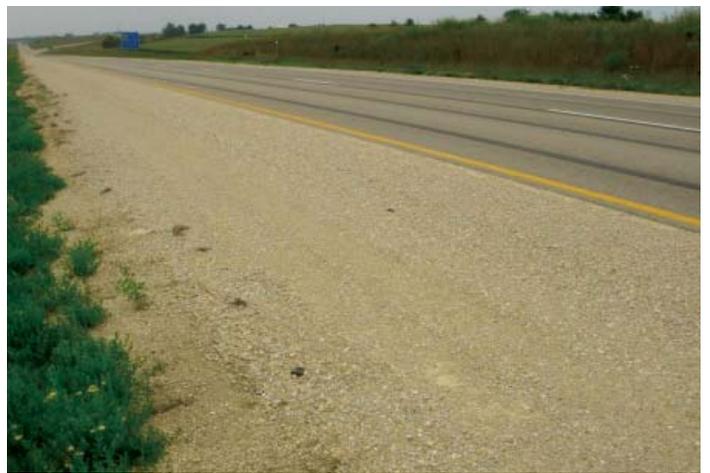
Inside shoulder near Nashua, Iowa: before stabilization (top) and two months after stabilization (bottom)

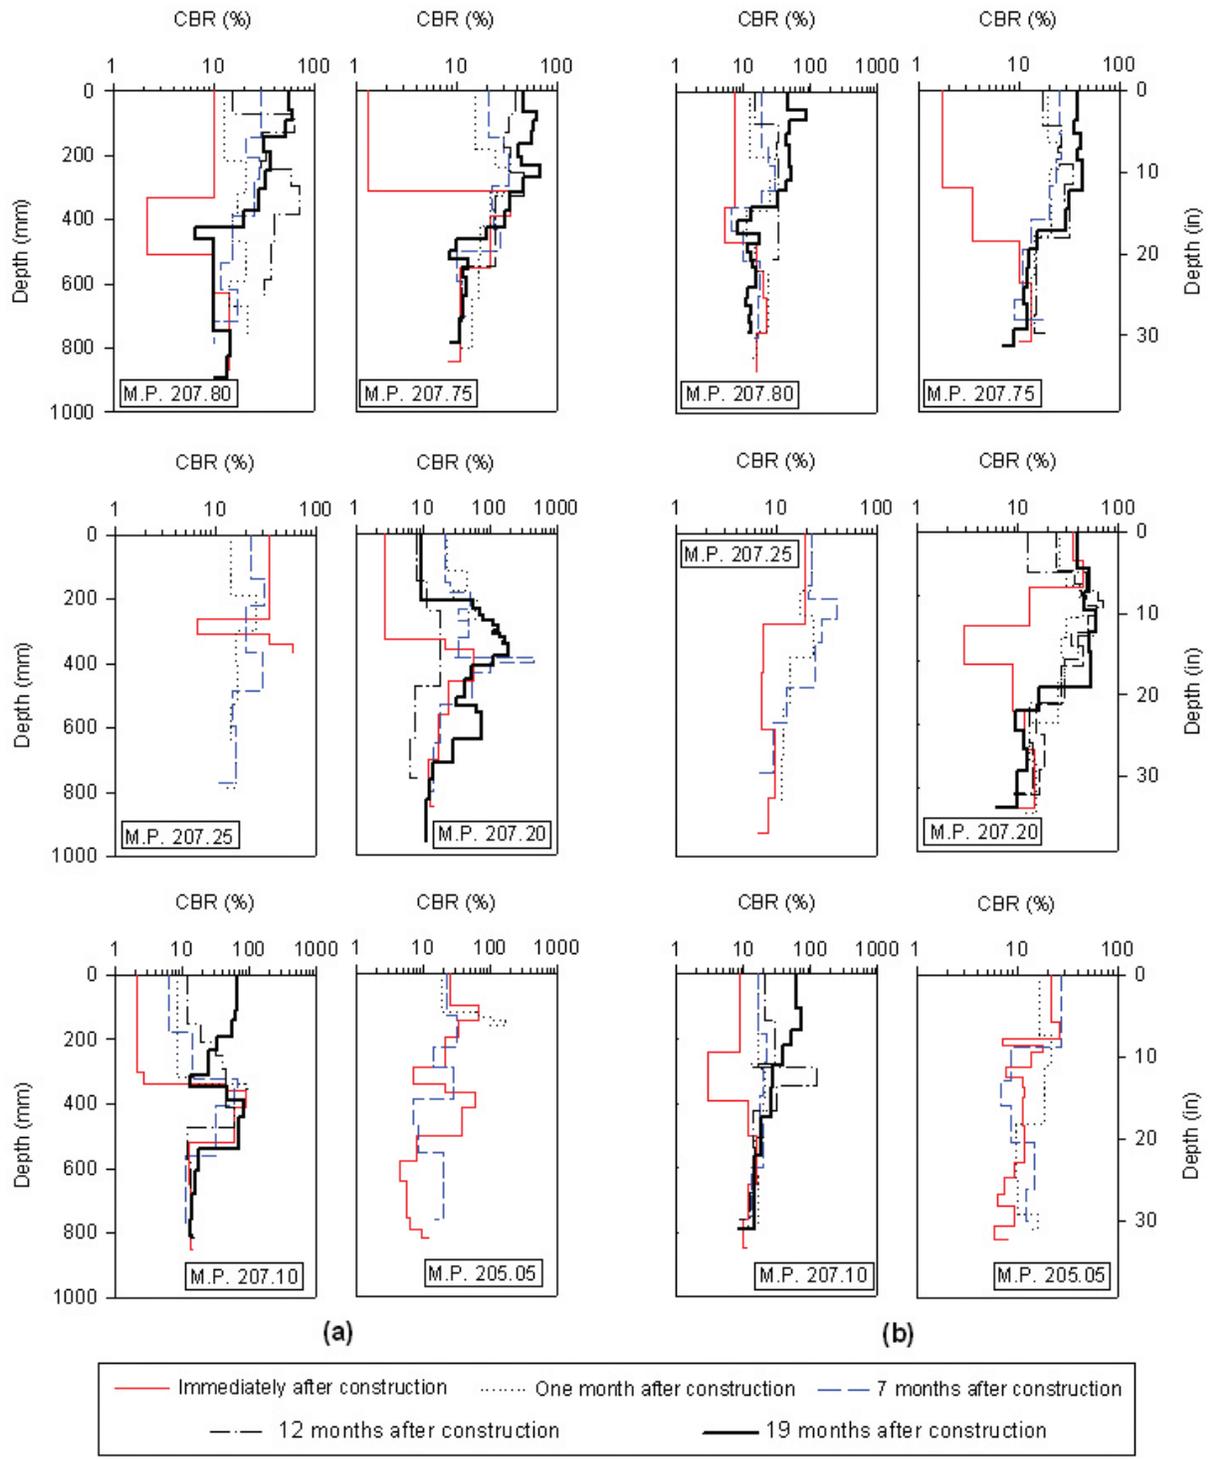
*Dynamic cone penetrometer test results with time for the fly ash–stabilized sections:
 (a) 3.0 ft and (b) 6.0 ft from the pavement edge*

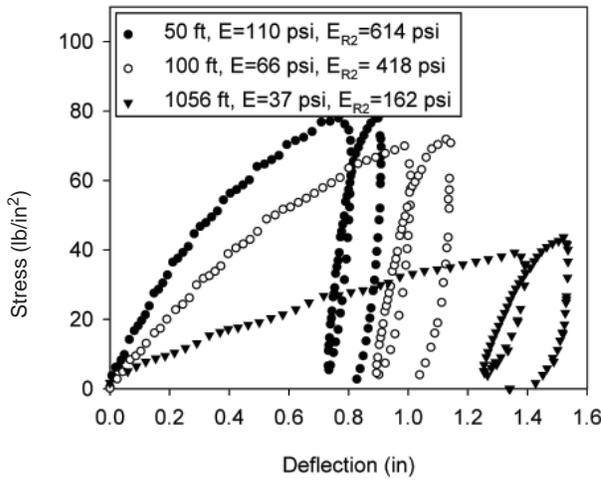
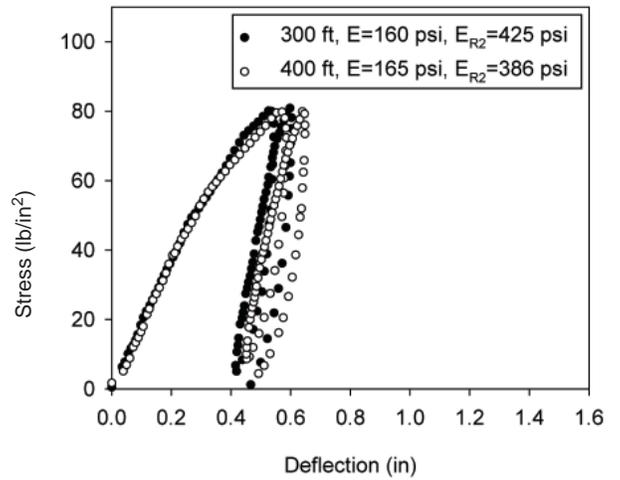
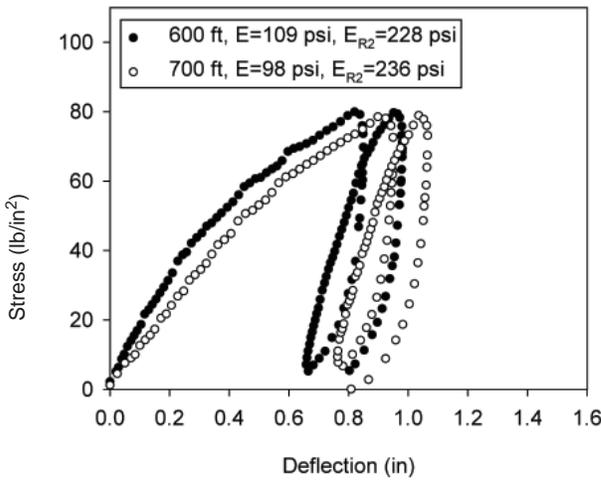
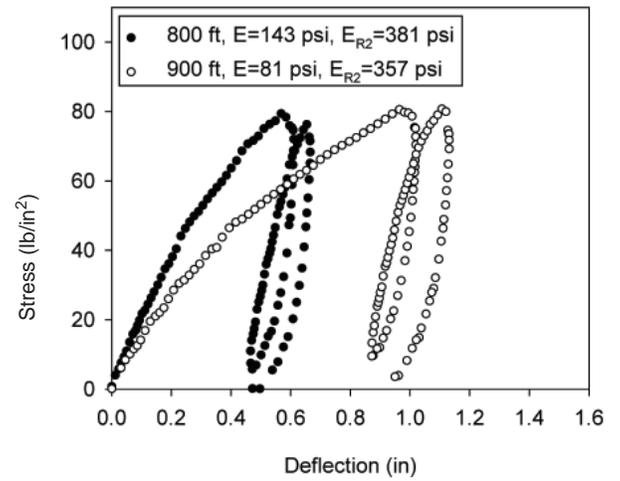
Control Section

BX1200

BX1100

BX4100

Plate load test results 10 months after construction, geogrid-stabilized sections

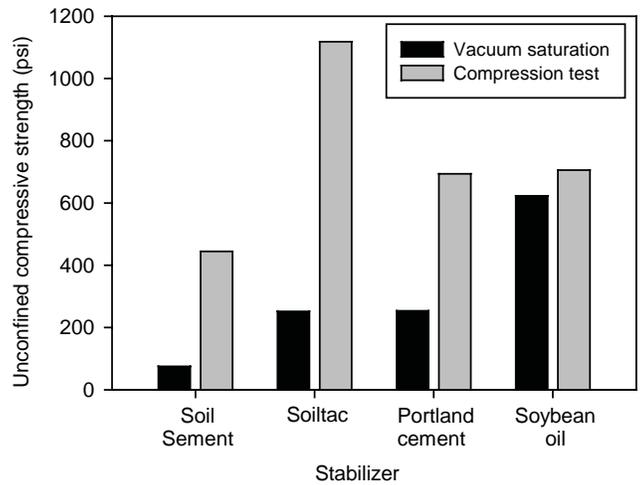
Summary of compressive strength results for the different stabilizers tested

To develop the findings from the field study, different stabilizers were selected to conduct a laboratory study of stabilization methods for shoulder granular material. The stabilizers selected for this study were Soil Sement polymer emulsion, Soiltac polymer emulsion, portland cement, and Dustlock soybean soil. The results of the study show that soybean oil can be a good candidate in stabilizing the shoulder granular layer.

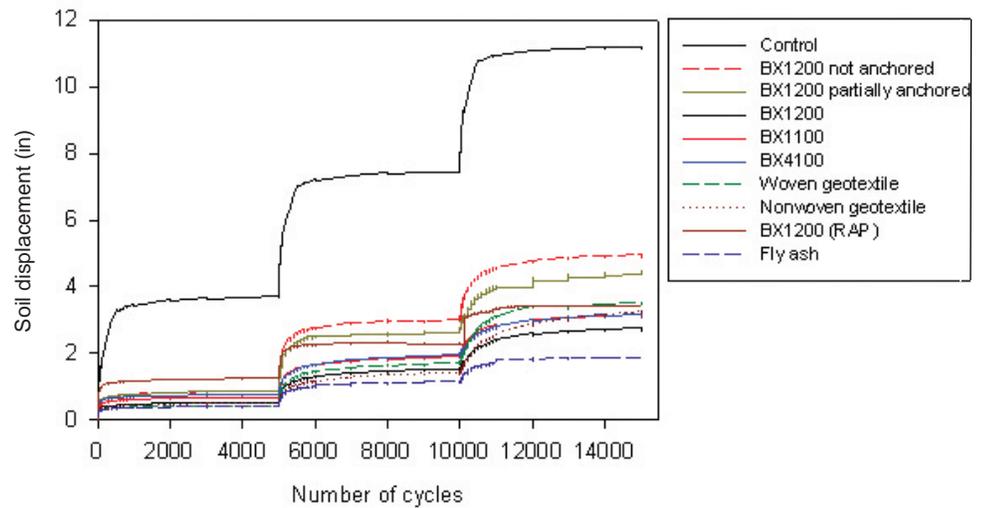
Summary of cumulative measured soil displacement for all laboratory box tests

To simulate a shoulder section overlying a soft subgrade, a laboratory study was conducted. Cyclic loading with three loading stages was used to study the performance of the laboratory model under different mechanical and chemical stabilization techniques. At each stage, a pressure was applied and sustained for 5,000 cycles at a frequency of 1 Hz. These pressures were 40, 80, and 120 psi. The soil properties before and after each test and the cumulative soil displacement over an increasing number of cycles were recorded.

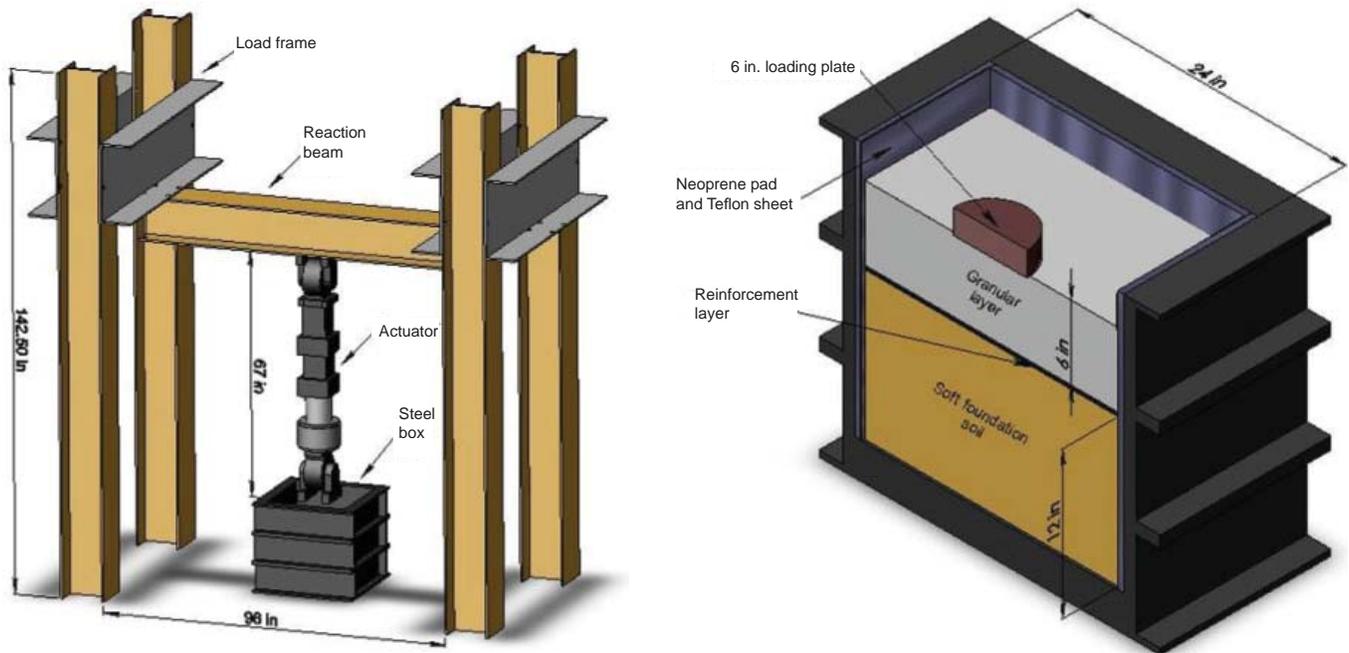
Schematic of the laboratory apparatus setup: Steel frame and hydraulic actuator for loading the stabilized soil (left) and steel box used to contain the soil (right)

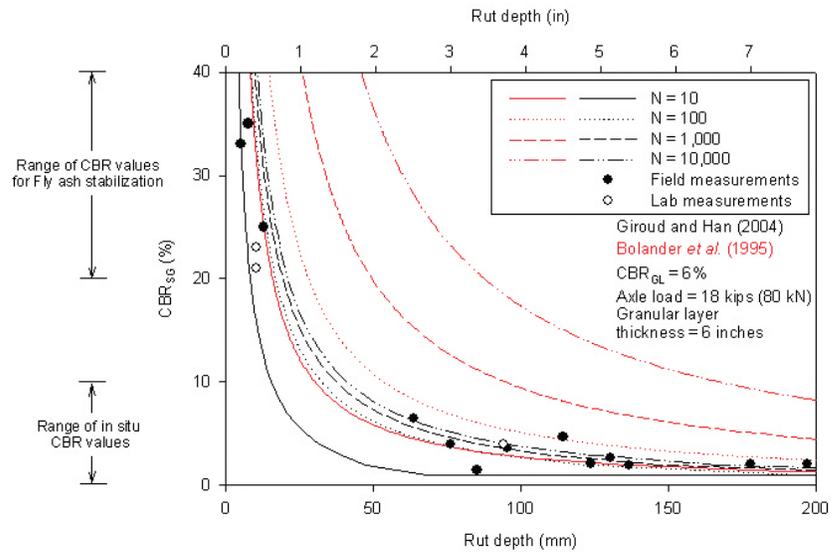
Shoulder design chart showing the relationship between subgrade CBR and expected granular shoulder rut depth for different load cycles

Using the results of these field and laboratory data, shoulder design charts were developed to help mitigate shoulder rutting caused by the bearing capacity failure of the subgrade layer. The design charts, validated by the field and laboratory data, were based on the semi-empirical method proposed by Giroud and Han (2004) and an equation developed by the U.S. Army Corps of Engineers in 1989 for predicting surface rutting for low-volume roads (Bolander et al. 1995). The charts can be a rapid tool for designing new granular shoulders and predicting the behavior of existing ones.

- To avoid shoulder rutting, it is recommended that the weighted average CBR value of the earth shoulder fill and the subgrade layers up to a depth of 20 in. should be greater than or equal to 12.
- The weighted average CBR value for the granular layer should not be less than 10.
- Dynamic cone penetrometer and Clegg impact tests can be used rapidly to assess the in situ CBR values during shoulder construction.
- The provided design charts can be used as a guide for constructing new shoulders. The allowable rut depth can be controlled by selecting an appropriate CBR value for each layer and accounting for the expected traffic level and loads. The design charts can also be used to predict the behavior of existing shoulder sections.
