# ULTRA-THIN PORTLAND CEMENT CONCRETE OVERLAY EXTENDED EVALUATION

Sponsored by  
the Iowa Highway Research Board  
and  
the Iowa Department of Transportation  
(Iowa DOT Project TR-432)

Final Report • January 2005

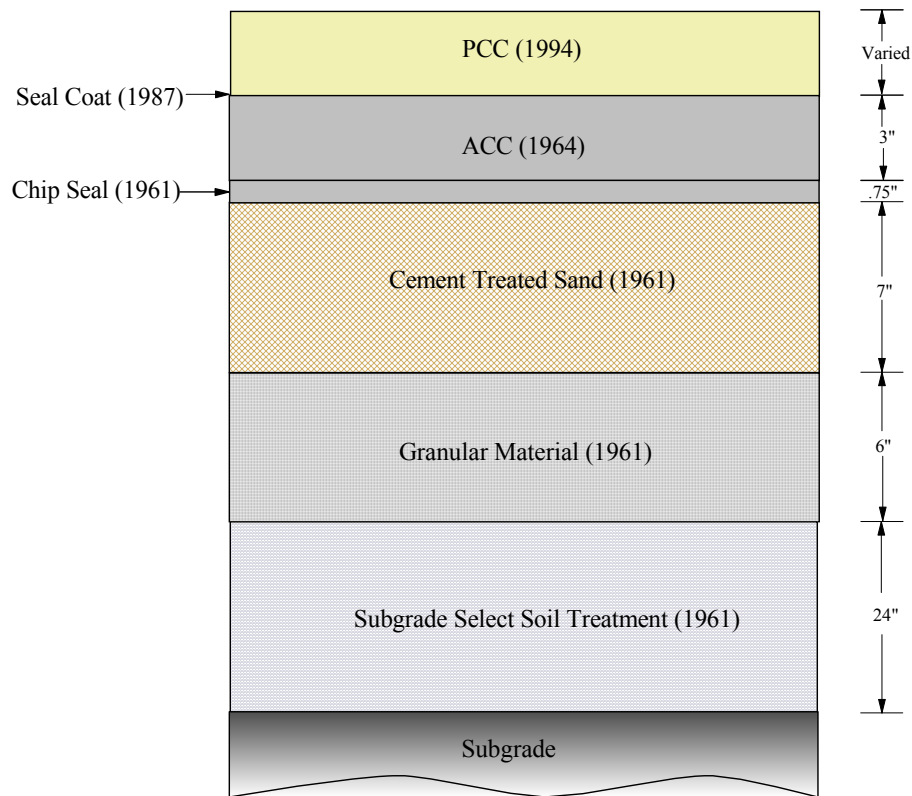
(ISHC) or Iowa DOT specifications effective at the time of contract letting. Figure 2 below shows a detailed cross-section of the pavement and Figures D.1 through D.3 show rehabilitation-specific project cross-sections.

**Figure 2. Pavement cross-section**

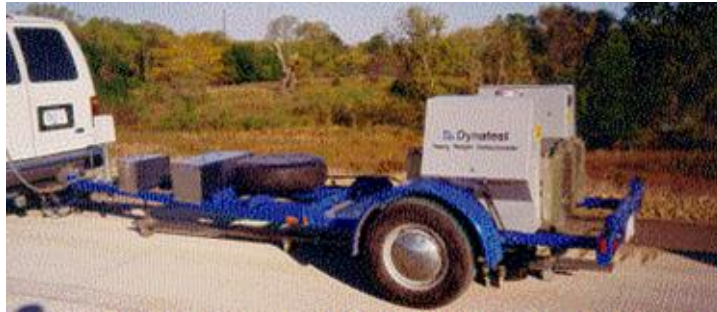
The FWD tests were conducted by ERES Consultants of Champaign, Illinois (see Figure 3). Testing was performed in the outside wheel path, 2 feet (0.6 m) from the outer edge, in each lane. Northbound lanes were tested between stations 2346+00 and 2694+50, and southbound lanes were tested between stations 2455+00 and 2697+25. FWD tests utilized seven deflection sensors placed at 0, 12, 24, 36, 48, 60, and 72 inches from the center of the load plate. Three test drops were conducted at each of 39 test locations with one drop per target load: 9,000, 12,000, and 16,000 force pounds. As indicated in the data tables, actual loads generated from the falling weights varied slightly from the target loads due to variations in pavement stiffness. Therefore, deflection measurements at each sensor were normalized for comparison between different test locations. The normalization was performed using linear interpolation. Ultimately, the results of the FWD testing were interpreted through calculating average deflection of basins and slopes between  $D_0$  and  $D_1$  as a representation of load transfer efficiency. The deflection load transfer efficiency was measured with the FWD by placing the load plate at the edge of the pavement section so only one of the slabs was loaded. Deflection sensors were placed equidistant from the joint, with one under the load and the remainder on the opposite side of the joint, and spaced at 12-inch intervals. The resulting assessment derived from the FWD tests is outlined under “Analysis and Results.” The sample test data is given in Appendix A, and graphs are available in Appendix B.

**Figure 3. Falling Weight Deflectometer**

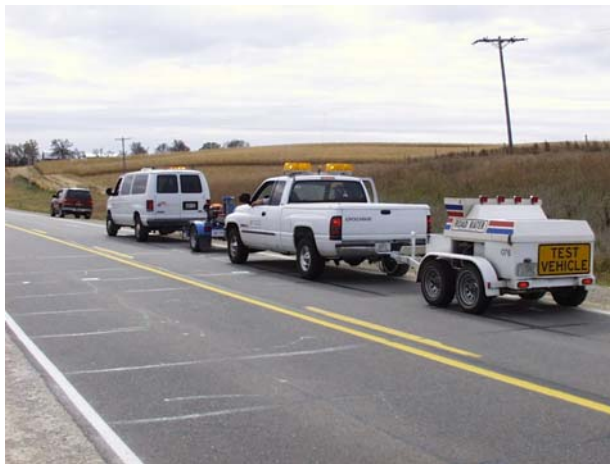
Additionally, the Iowa DOT's Road Rater was used on this project as part of a separate study to correlate the results of the ERES Falling Weight Deflectometer and the Iowa DOT's Road Rater.

**Figure 4. Measuring deflections with FWD and Road Rater**
