Center Islands with Raised Curbing for Rural Traffic Calming

A number of traffic-calming devices were evaluated to determine their effectiveness in reducing speeds along the main road through a small rural community. Five different treatments were selected and installed in six rural lowa communities. This tech brief highlights use of temporary curbing to create center islands.

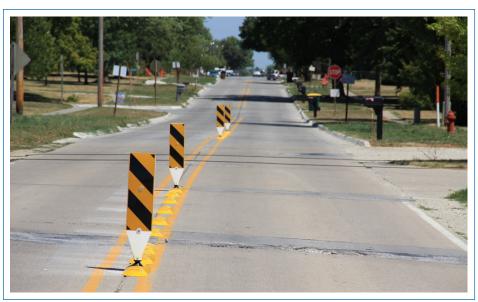
Mountable curbing at south entrance to St. Charles

The temporary curbing that was purchased is approximately 2 inches high by 40 inches long by 8 inches wide. The curbing has a rounded design that can be mounted by errant vehicles.

The treatment was placed at community entrances and extended into the community by several hundred feet depending on location. The first several sections of 40 inch curb sections were placed approximately 1 foot apart and subsequent sections were placed about 5 feet apart.

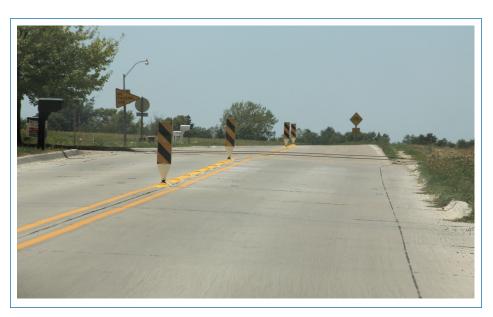
Mountable curbing installed at west St. Charles community entrance

Temporary islands were created using mountable curbing at the north, west, and south entrances. (A different treatment was placed at the east entrance to St. Charles). Mountable curbing was not appropriate for the east entrance given a horizontal curve, which may lead to some sight-distance issues for drivers being able to see the curbing in time.

St. Charles North	St. Charles South	St. Charles West
Mean Speed	-2.2	-1.9	0.4
85th Percentile Speed	-3	-1	0
Fraction of Vehicles Traveling Over Posted Speed Limit			
≥ 5 mph	-28.6%	-23.4%	5.9%*
≥ 10 mph	-45.8%	-28.6%	11.1%*
≥ 15 mph	-71.4%	-28.6%	0.0%*
≥ 20 mph	-100.0%	-50.0%	0.0%*
