Evaluation of Low Cost Traffic Calming for Rural Communities – Phase II

**Updated Final Report
October 2013**

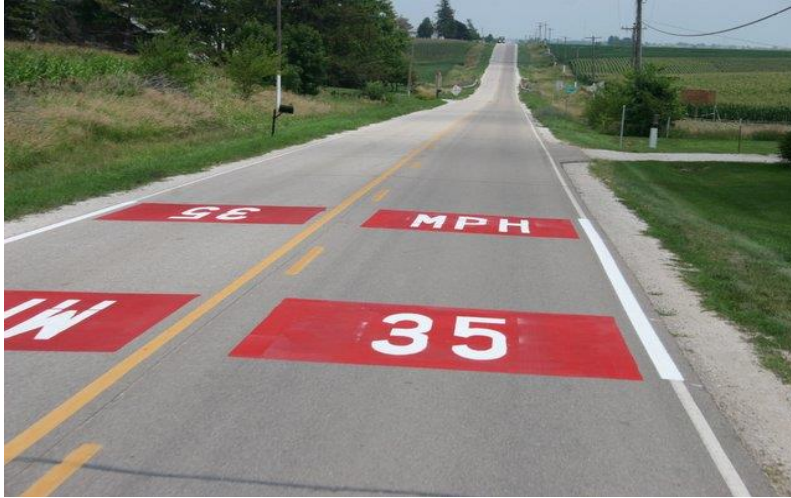
In a previous Iowa study, a modification of the European treatment was evaluated at the entrances to Dexter, Iowa along 350th Street (State Highway 925), as shown in Figure 3-5.

Figure 3-5: European-style traffic-calming treatment used in Dexter, Iowa

The treatment in Dexter resulted in a reduction in mean speed of 5.4 mph and a reduction in 85th percentile speed of 8 mph. The percentage of drivers traveling 5 or more mph over the posted speed limit was reduced by up to 32 percent and the percentage of drivers traveling 10 or more mph over the posted speed limit was reduced by 14.5 percent (Hallmark et al. 2007).

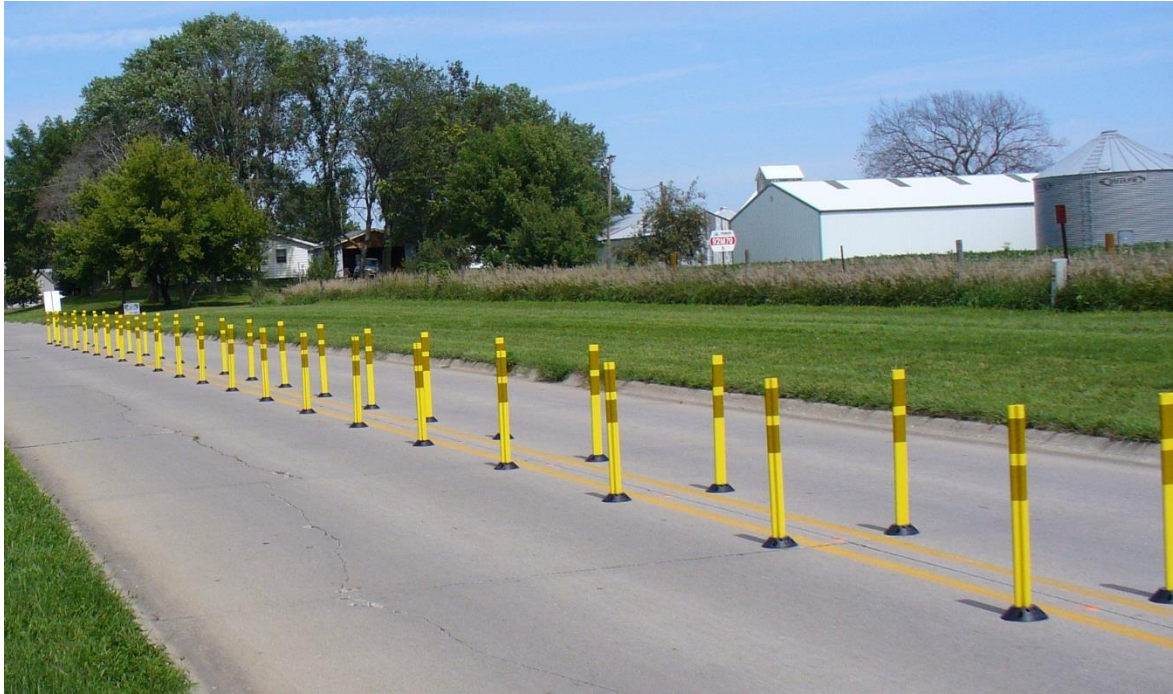
Use of vertical devices creates the sensation of less space and some discomfort to drivers, which encourages them to slow. In the previous traffic-calming study conducted by CTRE, 36 inch tall yellow tubular channelizers were spaced approximately 2 feet apart creating a center island, which narrowed travel lanes to approximately 11 feet for each direction as shown in Figure 3-9.

Figure 3-9: Temporary island treatment in Slater, Iowa (Hallmark et al. 2007)

The treatment was placed in Slater, Iowa and was very effective with reductions of up to 3 mph in both mean and 85th percentile speeds (Hallmark et al. 2007).

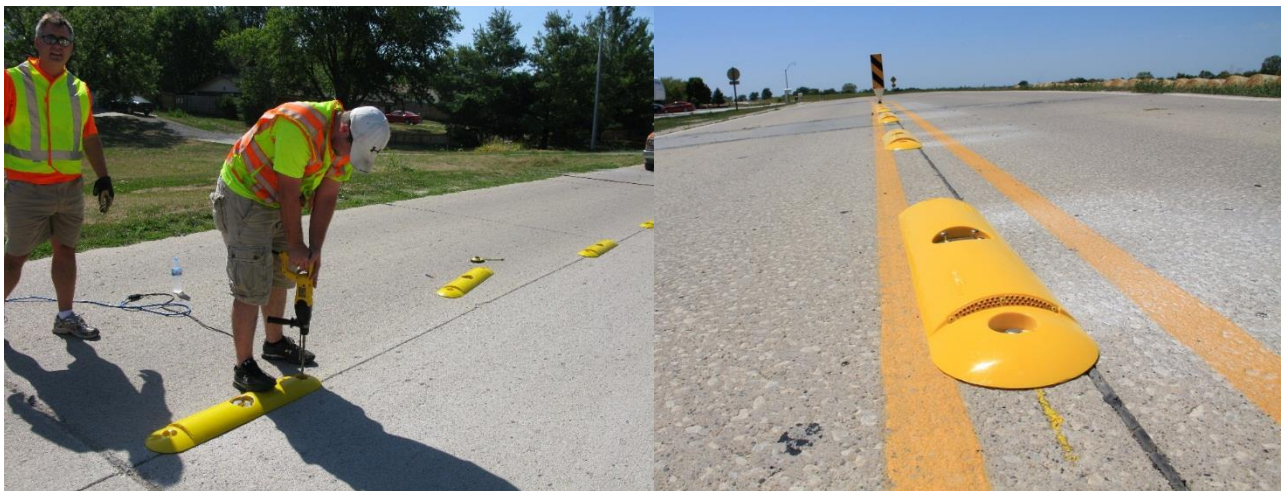
The treatment was affixed to the pavement using bolts as shown in Figure 3-11. As a result, the treatment could be removed and replaced as needed. This was important given the treatment needed to be removed for the winter months so that the city and county snowplow operators did not need to worry about plowing around the treatments during winter storm events.

Figure 3-11: Installation of raised curbing (left) and close-up of raised curbing (right)

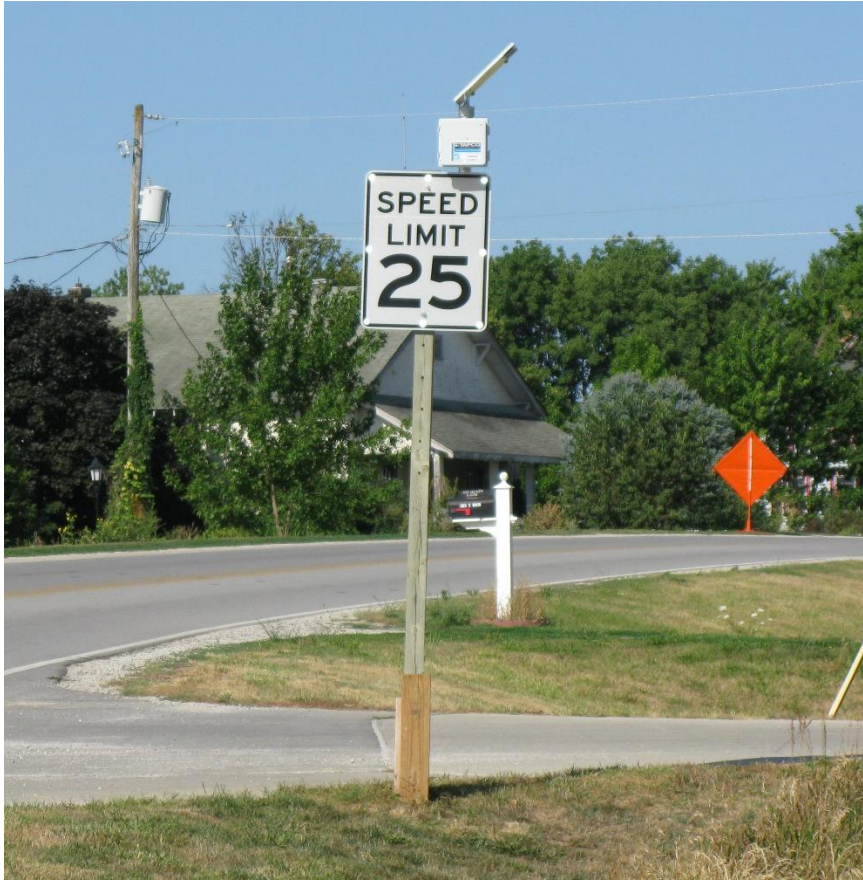
Another treatment evaluated was a speed limit sign that has radar-activated light-emitting diodes (LEDs) embedded around the border of the sign. The LED signs have been used extensively on stop signs and were recently available for speed limit signs. The sign is a normal speed limit sign with white LEDs around the periphery as shown in Figure 3-12.

Figure 3-12: Radar-activated LED speed limit sign

The purpose of the radar-activated LEDs is to get the attention of drivers traveling above a set speed threshold. As far as the team is aware, no studies have evaluated the effectiveness of the signs in reducing speeds.

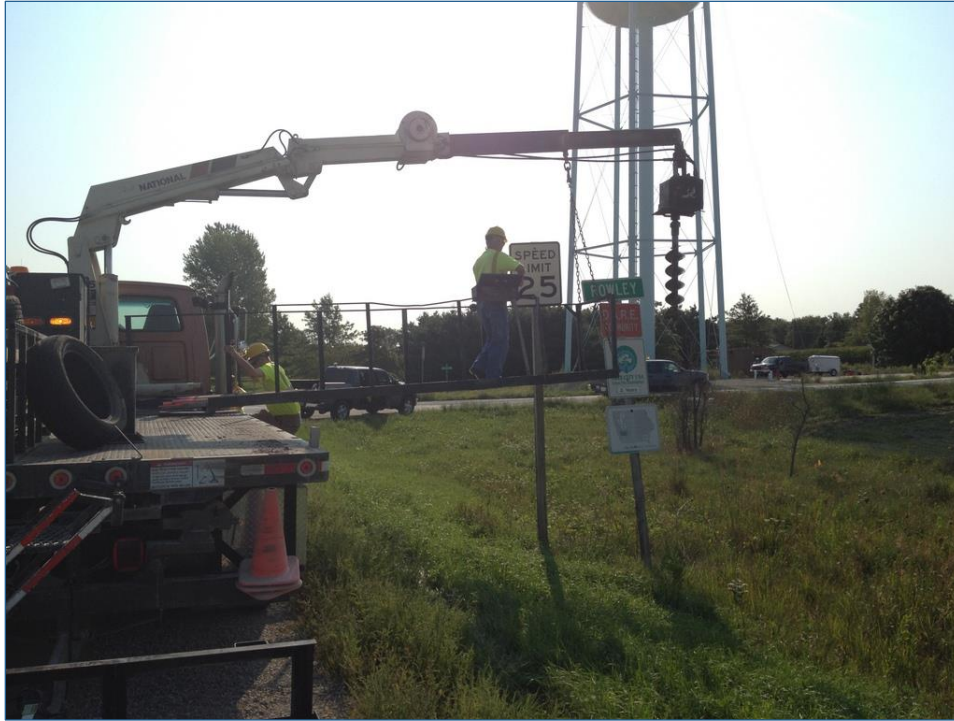
The LED signs were used for the first speed limit sign at two community entrances after the transition speed zones. The signs, which use solar panels for power, replaced existing speed limit signs on the existing posts (Figure 3-13).

Figure 3-13: Installation of LED speed limit sign

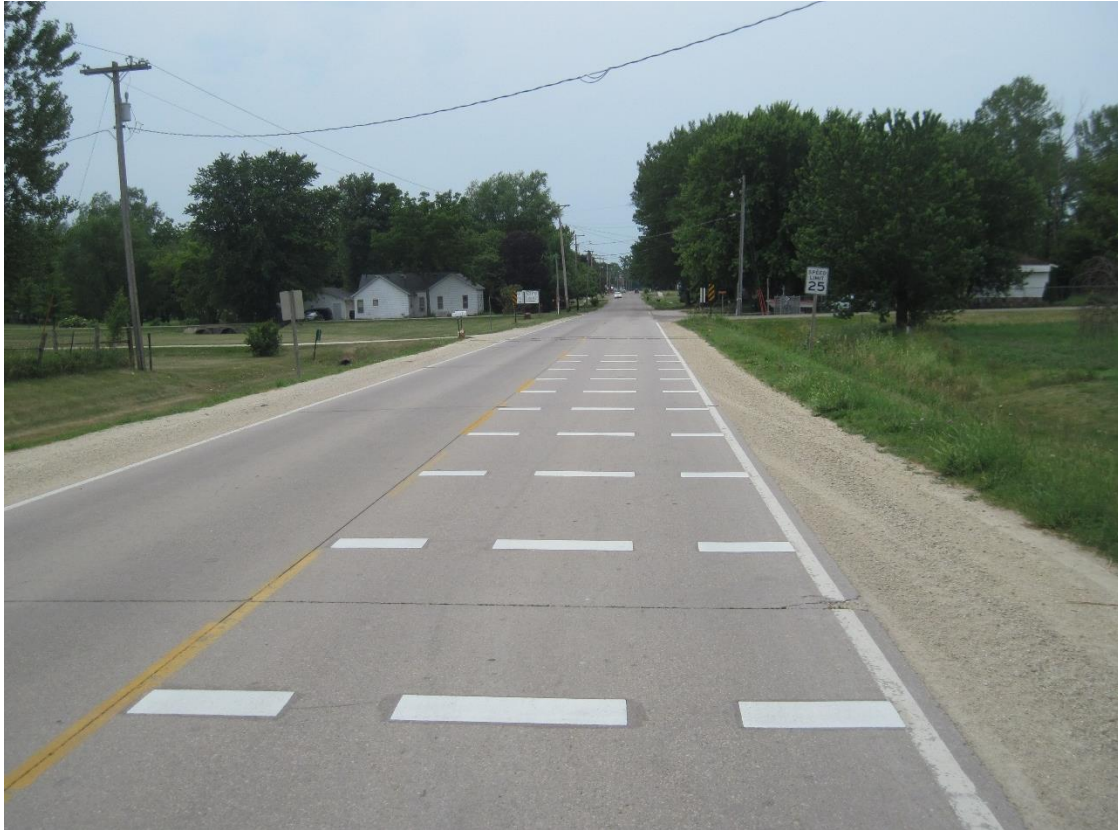
A transverse bar treatment was installed at the east side of the community (Figure 5-2). The bars were placed so they terminated at the first 25 mph speed limit sign. The treatment was placed in May 2012. The team worked with the Buchanan County engineer for installation and monitoring. The west community entrance was also a concern but, due to the presence of a bridge just at the community entrance, a suitable traffic-calming treatment was not available.

Figure 5-2: Transverse bar treatment at Hazleton east entrance

The most significant change was in the fraction of vehicles traveling over the posted speed limit. An 8 percent decrease was noted for vehicles traveling 5 or more mph over with a 12 percent decrease for vehicles traveling 10 or more mph over, and 25 percent for 15 or more mph over. Results were similar for the 12 month after period for vehicles traveling 5 or 10 or more mph over. Smaller reductions were noted for 15 or more mph over (decrease of about 16 percent).

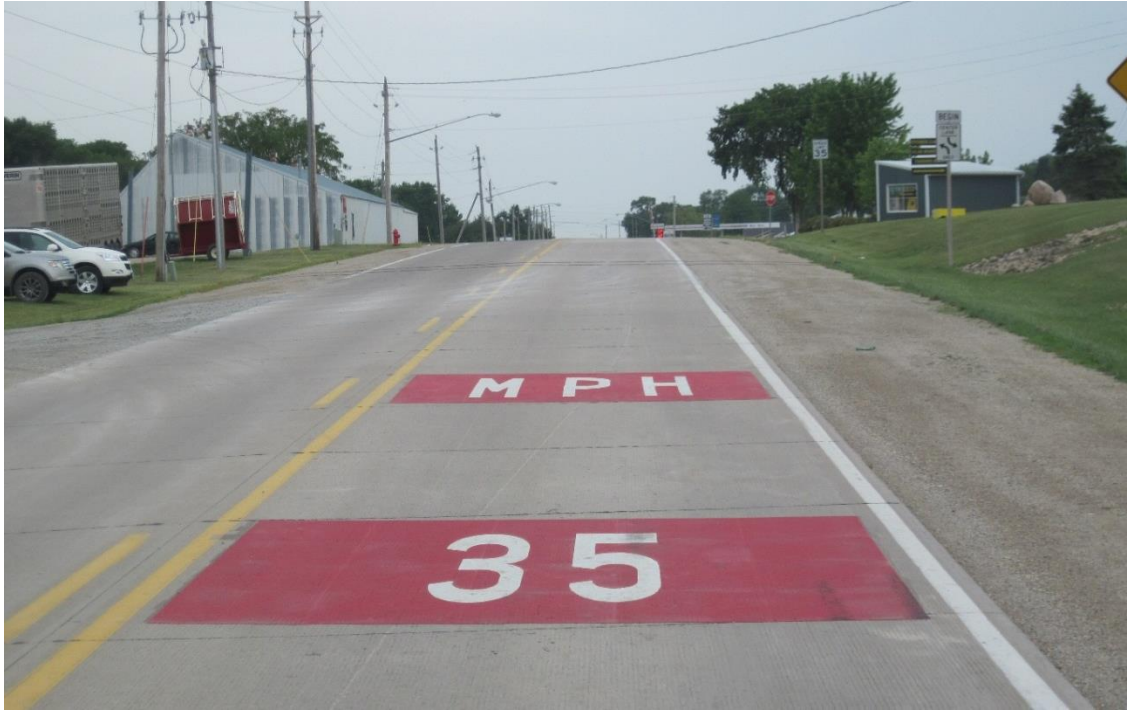
Figure 5-4: Colored entrance treatment for Jesup east community entrance

Mean speed at the east entrance decreased by 1.3 mph and 85th percentile speed decreased by 2 mph 1 month after installation of the initial treatment. Mean speed decreased by 1.4 mph and 85th percentile speed decreased by 1 mph 12 months after. Although these decreases were only moderate, much more significant decreases were noted in the fraction of vehicles traveling 5, 10, or 15 or more mph over the posted speed limit of 35 mph.

A 43.5 and 34.8 percent decrease was noted 1 and 12 months after initial treatment installation, respectively, for vehicles traveling 5 or more mph over, while a 40 and 60 percent decrease resulted for vehicles traveling 10 or more mph over.

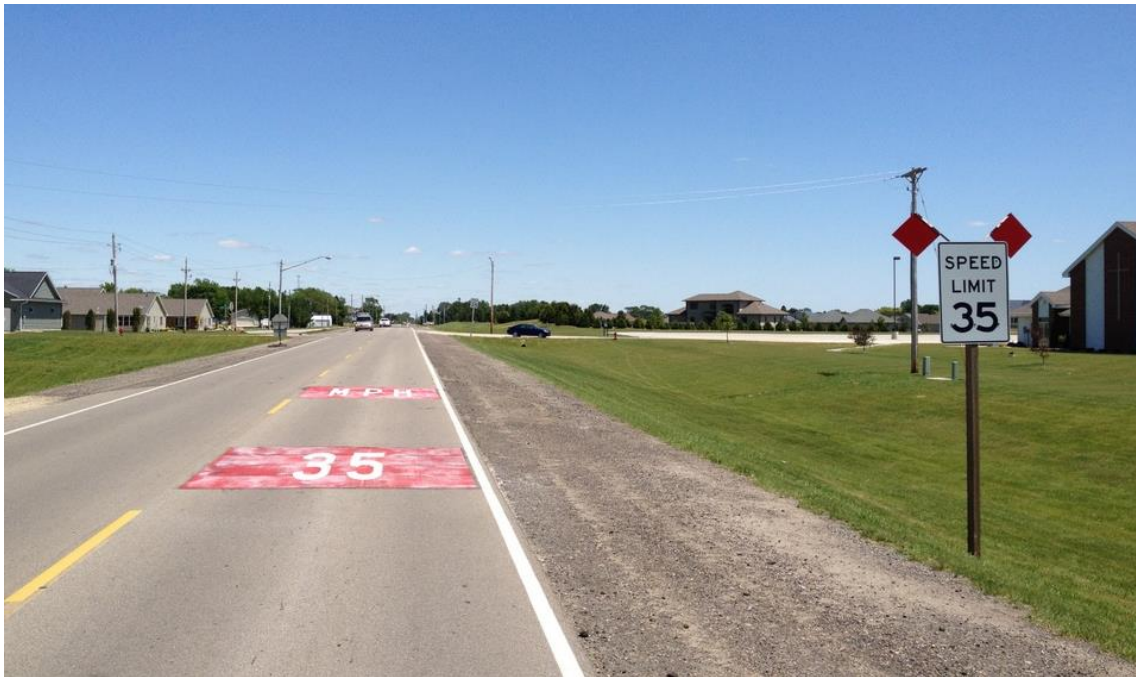
Figure 5-5: Colored entrance treatment for Jesup west entrance

As shown in Table 5-3 for the west entrance, similar decreases in mean and 85th percentile speeds (1.5 and 2 mph, respectively) were noted as for the east entrance for 1 month after installation of the initial treatment. Mean speed decreased by 0.8 mph and 85th percentile speed decreased by 1 mph 12 months after.

Significant changes in vehicles traveling over the posted speed limit of 35 mph were noted with a reduction of nearly 30 percent in the fraction of vehicles traveling 5 or more mph over and 40 and 50 percent in the fractions traveling 10 or 15 or more mph over, respectively.

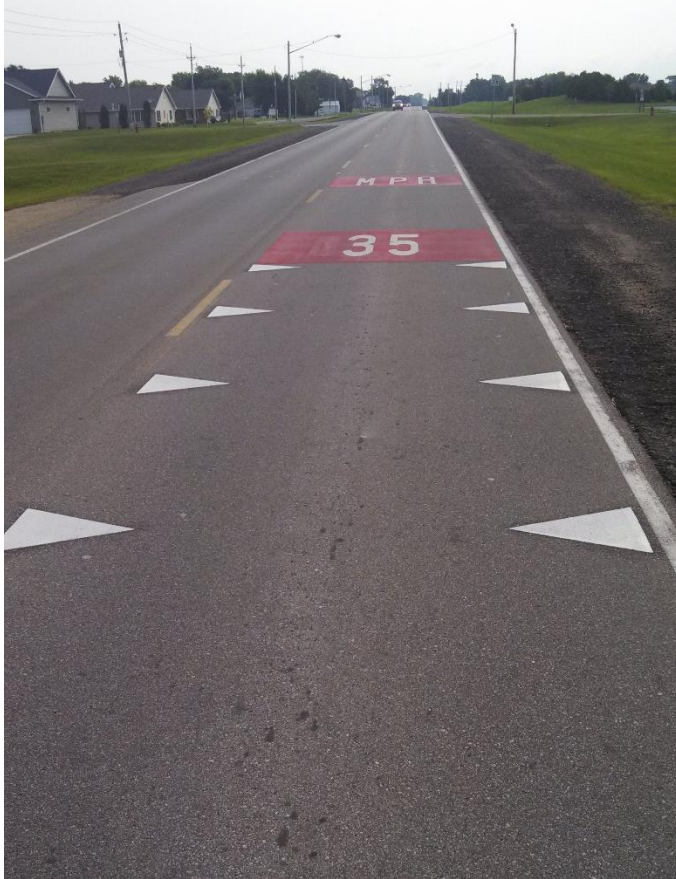
Figure 5-6: Jesup west colored entrance treatment with addition of dragon's teeth

After installation of the dragon's teeth, mean and 85th percentile speeds were similar to what was observed with the initial treatment. Results were similar for vehicles traveling 5 or 10 mph over the speed limit while a smaller reduction was noted for vehicles traveling 15 or more mph over (61 versus 100 percent). However, only a small fraction of vehicles were traveling at these speeds for any time period.

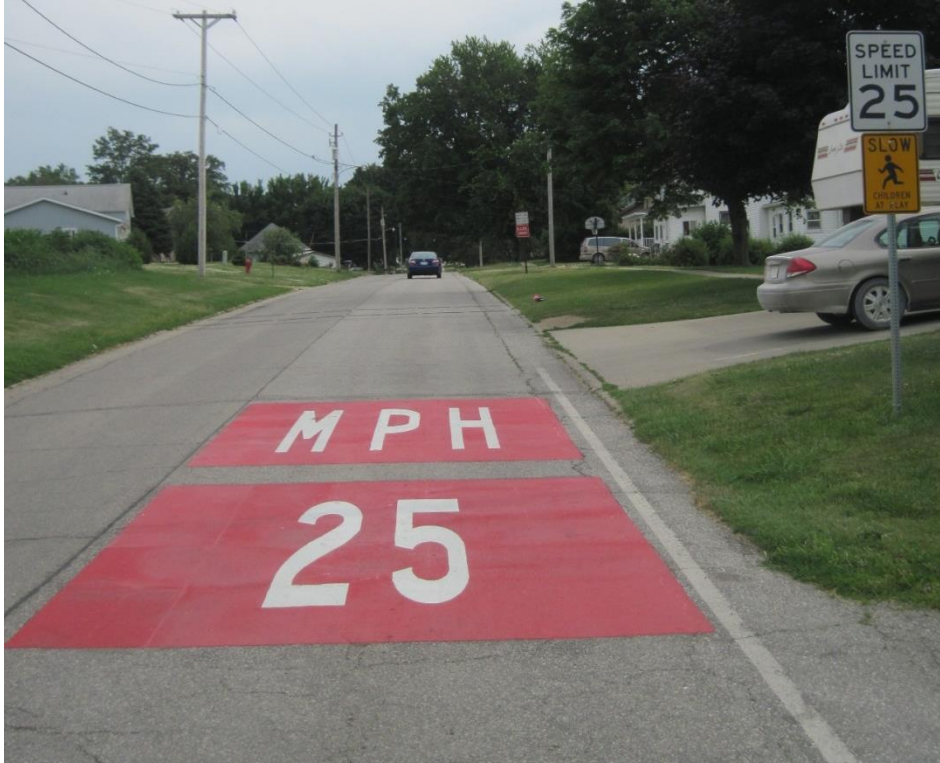
The treatment was placed so that it terminated at the first 25 mph speed limit sign as shown in Figure 5-8. The initial treatment was placed in May 2012. Dragon's teeth were added approximately 12 months later as shown in Figure 5-9.

Figure 5-8: Colored entrance treatment for north community entrance in Ossian

Reductions in mean and 85th percentile speeds from 1 to 2 mph resulted for the 1 and 12 month periods after installation of the initial treatment. At 1 month, the fraction of vehicles traveling 5 mph over the posted speed limit of 25 mph decreased by almost 30 percent, while the fraction traveling 10 or more mph over decreased by more than 36 percent. The fraction of vehicles traveling 15 or more mph over decreased by almost 60 percent. Decreases were also noted for vehicles traveling 5, 10, or 15 mph over the posted speed limit at 12 months, but they were less than half the reduction noted for 1 month.

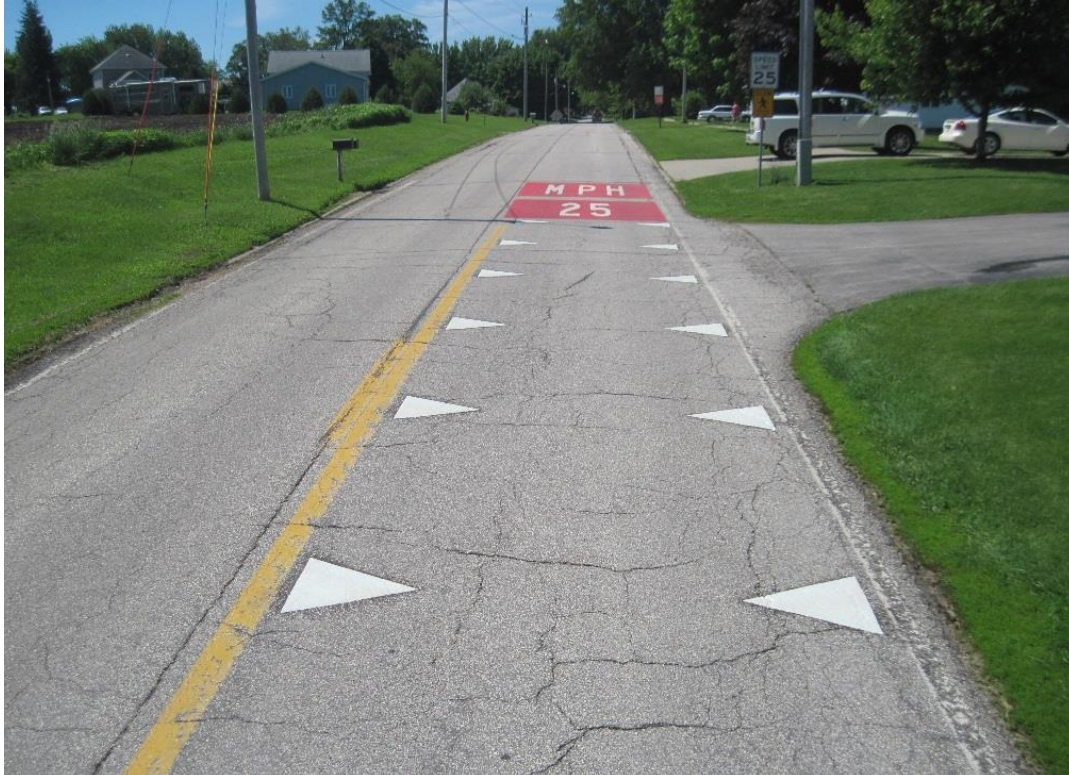
Figure 5-9: Ossian north colored entrance treatment with addition of dragon's teeth

After installation of the dragon's teeth, only minor reductions in mean and 85th percentile speeds were found. Lower reductions were also noted for vehicles traveling over the posted speed limit. As a result, the addition of dragon's teeth did not appear to result in increased compliance with the posted speed limit.

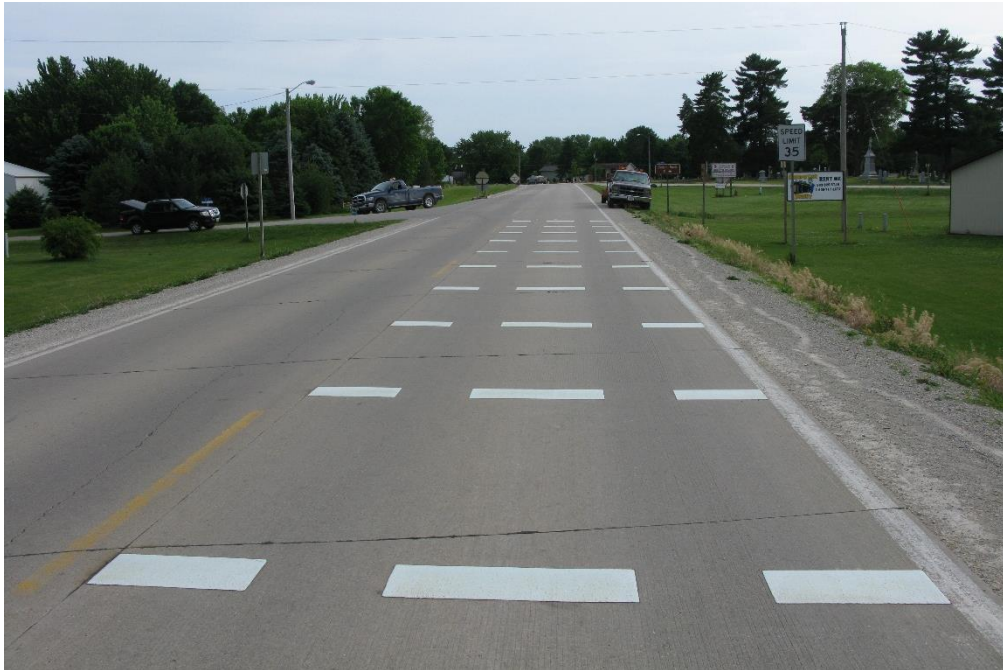
The treatments are shown in Figures 5-11 through 5-13.

Figure 5-11: Transverse bar treatment for north Quasqueton community entrance

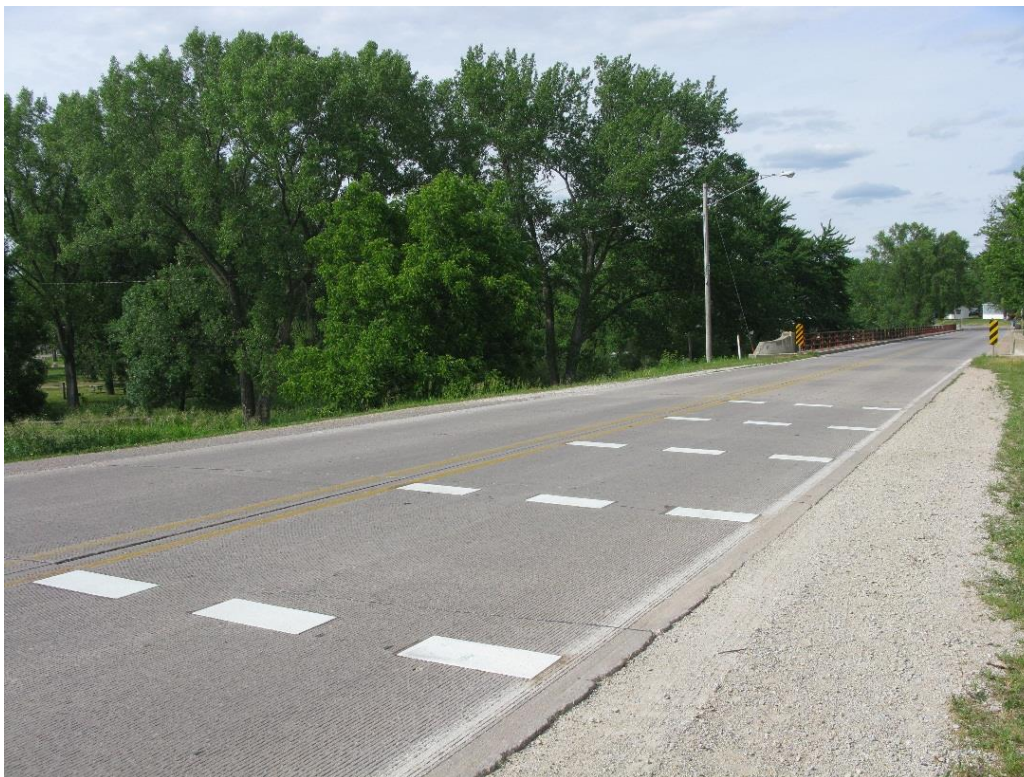
Figure 5-12: Close-up of transverse treatment at south Quasqueton entrance

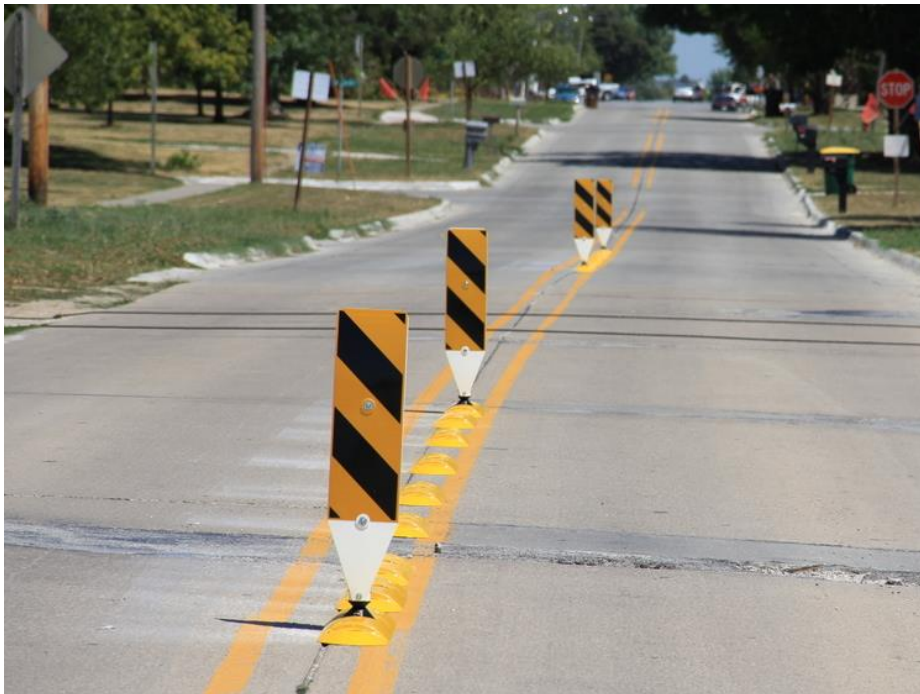
Figure 5-16: Mountable curbing at south entrance to St. Charles

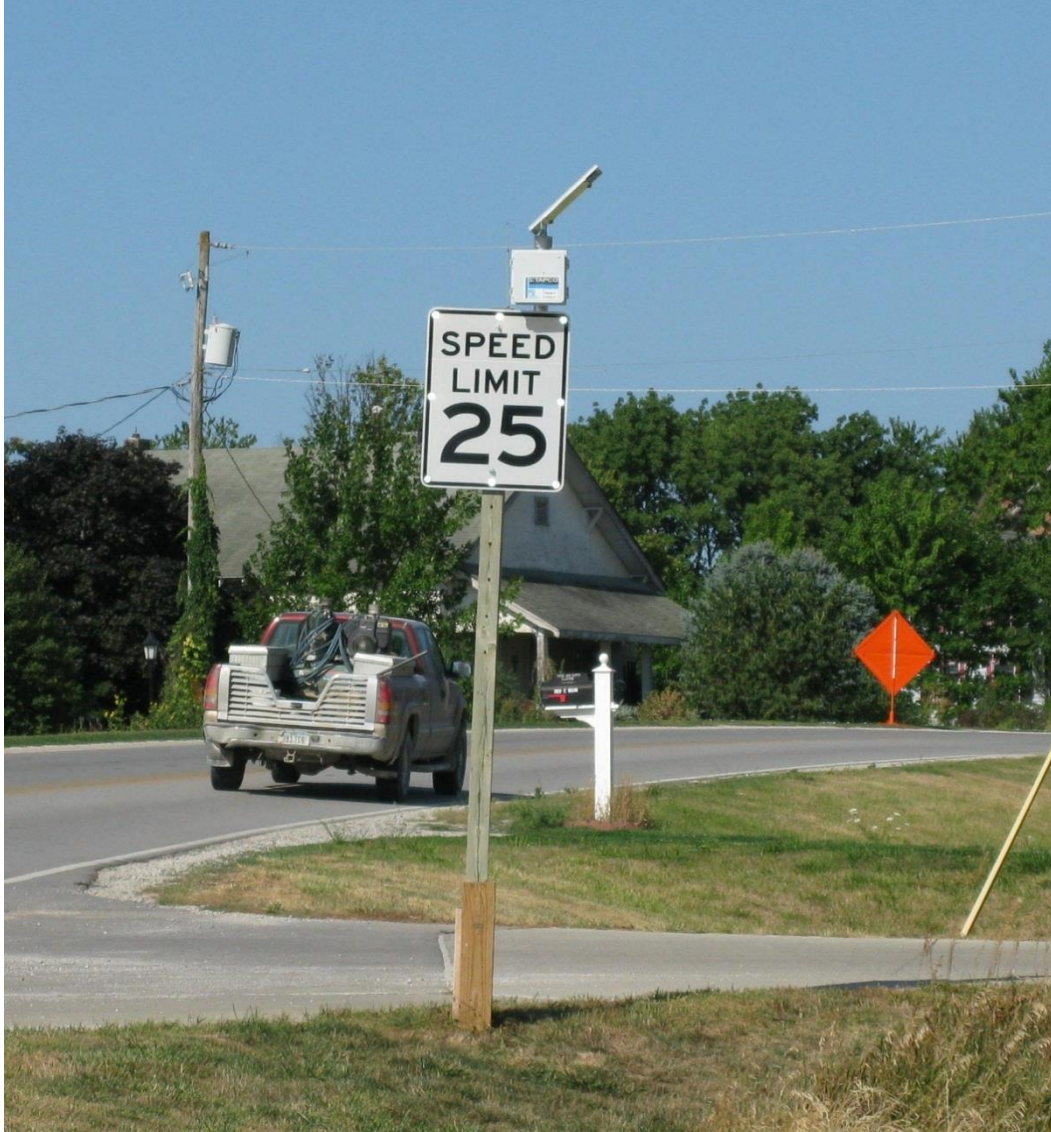
Figure 5-17: Radar-activated LED speed limit sign at east St. Charles community entrance

Minor changes occurred 1 month after installation of the sign with minor reductions in mean speed and with the fraction of vehicles traveling 5 or 10 mph over the speed limit. The fraction of vehicles traveling 15 or more mph over the limit increased from 4 to 5 percent (a 25 percent increase). No changes were noted in the upstream comparison site.

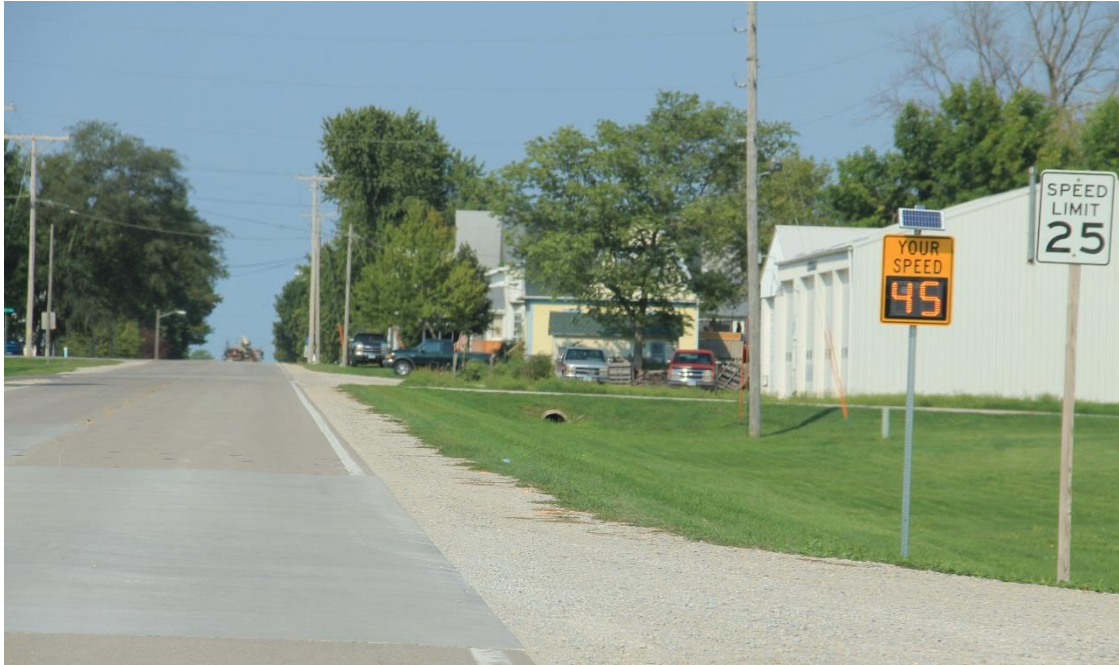
The community was suggested by the Buchanan County engineer who was installing traffic calming at select communities within the county. A dynamic speed feedback sign (DSFS) was installed at the same point as the first 25 mph speed limit at the east entrance as shown in Figure 5-19. A radar-activated LED speed limit sign was installed at west community entrance at the first 25 mph speed limit as shown in Figure 5-20.

Figure 5-19: DSFS installed at east Rowley community entrance

Table 5-11 shows results for the DSFS at the east community entrance to Rowley.

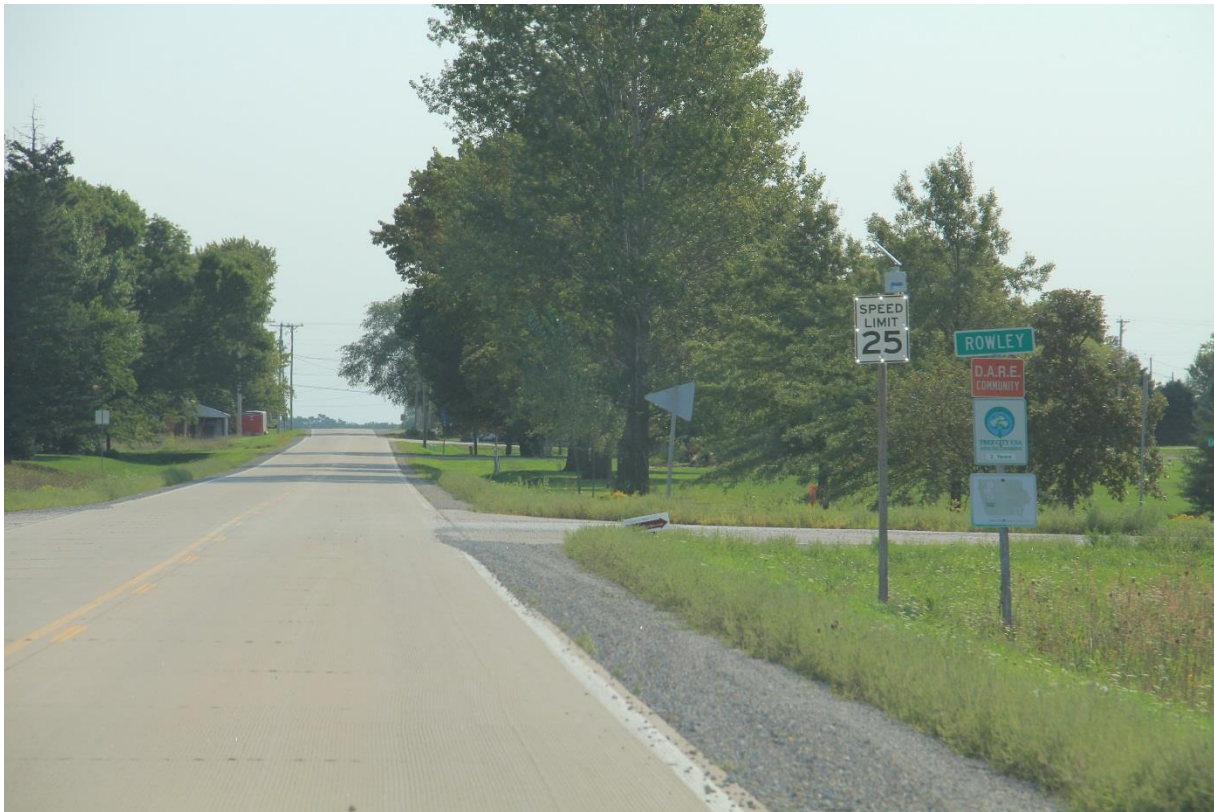
Figure 5-20: Radar-activated LED speed limit sign installed at west Rowley community entrance

Major reductions in speed were also noted for the radar-activated LED speed limit sign that was installed at the west entrance to Rowley, as shown in Table 5-12.
