Evaluation of Rumble Stripes on Low-Volume Rural Roads in Iowa—Phase II

# Evaluation of Rumble Stripes on Low-Volume Rural Roads in Iowa—Phase II

tech transfer summary

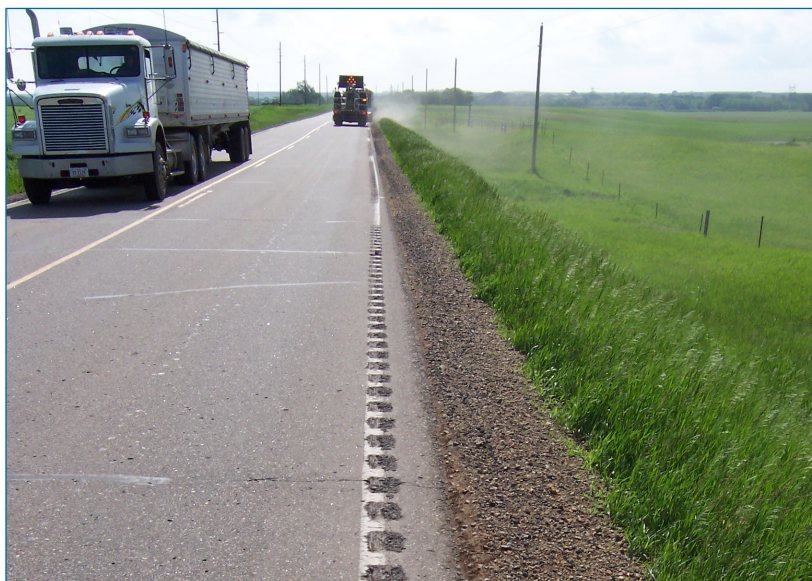
*Milling work for edge-line rumble stripes on a rural highway in Iowa*

This project involved installing rumble stripes, which are a combination of conventional rumble strips with a painted edge line placed on the surface of the milled area, along the edge of the travel lanes, but at a narrow width to avoid possible intrusion into the normal vehicle travel paths.

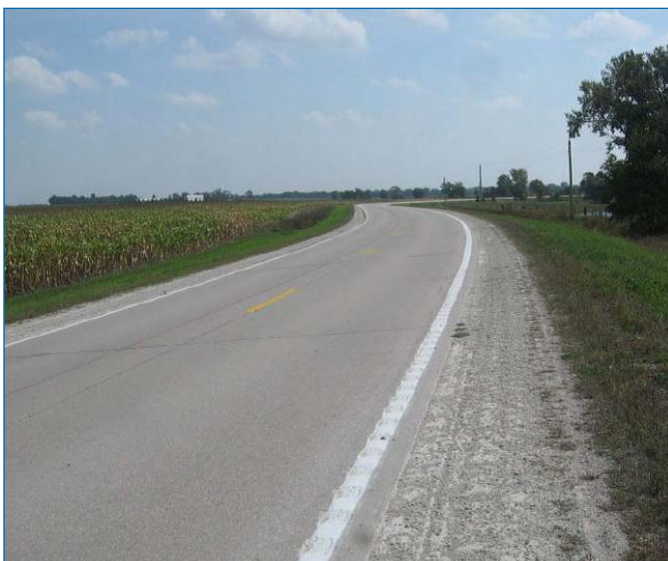
*Completed PCC rumble stripe installation in Buchanan County (image: Hawkins, CTRE)*

The first evaluation was pavement marking wear. One of the advantages attributed to rumble stripes is additional visibility of the pavement marking. It is thought that the shape of the rumble stripe itself provides a raised (vertical) surface so that the markings are more visible at night and particularly when some amount of precipitation is on the pavement surface.

In addition, the depression protects part of the pavement marking which can lead to improved wear. Consequently, part of the evaluation was to monitor wear over time.

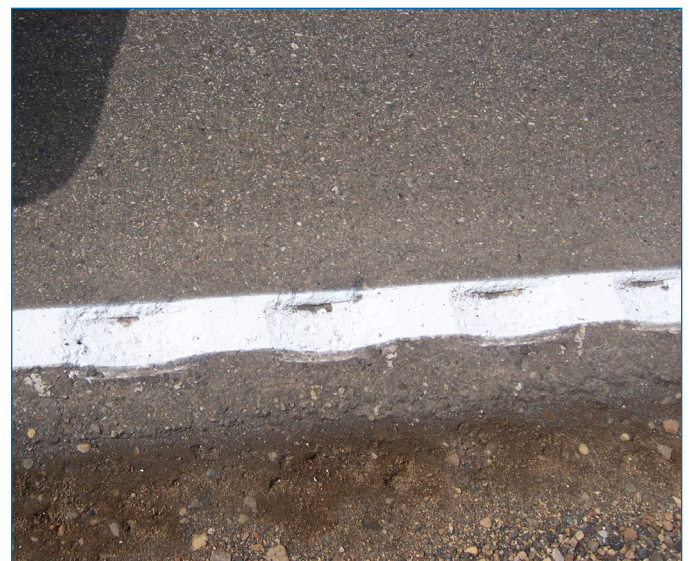
*Completed edge-line rumble stripe on a rural HMA highway in Iowa*

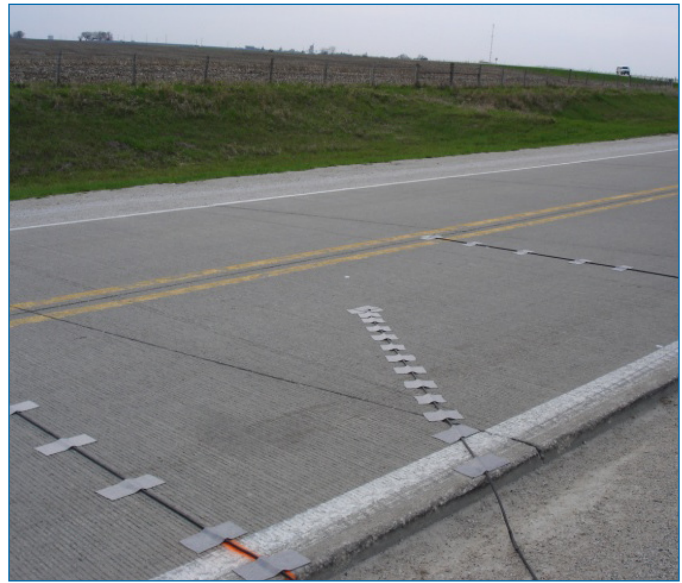
*Road tube layout to measure lateral displacement in the field (Z configuration)*

Lane position was evaluated before and after installation of edge-line rumble stripes as a surrogate measure of safety given only a short after-period was available for a crash analysis. Lateral position data were collected using a Z-configuration setup with road tubes at six locations.

Data were collected over several days before and, then, approximately one month after installation of the edge-line rumble stripes. Lateral position from the right roadway edge was measured using the road tubes. Distance from the lane center was calculated using lateral position and lane width. Data were evaluated for day and nighttime periods separately.

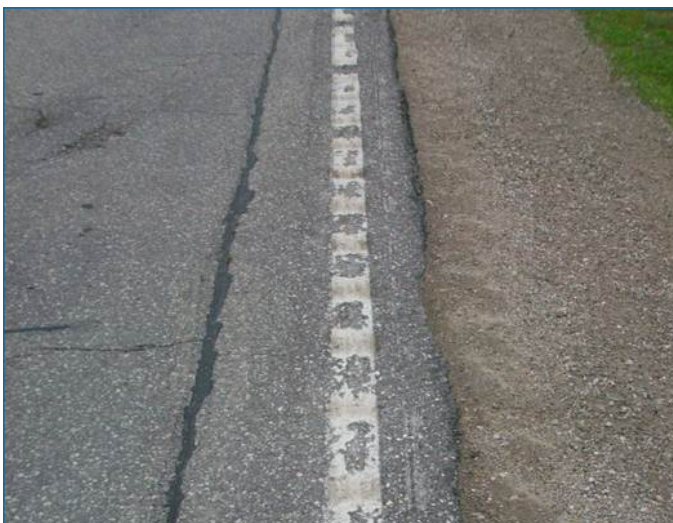
*Sample wear on HMA after two winters*

Several sites were visited two years after application of the rumble stripes and a qualitative assessment of pavement marking wear was conducted. At all of the sites, a significant portion of the regular pavement markings, which were flush with the pavement surface, had been worn away by the snowplows, while much of the marking within the rumble stripe remained.

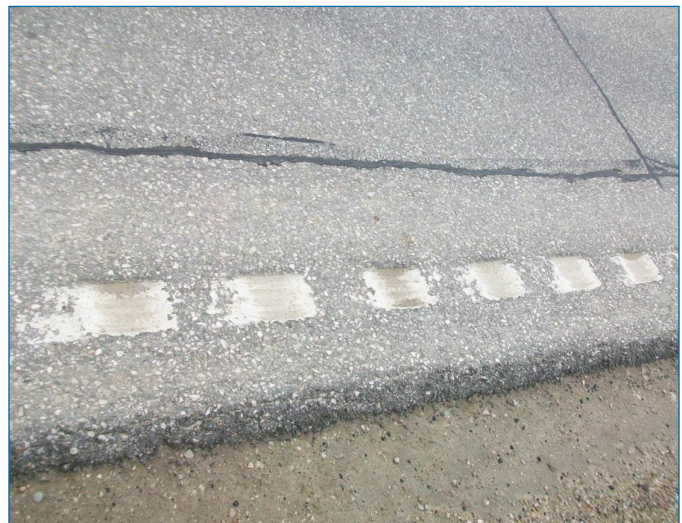
*Edge lines still visible in rumble stripe depressions after wear*

As a result, the rumble stripe was successful in preserving the pavement marking, which will lead to improved visibility. One problem that was noted with the rumble stripes is that material (sand, gravel, and dirt) tends to accumulate within the stripe.

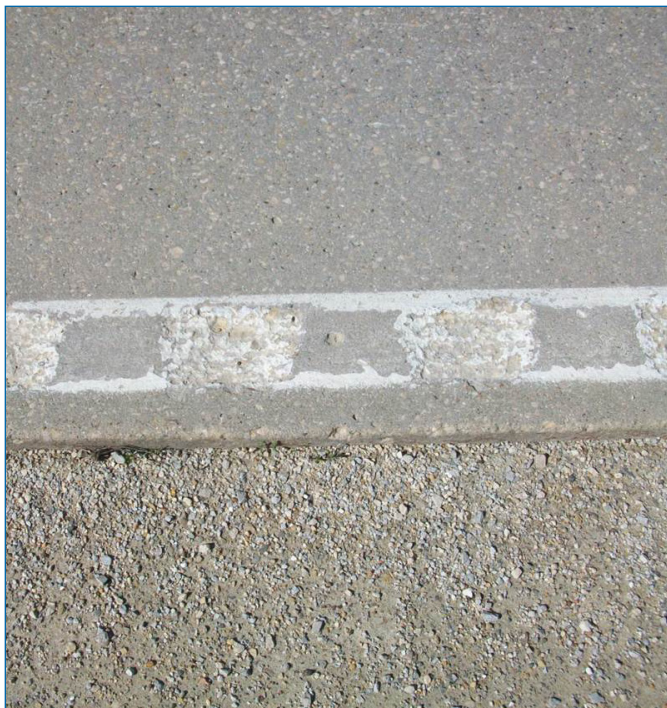
*Sample wear on PCC after two winters*

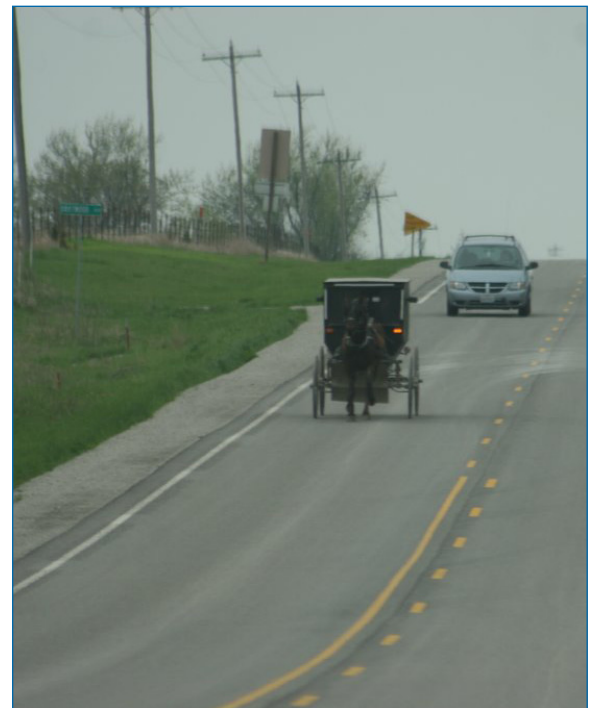
*The Amish group in Davis County indicated the wider rumble strips were a problem for them (image: Hawkins, CTRE)*

- Continue to monitor the reaction to rumble stripes from special road users, such as bicyclists, horse-drawn vehicle users, and agricultural equipment operators.
