# Field Measurement of Bridges for Long-term Structural Movement

Sponsored by the Iowa Department of Transportation,  
Highway Division, and the Iowa Highway Research Board

Iowa DOT Project HR-295  
ISU-ERI-Ames-89128

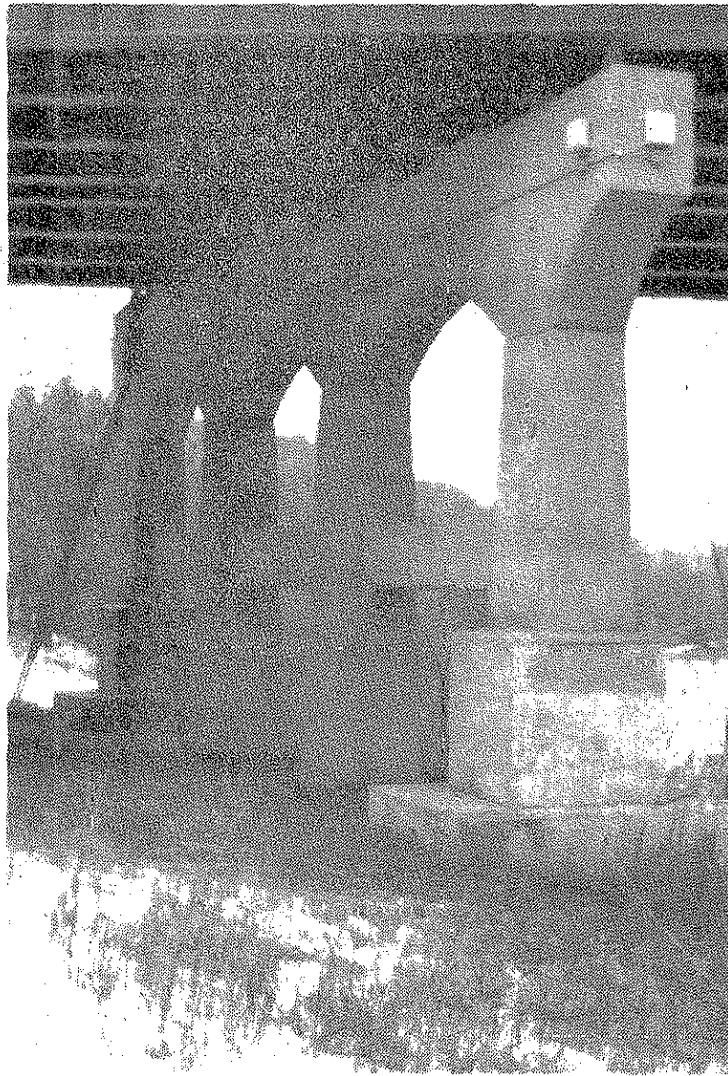
Fig. 10. Instrumentation layout on the Karl King bridge.

Fig. 10. Instrumentation layout on the Karl King Bridge.

*Structural*—The layout of the instrumentation used on Pier No. 4 is shown in Fig. 10. The tilt sensors were mounted on both of the main axes of the pier capbeam to provide

As shown in Fig. 10, the north and south tilt sensors are on opposite faces of the capbeam, and the east and west sensors also occupy opposite faces. The sensors were designed so that a clockwise rotation (of the sensors) represented a positive magnitude of tilt. Therefore, the orientation of the pairs of sensors (north-south and east-west) caused a magnitude of recorded tilt that was equal in magnitude, but opposite in sign (assuming, of course, that the pier moved as a unit equally in north-south and east-west directions). In order to allow a

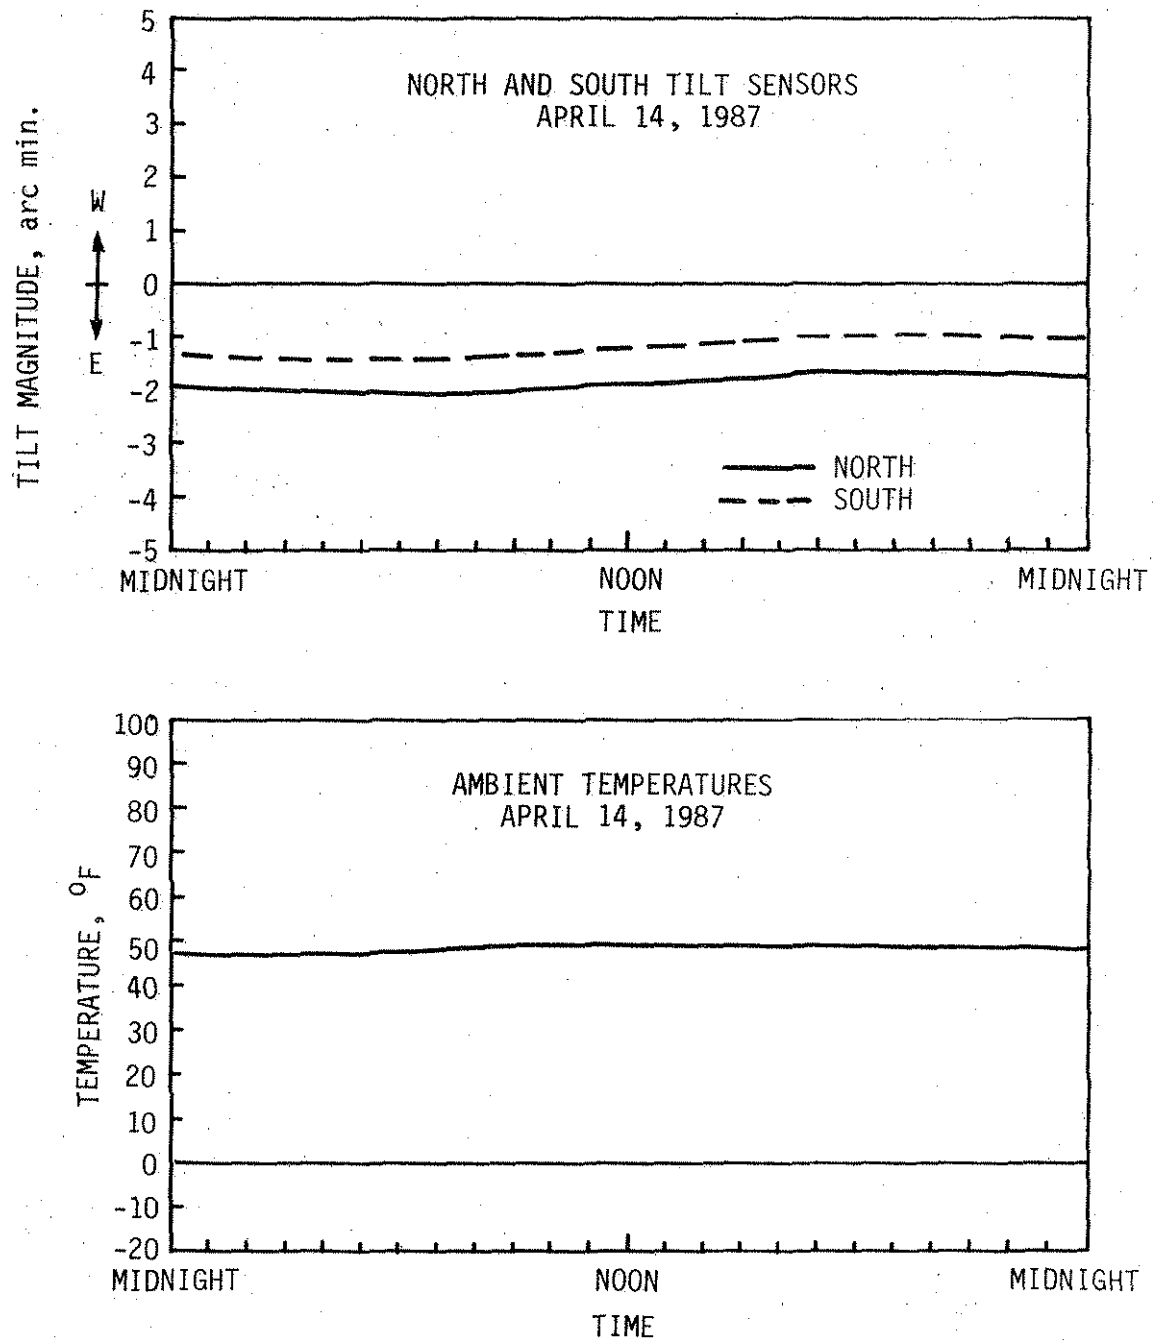
Fig. 27. Readings of north and south tilt sensors and ambient temperatures on April 14, 1987.
