DEVELOPMENT OF SELF-CLEANING BOX CULVERT DESIGN – Phase II

M. Muste, H-C. Ho
IIHR-Hydrosience & Engineering, The University of Iowa
Iowa City, IA 52242-1585

Iowa City, September 2013

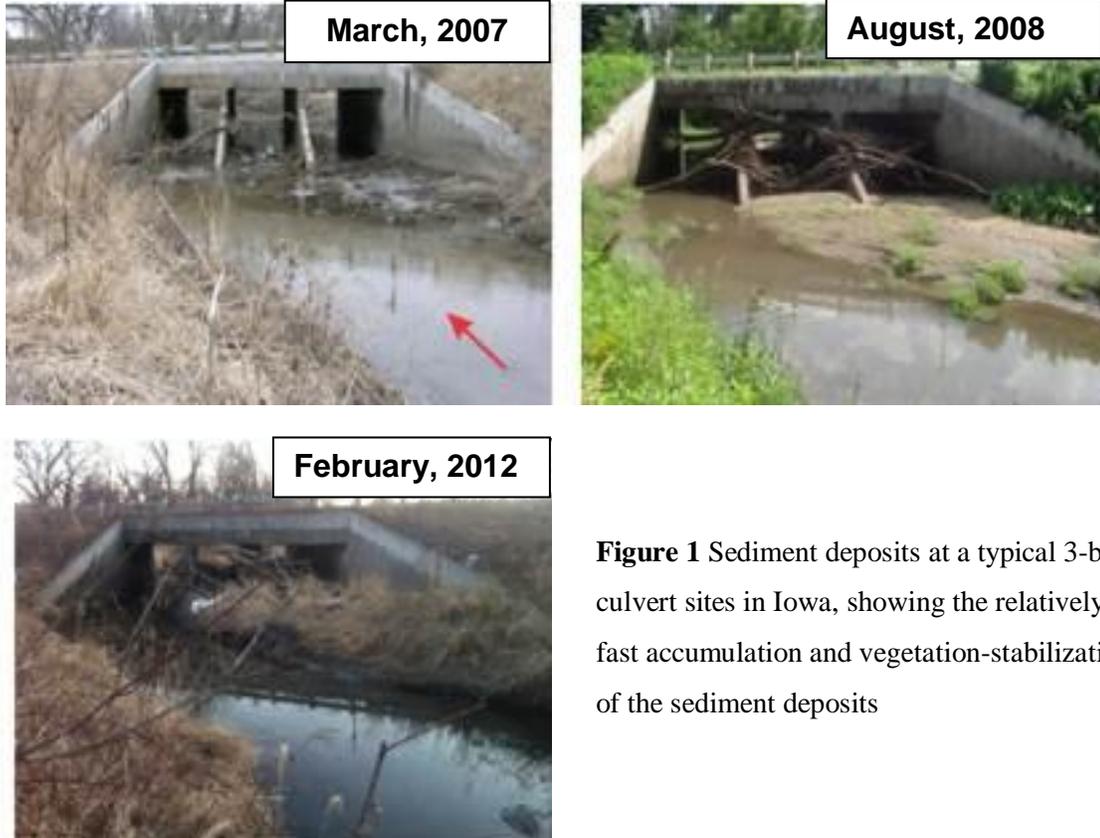
Figure 1 Sediment deposits at a typical 3-box culvert sites in Iowa, showing the relatively fast accumulation and vegetation-stabilization of the sediment deposits

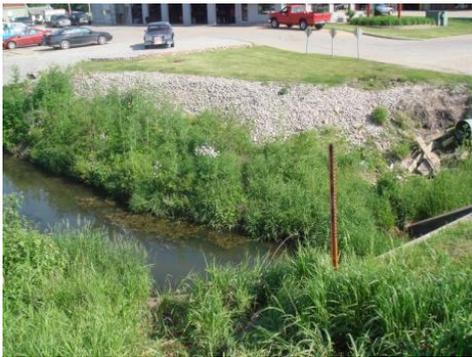
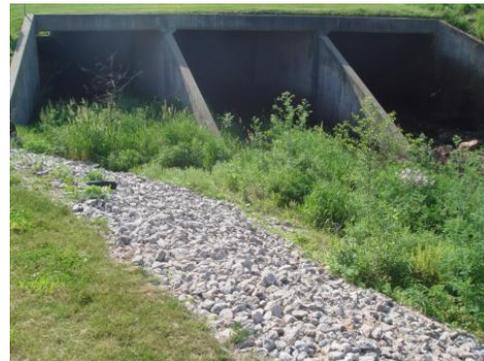
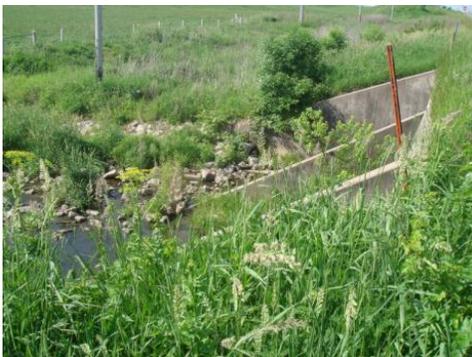
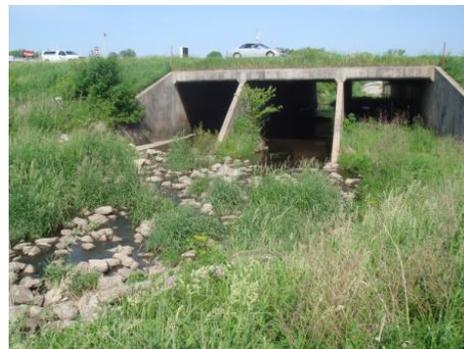
Upstream views

Downstream views

Figure 2 The status of the culvert selected for monitoring at the beginning of the study

The objectives associated with Phase II of TR 545 were centered on the site identified in objective a. The site is located on 1506 IA Hwy 1W and it is a triple 15'-18"-15"x12 reinforced concrete box (RCB). The culvert was built in 1981-82 replacing a previous culvert passing over Willow Creek. The culvert drains a mostly urbanized catchment developed rapidly after the culvert construction in 1981. The first cleanup after the construction of the culvert was made in 2000. At the time of inception of the present study the culvert was heavily silting throughout its more than 300-ft length as shown in Figure 2.

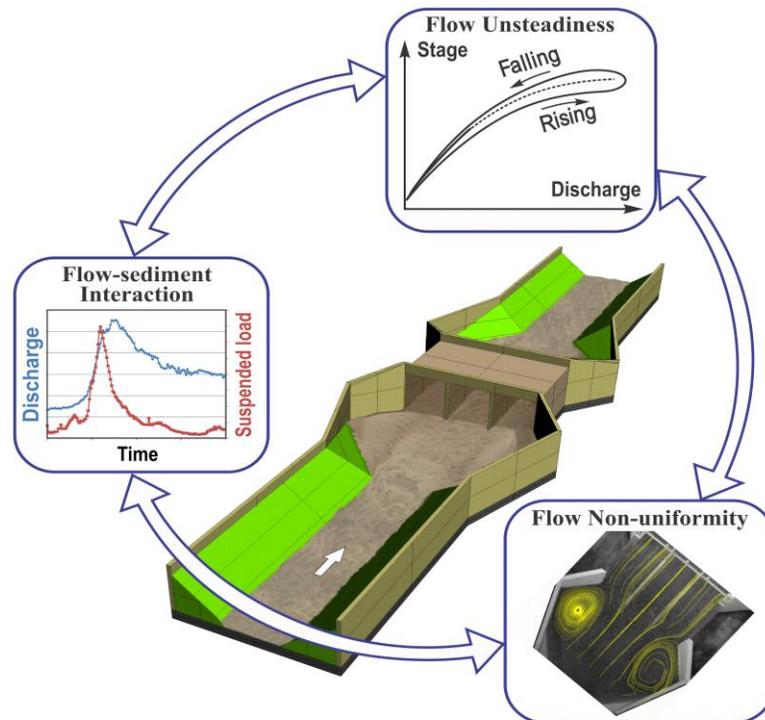
Figure 3 Complexity factors at flow through culverts

In general, current knowledge on sedimentation processes at culverts is limited and the literature on this topic is scarce. To date, there is no systematic research regarding the mechanics of sediment transport through multi-box culverts or the sediment deposition impact on the flow through culverts. While it is accepted that the sediment transport through culverts is strongly influenced by the nature of the local geological conditions and the soils in the drainage area adjacent to the culvert there are gaps in our knowledge about the flow and sediment transport at multi-barrel culverts. The limitations in our knowledge are due to limited focus given to this subject so far, as well as to the complexity of the flow carrying sediment through multi-barrel culverts. The complexity of the flow hampers setting precise modeling conditions for the laboratory and numerical investigations as it entails a series of aspects that require special attention, as described below. Moreover, it emphasizes the importance of the field measurements in furthering solution to this widely spread problem at Iowa culverts. Figure 3 illustrates the complexity factors involved.

The first study complexity of the flow through culverts is related to the change in flow geometry from the undisturbed cross section of the stream (usually trapezoidal) to the geometry of the multi-barrel culvert (at least double the stream cross section area in the undisturbed region), as illustrated in Figure 3. This change in geometry is occurring twice at culvert sites. First an expansion is usually involved upstream the culvert, while a contraction to the original cross section shape occurs downstream the culvert.

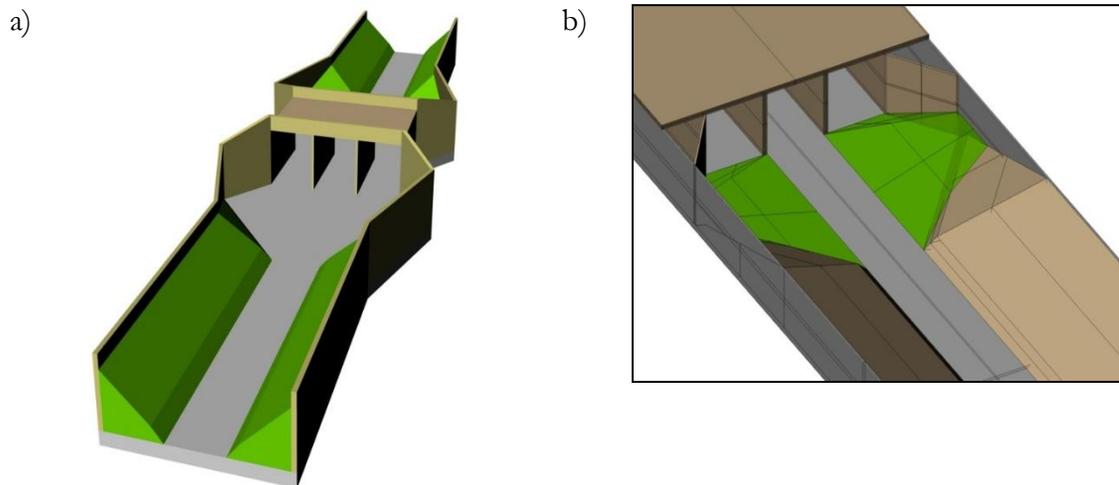
Figure 4 Schematic of the TRGB-G1-01 culvert tested in the study: a) original configuration: b) self-cleaning design established through TR 545

In order to obtain a realistic modeling, in Phase I of the project a Triple Reinforced Concrete Box Culvert (TRGB – G1 – 01) was adopted. The driving criterion for designing the self-cleaning culvert geometry was to make modifications in the upstream area of the culvert that would restore the shape and functionality of the original (undisturbed) stream. For this purpose, the lateral expansion areas were filled in with sloping volumes of material to both reduce the depth and to direct the flow and sediment toward the central barrel. All the initial tests for phase I of the project were conducted with a 3-box culvert and for a layout where the river approaches the culvert at an orthogonal angle. The Technical Committee requested our research team to expand the study coverage by testing the sensitivity of the design to various angle of incidence between the road and stream intersection. Those studies are described next.

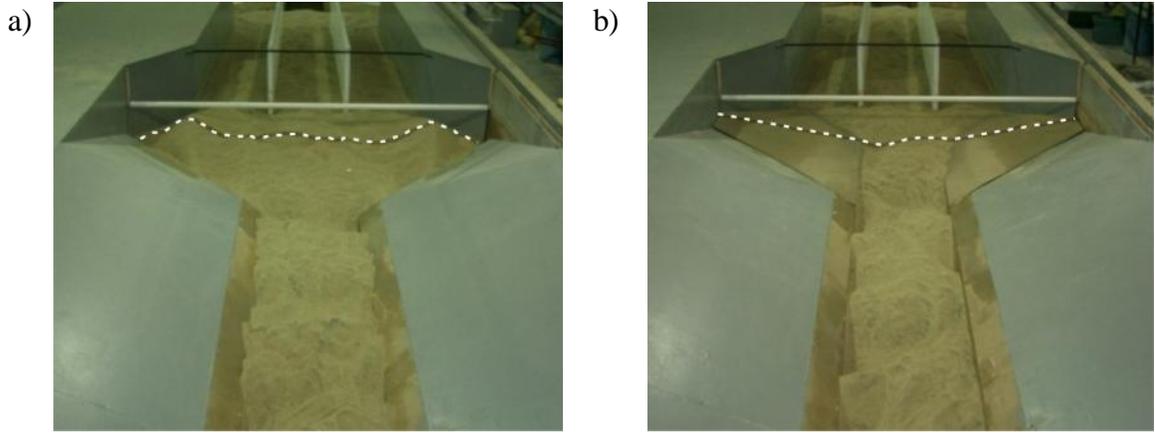
Figure 5 Sediment deposition patterns without and with fillet-based self-cleaning system: a) no hydro-cleaning design, b) hydro-cleaning design constructed

In order to familiarize the reader with the experimental protocol used in the study, salient features and instrumentation used in these additional tests are briefly described first. Flows with live-bed sediment transport were established for the same operating points for the original (without fillets) and the self-cleaning (with fillets) culverts. Identical experimental conditions and operating time were established in the comparison purpose. At the end of each experimental simulation the bathymetry of the upstream area of the culvert was documented using identical documentation procedures. Sediment deposition occurred in the critical area of the upstream culvert expansion where deposition occurs at the highest rates and with the most detrimental impacts (Fig. 7). Fig 7b shows that the proposed adjustment met the aforementioned main effects. The SeaTek multiple transducer arrays (MTAs) were deployed to survey the development of the bed forms in the culvert boxes. The experiment deployment was illustrated in Fig 8. Measurements were performed at 18 sections in the left and central boxes. The measured data for each section were continuously collected for 30 seconds. Assuming that the bed movement was negligible in the short time period with respect to the dominant scales of the sediment transport process, each bed profile in the box was obtained by averaging data over the 30 seconds. The sedimentation maps inside the culvert boxes for the culverts with and without the design were shown in Fig 9 and 10. The results were measured after running the test for 6 hours and for 12 hours, respectively. Fig 9a and b display the results with and without the design placed upstream of the culvert, respectively. The comparison of the sediment deposits showed that the design was able to mitigate the sediment deposition in the side boxes. The large sediment deposition present in the side boxes for the case of the standard design was mitigated when the design was installed. The design reduced the amount of deposited sediment in the side boxes by more than 70% after 12-hour operation (see Fig 10). Further study of head loss measurements in the model is ongoing to evaluate the effect of the hydro-cleaning design.

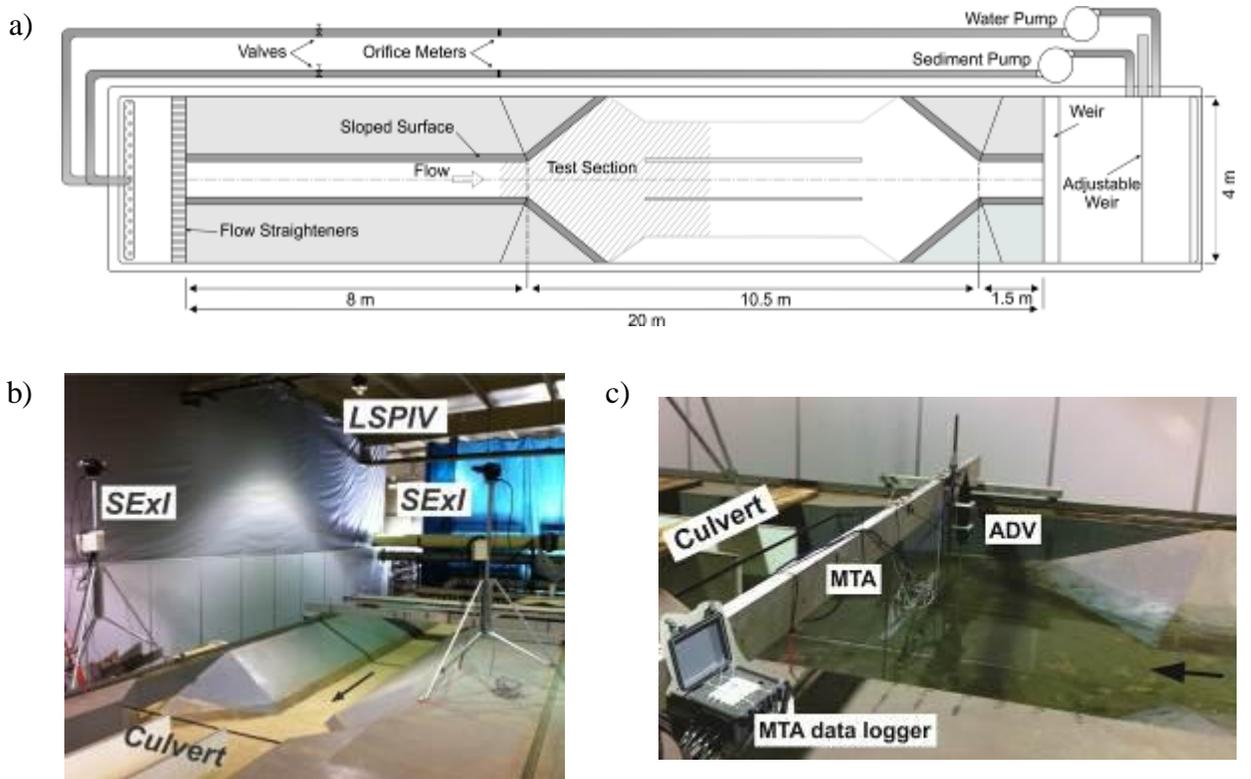
Figure 6 Arrangement of the acoustic sensors for the measurement of sediment deposition in the 1:5 scale culvert model

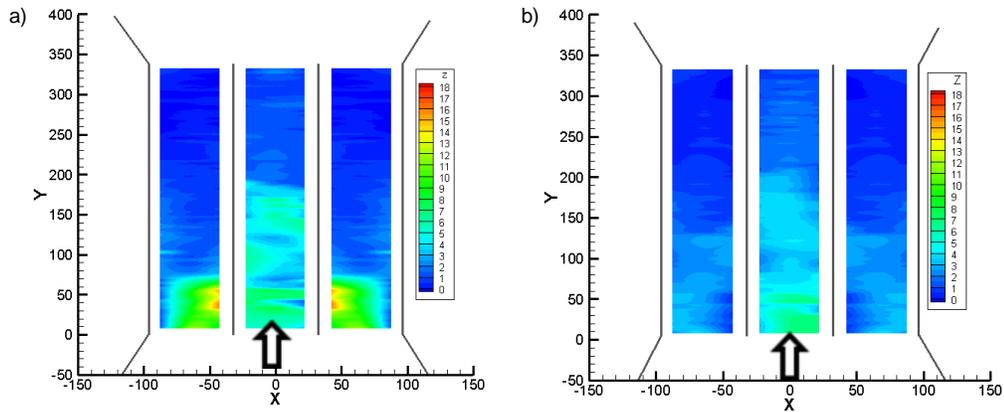
Figure 7 Mapping of the sediment deposits formed in three culvert boxes after 6-hours: a) without the design placed in expansion; b) with design placed in expansion

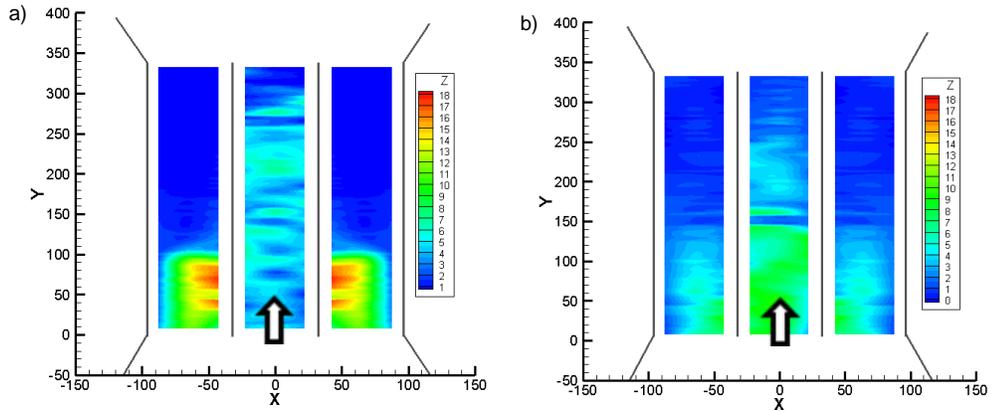
Figure 8 Mapping of the sediment deposits formed in three culvert boxes after 12-hours: a) without the design placed in expansion; b) with the design placed in expansion

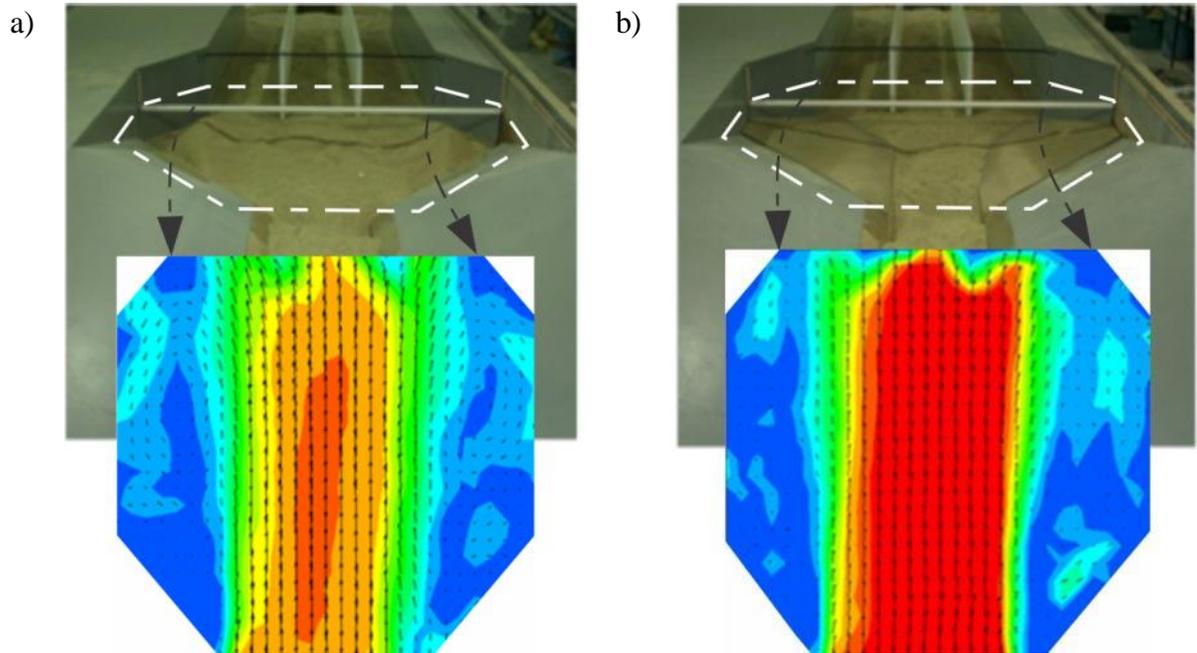
Figure 9 Velocity distributions upstream the 1:5 culvert model: a) original configuration, b) hydro-cleaning design implemented

Large-Scale Particle Image Velocimetry (LSPIV) was used to measure free surface velocity distribution for the reference culvert model and the hydro-cleaning design culvert in the expansion. The iso-velocity contours plotted in Fig 11 illustrated that the velocity magnitude was considerably increased throughout the center area of the expansion leading to an increased flow power that enhances the transport of sediment incoming toward the culvert. The LSPIV measurements undoubtedly demonstrated that water and sediment were forced to the central culvert box when the hydro-cleaning design was placed in the expansion. The above performance tests conducted to evaluate the hydro-cleaning design provide the following conclusions: 1) instead of creating or increasing the size of recirculation areas, the design removes them, 2) the design strengthens the convection of sediment into the central box, and 3) the design amplifies the turbulence at the entrance into the side boxes and mitigates the sediment deposition inside them.

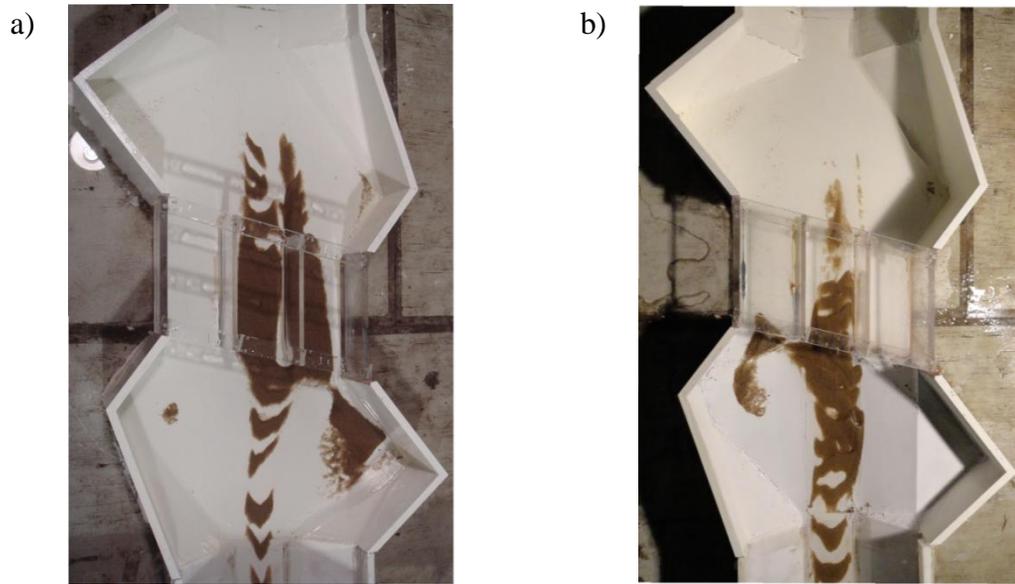
Figure 10 Sediment deposition pattern at 15 degree skewed culvert model after one-hour operation: a) no design in the expansion, and b) fillet-based design in the expansion

The stream location and the planned roadway centerline do not always establish a 90-degree discussed above. To minimize the environmental stress the culvert is often skewed with respect to the roadway centerline. The design skew angle can vary from 0-degrees to the maximum of about 45-degrees (Normann et. al, 1985). To assess the performance of the proposed fillet design (Figure 4), a 15-degrees skewed three-box culvert was conducted in the 1:20 scale model to simulate the storm events. The configuration of the fillet design in the skew model is similar to the aforementioned one which utilizes the hydro-cleaning concept. After one hour operation, the sediment particles started to accumulate in the central and right barrels because of the skewed angle (Fig 12a). The self-cleaning design was then placed upstream the culvert and repeated the same operation. The accumulation of sediment particles was mitigated shown in Fig 12b. The sediment particles were force to the center and were delivered to the downstream. The hydro-cleaning design shows the ability and efficiency to mitigate the sedimentation issue not only for the general three-box culvert but also for the skewed three-box culvert.

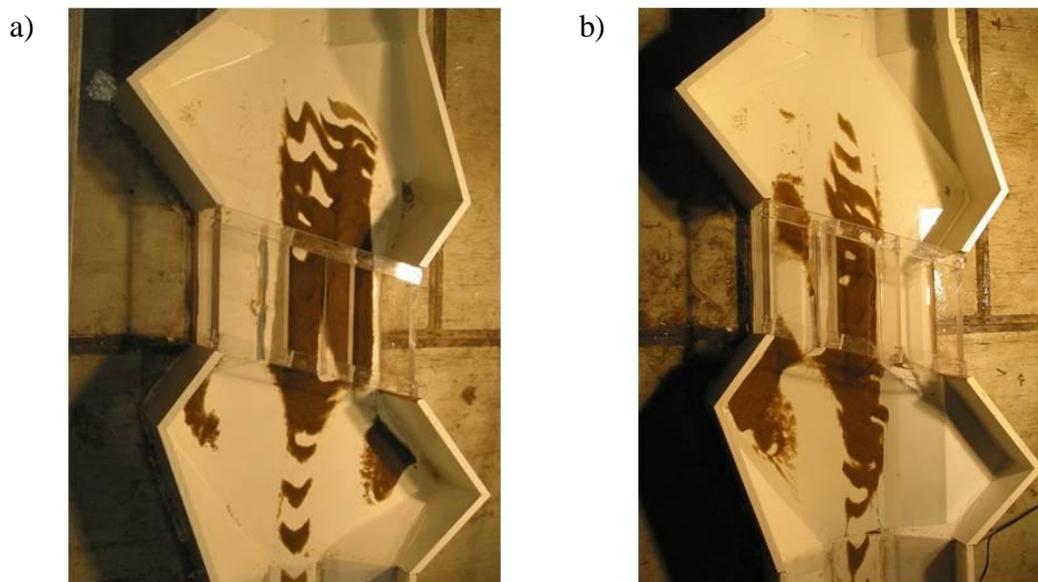
Figure 11 Sediment deposition pattern at 15 degree skewed culvert model after three-hour operation: a) no design in the expansion, and b) fillet-based design in the expansion

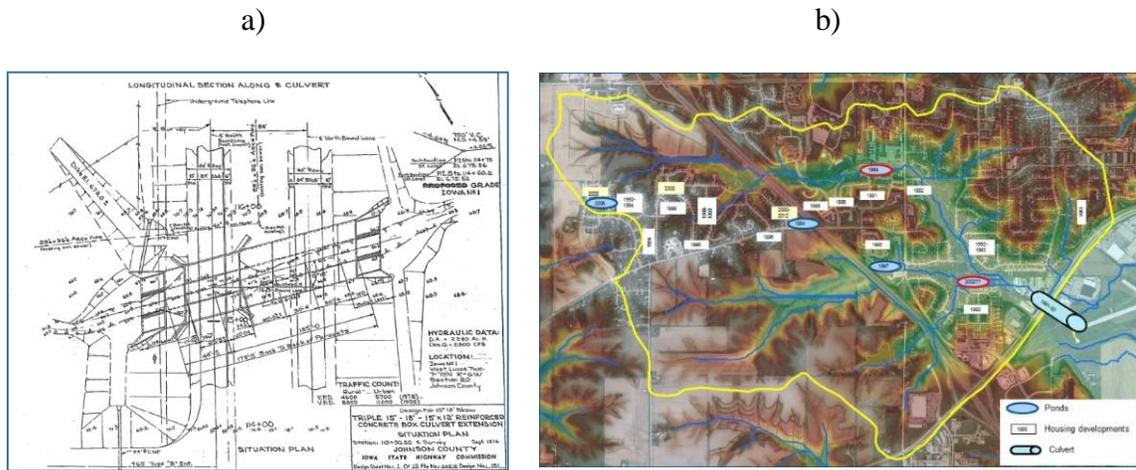
Figure 12 a) Construction drawings for the culvert for monitoring; b) drainage area for the culvert

The first culvert cleanup after its construction in 1981 was made in 2000. The second cleanup was conducted on September 15, 2011 for supporting the goals of the present research. The cleaned culvert monitoring was needed to provide a reference for the operation of a culvert designed with conventional design specifications, i.e., without special provisions for mitigation of sediment transport through the culvert. By cleaning the culvert to its original conditions, the culvert was brought back to the stage of the stream-structure configuration in place after the finalization of its construction in 1981. Figure 13 shows the status of the culvert before and after the cleanup conducted on September 15, 2010.

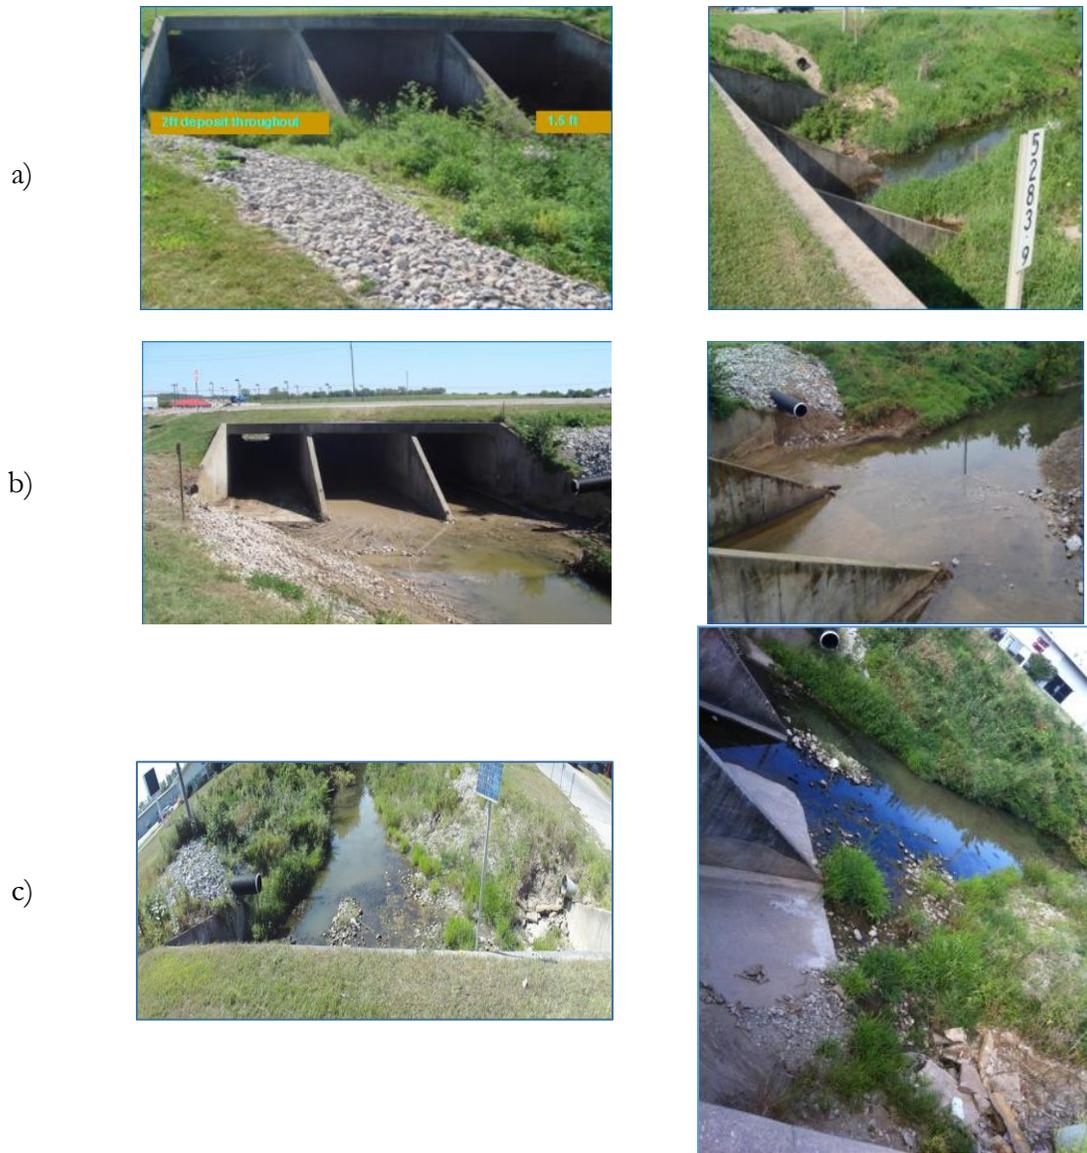
Figure 13 The culvert site under monitoring on Hwy 1, Iowa City: a) before cleanup (September 15, 2010); b) the culvert right after the September 15, 2010 cleanup; c) the status of the culvert after two years of operation (August 29, 2012)

A snapshot of the culvert after the first year of monitoring is provided in Figure 13c. This culvert photo-document demonstrates that following one year of operation, the culverts started to initiate deposition patterns that replicate the 10-year sediment deposit geometry as can be inferred comparing Figures 13 a and 13c. Moreover, it can be noticed that after just one year of operation, the vegetation grew on the sides of the culvert upstream areas (see Figure 13c). The vegetation growth is an accelerating factor for sediment deposition by lowering the flow velocity during storms and providing a favorable environment for sediment settling.

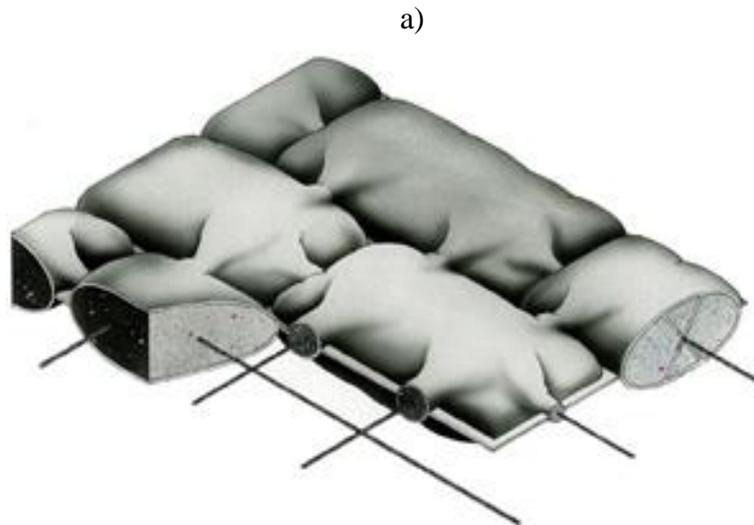
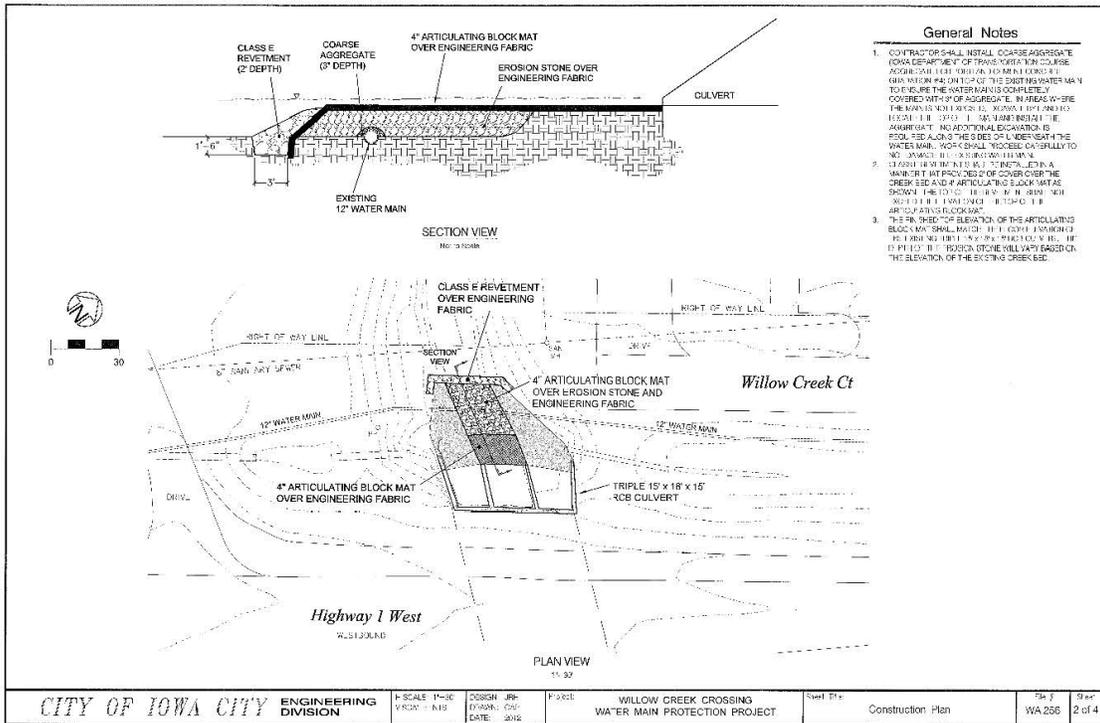
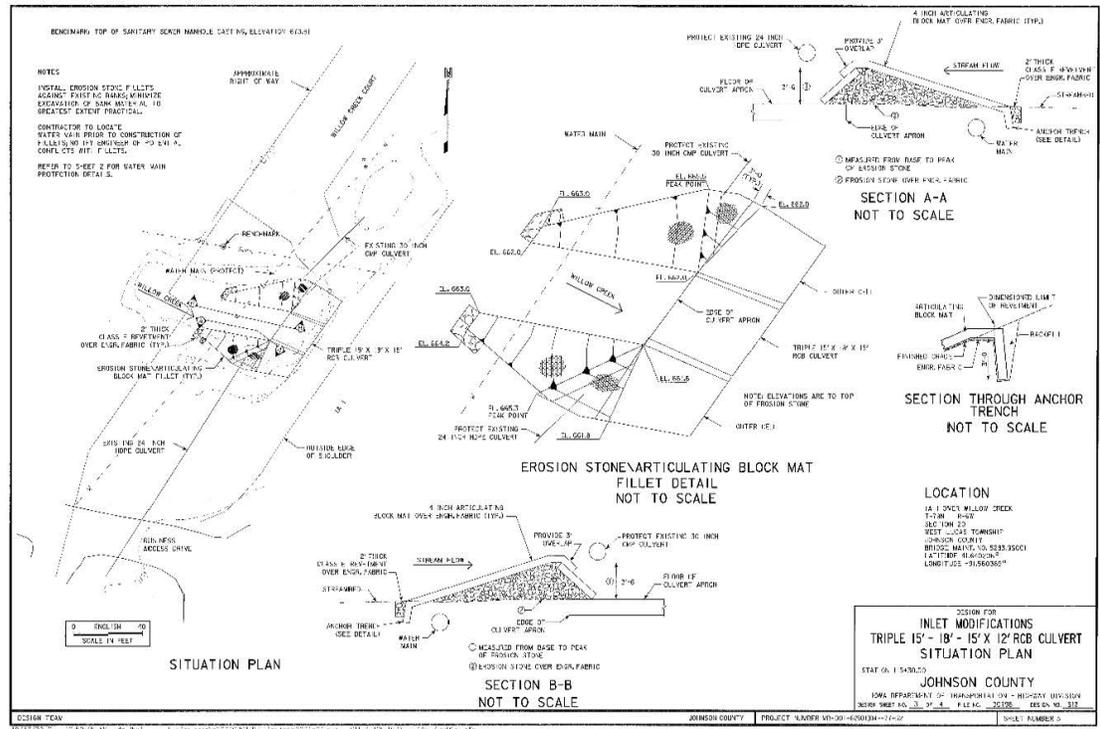
Figure 14 Construction drawings for setting the self-cleaning structure for the culvert: a) conceptual sketch for the articulating black mat: b) construction drawings (Continues on the next page)

Figure 14 Construction drawings for setting the self-cleaning structure for the culvert: a) conceptual sketch for the articulating black mat; b) construction drawings

The specific geomat used for the construction of the self-cleaning structure at our site is articulating block mats (ABM) produced by Texicon (<http://www.texicon.com>). ABM provides a cable-reinforced, articulating concrete block mattress for use over soft subgrades or where a revetment is exposed to attack by waves. When filled with a fine aggregate concrete, they form a system of staggered, interconnected, cable-reinforced, concrete blocks. The permeable interwoven perimeter of each block serves as a drain, filter, and hinge. The hinge permits articulation of the filled compartments (blocks). Factory installed high-strength cables and optional transverse cables are threaded between the two layers of fabric and through the fabric form's grout ducts to link the concrete blocks. The cables are self-positioning within the fabric formed concrete blocks and are embedded at approximately the vertical center of the concrete blocks.

A generic view of the BMA used at our site is provided in Figure 14.a. The construction drawings for setting the self-cleaning structure are provided in Figure 14.b. The construction work was accomplished by DeLong Construction, Inc, Washington (IA) during two winter weeks (December-Jan, 2012-13) with an approx. cost of \$37,000. A photo documentary of the construction is provided in Appendix A.

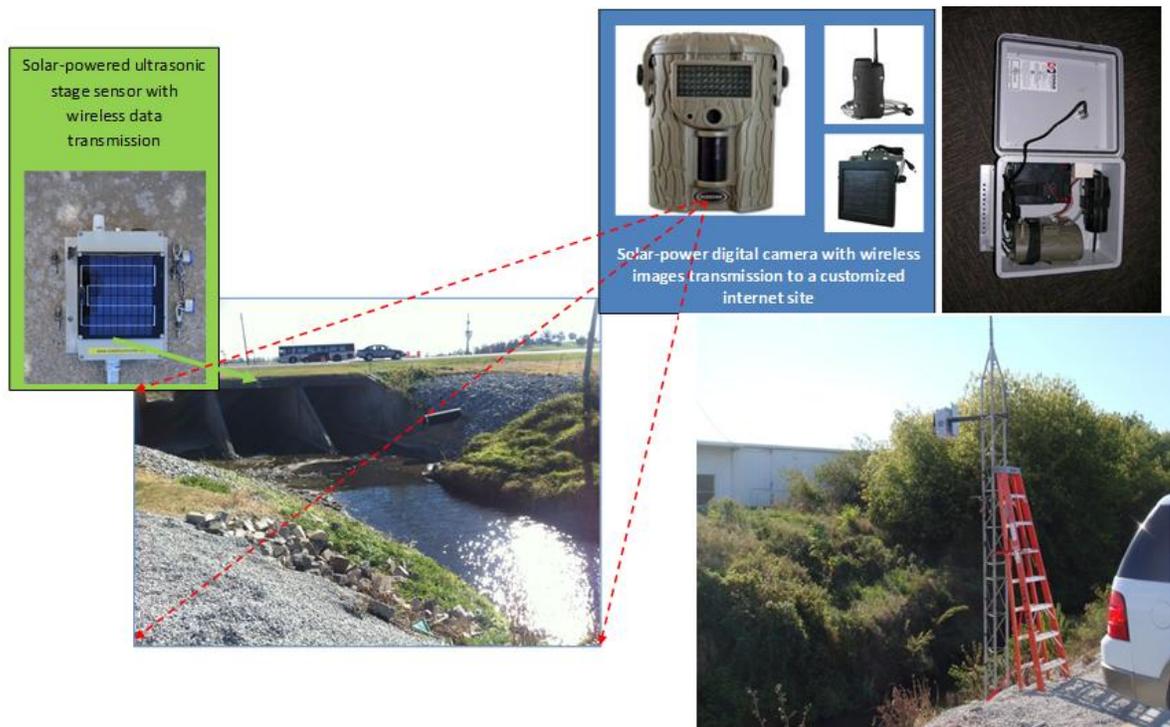
Figure 15 Real-time webcam deployed at the culvert site under monitoring

During the monitoring activities conducted in 2011, the research team temporarily deployed at the culvert site a real-time camera with continuous recording and communication via cell phone network (see Figure 15). The system is powered by solar panels and a backup battery during nights and overcast sky. Recording settings and other operation controls can be executed remotely via the Internet. The continuous real-time monitoring enables to track the stage at the site and the flow patterns developing at the culver entrance as the storm unfolds.

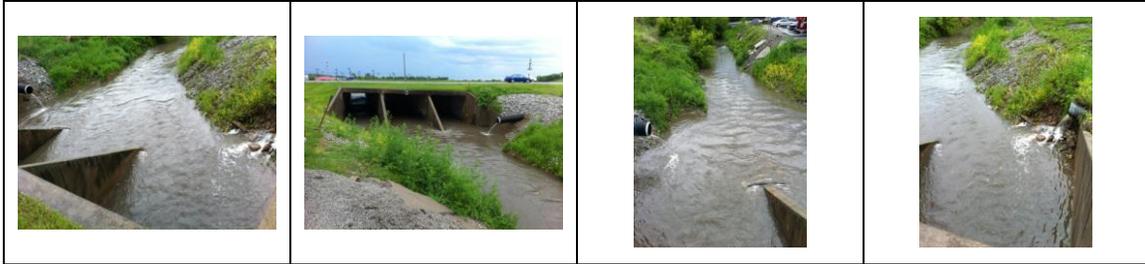
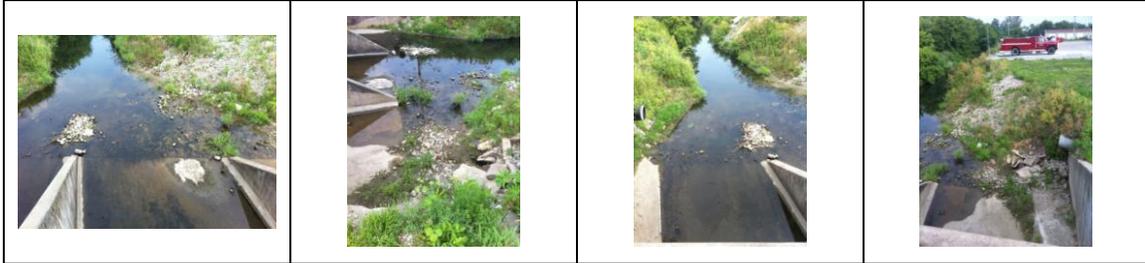
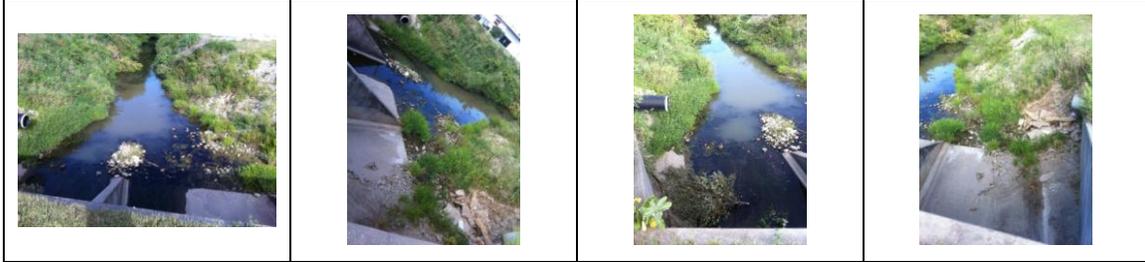
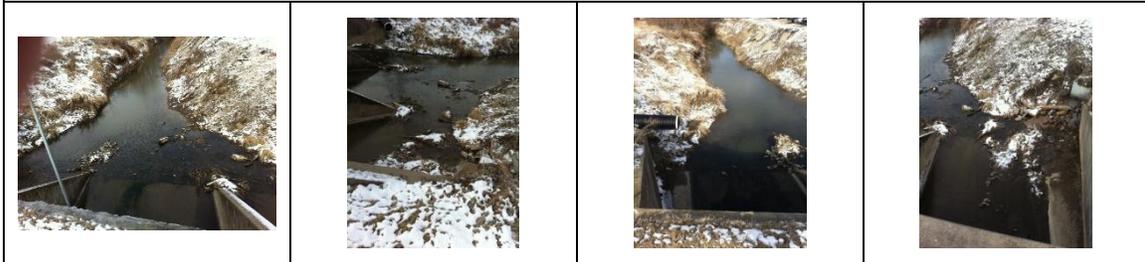
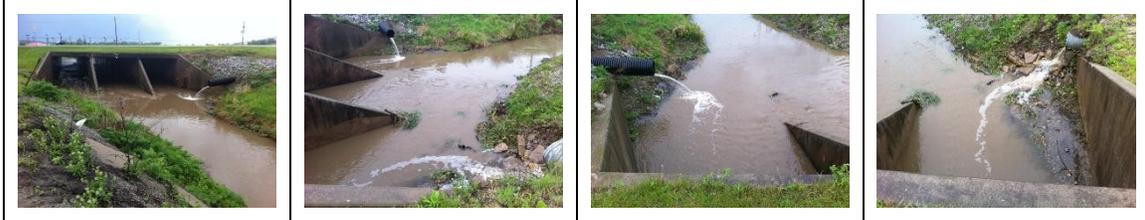
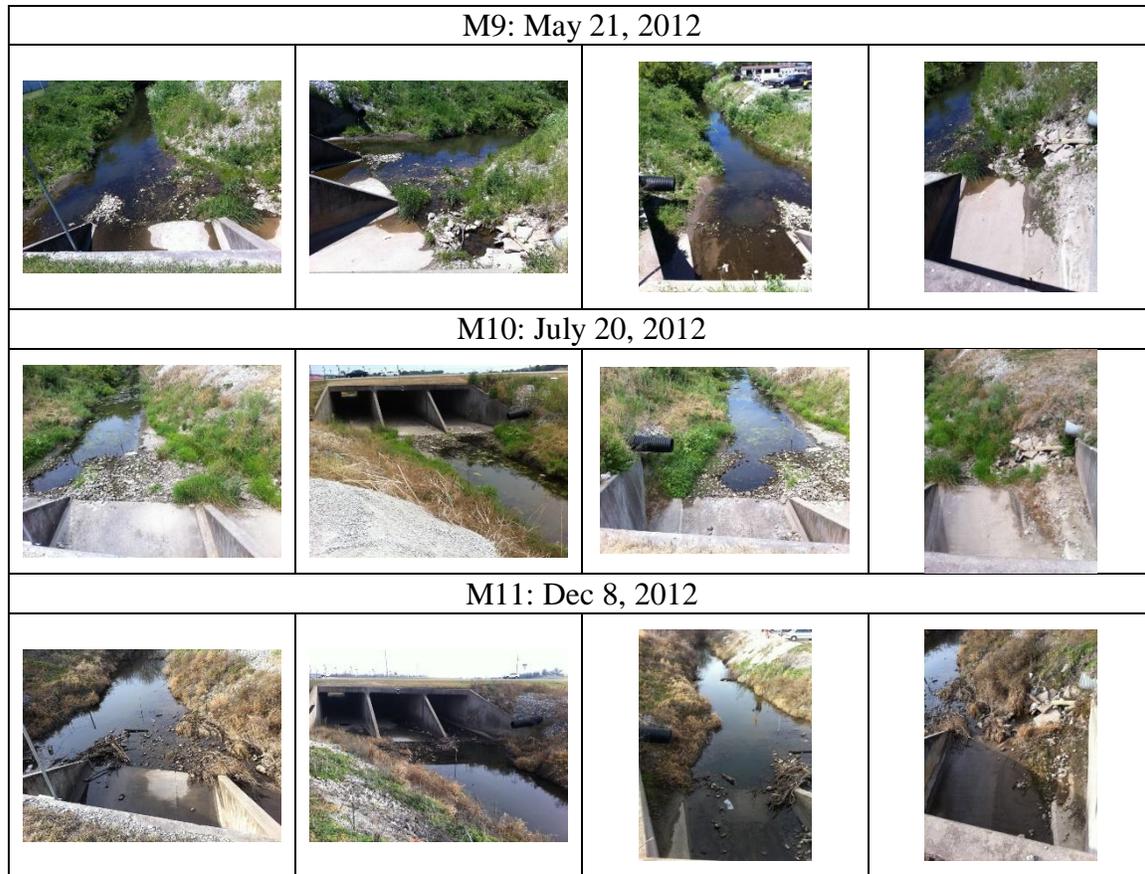
Table 2 Photographic tracking of the culvert site before fillets installation

The photos taken on July 16, 2011 and May 21, 2012 showed that sediment deposits established on the left and right barrels led to vegetation growth at short time after the sediment pockets were formed. The vegetation growth is an additional factor in sediment retention by reducing the flow velocity through the vegetated area and developing a sheltered area for sediment settling as the velocity of the vegetated bed further reduce the velocity of the flow. This reduction impedes development of high shear stresses that can mobilize the sand when the area is exposed to high flow events. In turn, the fresh soil layer brings soils rich in nutrient that further accelerates the vegetation growth. The two-year photographic documentary of the culvert site before the self-cleaning structure implementation clearly showed the initiation of the sediment deposits following the pattern that was observed before the 2010 cleaning. This observations lead to the conclusion that the processes was on its way and have had resulted in clogging of the side barrels as observed before the cleanup.

Following the culvert cleanup, the culvert brought to its original status was monitored for observing flow and sedimentation during high flow events for more than two years. As can be observed from the sequence of photos assembled in Table 2, the results indicated that the sedimentation areas prone to sediment retention were the upstream area of the left and right barrels. The sedimentation increased during storm events. Specifically, the high flow events that passed through the culvert on May 21,

2011, May 29, 2011, and April 14, 2012 have brought most of the deposited material during the pre-construction monitoring phase.

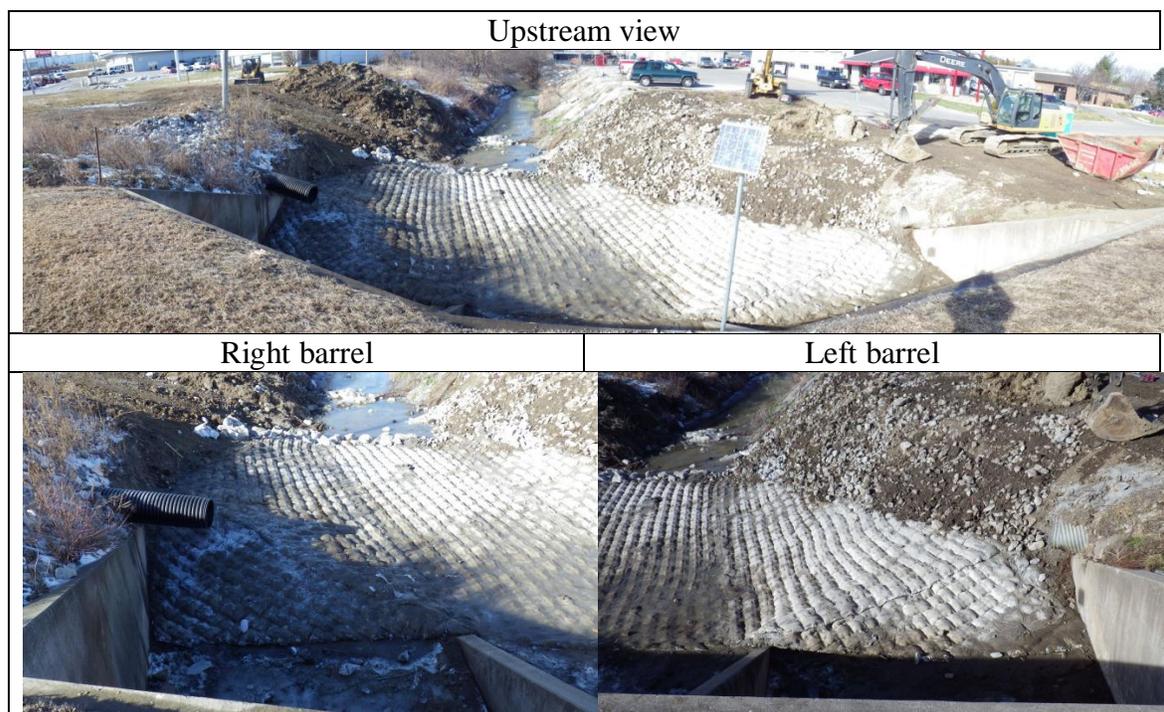
Table 3 The fillet covered with the articulating black mats following their construction

The fillets as the self-cleaning culvert designed were installed during two weeks starting on December 9th, 2012. Table 3 assembles the photographic records gathered during the December 2012 – September 2013 time interval (the time covered by the project funding). The associated time series data of precipitation and water depth data are shown in Figure 18. The photographic and field observations showed no signs of sediment deposition inception in the upstream area of the culverts during, after or in the long term. Practically, at the end of the project funding there were no signs of any deposition in the areas previously covered by sediment and vegetation. Moreover, the articulating block mat layer provided a good protection against vegetation growth such that the area is up to now vegetation free as can be observed from the photo documentary. Sporadic observations were made until December 2013 to further observe changes during the fall storm events. The status of the culvert is practically the same since December 2012.

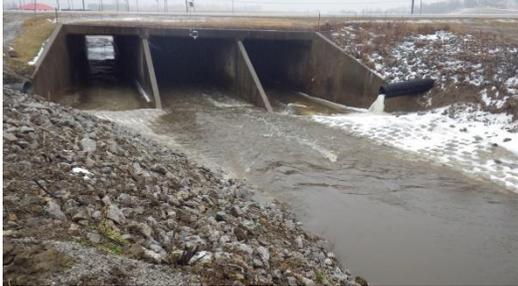
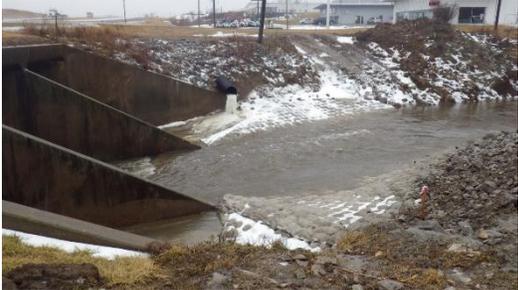
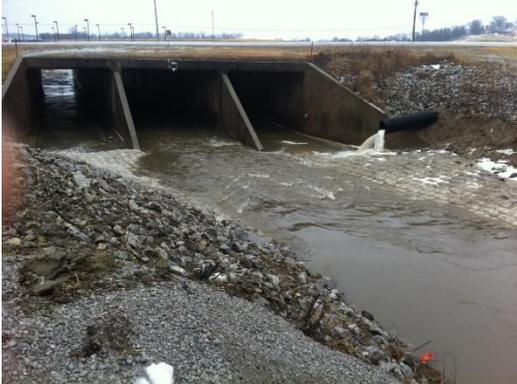
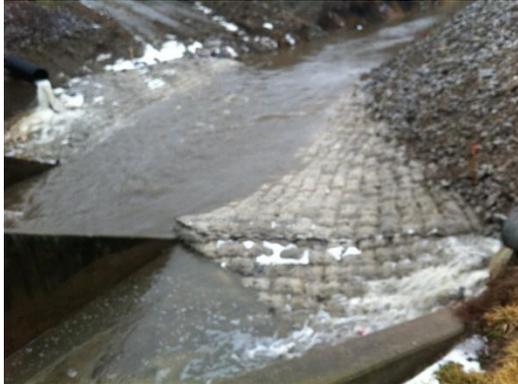
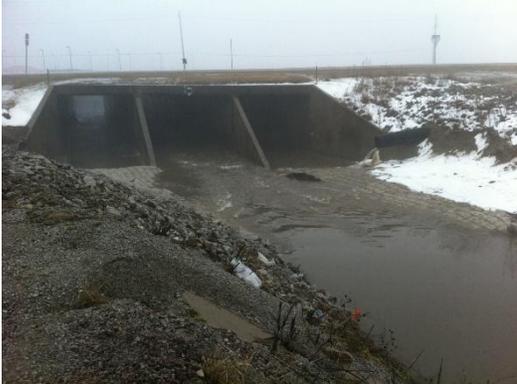
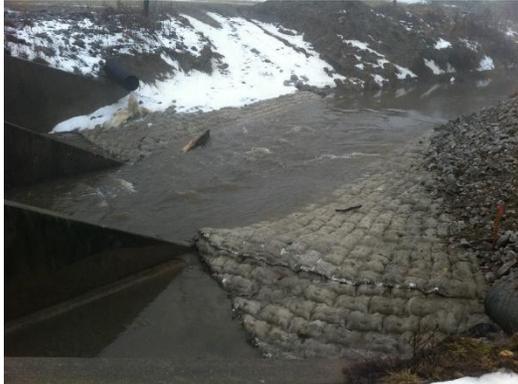
Table 4 Photographic tracking of the culvert site after fillets installation

Another beneficial effect of the construction of the fillets is the fact that they keep the geometry of the flow very close to the original stream bed by maintaining the flow in the main barrel for different storm event intensities, as can be observed for M13,

M14 and M16 storm events (see Table 4). During the highest flow event on April 20, 2013 (see Figure M16 in Table 4) the dominant discharge is as expected flowing through the main barrels with less discharge and more turbulent flows in the side barrels. The sequence of photographs M16 and M17 show that even the largest storm of the year has not left sediment deposited in the side barrels. The photo evidence in Table 5 shows that the vegetation growth was practically none, excepting some growth of algae ins some area of the culvert entrance. The culvert is absolutely clean at the time of writing this report. These set of visual evidence clearly demonstrates that the proposed solution works efficiently both in terms of hydraulics and transport processes.

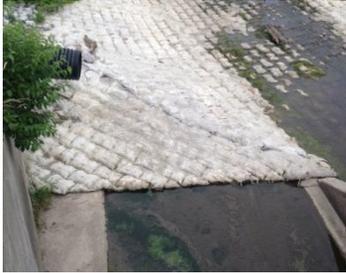
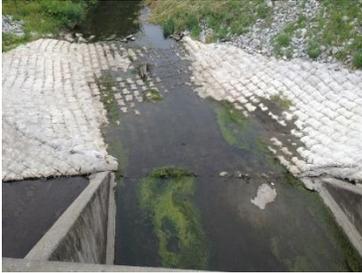
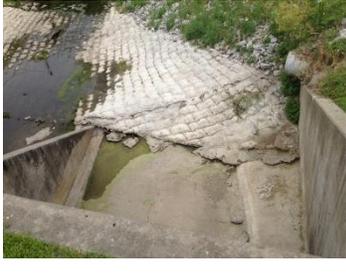
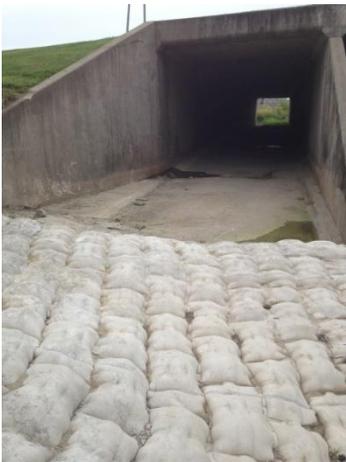
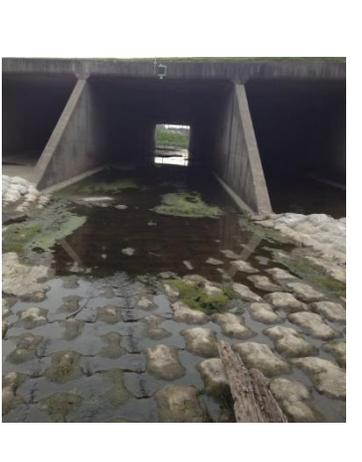
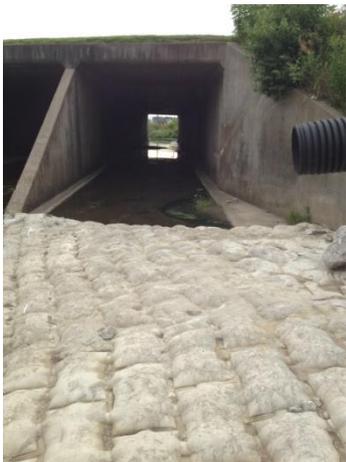
Table 5 Documentation of the culvert performance following the highest storm event

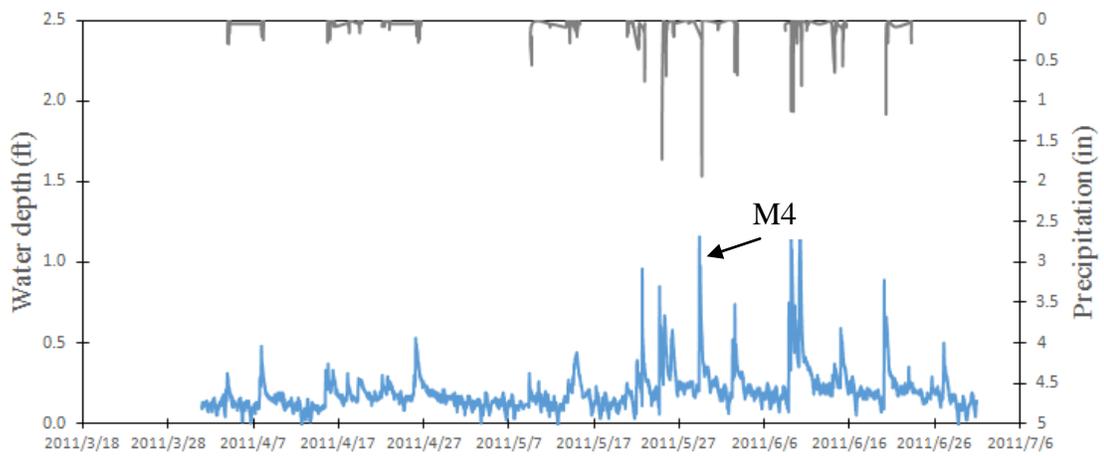
Figure 16 Stage and precipitation records at the culvert site (2011/04/01 ~ 2011/ 06/30)

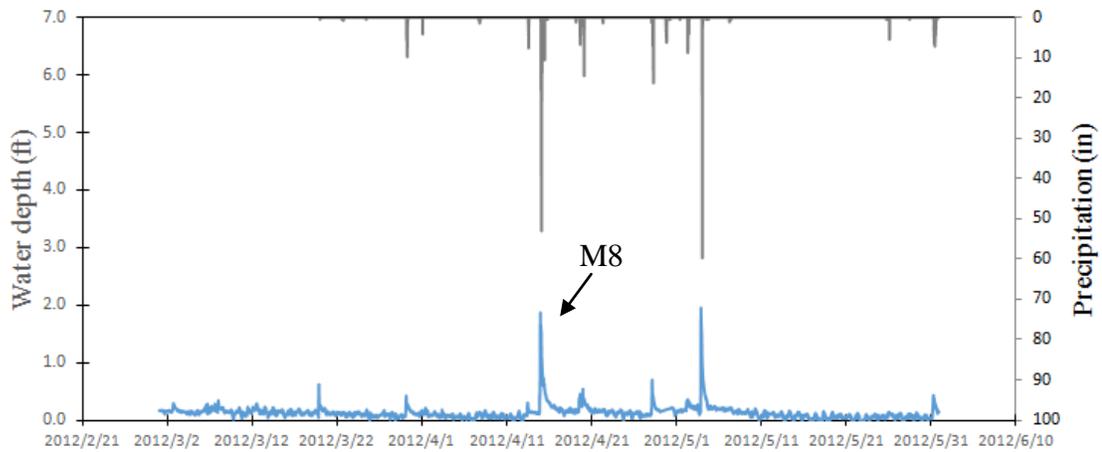
Figure 17 Stage and precipitation records at the culvert site (2012/03/01 ~ 2012/05/31)
