DEVELOPMENT OF SELF-CLEANING BOX CULVERT DESIGN – Phase II

M. Muste, H-C. Ho
IIHR-Hydrosience & Engineering, The University of Iowa
Iowa City, IA 52242-1585

Iowa City, September 2013

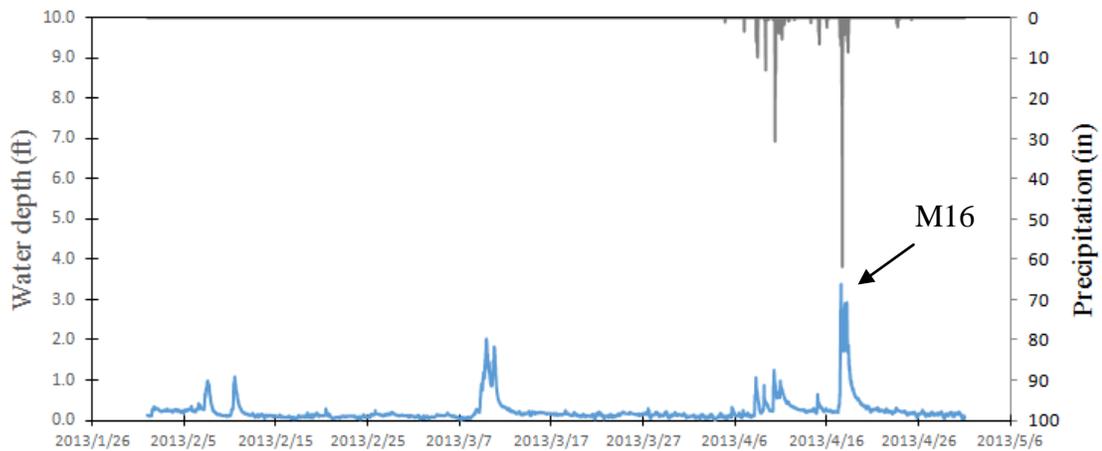
Figure 18 Stage and precipitation records at the culvert site (2013/02/01 ~ 2013/4/30)
