Thin Bonded Overlay Evaluation

Construction Report

August 1999

Iowa DOT Project HR-559
FHWA Work Order No.: DTFH71-94-TBO-IA-37

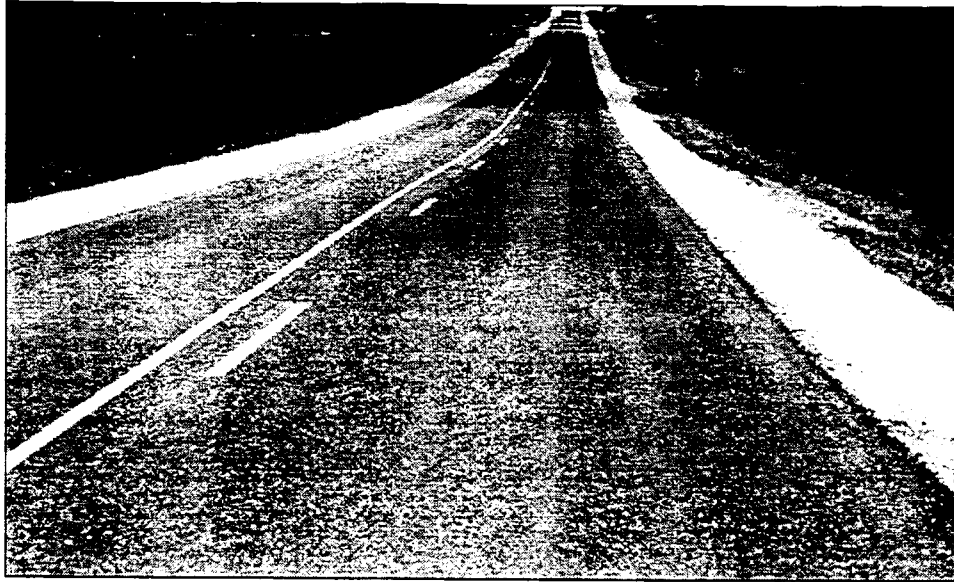
Figure 3 - CIPR surface

Cold-in-place-recycling was performed one month in advance of UTW to allow time for adequate traffic compaction and curing. A continuous recycling train was used to place the CIPR. A 12-foot wide milling device at the front of the recycling train removed ACC. The milling device followed the crown of the road and used grade control with a constant removal depth of 3.75 inches. The removed material was fed into a crushing and screening unit where it was sized. It was then moved into the pugging chamber and combined with approximately 2.3 % CSS – 1 emulsion by weight of material. The rejuvenated material was evenly deposited back onto the milled surface. Compaction was achieved with nine passes of a pneumatic-tired roller, followed by a steel-wheeled roller in a non-vibratory mode. Figure 3 shows a typical CIPR surface on highway 21.
