Pavement Evaluation Using the Road Rater™ Deflection Dish

Final Report for MLR-89-2

Highway Division Iowa Department of Transportation PAVEMENT EVALUATION USING THE ROAD RATER TM DEFLECTION DISH

> Final Report for Project MLR-89-2

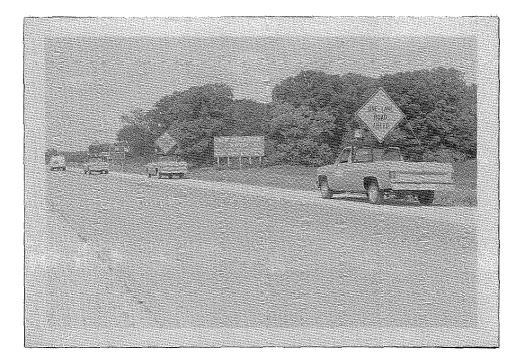
Figure 10 Road Rater Safety Vehicles

The Iowa DOT paid \$25,000 for its Model 400 Road Rater mounted in a van in 1975. Another Model 400 Road Rater was purchased in 1986 due to increased demand for deflection testing and cost \$40,000 mounted in an Iowa DOT van. Two Road Rater crews operate simultaneously in the springtime annually. Safety vehicles with signs (or a flashing arrow board) are used to control traffic and protect the test vehicle (Figure 10).
