# **RETROFIT METHODS FOR DISTORTION CRACKING PROBLEMS IN PLATE GIRDER BRIDGES**

Iowa DOT Project TR-436  
CTRE Project 99-50

Final Report • January 2003

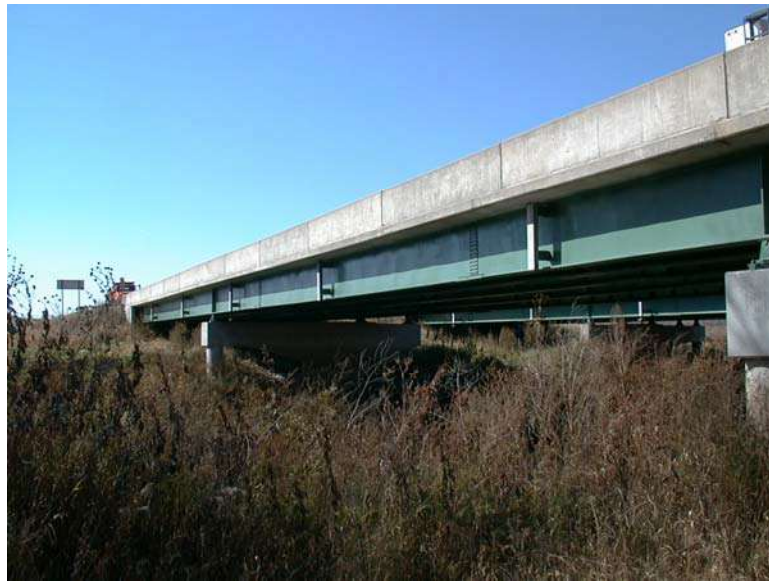
**Figure 2.1. Photograph of test bridge looking northwest.**

Bridge 5075.5R080, shown in Figure 2.1, is a two-lane, three-span, multiple steel girder bridge crossing the North Skunk River near Kellogg, Iowa. It was built in 1960 and carries eastbound traffic on I-80 in central Iowa. The bridge cross section, with diaphragms, is shown in Figure 2.2. The original structure was built with four welded A36 steel plate girders, but in 1978 a fifth plate girder (G5) was added to widen the driving lane shoulder. I-shaped diaphragms support all the girders laterally at a spacing of approximately 20 feet. The bridge has multiple examples of web gap fatigue cracking near diaphragm connections in the negative moment region. The webs with cracks have had holes drilled in the web following crack discovery. Cracking occurs in the new girder as well as the original girders, especially in the exterior girders. The high occurrence of fatigue cracking in this bridge makes it a critical bridge for fatigue and a prime specimen for retrofit testing.

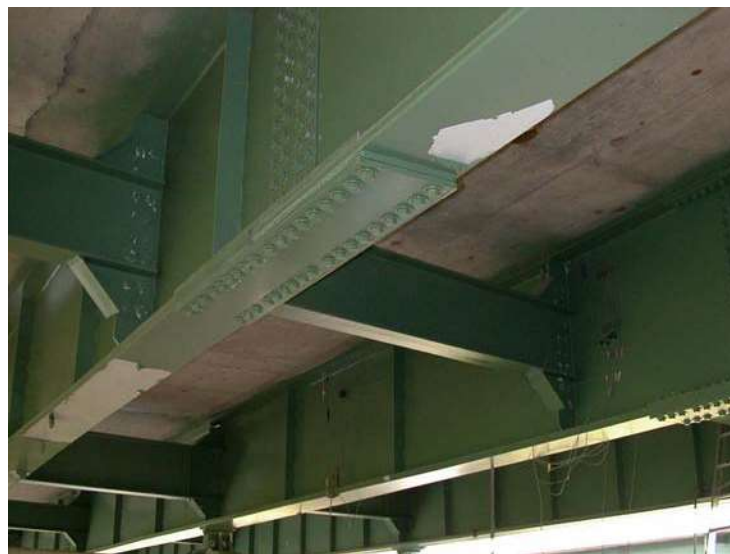
**Figure 2.5. Photograph of underside of the bridge looking northwest.**

Figure 2.5 shows a photograph of typical diaphragms and girders. The diaphragms are rolled W18x50 sections in the spans, W21x68 at the abutments, and W24x76 at the piers. The diaphragms are spaced at 21 feet in the center span and 20 feet 7 inches in the end spans. They are bolted to vertical stiffeners as illustrated in Figure 2.6. The vertical stiffeners are welded to the web and the girder compression flange. In the negative moment region above the piers the top flange is in tension and is not welded to the stiffeners. Figure 2.7 shows a photograph of a typical web gap in a negative moment region. A web gap of about 1 inch in the vertical direction exists between the top of the stiffener weld and the bottom of the girder top flange where the stiffener is clipped. As noted previously, fatigue cracks have been found to occur in this region.

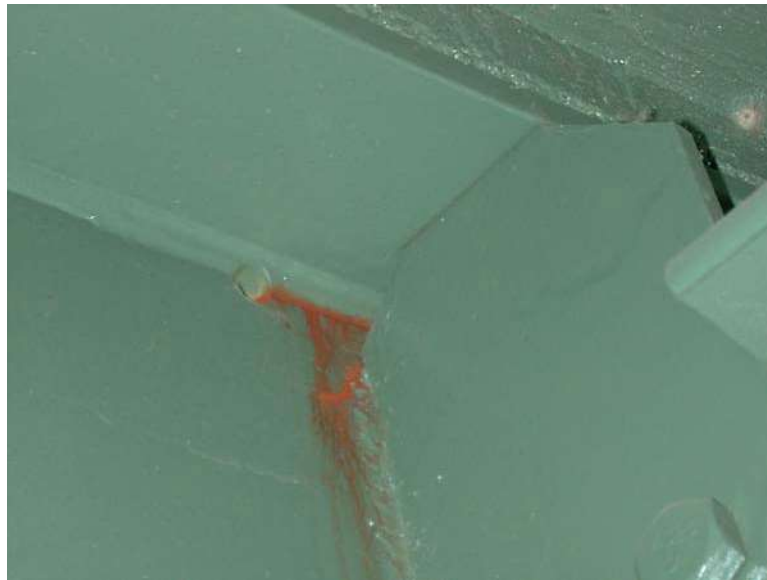
**Figure 2.11. Photograph of typical drilled hole retrofit in a web.**

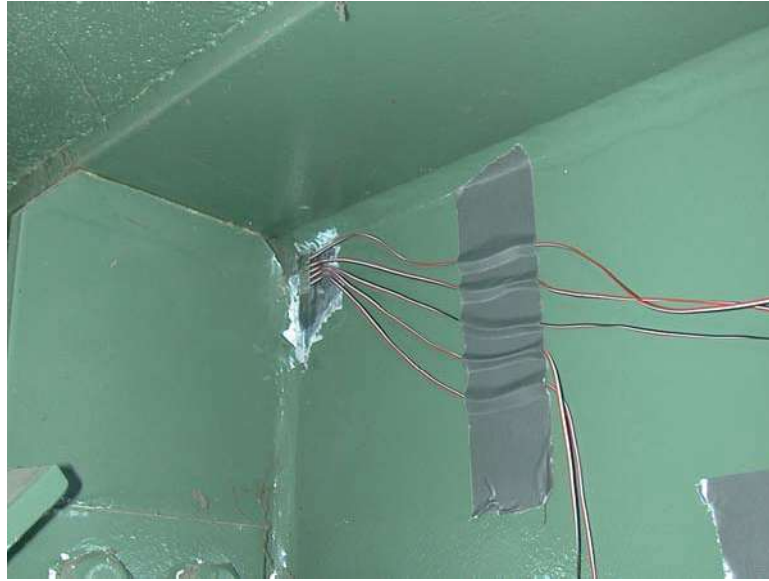
a. Close-up of typical gradient gage.

Bondable 120-Ohm gradient strain gages were used to measure web gap bending strain and to show the strain distribution in the web gap, which is important in determining the effectiveness of the diaphragm connection retrofit. The gradient gages consisted of five small foil backed strain gages factory assembled in a very small unit. They were mounted in, or as close to, the web gap as possible as seen in Figure 2.13.

As mentioned previously, the web gap on this bridge was approximately 1 inch deep. This made it difficult to place the gradient gages directly in the gap. In this investigation only the top three gages of the gradient were used for data interpretation because the other gages were too far from the web gap to produce reliable data. It is also important to note that the G1 web gap has a drilled retrofit, which forced the gradient gage to be mounted outside the web gap.

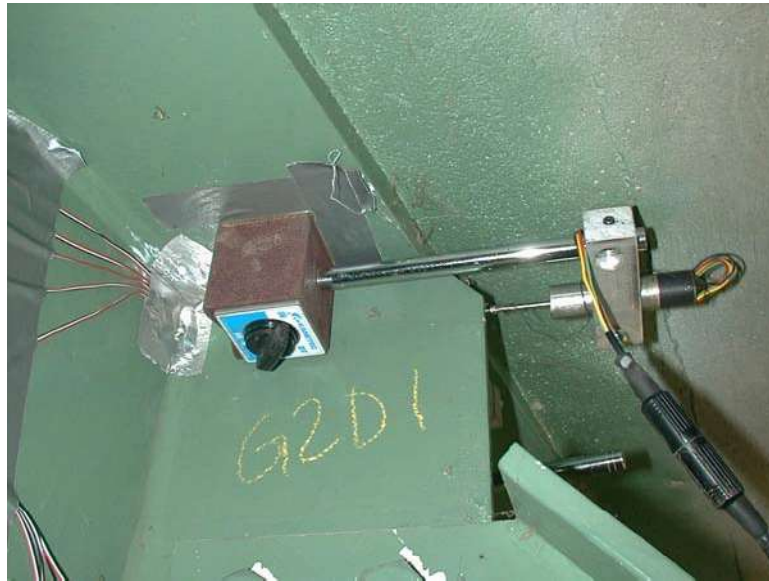
a. G2 out-of-plane displacement transducer looking west.

Direct current displacement transducers (DCDTs) were used to measure displacement of the web gaps. They were attached by magnetic stands to the girder webs and flanges at the connections with D1 as shown in Figure 2.15. G1 and G2 each had a DCDT for out-of-plane displacement measurement. The transducer measured out-of-plane displacement of the web by measuring the horizontal displacement of the web stiffener relative to the top flange, which was restrained from movement by the bridge deck.

**Figure 2.15. Out-of-plane displacement instrumentation.**

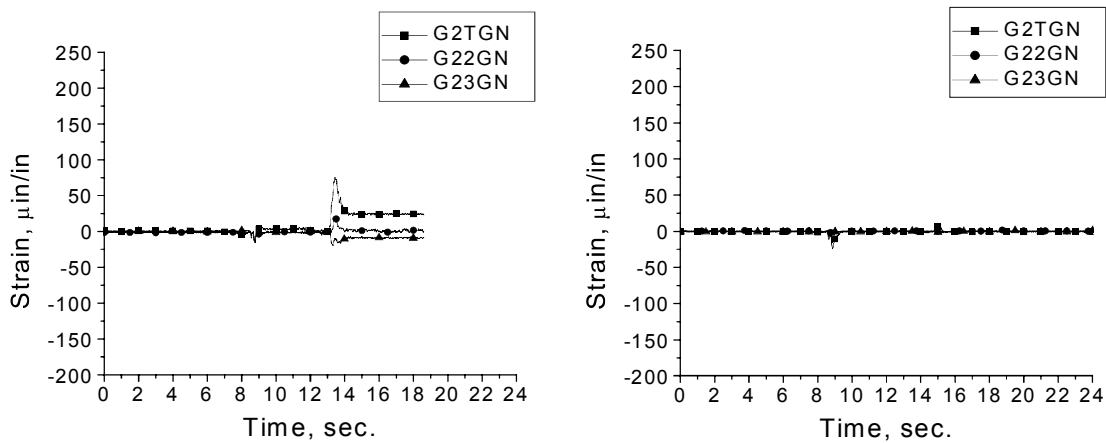
Figure 2.20 shows the strain in the north side of the G2 web gap. The location of the load trucks is the same as the previous figure. The gage positions in the web are also illustrated in Figure 2.20.

a. Gradient gage labels.

b. All bolts tight.

c. Bottom row bolts tight.

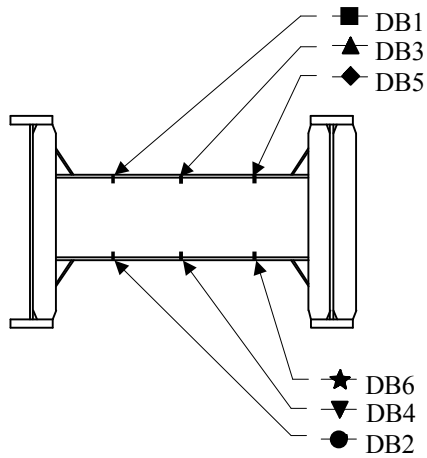
Figure 2.21 shows the strains in D1 between G1 and G2 with the bolts in the tight, bottom tight, and loose conditions. The first spike is due to Truck 1 traveling in the passing lane and the second spike is Truck 2 traveling in the driving lane. An illustration of D1 between G1 and G2 shows the location of the gages on the flanges.

a. Diaphragm gage labels.

d. All bolts loose.

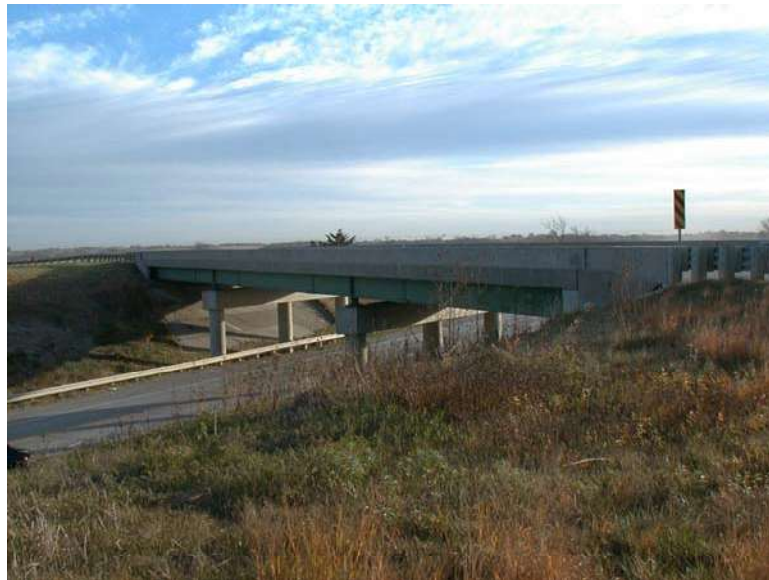
**Figure 3.1. Photograph of test bridge looking northeast.**

Bridge 2700.0R035, shown in Figure 3.1, is a multiple steel girder bridge constructed in 1969 of A36 steel. It carries northbound traffic of I-35 across US-69 on the border of Iowa and Missouri at Iowa milepost 0. It is a three-span structure with five steel girders supporting an 8-inch concrete deck. The piers are skewed 40-degrees to the girder longitudinal axis and are numbered 1 and 2 from south to north. The girders and diaphragms are designated G1 through G4 and D1 through D4, respectively, with D0 indicating diaphragms at piers or abutments as shown in Figure 3.2. The deck is 43 1/3 feet wide and consists of two lanes with shoulders. Shear lugs on the top flanges of the girders create a composite structure between the steel girders and the concrete deck. The centerline of the roadway is 2 feet west of the center girder as illustrated in Figure 3.3. The southern and northern spans, Spans 1 and 3, respectively, are 58 feet 6 inches in length. The center span, Span 2, is 75 feet in length.

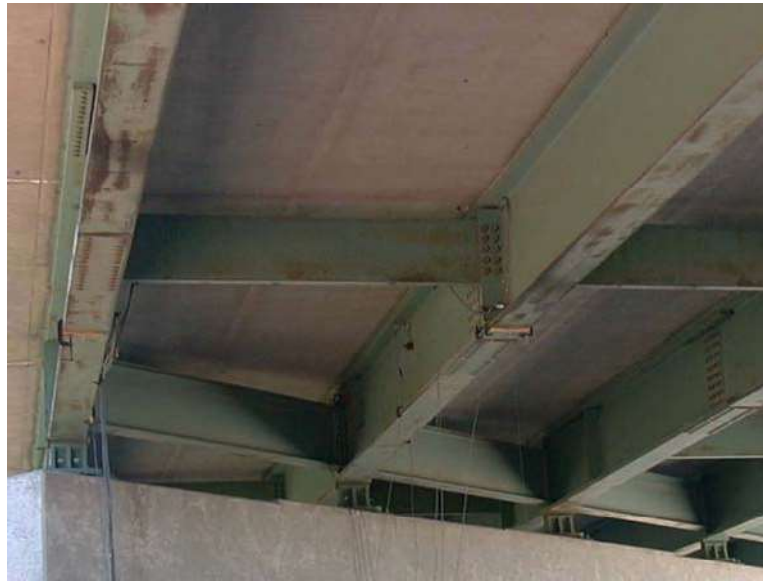
**Figure 3.5. Underside view of diaphragm and girders.**

The bridge has channel diaphragms connecting the five girders. The channel diaphragms are rolled 18C42.7 sections and are bolted to girder web stiffeners at varying spacings from 12 to 22 feet as shown in Figure 3.5. A typical diaphragm/girder connection is illustrated in Figure 3.6. The web stiffeners are welded to the web with small gaps at the top and bottom corners of the girder (i.e., the web gap). The web stiffeners are not connected to the top flange of the girders in the negative moment region. The web gap is 3/4 inches between the stiffener and the top flange as pictured in Figures 3.6 and 3.7. Fatigue cracks, subsequently described, in the web gap are typically parallel to the girder flange and are a couple of inches long extending on both sides of the stiffener.

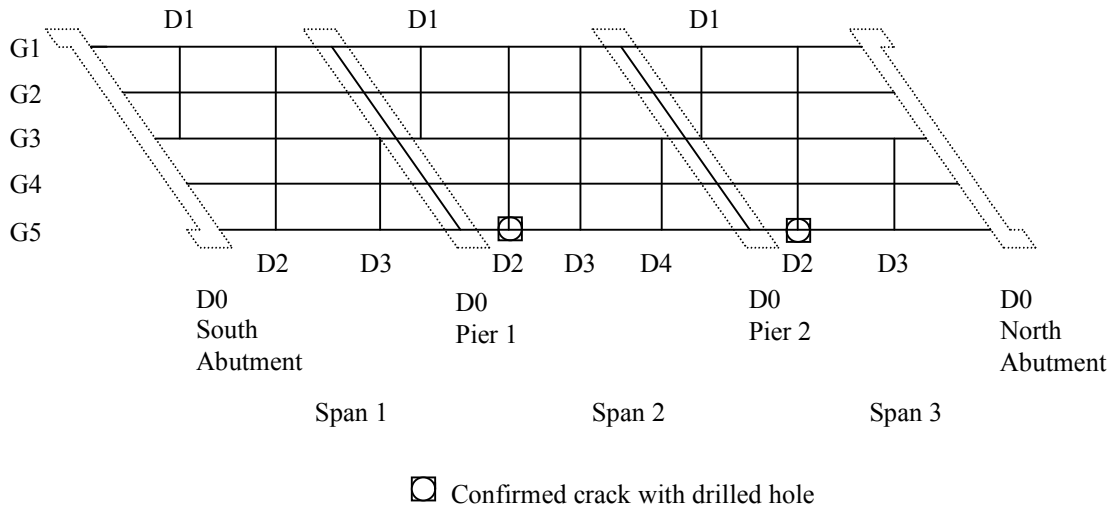
Typically, the girders in the negative moment regions have a much higher frequency of fatigue cracking due to the composite action of the top flange with the concrete deck above the web gap and no stiffener weld to the top flange. Exterior girders also tend to have a higher frequency of fatigue than interior girders. Bridge 2700.0R035 exhibits these common arrangements of fatigue cracking, as depicted in Figure 3.10.

**Figure 3.10. Confirmed crack and drilled hole retrofit locations.**

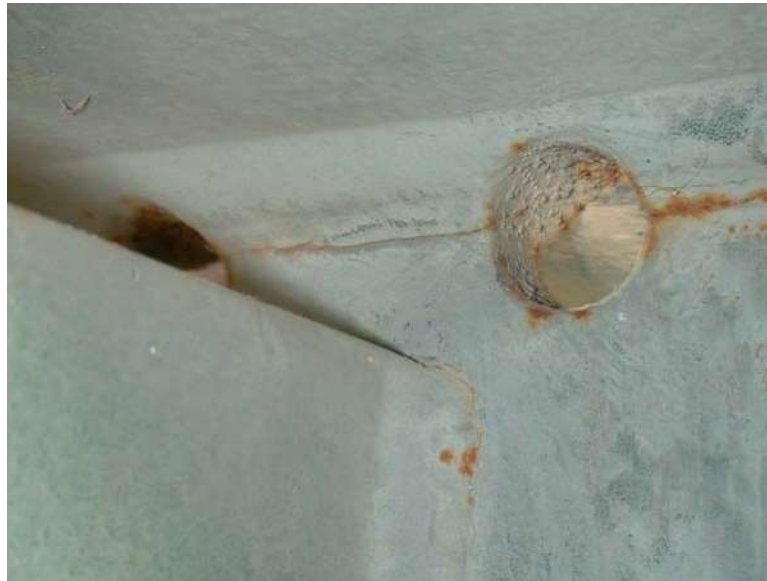
A drilled hole retrofit was implemented on this bridge as a standard Iowa DOT maintenance procedure on fatigue cracking in web gaps. When a fatigue crack was discovered, the terminus was drilled out with a one-inch diameter hole to reduce the stress concentration at the tip of the crack. As shown in Figure 3.11, this method was not always successful in stopping crack propagation. A new retrofit is needed to provide a more permanent solution to the problem.

**Figure 3.11. Typical drilled hole retrofit in web with continued cracking.**

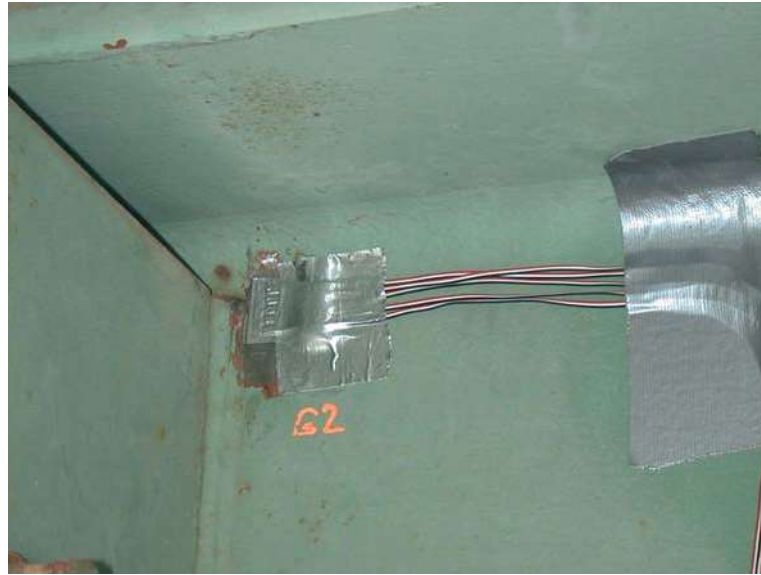
a. Photograph of gradient strain gage in web.

Bondable 120-Ohm gradient strain gages were used to measure web gap strain. The gradient gages consisted of five small foil-backed strain gages in a factory assembled unit. They were mounted in, or as close to, the web gap as possible as shown in Figure 3.13. The gages were oriented to measure web strain in the vertical direction in the web gaps of G1 and G2.

**Figure 3.13. Web gap gradient instrumentation.**

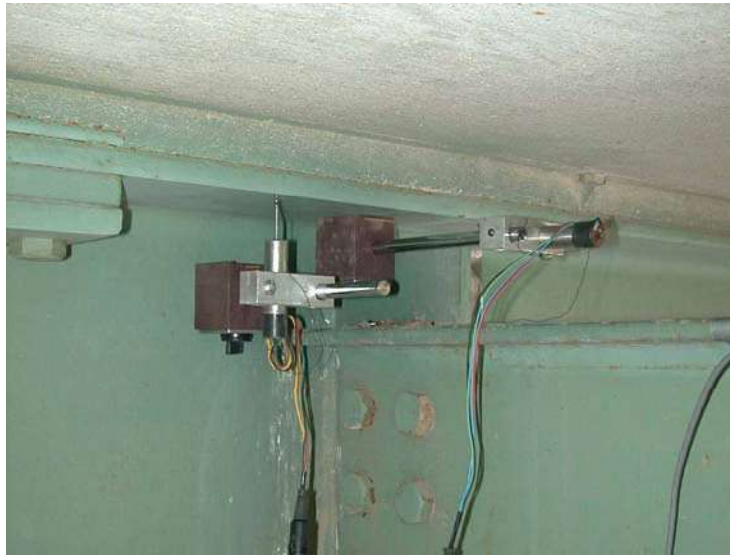
a. Photograph of out-of-plane and tipping transducers (not discussed) on G2.

Direct current displacement transducers (DCDTs) were used to measure displacement of the web gaps. Magnets were used to attach the gages to G1 and G2 near the connection with D3. G2 had an out-of-plane transducer measuring the displacement of the stiffener relative to the bottom side of the top flange where the magnet was connected. Figure 3.15 shows the connection of the transducer on G2. G1 is not pictured and is connected to the girder in an opposite manner. It measured out-of-plane displacement of the web by connecting to the stiffener and measuring the displacement of the top flange. The two gages measured the same type of out-of-plane displacement from different positions on the girder.

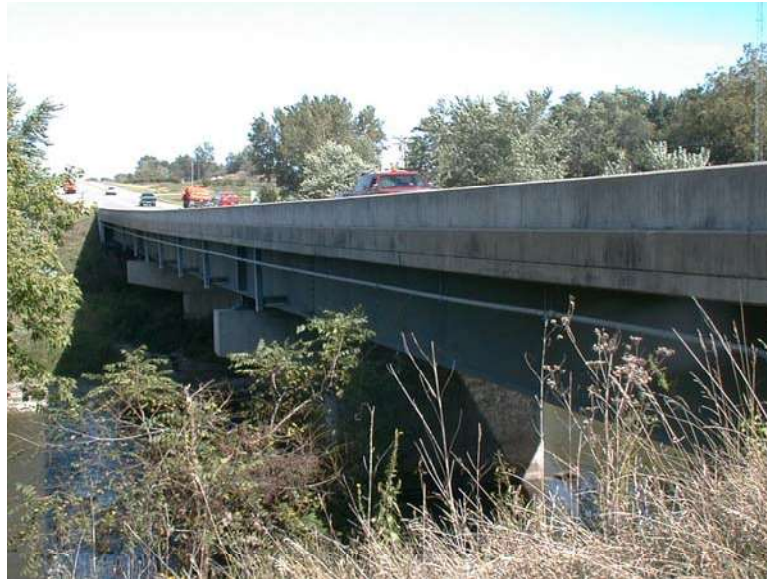
**Figure 4.1. Photograph of bridge looking northeast.**

Bridge 4048.2S017, pictured in Figure 4.1, was selected for testing because it is an X-type diaphragm multiple girder steel bridge with no existing fatigue cracking in the web gaps. It was also used in previous bolt loosening retrofit research for the Iowa DOT [1,2]. It is a five-girder bridge built in 1970 and carries north and south Iowa Highway 17 traffic across the

Boone River in central Iowa's Hamilton County. The bridge has three spans with no skew, and an 8-inch concrete deck. The two end spans are 97 feet 6 inches, and the center span is 125 feet. Figure 4.2 shows a plan view of the bridge; girders are designated with G and diaphragms are labeled with D with diaphragms at piers and abutments numbered 0.

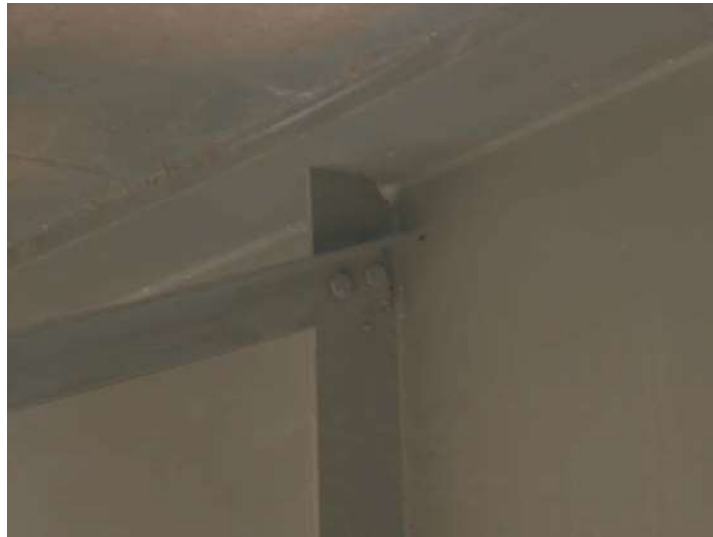
**Figure 4.6. Photograph of typical web gap.**

The diaphragms in this bridge are an X-type diaphragm made up of angles and a horizontal T section as illustrated in Figure 4.4. The exception is that diaphragms at the abutments and piers, D0, are wide flange sections. The diaphragms are spaced at 20 feet along the length of the bridge. The angles are L4x3x5/16 and the T is an ST5WF10.5 and they are bolted to web stiffeners on the main girders as shown in Figure 4.5. The connection of the stiffener to the web stops short of the fillet weld of the top flange where clips in the stiffener do not touch the girder web. The area of the web between the stiffener weld and the top flange, pictured in Figure 4.6, is the web gap.

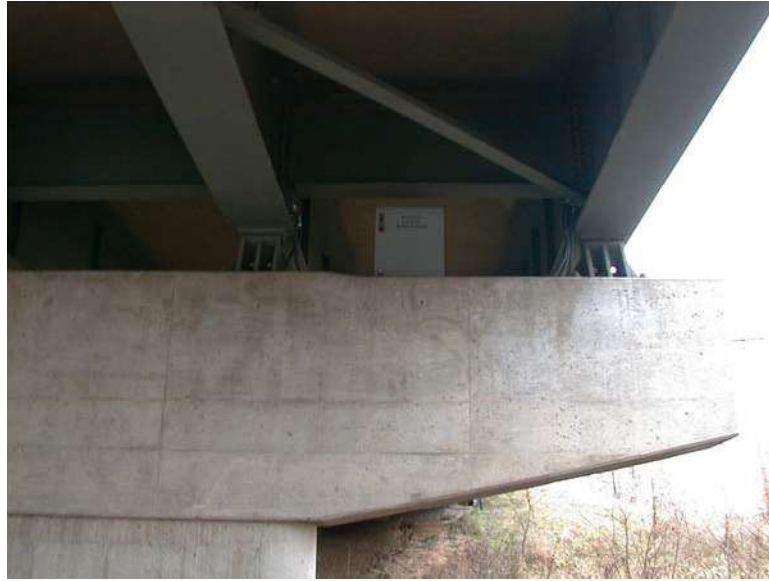
Due to the long-term nature of this test, a remote monitoring DAS was used. The system requirements for an on-site application include the capability of stand-alone data collection so that no supervision of the system is required, ability to withstand the harsh environment of remote deployment, and ability to be controlled and monitored by modem or radio connection. The system selected after product testing was a Campbell Scientific CR 9000 DAS. It possessed a high scan rate and had a modem connection for upload, download, and real-time viewing of data. Initially a system with 28 channels was purchased, and the instrumentation for the test was designed with that limit. An enclosure for the unit was attached to the top of Pier 2 between G1 and G2 as shown in Figure 4.9. The enclosure provided protection for the DAS from the elements and vandalism during the test period. Instrument cables were wired into the box through electrical conduit to limit the environmental access to the DAS electrical systems. Electrical power and telephone utilities were installed at the site and routed to the enclosure to power and control the system. The same instrumentation was used for both the short-term and long-term tests.

**Figure 4.9. Photograph of DAS enclosure on Pier 2.**

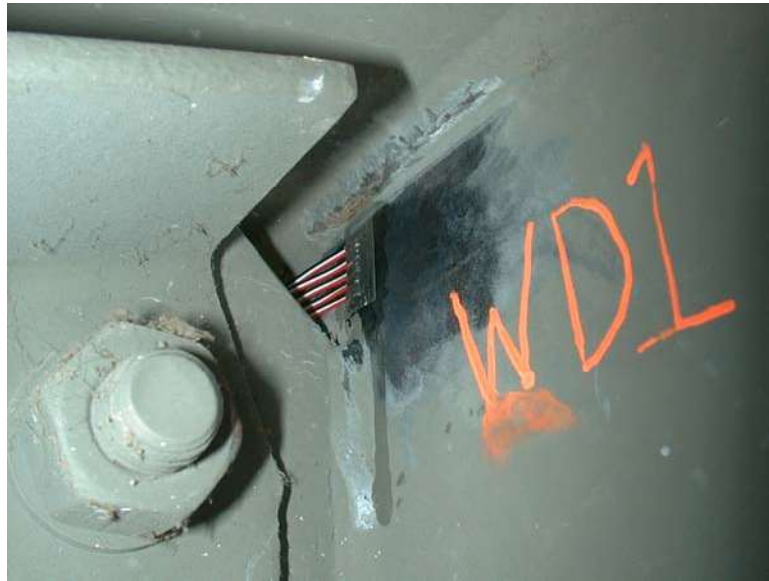
a. Photograph of G1 gradient gage.

Gradient strain gages were used to measure strain in the web gaps. The gradient gages consisted of five foil-backed strain gages assembled in one unit. The entire gage was approximately 1 inch by 1/2 inch as seen in Figure 4.10. One gage was placed in the G1 web gap at D5, and another in the G2 web gap at D5. These gages are not rugged and had to be replaced during the course of the testing as the environment eventually damaged the gages.

**Figure 4.10. Web gap gradient gage location.**

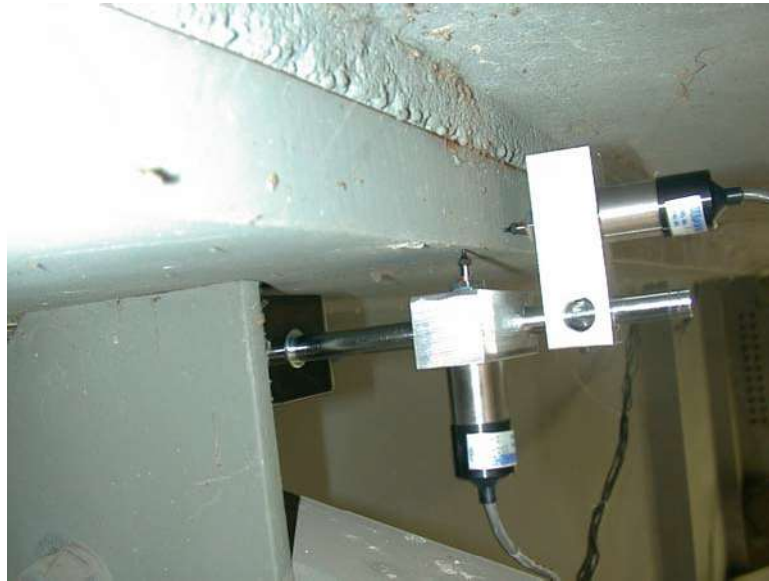
a. Photograph of out-of-plane and tipping transducers.

Environmentally shielded direct current displacement transducers (DCDTs) were used to measure out-of-plane displacement in the web gap. The DCDTs had covers to protect movable parts from the environment and to allow them to function properly in dust, condensation, and ice. The transducers can be seen in Figure 4.11.

Two DCDTs were mounted on G1 as well as G2. Magnets were used to hold the gages to the bridge and epoxy was used to reinforce the magnetic attachment. One gage measured the out-of-plane displacement of the web between the top of the web stiffener and the vertical face of the top flange. The other measured tipping in the girder flange between the girder web and the edge of the underside flange face, which is not discussed in this report.

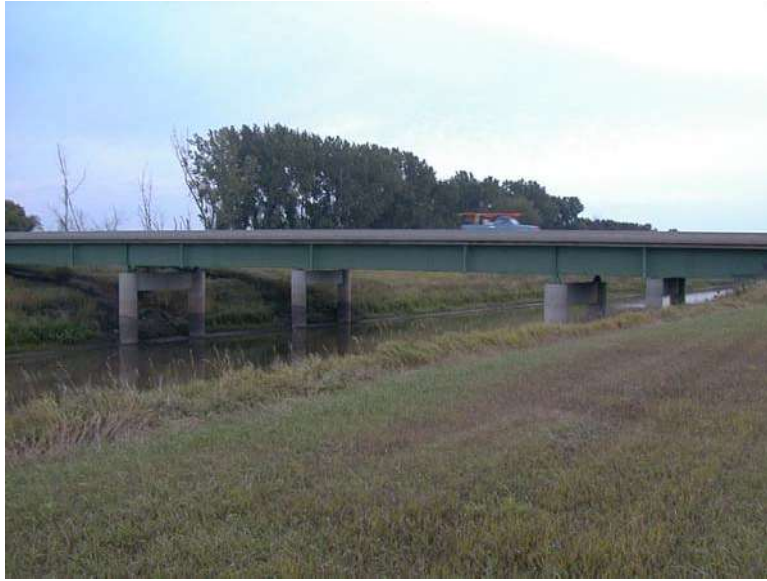
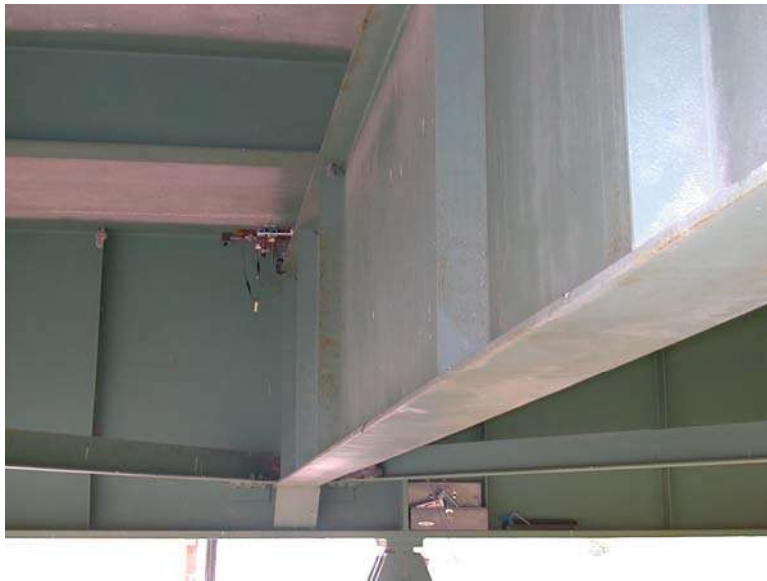
**Figure 5.1. Photographs of bridge.**

Bridge 4397.3L029 is a three-span steel girder bridge with two main girders with stringers and floor beams supporting the deck, as pictured in Figure 5.1. The end spans are 94 feet 6 inches and the center span is 121 feet as illustrated in Figure 5.2. The bridge carries northbound traffic on I-29 in northwest Iowa north of Missouri Valley. The piers are skewed approximately 10 degrees and the deck has a variable thickness between 7 and 8 inches.

a. Photograph of bridge looking northeast.

b. Photograph of floor beams and stringers under bridge deck.

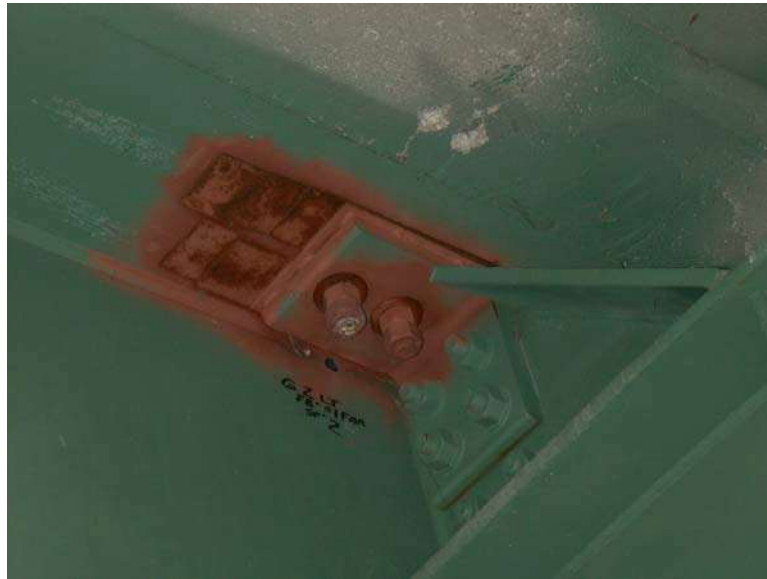
**Figure 5.6. Photograph of repaired retrofit at floor beam connection.**

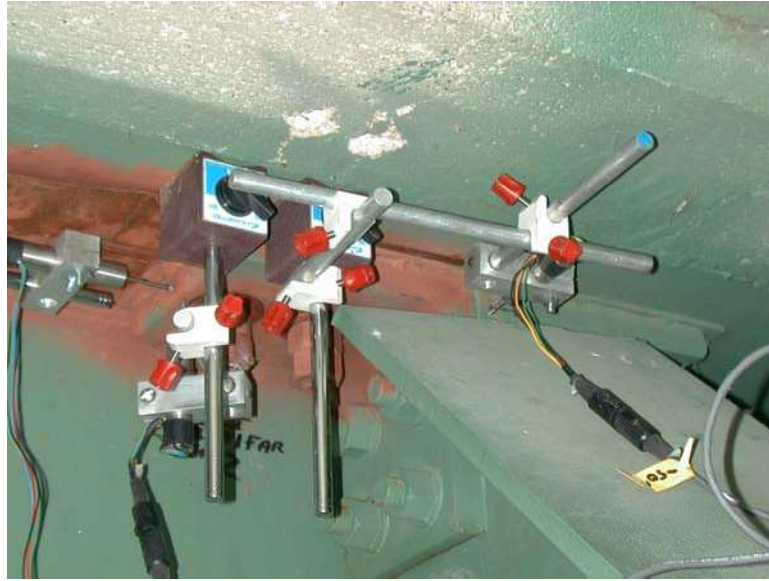
**Figure 5.10. Photograph of displacement transducers at retrofit.**
