REDUCING the ADVERSE EFFECTS of TRANSVERSE CRACKING

**Construction Report
Project HR-217**

**Highway Division
February 1981**

CONSTRUCTION REPORT
FOR
PROJECT HR-217

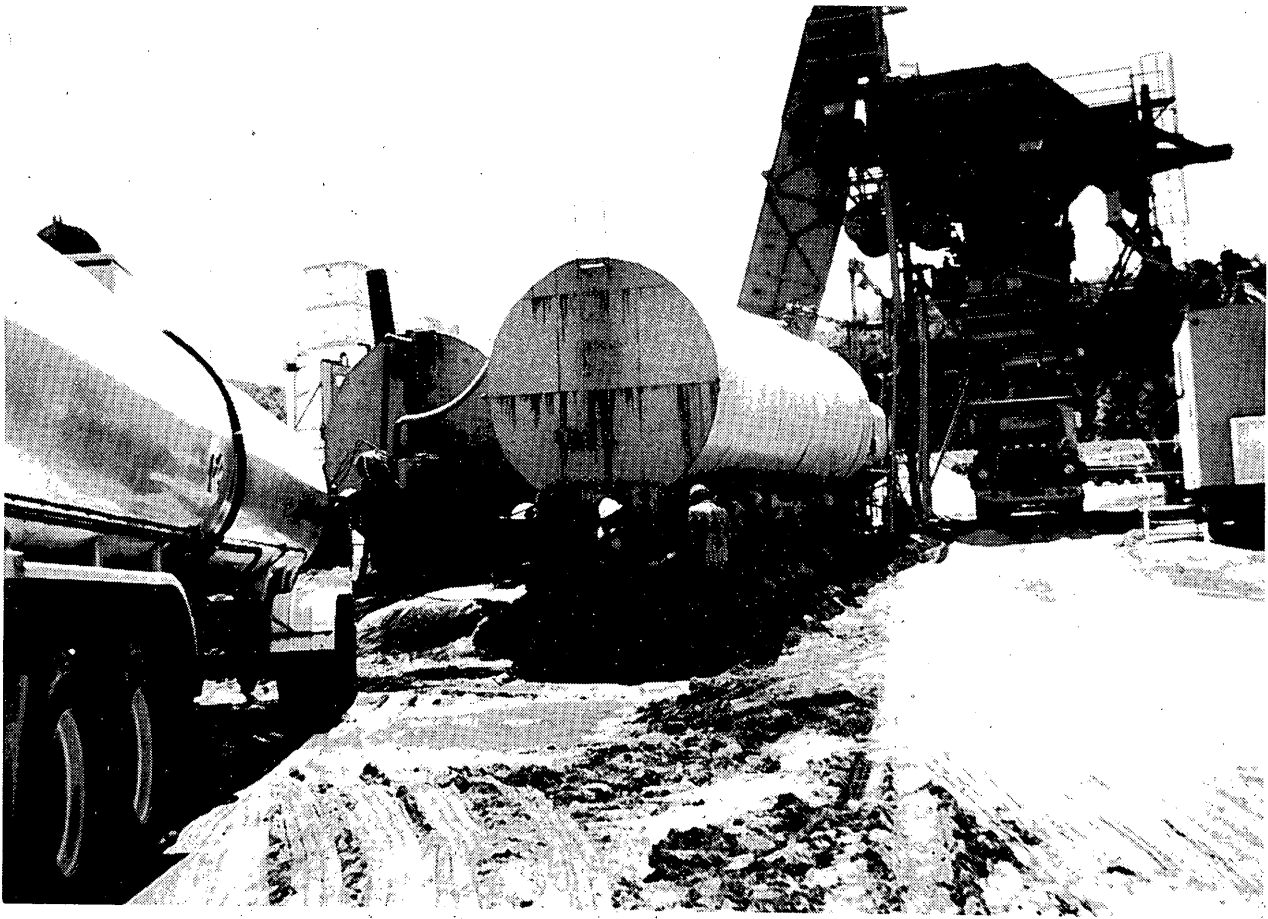
Figure 1 - Cedar Rapids Batch Plant With Dual Storage for Two Sources of Asphalt Cement

Most of the construction operation was standard practice. All asphaltic concrete mix was produced in a Cedar Rapids batch plant (figure 1) located at the B. L. Anderson Anamosa Quarry.

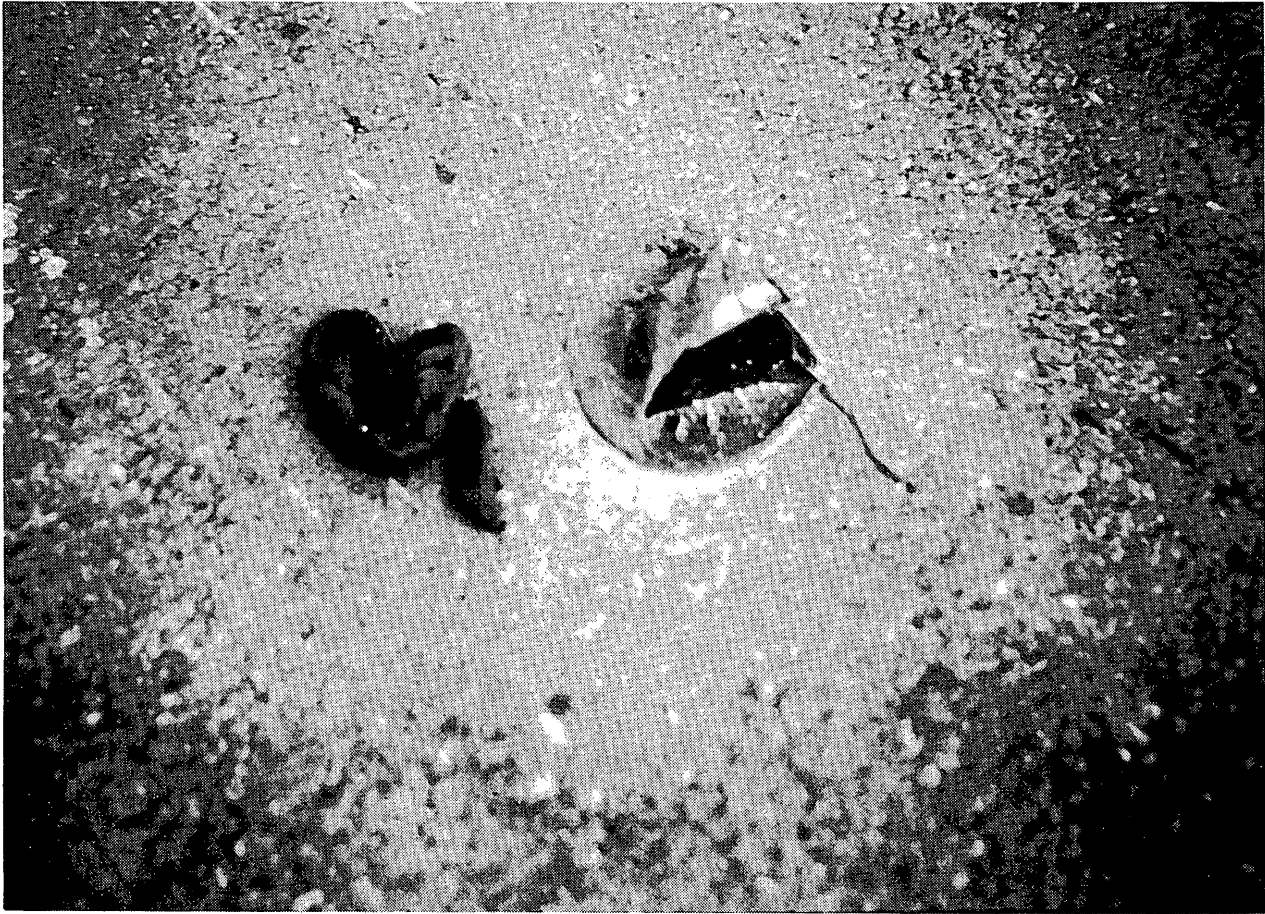
Figure 6 - Sealant Material Tracked by Traffic

An excess of sealant material was used leaving some along the joint (figure 5) and allowing traffic to carry some down the roadway (figure 6).
