Soil Erosion Control for Secondary Roads

Final Report

Research Project HR-155

M. J. Mausbach and W. D. Shrader

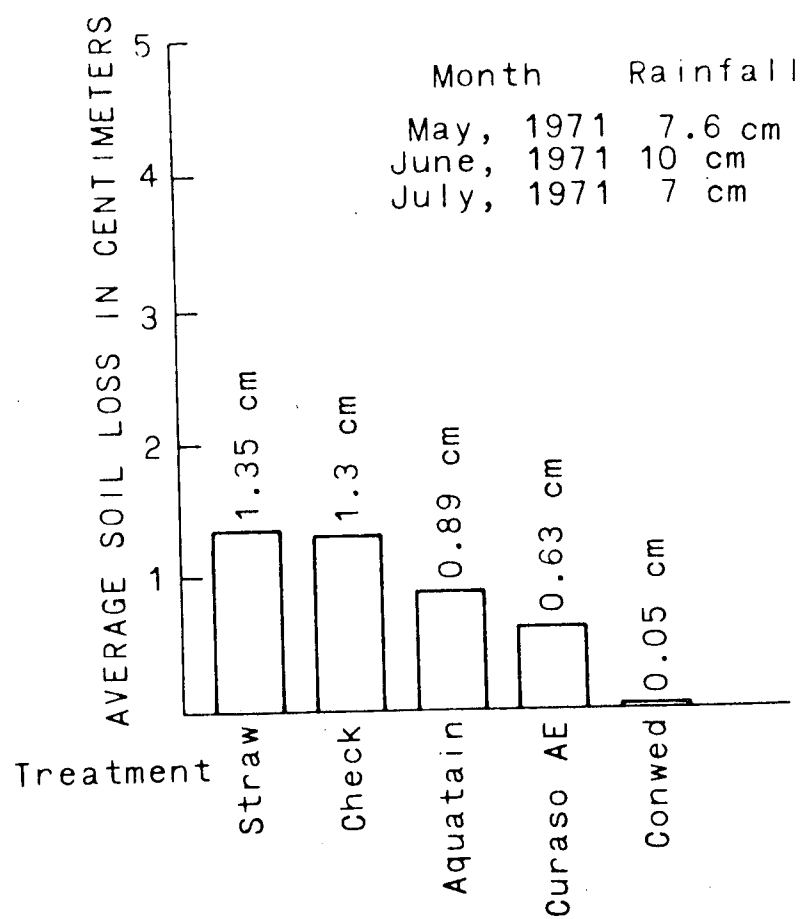
Figure 2. Soil loss and monthly rainfall at the Hamilton County site

Hamilton County Site. Seeding of the Hamilton Country Site was completed on April 24, 1971. Normally May is a period of frequent and abundant rain, but in 1971, rainfall in May (Figure 2) was only 7.6 cm, some 3 cm below normal, and the first large rain did not come until 2 months after seeding. As a result of drouth, all seedings on all treatments were essentially failures.

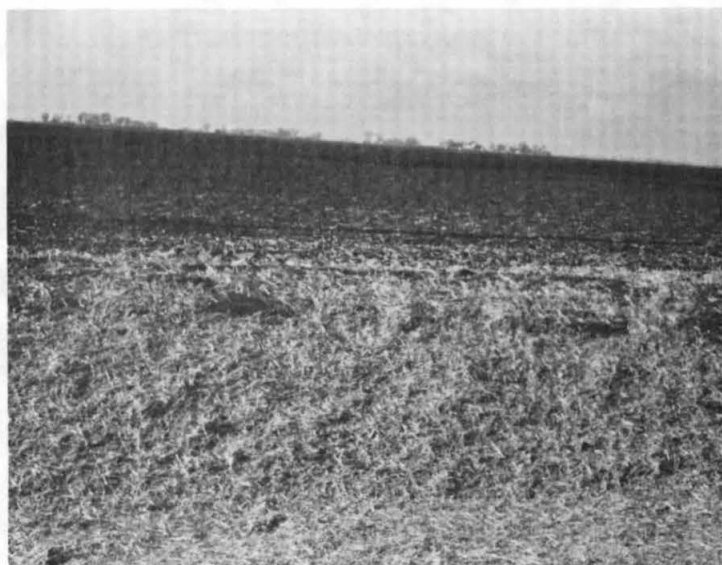
Figure 4a. Effect of wind on straw not anchored in Hamilton County at time of application

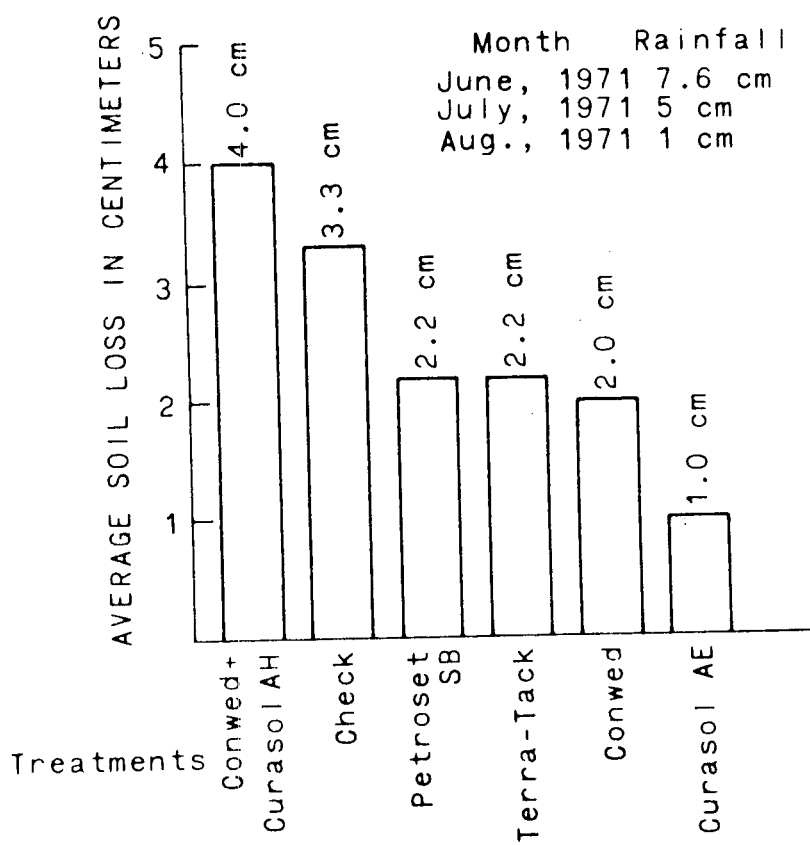
Figure 5. Soil loss and monthly rainfall at the Clayton County site

As is shown in Figure 5, there were large differences in erosion between treatments. Erosion, however, was excessive on all plots. The lowest rate was 147 metric tons per hectare on the Curasol AE treatment. As is shown in Figure 6, the Conwed, Curasol AE, and Conwed + Curasol AH treatments had better vegetative cover and more uniform growth than the other treatments. This cover difference was more pronounced in July than it was in late summer. The Petroset SB treatment seemed to inhibit

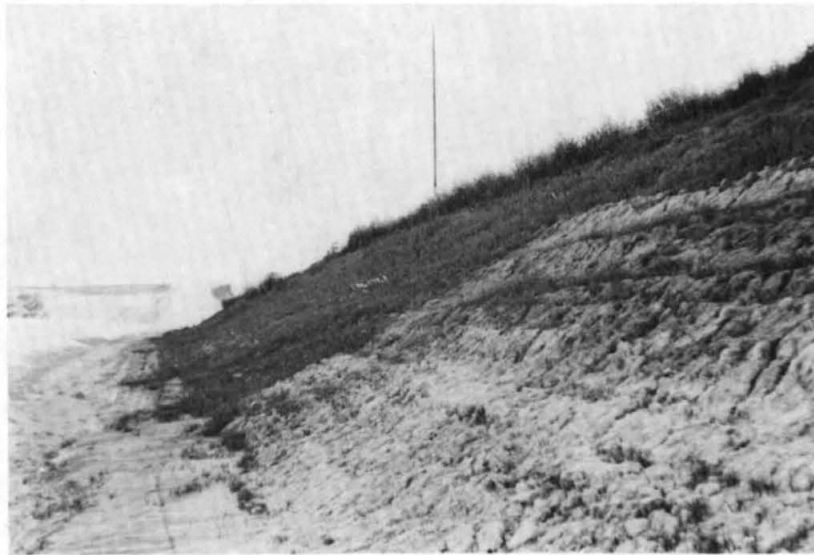
Figure 7. Comparison of Petroset SB in the foreground with Conwed + Curasol AH in background (Clayton Co. site)

growth or germination of seeds when sprayed along with the seeds (Figure 7).<sup>3/</sup> This project was overseeded in the spring of 1972, and satisfactory cover was obtained on all plots.

<sup>3/</sup> The toxicity of Petroset SB applied directly to the seeds was confirmed in a greenhouse study.

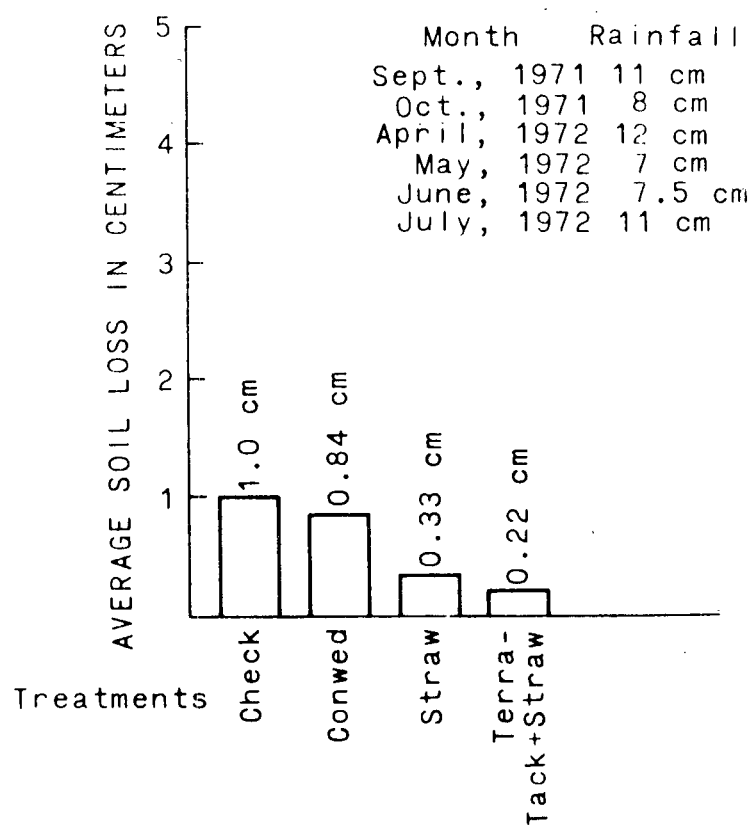
Figure 8. Soil loss and monthly rainfall at the Van Buren County site

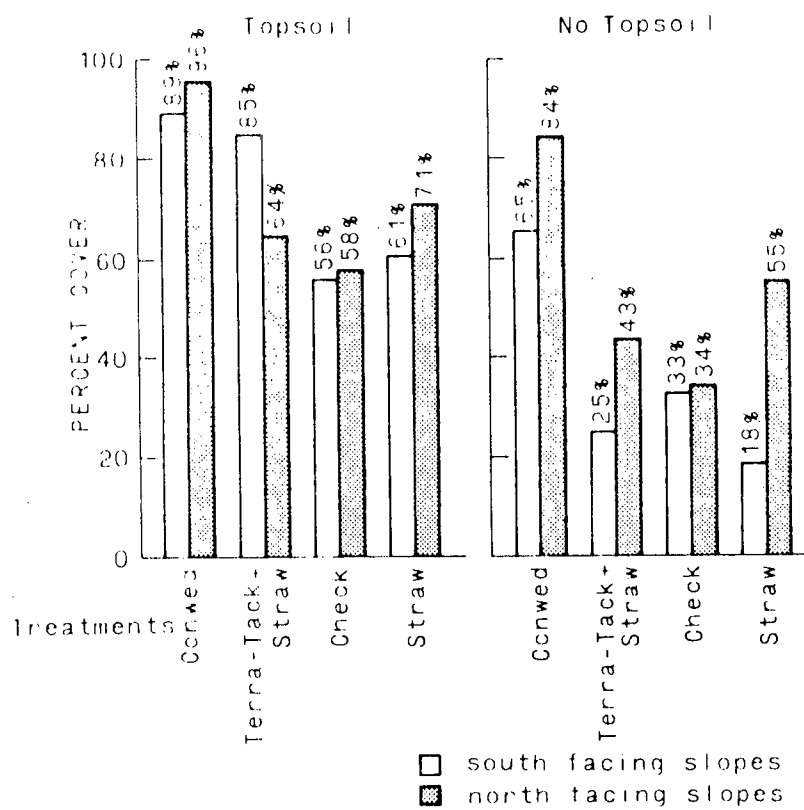
Figure 9. Cover at the Van Buren County site

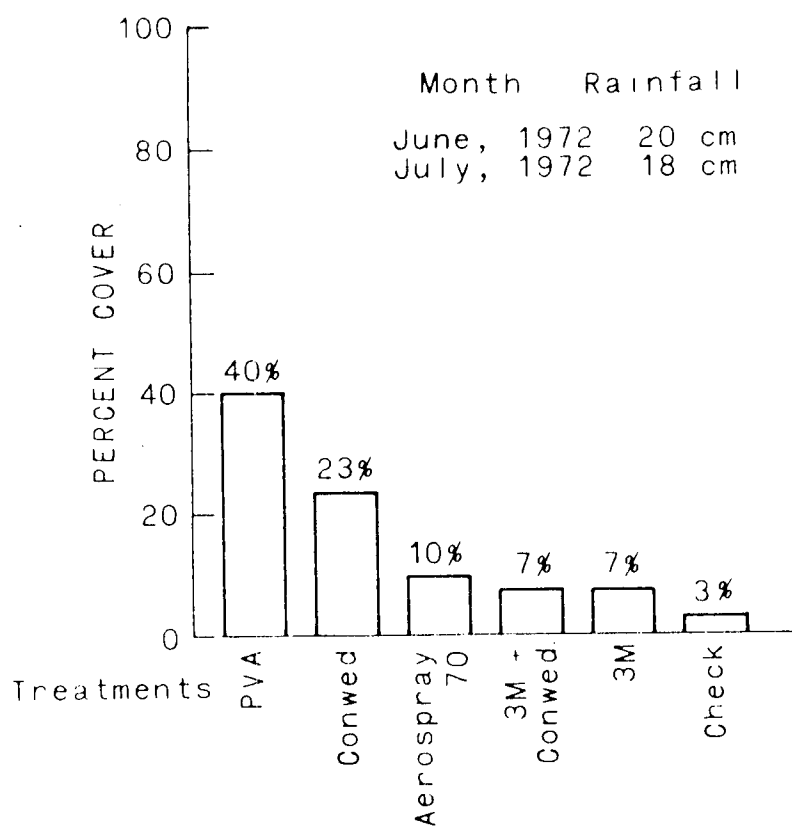
Figure 12. Cover and monthly rainfall at the Ida County site

Ida County Site. Soil loss measured June 23, 1972, and percentage of cover measurements from Aug. 1, 1972 are presented in Figures 11 and 12, respectively. Rainfall again was plentiful at this site after seeding (Figure 12), with the area receiving a high intensity 9 cm rain approximately 2 weeks after seeding. Soil erosion, therefore, was great for all treatments. There are apparent differences between treatments, but no treatment effectively controlled erosion. The largest difference is in cover measurements with only the PVA-treated area adequately covered. The PVA treatment seemed to prevent surface seal and allowed a good environment for germination of the seeds (Figure 13). The Comwed treatment was next in cover, with all the other treated areas very low in cover. Further studies with PVA are in process at this site.

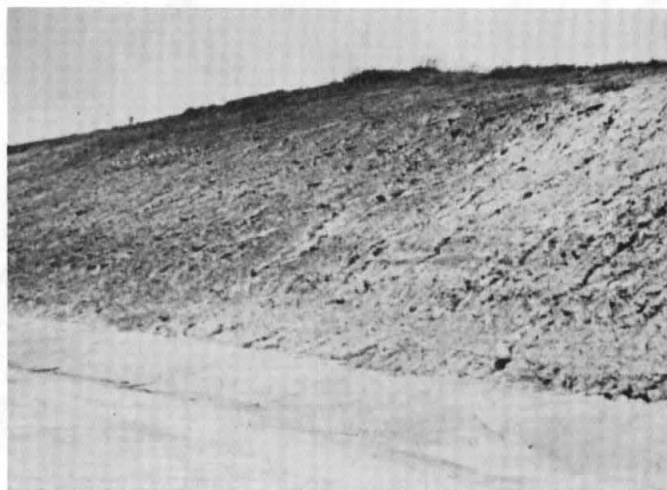
Figure 13a. Comparison of PVA with Aerospray-70, Ida County site -- soil surface difference of PVA in background and Aerospray-70 in foreground

No soil stabilizer studied controlled erosion as well as the standard straw mulch. In Ida County, where a very intense rain of infrequent occurrence fell, the PVA treatment prevented surface seal (Figure 13), which precedes runoff and erosion. Rill erosion resulted because rainfall exceeded the infiltration capacity of the soil. Perhaps, under more normal conditions, this treatment may control erosion. It was effective in preventing erosion in laboratory studies.<sup>4/</sup> The 3M-XB2386 soil stabilizer also was studied at the Ida County site. It did not control erosion, but there are doubts over the quality of the 3M-XB2386 material used at this study site. Consequently, it will be retested when production problems are solved. None of the other soil stabilizers studied showed promise for the control of soil erosion, or even the prevention of surface sealing.

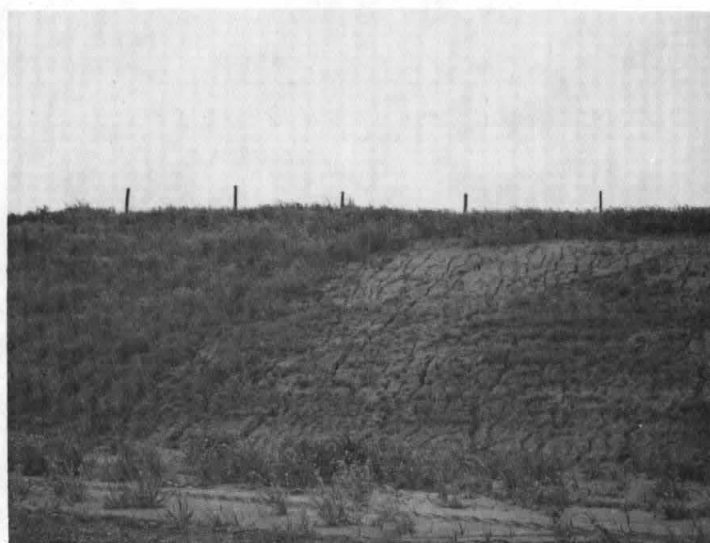
Figure 13b. Comparison of PVA with Aerospray-70, Ida County site -- vegetation difference of PVA on the left and Aerospray-70 on the right

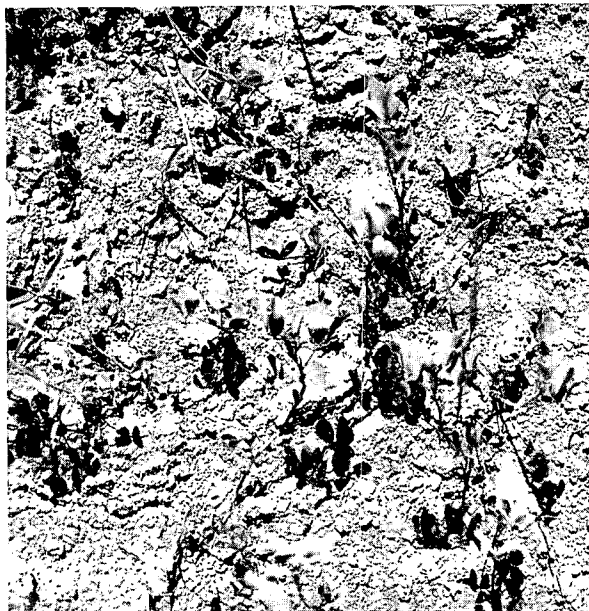
Plate 1. Roadbank in Poweshiek  
County, Iowa treated  
with PVA 72-60 polymer.
