8012-008 Lake Morris Final Project ReportFinancial Accountability**Watershed Improvement Funds**

8012-008 Lake Morris Watershed Before and After Pictures of Grade Stabilization on East Side

8012-008 Lake Morris NRCS IA-23 Construction Specification Earthfill Pictures

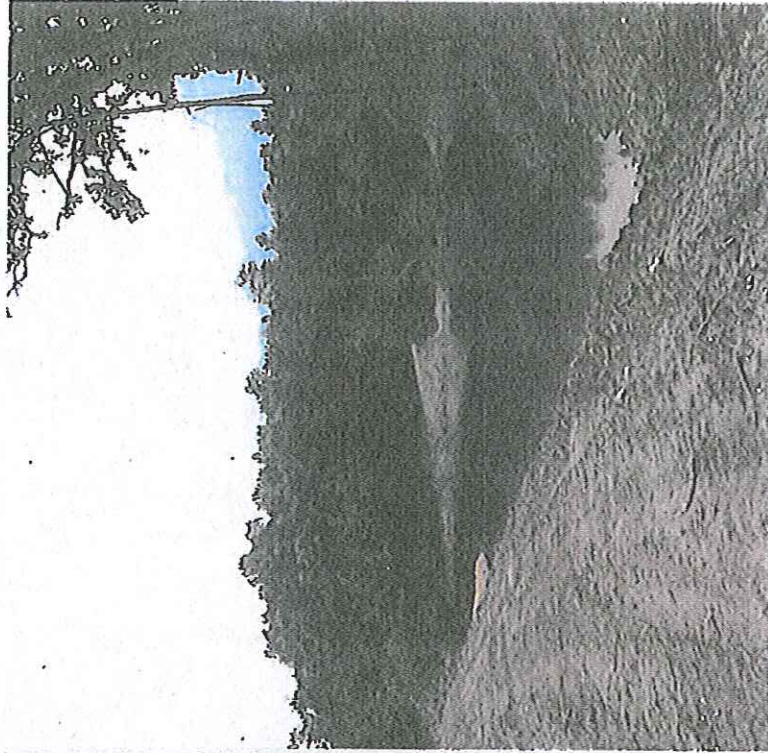
The Grade Stabilization Structure -- up to the right of the dam line (surrounded by trees) is where the old road was.

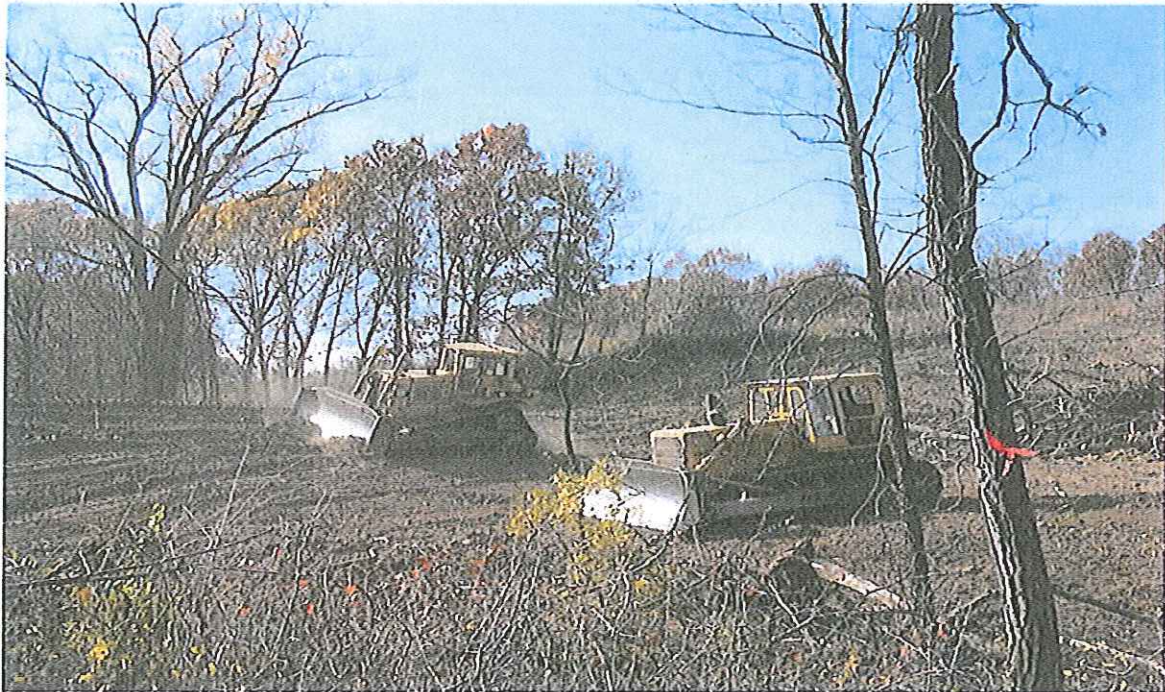
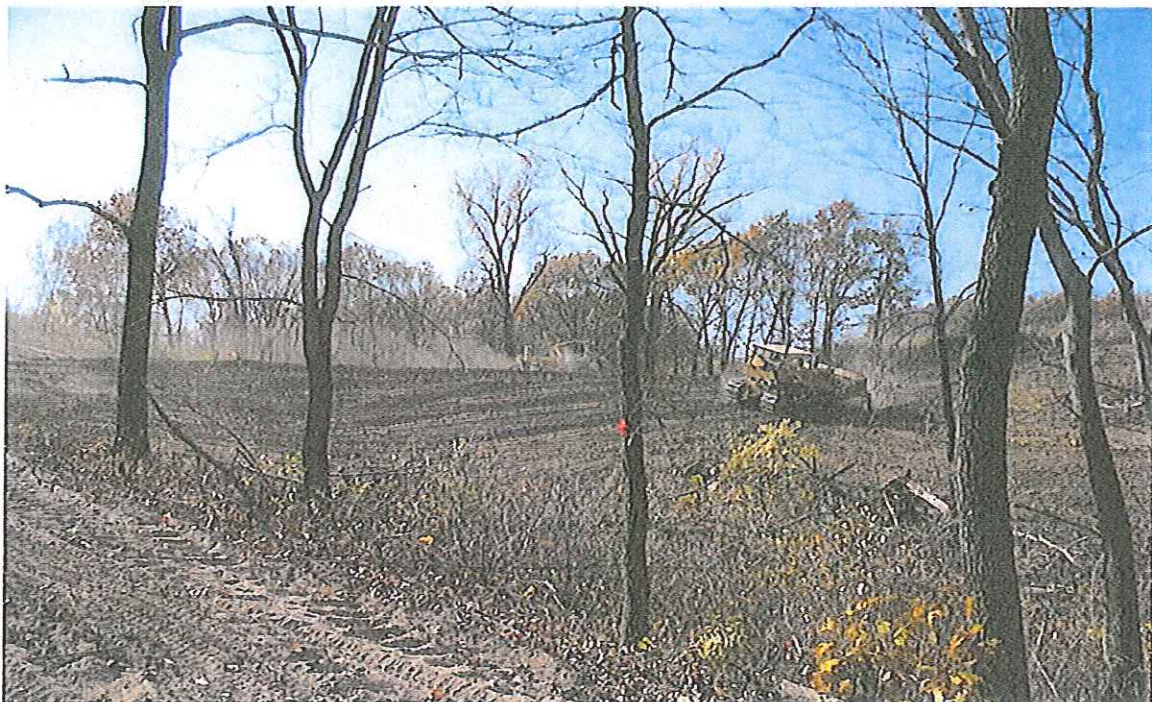
NRCS Construction Specification IA-23 Earthfill requires "When moving fill material from the borrow area(s) to the embankment by use of bulldozers only, the following step shall be followed: Immediately after the borrow material is pushed to the embankment, it shall be spread in horizontal lifts placed parallel to the centerline of the embankment."
