WIRB Final Project Report

Project Name: East Okoboji Beach Drainage LID Retrofit Project

Project Number: 8006-003

Reporting Period: 2-1-2009 – 2-1-2012

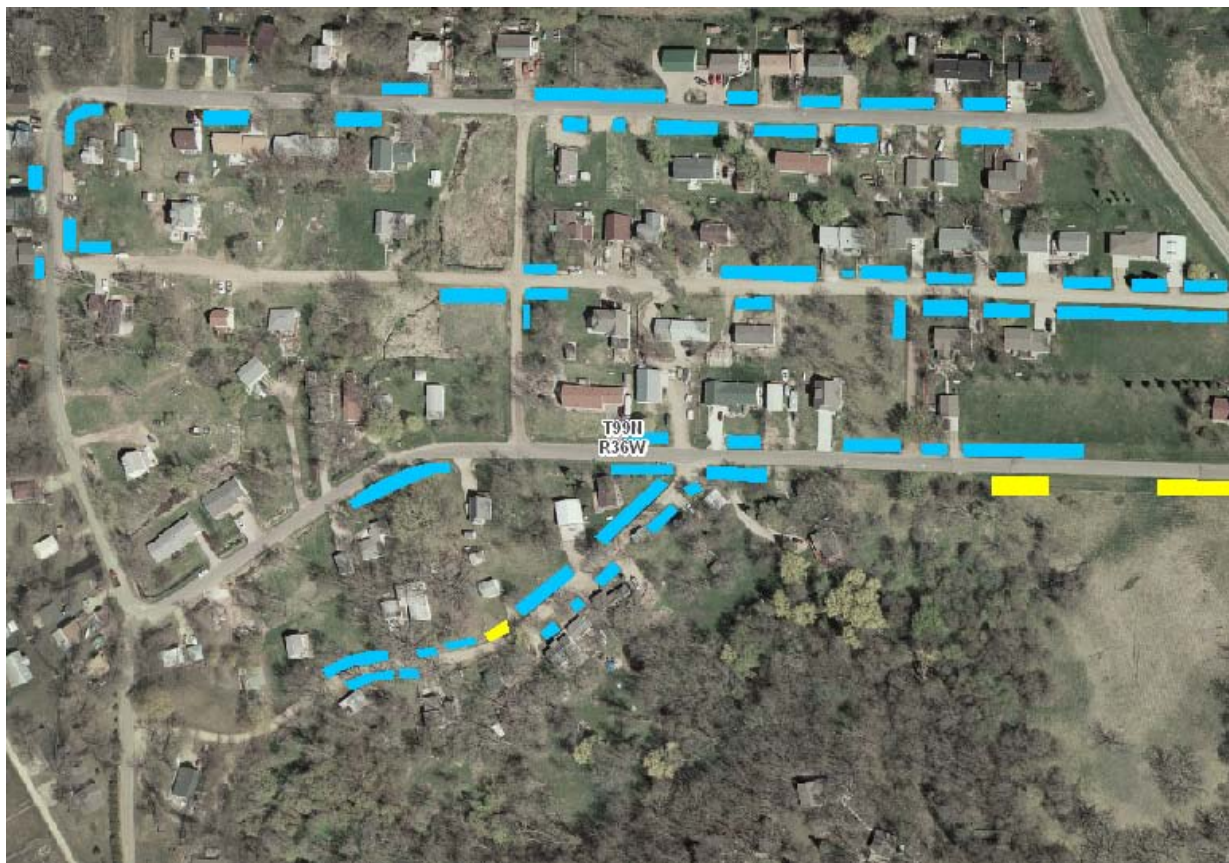
Photo 3. EOB North

To illustrate the location of every LID practice that was installed with the project, see photos 3 and 4 below. Photo 3 shows the North half of the subdivision while photo 4 shows the South half of the subdivision. Each of the individual LID practices is represented by different colors. The enhanced swales are shaded blue, the enhanced swales with plants are shaded red, rain gardens are shaded yellow, and the bio-retention cell is shaded green.

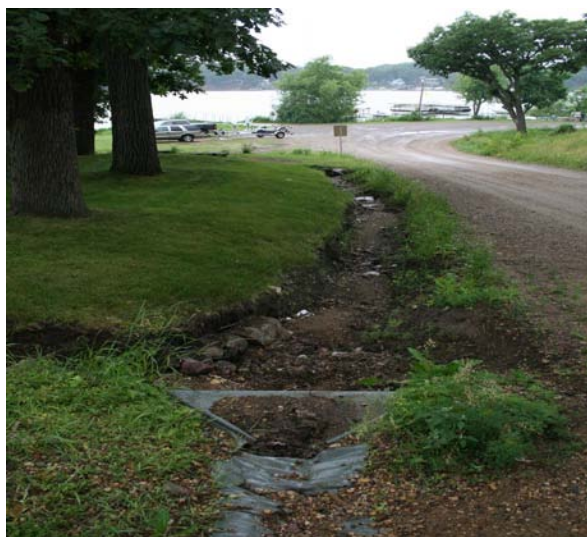
Photo 5 before

See photos 5-6 and 7-8 below that illustrate the difference the project has had. Before the paved roads water was directed into ditches, but without proper cover and the instillation of LID practices gullies were allowed to form that would have kept increasing in size without the project. Once the water, already full with suspended solids and nutrients, flowed off the gravel roads, it was then combined with the sediments from the eroding ditch to generate large amounts of pollutants in it. Now when the stormwater runs off it is conveyed to the ditch on a cleaner surface and filtered and infiltrated into the LID cells.

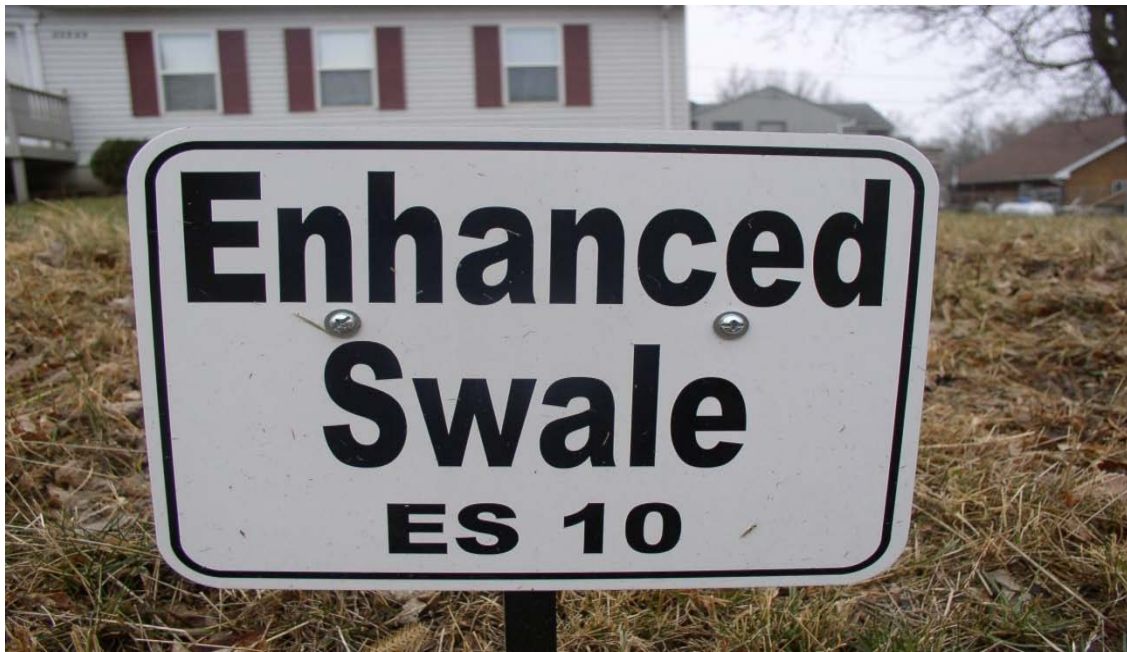
Photo 9 Enhanced Swale Sign

Signs were installed throughout EOB that mark each individual LID practice that are visible by either walking or driving on the road adjacent to each practice. Each of these signs is placed within the cell and is assigned a number (See photos 9 – 12 that show the types of signs). These signs will assist the public in identifying the individual practices and show the placement of each of them.
