EVALUATION OF INTERSECTION CONFIRMATION LIGHTS IN MEDIUM TO LARGE COMMUNITIES IN IOWA TO REDUCE RED LIGHT RUNNING VIOLATIONS

FINAL REPORT
February 2015

1. Report No. IHRB Project TR-657	2. Government Accession No.	3. Recipient's Catalog No.	
4. Title and Subtitle Evaluation of Intersection Confirmation Lights in Medium to Large Communities in Iowa to Reduce Red Light Running Violations		5. Report Date February 2015

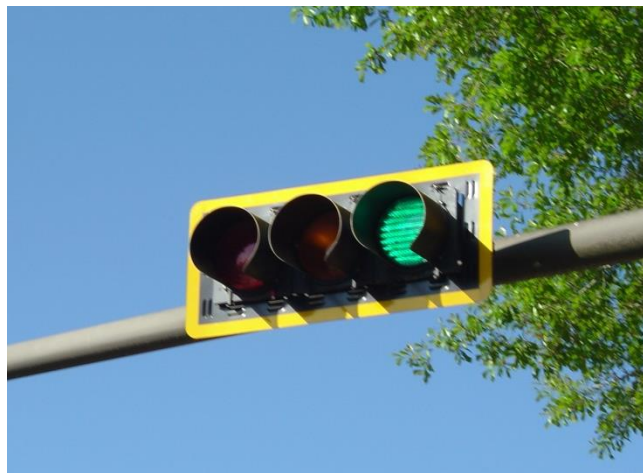
Figure 1. Retroreflective backplate border (FDOT, 2014)

Another technique of making signal head conspicuous is to use retroreflective materials on the borders of backplates as shown in Figure 1.

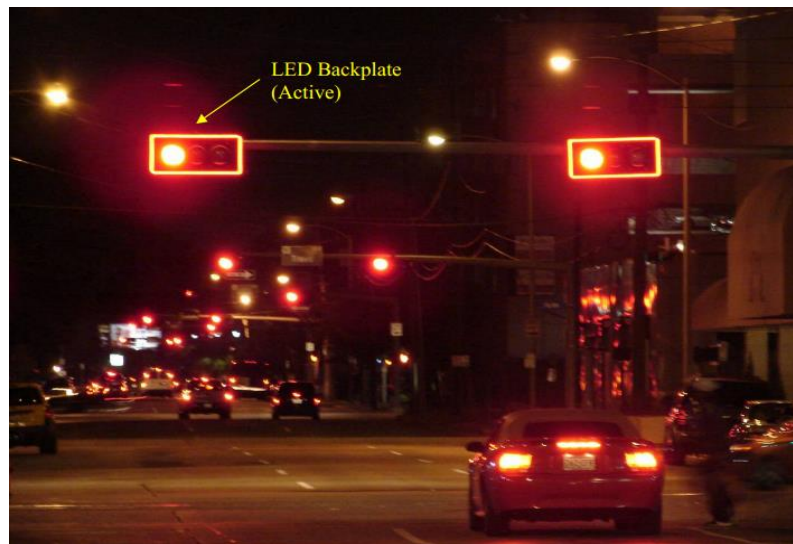
Figure 4. LED backplate (Active) in Houston, Texas (Tydlacka et al., 2011)

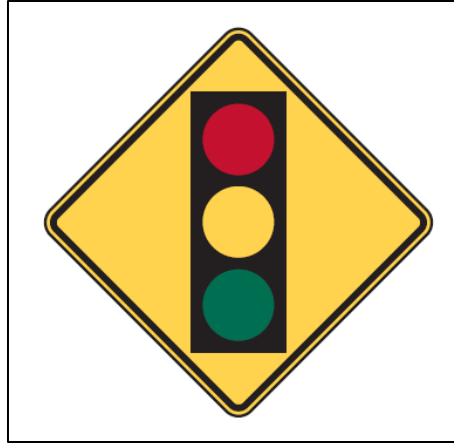
Figure 5. Signal Ahead sign, W3-3 (MUTCD 2009)

Advance warning signs gain the attention of road users to unexpected roadway conditions that might be not readily apparent to them. According to the MUTCD (2009), the “Signal Ahead” sign (W3-3) shown in Figure 5 can be used to alert drivers of the presence of a signalized intersection ahead.

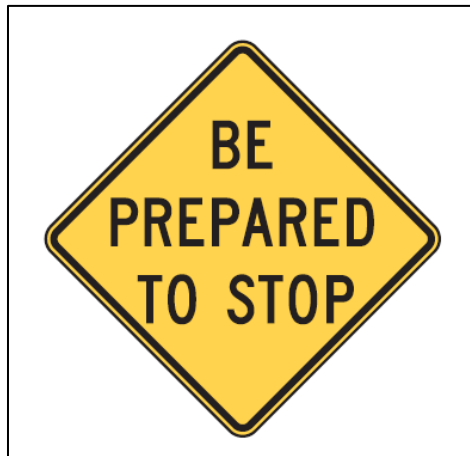
Figure 6. Be prepared to stop sign, W3-4 (MUTCD 2009)

Polanis (2002) analyzed a before-after crash data (36 to 48 months) from collision diagrams prepared by police department in the city of Winston–Salem, North Carolina to evaluate the effectiveness of eight engineering countermeasures to reduce RLR. A before-after study of “Signal Ahead” signs was one of the strategies evaluated. It was found that installation of the “Signal Ahead” sign at 11 study locations showed a 44 percent reduction in right angle crashes. Another type of advance warning sign is the “Be Prepared To Stop” sign (W3-4) as shown in Figure 6.

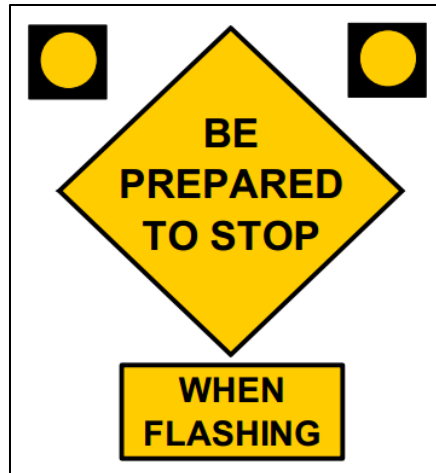
Figure 7. “Be prepared to stop” sign supplemented with flashing beacons and when flashing plaque (MUTCD 2009)

Flashing beacons and “When flashing” plaques (W16-13P) shown in Figure 7 can be added to this sign to alert drivers that the green light is about to change to red in few seconds (MUTCD 2009).

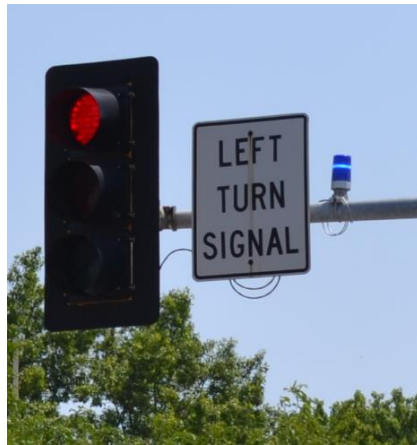
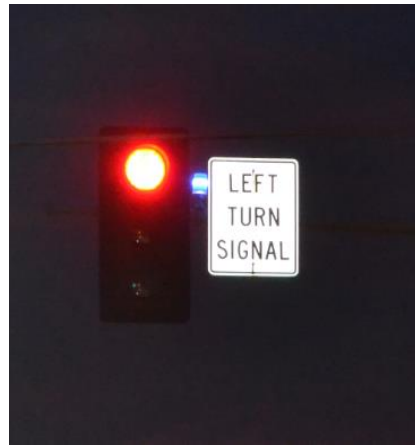
Figure 8. Blue confirmation light in operation at day and night time

Confirmation lights are a relatively small, low-cost light mounted on the top or the bottom of a traffic signal head or mast arm. This light is sometimes referred to as “Red-Signal Enforcement Lights” or “Red Indication Lights” or “Rat Boxes” or “Tattletale Lights” (Hsu et al., 2009). The confirmation light activates simultaneously during the red signal phase to aid a police officer located downstream of the intersection in observing a RLR violation. After the confirmation light turns on, it is visible 360 degrees from any intersection approach. The confirmation light is wired directly into the red signal aspect and only activates when red light is indicated as shown in Figure 8 a, b and c also show confirmation lights in operation during the day and night times respectively in Lawrence, Kansas.

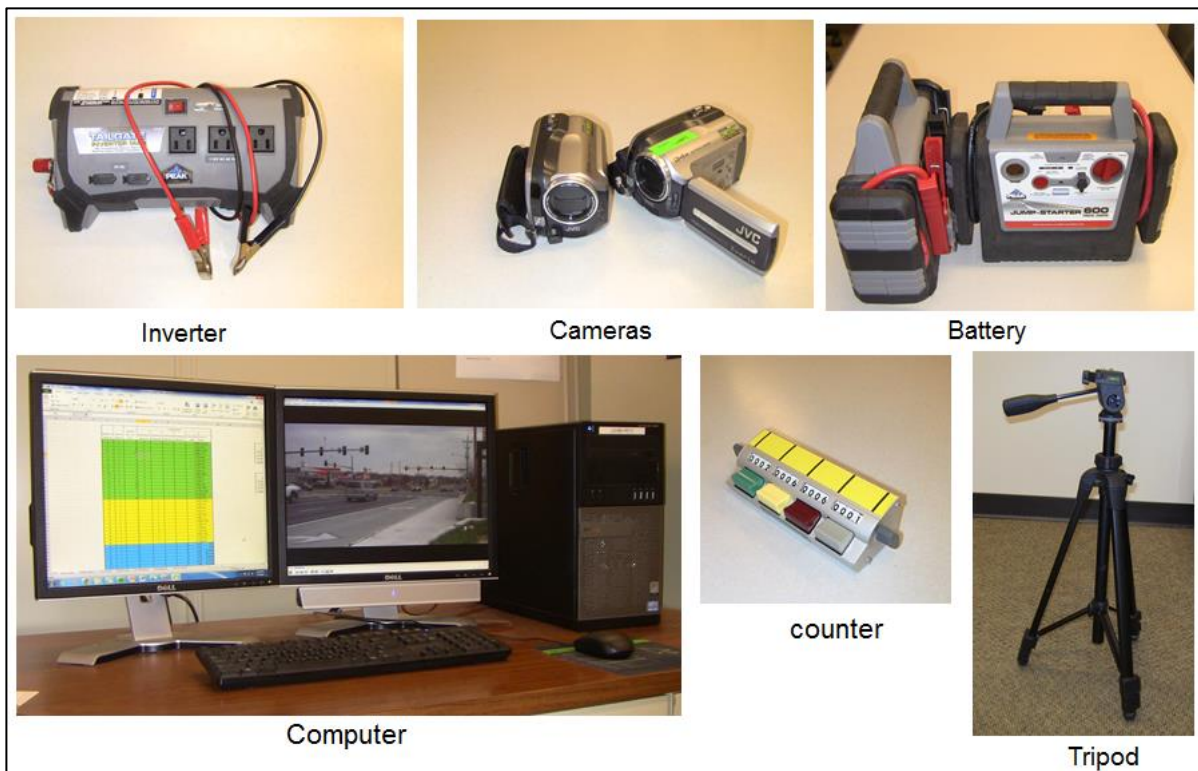
Figure 10. Equipment used for field data collection effort

As shown in Figure 9, the research team was interested in a field of view that could monitor a single approach. The field of view also needed to be able to see the stop bar, all approach lanes and traffic signals. This was complicated sometimes by the rising sun and evenings where it was dark at the beginning or end of the peak hour. The research team used commonly available equipment. The high definition video cameras used to collect the data had a maximum battery life of 0.5 to 1 hour, thus needing either an extended battery pack, or a deep cell battery and inverter as shown in Figure 10.

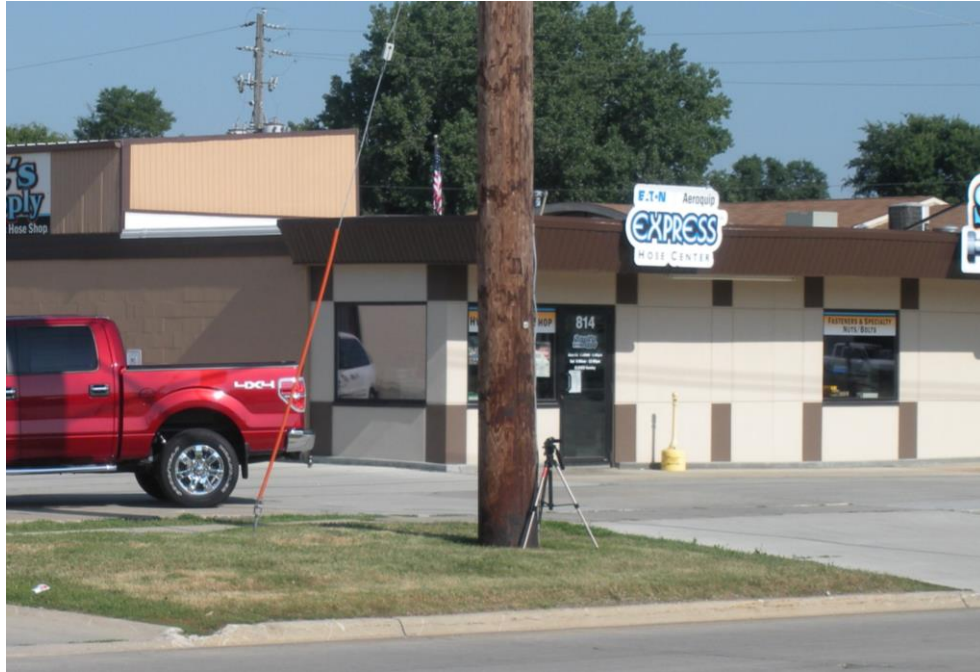
Figure 11. Camera setup at an intersection

Another important aspect to the data collection methodology was setting up the video camera equipment at all four approaches and subsequently not changing driver behavior while recording vehicles. Prior to video data collection at any intersection, field researchers were instructed to inform local police departments to let them know of the locations they would be filming each time they recorded traffic. The cameras were set-up near utility posts or in the median where possible. Researchers were careful to place cameras in public property, and in places where it would be hard for motorists to notice or easily be able to steal the equipment. An example of a video camera setup in the right-of-way near an intersection in Altoona, IA is shown in Figure 11.

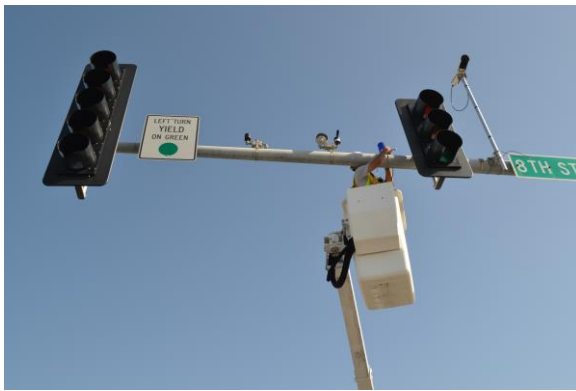
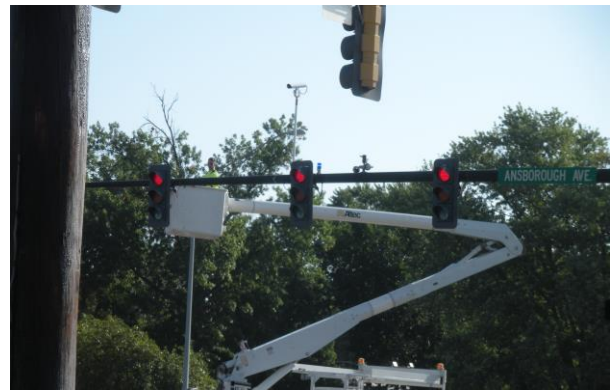
Figure 13. Field installation of the confirmation light in (a) Altoona and (b) Waterloo

On August 30, 2013, between 8 a.m. and 9 a.m., the confirmation lights were installed at 8th Street and 34th Street in Altoona, IA and University Avenue and Ansborough Avenue Waterloo, IA. Both communities were interested in monitoring RLR violations on through and left turn approaches and so at the request of the department, the lights were installed on all the approaches where possible. The southbound approach at University Avenue and Ansborough Avenue and all approaches at 8th Street and 34th Street had protected-permitted left turn signals which made it difficult for the confirmations lights to work as expected. During the permitted phase, both the red and green signal indicators would be indicated. The confirmation light was simultaneously activated during this phase. It was very difficult or nearly impossible for a police officer located downstream of an intersection to tell whether a violation occurred during the permitted phase or

after the signal indication was red. In order to avoid such confusion, the confirmation lights were not installed on intersection approaches that had protected/permitted left turn. Figure 13 shows a field installation of the confirmation lights by the City of Altoona and the City of Waterloo.

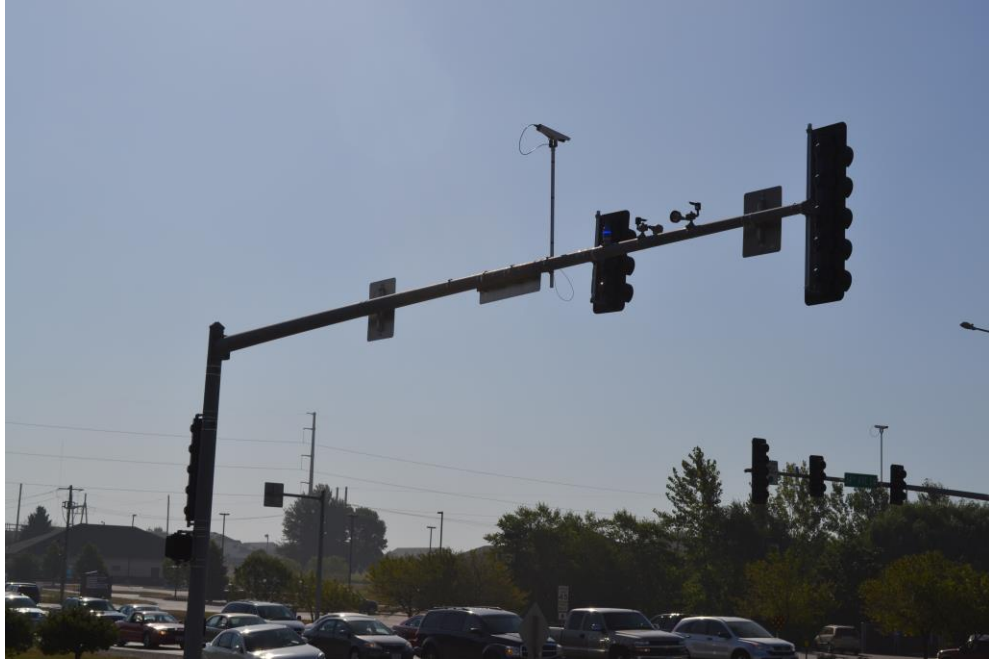
Figure 14. Confirmation Lights at 8th Street and 34th Street in Altoona, IA

Additionally, the research team consulted with the University of Kansas and the City of Altoona and the City of Waterloo to jointly release a statement regarding the project. A copy of the press release can be found in the Appendix. The coordinated press release was designed to inform drivers that a change was happening at the designated intersections and a different color was going to be present besides red, yellow and green. The press release was also designed to show a commitment to intersection safety by the research team and both communities. Shown in Figures 14 and 15 are the blue confirmations lights Altoona, IA and Waterloo, IA respectively.

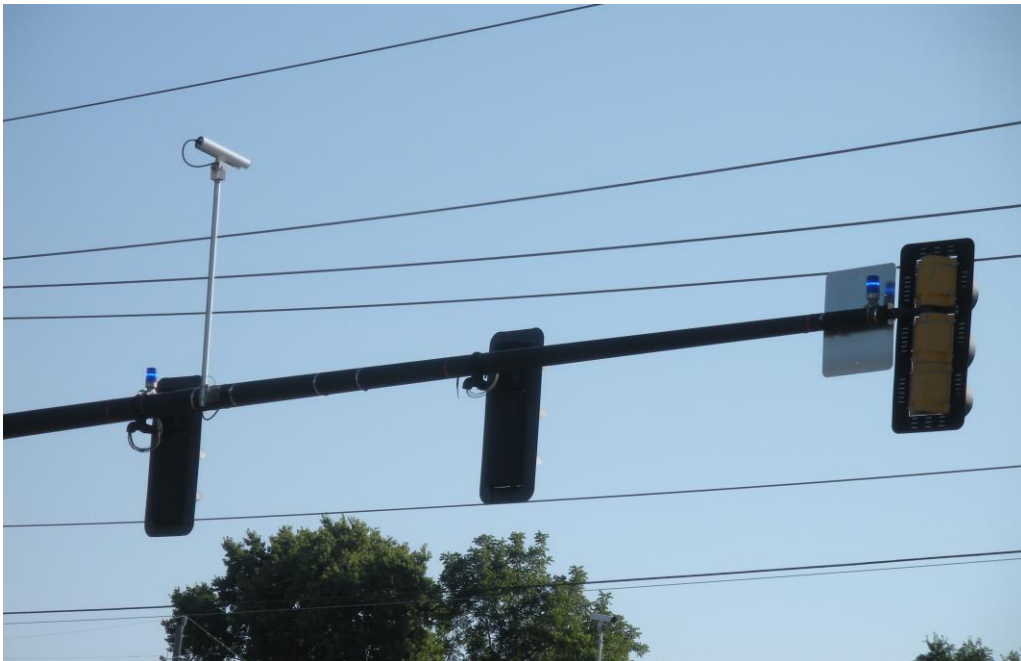
Figure 15. Confirmation Lights at University Avenue and Ansbrough Avenue in Waterloo, IA

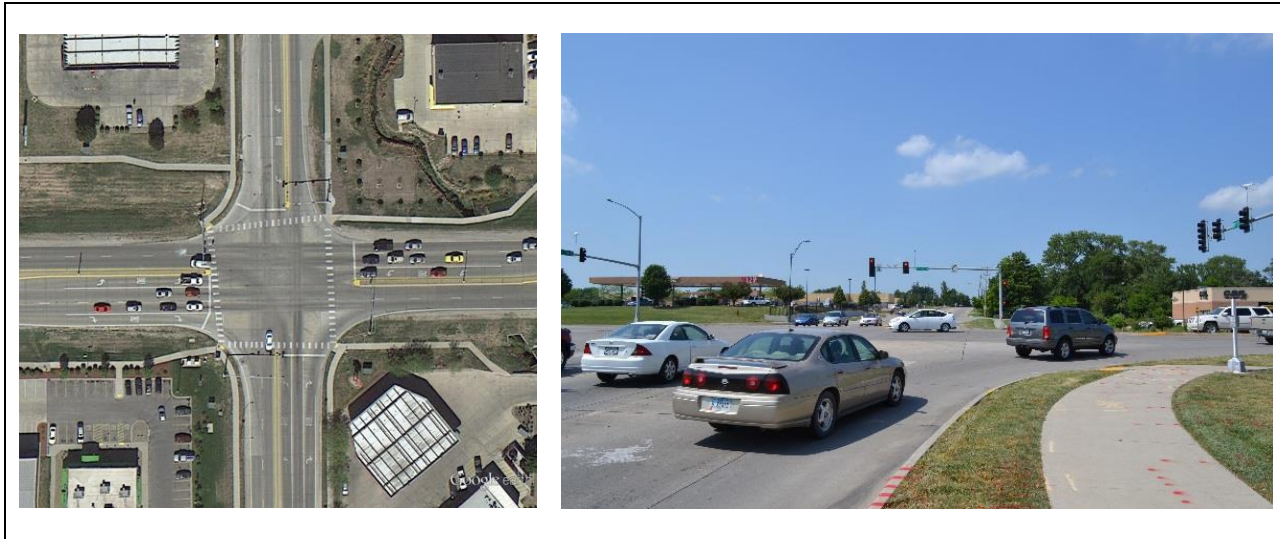
Figure 16. Treatment Site, 8th Street and 34th Street (aerial image: Google Earth, 2013)

The intersection of 8th Street and 34th Street was chosen as the site for deployment of the confirmation lights. Eighth Street is the East/West corridor. For the westbound approach there is one through lane, one shared through/right turn lane, and a left turn lane. For the eastbound approach there are two through lanes, one right turn lane, and one left-turn lane. 34th Street is the North/South corridor. For the southbound approach there is one through lane, one with shared right turn movement, and a left turn lane. The northbound approach has one lane for each movement. Figure 16 shows an aerial view of the intersection and a street view from the northbound approach.

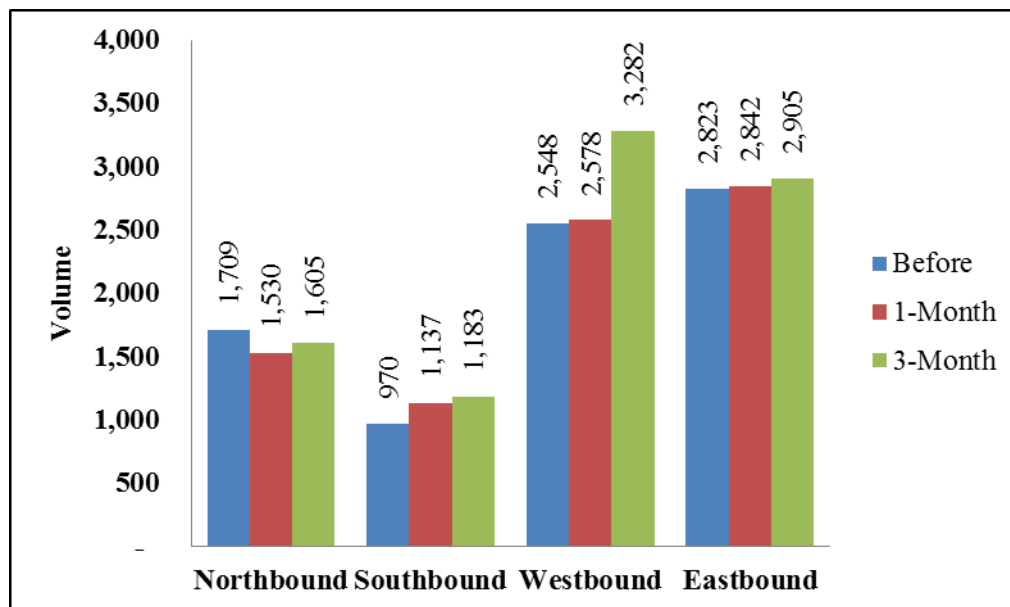
Figure 17. Traffic volumes for 8th Street and 34th Street

At the intersection there are gas stations at the southeast and northwest corners. Commercial areas are located at the northeast and southwest corners of the intersection. All overhead signals have backplates installed. All left turning movements are protected/permited; therefore confirmation lights for the through movements only were installed at this intersection. The northbound and eastbound approaches have protected right turns. There are pedestrian walkways with pedestrian countdown signals on all approaches. The traffic volumes recorded in during all study periods is shown in Figure 17.

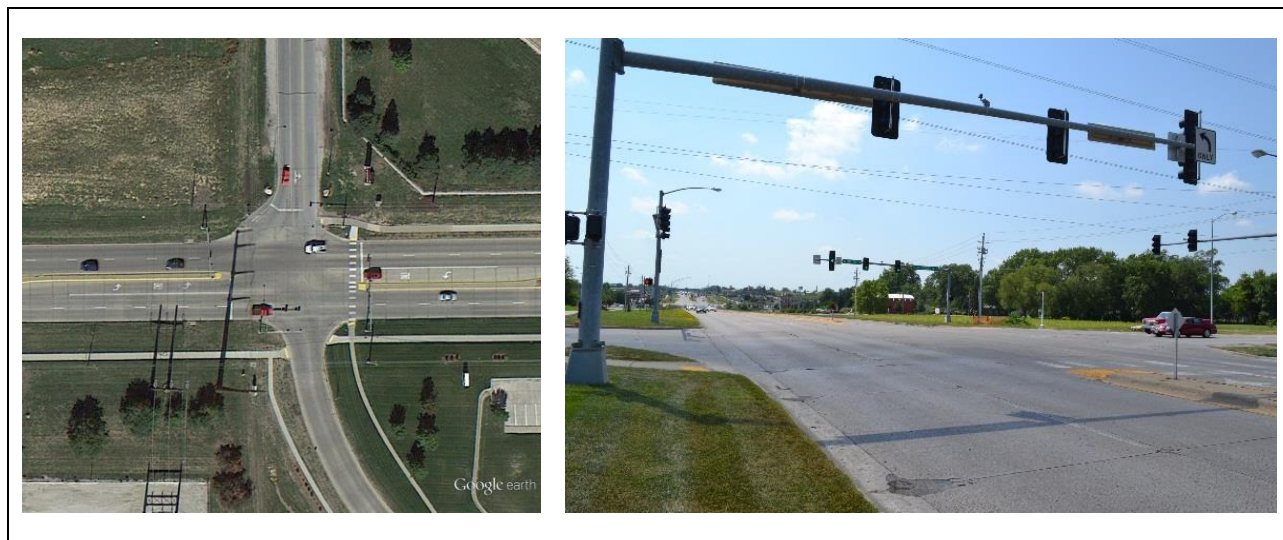
Figure 20. Spillover Site, 8th Street and 28th Street (aerial image: Google Earth, 2013)

For the westbound and eastbound approaches there is one through lane, one shared through/right turn lane, and a left turn lane. 28th Street is the North/South corridor. For the southbound approach there is a right turn lane, and a shared through/left-turn lane. The northbound approach has one lane for all movements. Figure 20 shows an aerial view of the intersection and a street view from the northbound approach.

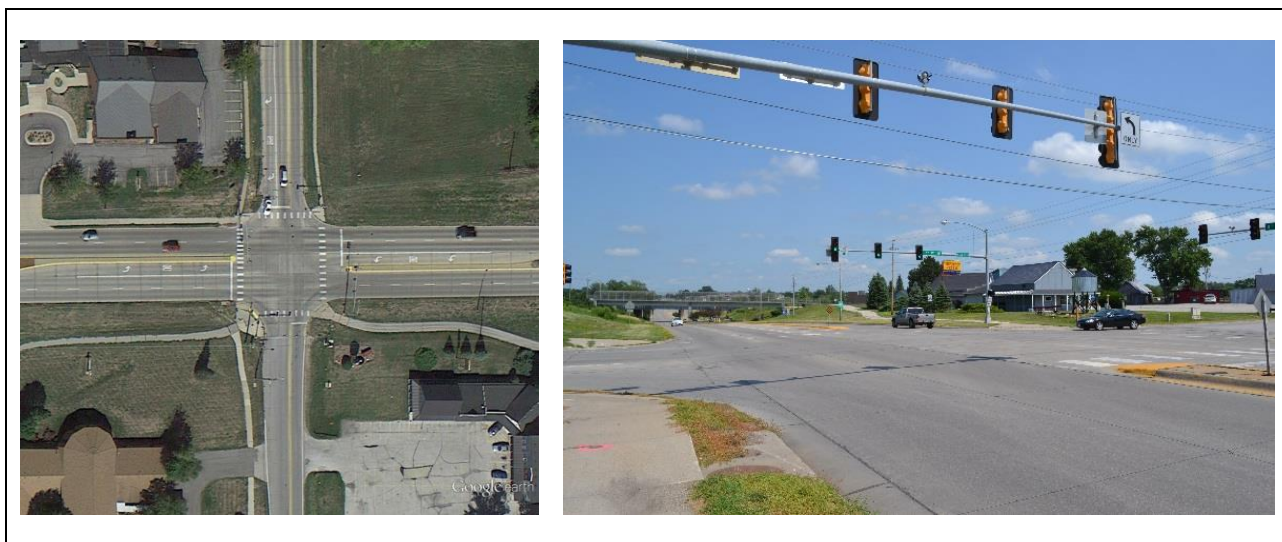
Figure 27. Control Site, 8th Street and 17th Street (aerial image: Google Earth, 2013)

The westbound and eastbound approaches consist of one through lane, one shared through/right turn lane, and a left turn lane. The southbound approach consists of one with shared left turn/through movement, and a right turn lane. The northbound approach consists of one lane for all movements. The area surrounding the intersection is mainly residential. Figure 27 shows an aerial view of the intersection and a street view from the northbound approach.

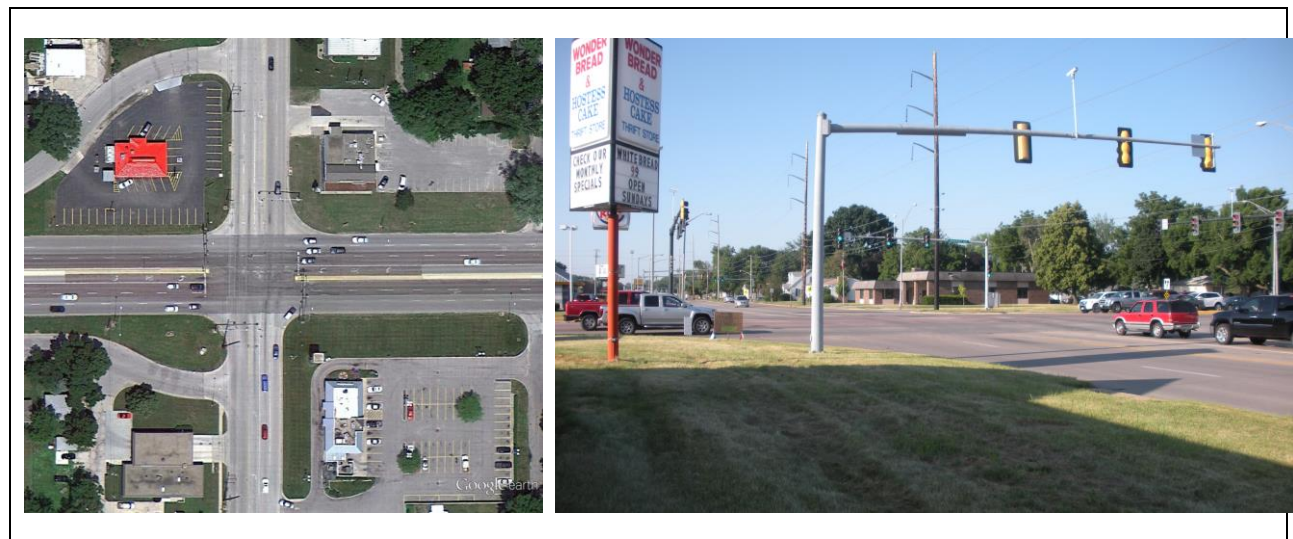
**Figure 36. Treatment Site, University Avenue and Ansborough Avenue
(aerial image: Google Earth, 2013)**

The intersection of University Avenue and Ansborough Avenue was chosen as the site for deployment of the confirmation lights. University Avenue is the East/West corridor. The eastbound and westbound approach consists of two through lanes, one shared through/right turn lane, and a left turn lane. Ansborough Avenue is the North/South corridor. The northbound/southbound approaches consists of two through lanes, one with shared right turn movement, and a left turn lane. Figure 36 shows an aerial view of the intersection.

The site has restaurants on the northwest and southwest corners, a closed shop in the northeast corner, and a fire station on the southeast corner. There are frontage roads along University Avenue, west of Ansborough Avenue. At the time of this research the north frontage road was closed due to construction. Eastbound traffic travels on a curve on University Avenue. To enhance awareness of the upcoming traffic signal, the city installed a flashing advance warning system that is located approximately 520 feet upstream from the intersection. All overhead signals have backplates to enhance visibility. There is one signal head per lane, per movement. The eastbound, westbound, and northbound left turn movements are protected only. The

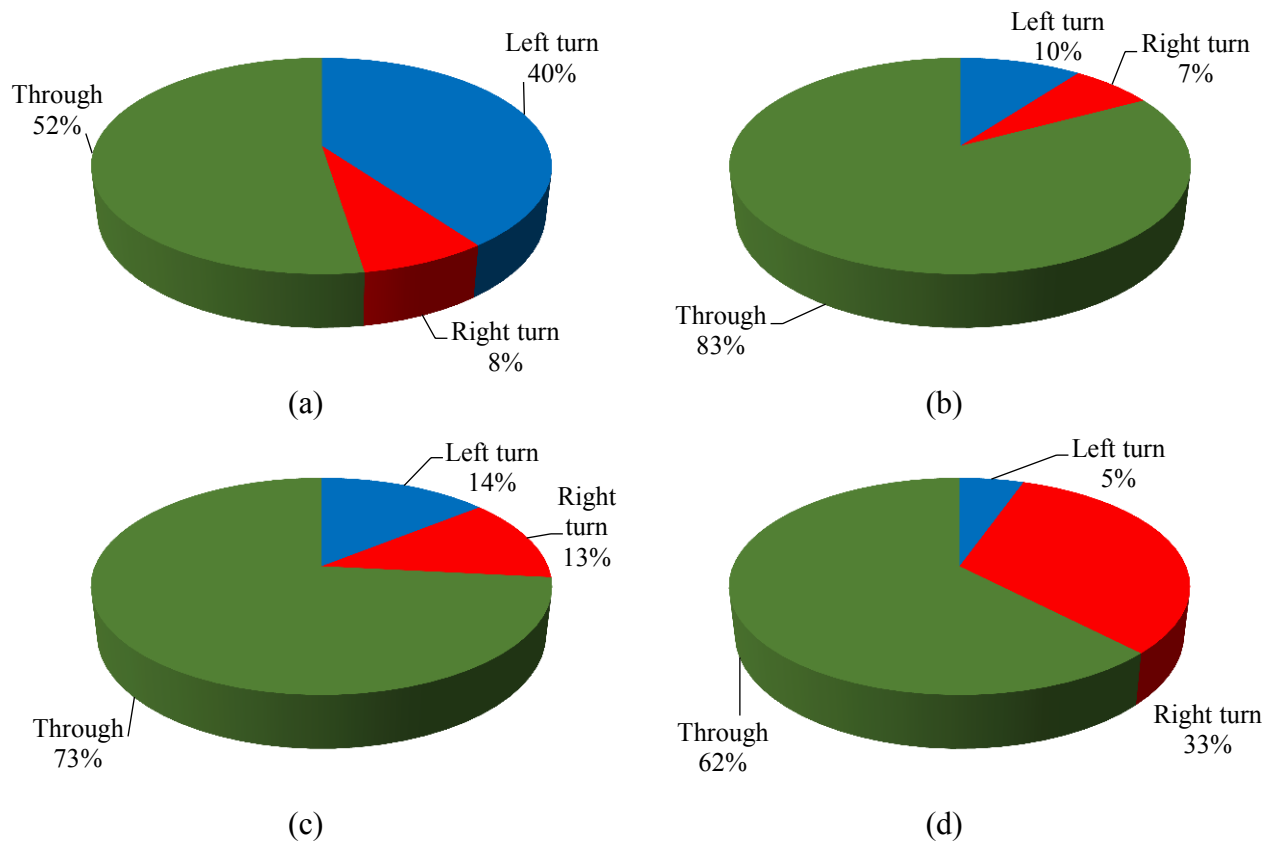
Figure 38. Peak hour turning movement percentages for University Avenue and Ansborough Avenue (a) northbound (b) southbound (c) westbound (d) eastbound

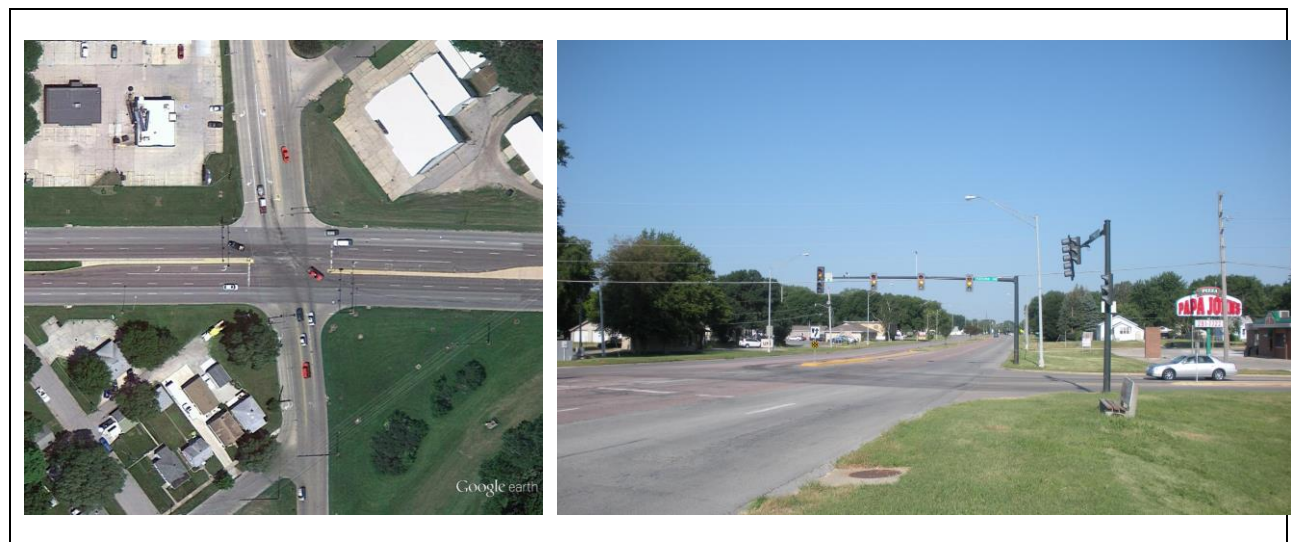
Figure 40. Spillover Site, University Avenue and Fletcher Avenue (aerial image: Google Earth, 2013)

University Avenue and Fletcher Avenue is located east of the deployment intersection. For the westbound and eastbound approaches on University Avenue there are three through lanes, one left turn lane, and no right turn lane. As shown in Figure 40, on the northbound approach there is one left turn lane and a shared through/right turn lane. The southbound approach along Fletcher Avenue has one lane for each movement.

In the northwest corner of the intersection there are shops on the north side of the intersection, and a residential neighborhood on the southwest corner of the intersection. There are medians on along University Avenue and the north side of Fletcher Avenue. There is one signal head per lane per movement. All overhead signals have backplates. All left turn movements at the intersections are protected/permitted. Figure 41 shows volumes at each approach for each period of the study.

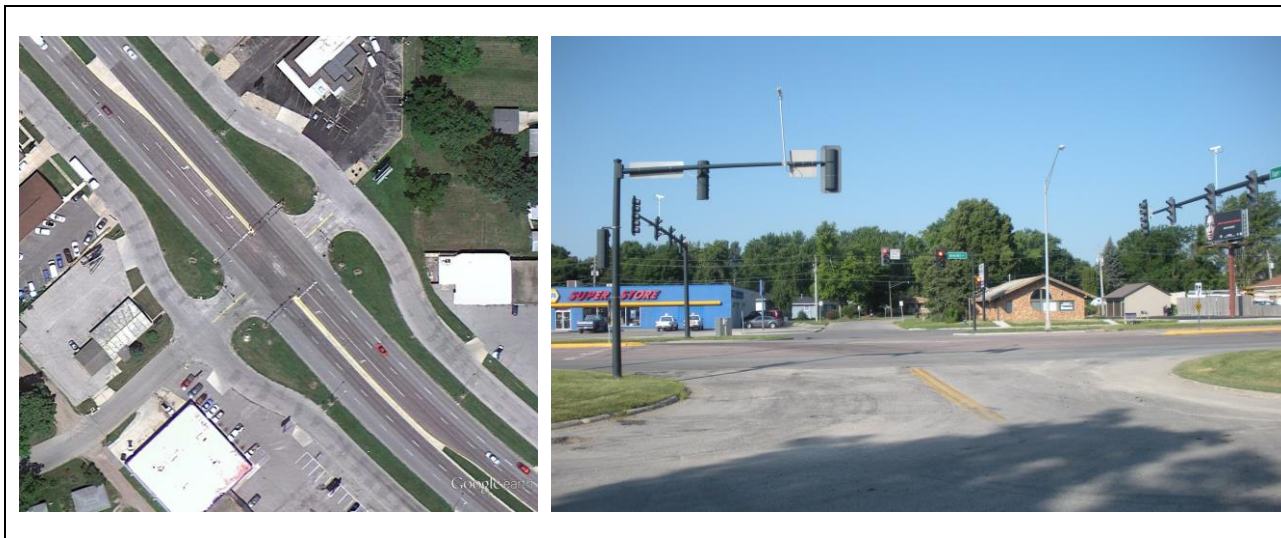
Figure 43. Spillover Site, University Avenue and Sager Avenue (aerial image: Google Earth, 2013)

University Avenue and Sager Avenue is the next signalized intersection west of University Avenue and Ansborough Avenue as shown in Figure 43. For both approaches on University Avenue there are three through lanes, and one left turn lane. Sager Avenue gives access to the frontage road along University Avenue, and a residential area. Both approaches at Sager Avenue have a left turn lane and a shared through/right turn lane.

Although the intersection is on a curve, movements along University Avenue are defined as eastbound and westbound, while traffic on Sager Avenue is northbound and southbound. On the south and north end of Sager Avenue there are commercial and residential areas. There was construction on the frontage road in the north end of the intersection when counts were being taken. There is one signal head per lane per movement. All overhead signals have backplates. Left turns for westbound and eastbound approaches are protected/permitted and left-turn movements along Sager Avenue are permitted only. Figure 44 shows the recorded peak hour volumes for all periods of the study.

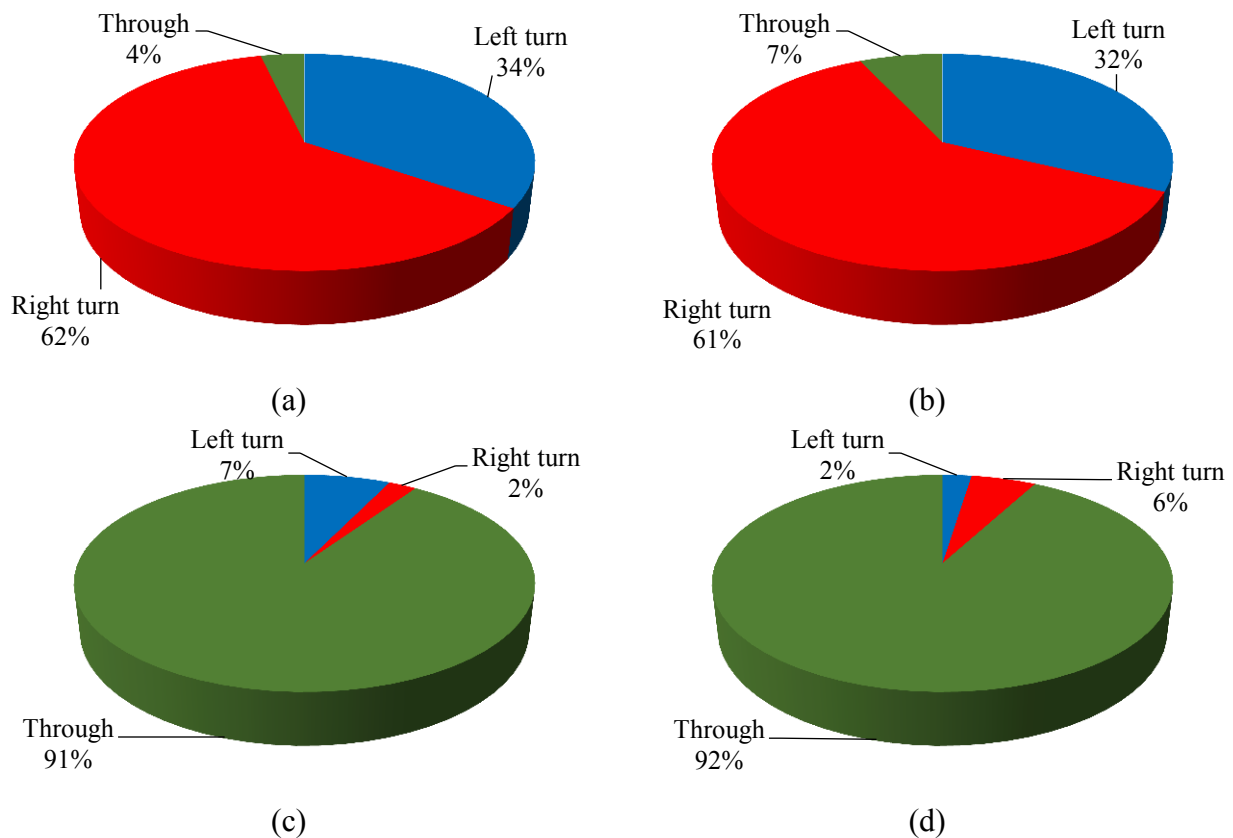
Figure 45. University Avenue and Sager Avenue peak hour movement percentages (a) northbound (b) southbound (c) westbound (d) eastbound

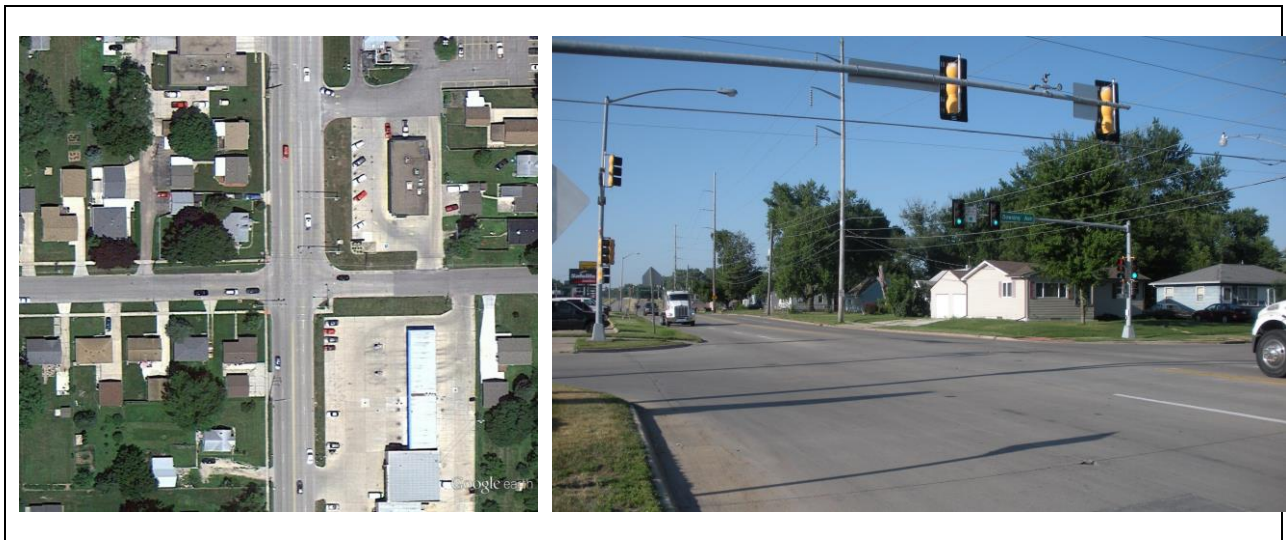
**Figure 46. Spillover Site, Ansborough Avenue and Downing Avenue
(aerial image: Google Earth, 2013)**

Ansborough Avenue and Downing Avenue is the first signalized intersection south of University Avenue and Ansborough Avenue as shown in Figure 46. The northbound and southbound approaches have two lanes with shared turning movements. The eastbound and westbound approaches along Downing Avenue have one lane. Downing Avenue is a collector road that gives access to residential areas, while Ansborough Avenue is a collector road.

On the east side of the intersection there are commercial shops. For the westbound approach there are no overhead signals, it only has a post mounted signal. The eastbound approach has one overhead signal with a backplate and a post mounted signal. The approaches along Ansborough Avenue have two overhead signal heads with backplates, and a post mounted signal. All left turn movements at the intersection are permitted only. Figure 47 shows the total peak volumes for each approach.

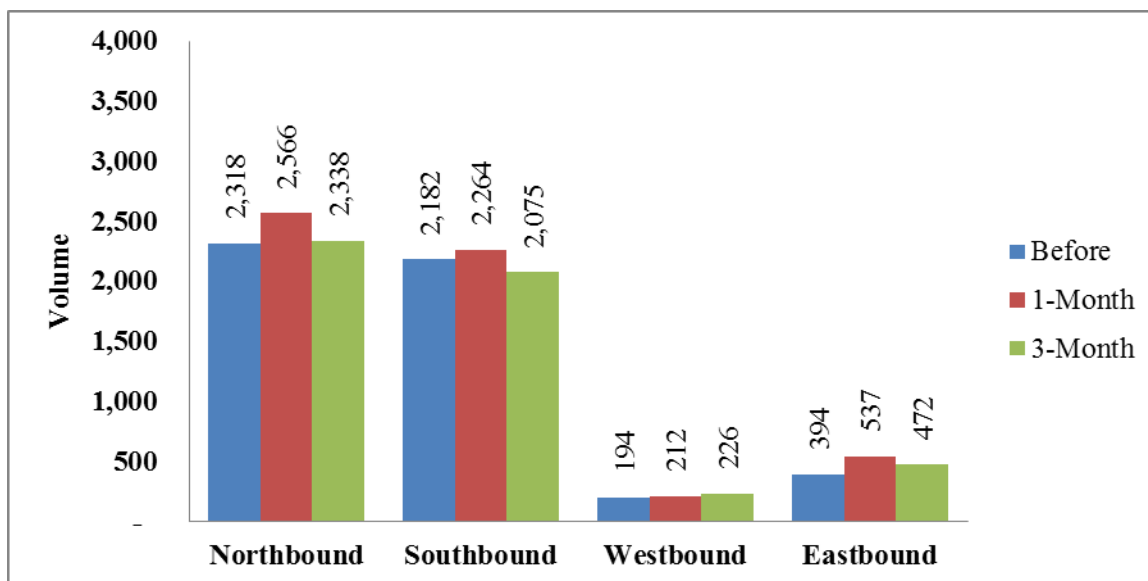
Figure 47. Traffic volumes for Ansborough Avenue and Downing Avenue

The northbound and southbound approach is where most of the traffic was observed. Around 60 percent of the total traffic for both of these approaches happened in the afternoon peak hour. The eastbound approach experiences more traffic than the westbound approach. Over 60 percent of

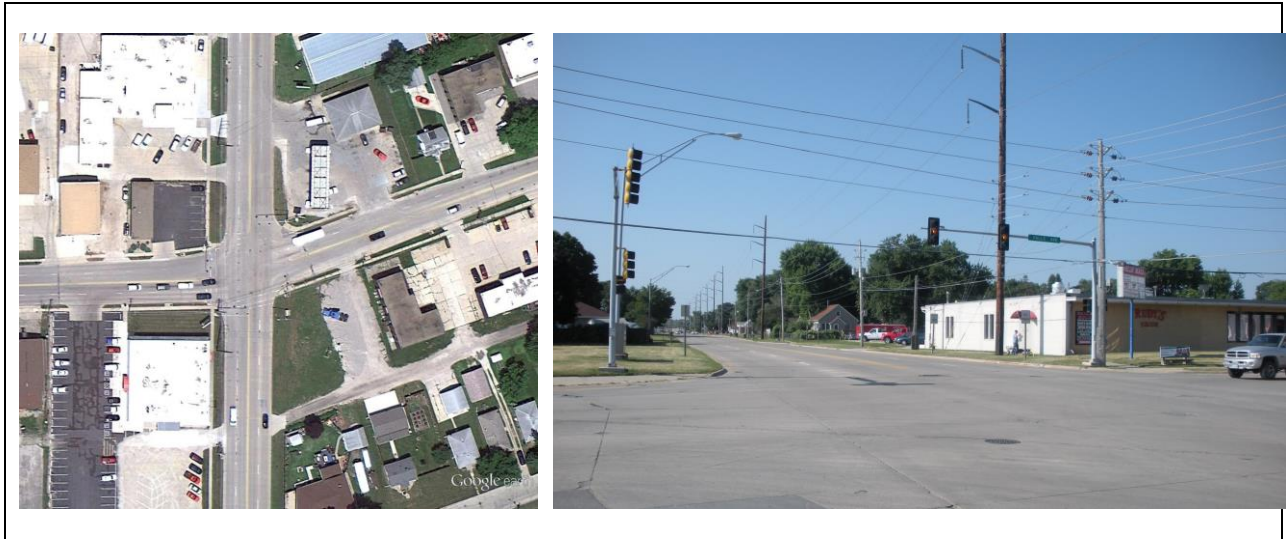
Figure 49. Spillover Site, Ansborough Avenue and Falls Avenue (aerial image: Google Earth, 2013)

This intersection is located north of the deployment site and shown in Figure 49. The southbound, northbound, and westbound approaches have two lanes and no separate lanes for turning movements. The eastbound approach has a left-turn lane and a through/right turn lane. There is an overhead signal for each travel lane. All overhead signals have backplates installed. The eastbound approach has three signal heads, one overhead signal and one mounted on the post. The westbound, northbound and southbound approaches have permitted left turn movements. The eastbound approach has protected/permitted left turns.

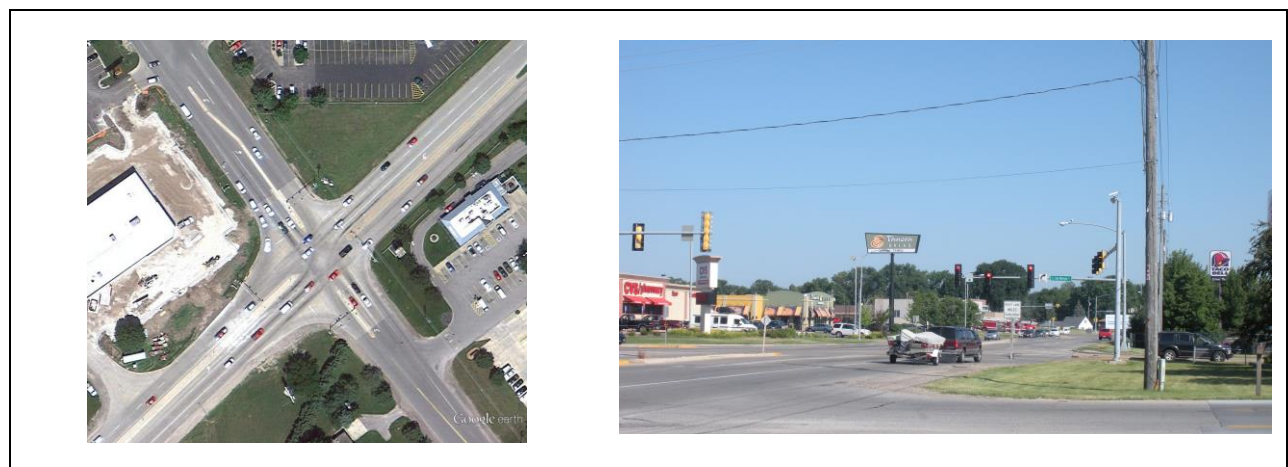
Figure 53. Control Site, La Porte Road and East San Marnan Drive (aerial image: Google Earth, 2013)

This intersection is located in a commercial area in town and shown in Figure 53. The intersection is near an I-380 interchange. For traffic along E. San Marnan Drive there is a left turn lane, and two through lanes. The both approaches of La Porte Road have a left turn lane, a through lane, and a right turn lane.

San Marnan Drive was considered the eastbound and westbound corridor, and La Porte Road was defined as the northbound and southbound road. There are three signal heads per approach. All signal have backplates installed. For the eastbound/westbound approaches on East San Marnan Drive left turns are protected only. The northbound/southbound approaches of La Porte Road have a protected/permitted left turn and a protected right turn. Figure 54 shows the summation of the morning and afternoon peak volumes for all three periods of the study.

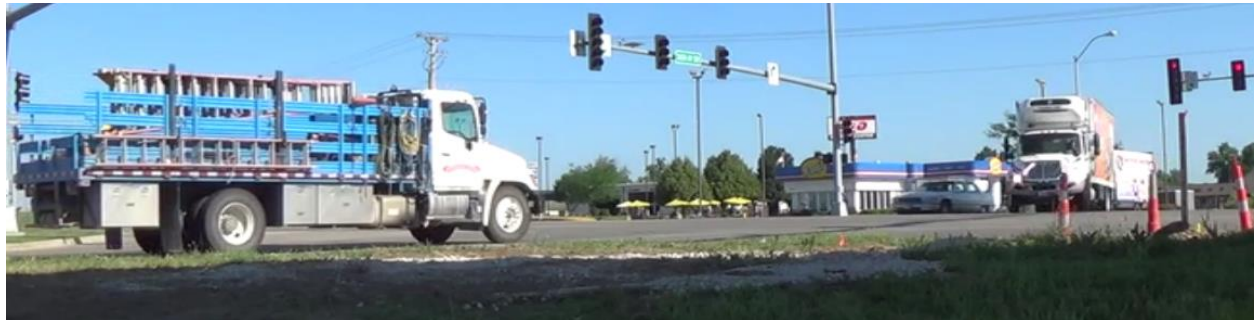
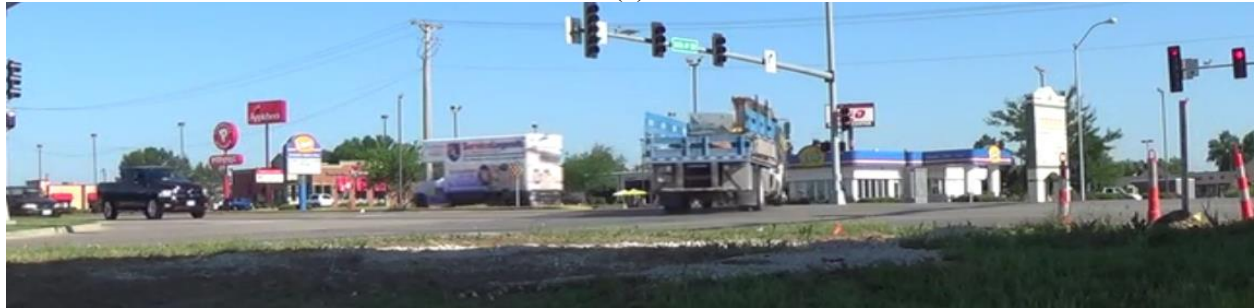
Figure 62. Left turn at the spillover sites 49 seconds into the red

As shown in the previous figures, seven out of the nine violations were left-turn movements. Six violations occurred within one second into the red phase. There was one violation that occurred 49 seconds into the red at the northbound approach of 8th Street and 36th Street. Figure 62 shows the sequence of events for this violation.

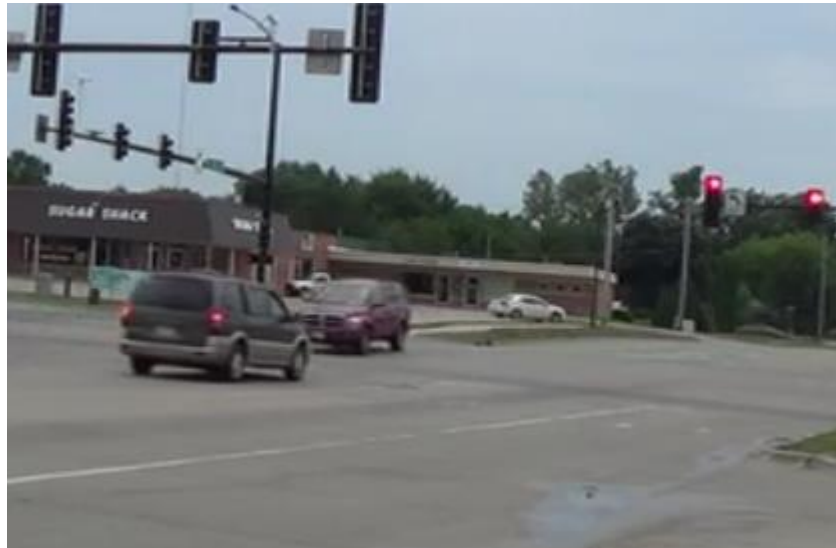
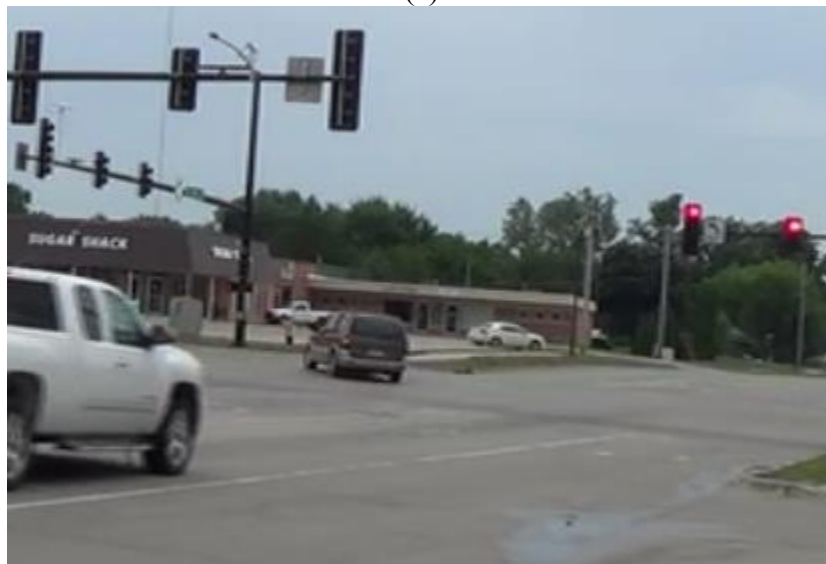
Figure 65. Left turn at a control site sites 12 seconds into the red

Figure 64 shows that the majority of left-turn violations happened within one second into the red. The violations with a time longer than two seconds occurred at 8th Street and 1st Avenue, and Adventureland Drive and 1st Avenue. All three violations had a measured time into the red of

five, 10, and 12 seconds. In the occurrence where the vehicle crossed the intersection five seconds into the red the motorist was behind a heavy truck. The violation that occurred 12 seconds into the red was a vehicle making a left turn and disregarding the red signal. Figure 65 show the events for the violations that took place 12 seconds into the red.

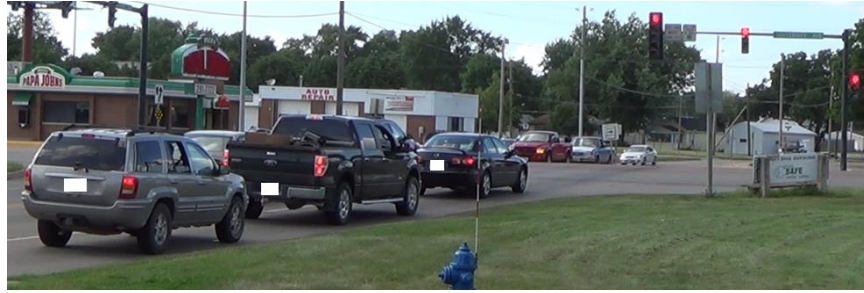
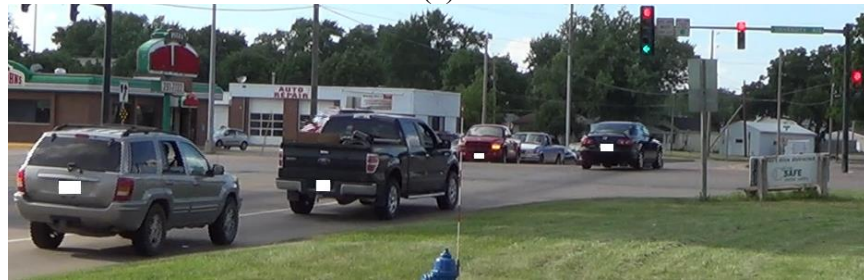
Figure 72. Sequence of events at University Avenue and Fletcher Avenue (a) vehicle stopped at intersection (b) vehicles crossing intersection

As shown in Figure 72, the events happened at the northbound approach of University Avenue and Fletcher Avenue. The motorist was stopped for most of the cycle as shown in Figure 72(a) and when the green arrow for the protected left turn came on the motorist proceeded through the intersection as seen in Figure 72 (b). This violation occurred 70 seconds into the red. Another violation happened at University Avenue and Sager Avenue. Figure 73 shows pictures of the violation.

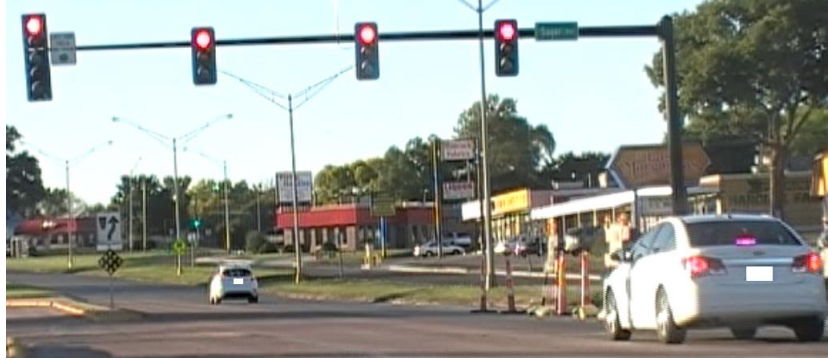
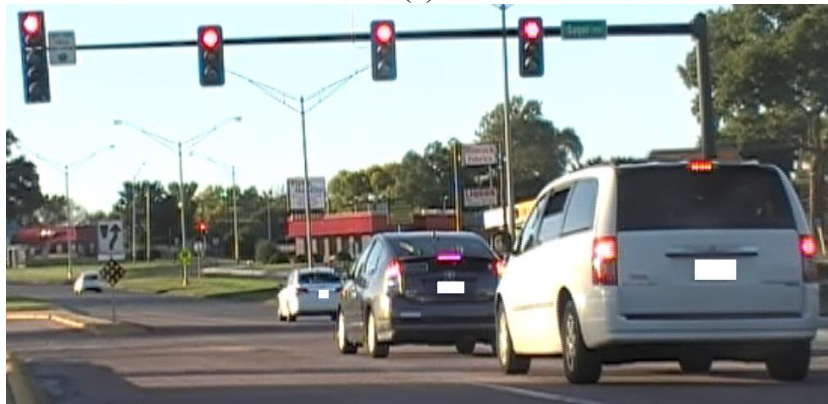
Figure 73. Sequence of events at University Avenue and Sager Avenue (a) vehicle stopped at intersection (b) vehicles crossing intersection

As shown in Figure 73 (a) the car was stopped at the westbound approach of the intersection. A vehicle from the northbound approach turned left onto University Avenue. After the left-turning vehicle drove away, the motorist in the white car began to roll forward. Figure 73 (b) shows that after there were no more vehicles approaching, the white car proceeded through the intersection. This was filmed during one-month after the deployment of the countermeasure. The southbound approach was closed to traffic during this time, which could have played a factor into the decision making of the motorist. Additionally, Sager Avenue carried very low volumes compared to University Avenue, and that the path length to cross was not very long may also be factors that contributed to such a decision. The vehicle started crossing the intersection 23 seconds into the red phase. The third violation occurred at Ansborough Avenue and Downing Avenue as shown in Figure 74.
