EVALUATION OF INTERSECTION CONFIRMATION LIGHTS IN MEDIUM TO LARGE COMMUNITIES IN IOWA TO REDUCE RED LIGHT RUNNING VIOLATIONS

FINAL REPORT
February 2015

1. Report No. IHRB Project TR-657	2. Government Accession No.	3. Recipient's Catalog No.	
4. Title and Subtitle Evaluation of Intersection Confirmation Lights in Medium to Large Communities in Iowa to Reduce Red Light Running Violations		5. Report Date February 2015

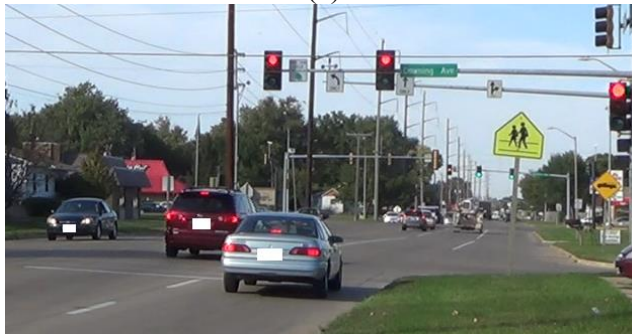
Figure 74. Sequence of events at Ansborough Avenue and Downing Avenue (a) vehicle stopping at intersection (b) vehicles crossing intersection

As shown in Figure 74, at Ansborough Avenue and Downing Avenue a vehicle crossed the intersection three seconds into the red. In Figure 74 (a) the vehicle was approaching the intersection already applying the brakes. In Figure 74 (b) the vehicle was still applying the brakes while crossing the intersection. The motorists did not start applying the brakes in time to stop before the entering the intersection. When the vehicle was by the traffic signal it released the brakes and drove through the intersection. This sequence of events could be attributed to speeding and/or distracted driving.

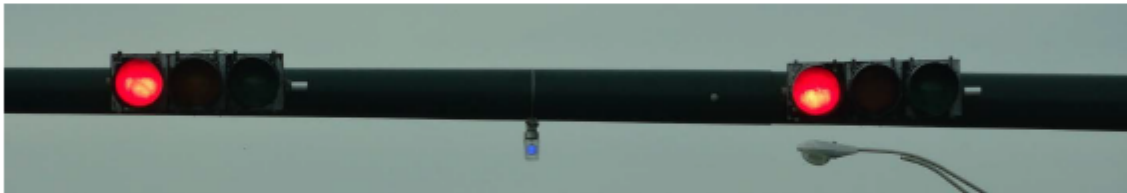
Blue Confirmation Light Mounted to a Mast Arm in Naples, Florida
