# Evaluation of Rumble Stripes on Low-Volume Rural Roads in Iowa—Phase I

**Final Report**  
**July 2009**

**Sponsored by**  
the Iowa Highway Research Board  
(IHRB Project TR-577), the Iowa Department  
of Transportation (InTrans Project 07-304),  
the Federal Highway Administration, and  
the Midwest Transportation Consortium

| <b>7. Author(s)</b><br>Shauna Hallmark, Tom McDonald, and Robert Sperry | | <b>8. Performing Organization Report No.</b><br>InTrans Project 07-304 | |

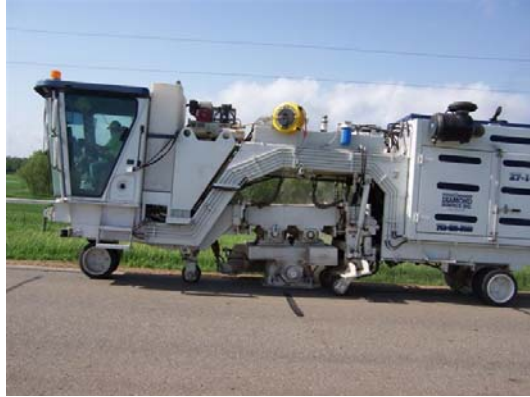
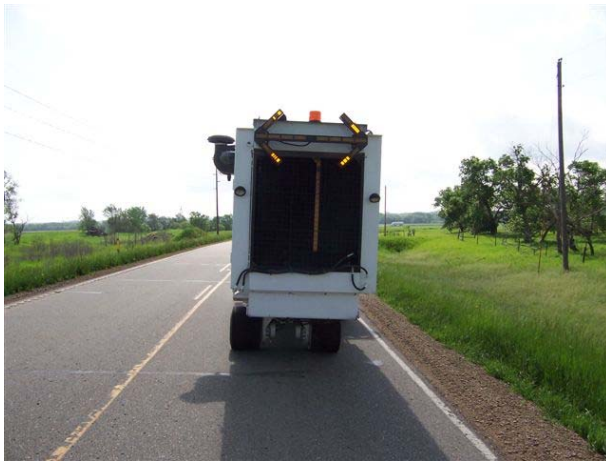
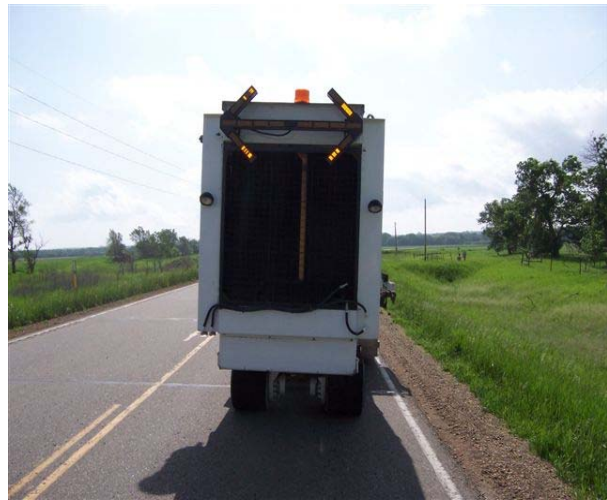
**Figure 3-4. Milling machine**

**(a) Milling machine owned by Diamond Surfaces, Inc., used for most of work**

**(b) Side-shift left—provided most weight over mill head**

**(c) Side-shift right position**

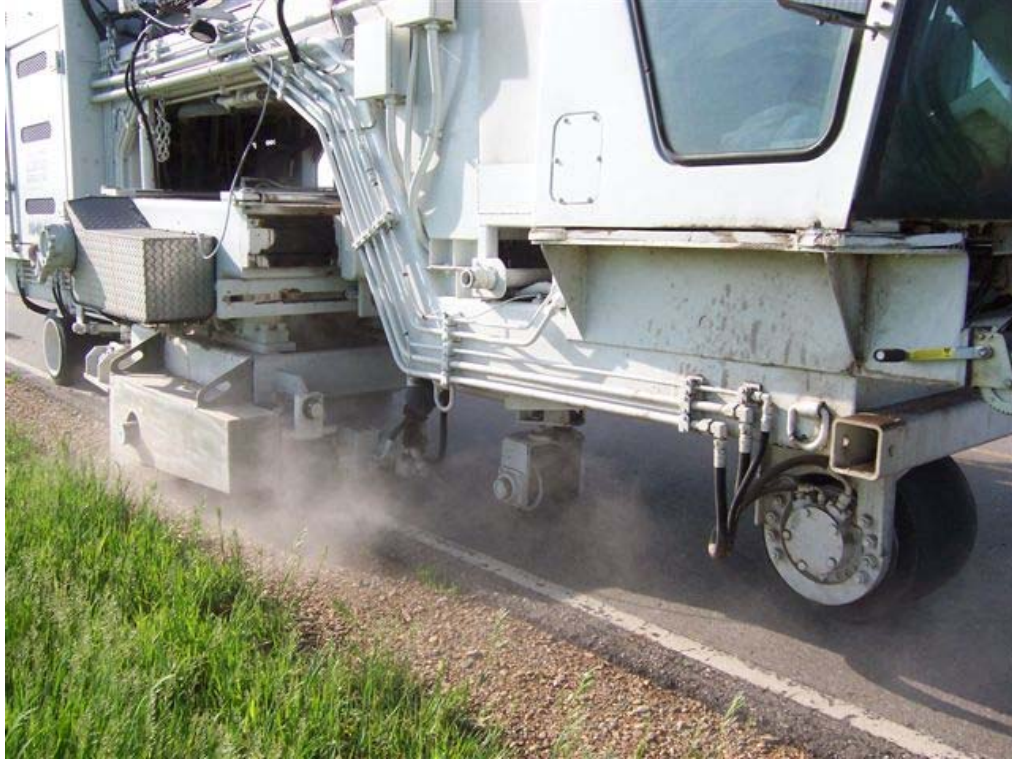
**Figure 3-5. Close-up of the milling process**

The process had three steps: (1) mill in rumble strips, (2) sweep the pavement debris from the rumble strips, and (3) repaint the edge line through the rumble strip. The three steps are shown in Figures 3-5 to 3-7.

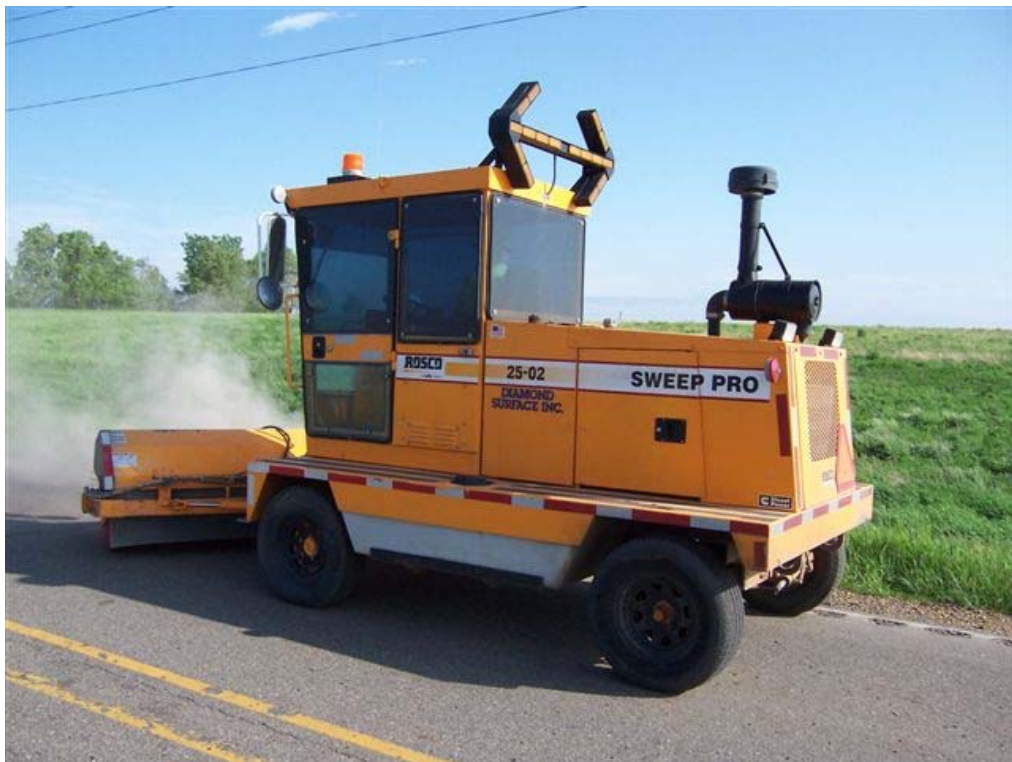
**Figure 3-6. Machine sweeping completed rumble strips after milling**

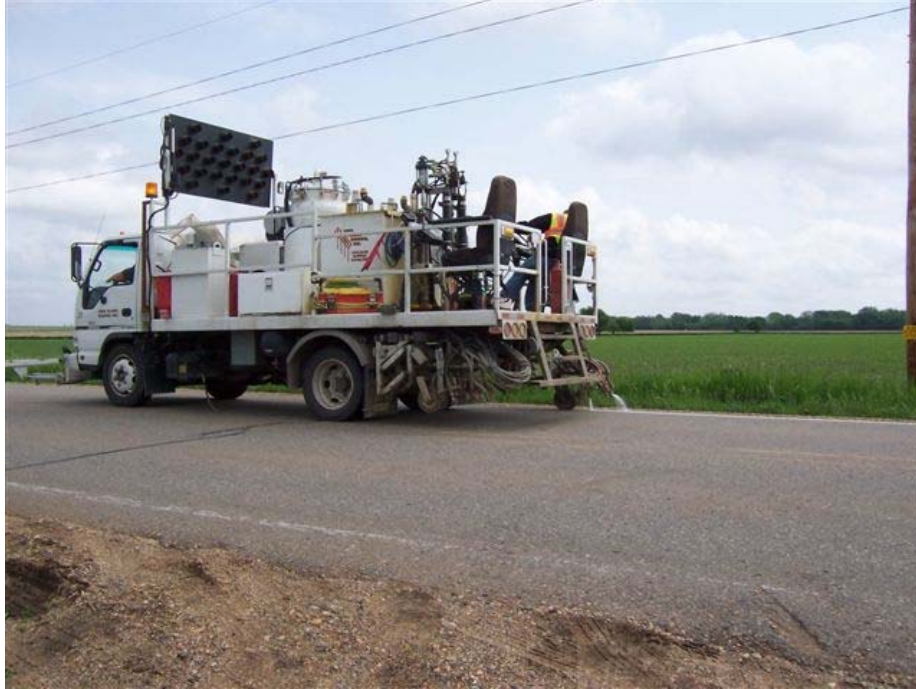
**Figure 3-7. Regular paint truck painting edge line**

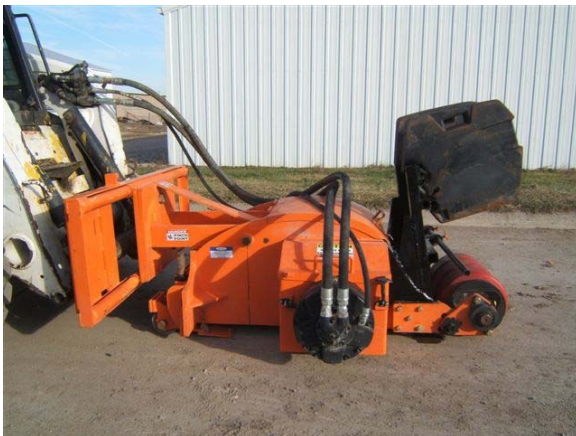
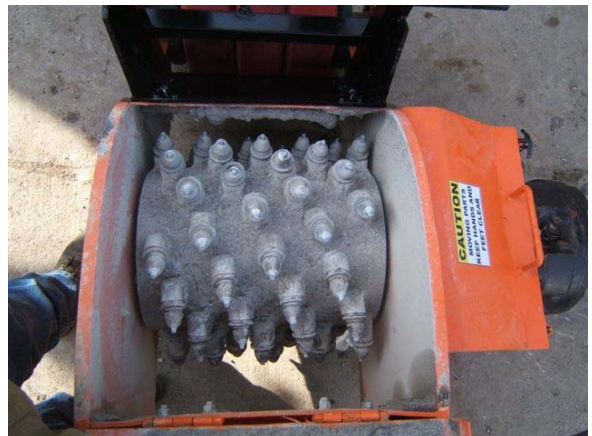
**Figure 3-8. Milling equipment (photos courtesy Iowa Plains Signing, Inc.)**

**(a) Milling attachment**

**(b) Milling head**

Work was suspended in early June to allow the contractor time to work on modifications to another piece of equipment that could complete the work that had been omitted on the inside of curves due to operational problems that will be described in the next section. The equipment shown in Figure 3-8 was adapted to allow milling along the low side of horizontal curves and to be performed more adequately, although the milling depth was still minimal and the alignment was less than ideal.

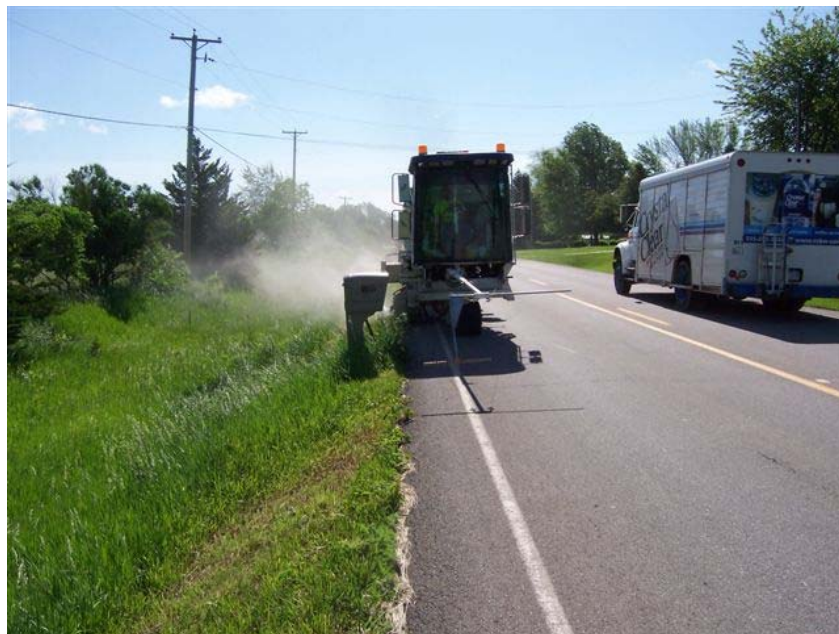
**Figure 3-13. Milling operation omitting short areas around mailboxes in Polk County**

Milling in the rumble strips also resulted in some breakup of the pavement surface, as shown in Figure 3-12. In one county, milling was suspended around mailboxes to avoid damage, as shown in Figure 3-13.

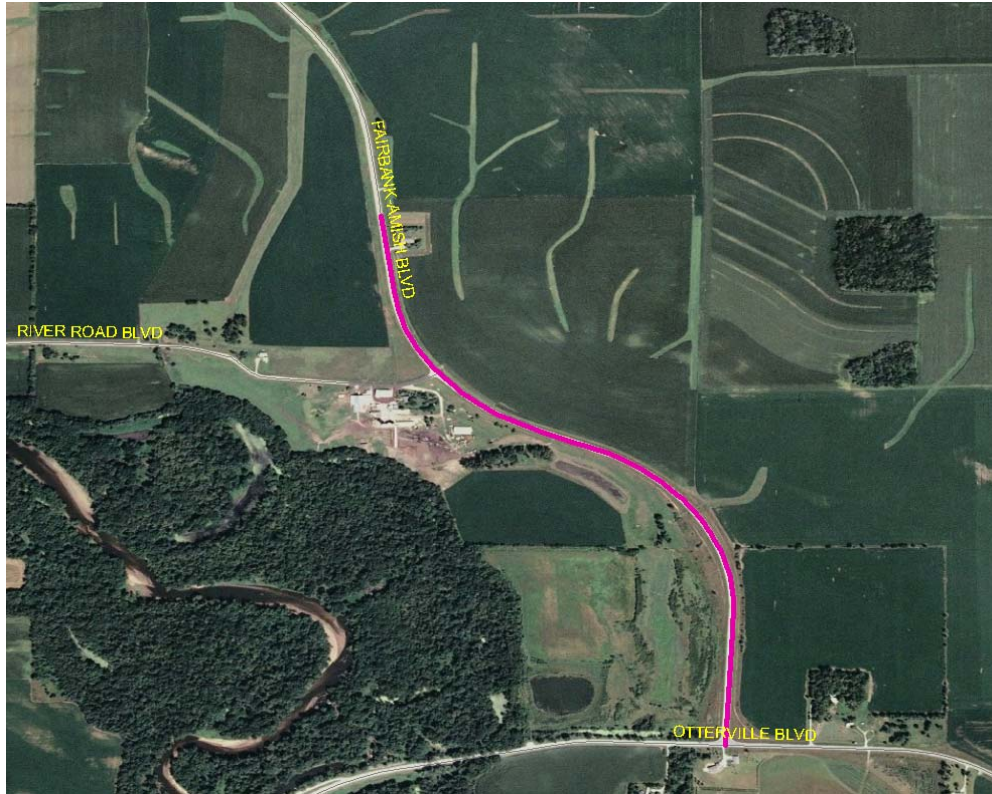
**Figure 4-2. Test section on W-13**

County Road W-13 is in Buchanan County, as shown in Figures 4-1 to 4-3. The section has PCC pavement and starts near the intersection of W-13 and Otterville Boulevard and crosses the intersection with River Road Boulevard. The test section is 7,400 linear feet. Crash data from 2001 to 2006 indicated that the section had a total of 47 crashes, with 16 ROR crashes.

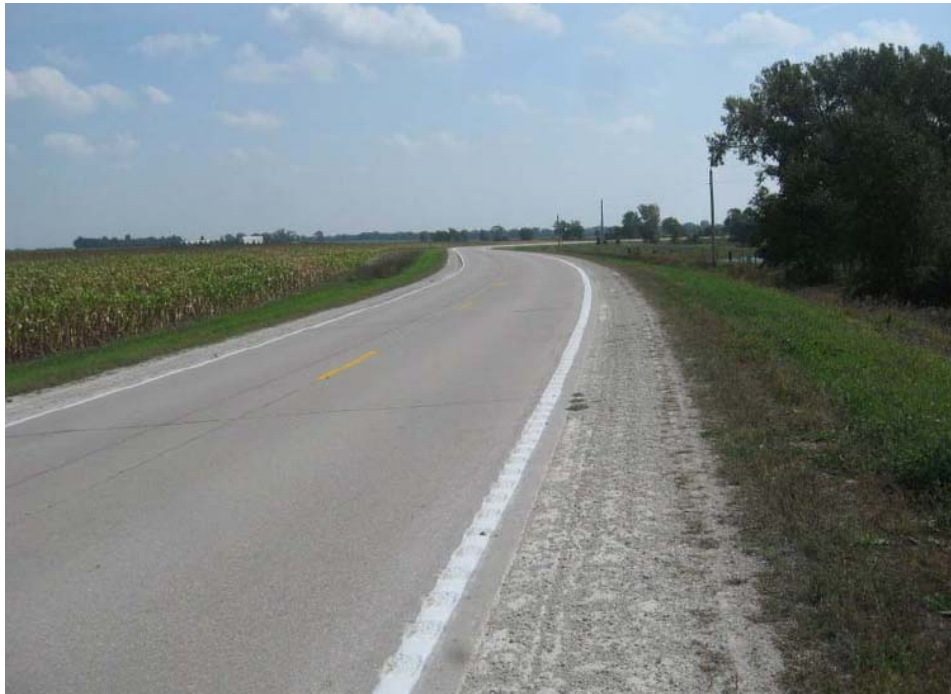
**Figure 4-3. Rumble stripe installation on W-13 (photo courtesy of Neal Hawkins, CTRE)**

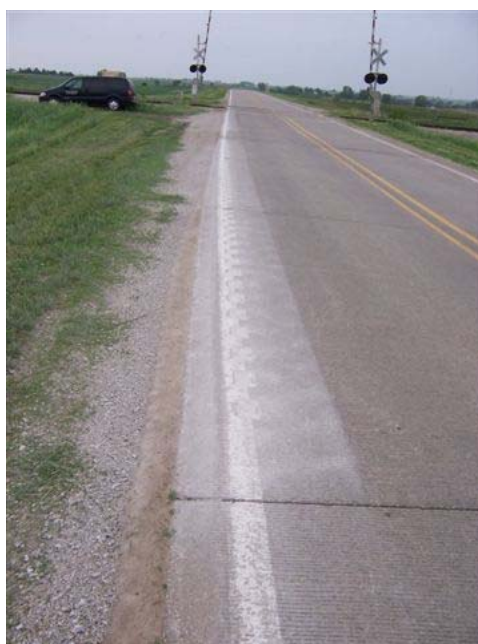
**Figure 4-6. Rumble stripe installation on P-53**

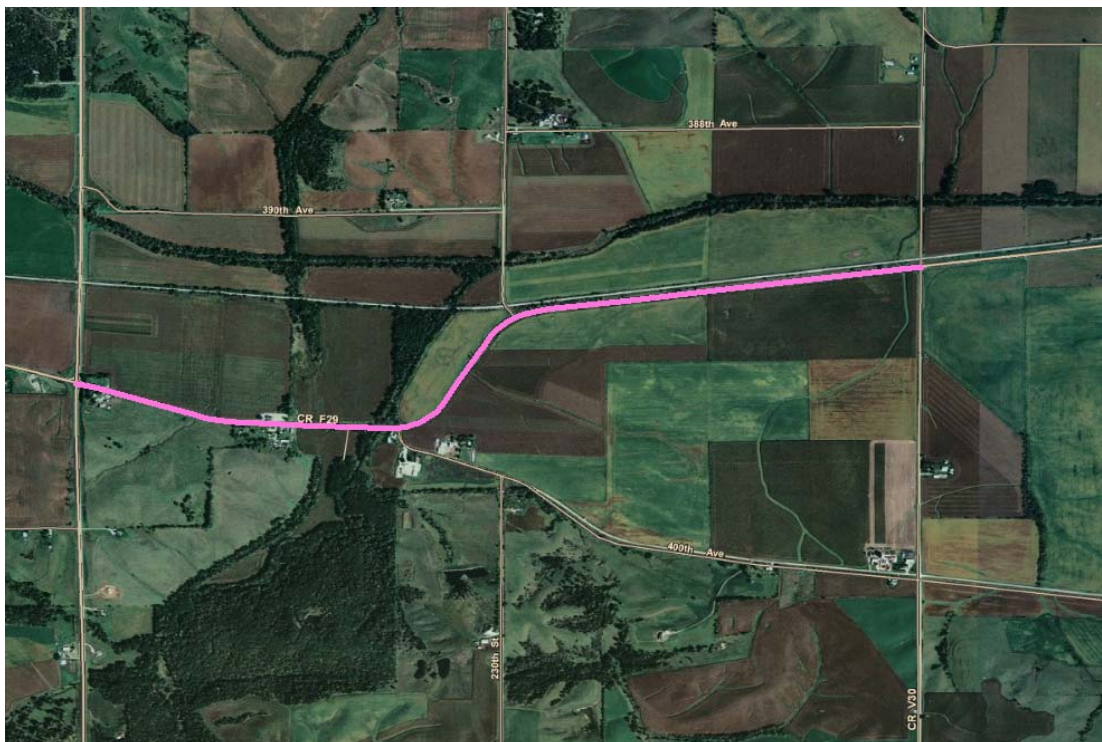
**Figure 4-11. Test section on F-29**

County Road F-29 (Old US 6) is located in Poweshiek County, as shown in Figures 4-10 to 4-12. The pavement is HMA. The section includes two segments. One is located 100 feet west of 400th Avenue to approximately 0.3 miles east of 230th Street, and the other simply encompasses a curve west of Victor. Both segments in the section total 9,560 linear feet. Crash data from 2001 to 2006 indicated that the section had a total of 11 crashes, with 8 ROR crashes.

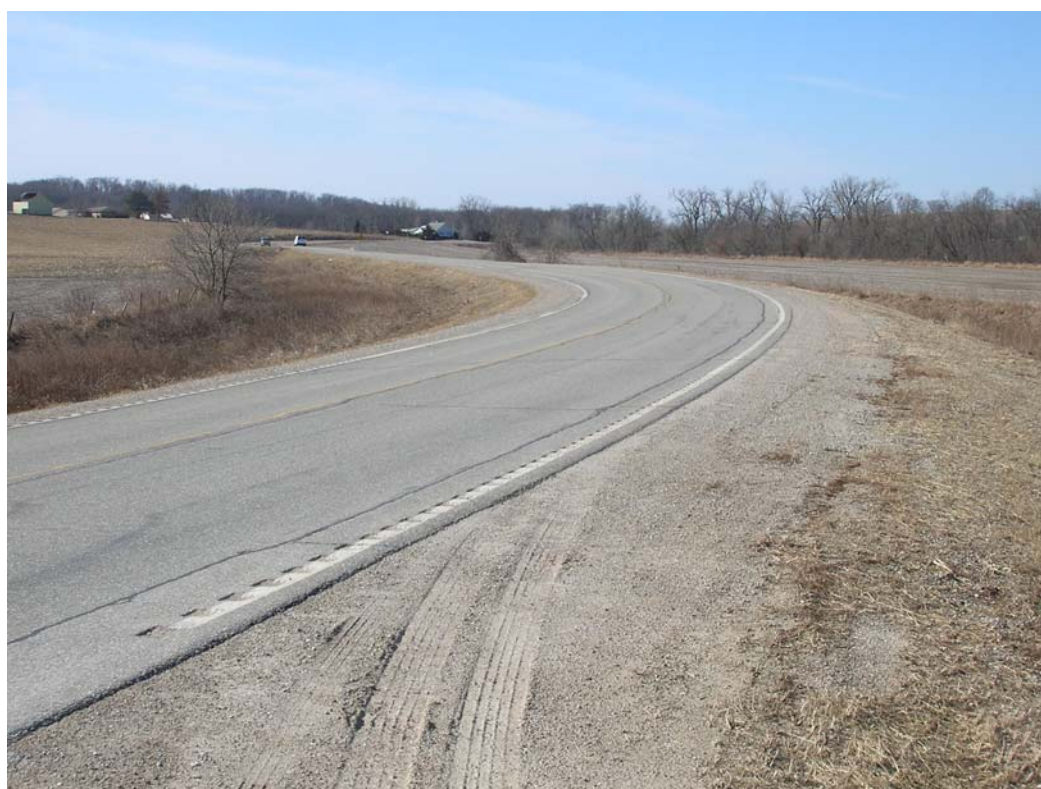
**Figure 4-12. Rumble stripe installation on F-29**

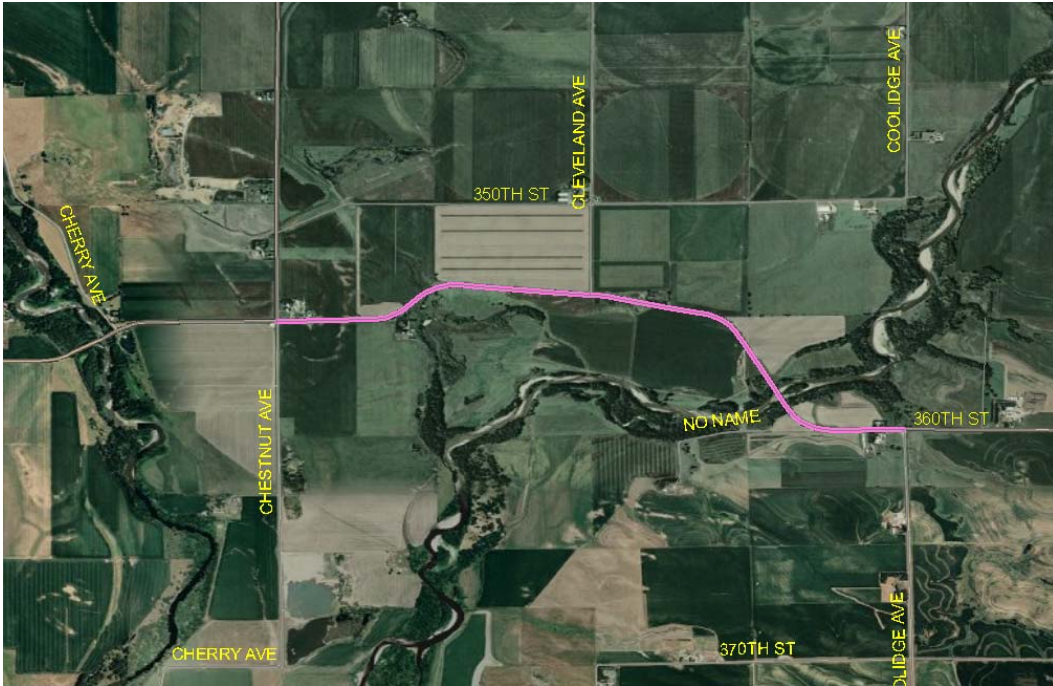
**Figure 4-14. Test section on B-30**

County Road B-30 (360th Street) is in Sioux County, as shown in Figures 4-13 to 4-15. The pavement is HMA. The section starts approximately 0.2 miles east of County Road K-18 (Chestnut Avenue) and runs approximately 0.8 miles to the east. The section is 8,500 linear feet. Crash data from 2001 to 2006 indicated that the section had a total of 17 crashes, with 9 ROR crashes.

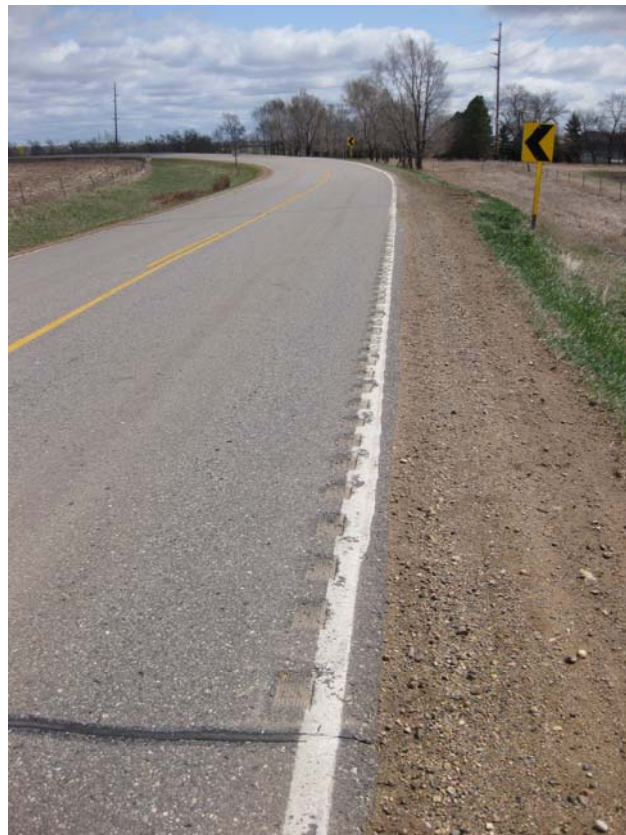
**Figure 4-15. Rumble stripes on B-30**

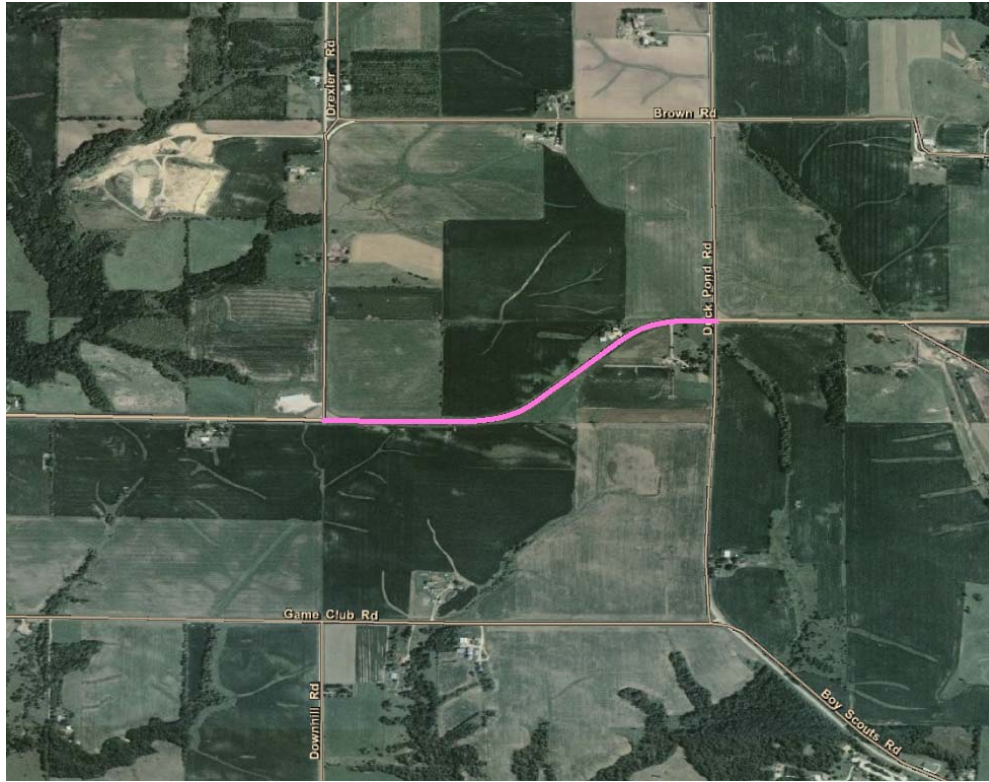
**Figure 4-17. Test section on E-16**

County Road E-16 (Sawyer Road) is in Linn County, as shown in Figures 4-16 to 4-18. The pavement is newly constructed PCC. The section starts approximately at the intersection of Drexler Road and ends at the intersection with Duck Pond Road. The section is approximately 5,500 linear feet. For the period of 2001 through 2006, there were a total of 13 crashes, of which 6 were ROR incidents.

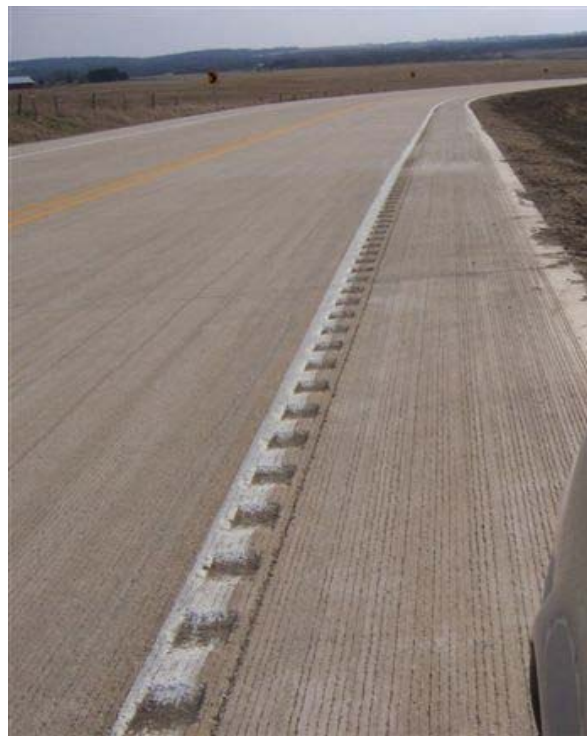
**Figure 4-18. Rumble stripe installation on E-16**

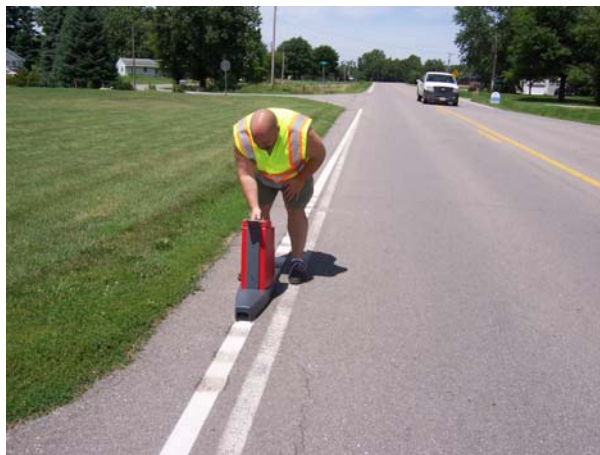
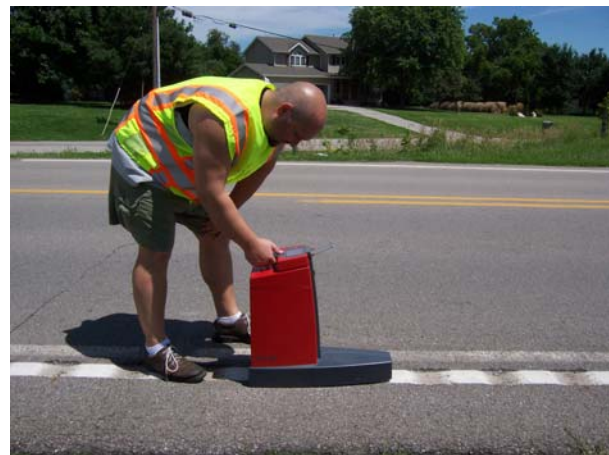
**Figure 5-1. Retroreflectivity data being taken**

**(a) Fall readings**

**(b) More readings in spring after winter snowplow work**

Evaluation of the wear and visibility of pavement markings was conducted for all test sections. After initial installation, pavement markings were repainted through the rumble stripe section. The wear on pavement markings was evaluated using a retroreflectometer, as shown in Figure 5-1.

Retroreflectometer readings were taken at two positions within each test section. Readings were taken directly over the rumble stripes at approximately 500- to 1,000-foot intervals at locations where the rumble stripes were actually present (within the grooved portion). Four readings were taken in each location and then averaged. When the rumble stripes were installed, an extra 500 feet of edge line was painted beyond the rumble strip so data could be compared for sections without rumble strips. However, some of these areas were repainted by the counties during the period, and while the county repainted areas outside the rumble stripes, they did not repaint the rumble stripes themselves. As a result, those sections could no longer be used as controls. Therefore, data were collected intermittently on the solid painted areas between rumble stripes to further define the comparison. This was used as a control section. Initial data were collected mainly within those 500-foot sections but was expanded (and later eliminated) at each project for subsequent collections. This is shown in Figure 5-1.

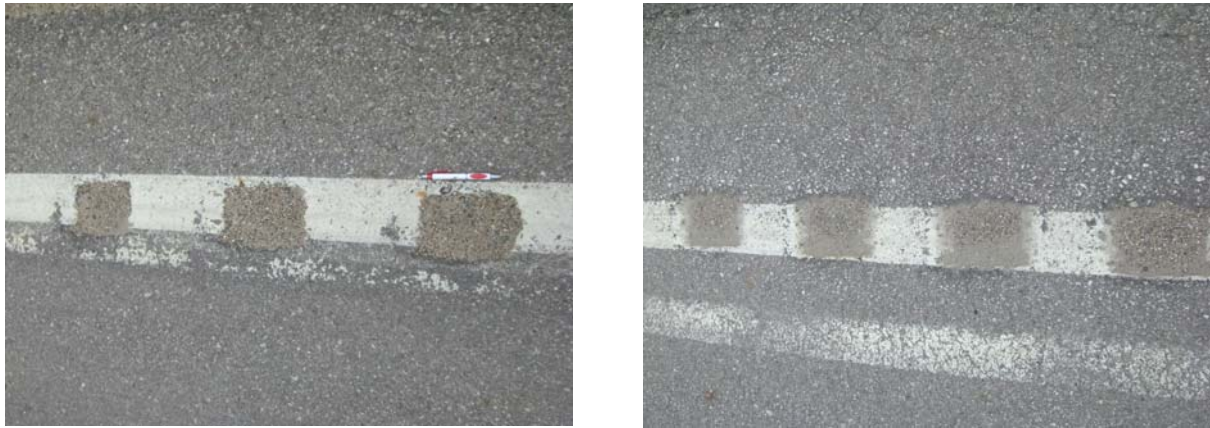
**Figure 5-2. Rumble stripes filled with sand**

Although the appearance of the stripes seemed the same for the initial and most of the fall collections, county maintenance crews had pulled up the gravel shoulders on the Poweshiek project, filling the stripes with loose granular material. This rendered them ineffective until the paint contractor blew out the material with compressed air. Also, the spring collection period revealed that the many of the stripes had been filled or partially filled with loose gravel material,

even on the Polk County roads with paved shoulders. See Figure 5-2. This may be attributed to winter maintenance using sand (sometimes mixed with salt) on slick roads. The amount of filling seemed to be much heavier on the asphalt pavements than on the PCC pavements.

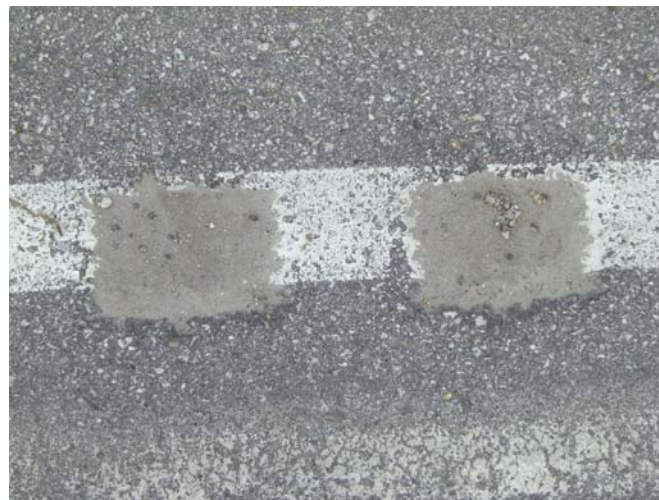
**Figure 5-3. Rumble stripe with caked fines in bottom**

Some of the stripes, especially at the tops of hills, on straight road segments seemed to accumulate only a small amount of caked fines in the bottom of the stripe. See Figure 5-3.

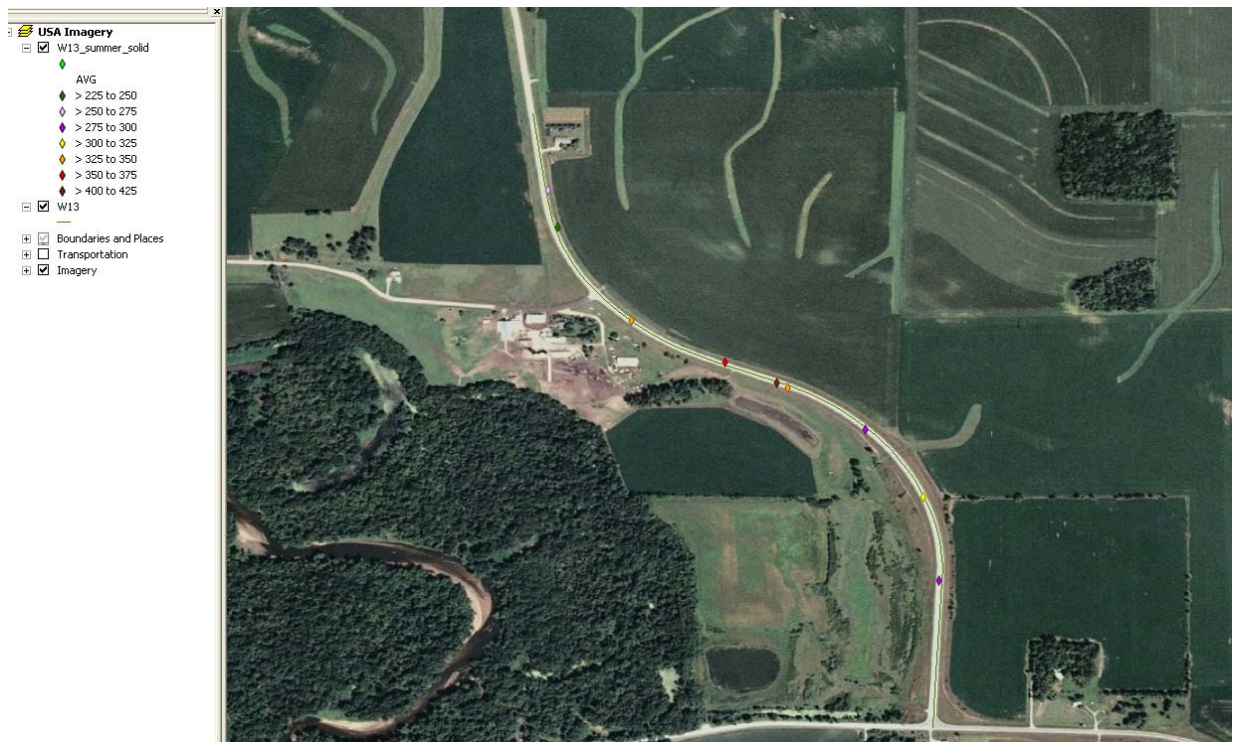
**Figure 5-7. Summer readings for control for test section W-13**

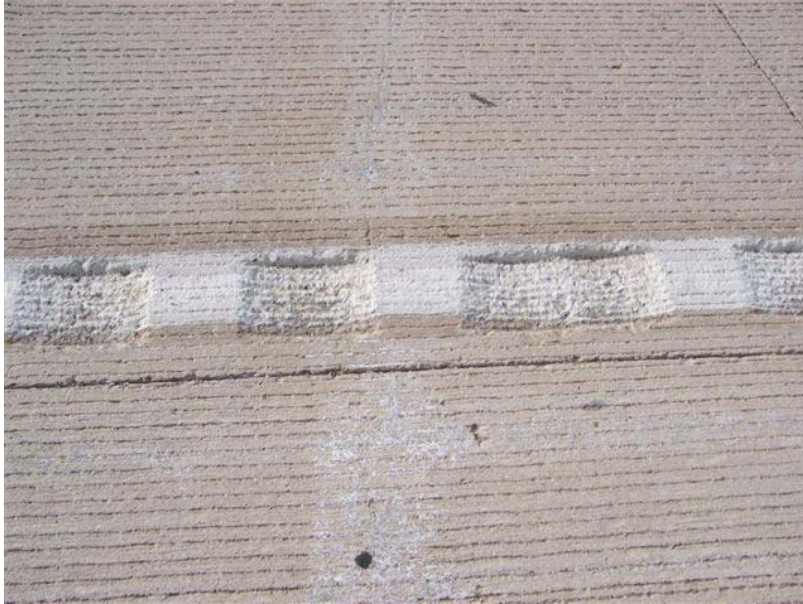
**Figure 5-16. Similar wear for rumble stripe and flat section on E-16 (taken spring 2009)**

In other areas, the paint seemed to be holding up well in both the rumble stripes and flat sections. Figure 5-15 shows a portion of F-29 taken in spring 2009. Figure 5-16 shows a portion of E-18 taken in spring 2009.

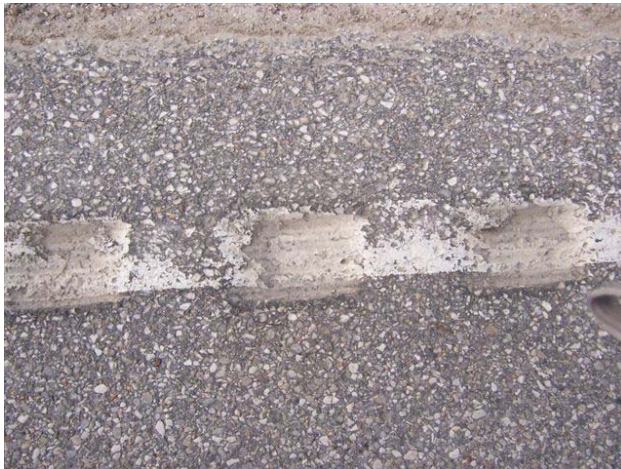
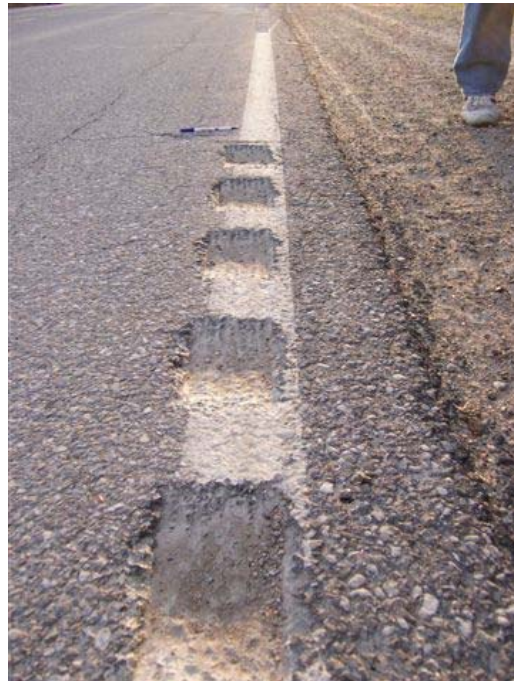
**Figure 5-17. Another portion of F-29 showing less wear in the rumble stripe than in the flat area (taken spring 2009)**

In other areas, the paint in the rumble stripe appeared to weather better and show less wear than the pavement markings on the flat portion of the roadway. Figure 5-17 shows a portion of F-29 that shows less wear in the groove than in the flat areas. Figure 5-18 shows a similar scenario for P-53.

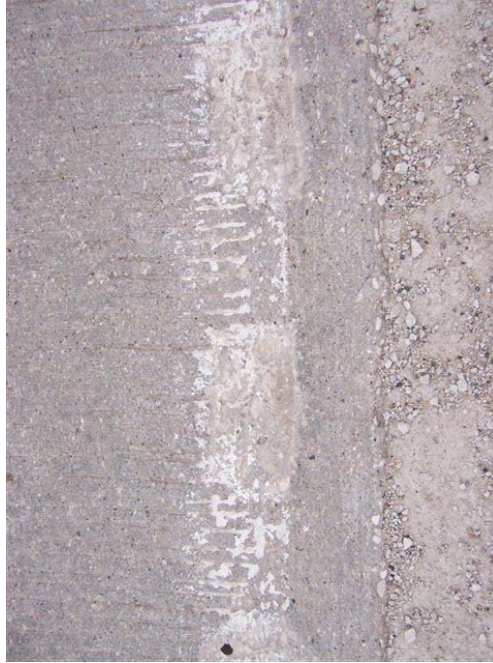
**Figure 5-18. Another portion of P-53 showing less wear in the rumble stripe than in the flat area (taken spring 2009)**

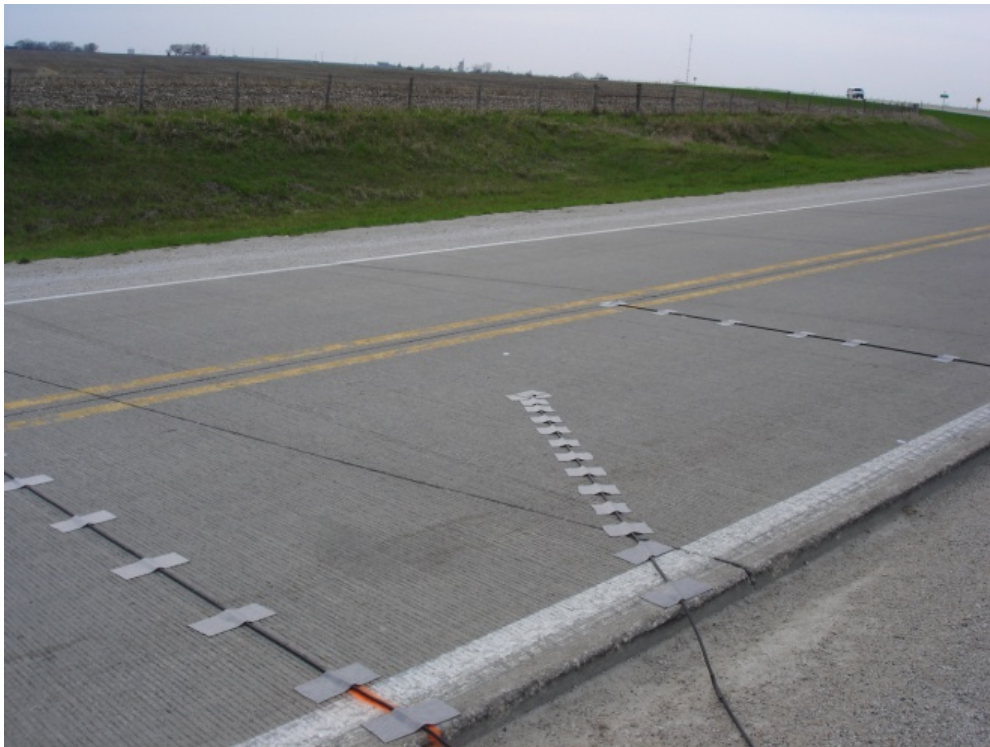
**Figure 5-20. Road tube layout to measure lateral displacement in the field**

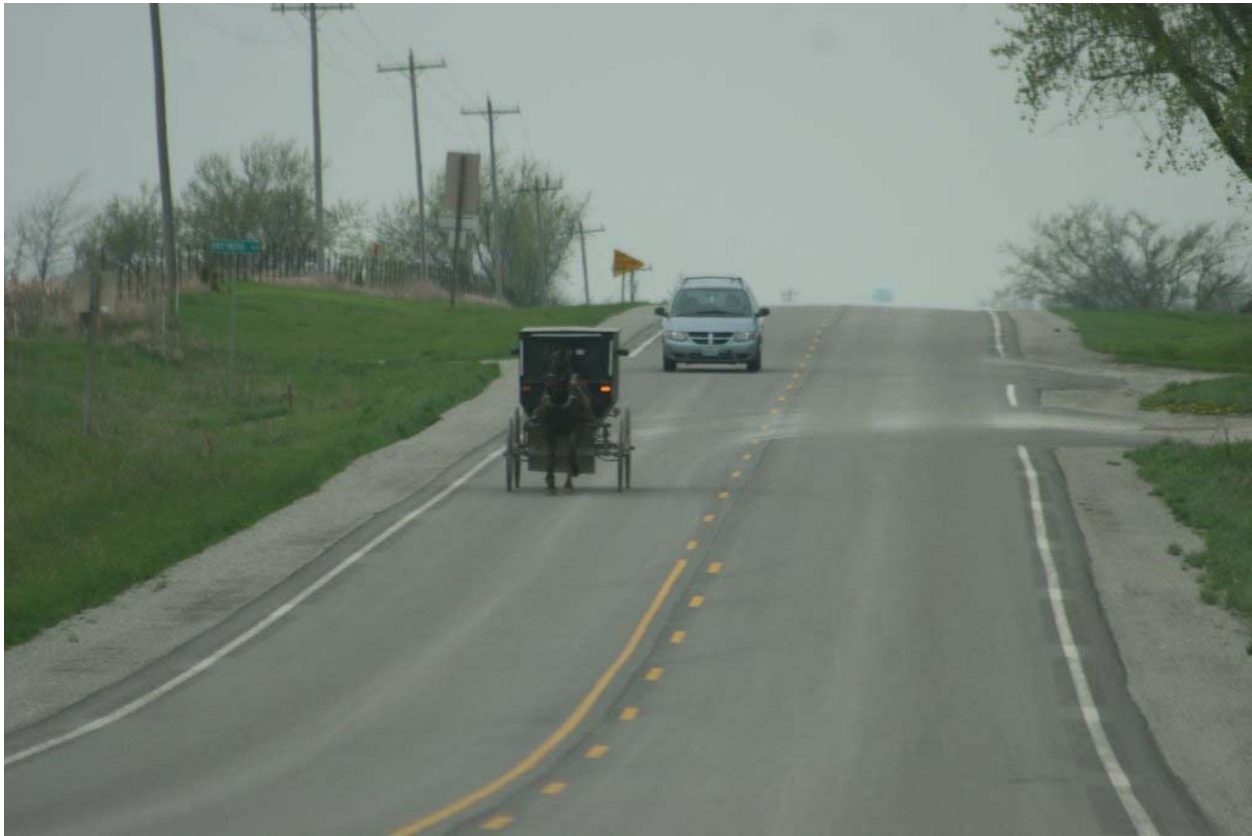
**Figure 5-21. Edge line rumble strips in place along Iowa 2 (image courtesy of Neal Hawkins, CTRE)**

There are no test sections in Davis County as part of this research. However, rumble stripes are present along Iowa 2 in that county, as shown in Figure 5-21. As shown, the rumble strip is wider than that used along test sections. The Amish group in Davis County indicated that recently installed rumble strips were a problem for the horse and buggies. They indicated that the horses were reluctant to cross the strips and could easily injure their feet. They also indicated that the vibrations caused by rumble strips were hard on the buggies and that the buggies can

fishtail when crossing the strips. The Amish indicated that they would prefer not to have rumble strips on roadway sections that they commonly use. Note the narrow shoulders present on Iowa 2 along with the rumble strips, as shown in Figure 5-21. In this section, there is very little room for the buggies to maneuver around the rumble strips. It should be noted that the standard width for milled rumble strips on Iowa DOT roadways such as Iowa 2 is 16 inches.
