Iowa Highway Research Board

Project HR - 74

LIVE LOAD DEFLECTIONS IN A  
PRESTRESSED STEEL BEAM BRIDGE

December, 1963

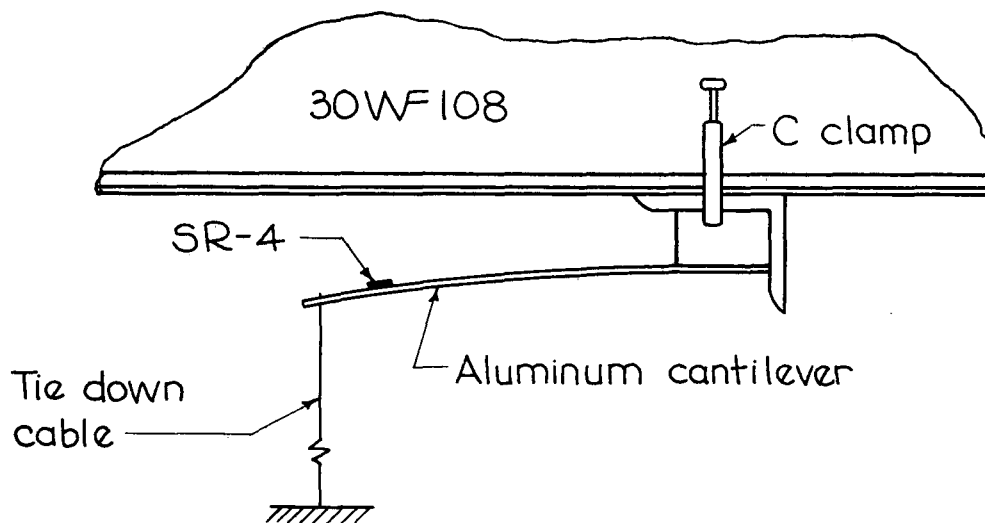
Figure 1

An SR-4 strain gage was attached near the free end of an aluminum alloy cantilever beam, which, in turn, was rigidly attached at the other end to one of the bridge beams so that the cantilever was parallel to the length of the beam, approximately on its center line. The free end of the cantilever was tied down by a light cable to a weight on the ground below the bridge. The cable was tightened until the cantilever had an initial deflection of about two inches.

DEFLECTION GAGE

As the bridge beam deflects under load, the cantilever deflection changes by an equal amount in the opposite direction, and the strain recorded by the SR-4 gage changes in proportion to the deflection. This change of strain is recorded on the oscillograph tape as four times the deflection, and this multiplication allows the deflection to be scaled to  $\pm 0.01$ ".

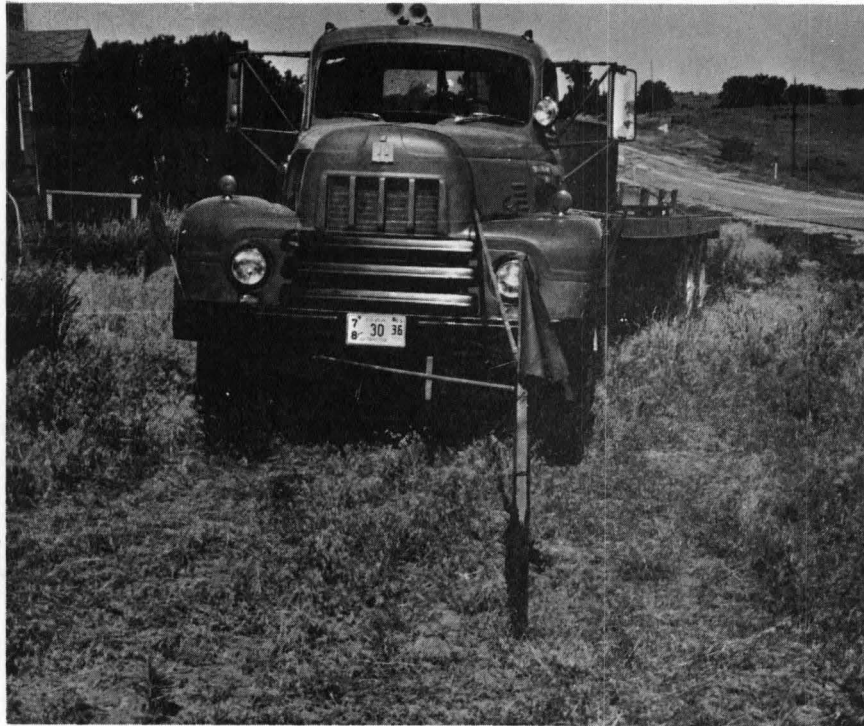
Photo 5: Test truck, showing tell tale guide for driver.

In order to guide the truck in the test runs, lines of tape were placed longitudinally on the bridge floor to locate the center line of the truck at 4.5', 7.5' and 10.5' from each gutter (see figure 3) and a boom was attached to the front of the truck with a tell tale hanging down located so that it was visible to the driver. By keeping this tell tale above the appropriate line of tape, the driver was able to follow the proper path.
