ESTABLISHING LOAD TRANSFER IN EXISTING  
JOINTED CONCRETE PAVEMENTS

Georgia Department of Transportation  
Office of Materials and Research  
Pavement & Physical Research Branch

Prepared for Presentation at the  
1985 Annual Meeting of the  
Transportation Research Board  
Washington, D.C.

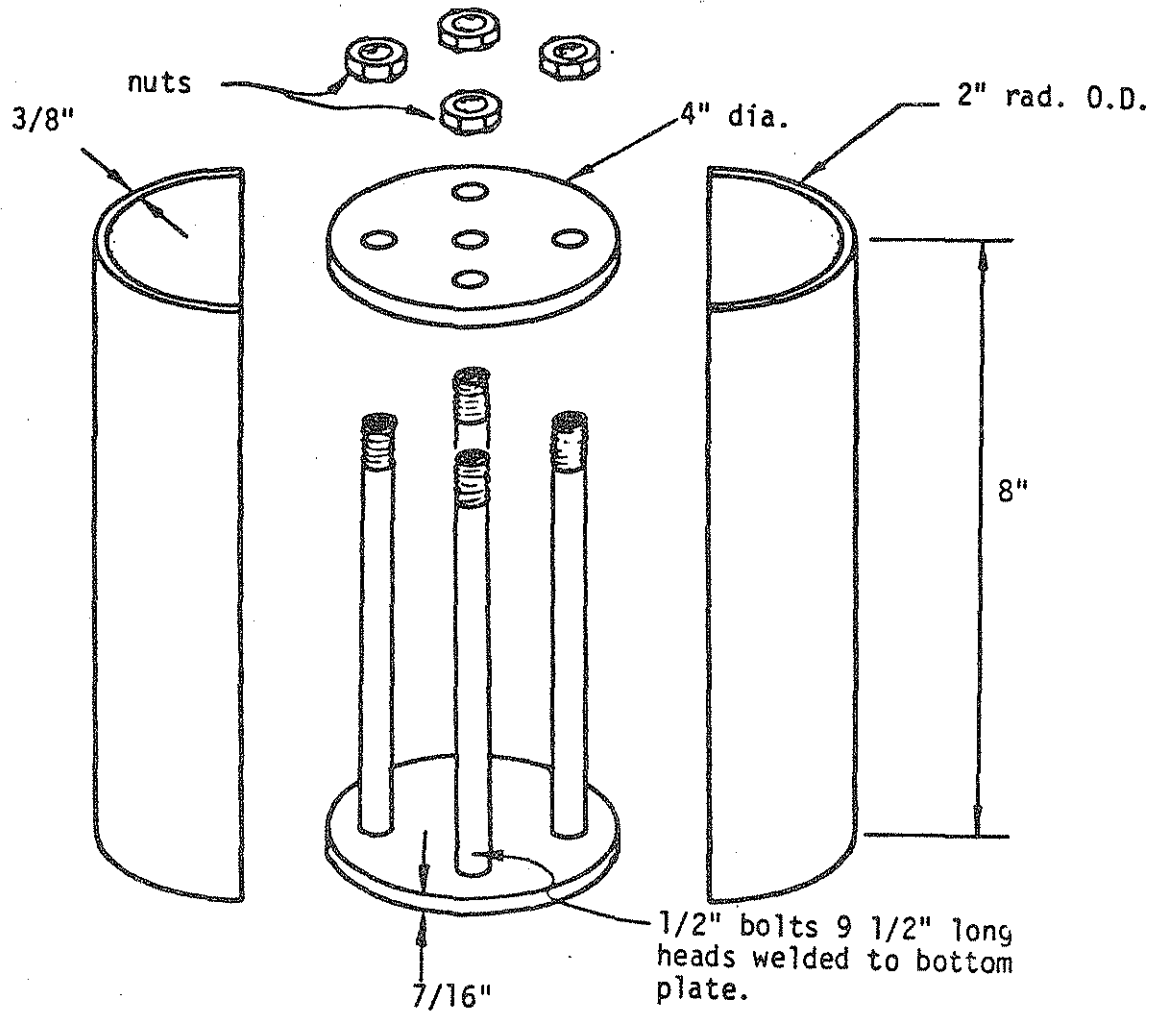
Figure 1 Georgia Split Pipe Device

Georgia Split Pipe Device - This device was developed by the Georgia DOT Office of Materials and Research personnel and is shown in Figure 1. To install these devices the two sides of the "split pipe" are epoxied to either

side of the 4 inch diameter core hole and the epoxy allowed to set. The top and bottom plates rest on the top and bottom edges of the two split pipe pieces. The four bolts are tightened and the load transfer between the slabs is carried by the four bolts and the epoxy bond between the split pipe pieces and the concrete core hole surfaces. Thermal expansion movement is accommodated by the slippage of the top and bottom plates on the end of the split pipe pieces.

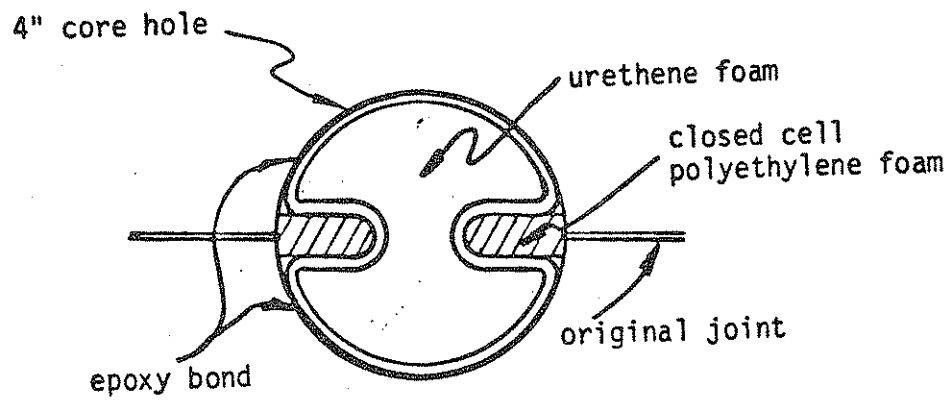
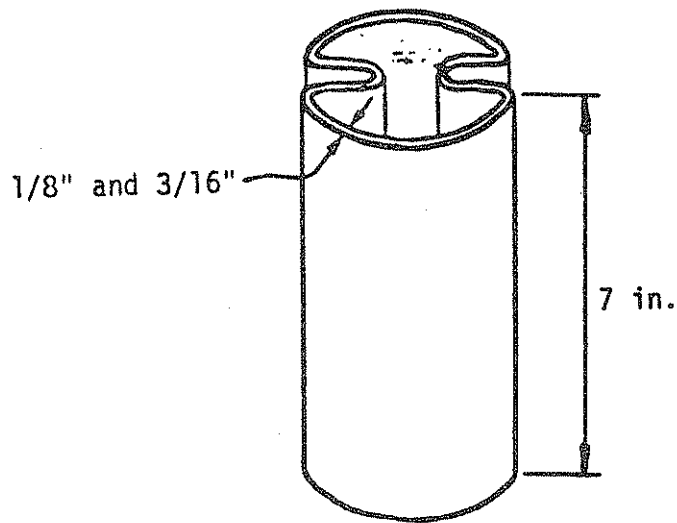
Figure 2 Figure Eight Device

Figure Eight Device - This device is a single piece cylindrical metal shell formed in the shape of the numeral eight as shown in Figure 2. The device is installed in a 4 inch diameter core hole and epoxy is used to bond the device to the walls of the core hole. The center of the device and the indentations on the side are filled with foam to keep out debris. The device has previously been used experimentally in France (4).

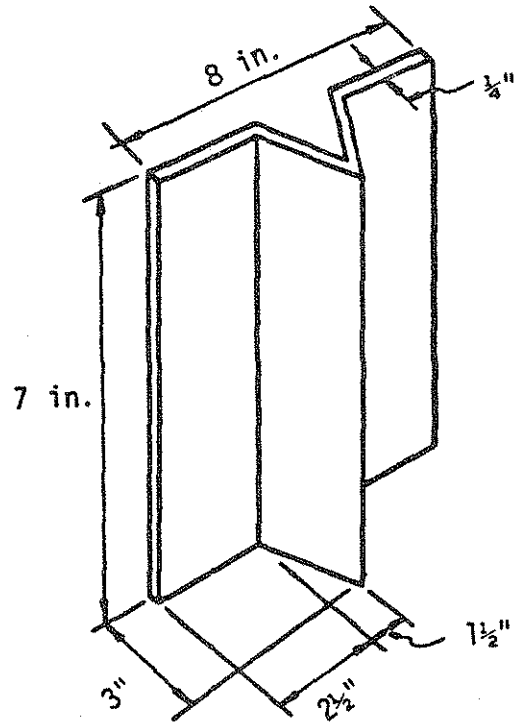
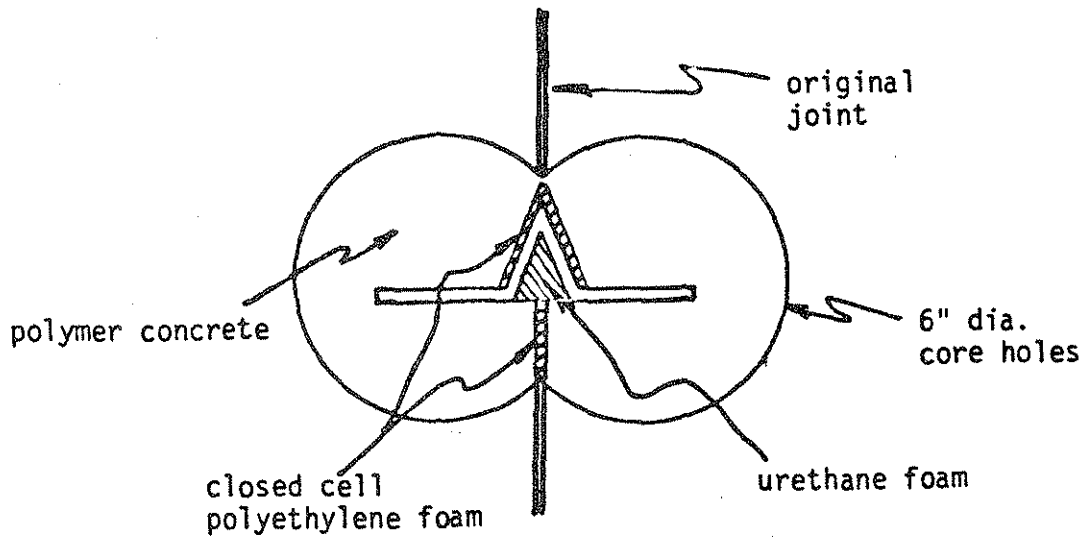
Figure 3 Vee Device

Vee Load Transfer Device - This type load transfer device was first proposed in a report published by FHWA in 1977 (3) along with the "Figure Eight" device. The device consists of a 1/4 inch thick steel plate bent into the shape of a V as shown in Figure 3. The device is not commercially available and was specially fabricated for this research project.

In order to be able to install the Vee device, two 6 inch diameter core holes have to be drilled which are filled with a patching material after the installation. The V portion was filled with a urethane foam and a thin layer of polyethylene foam was placed around the outside of the V to allow for expansion and contraction of the slab. An additional piece of foam was used to reestablish the joint.

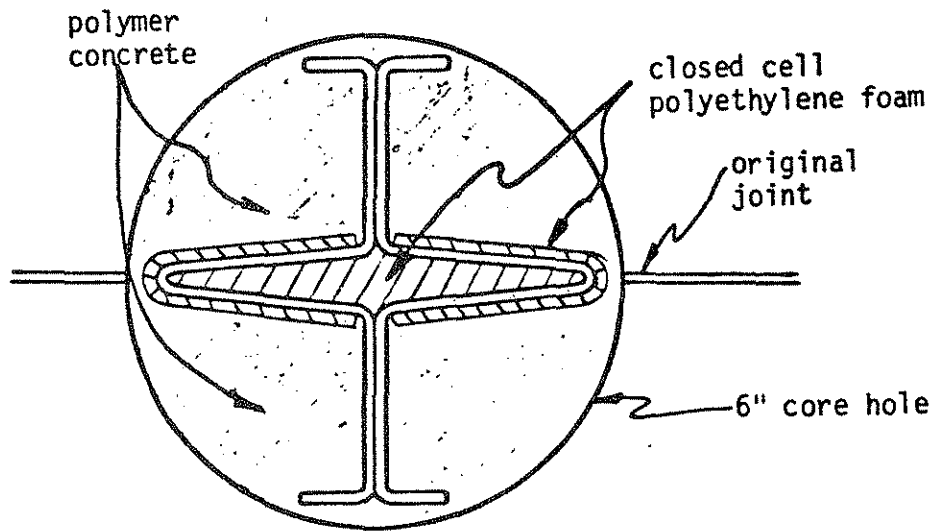
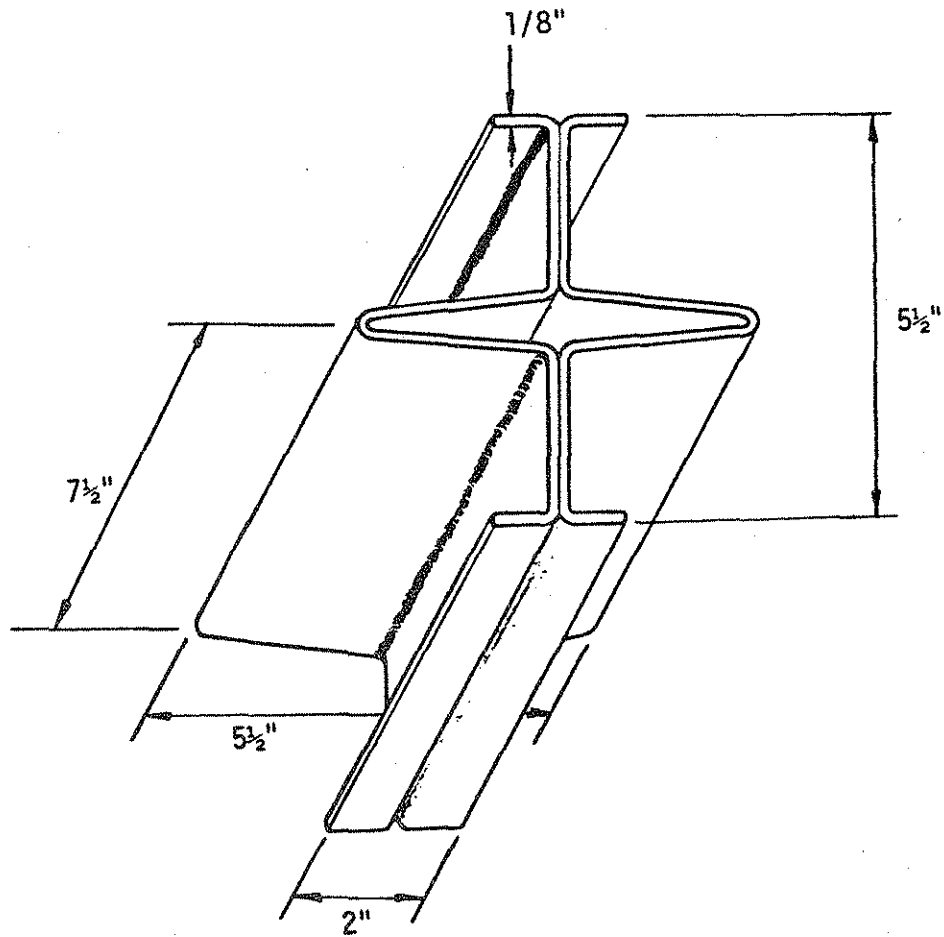
Figure 4 Double Vee Device

Double Vee Load Transfer Device - This device essentially is two Vee devices placed back-to-back and down-sized to accommodate installation in a

6 inch core hole. The device was designed and initially tested at the University of Illinois (5) and is now commercially available under the trade name of LTD Plus. Some minor additional design changes to the device shown in Figure 4 have taken place since its use in this research project. The center section of the device is filled with foam to keep out debris and a thin foam pad is placed around the outside of the V portion to allow for expansion and contraction movement. The devices used in this project are epoxy coated to prevent rusting and current devices are manufactured from stainless steel.

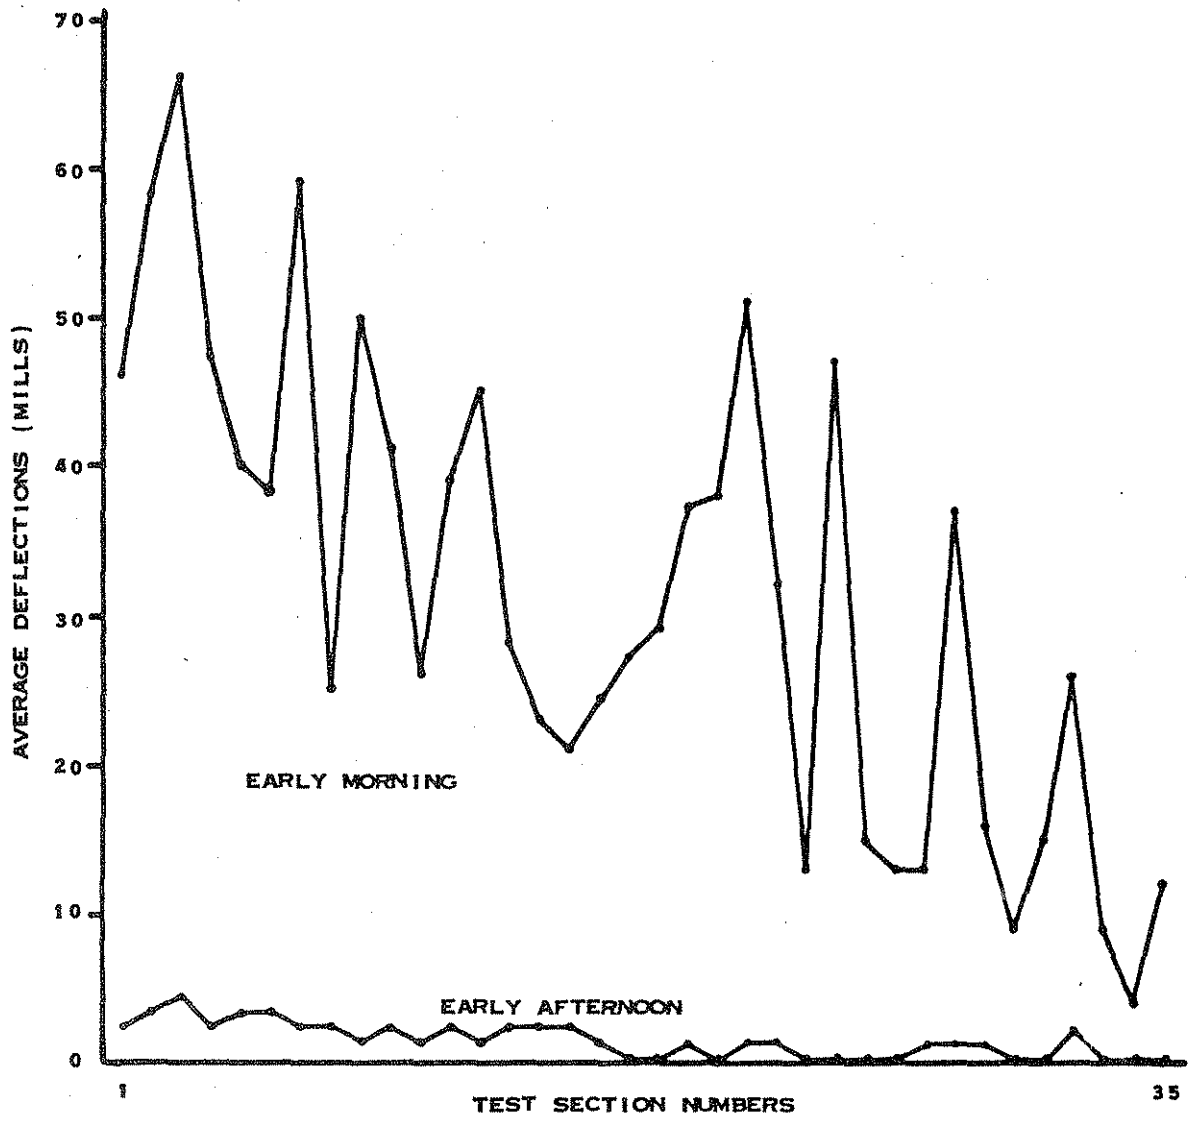
FIGURE 5 DEFLECTION LEVELS OF LEAVE SLAB CORNERS  
SEPTEMBER 1982

The effects of seasonal changes on the load transfer conditions was evident from the three series of tests which were conducted at different times of the year and clearly showed that the higher deflections were obtained in September 1982 and always occurred in the early morning test series for all three evaluation periods. The deflections obtained with the load on the leave side of the joint also were generally larger than the deflection obtained on the approach side when loaded. The deflection data also shows that the vertical movement measured in the early afternoon is generally negligible regardless of the magnitude of the movement measured in the early morning (Figure 5). Performance comparisons between the various load transfer systems were therefore based on deflections measured during the early morning hours when significant slab movements are likely to take place.

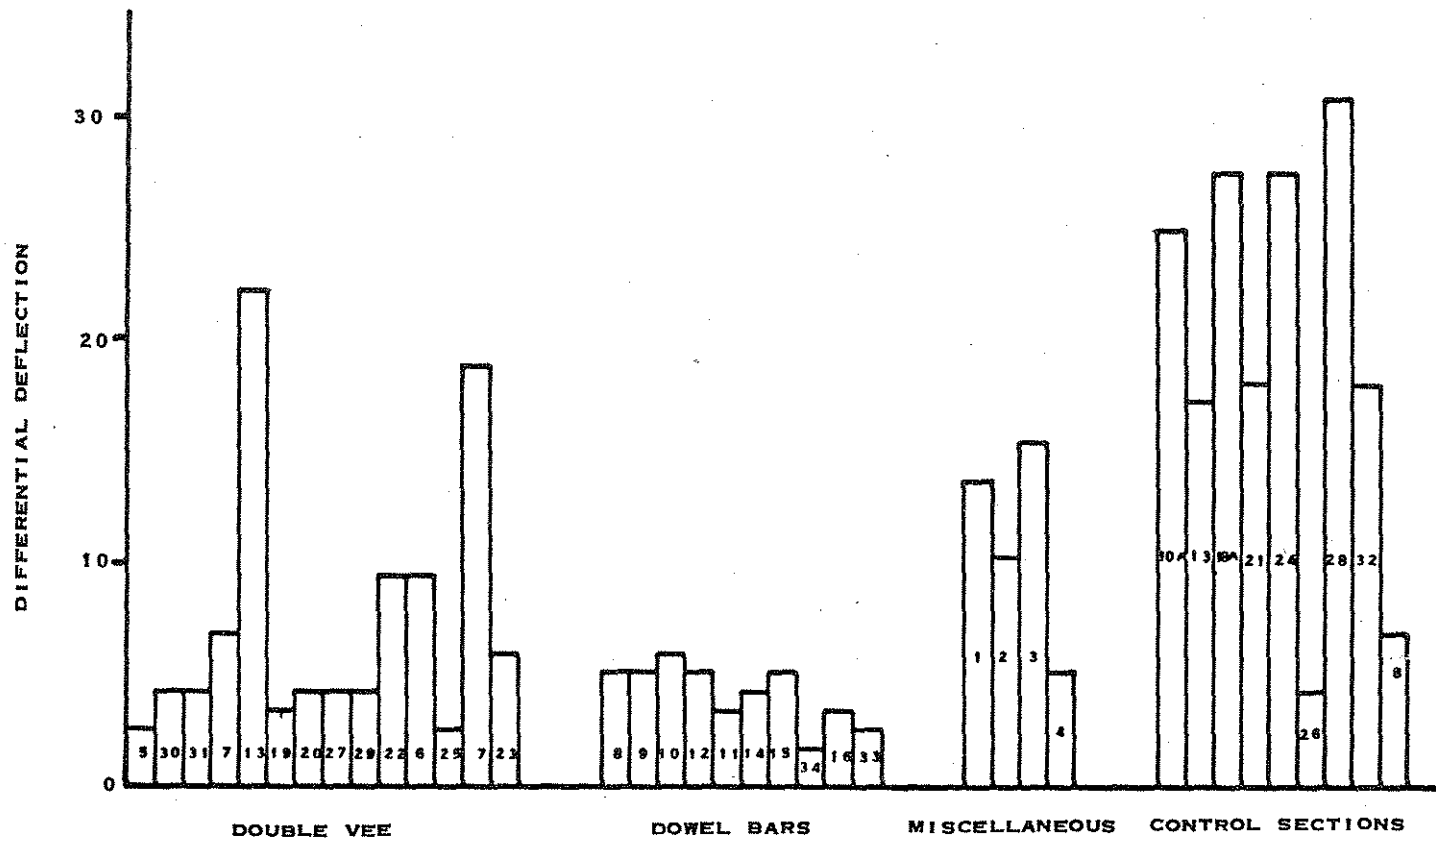
FIGURE 6 DIFFERENTIAL DEFLECTION VALUES - MARCH 1983  
EARLY MORNING LOAD ON LEAVE SLAB

The critical time period for analysis is the deflections obtained during the early morning testing with the load placed on the leave side of the joint. The average differential deflection values for each test section is shown in Figure 6 for the March 1983 test period with the load placed on the leave slab. The bar charts in Figure 6 clearly show that all the sections with the dowel bars were performing well along with ten of the fourteen sections containing Double Vee devices. Section four containing the Vee device shows good performance on the bar chart, however, the data is suspect for this section for March 1983 since the deflection difference obtained in September 1982 was 35 mills. The March 1983 readings were generally much less than those obtained in September 1982 for sections showing poor performance. For the sections with good performance there generally was not much difference between the September 1982 and March 1983 differential deflection values. This fact is an indication of the seasonal influence on sections with little or no mechanical interlock. When adequate mechanical interlock is present, the seasonal influences are minimized in a manner similar to that noted previously for the daily temperature cycle changes.
