CENTER FOR
PORTLAND CEMENT CONCRETE
PAVEMENT TECHNOLOGY

Development of In Situ Detection Methods for Materials-Related Distress (MRD) in Concrete Pavements: Phase 2

Final Report
August 2005

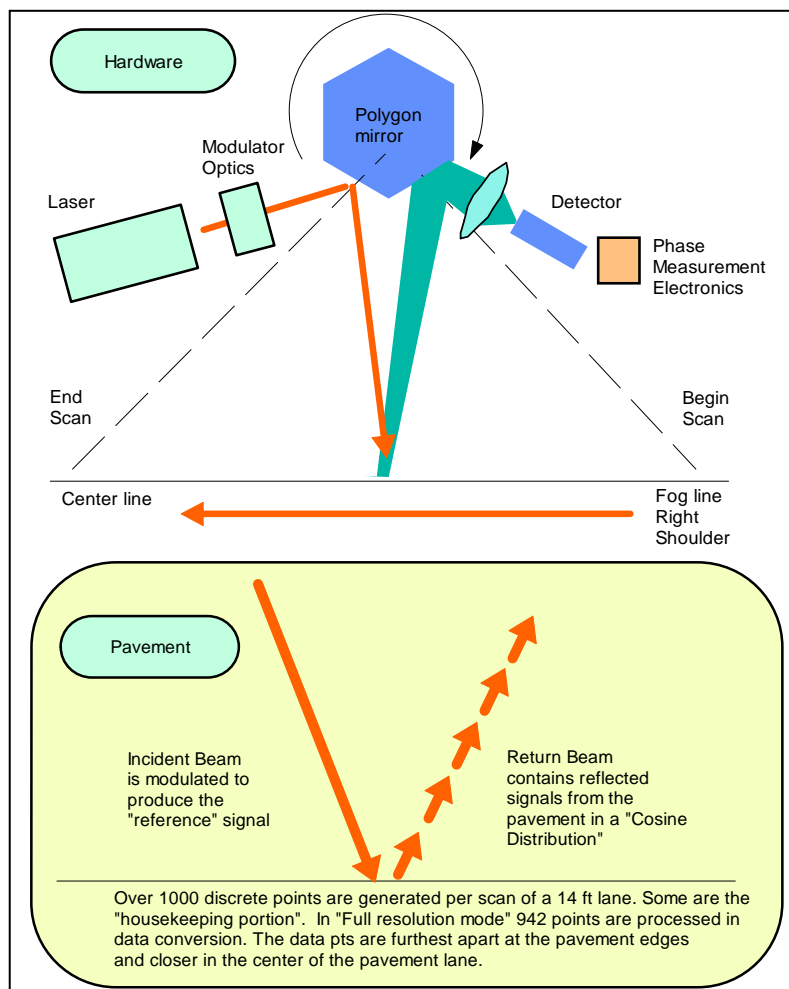
Figure 1. Illustration of the main features of the PPS system

The concept behind the PPS system can be briefly summarized as follows (Mandli 2005). A modulated laser beam is reflected off a rotating mirror. The beam strikes the pavement surface and is reflected back at the rotating mirror; however, the reflected beam has been phase-shifted

(i.e., Doppler-shifted) so that it exhibits a time delay relative to the incident laser beam. The detector measures the phase shift and the signal intensity at each point along the scan line. Since the mirror is spinning at about 167 revolutions per second, the laser beam is able to make about 1,000 scans per second. The system is composed of both hardware and software components, shown in Figure 1 (Mandli 2005). The hardware components consist of an amplitude modulation (AM)-modulated laser, a rotating polygon mirror, detector optics, and phase measurement electronics. Data is processed after the information has been collected and saved to fixed storage; calculations include the normal pavement engineering information (e.g., International Roughness Index, rutting, etc.). For the purpose of this study, the system was used to scan for distress features, such as fine cracking that is a common symptom of materials-related distress.

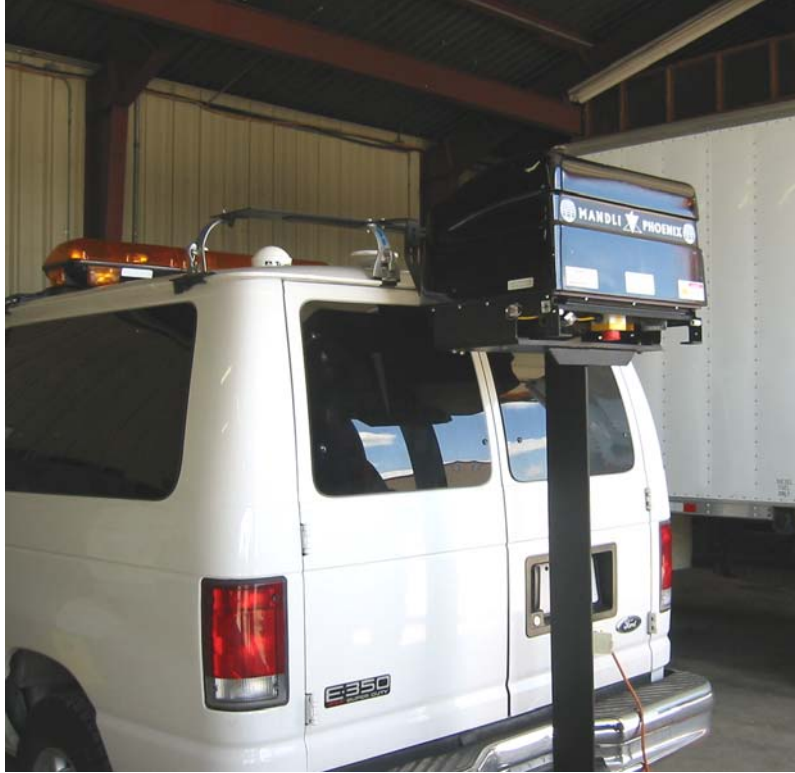
Figure 2. PPS device mounted on the Iowa DOT video log van

Mandli Communications, Inc. was contacted to perform an extended field demonstration of their pavement evaluation system. The initial system consisted of a PPS integrated into the existing Iowa DOT video log van. See Figure 2 (Smadi 2005). A second system, considerably more robust than the first, was developed under an alternate FHWA program (Smadi 2005). The system consisted of a PPS and a downward imaging system (dual line-scan cameras, but without a lighting system). Again, the systems were integrated into the Iowa DOT video log van.

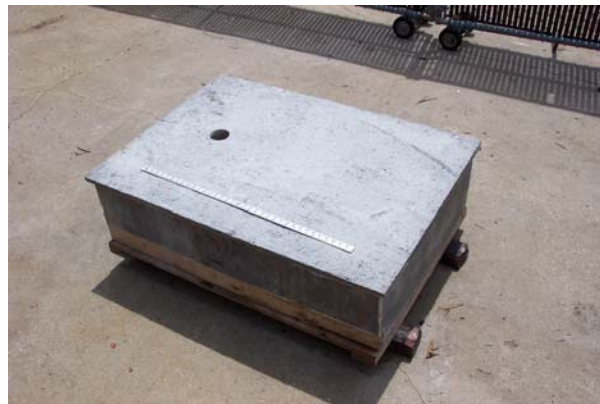
Figure 3. Slab containing crossed reinforcing bars (3/8-inch nominal diameter)

The results of the laboratory studies on the various slabs are summarized below. The laboratory investigations were conducted to clarify specific issues relevant to this project. The concrete slabs were constructed to illustrate the ability of GPR to locate and visualize features in the slab. See Figure 3. The ruler shown on the slab is 36 inches long.

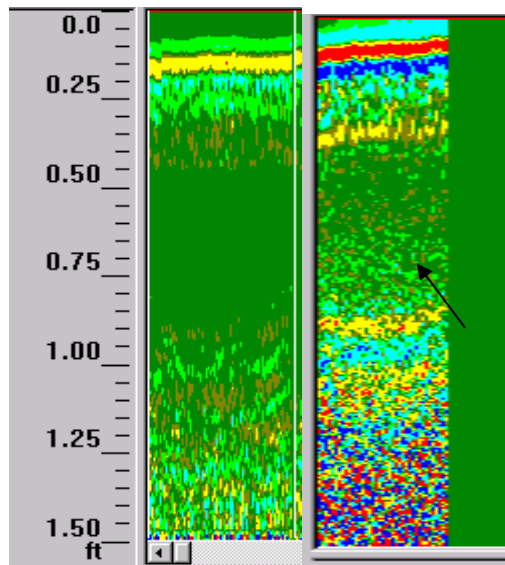
Figure 6. Possible detection of moisture gradients due to ASR expansion

The results from the concrete and mortar slabs containing reactive aggregate were less dramatic. Transects from the concrete slab suggested that a moisture gradient was developing in the concrete slab. This was observed near the region in which the reactive aggregate was placed (see Figure 6). Cores extracted from the slab indicated that the fused quartz aggregate was exhibiting cracking caused by ASR; however, the cracking was not observed on the surface of the slab. Since the coring operation penetrated through the region of reactive aggregate in the slab, the experiment was effectively terminated because water now had access to the center of the slab. Therefore, additional studies (the mortar studies) were initiated to study the issue in more detail.

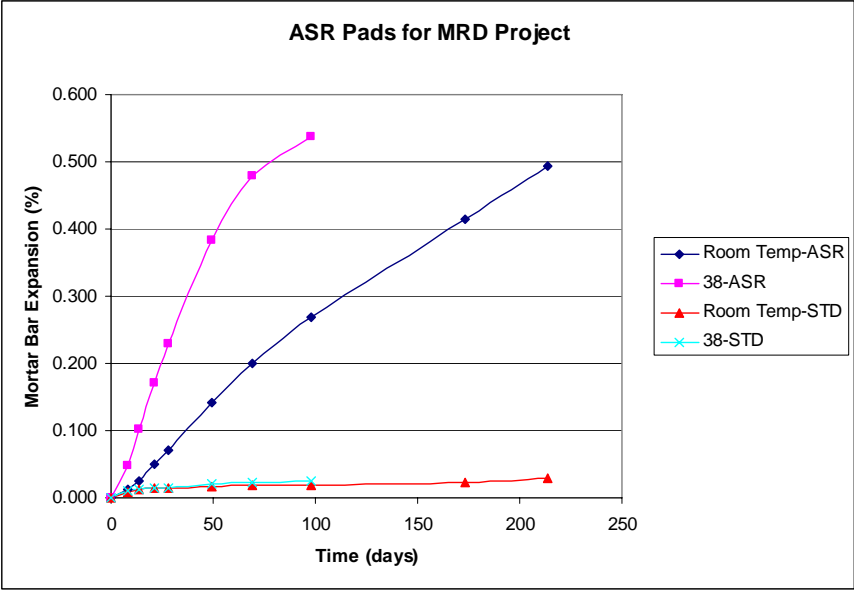
Figure 7. Mortar bar expansion versus time for ASR cracking experiments

The mortar studies were conducted with better experimental control. Expansion was measured via mortar bar expansion tests, so the slabs did not need to be cored. In addition, the mortar slabs were constructed with high-alkali cement to accelerate cracking. The mortar bars expanded rapidly (see Figure 7) and, after about five months of curing, the slab showed macroscopic

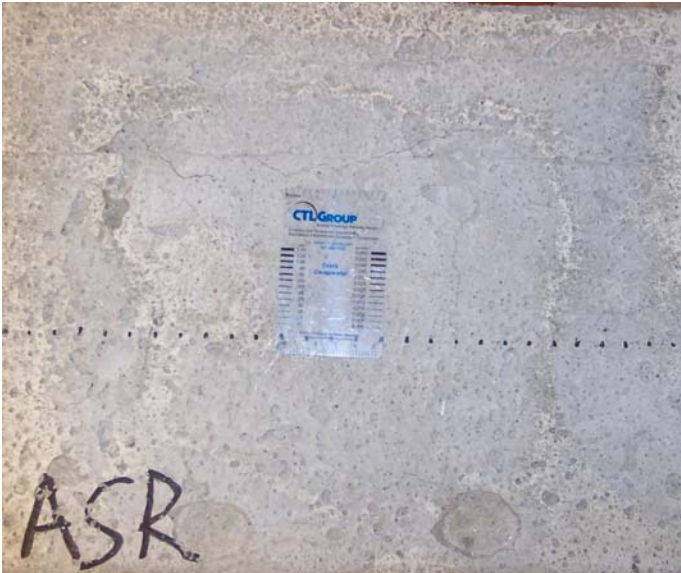
Figure 8. Surface cracking on the specimen containing ASR-reactive aggregate

surface cracking (see Figure 8). The control specimens did not exhibit distress during the experiment. Unfortunately, the results of the GPR scans were still not conclusive. This was consistent with the behavior observed at site 3 (P 73). Perhaps uniform expansion is not measurable with GPR. More experimentation is needed before firm conclusions can be made.
