# Investigation of High Performance Concrete Pavement

Final Report  
for  
MLR-05-01

Highway Division

**Iowa Department  
Of Transportation**

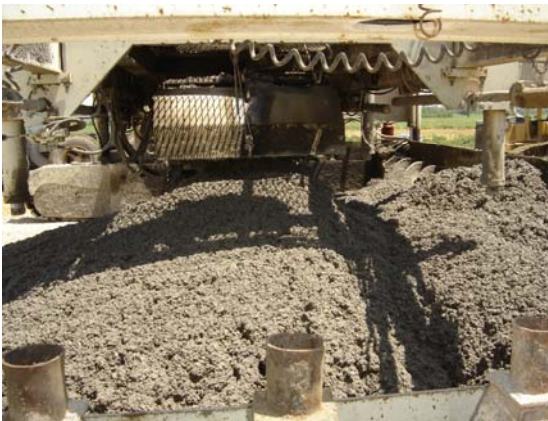
**Figure 2. Mix at Belt Placer**

As is typical of the Shilstone mix designs, the concrete appears rocky at the belt placer. After vibration in the paving machine, the slab is uniform and well consolidated.

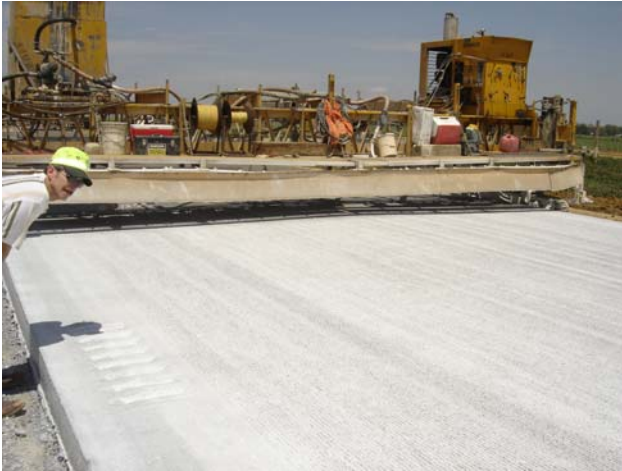
**Figure 4. Application of Curing Compound**

Application of curing was checked at various times. Application was between 18 and 30 minutes after the paver.

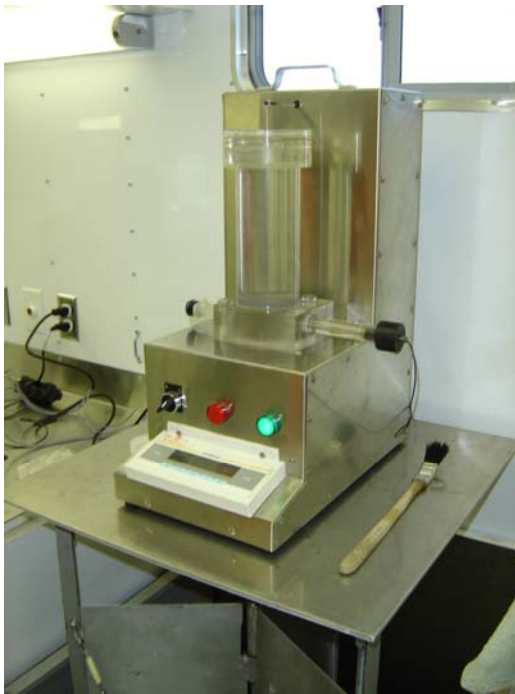
**Figure 5. Air Void Analysis (AVA) Equipment**

The AVA can determine the spacing factor of plastic concrete from a sample of mortar. It utilizes the principles of Stoke’s Law to calculate the rise of various size bubbles through a viscous liquid. As the bubbles rise through the liquid, a weight loss is measured under a dish in the liquid. AVA test results are shown in Table 4.

Plastic air content was determined before and after the paver using the pressure meter. The ISU concrete trailer performed air void analysis in the plastic concrete using the air void analyzer (AVA) (Figure 5).

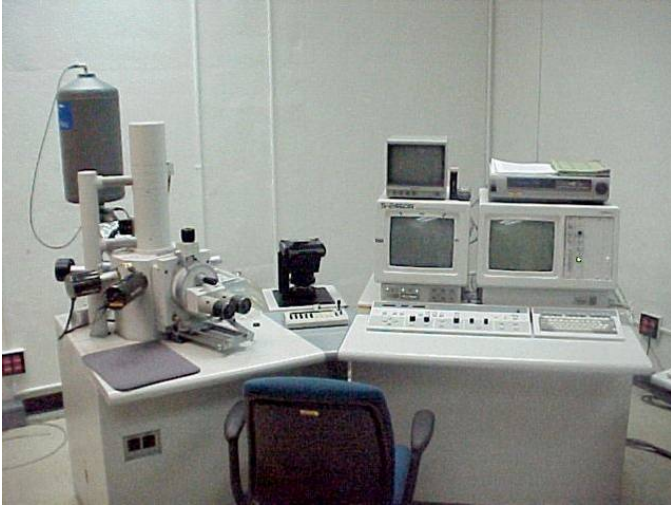
**Figure 6. Scanning Electron Microscope (SEM)**

Hardened air was measured on core slices obtained from the project. The SEM is used to sample 20 images at 40X from a polished sample. The images are analyzed using image analysis software to determine bubble distribution. The hardened air results using the SEM and image analysis are shown in Table 5.

Cores were obtained and hardened air analysis was performed by the MARL laboratory at ISU using the scanning electron microscope (SEM) (Figure 6) and image analysis. In addition, ISU also performed hardened air analysis on cores using the RapidAir 457 (Figure 7).

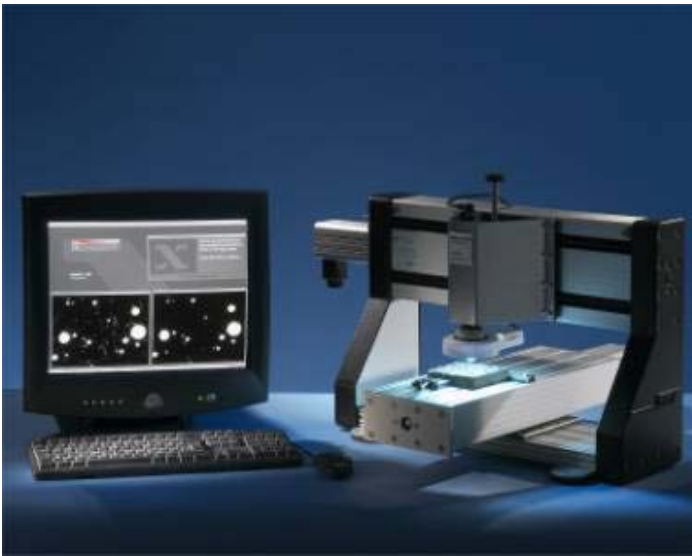
**Figure 7. RapidAir 457 Equipment**

Three core slices were also tested on the RapidAir457 equipment. The unit requires the sample that to be prepared with a black and white contrast. The contrast is achieved with black ink and a

white powder (BaSO<sub>4</sub>) filled into the voids. The sample is scanned and air voids results are quickly obtained. The hardened air results using the RapidAir457 are shown in Table 6.

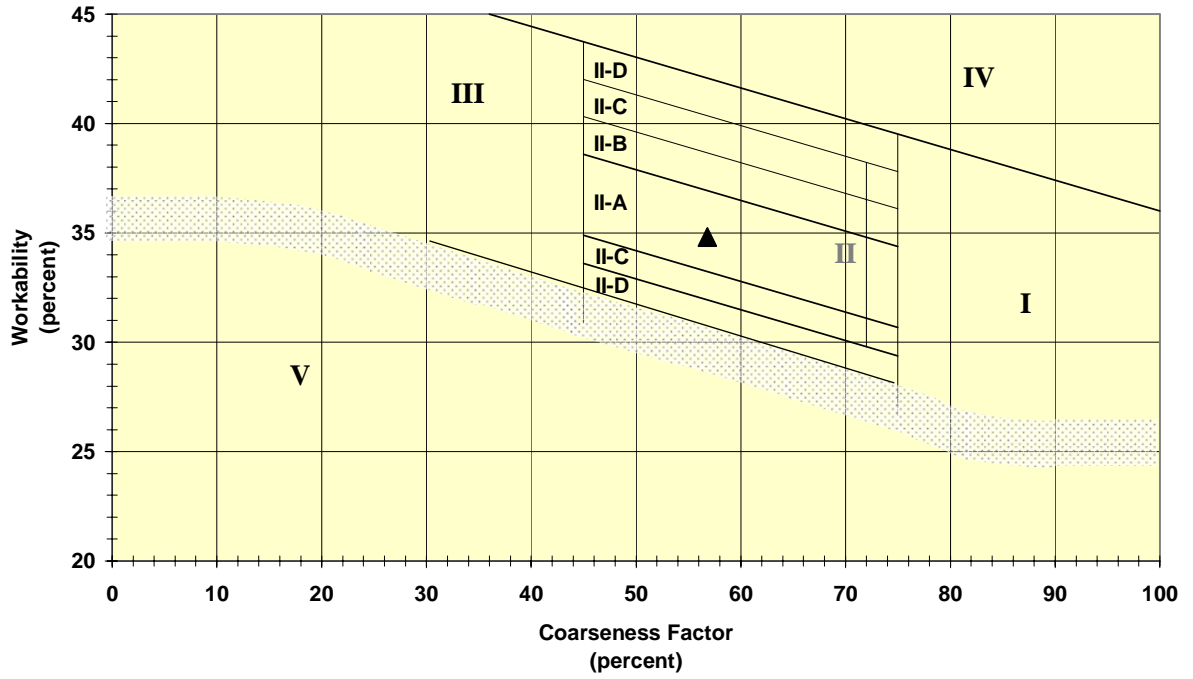
Figure 2 – Coarseness Workability Factors – Mix Design.

<sup>1</sup> Workability Factor VS Coarseness Factor  
for Combined Aggregate

The target gradation for the mix design had a coarseness factor of 56.8 and a workability factor of 34.8. The mix design and gradation charts are shown in the Appendix Figures 1 through 4. The average coarseness factor and average workability factor obtained on the project was 57.5 and 34.8, respectively. The coarseness and workability factors for the project are shown in the Appendix Figure 5.
