INVESTIGATION OF VIDEO CRACK & PATCH SURVEYING FOR PAVEMENT MANAGEMENT

**FINAL REPORT
FOR
MLR-92-1**

MAY 1992

**Iowa Department
of Transportation**

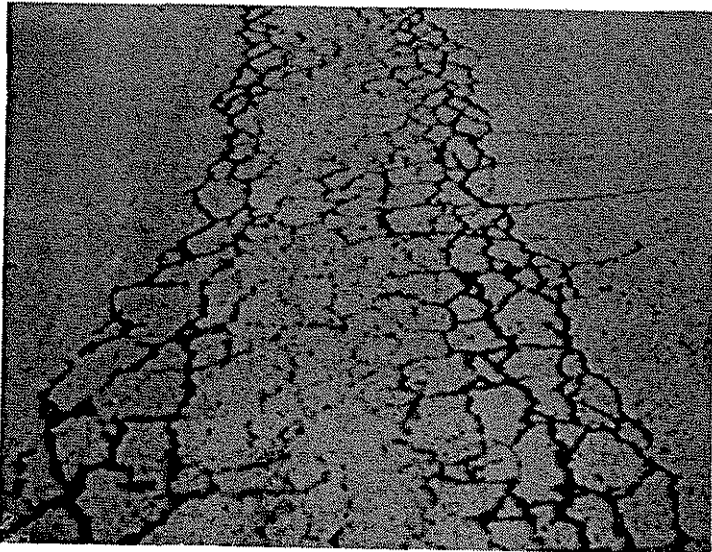
Figure 1

Cracking, C, is defined as the square feet per 1000 square feet of pavement surface exhibiting alligator or fatigue cracking. This type of cracking is defined as load related cracking which has progressed to the state where cracks have connected together to form a grid like pattern resembling chicken wire or the skin of an alligator. This type of distress can advance to the point where the individual pieces become loosened.

Alligator cracking

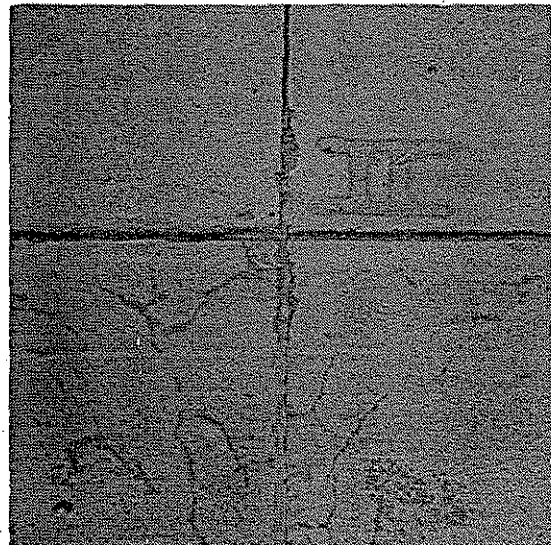
Figure 4

D-cracking, D, refers to a characteristic pattern than can develop in portland cement concrete. Initially, the occurrence of D-cracking may be preceded and accompanied by staining of the pavement surface near joints and cracks. However, not all stained joints and cracks develop D-cracking. D-cracked concrete will first exhibit fine parallel cracks adjacent to the transverse and longitudinal joints at the interior corners. The D-cracks will bend around the corner in a concave or hourglass pattern. As the D-cracking progresses, the entire length of the transverse, longitudinal and random cracks will be affected. The cracked pieces may become loose and dislodged under the action of traffic. The occurrence of D-cracking in the check sections will be rated on a point scale as described in the Test Procedure section.

D-cracking - Initial stages

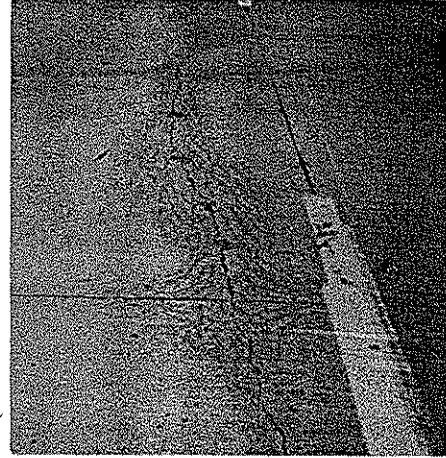
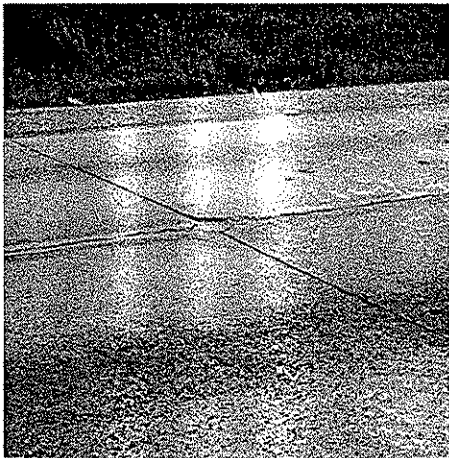
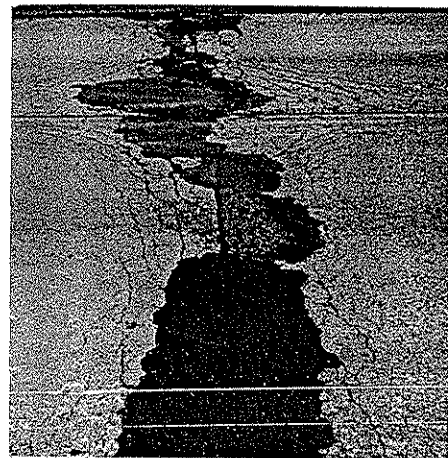
Figure 6. Examples of D-crack occurrence Factors

- 0 = No D-cracking noticeable.
- 1 = D-cracking is evident at most joints and has progressed across width of slab. Pavement is in sound condition and no maintenance is required due to D-cracking.
- 2 = D-cracking is evident at most joints and has progressed across width of slab. Pavement is in sound condition and no maintenance is required due to D-cracking.
- 3 = D-cracking is evident at virtually all joints and random cracks. Minor raveling and spalling are occurring and traffic is causing some loosening of cracked pavement. Some minor maintenance of spalled areas is required.
- 4 = D-cracking very evident as in 3 above. Spalling and removal by traffic has progressed to point that regular maintenance quality of pavement is now noticeable.

5 = D-cracking has continued to progress at sites identified in 3 above and requires regular maintenance patching. Full depth patches may be necessary. Ride quality has deteriorated to point where reduced driving speed is necessary for comfort and safety.
