Evaluation of Long-Term Field Performance of Cold In-Place Recycled Roads:

Summary Report

Final Report
May 2007

Sponsored by
the Iowa Highway Research Board
(IHRB Project TR-502)
and
the Iowa Department of Transportation
(CTRE Project 03-160)

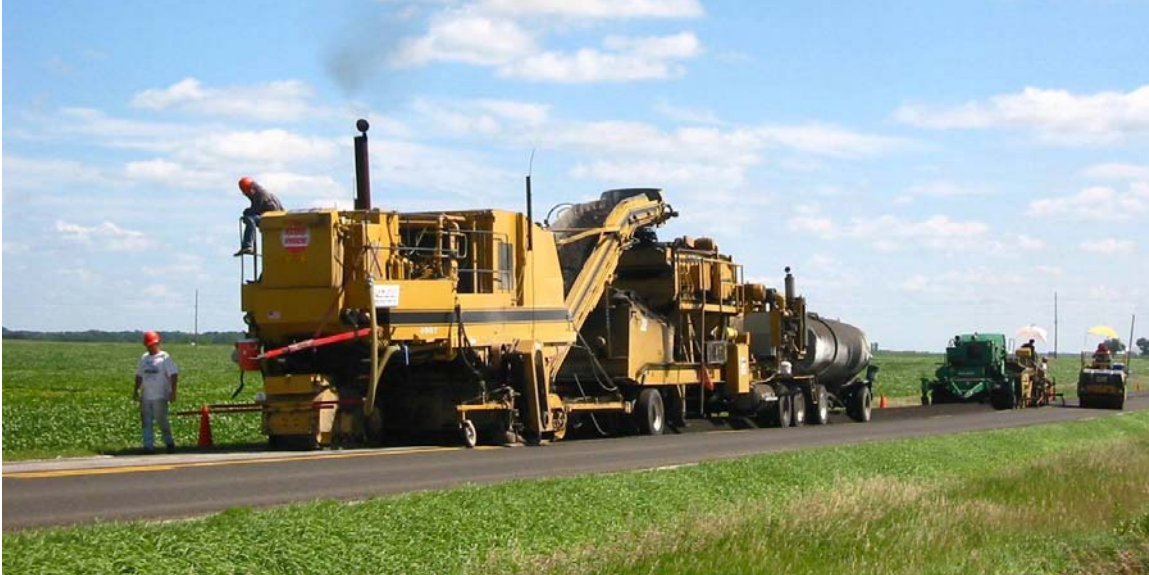
Figure 2. Picture of a typical CIR recycling train

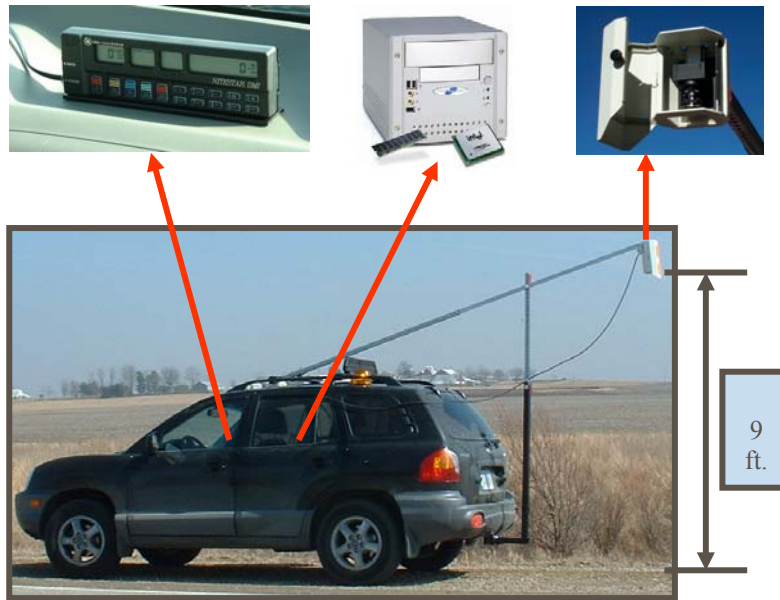
(a) Configuration of automated image collection system

(i) Length of longitudinal crack

(ii) Area of alligator cracking

(b) Screen shots demonstrating manual crack measuring process

Figure 4. Field distress measurement system

Images of field distresses for the sample were digitally captured by University of Iowa researchers (Lee and Kim 2006) and analyzed using a partially automated, technician-assisted procedure. As shown in Figure 4 (a), images were digitally captured using a vehicle-mounted digital camera that was computer-synchronized with the vehicle's speed to capture overlapping images of the road at highway speed. The images were then analyzed on a personal computer, where the operator traced cracks using a mouse and outlined areas of other distresses. Distresses included transverse, longitudinal, block, and alligator cracking; patching; raveling; and bleeding.

To determine crack severity, the operator estimated crack width by scaling. The resulting measurements were then processed to calculate a pavement condition index (PCI) according to the method outlined by (Shahin and Walther 1990). Figure 4(b) provides sample screen shots that demonstrate the crack measurement process. While this approach was more automated than the approach used in the 1996 study (Jahren et al. 1996), the University of Iowa research team conducted a side-by-side comparison of the two methods and found that they produced equivalent results (Lee and Kim 2006). Rut measurements were taken at 50 ft. intervals by the University of Iowa researchers using a dipstick measuring device on a 4 ft. straightedge.

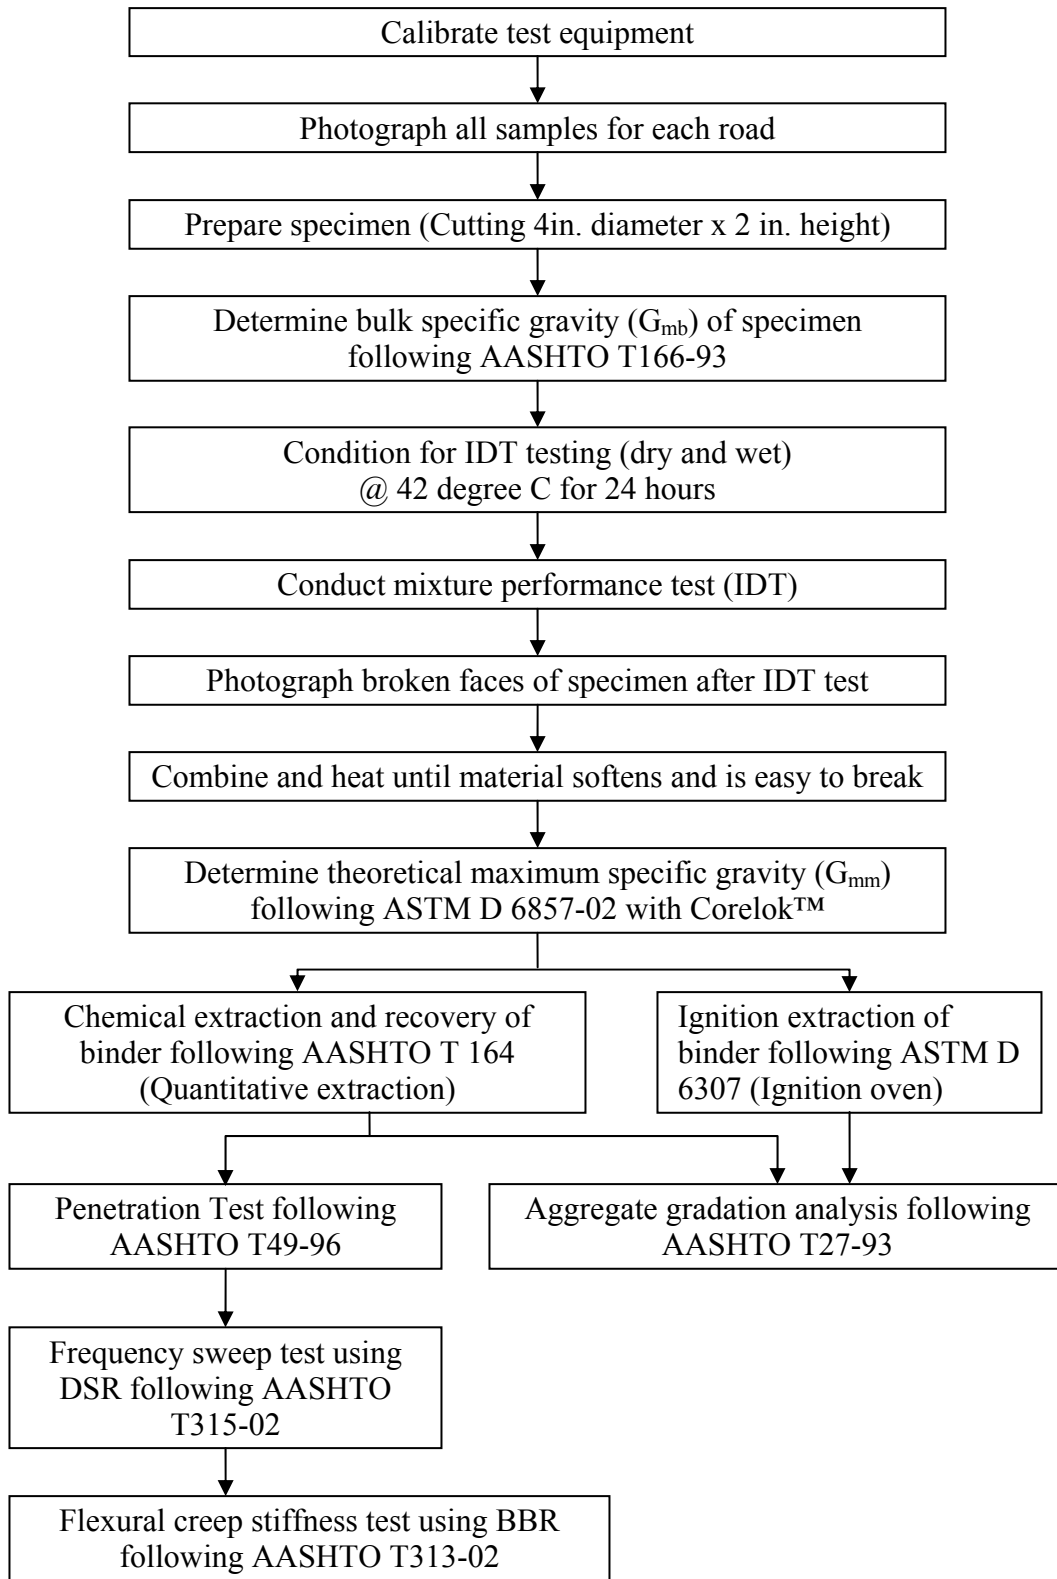
Figure 6. Flow chart for laboratory testing

to remove the non-CIR portions and to produce the correct sample size (4 in. diameter, 2 in. height) and were then weighed and measured. Then the cores were subjected to several tests, as illustrated in the flow chart in Figure 6.

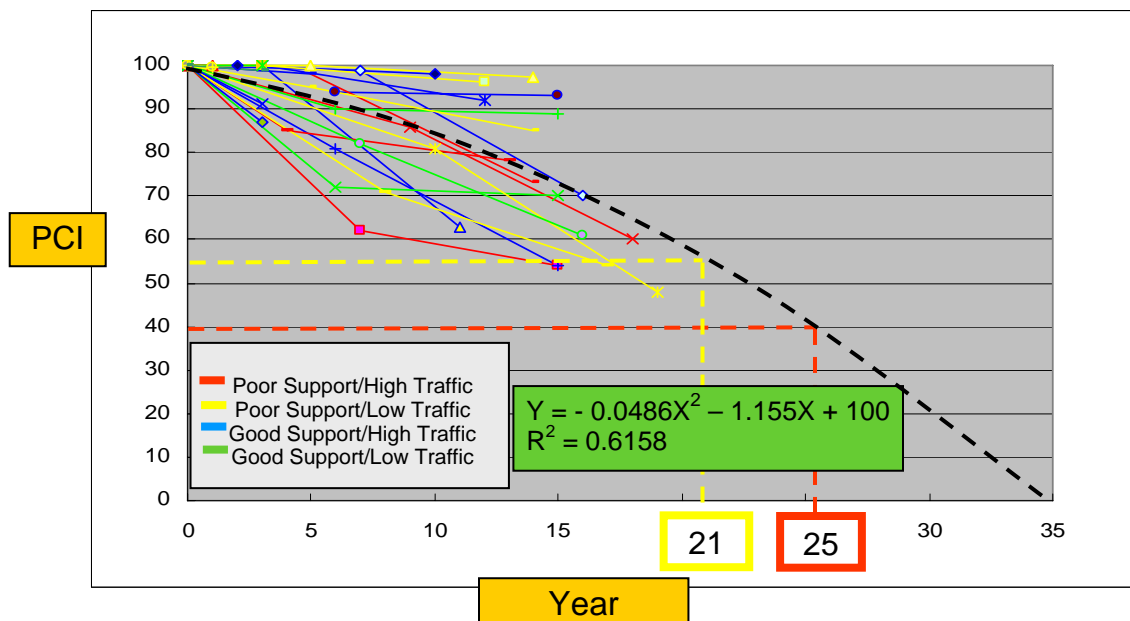
Figure 7. PCI performance over several years based on distress surveys

Plots of PCI versus age were produced for all of the sample roads. The PCI from the 1996 survey (Jahren et al. 1997) and the PCI from this survey were both plotted. A PCI of 100 was selected for the year of CIR rehabilitation. Visual review of the plots indicates that the rate of deterioration has likely diminished for the segment of time between the first and second survey compared to the segment of time between initial recycling and the first survey. Figure 7 illustrates this trend.

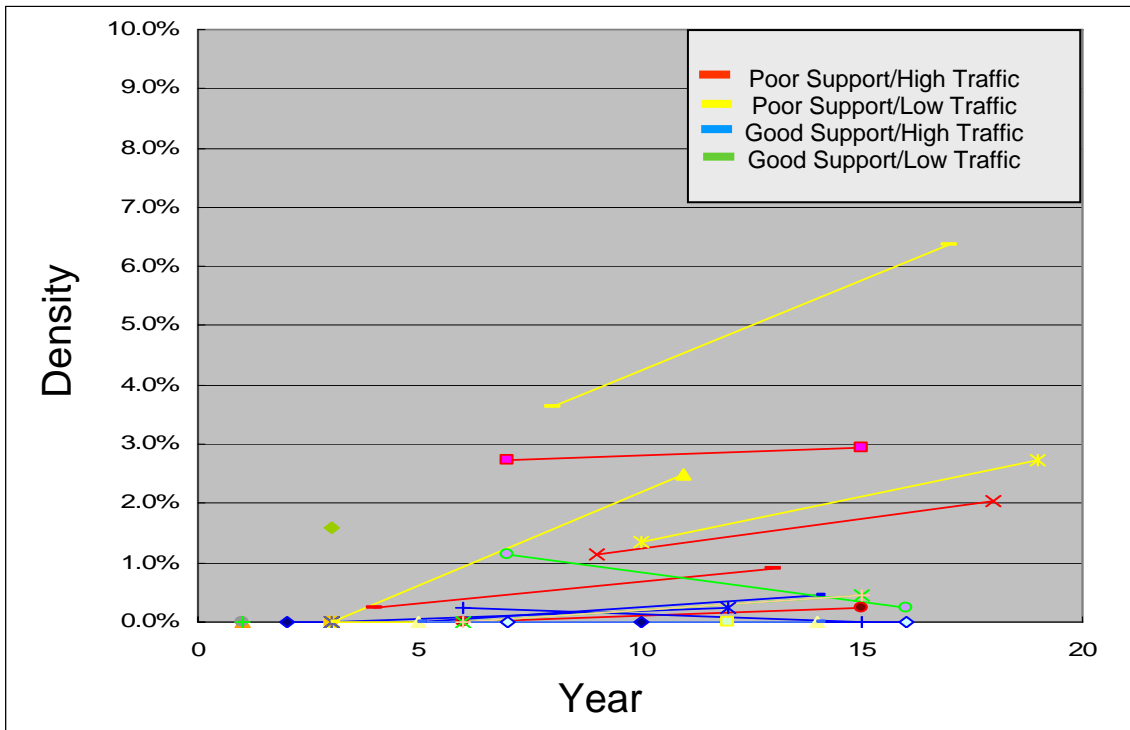
Figure 9. Changes in rutting density over time

Changes in the individual distresses were examined, as illustrated in Figures 8 through 13. For most roads, visual review of the plots indicated that the increases in the density of transverse cracking and rutting were noticeably less than the increases in longitudinal cracking, alligator cracking, and edge cracking. In each plot, however, there were exceptions to the trend. Some sample roads suffered large increases in distress, while other roads had smaller or no increases. A review of the plots would suggest that increases in the distress density for transverse cracking and rutting occur early in the pavement life, while increases in the other distresses occur later in the pavement life. In two cases, the density of block cracking decreased with time, and further analysis indicated that the block cracking converted to alligator cracking.

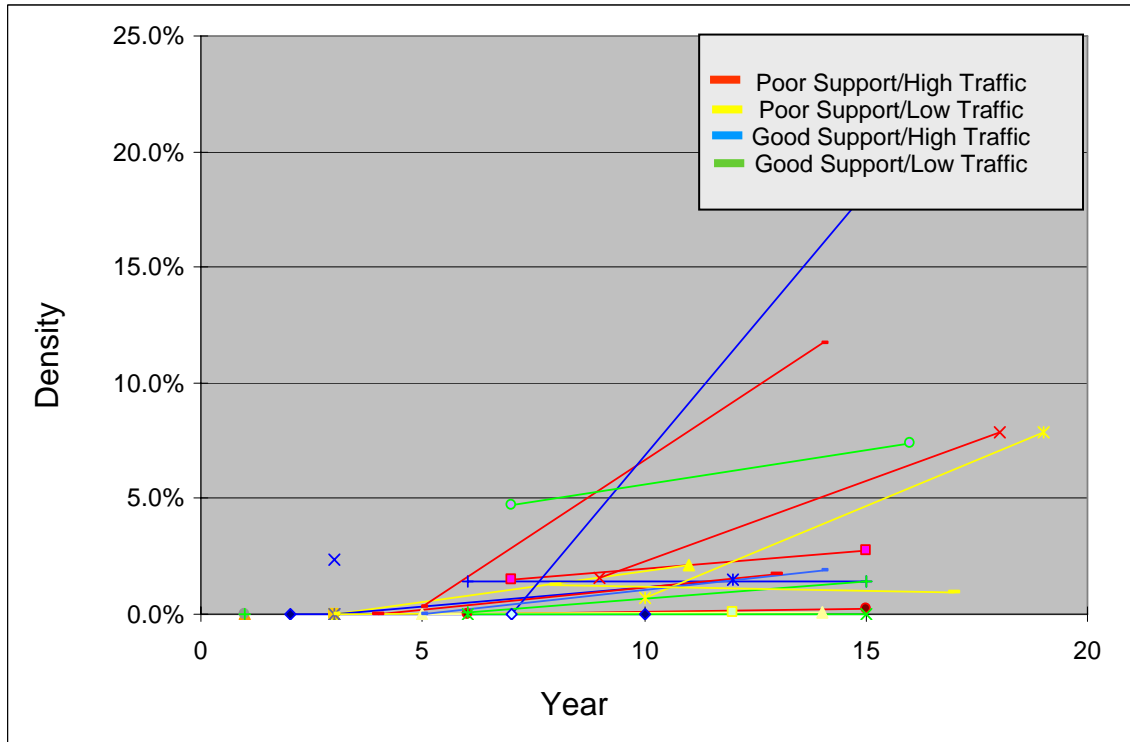
Figure 10. Changes in longitudinal cracking density over time

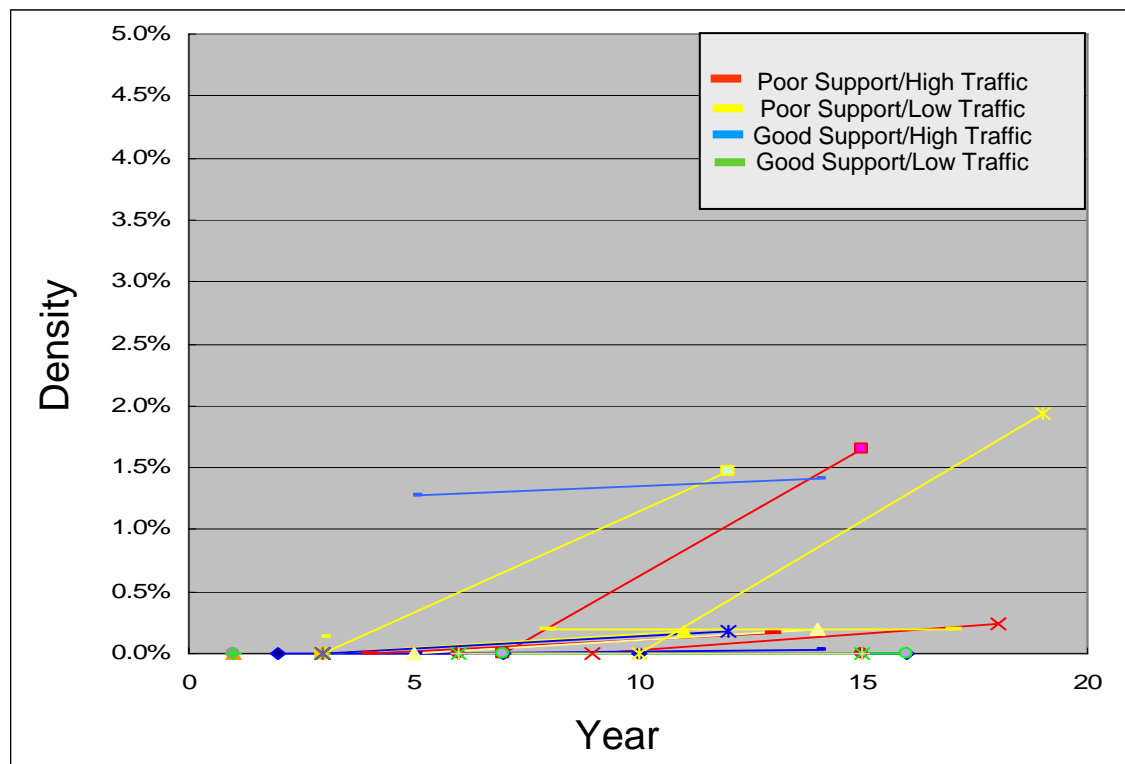
Figure 11. Changes in edge cracking density over time

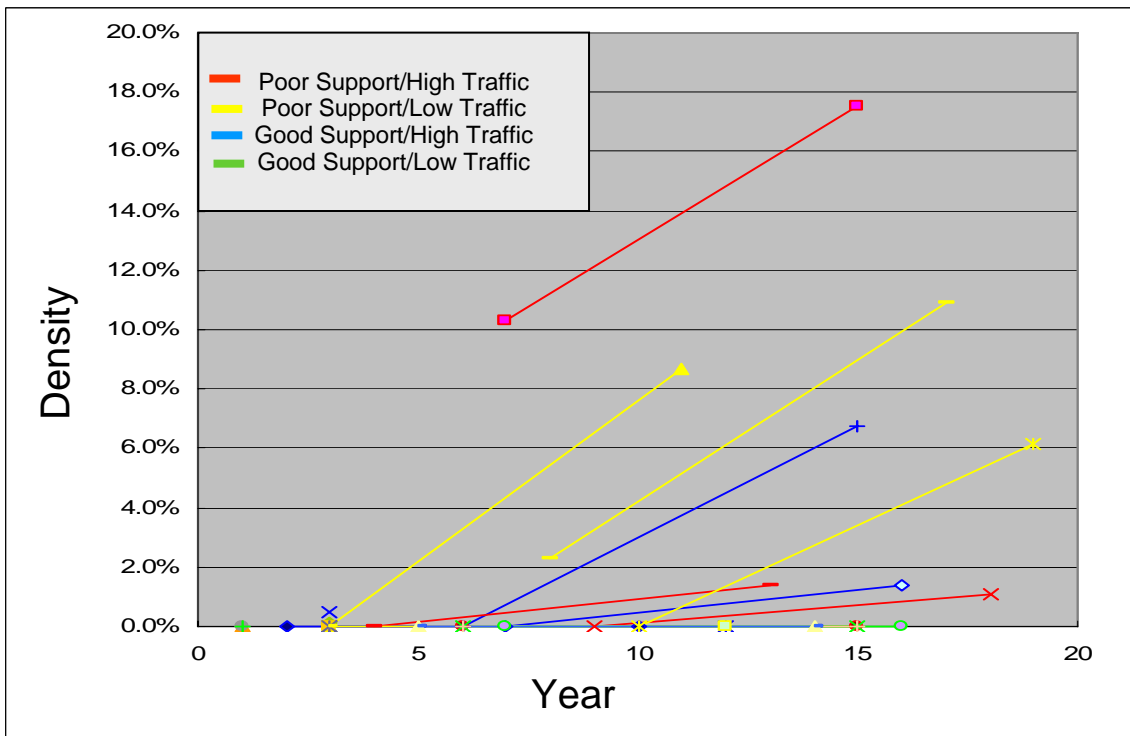
Figure 12. Changes in alligator cracking density over time

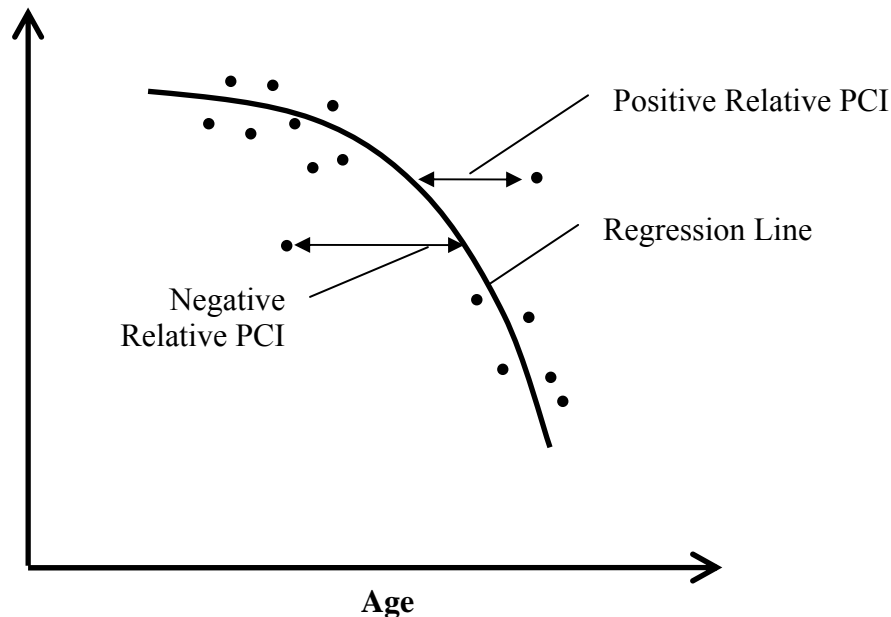
Figure 14. Relative PCI

One goal of this investigation was to identify material properties associated with good and poor performance. The concept of relative PCI was developed to separate good from poor performance, and it became the response variable for subsequent statistical modeling efforts. A regression relationship between the actual PCI and age of CIR roads was developed to identify the expected performance of CIR roads (expected PCI). Then, road performance (actual PCI) was compared to this regression relationship (expected PCI). Roads that performed better than expected at a particular age were assigned positive relative PCI values, while roads performing worse than expected were assigned negative relative PCI values (Figure 14). The magnitude of

the relative PCI was the difference between the expected and actual PCI. The relative PCI values ranged from -22 to +18. The road with the lowest relative PCI was IA 175 in Calhoun County, which was suffering distress from rutting and longitudinal cracking. The road with the highest relative PCI was Tama County V18.

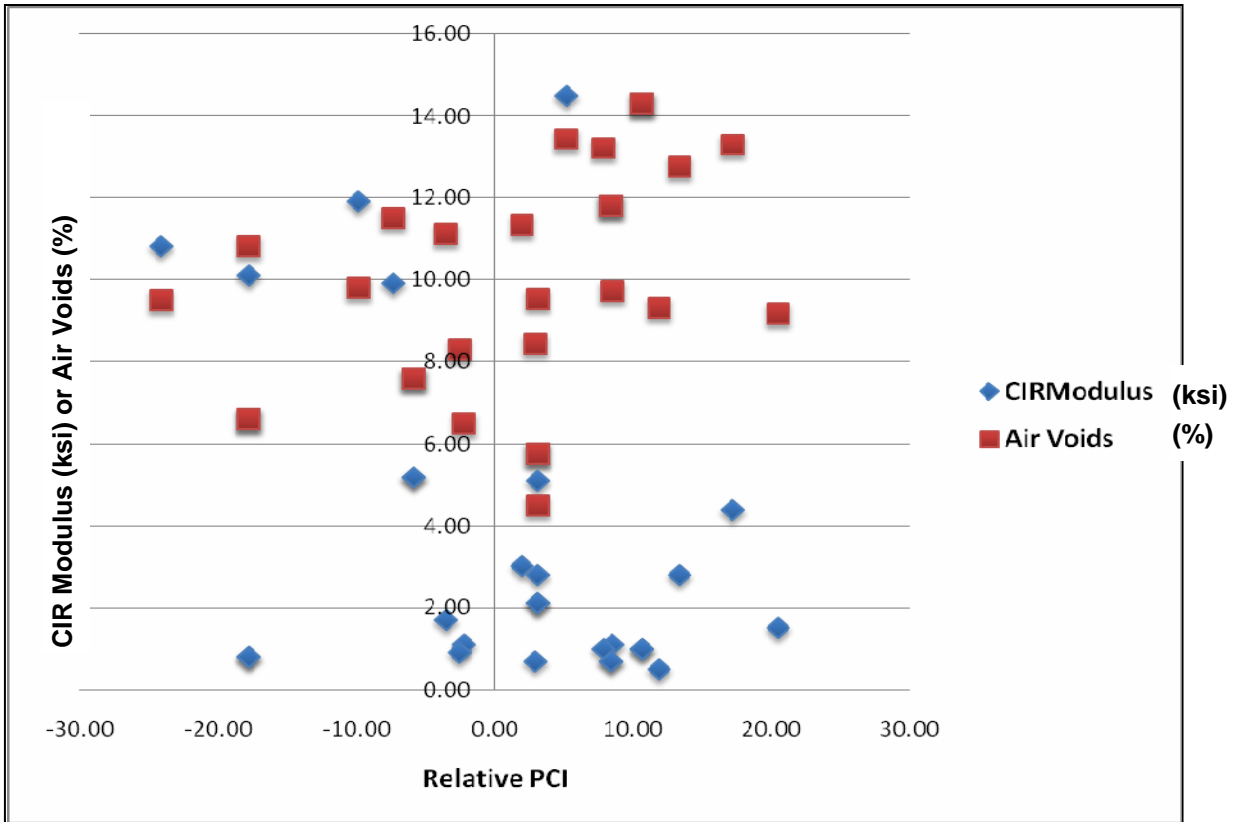
Figure 15. Selected material properties vs. relative PCI

First, a descriptive statistical analysis was conducted by visually reviewing scatter plots of each of the variables versus relative PCI. This visual review of the plots suggested that a trend may exist between relative PCI and V_a, and between relative PCI and CIR modulus, with higher relative PCI values associated with higher V_a values and a lower CIR modulus (Figure 15).
