Investigation of Steel-Stringer Bridges

tech transfer summary

Investigation of Steel-Stringer Bridges: Superstructures and Substructures

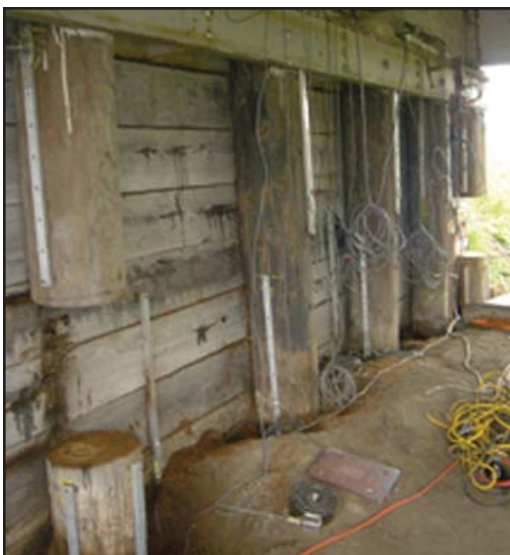
Humboldt County bridge with sections removed from three piles

Destructive evaluation was performed at one bridge where three out of the seven supporting timber piles at one abutment were consecutively removed to simulate pile deterioration. After removing each pile, the bridge was load tested to measure pile loads and strains on intact piles. The data were used to determine the stress in each pile and thus predict the variation of load distribution with different degrees of pile damage. To determine the feasibility of repairing localized deteriorated sections in timber piles, one of the removed pile sections was repaired using a splicing technique, and the percent restoration of pile capacity was measured.

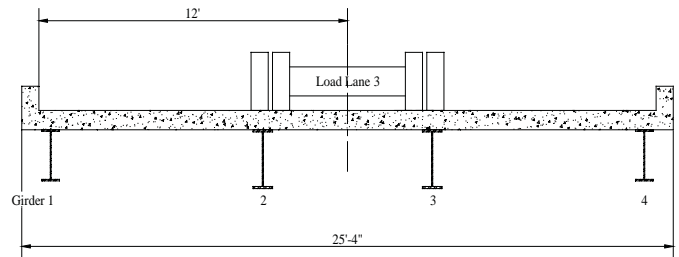
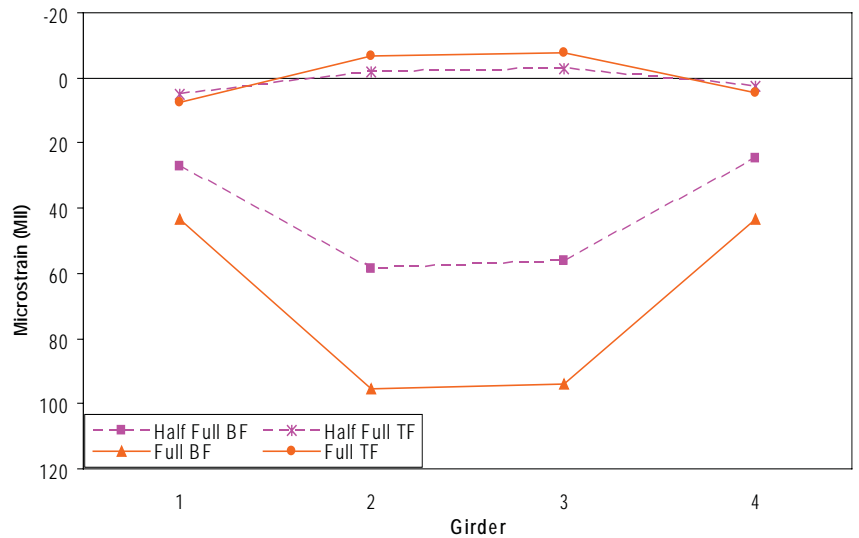
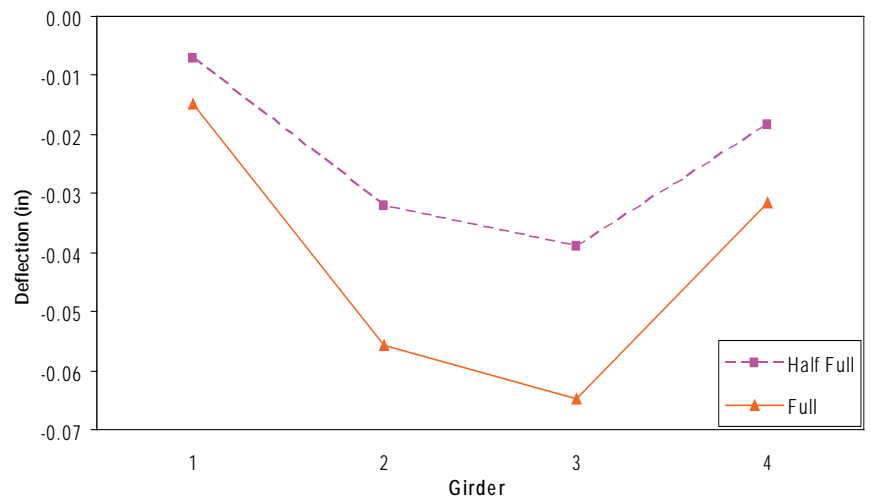
a. Lane 3 Loading

b. Strain Profile

c. Deflection Profile

Strain and deflection results for 33.3-foot bridge in Carroll County, Iowa

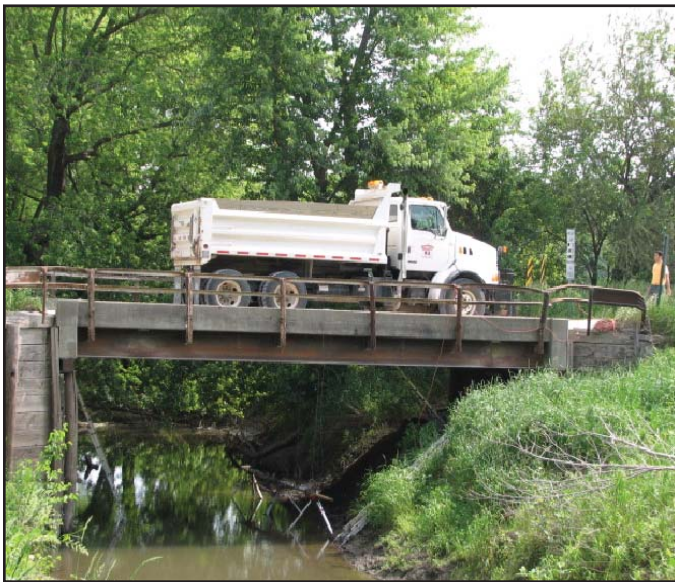
Testing of the Mahaska County bridge

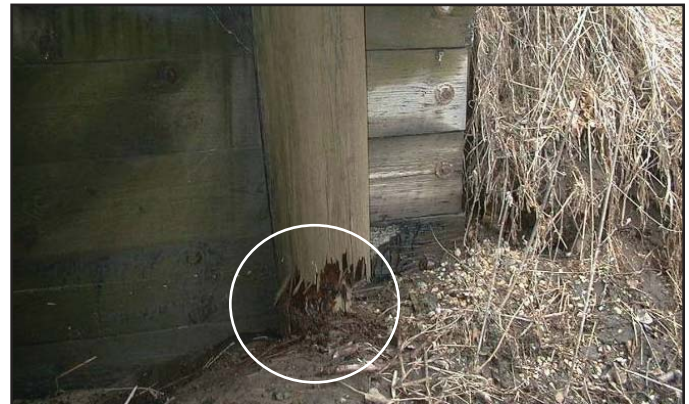
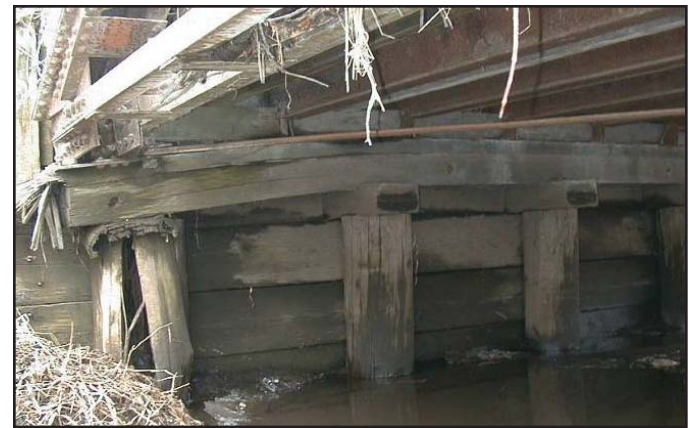
Biological deterioration resulting in reduction in pile cross section (top) and complete deterioration of a pile section causing failure of pile cap (bottom)

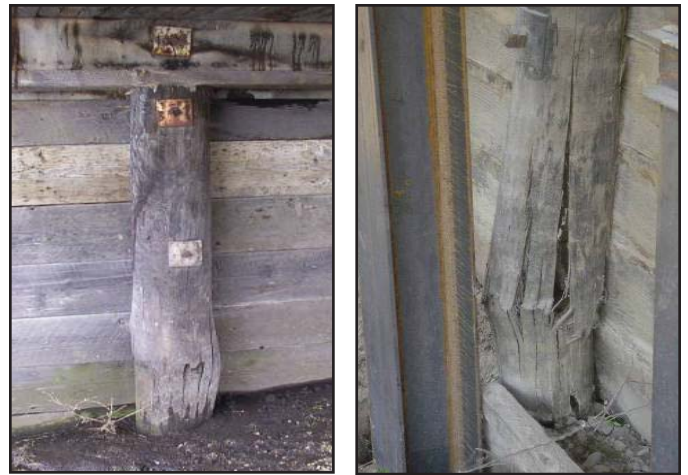
Compression failure of deteriorated pile section caused by overloading leading to bulging of timber fibers (left) and mushrooming of the pile section (right)

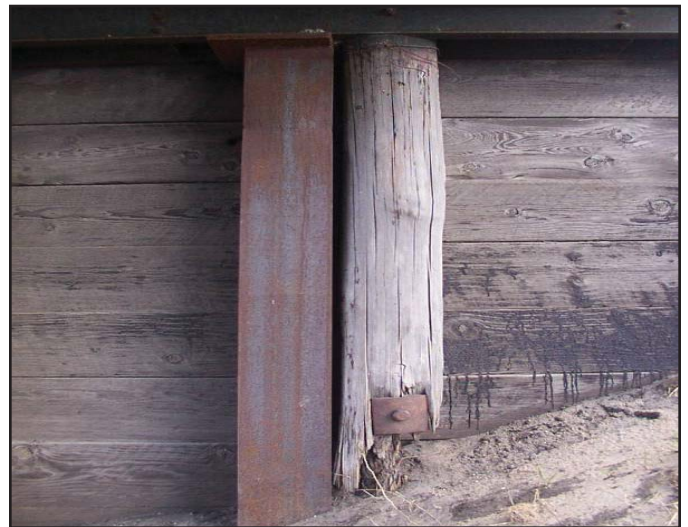
Steel pile driven adjacent to a defective timber pile

Several substructure repair techniques are being implemented in Iowa. These techniques include (1) addition of a timber or steel pile adjacent to the defective pile when the deterioration of that pile exceeds 50%, and (2) construction of a new substructure system (i.e., replacing all existing piles) when advanced deterioration is widespread in more than one pile, threatening the integrity of the bridge. These repair techniques are considered major maintenance.

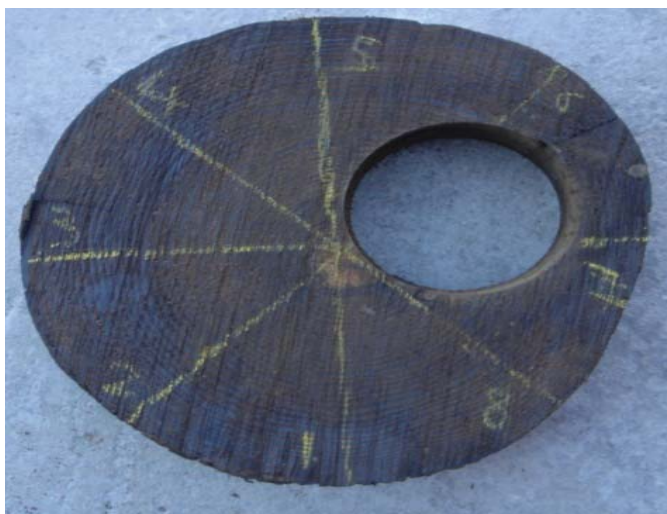
Two-dimensional tomography image revealing the timber pile internal condition

A nondestructive ultrasonic stress wave technique was used to develop cross-sectional tomography images of timber piles for the purpose of evaluating internal defects. Stress waves are generated from an impact on the side of the pile. By measuring the wave travel time through a pile in the radial direction, the wave propagation speed can be calculated, which can be used as a predictor of the internal condition of the pile. Multiple stress wave measurements at different radial orientations, together with an image reconstructing technique, were used to produce two-dimensional tomography images of internal timber pile deterioration.

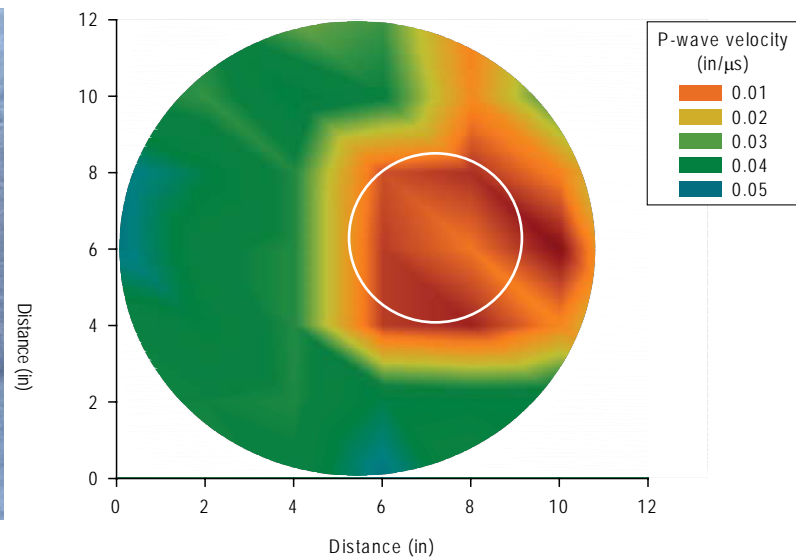
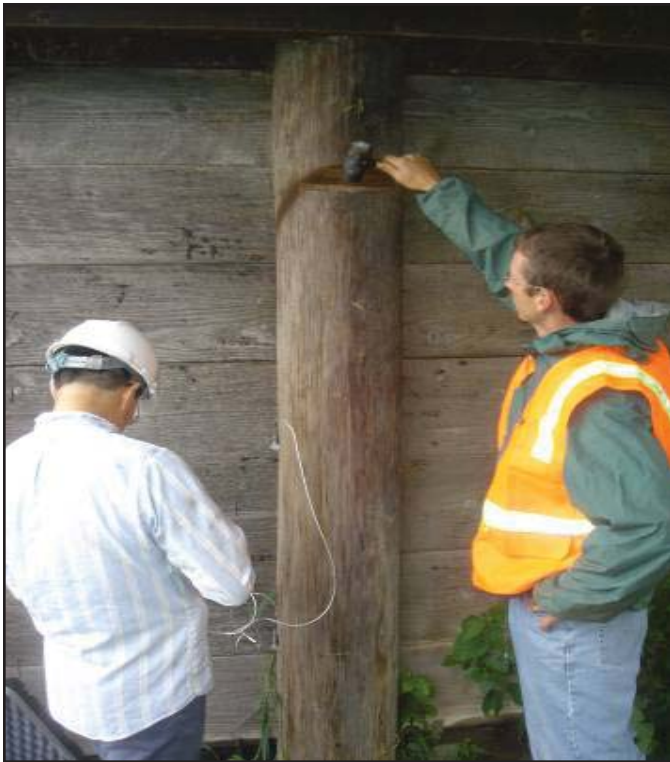
Pile integrity test: impacting the pile to generate a compression wave

Determining the pile length is critical in calculating the residual capacity of timber piles. Pile integrity tests were performed at one bridge to estimate the pile length or detect major cracks below the ground level. This method is based on vertically impacting the pile and measuring the time for the reflected compression wave to reach an accelerometer. The pile integrity method can estimate the length of the pile within approximately 15% of the actual length (Wightman et al. 2003).

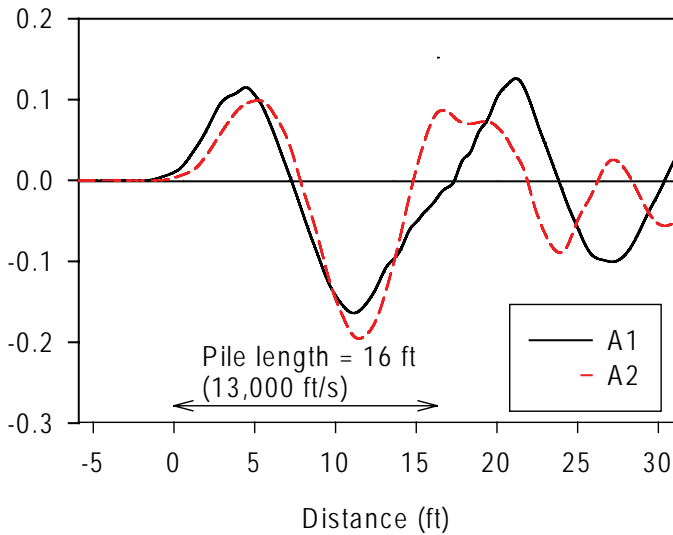
Pile integrity test results, with pile toe estimated to be 16 feet below ground level (measured wave speed = 13,000 feet/second)

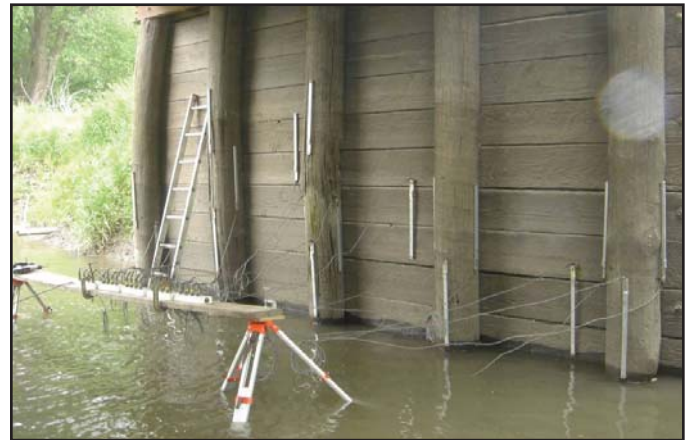
Bridge abutment instrumented with strain gauges

Substructure static load tests were conducted at five bridges, and the strain responses of the abutment piles and backwall were measured using strain gauges with gauge lengths varying from 12 to 24 inches. Due to the non-homogeneity of wood as well as localized deteriorated zones along the pile, the exposed portion of each pile was instrumented with more than one strain gauge to capture pile behavior at both strong and weak sections.

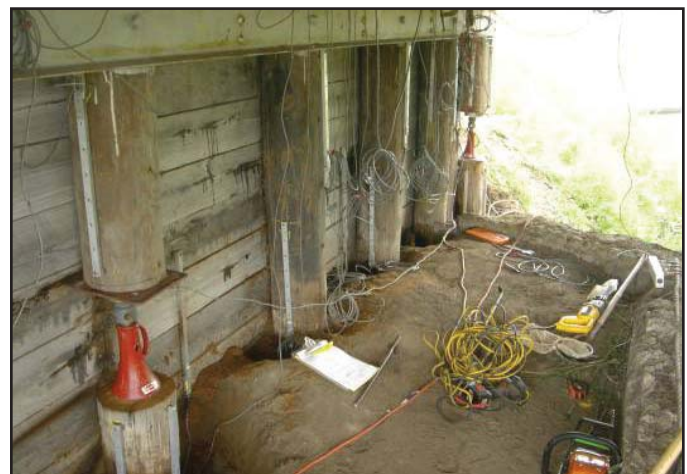
Pile sections removed to simulate timber pile deterioration

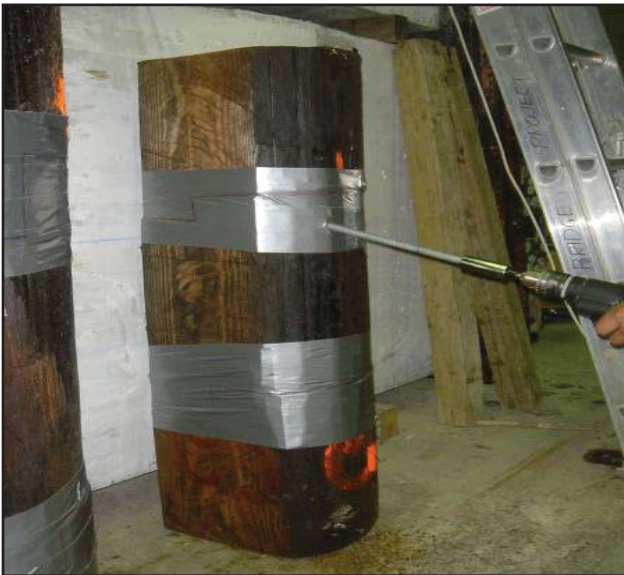
Timber pile repair using mechanical splicing

The selected repair methods were (1) mechanical splicing, (2) replacing the damaged section with a new section with a fiber reinforced polymer (FRP) wrap, and (3) using epoxy material with FRP wrap.

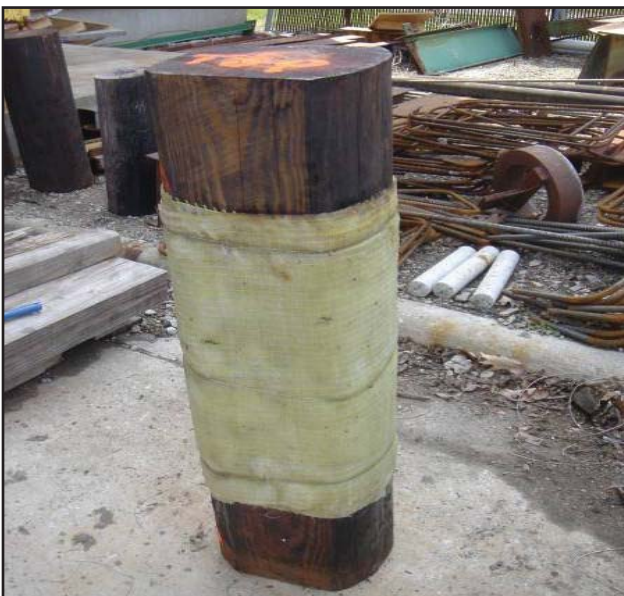
Timber pile repair using fiber reinforced polymer (FRP) wrap

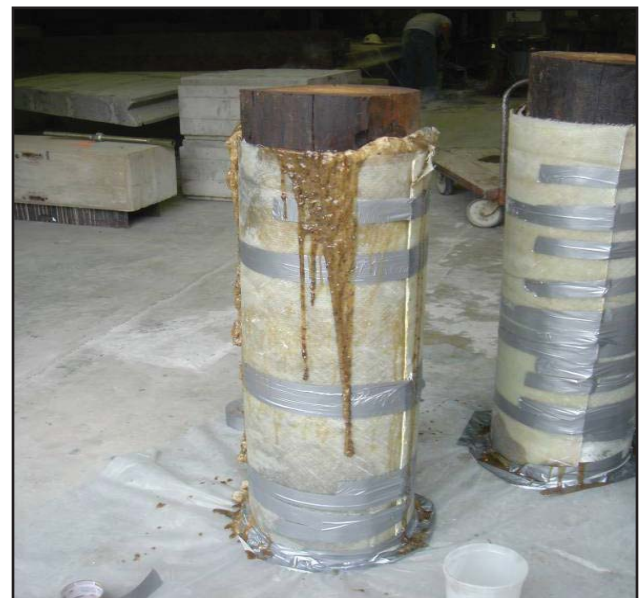
Timber pile repair using epoxy filler with FRP shell
