The Deleterious Chemical Effects of Concentrated Deicing Solutions on Portland Cement Concrete

**Study SD2002-01
Executive Summary**

**Prepared by
Michigan Tech Transportation Institute
1400 Townsend Drive
Houghton, MI**

April 2008

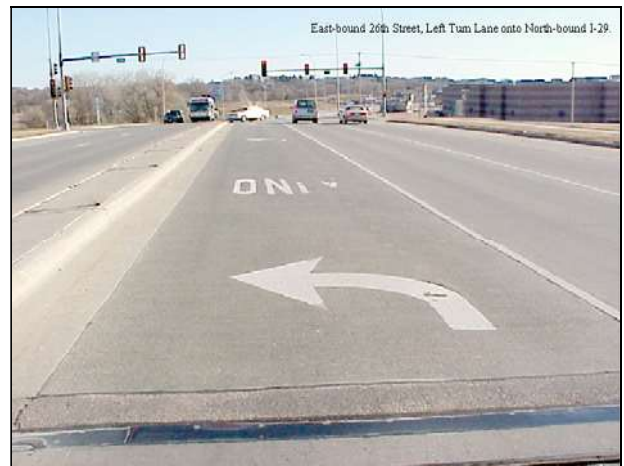
Figure 1. Photograph of core site.

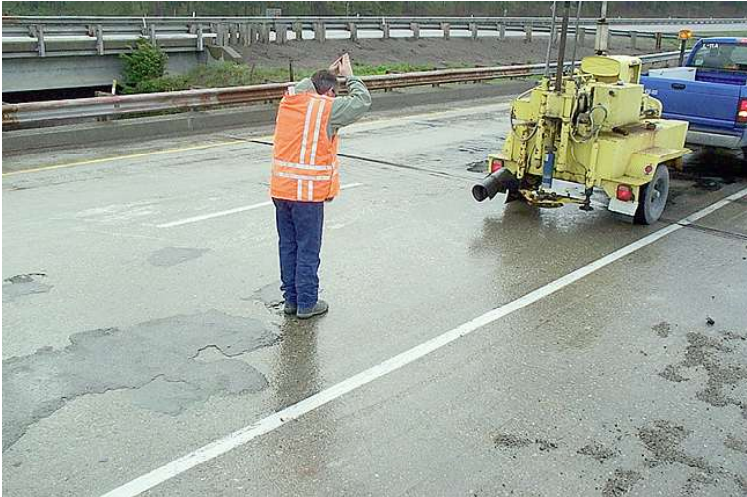
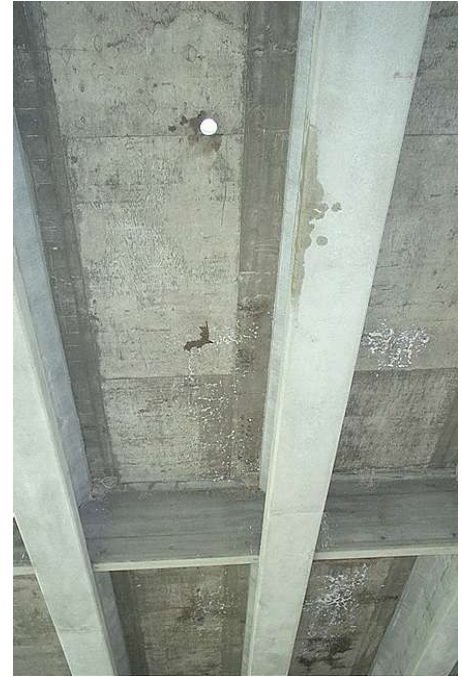
Figure 7. Photographs of core site (left) and from beneath bridge deck (right) after coring operation.

Hole from core T-2 is visible. Dampness permeating through cracks visible beneath the area of core T-1. White efflorescence common directly below regions covered with cold patch material.

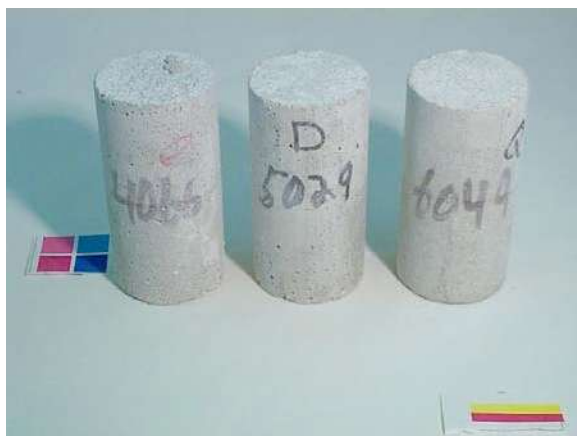
Figure 13. Cylinders exposed to NaCl solution after 84 days of constant low temperature test.
From left to right: 0.40, 0.50, and 0.60 w/c mortar cylinders.

A constant low temperature experiment was designed to monitor chloride ingress at 28, 56, and 84 days at a temperature of 40°F [4 °C]. As shown in Figure 13, the cylinders in the NaCl solution showed no deterioration after 84 days. Figures 14 and 15 show cylinders from the MgCl₂ and CaCl₂ treatments were severely deteriorated by 84 days. The cylinders in the CMA solution showed little to no distress after 84 days as shown in Figure 16, although there was some staining evident in the 0.60 w/c cylinders. The control cylinders in the lime water solution, as shown in Figure 17, showed no signs of distress after 84 days.

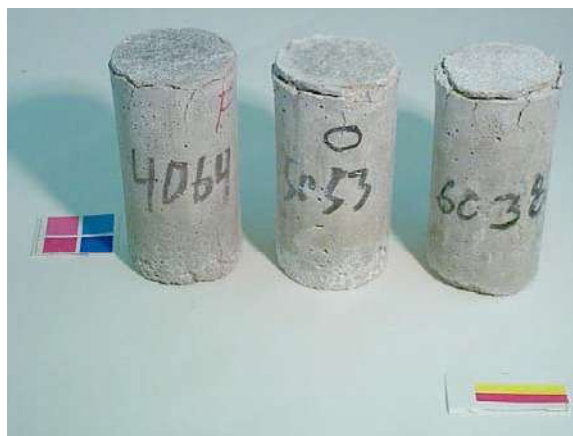
Figure 14. Cylinders exposed to MgCl₂ solution after 84 days of constant low temperature test.
From left to right: 0.40, 0.50, and 0.60 w/c mortar cylinders.

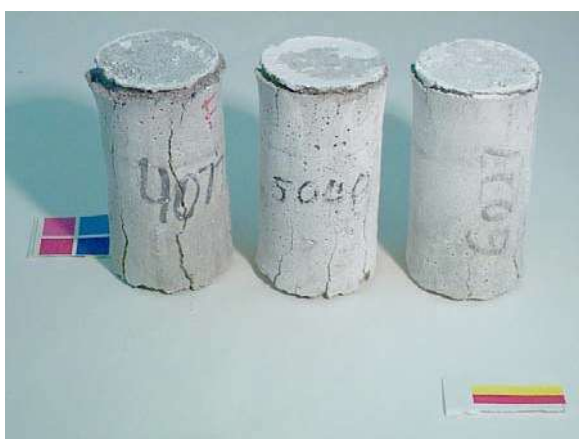
Figure 15. Cylinders exposed to CaCl₂ solution after 84 days of constant low temperature test.
From left to right: 0.40, 0.50, and 0.60 w/c mortar cylinders.

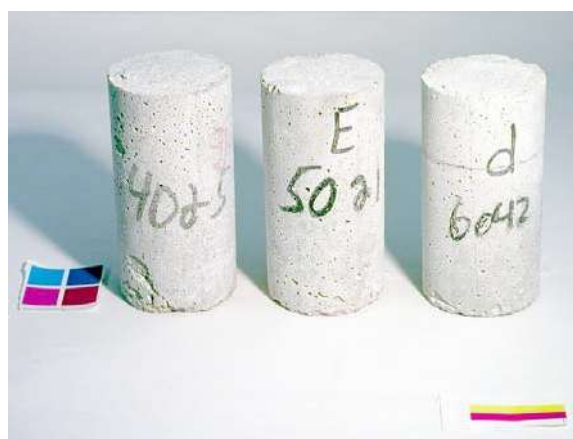
Figure 16. Cylinders exposed to CMA solution after 84 days of constant low temperature test.
From left to right: 0.40, 0.50, and 0.60 w/c mortar cylinders.

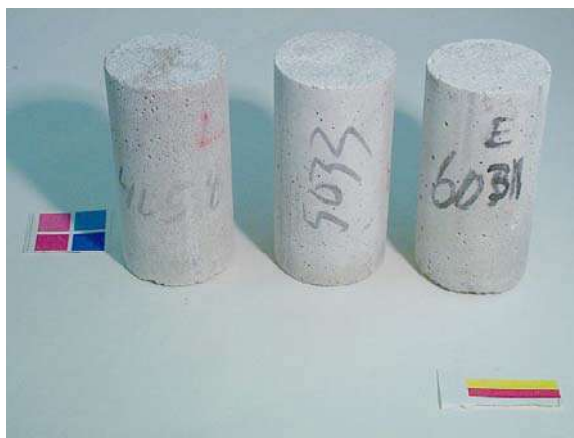
Figure 17. Control cylinders exposed to lime water solution after 84 days of constant low temperature test.
From left to right: 0.40, 0.50, and 0.60 w/c mortar cylinders.

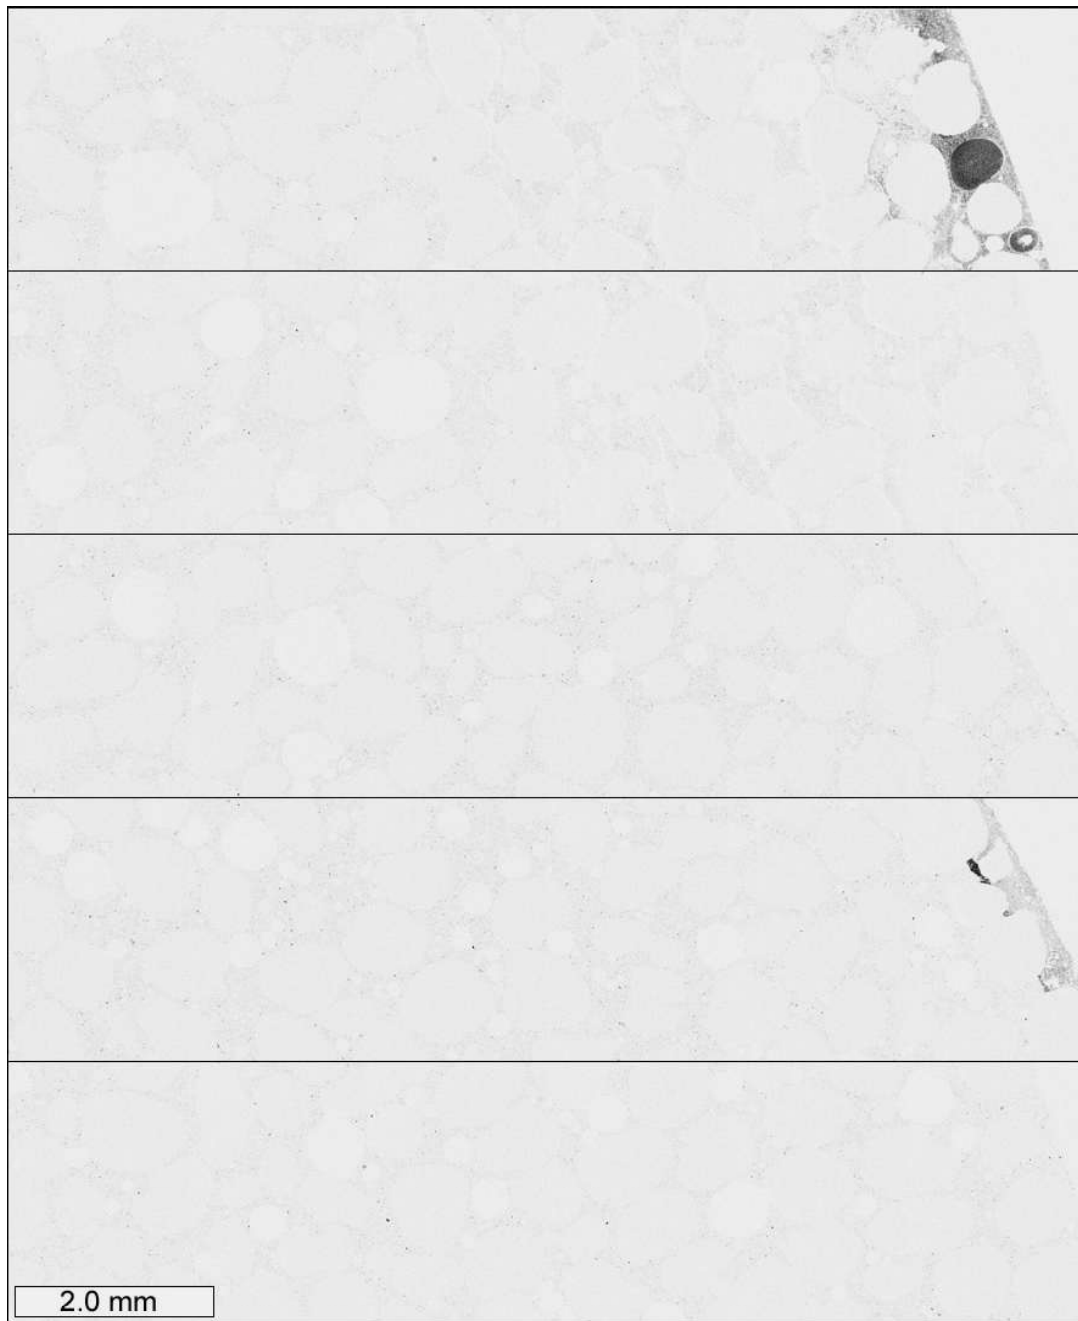
Figure 21. Elemental map for magnesium collected from thin sections prepared from mortar cylinders immersed in chemical solutions.

From top to bottom: magnesium chloride, calcium chloride, sodium chloride, calcium magnesium acetate, and lime water. Dark areas indicate higher concentrations.

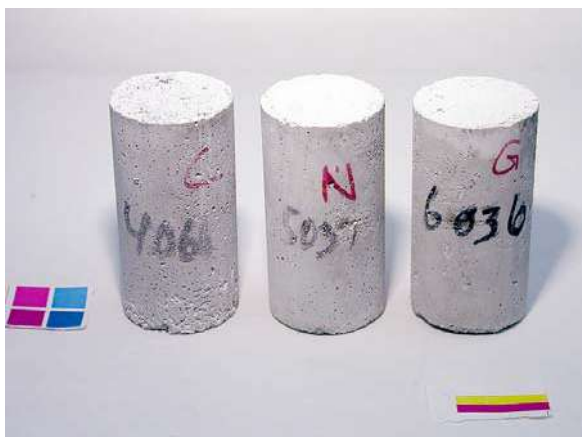
Figure 24. Cylinders exposed to CaCl_2 solution after 56 days of constant low temperature test.
From left to right: 0.40, 0.50, and 0.60 w/c mortar cylinders. Solution strength was 3% CaCl_2 .

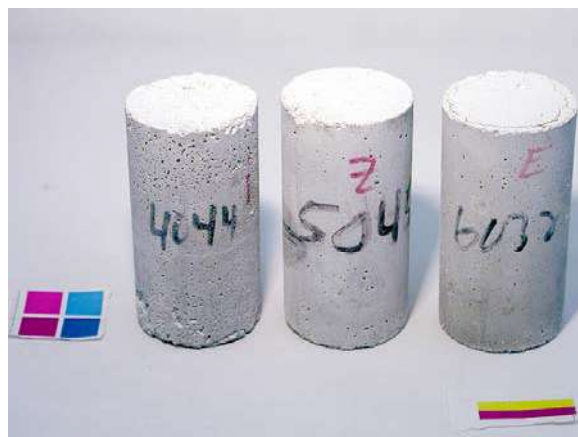
Figure 25. Cylinders exposed to CaCl_2 solution after 56 days of constant low temperature test.
From left to right: 0.40, 0.50, and 0.60 w/c mortar cylinders. Solution strength was 7% CaCl_2 .

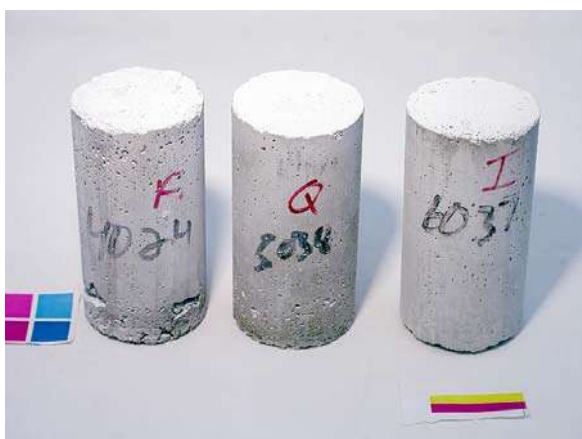
Figure 26. Cylinders exposed to CaCl_2 solution after 56 days of constant low temperature test.
From left to right: 0.40, 0.50, and 0.60 w/c mortar cylinders. Solution strength was 10% CaCl_2 .

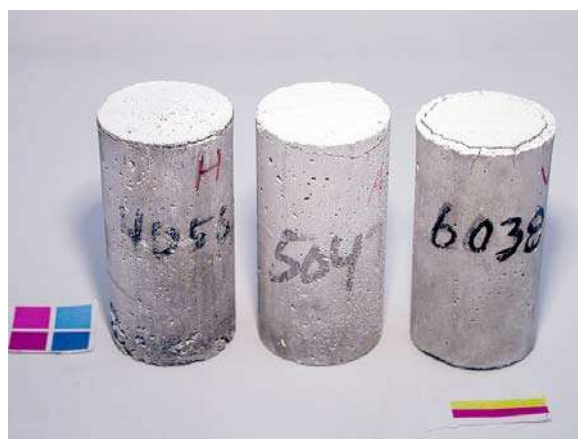
Figure 27. Cylinders exposed to CaCl_2 solution after 56 days of constant low temperature test.
From left to right: 0.40, 0.50, and 0.60 w/c mortar cylinders. Solution strength was 14% CaCl_2 .

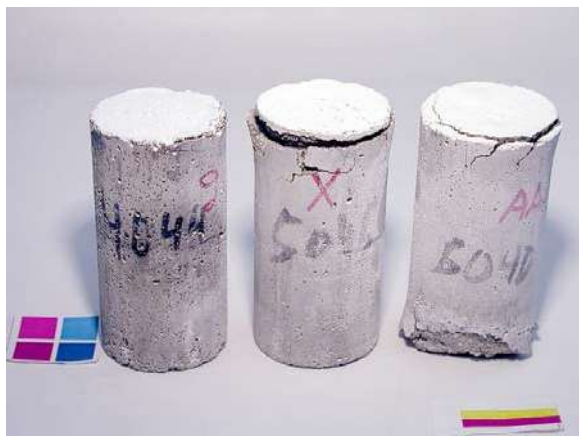
**Figure 28. Cylinders exposed to CaCl_2 solution after 56 days of constant low temperature test.
From left to right: 0.40, 0.50, and 0.60 w/c mortar cylinders.
Solution strength was 17% CaCl_2 .**

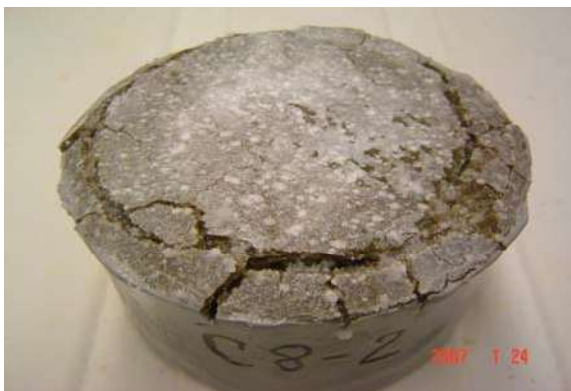
Figure 33. Deteriorated disc sample exposed to 20% MgCl₂ after 150d of exposure.

Mortar cubes were exposed to different concentrations of MgCl_2 and CaCl_2 to determine the effect of exposure solution concentration on the 30 day compressive strength of the mortar. The effect of concentration on compressive strength is shown in Figure 32. A minimum in compressive strength was seen at solution concentrations of 20% MgCl_2 and 22% CaCl_2 . Examples of the distress observed are shown in Figures 33 and 34.

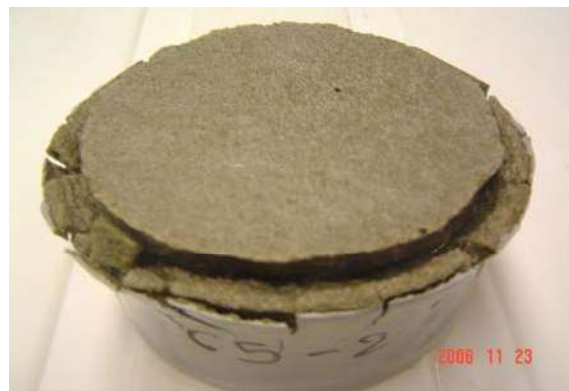
Figure 34. Deteriorated disc sample exposed to 28% CaCl₂ after 150d of exposure.

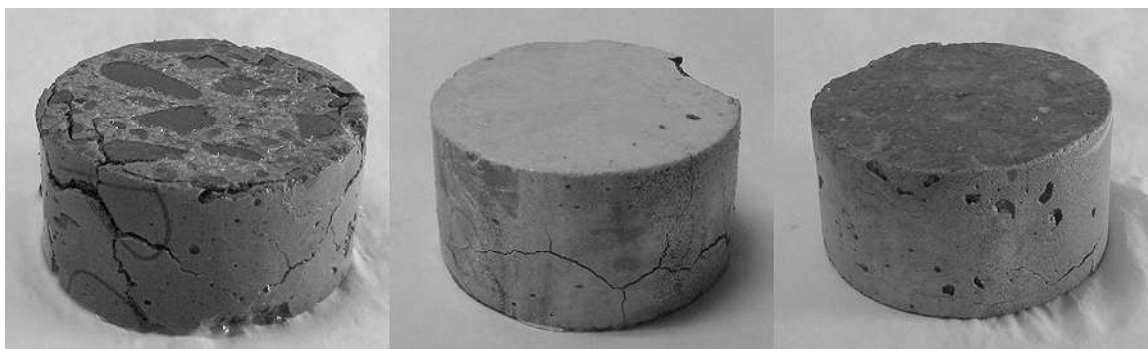
**Figure 35. Photographs of 4 inch (100 mm) diameter 0.45 w/c OPC concrete specimens after 500 days in high concentration brines.
From left to right: CaCl₂, MgCl₂, and MBAP brines.**

Concrete and mortar specimens were removed from the brine solutions at 60 and 500 days. None of the specimens showed any obvious external signs of deterioration at 60 days. At 500 days, many of the specimens from the high-concentration CaCl₂, MgCl₂, and MBAP brines exhibited external cracking, examples of which are shown in Figure 35.

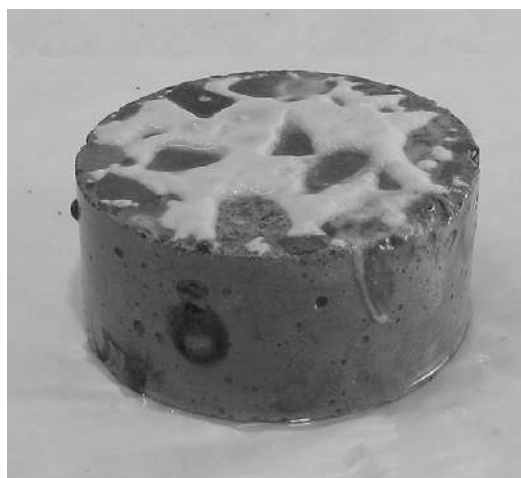
Figure 37. White precipitate on exterior of 4 inch (100 mm) diameter concrete specimen after 500 days immersion in low-concentration CMA solution.

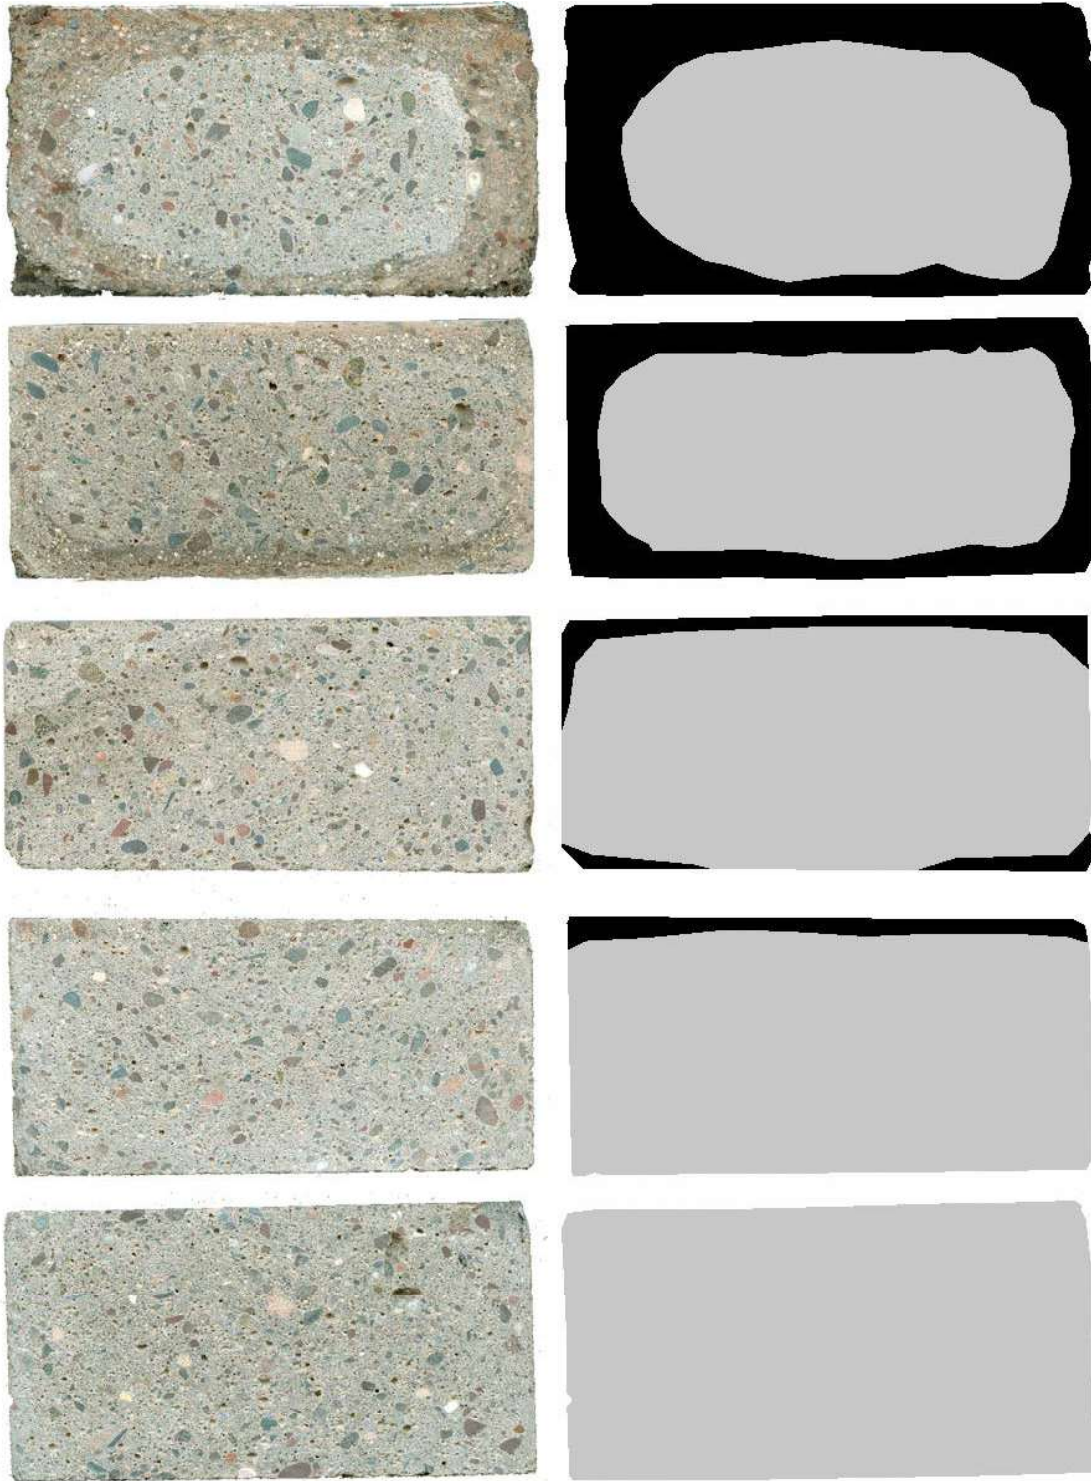
Figure 38. Visible alteration on saw-cut plane through 0.45 w/c mortar specimens, from top to bottom: CaCl₂, MgCl₂, MBAP, NaCl & CMA high-concentration brines at 500 days.

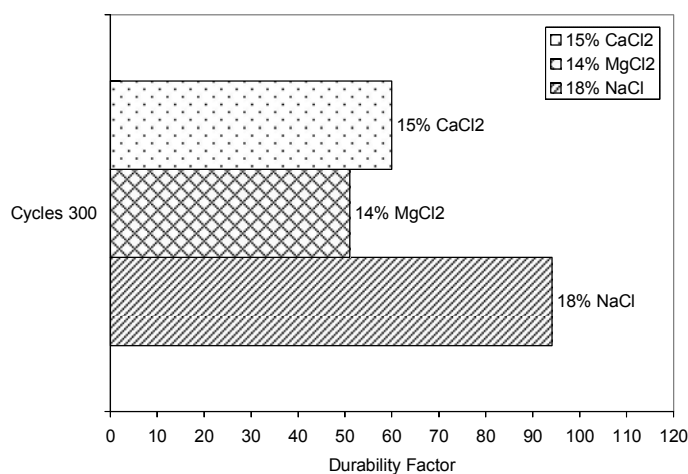
Figure 48. Durability factor of concrete prisms exposed to deicers under freezing and thawing cycles.

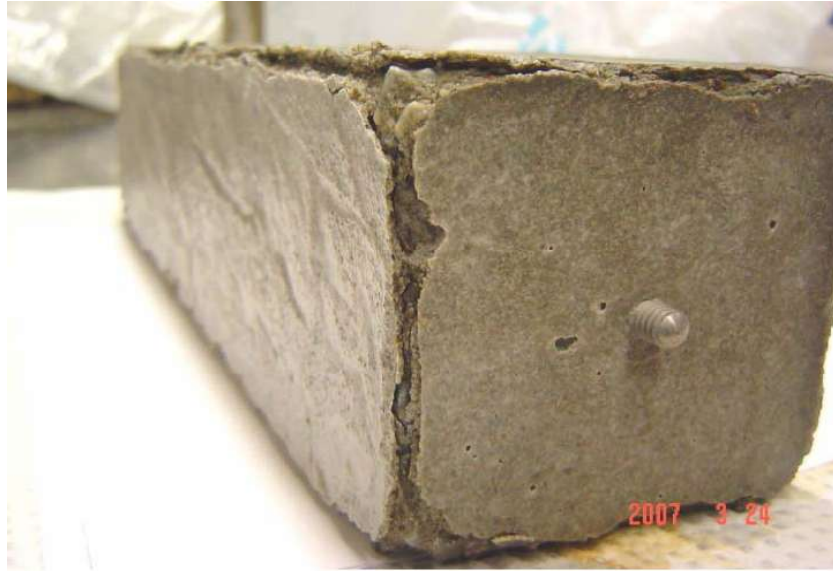
Figure 49. Photographs of concrete prisms subjected to 133 freezing and thawing cycles in 15% CaCl_2 solution.

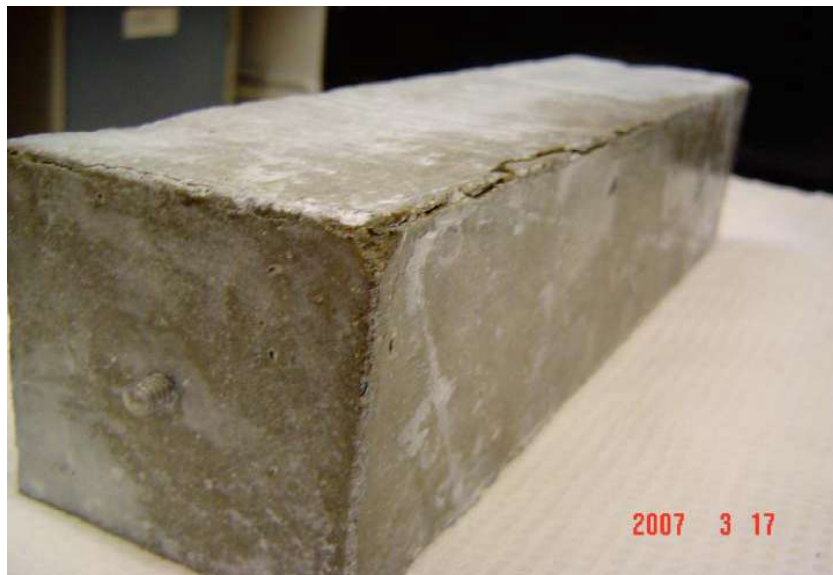
Figure 50. Photographs of concrete prisms subjected to 133 freezing and thawing cycles in 14% MgCl_2 solution.
