PREFORMED PHOENIX ETHYLENE PROPYLENE DIENE MONOMER (EPDM) COMPRESSION JOINT SEALS

**Final Report
For
MLR-93-2**

September 1999

**Iowa Department
of Transportation**

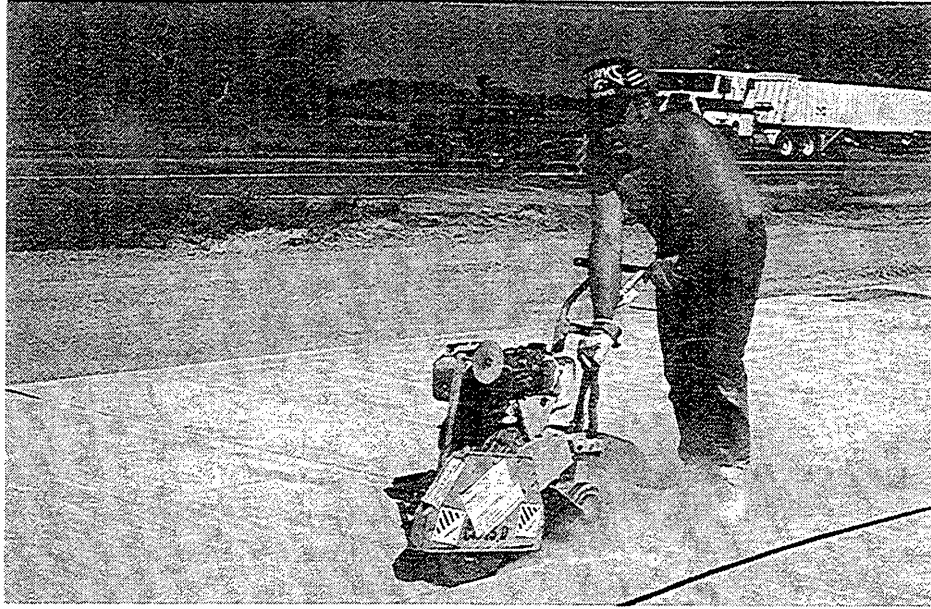
Figure 1
Sawing Beveled Edge on Longitudinal Joint

Joint sealing was done by Phoenix on August 19 and 20, 1992. The transverse joints were beveled and sealed first. The joint beveling was done to allow the seal to enter the joint more easily. In addition, the beveling removed weakened joint edges and spalls. The longitudinal joint was then beveled (Figure 1), which included the notching of the transverse seal. The longitudinal joint was sealed immediately after being beveled. Joint widths and seal widths are given in Table 1. It should be noted that a few joints which had cracked full thickness and had opened unusually wide did get wider seals than the normal joints. Figures 2 and 3 show equipment used for seal installation. A soap/water solution was used to clean and lubricate the seal before installation. Figure 4 shows the seal installed in the beveled joint. The top of the seal was installed approximately $\frac{1}{4}$ in. below the surface or down to just below the lowest point of the bevel.

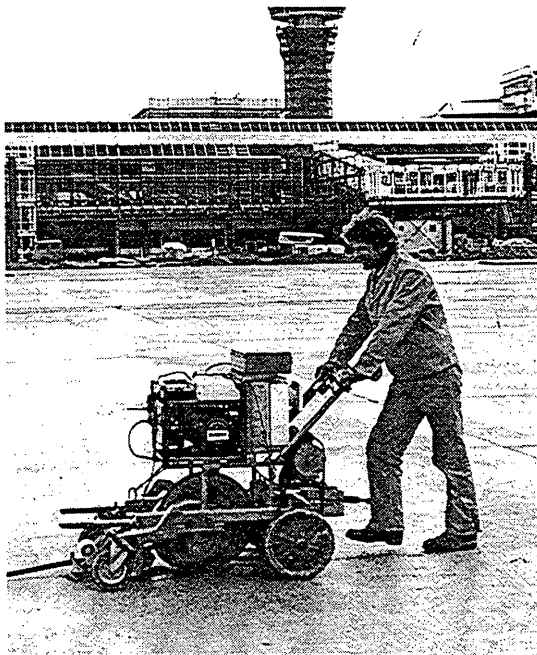
Insertion apparatus

By using a insertion apparatus specially developed for these sections, it is possible to lay the joint section without elongation at high speed. Insertion can take place under all weather conditions, except with snow and ice, thus extending the previously possible active construction times.

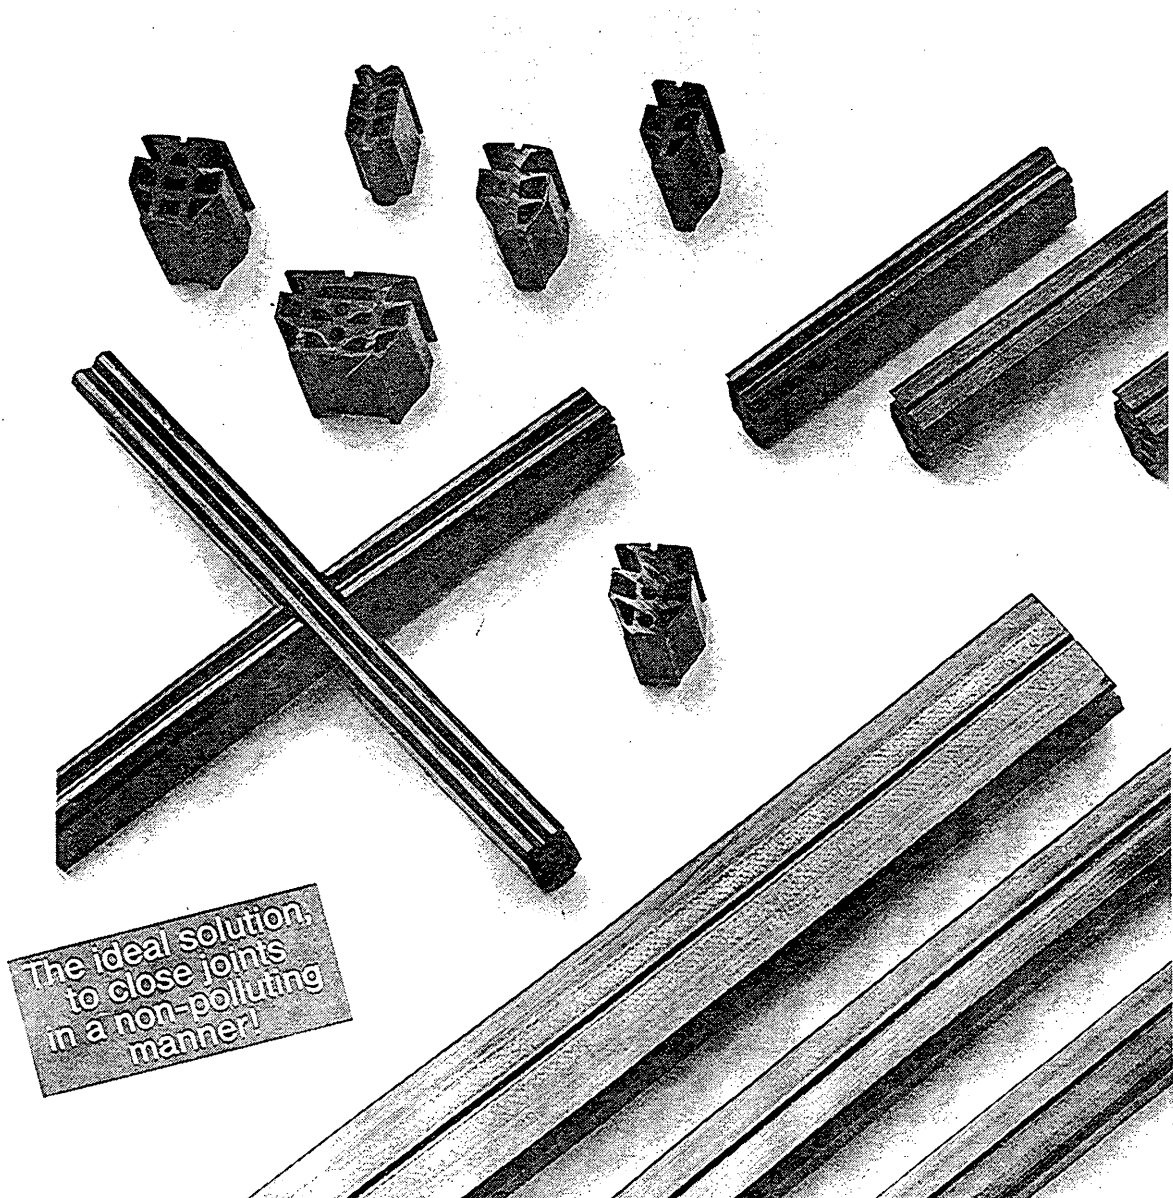
Nominal joint width	Profile designation	Minimum joint width during assembly	Maximum joint width in winter
mm	mm	mm	mm
4	M 214 39	3.5	6.8
6	M 214 66	5.0	9.7
8	M 214 37	8.0	12.7
10	M 214 45	9.0	14.7
12	M 214 46	11.0	16.5
15	M 214 47	14.0	19.5
20	M 214 49	19.0	24.2
25	M 214 48	24.0	29.2

Joint seals for concrete surfaces
