The Deleterious Chemical Effects of Concentrated Deicing Solutions on Portland Cement Concrete

Study SD2002-01
Technical Appendices

Prepared by
Michigan Tech Transportation Institute
1400 Townsend Drive
Houghton, MI

April 2008

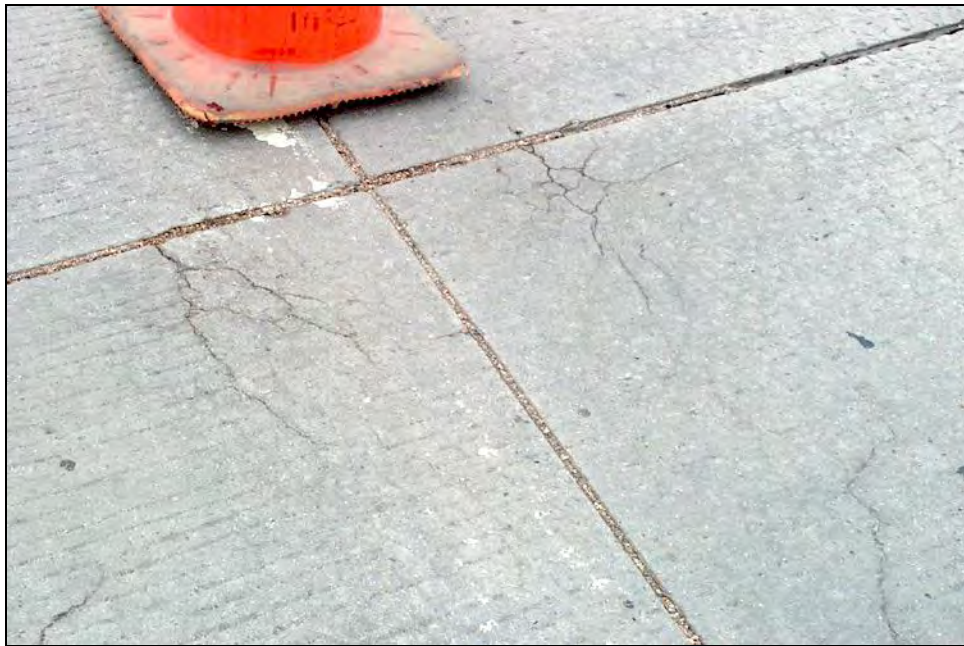
Figure A2.1. Photograph of cracks in pavement.

This pavement, constructed in 1996, exhibited visible signs of distress. Figure A2.1 shows the type of cracking observed in the field. The pavement has been exposed primarily to NaCl deicer. Figure A2.2 shows the location of the cores taken, and Figures A2.3 and A2.4 show photographs of the individual cores. Two of the cores were cut into slabs and polished: core CO-1 (near a joint), and core CO-5 (mid-panel). Figures A2.5 through A2.8 show the slabs as polished, after staining with phenolphthalein, and after treatment to enhance air voids and cracks. The phenolphthalein stain showed normal carbonation depths. The black and white treatment did not reveal any macro-cracking in either of the cores. Table A2.3 summarizes the air void parameters. Both sets of slabs showed adequate entrained air, with spacing factors of 0.182 mm and 0.175 mm for cores CO-1 and CO-5, respectively. Figure A2.9 shows an example stereomicroscope image of the air void structure. Some alkali silica reactivity (ASR) was observed with minor gel production and cracking, as illustrated in Figure A2.10. A w/c ratio estimation was performed on a thin section prepared from the top of core CO-6. Figures A2.11 and A2.12 show the images used to make the measurements. The results of the w/c estimation are summarized in Table A2.4, with an average w/c value of 0.47 as compared to the 28-day moist cured mortar sample standards. Figures A2.13 through A2.16 show chloride profiles from cores CO-6 and CO-8. Figure A2.17 shows fly ash particles present in the concrete. The exact cause of the observed distress is indeterminable but the most dominant symptoms seem to be associated with ASR.

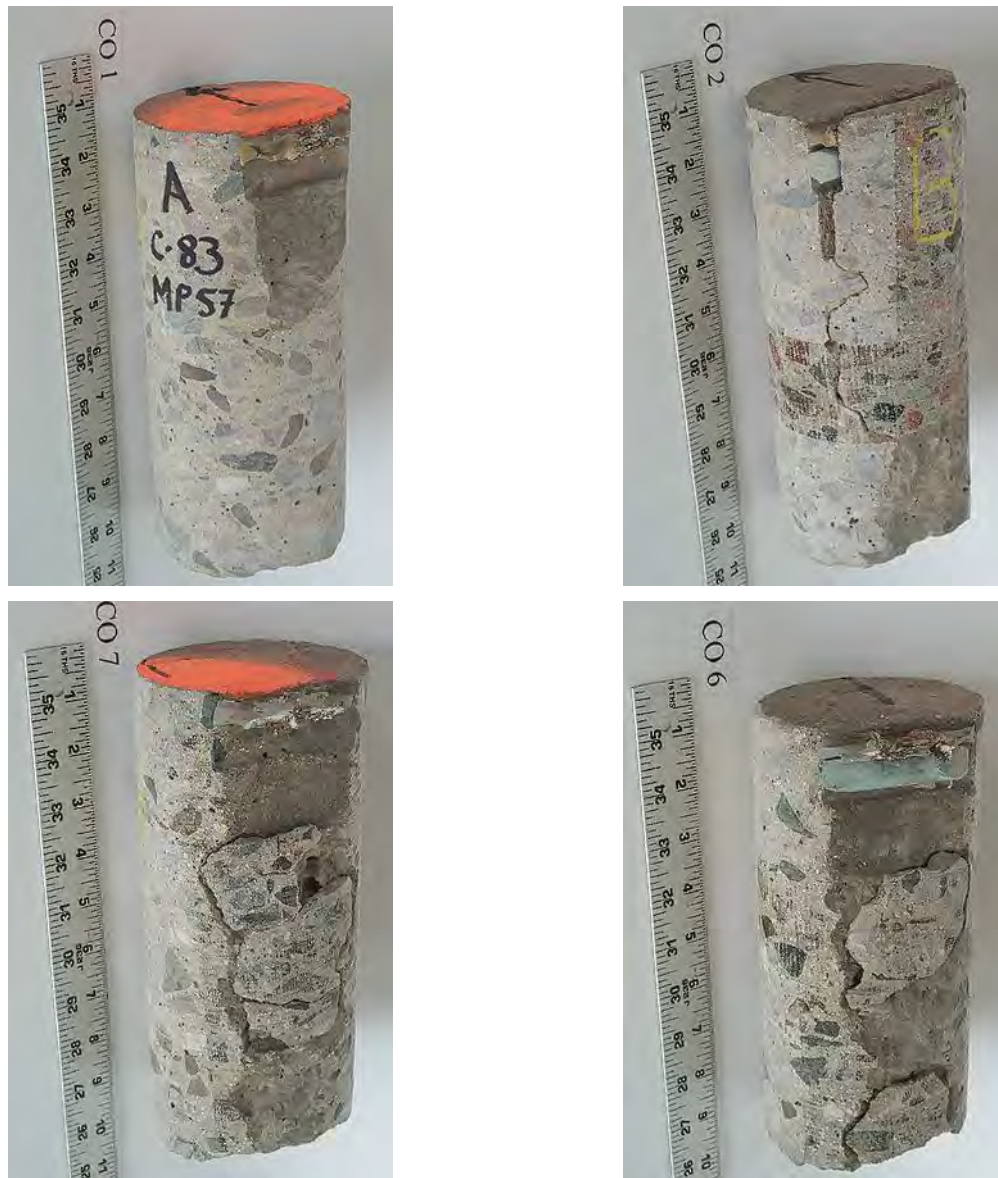
Figure A2.3. Cores taken at joint.

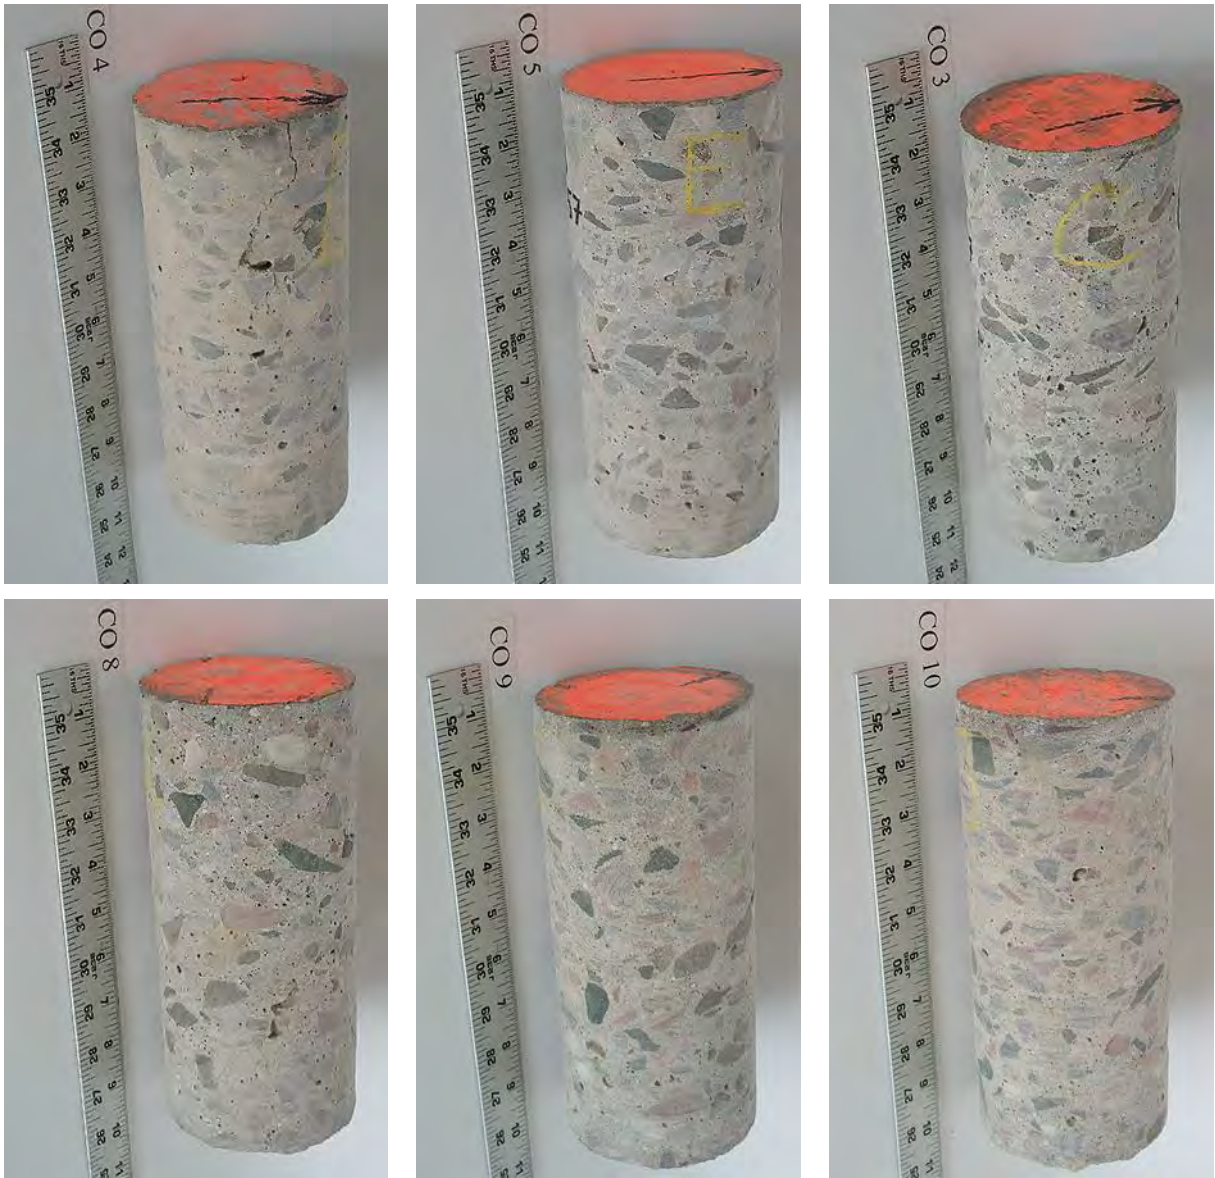
Figure A2.4. Cores taken away from joint.

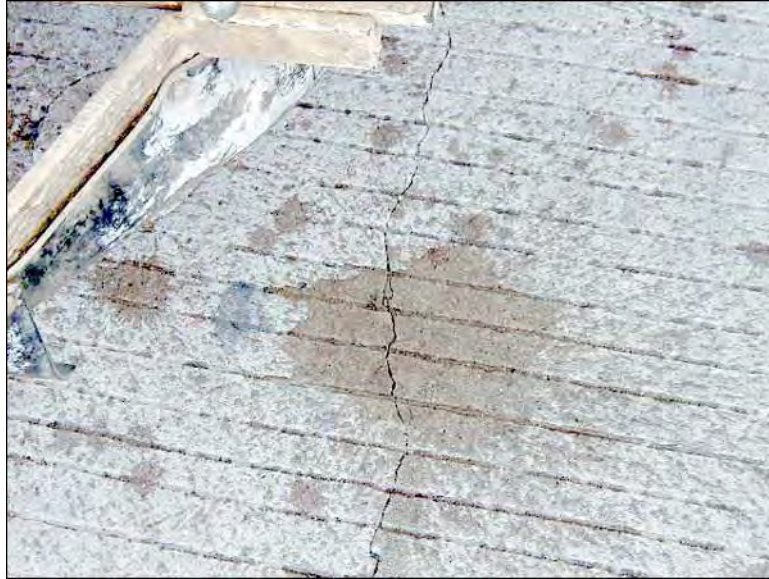
Figure A2.19. Photograph of crack in bridge deck.

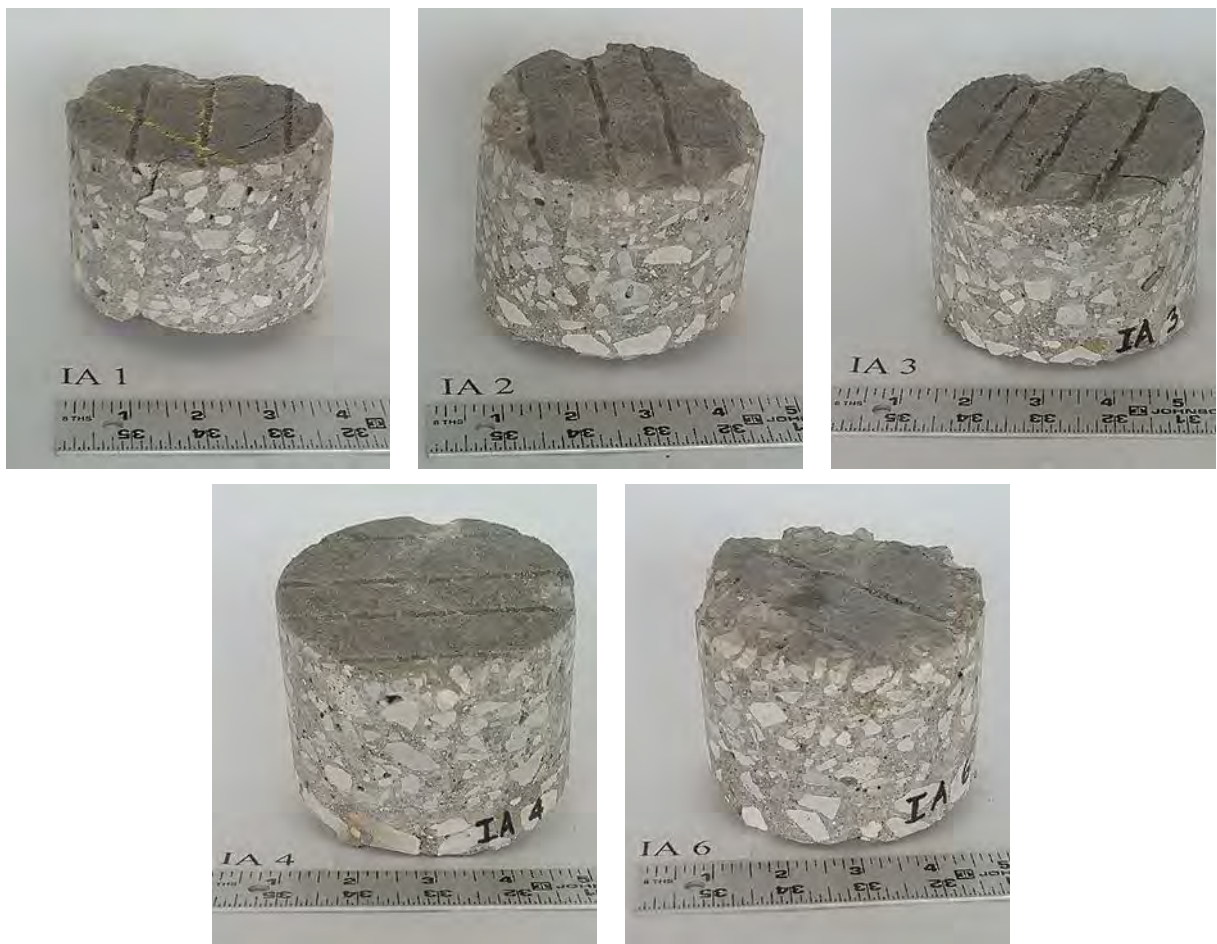
Figure A2.20. Partial depth cores through bridge deck from right hand side of lane.

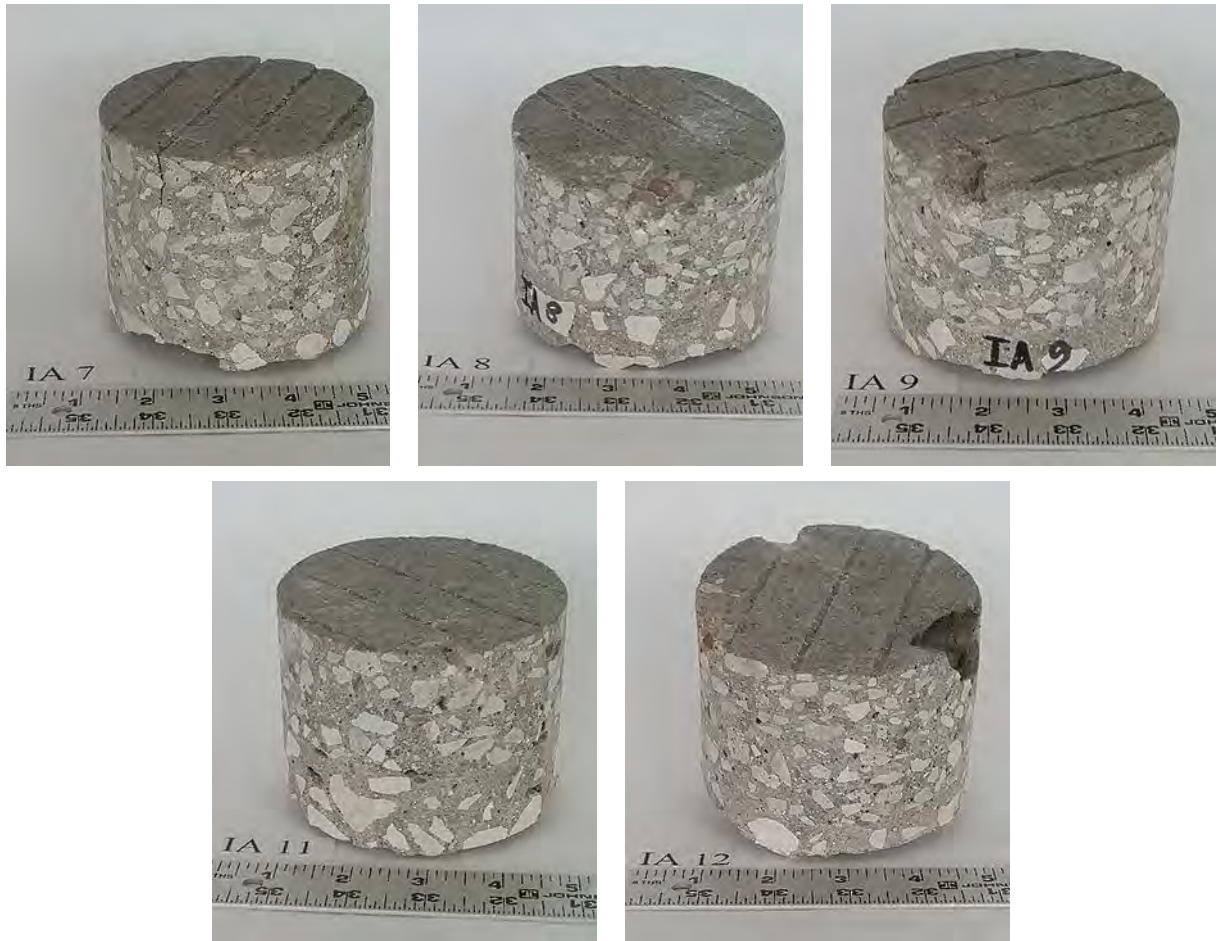
Figure A2.21. Partial depth cores through bridge deck from left hand side of lane.

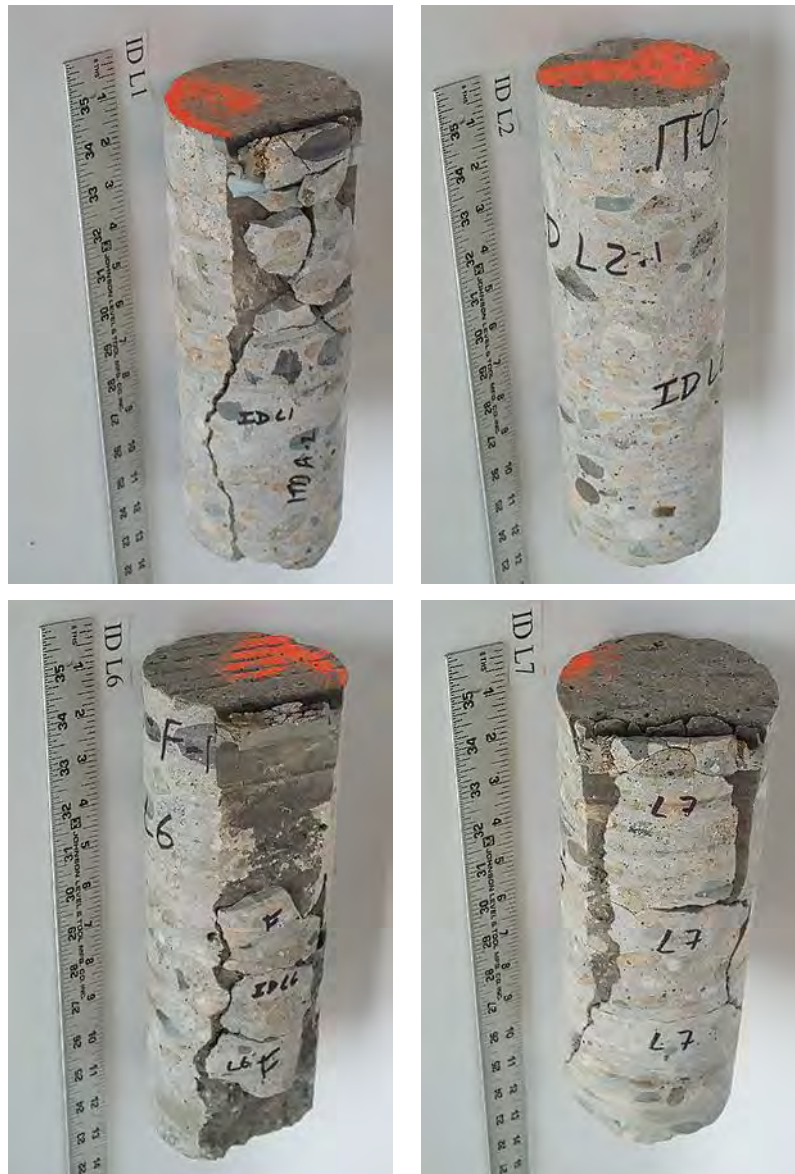
Figure A2.36. Cores from left lane taken near pavement joints.

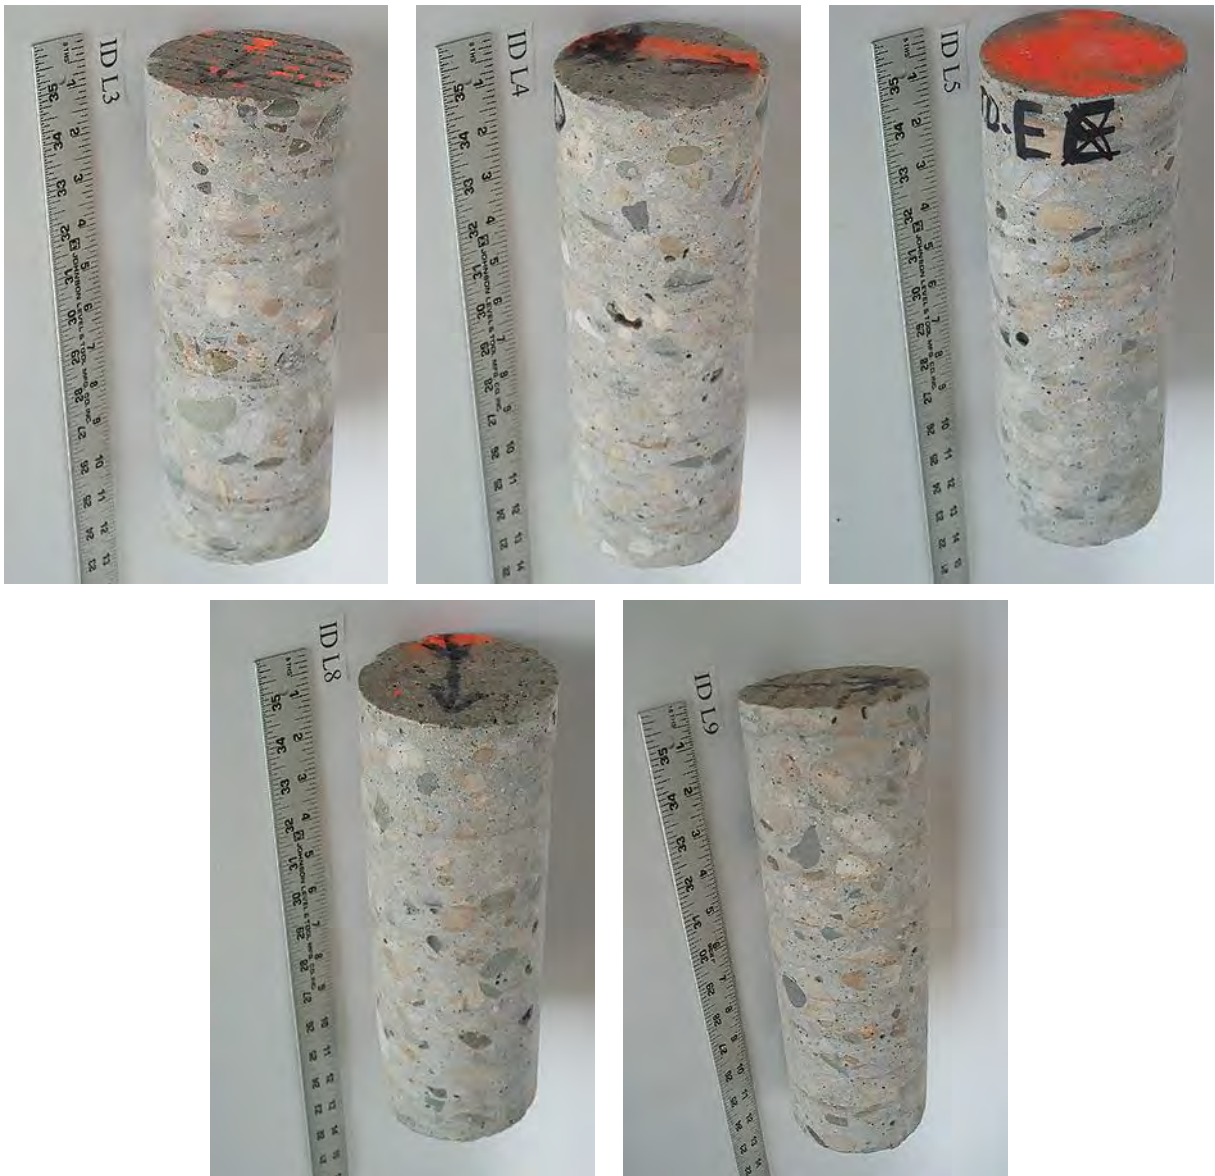
Figure A2.37. Cores from left lane taken away from pavement joints.

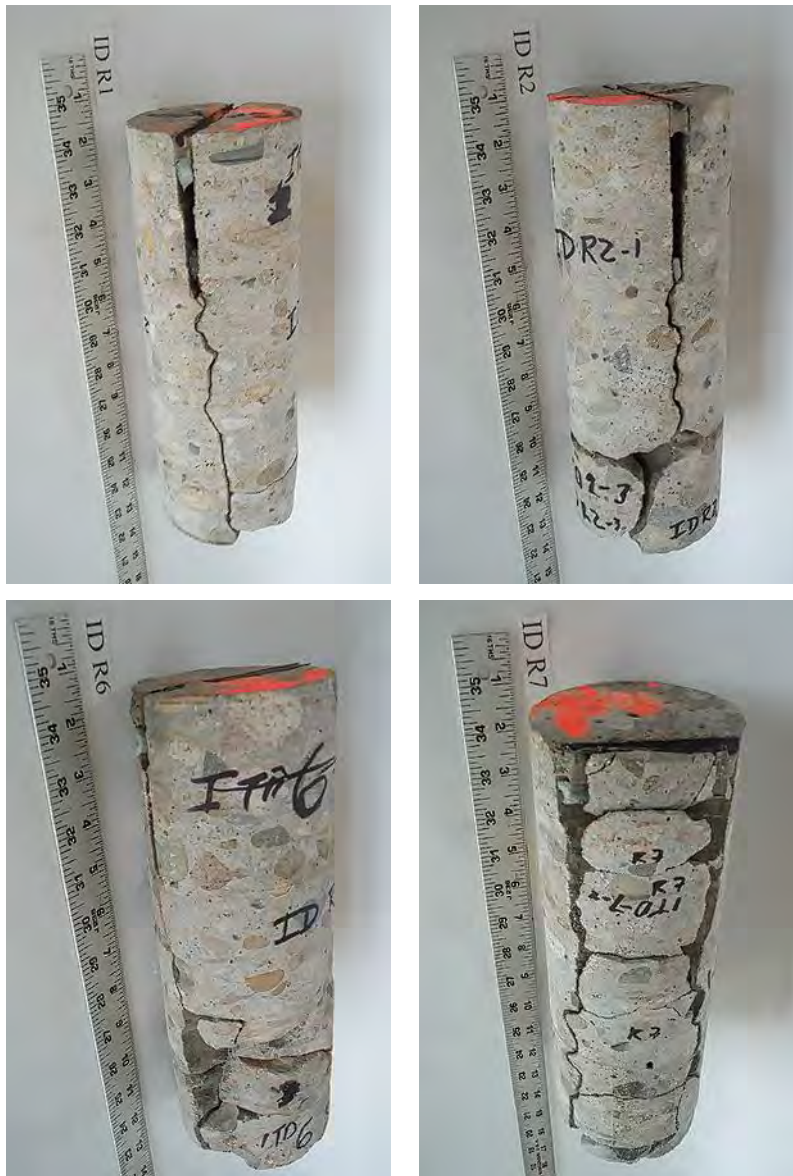
Figure A2.38. Cores from right lane taken near pavement joints.

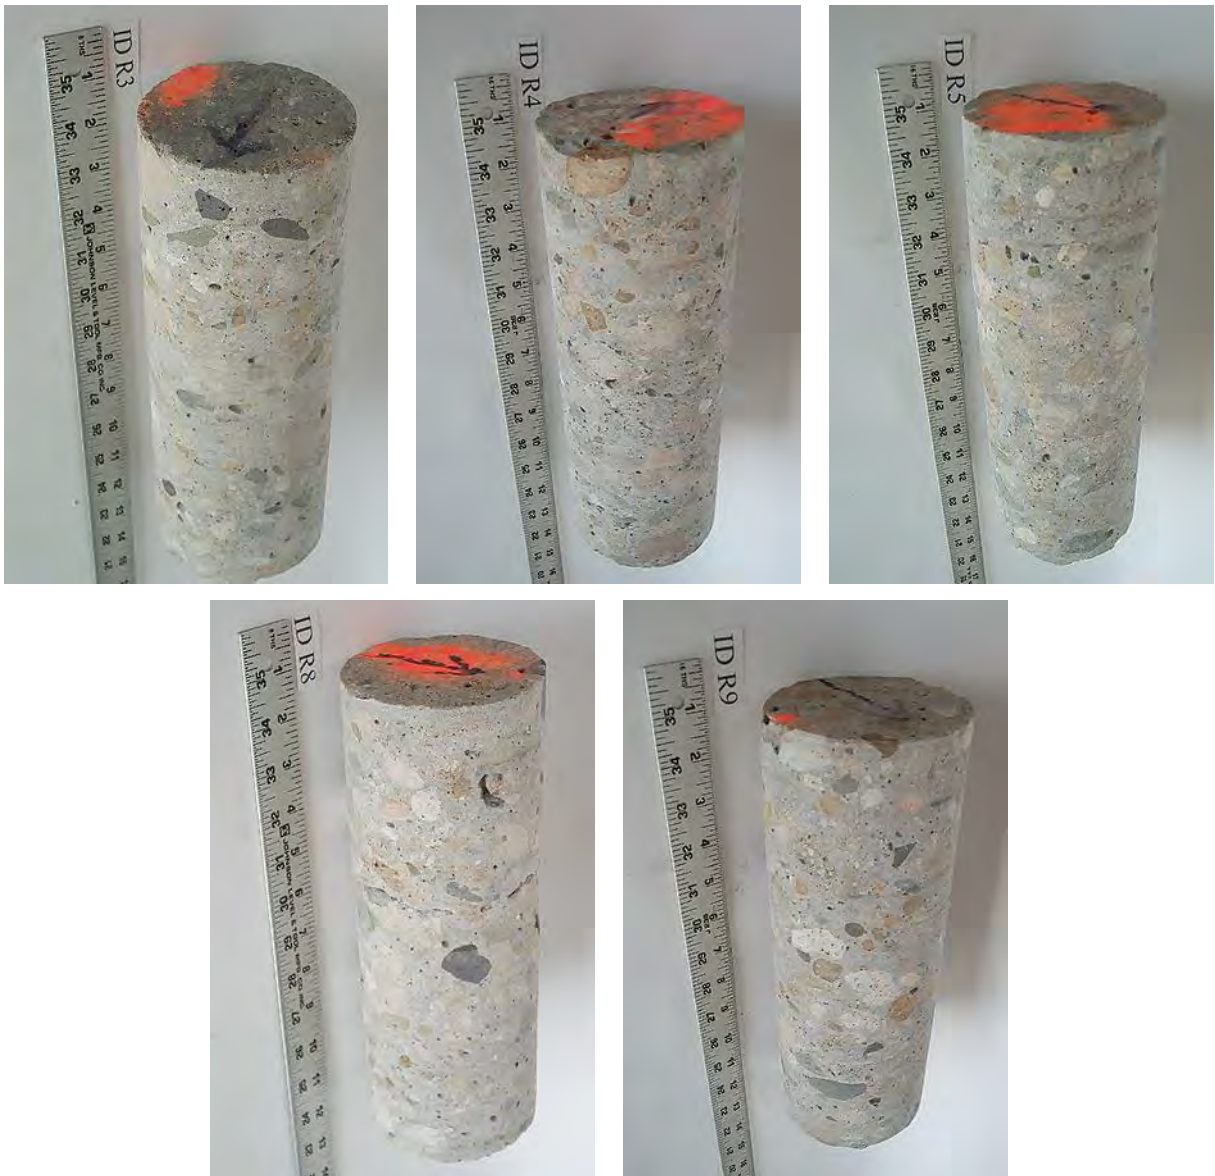
Figure A2.39. Cores from right lane taken away from pavement joints.

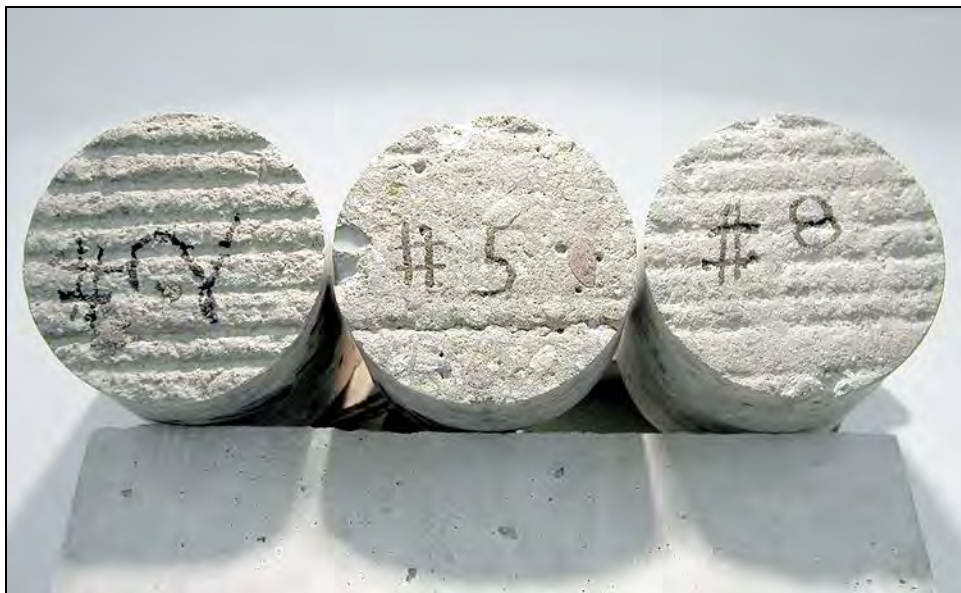
Figure A2.57. Photograph to show variation in surface wear from core to core.

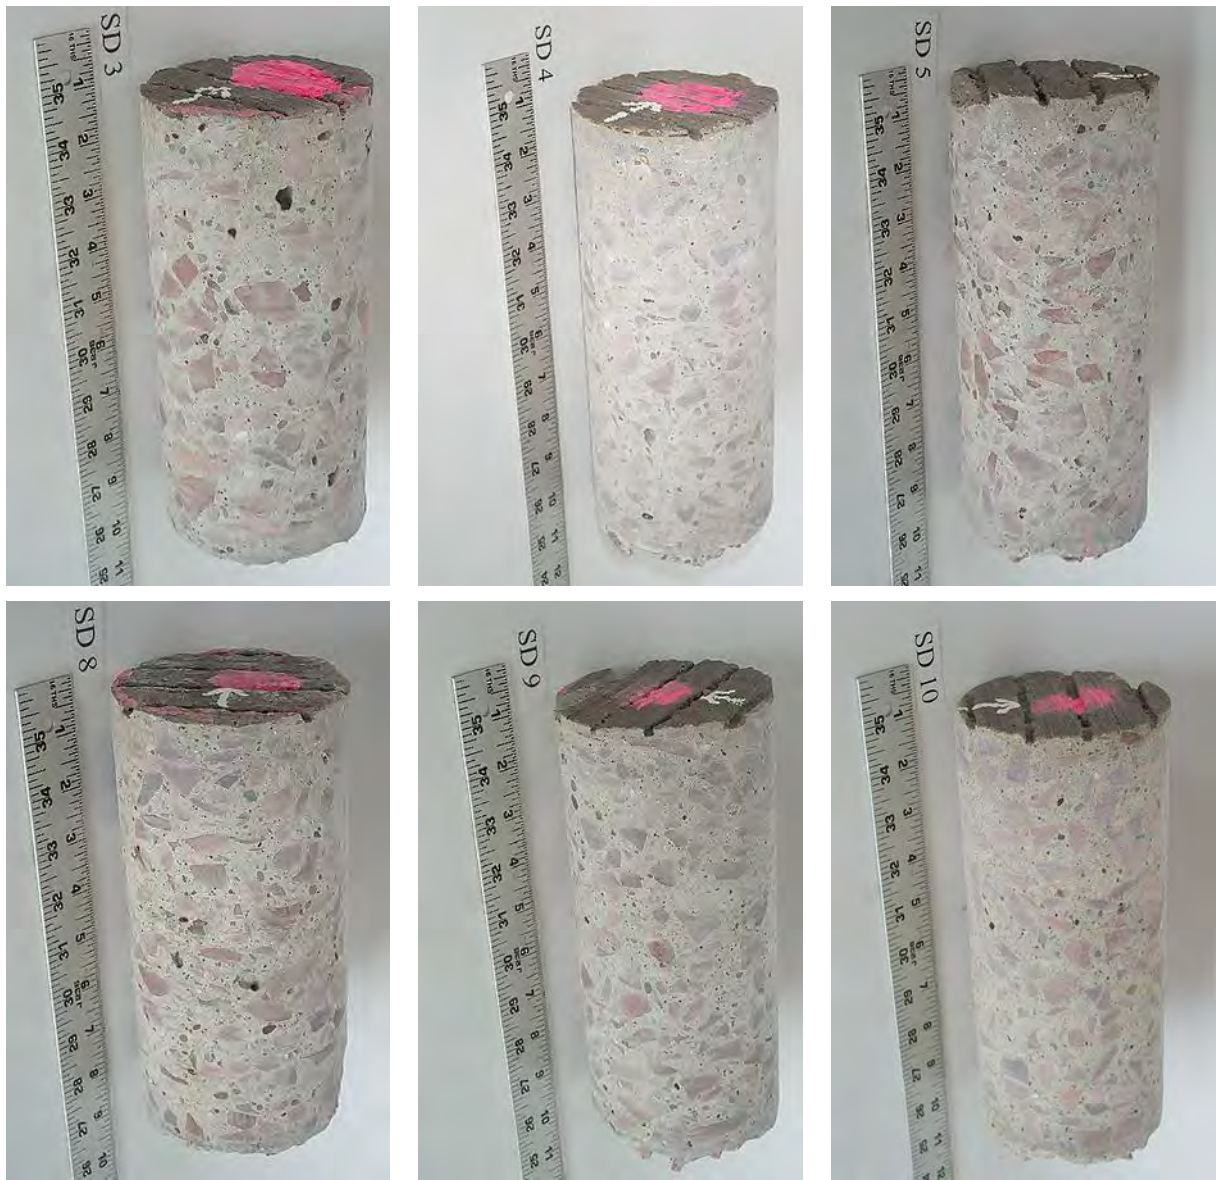
Figure A2.74. Cores taken away from joint.

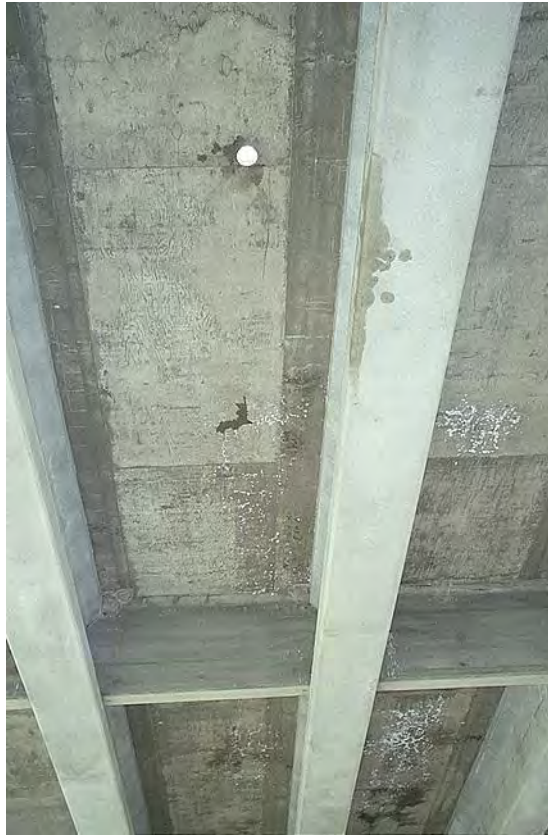
Figure A2.97. Photograph from beneath bridge deck after coring operation. Hole from core T-2 is visible. Dampness permeating through cracks visible beneath the area of core T-1. White efflorescence common in areas directly below regions covered with cold patch material.

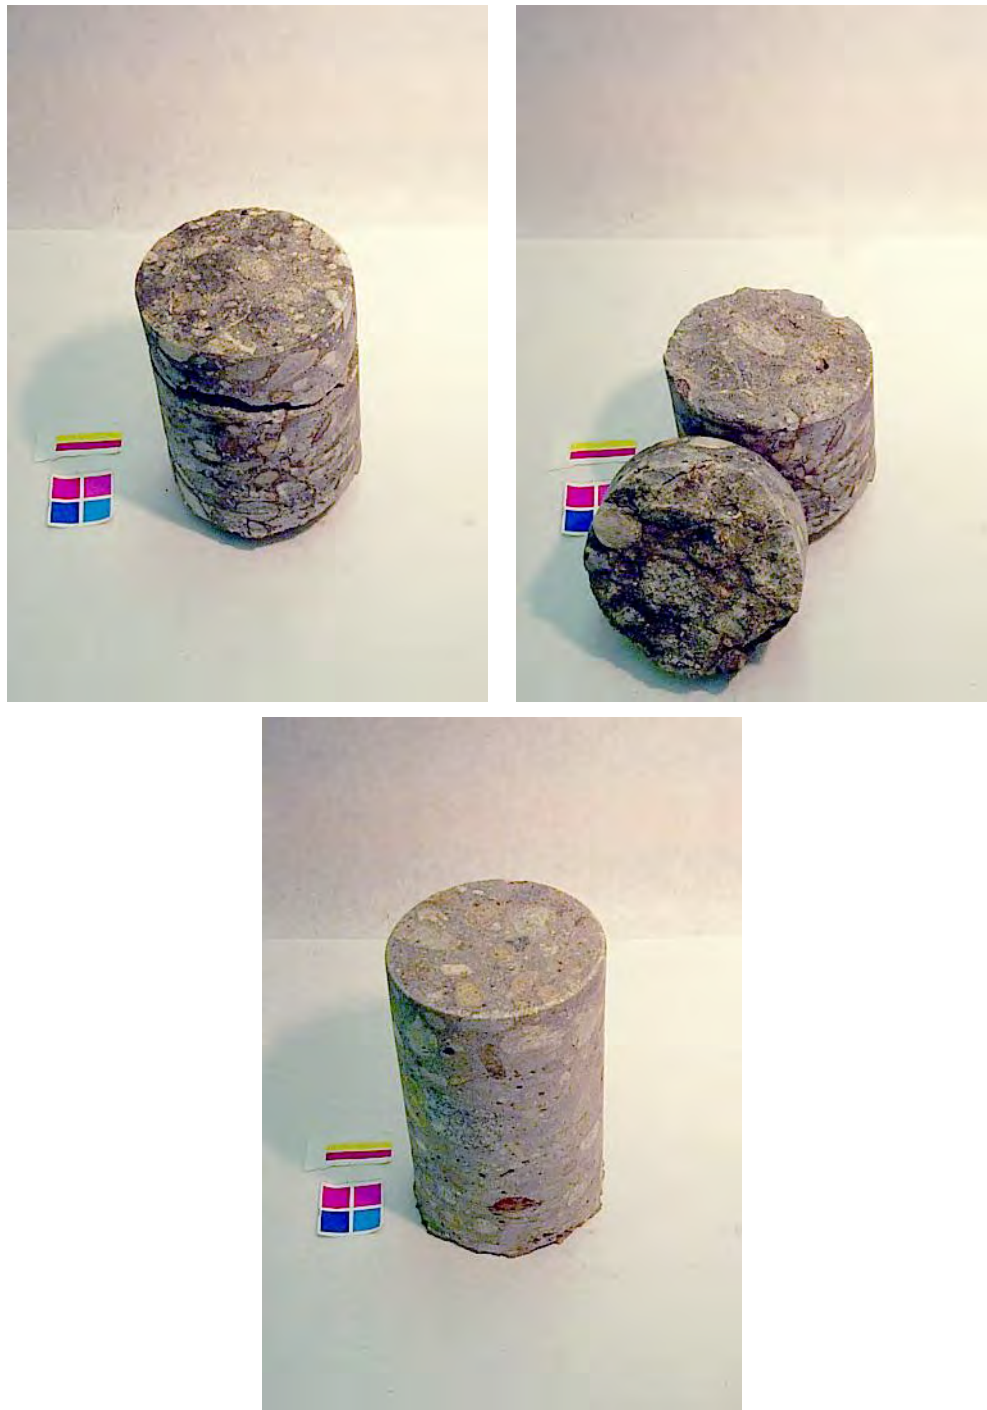
Figure A2.98. Cores retrieved from site, core T-1 (top), core T-2 (bottom).

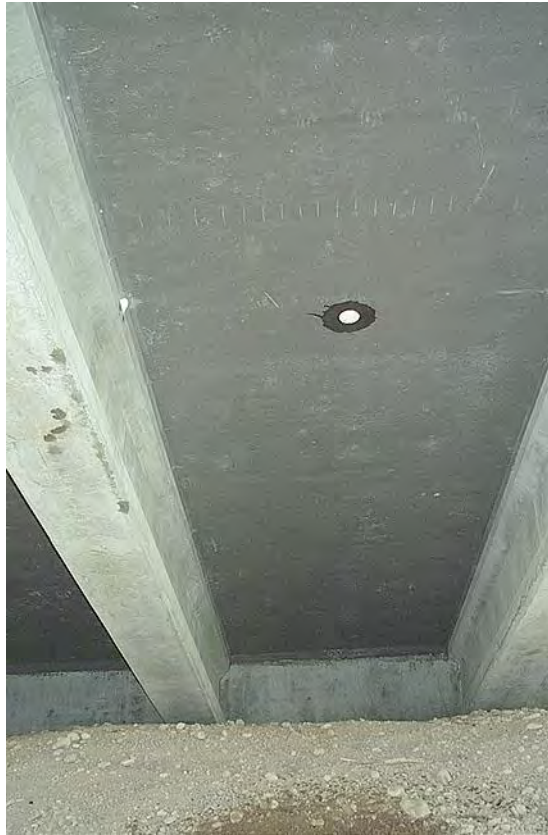
Figure A2.113. Photograph from beneath bridge deck after coring operation, hole from core S-1 is clearly visible, light coming through hole from core S-2 is partly obscured by the pre-stressed beam.

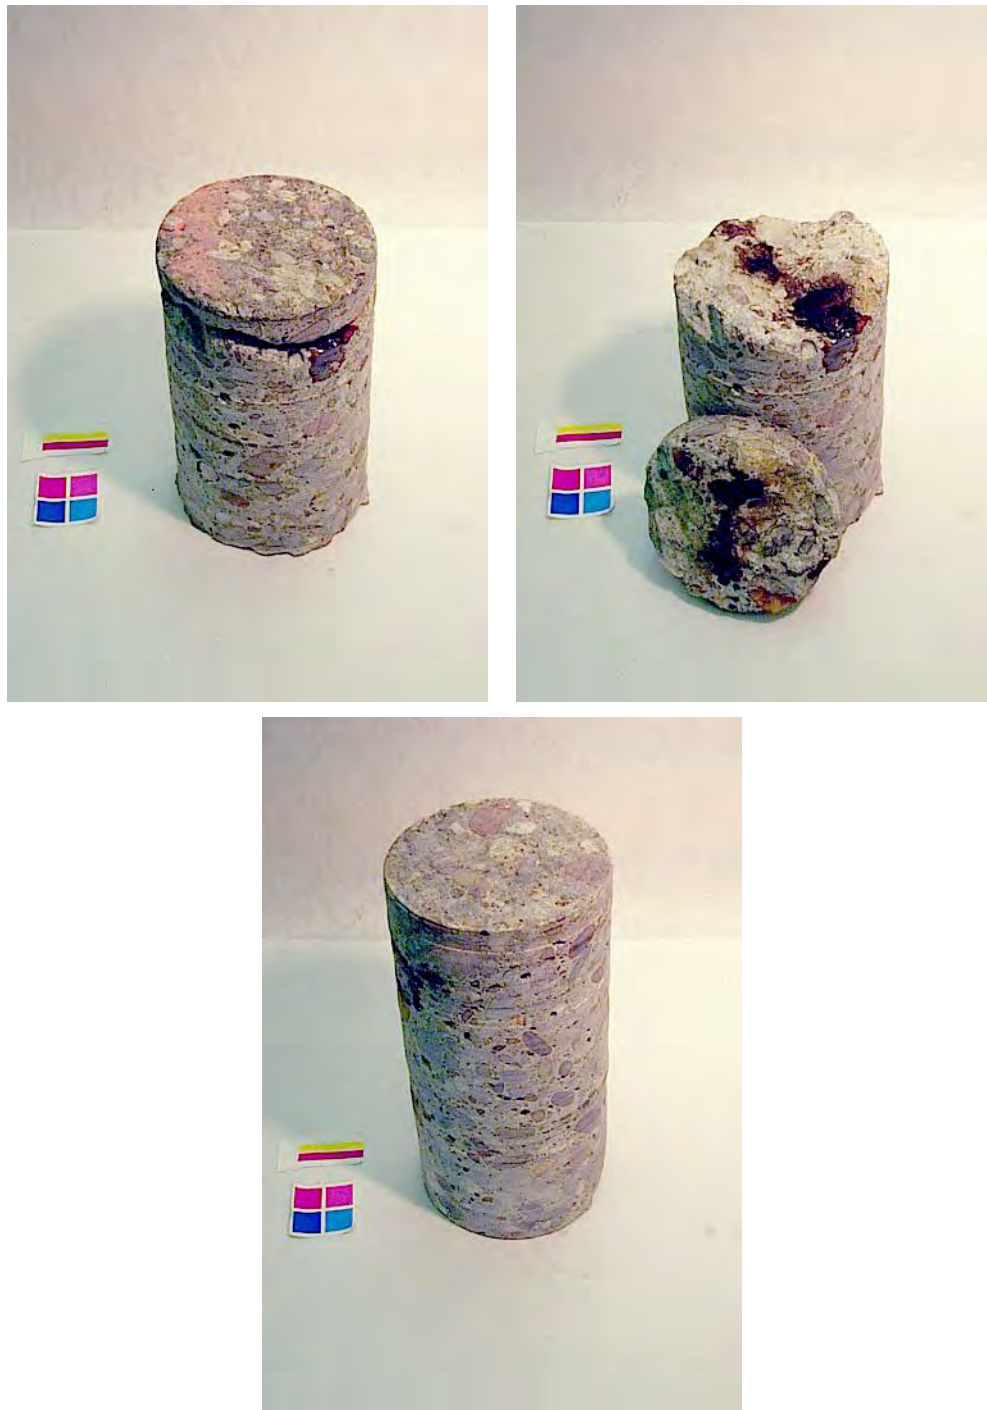
Figure A2.114. Cores retrieved from site, core S-1 (top), core S-2 (bottom).

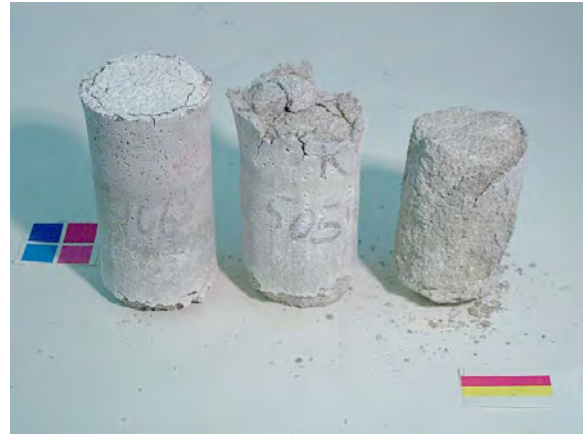
Figure A3.4. Cylinders exposed to CaCl_2 solution after 84 days of cyclic temperature test. From left to right: 0.40, 0.50, and 0.60 w/c mortar cylinders.

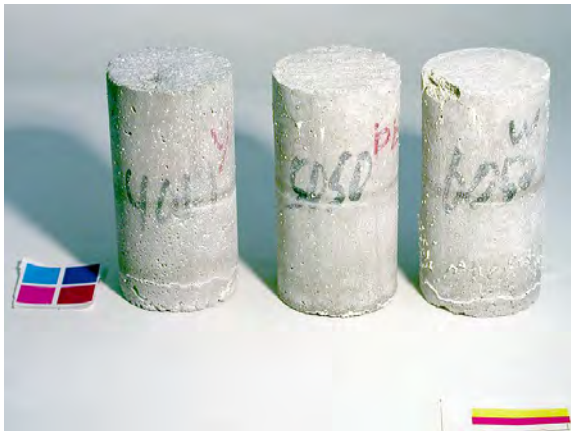
Figure A3.5. Cylinders exposed to CMA solution after 84 days of cyclic temperature test. From left to right: 0.40, 0.50, and 0.60 w/c mortar cylinders.

The cylinders exposed to the CMA solution were cycled to 84 days. Figure A3.5 shows the cylinders exposed to CMA at 84 days, with limited cracking, crumbling, and expansion evident near the top of the 0.60 w/c cylinder. The control cylinders exposed to limewater were in good condition at 84 days, as shown in Figure A3.6. Table A3.1 summarizes the visual ratings for all cylinders exposed to the cyclic temperature experiment over time for both the control (limewater) and deicer solutions.

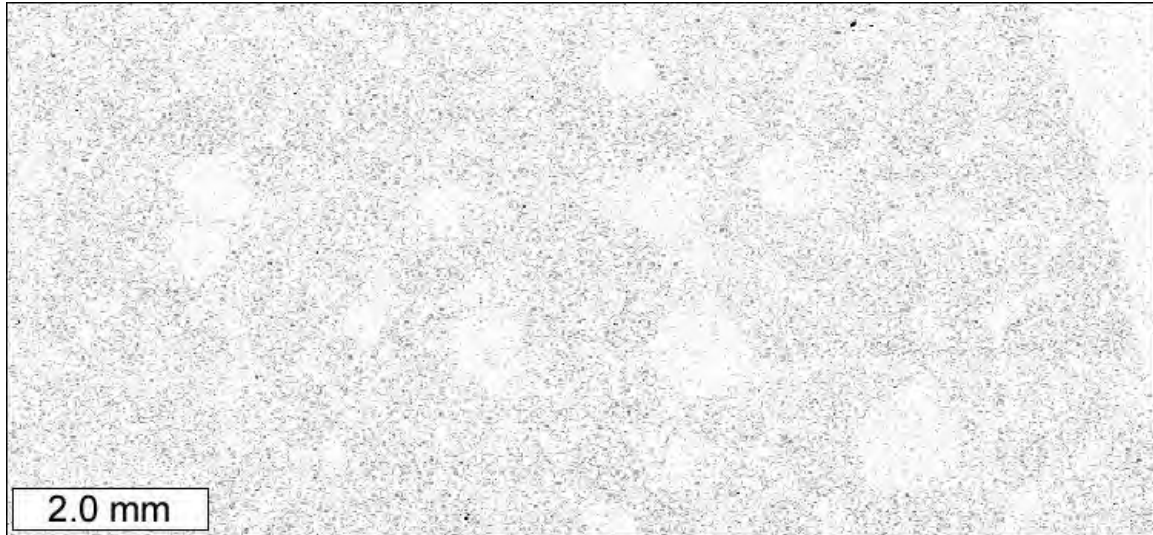
Figure A3.13. Sodium $K\alpha$ X-ray map from control cylinder. Darker areas correspond to higher $K\alpha$ X-ray counts.

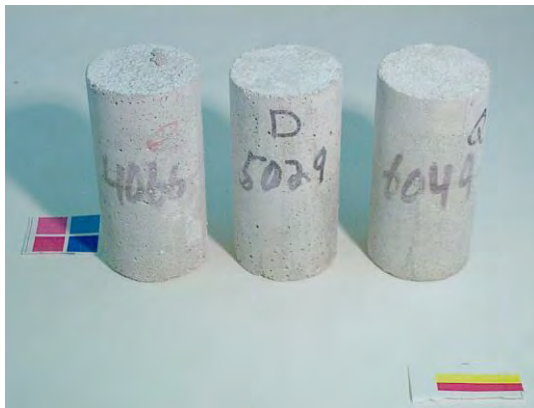
Figure A3.19. Cylinders exposed to NaCl solution after 84 days of constant low temperature test. From left to right: 0.40, 0.50, and 0.60 w/c mortar cylinders.

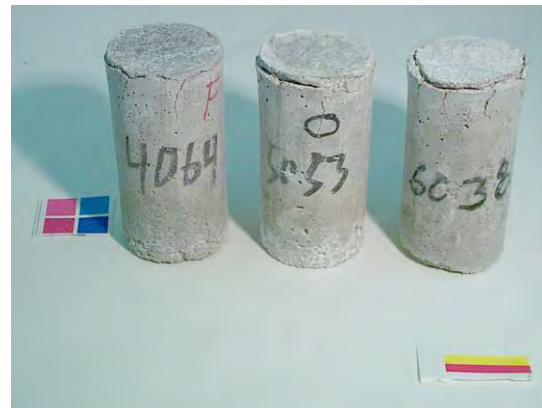
Figure A3.20. Cylinders exposed to $MgCl_2$ solution after 84 days of constant low temperature test. From left to right: 0.40, 0.50, and 0.60 w/c mortar cylinders.

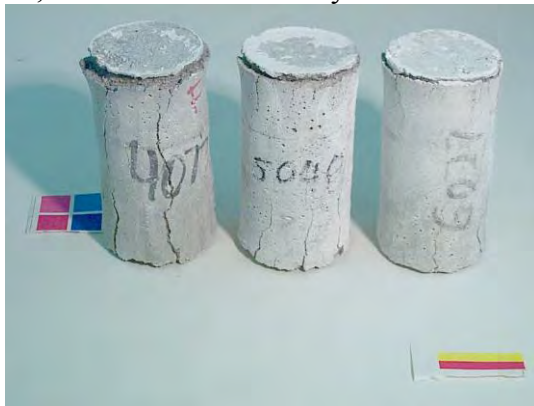
Figure A3.21. Cylinders exposed to $CaCl_2$ solution after 84 days of constant low temperature test. From left to right: 0.40, 0.50, and 0.60 w/c mortar cylinders.

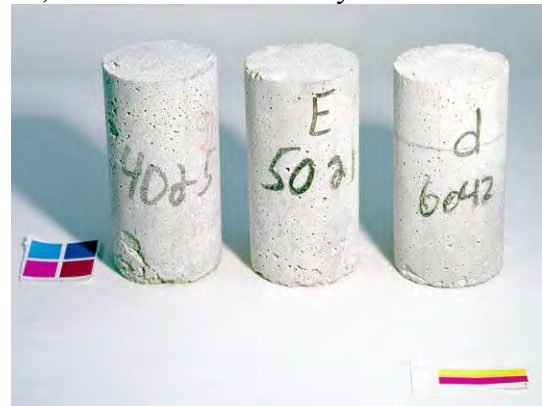
Figure A3.22. Cylinders exposed to CMA solution after 84 days of constant low temperature test. From left to right: 0.40, 0.50, and 0.60 w/c mortar cylinders.

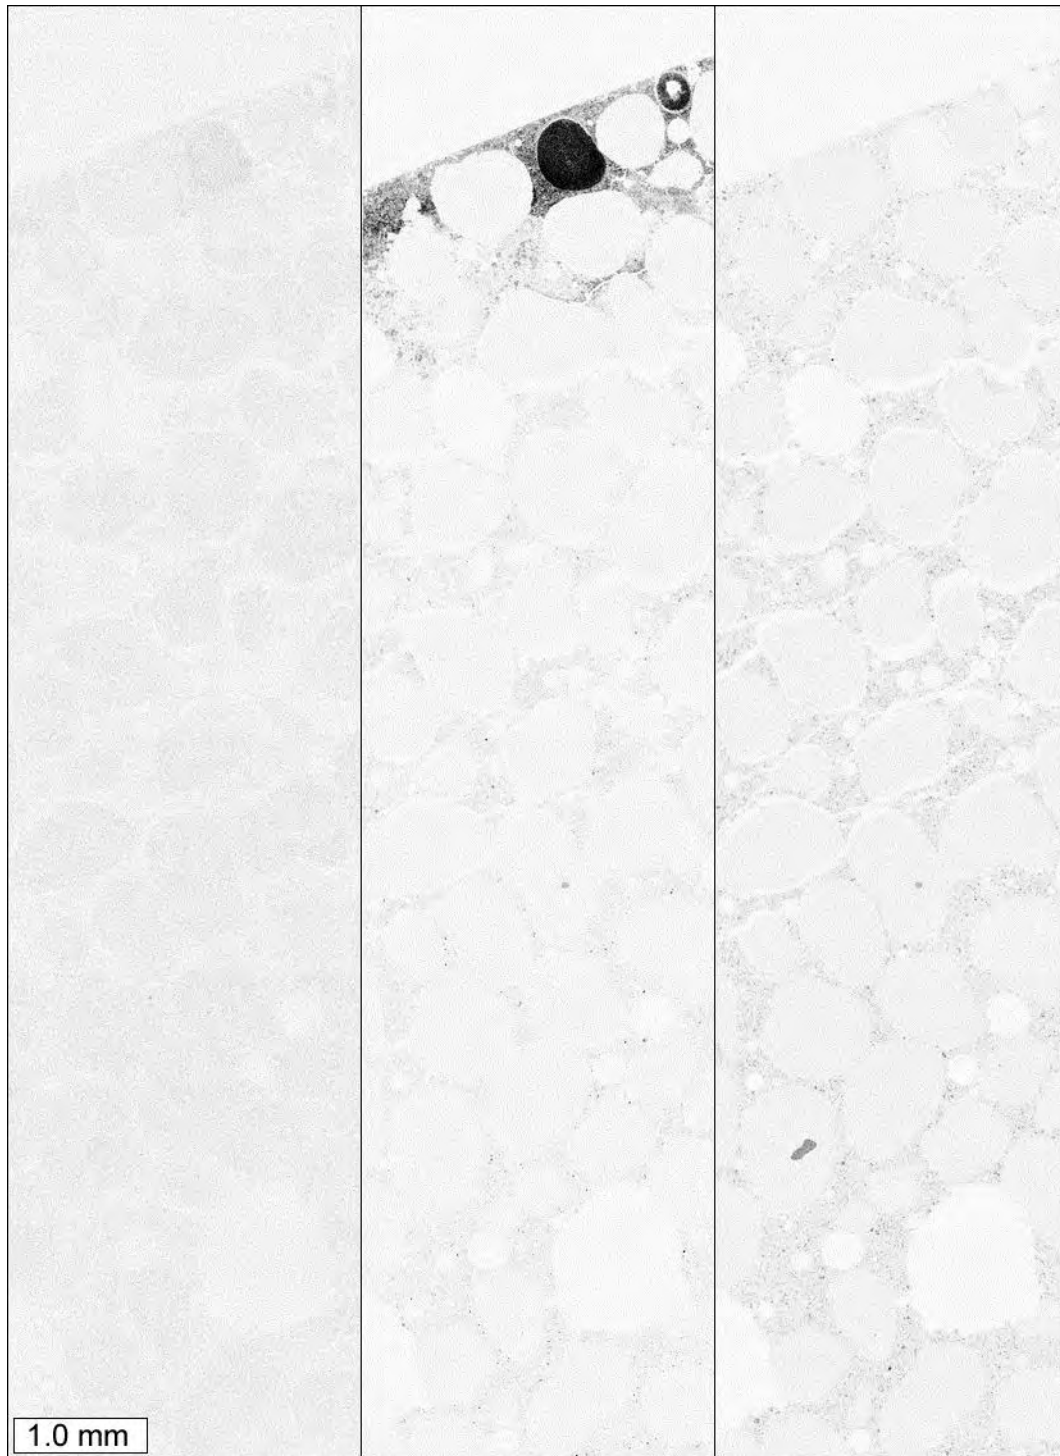
Figure A3.36. Elemental maps, from left to right: sodium, magnesium, and aluminum. The elemental maps were collected from a thin section prepared from a cylinder immersed in magnesium chloride solution. Darker areas indicate a higher concentration.

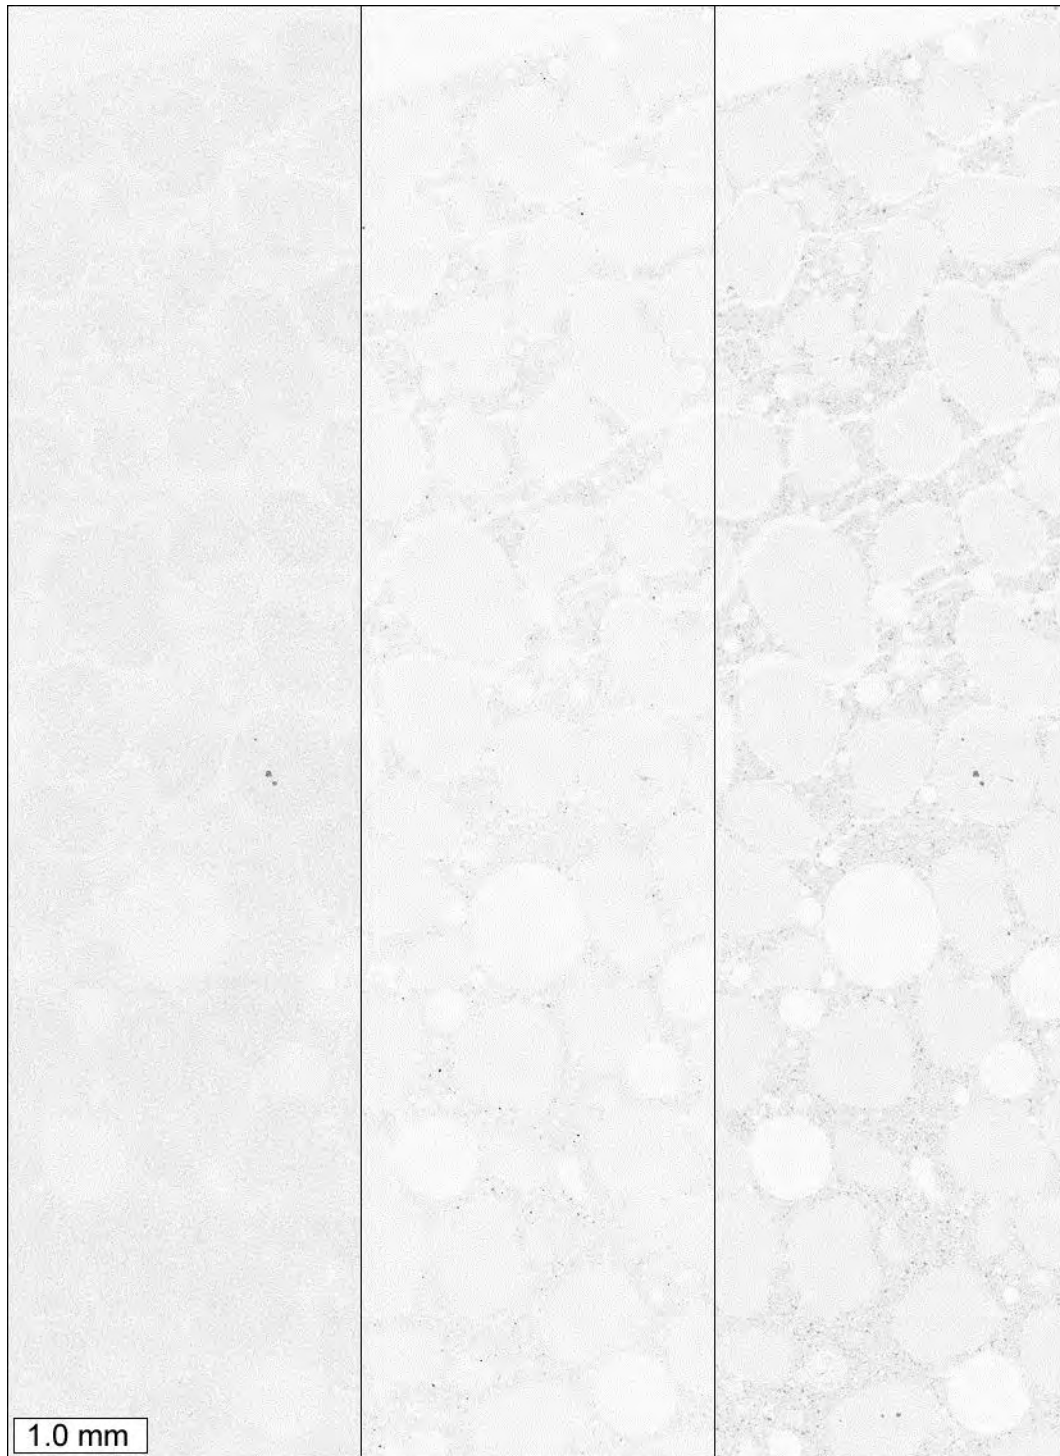
Figure A3.41. Elemental maps, from left to right: sodium, magnesium, and aluminum. The elemental maps were collected from a thin section prepared from a cylinder immersed in calcium chloride solution. Darker areas indicate a higher concentration.
