The Deleterious Chemical Effects of Concentrated Deicing Solutions on Portland Cement Concrete

Study SD2002-01
Technical Appendices

Prepared by
Michigan Tech Transportation Institute
1400 Townsend Drive
Houghton, MI

April 2008

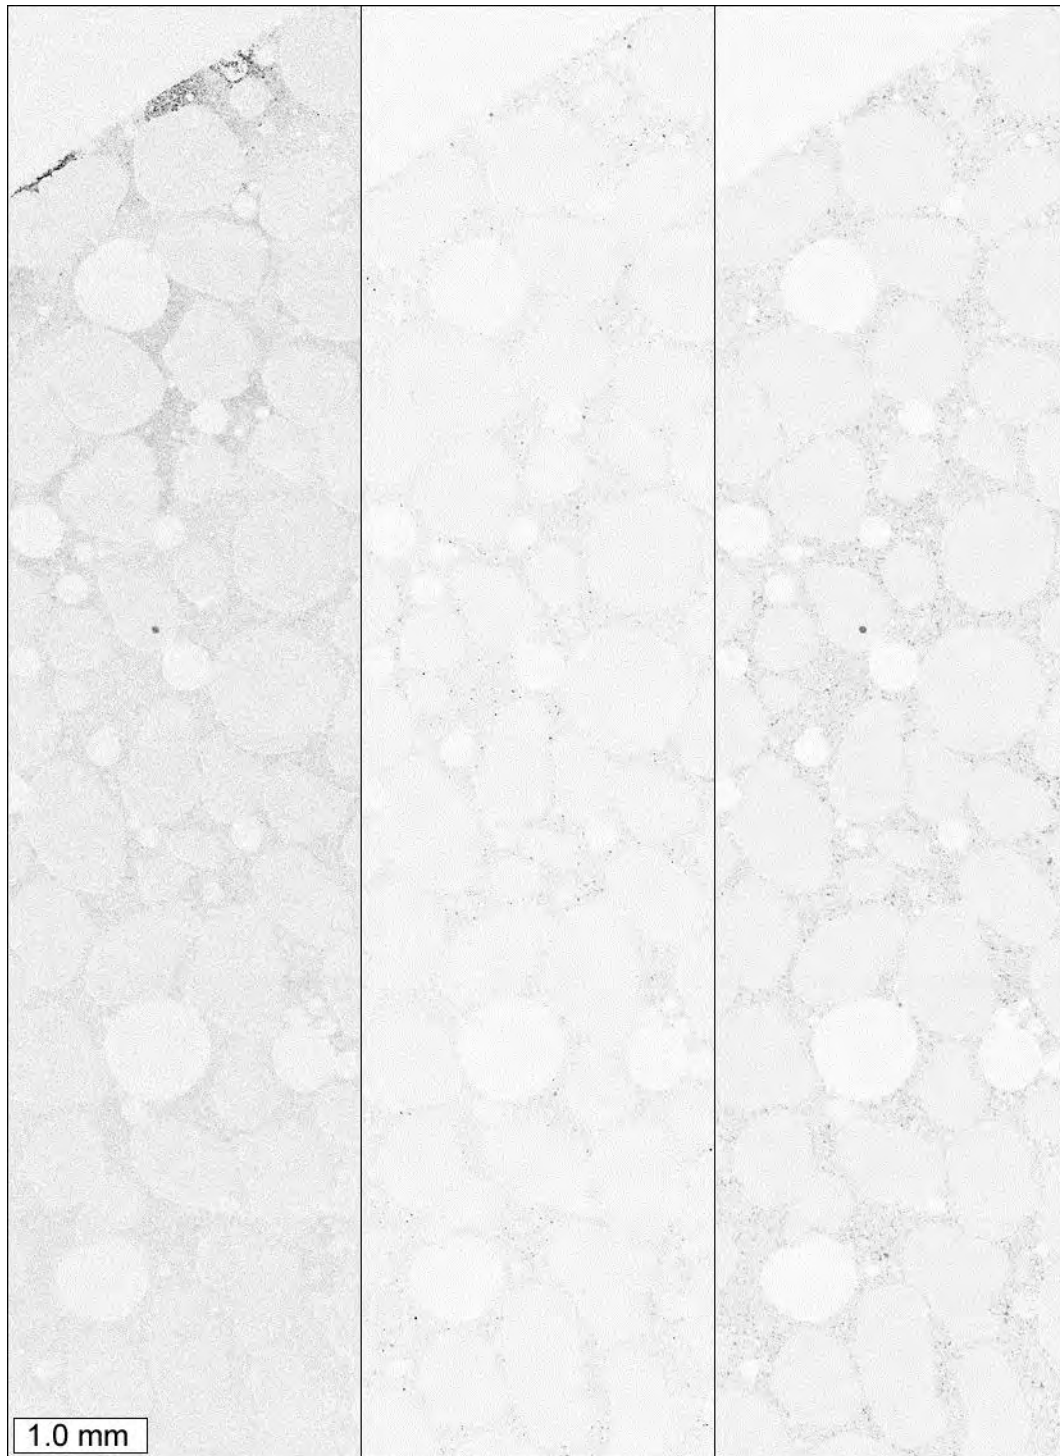
Figure A3.46. Elemental maps, from left to right: sodium, magnesium, and aluminum. The elemental maps were collected from a thin section prepared from a cylinder immersed in sodium chloride solution. Darker areas indicate a higher concentration.

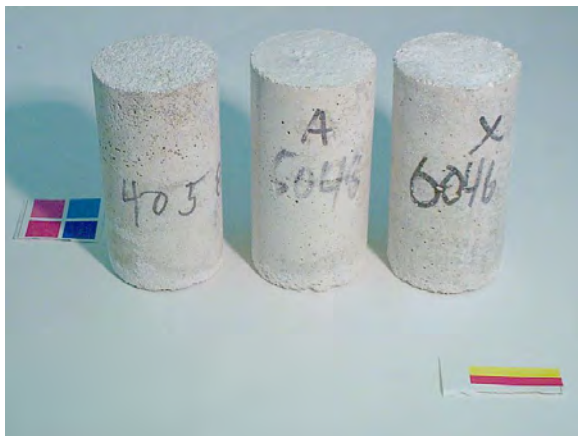
Figure A3.59. Cylinders exposed to NaCl solution after 84 days of constant high temperature test. From left to right: 0.40, 0.50, and 0.60 w/c mortar cylinders.

The constant high temperature experiment was run in the same manner as the constant low temperature experiment, but at an elevated temperature of 135 °F [57 °C]. At 84 days the cylinders in the NaCl solutions showed no distress, as shown in Figure A3.59. The cylinders in the MgCl₂ solution began to show some cracking at 84 days, as shown in Figure A3.60. Figure A3.61 shows the CaCl₂ specimens after 84 days and no visible signs of distress are present. As shown in Figure A3.62, the cylinders in the CMA solution began to disintegrate after 28 days. It was decided to abort the CMA test at 28 days. At 84 days, the control samples in limewater were still unaffected as shown in Figure A3.63. Table A3.8 summarizes the visual ratings for the cylinders over time for all the limewater and deicer solution exposure tests.

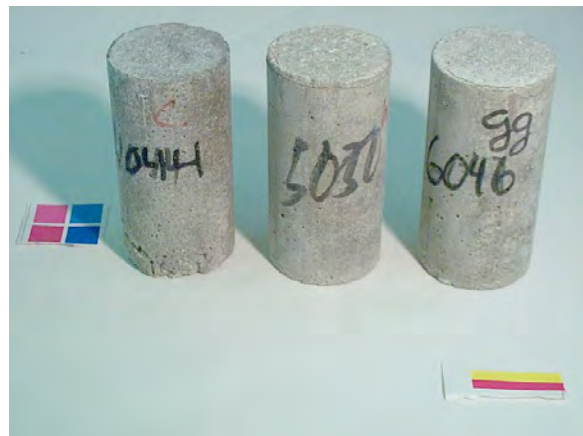
Figure A3.60. Cylinders exposed to MgCl₂ solution after 84 days of constant high temperature test. From left to right: 0.40, 0.50, and 0.60 w/c mortar cylinders.

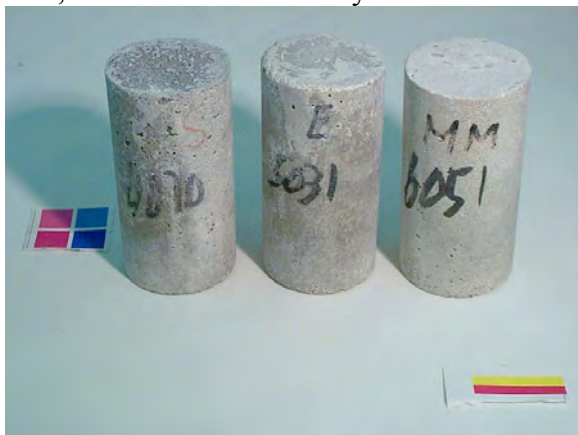
Figure A3.61. Cylinders exposed to CaCl₂ solution after 84 days of constant high temperature test. From left to right: 0.40, 0.50, and 0.60 w/c mortar cylinders

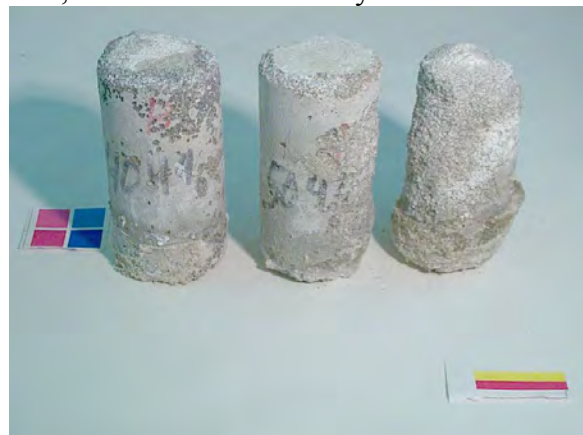
Figure A3.62. Cylinders exposed to CMA solution after 28 days of constant high temperature test. From left to right: 0.40, 0.50, and 0.60 w/c mortar cylinders.

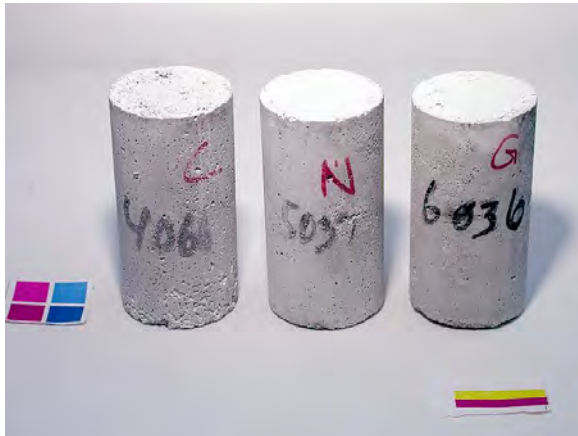
Figure A3.71. Cylinders exposed to CaCl_2 solution after 56 days of constant low temperature test. From left to right: 0.40, 0.50, and 0.60 w/c mortar cylinders. Solution strength was 3% CaCl_2 .

As can be seen clearly in Figures A3.71 through A3.75, concentration clearly has an affect on the observed damage at a given time for mortars exposed to the low temperature test.

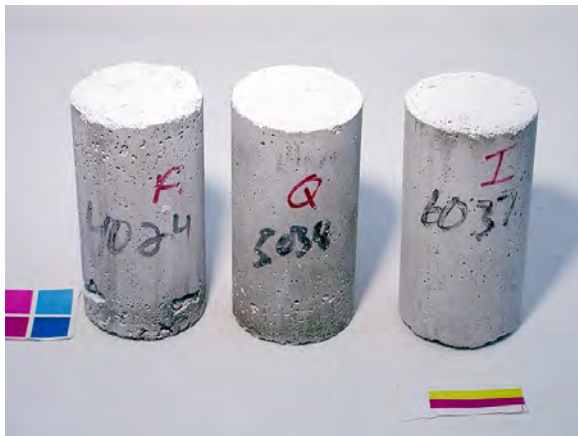
Figure A3.73. Cylinders exposed to CaCl_2 solution after 56 days of constant low temperature test. From left to right: 0.40, 0.50, and 0.60 w/c mortar cylinders. Solution strength was 10% CaCl_2 .

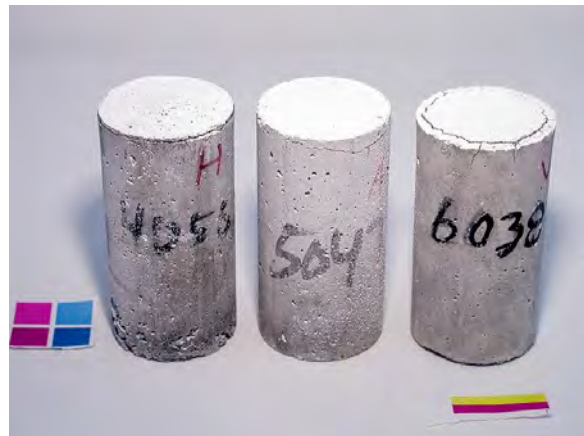
Figure A3.74. Cylinders exposed to CaCl_2 solution after 56 days of constant low temperature test. From left to right: 0.40, 0.50, and 0.60 w/c mortar cylinders. Solution strength was 14% CaCl_2 .

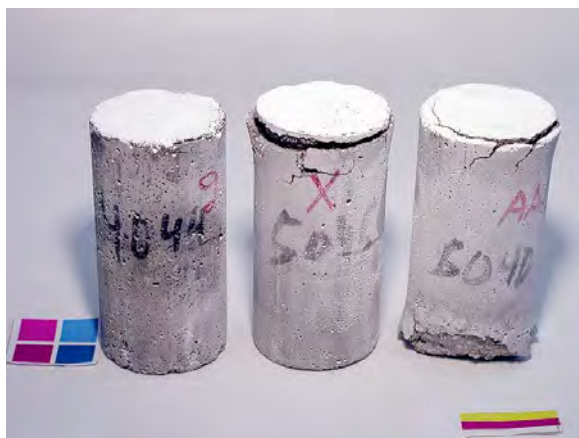
Figure A3.75. Cylinders exposed to CaCl_2 solution after 56 days of constant low temperature test. From left to right: 0.40, 0.50, and 0.60 w/c mortar cylinders. Solution strength was 17% CaCl_2 .

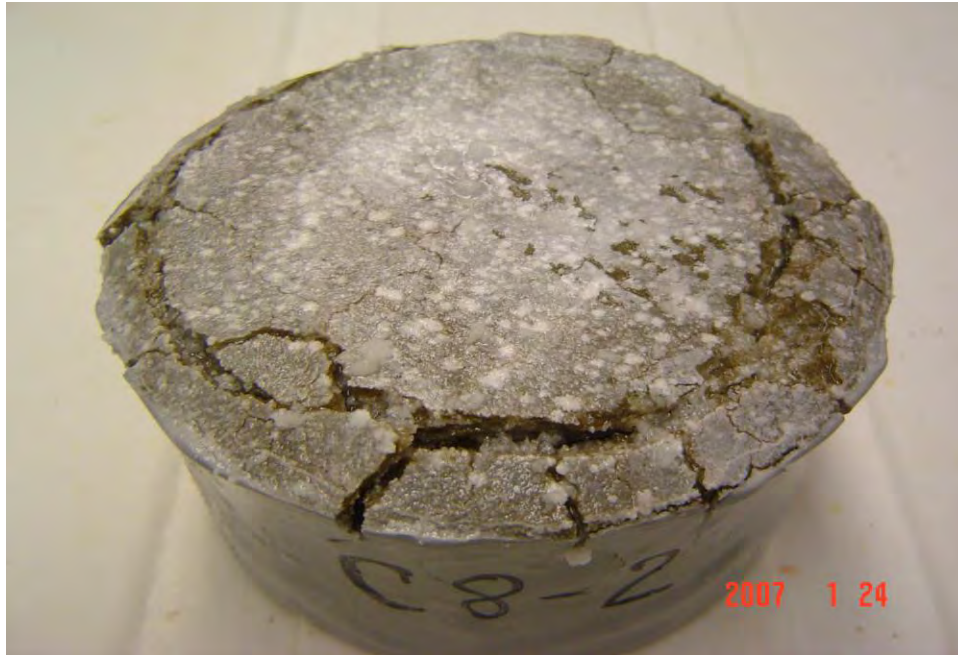
Figure A3.90. Deteriorated disc sample exposed to 20% MgCl_2 after 150 days of exposure.

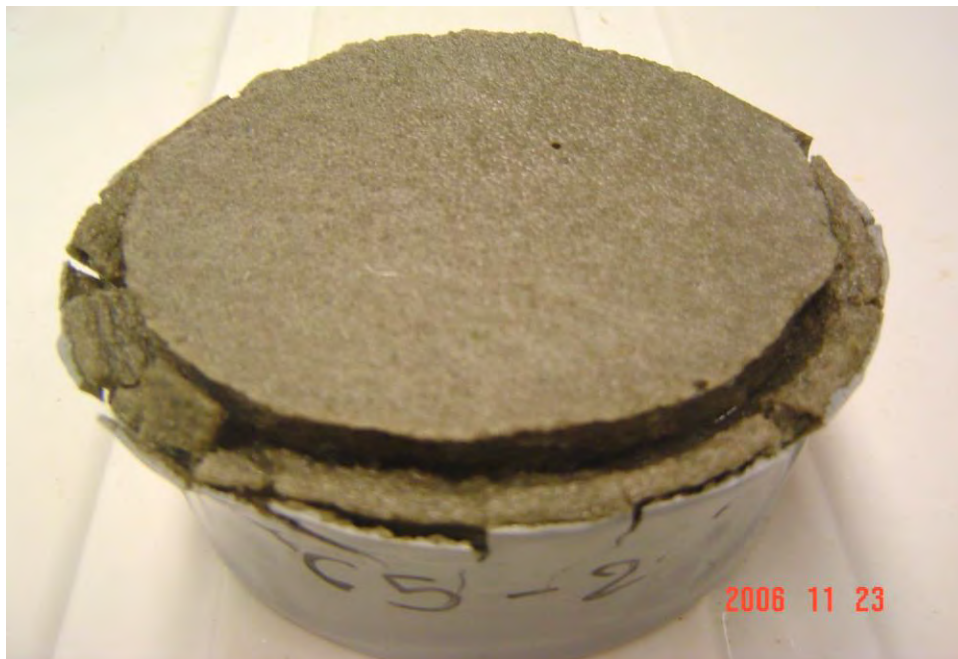
Figure A3.91. Deteriorated disc sample exposed to 28% CaCl_2 after 150 days of exposure.

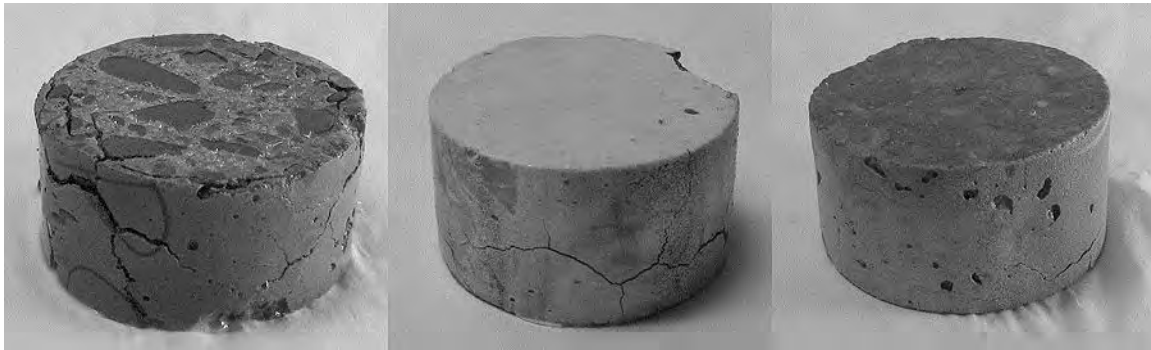
Random concrete and mortar specimens were removed from the various brine solutions after 60 days of exposure, with the remainder being removed after 500 days exposure. After removal from the brines, the specimens were blown dry with an air hose and cut with a kerosene cooled diamond saw. Specimens showing obvious external deterioration or other interesting features were photographed prior to drying. None of the specimens showed any obvious external signs of deterioration at 60 days. At 500 days, many of the specimens from the high-concentration CaCl_2 , MgCl_2 , and MBAP brines exhibited external cracking, examples of which are shown in Figure A3.128.

Figure A3.128. Photographs of 4 inch [100 mm] diameter 0.45 *w/c* ordinary portland cement (OPC) concrete specimens after 500 days in high concentration brines. From left to right: CaCl₂, MgCl₂, and MBAP brines.

A coating of mineral precipitates can be seen on the specimens in Figure A3.128. Mineral coatings were typically observed on specimens from the CaCl₂, MgCl₂, and MBAP brines. The mineral precipitates on the specimens from the MgCl₂ brine were white and very fine grained. Similar white precipitates were present on the specimens from the MBAP brine, but to a lesser degree. The mineral precipitates on the specimens from the CaCl₂ brine consisted of slender translucent crystals, examples of which are shown in Figure A3.129. External precipitates were not observed on specimens from the other brines, with the exception of specimens immersed in the low-concentration CMA brine. Figure A3.130 illustrates the white very fine-grained precipitate present on the surface of a specimen from the low-concentration CMA brine. Several circular deposits of black mold can also be observed along the sides of the specimen in Figure A3.130.

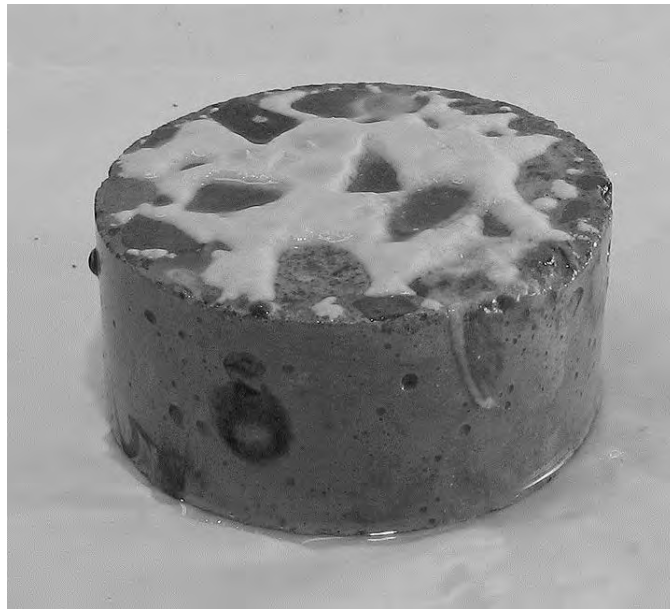
Figure A3.130. White precipitate on exterior of 4 inch [100 mm] diameter concrete specimen after 500 days immersion in low-concentration CMA solution.

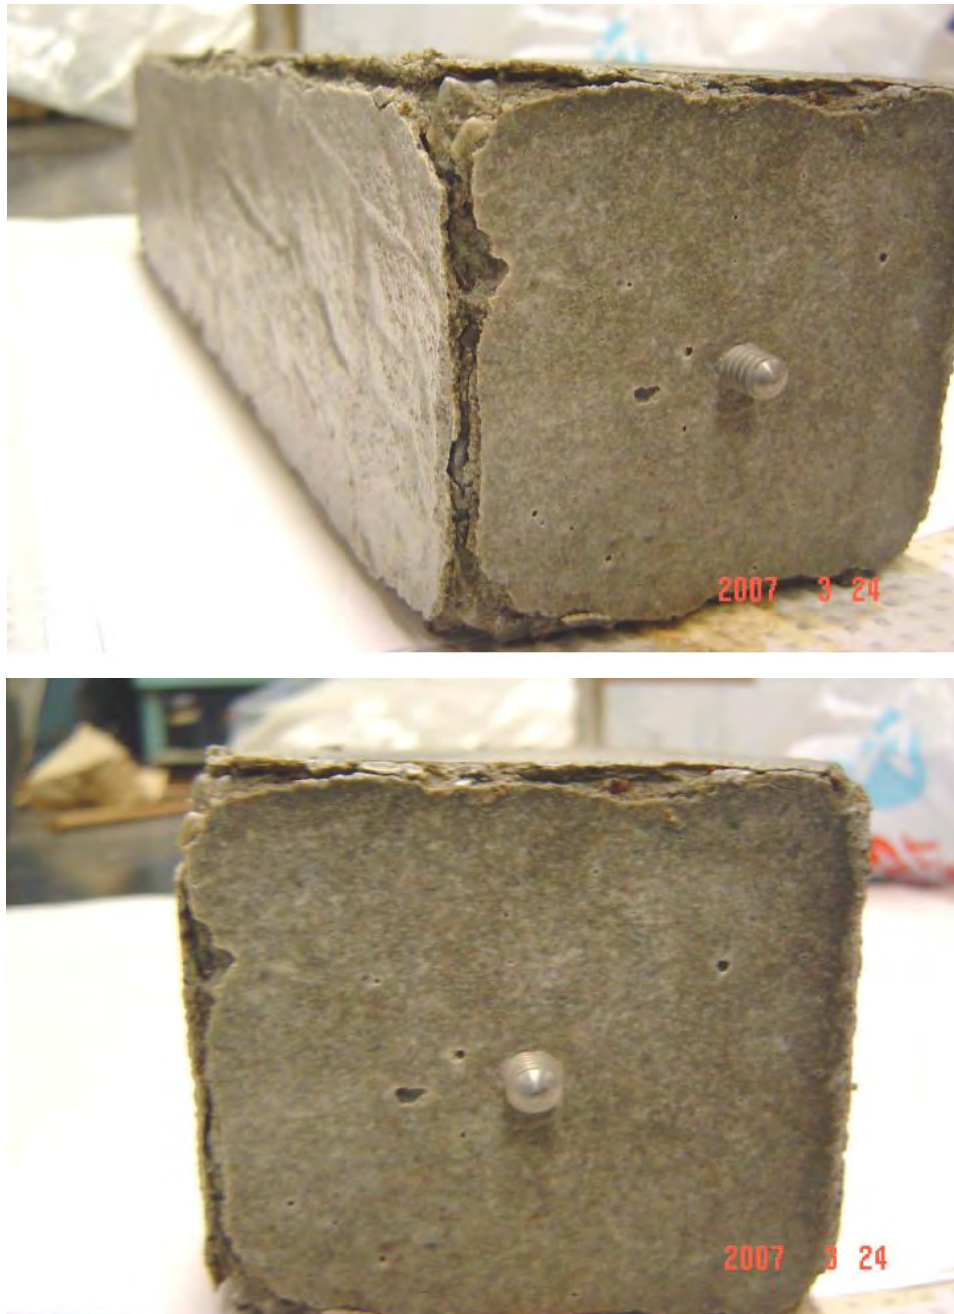
Figure A3.229. Photographs of concrete prisms subjected to 133 freezing and thawing cycles in 15% CaCl_2 solution.

Figures A3.229 and A3.230 show photographs of the concrete prism specimens exposed to CaCl_2 and MgCl_2 and used for determining the resistance to freeze-thaw action. Both deicers caused the prisms to expand and crack along the edges but it was observed that in addition to this, the prisms exposed to MgCl_2 precipitated a white gel compound that started to fill the cracks. This could explain why the prisms exposed to CaCl_2 loss mass while those exposed to MgCl_2 gained mass even though both seem to undergo a similar deterioration process. The precipitation of this gel compound, identified as magnesium oxychloride, seemed to be associated with greater damage in the concrete prism as shown by the reduced durability factor for samples exposed to MgCl_2 , as compared to the durability factor for specimens exposed to CaCl_2 .
