Road Safety Audit for Union County IA 25 from the WCL of Creston to North H-24 Intersection

**Final Report
July 2008**

ROAD SAFETY AUDIT FOR UNION COUNTY IA 25 FROM THE WCL OF CRESTON TO NORTH H-24 INTERSECTION

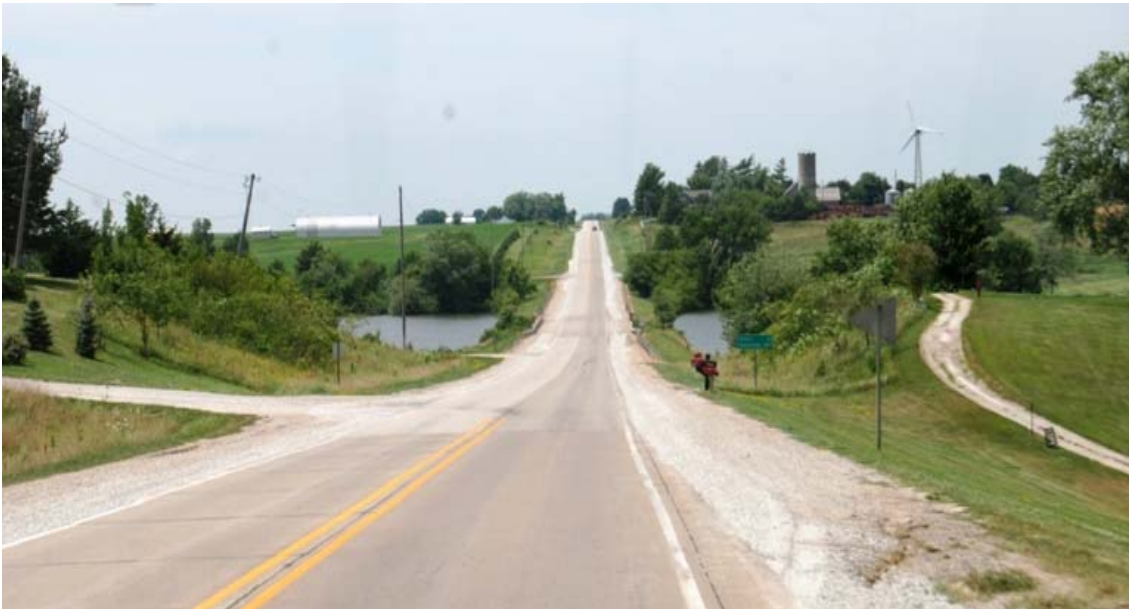
Pavement edge lines appeared quite worn west of Creston. Non-breakaway steel mailbox supports were noted in two locations with one mailbox protected with concrete-filled bollards.

Figure A.2. IA 25 westbound just west of Creston City Limits

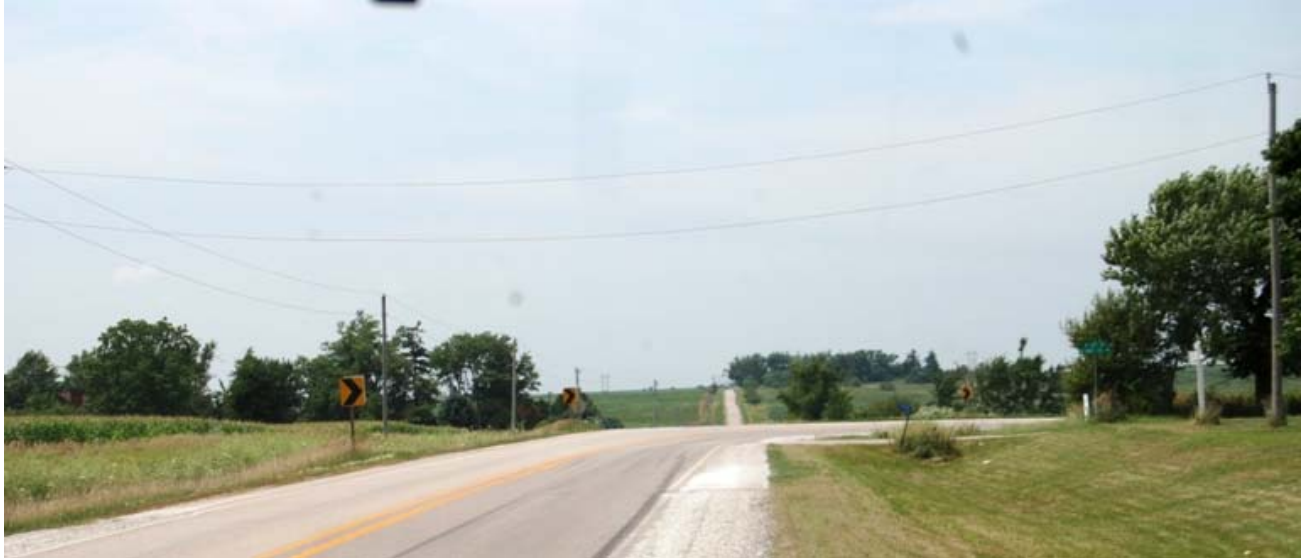
Standard curve warning signs with 45 mph advisory speed plaques are in place in advance of a curve west of Creston, and standard chevrons are in place through the super-elevated curve. Approximately 4 ft wide paved shoulders were placed through the curve as part of a 1996 pavement surface improvement project. However, no rumble strips were milled into the shoulders. Members of the audit team felt the addition of rumble strips would be beneficial.

A “Y” configuration intersection exists in this curve with granular surfaced approaches at each end of the curve. Foreslopes in the curve area appeared steeper than many other locations. Reconstruction to a “T” configuration might be beneficial for the intersecting side road traffic.

Figure A.3. Entering curve westbound

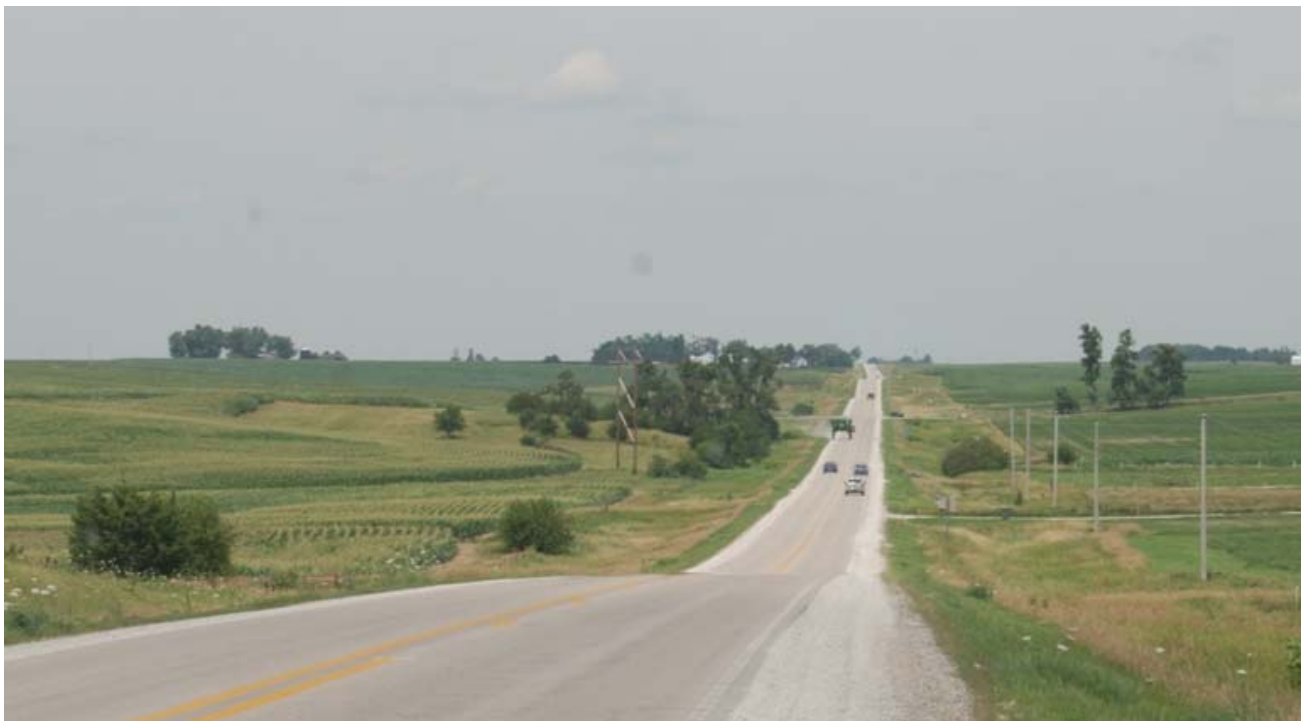
Northerly from the curve area, the granular shoulders appeared slightly narrower than along the previous section west of Creston, and several sections of steeper foreslopes were noted. In addition, two large, approximately 8 ft by 8 ft, reinforced box culverts were noted, both marked with triple amber delineators. Both culverts have ends immediately at the shoulder edge, and several feet of very steep foreslopes exist on either side of the culverts.

Figure A.4. Northbound view just north of curve

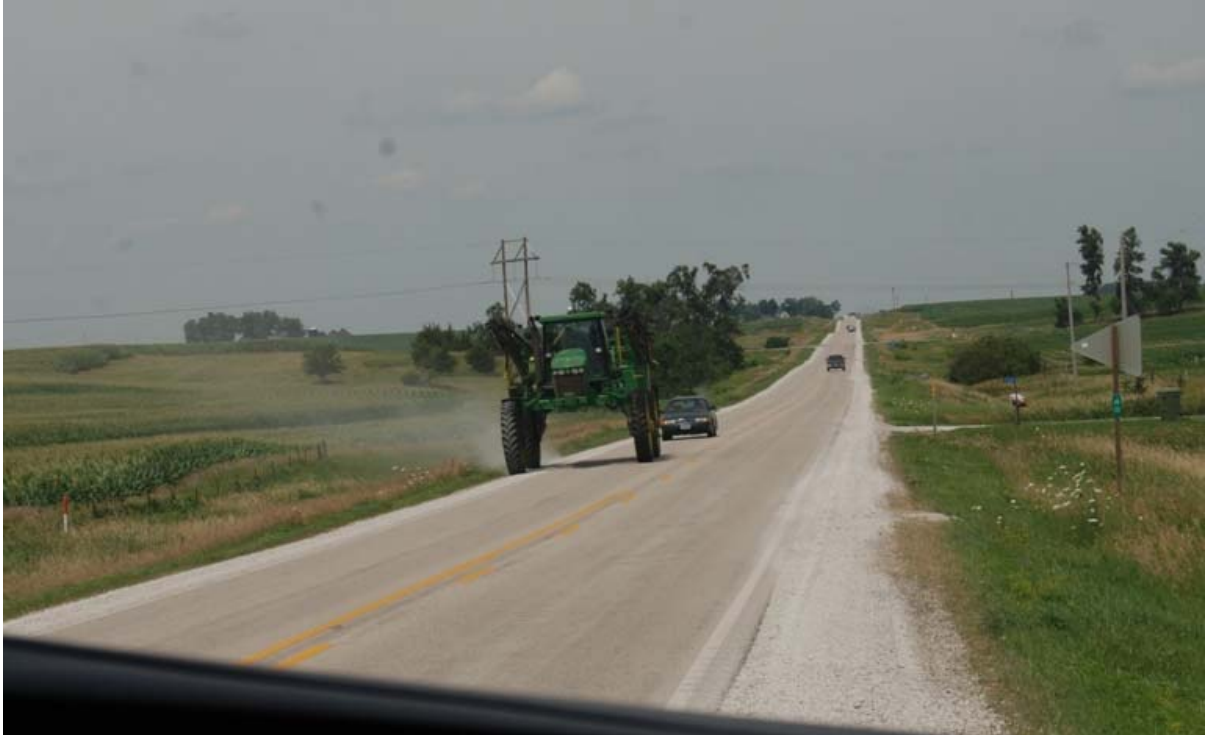
Sgt. Eyberg suggested that farm equipment warning signs and "Share the Road" plaques be considered for the IA 25 section, especially in light of the crashes involving farm machinery in the crash history. Crash history, existing conditions, and the *Manual on Uniform Traffic Control Devices* (MUTCD) guidance should be studied in more detail before erecting this signage. Sgt. Eyberg also suggested that "School Bus Stop Ahead" signs be considered where appropriate.

Figure A.5. Agricultural equipment

- Discuss replacement of heavy steel mailbox supports with the property owners.
- Several crashes, including one fatal, involved slow moving farm equipment. If that type of vehicle is a frequent road user, consider installation of Vehicular Traffic signs, W11-5 or W11-5a, possibly accompanied by Share the Road, W16-1, plaques.

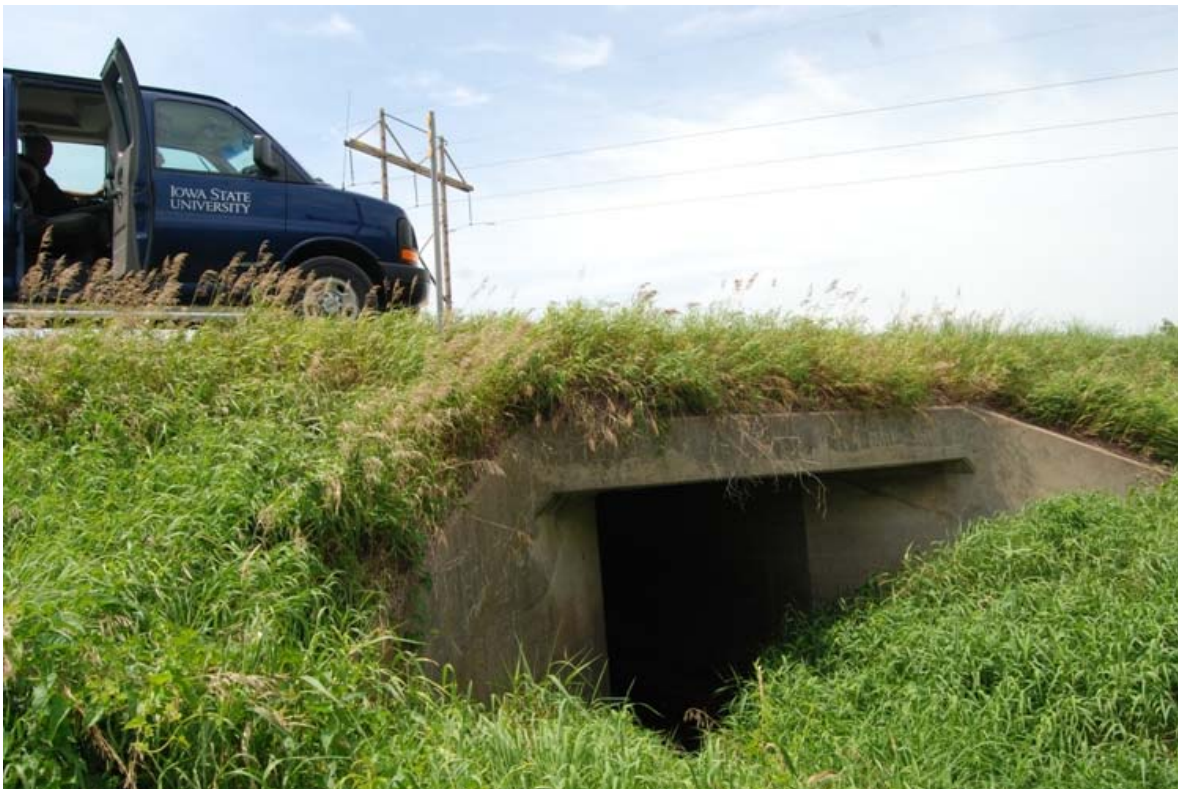
Figure A.6. Large culvert under IA 25

- Consider a future resurfacing, restoration, and rehabilitation (3R) project to widen the 22 ft pavement when surface conditions indicate a need for restoration. Include extension or shielding of large reinforced box culverts as part of the project.

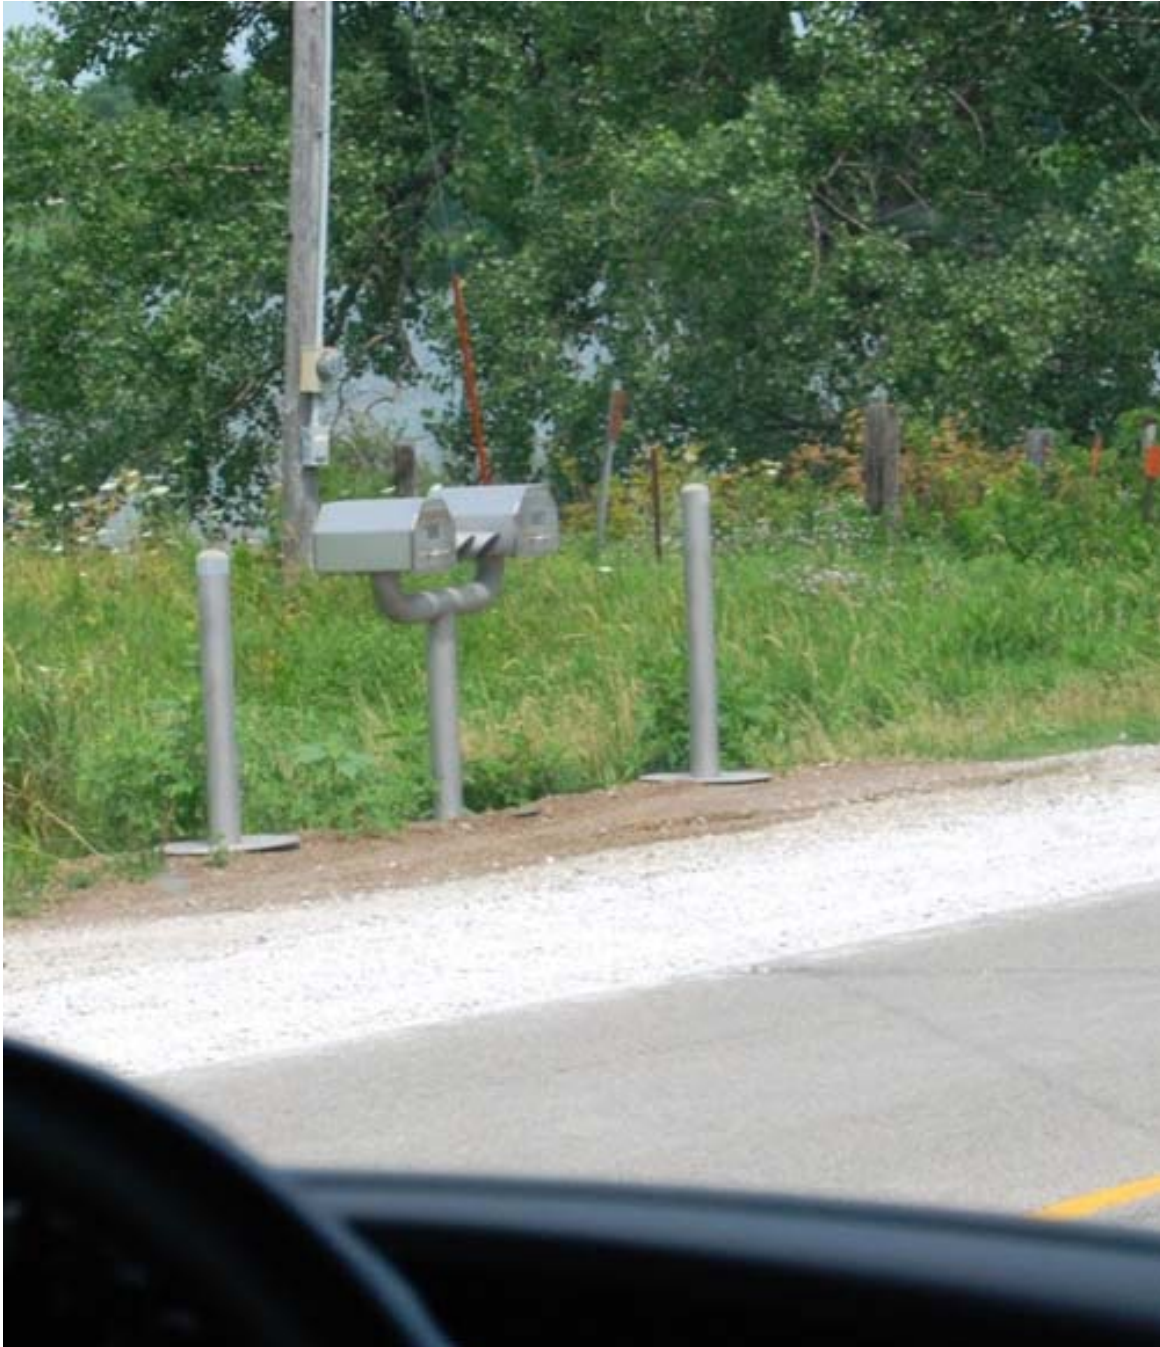
Figure A.7. Mailbox support and guard posts

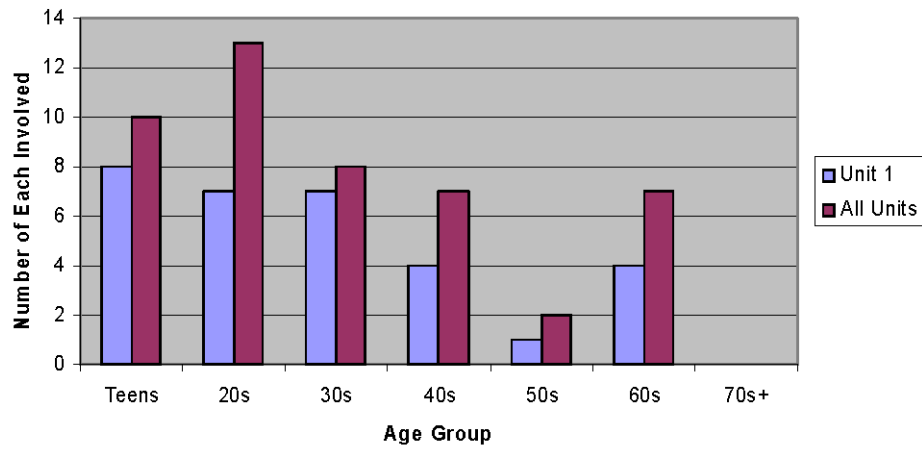
Figure C.11. Crashes by driver age

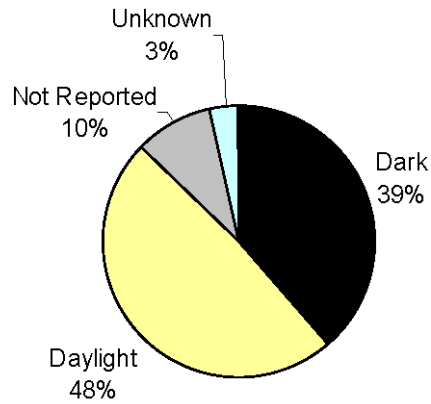
Approximately 48% of the crashes occurred in daylight conditions, and 39% in the dark.

Figure C.12. Crashes by light conditions

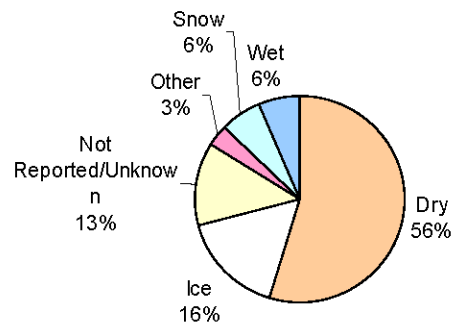
Roadway surface conditions were dry for 56% of the total crashes; wet surface, snow, and ice were noted for 28% of the crashes. Adverse weather conditions were noted in approximately

Figure C.13. Crashes by surface conditions
