# Road Safety Audit for County Road H-46 from Redwood Avenue to the Southerly Corporate Limits of Fairfield in Jefferson County, Iowa

# Final Report January 2010

# ROAD SAFETY AUDIT FOR COUNTY ROAD H-46 FROM REDWOOD AVENUE TO THE SOUTHERLY CORPORATE LIMITS OF FAIRFIELD IN JEFFERSON COUNTY, IOWA

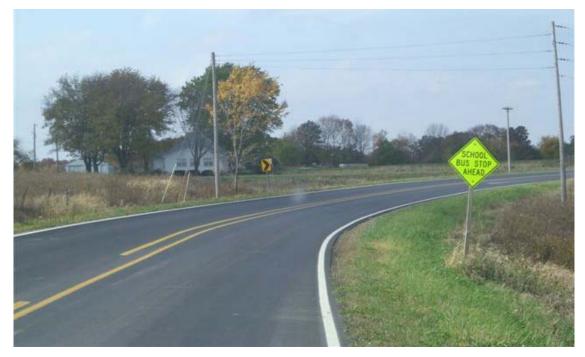
Palm Boulevard intersects H-46 from the south near a horizontal curve. One fatal crash, possibly weather related, was recorded in this area during the review period. Widely spaced, larger size chevron warning signs mounted on brackets are in place through this curve. For northbound traffic approaching this area, a curve warning sign with a 45 mph advisory speed is in place. A School Bus Stop Ahead warning sign is also located in advance of the curve.

Figure A.1. School bus warning sign and chevron along horizontal curve at Palm Boulevard intersection

The existing chevrons along the curve near the Palm Boulevard intersection would be more effective if these devices were repositioned to more closely comply with 2009 Edition of the *Manual on Uniform Traffic Control Devices* (MUTCD) guidelines. In addition, at least one more chevron should be added to enhance visibility of the curve for southbound drivers approaching the area from the north.

- Review the existing chevrons on the curve near Palm Boulevard for needed upgrades, such as adding of mounting brackets, re-spacing to match 2009 MUTCD guidelines, and possibly using fluorescent yellow, microprismatic sheeting. Consider similar sheeting for the curve warning signs at this location.
- Consider installing a hidden driveway warning sign easterly of Palm Boulevard for northbound traffic.
- Discuss with the affected property owner the removal of a large tree that hampers visibility at the Osage Avenue intersection.
- Study the feasibility of deer fencing along the right-of-way between Palm Boulevard and Queenscup Road, where there has been a high concentration of deer crashes.
- Monitor the pavement surface for friction quality.
- With a future resurfacing project, consider installing milled-in pavement markings for better longevity and performance.

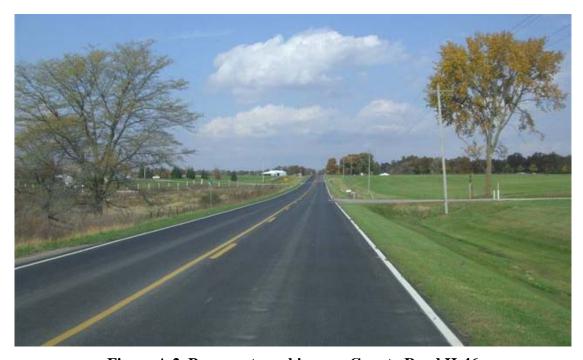
The pavement markings on the newly applied Gilsonite surface treatment were quite visible, with good retroreflection. In addition, the markings beyond the Gilsonite section also appeared very satisfactory.

Figure A.2. Pavement markings on County Road H-46

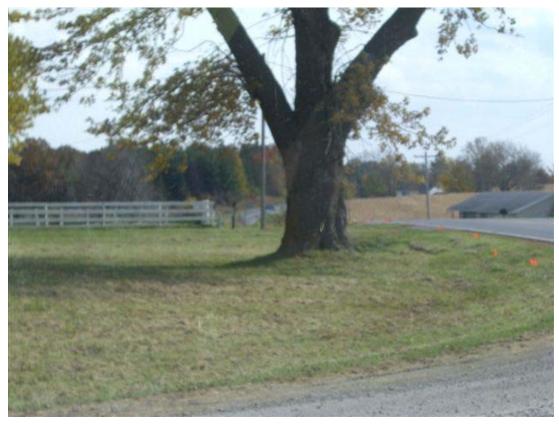
Figure A.3. Large tree obstructing view from side road at Sage Avenue intersection

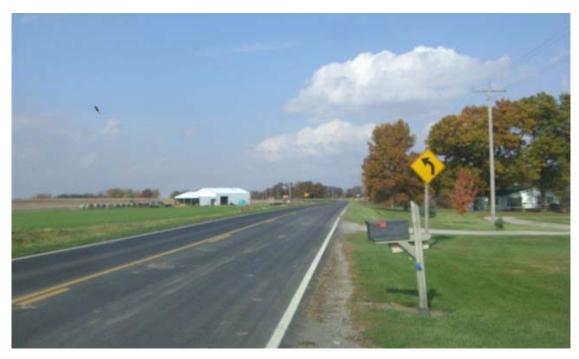
Figure A.4. Curve sign and mail box

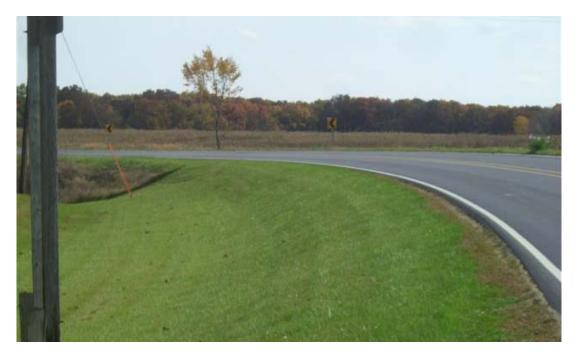
Figure A.5. Chevron installation along horizontal curve

Only one curve in the reviewed section has been delineated beyond standard pavement markings. Enhanced guidance along several curves with higher degrees of radius would be effective, perhaps using single white delineators spaced according to 2009 MUTCD guidelines or using devices similar to the Carsonite product to provide flexible supports.

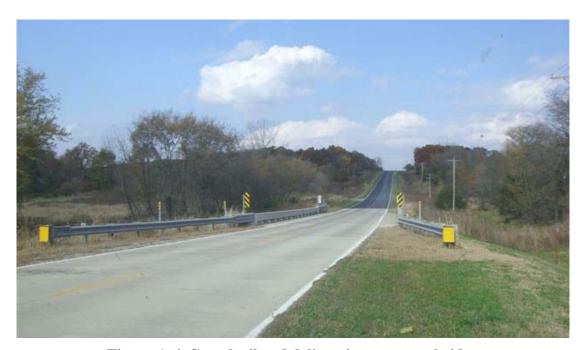
Southeasterly from Pine Avenue, a newer bridge with a current guard rail exists. Vertical panels marking the bridge ends are in good condition. Beyond the bridge, H-46 features a long vertical rise with numerous private entrances and roads. One private road serves seven to eight residences. Advance sight distance to this private road connection for northbound drivers is hampered by the vertical geometry of H-46.

Figure A.6. Guardrail and delineation at newer bridge

Visibility of the bridge and guardrail southerly from Pine Avenue could be improved by replacing the vertical panel object markers and delineators. Additional delineation along the face of the guardrail would also be very effective.

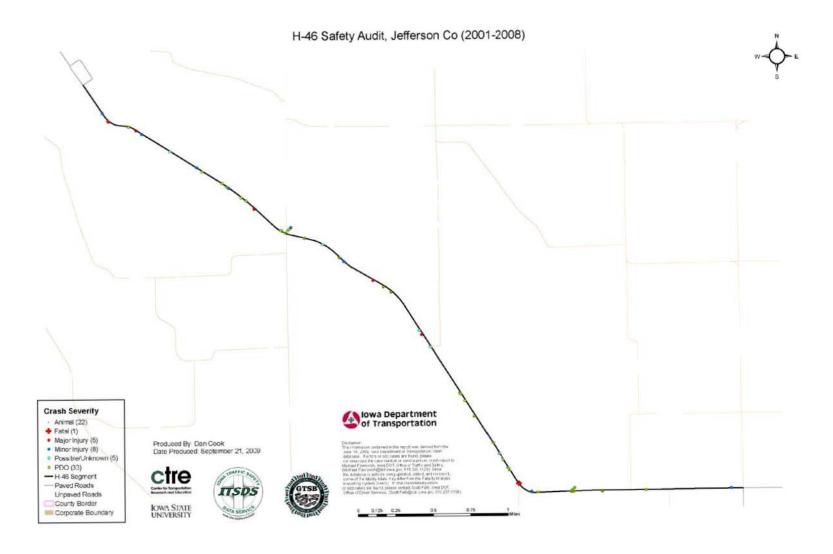
Figure B.1. Crash map for 2001 to 2008

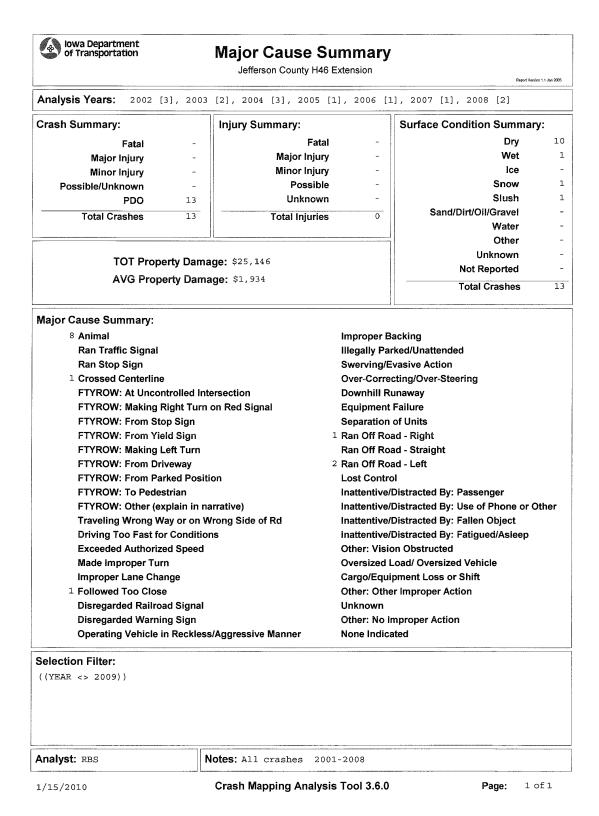
Figure B.2. CMAT major cause summary
