7040-015 Saylor Creek Sub-Watershed Final Report

PROJECT: Saylor Creek Channel Improvements
Ankeny, Iowa

TITLE: South Channel Area

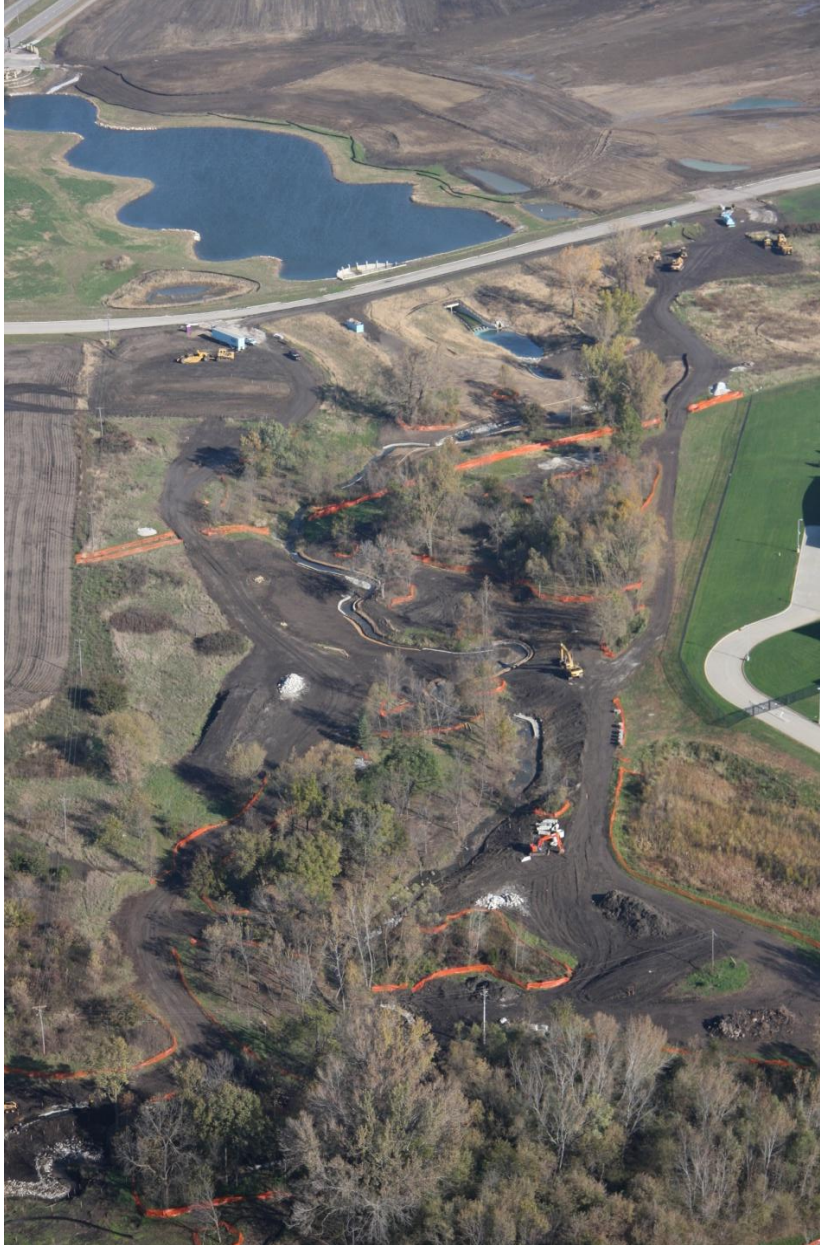
Photo courtesy of DRA Properties, LLC

The photo on Page 4 was taken when the work was in progress, in the fall of 2009. Note the white strips along the stream meanders. Those are the A-Jacks® toe armoring. The orange construction fence is protecting trees and wetland areas from damage. The orange fence in a straight line across the construction area is designating the route of a high-pressure gas main, and restricted the construction equipment to only cross over the gas main where additional protection measures were provided. The areas cleared of trees were locations where the formerly vertical banks were sloped back to a stable angle. The attached drawing labeled as Figure 6 shows the improvements as they were proposed in the conceptual design plan and submitted with the initial application for WIRB funding. The next drawing, entitled South Channel Area, shows the actual constructed improvements based on as-built surveys.

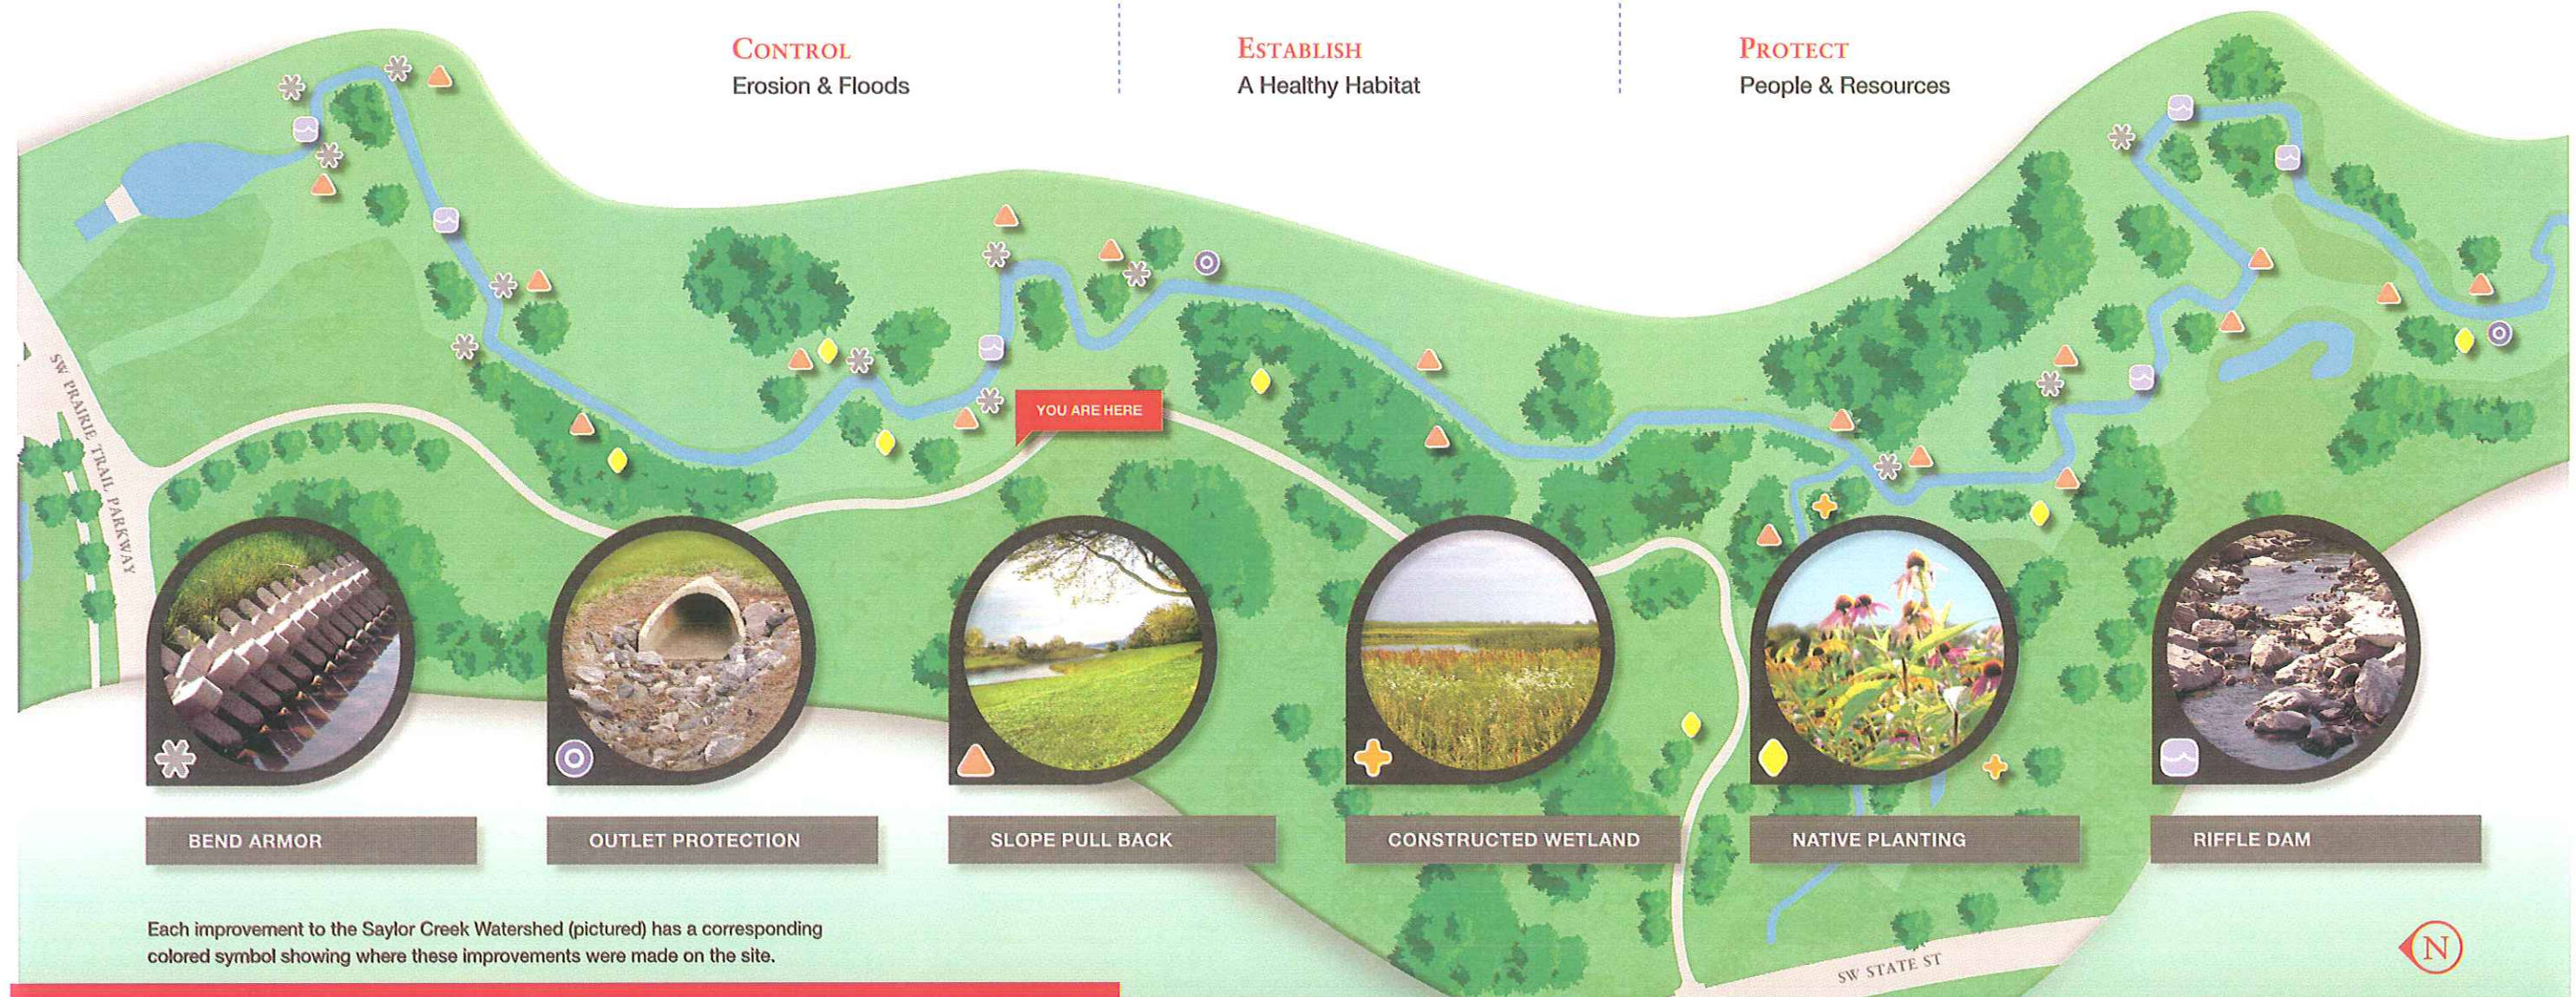
Saylor Creek Restoration

Each improvement to the Saylor Creek Watershed (pictured) has a corresponding colored symbol showing where these improvements were made on the site.

- **Bend armor** – stacked, interlocking concrete "jacks" protect the base of creek bends from water flow erosion
- **Outlet protection** – structural reinforcements slow heavy storm water flows exiting the pipe to prevent erosion
- **Slope pull back** – harsh, vertical banks are shaped into stable slopes that spread water out so it rises slower in big rains

- **Constructed wetland** – prairie grasses and wetland plants hold water, filter it and make great refuges for wildlife
- **Native planting** – beautiful, deep-rooted plants absorb, retain and re-distribute water; they hold soil in place
- **Riffle dams** – water "ruffles" over these gravel/rock dams creating oxygenated still pools where aquatic life thrives
