## **Watershed Improvement Review Board**

# **Final Report**

Project Name: Viking Lake Watershed

**Project Sponsor:** Southwest Regional Water District (SWRWD)

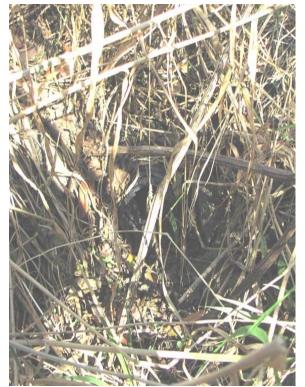
Example of algae-choked water suffering from nutrient enrichment

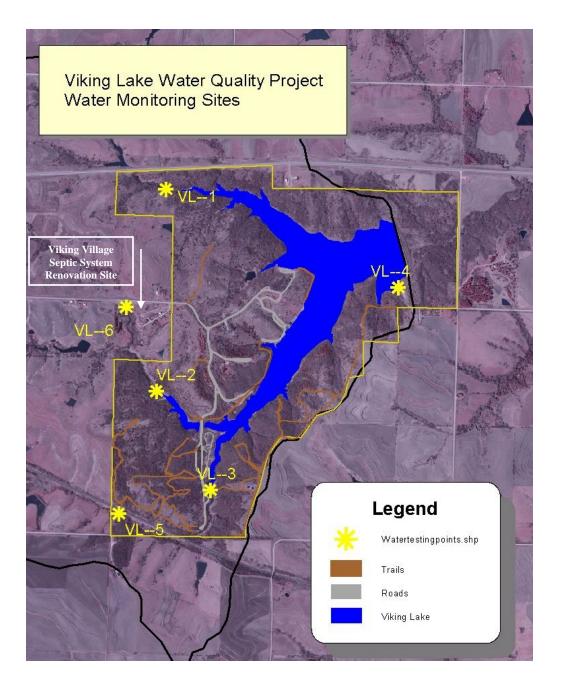
Only surviving preconstruction photo of pipe which outletted directly into lake tributary. Photo taken during no flow conditions.

The small housing development, commonly known as Viking Village, contained an unknown number of residential septic systems which were not functioning in accordance with Iowa Code. Two open discharges were located and it was assumed that others existed. During periods of normal to above-normal rainfall, grey water was observed to be flowing into one of the primary tributaries to Viking Lake, below the development. Water monitoring tests conducted substantiated concerns that bacterial and nutrient contamination was coming from the development.

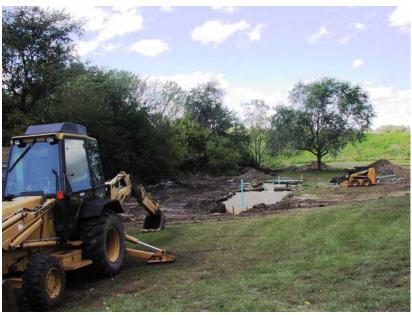
Installation of the sand filters and dosing tank.

septic tanks is periodically dosed into buried sand filters serving as the secondary treatment for the system. The effluent dosing allows metered volumes of wastewater to enter the sand filters by recording hours the pump runs to ensure maximum system efficiency. The system was equipped with an alarm to notitiy system managers if there was a malfunction in the equipment. Clean water is then outletted into a tertiary treatment wetland, on private property, for an extra measure of protection. This water then drains into a wetland, which was renovated during the Viking Lake Water Quality Project, located on DNR park property. A small water and sediment control basin was installed to protect the filter area, system equipment, and inspection pipes from overland flows. A discharge/sampling well was also installed to monitor system performance and provide a collection point for analytical samples.

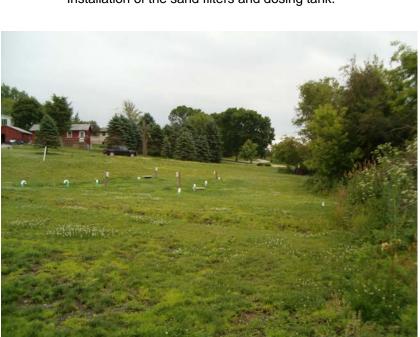
Finished project Year 1, looking south.

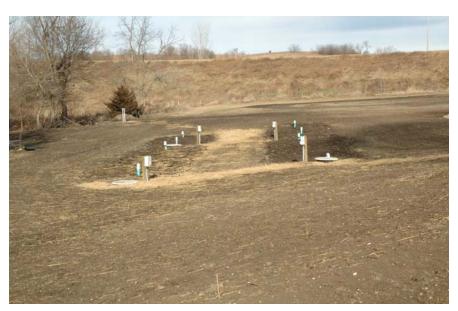
Completed earthwork and new seeding.

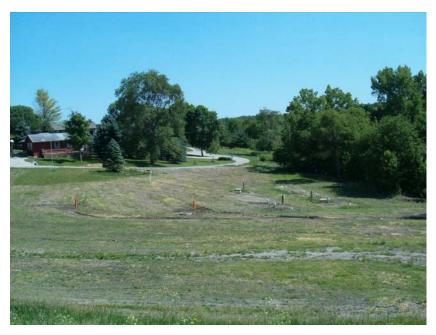
Finished project Year 2, looking south.
