**Interim Report
ISU-ERI-Ames-76036**

ULTIMATE LOAD BEHAVIOR OF FULL-SCALE HIGHWAY TRUSS BRIDGES: PHASE II— SERVICE LOAD AND SUPPLEMENTARY TESTS

Highway Division—Iowa Department of Transportation

ERI Project 1118S

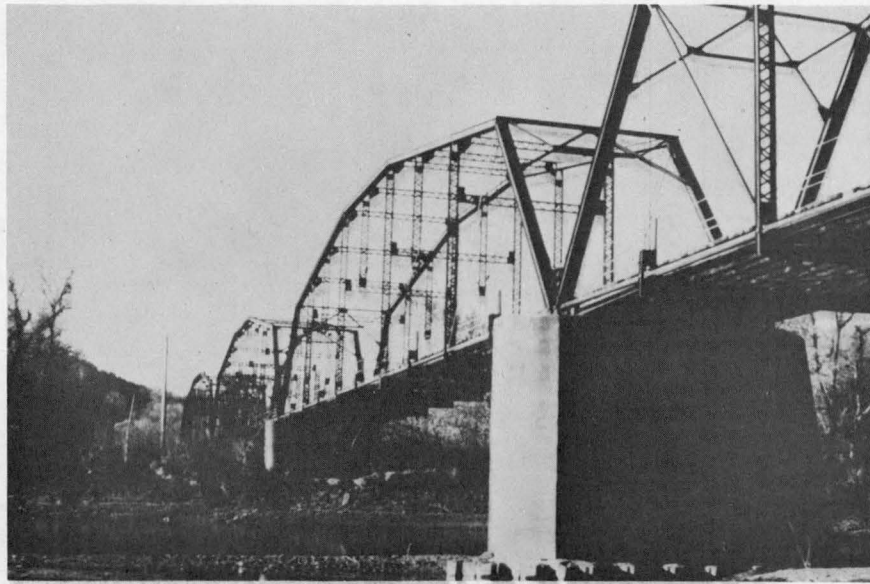
Fig. 1. Photographs of the Hubby Bridge.

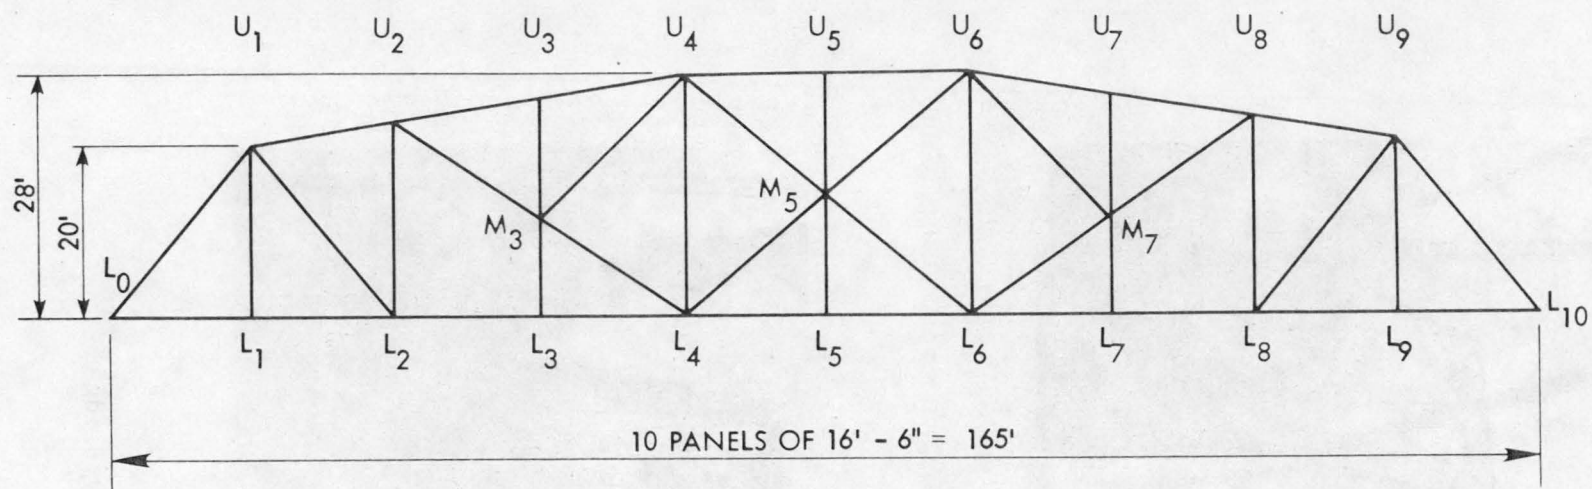
a. Member Layout

b. General Layout

Fig. 2. Details of the Hubby Bridge.

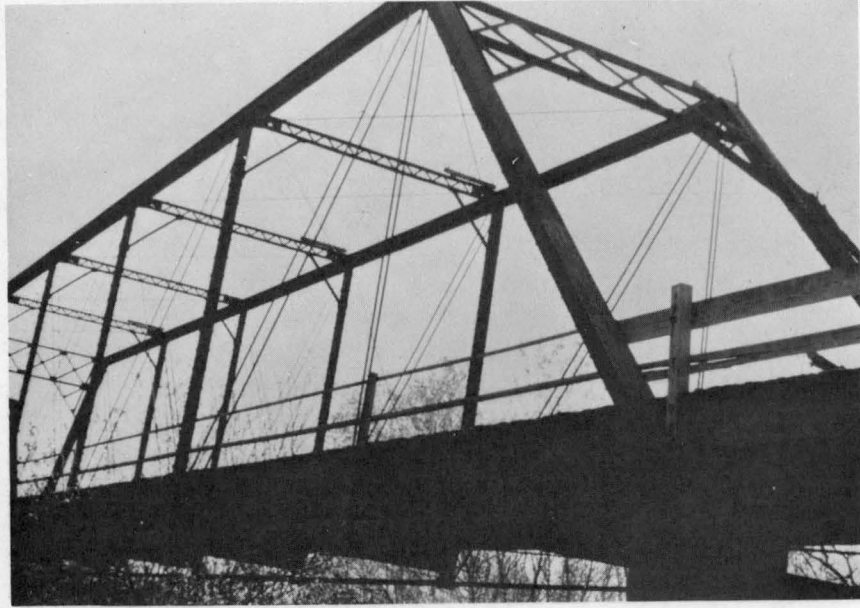
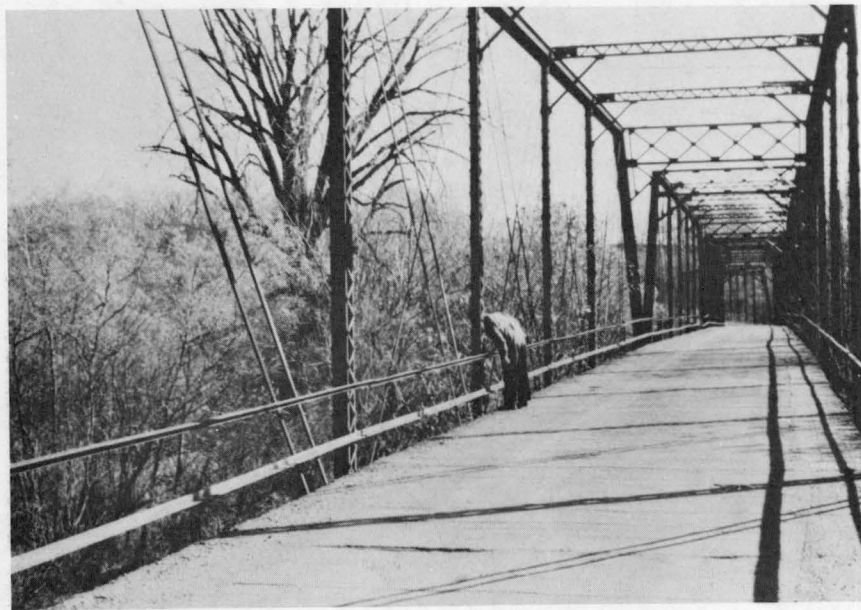
Fig. 3. Photographs of the Chestnut Ford Bridge.

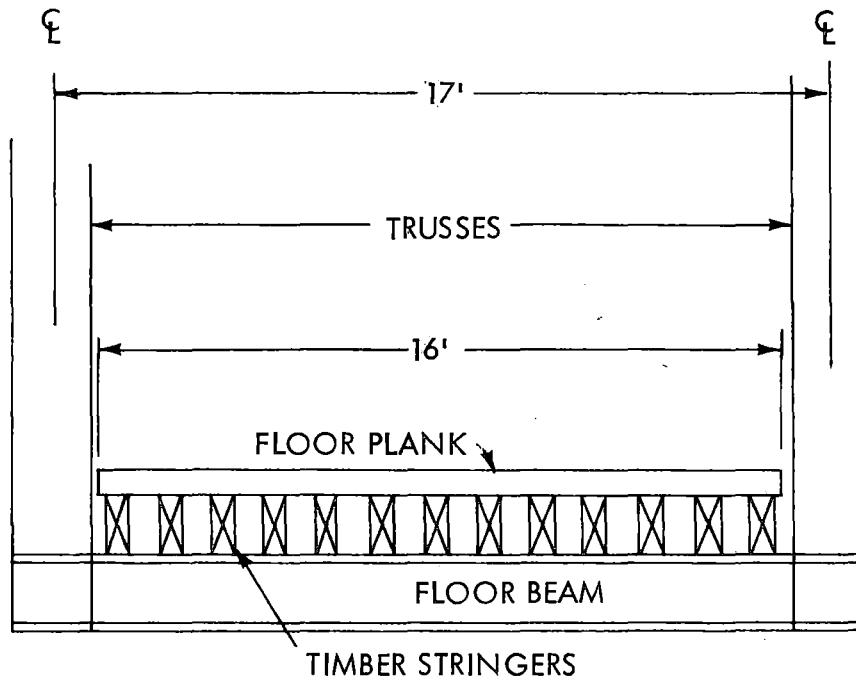
b. End View

Fig. 6. Timber deck layout - Chestnut Ford Bridge.

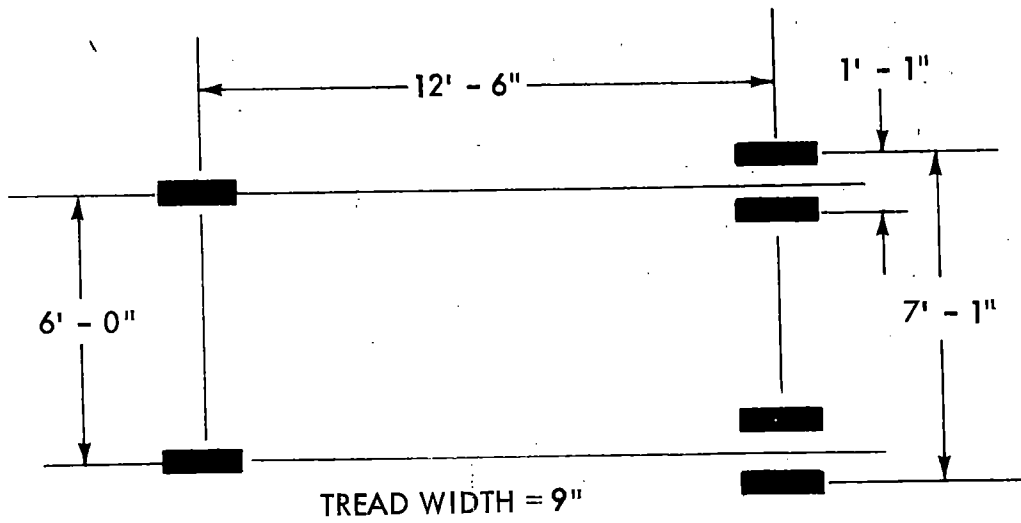
Fig. 7. Description of truck for Hubby Bridge testing (wheel locations).

experimental truck (Figs. 7 and 8), at each panel point and calculating the resultant bar force using determinate analysis. Each of the graphs shows the theoretical influence line for the member as a solid line. In the testing of the two spans of the Hubby Bridge both the north and the south truss were instrumented. The experimental influence lines for both trusses are shown as broken lines. Only the influence lines for a truck on the centerline of the bridge are shown. For the truck on other transverse positions on the bridge, the influence lines would have the same shape and be proportional to those shown.

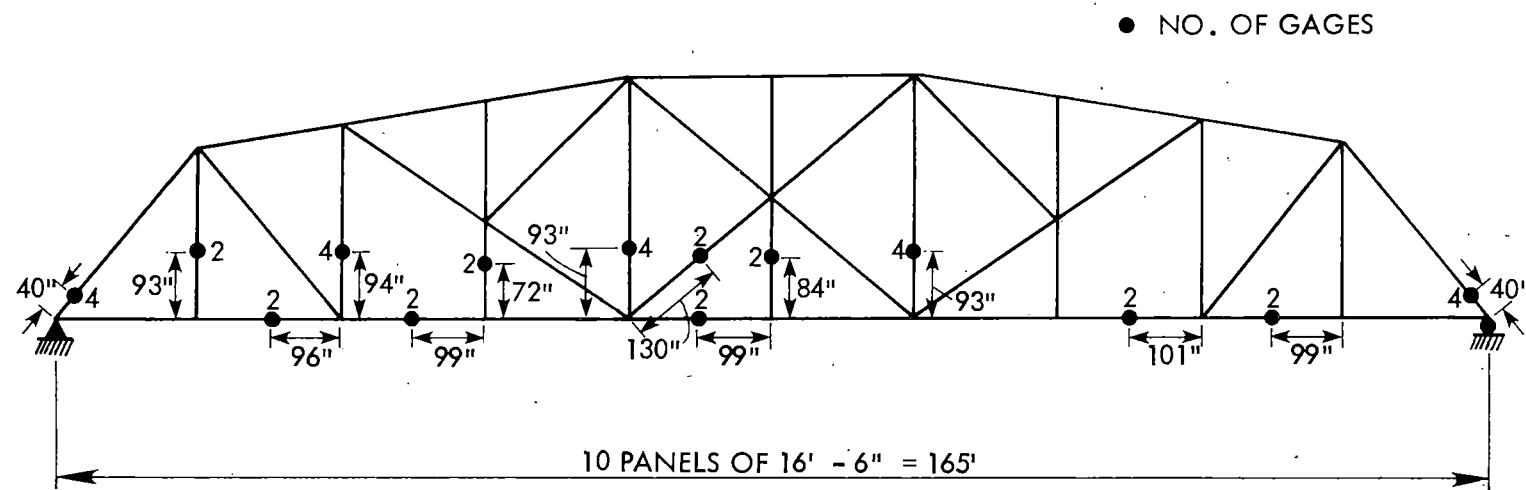
Fig. 10. Location of strain gages on Span 1 - Hubby Bridge.

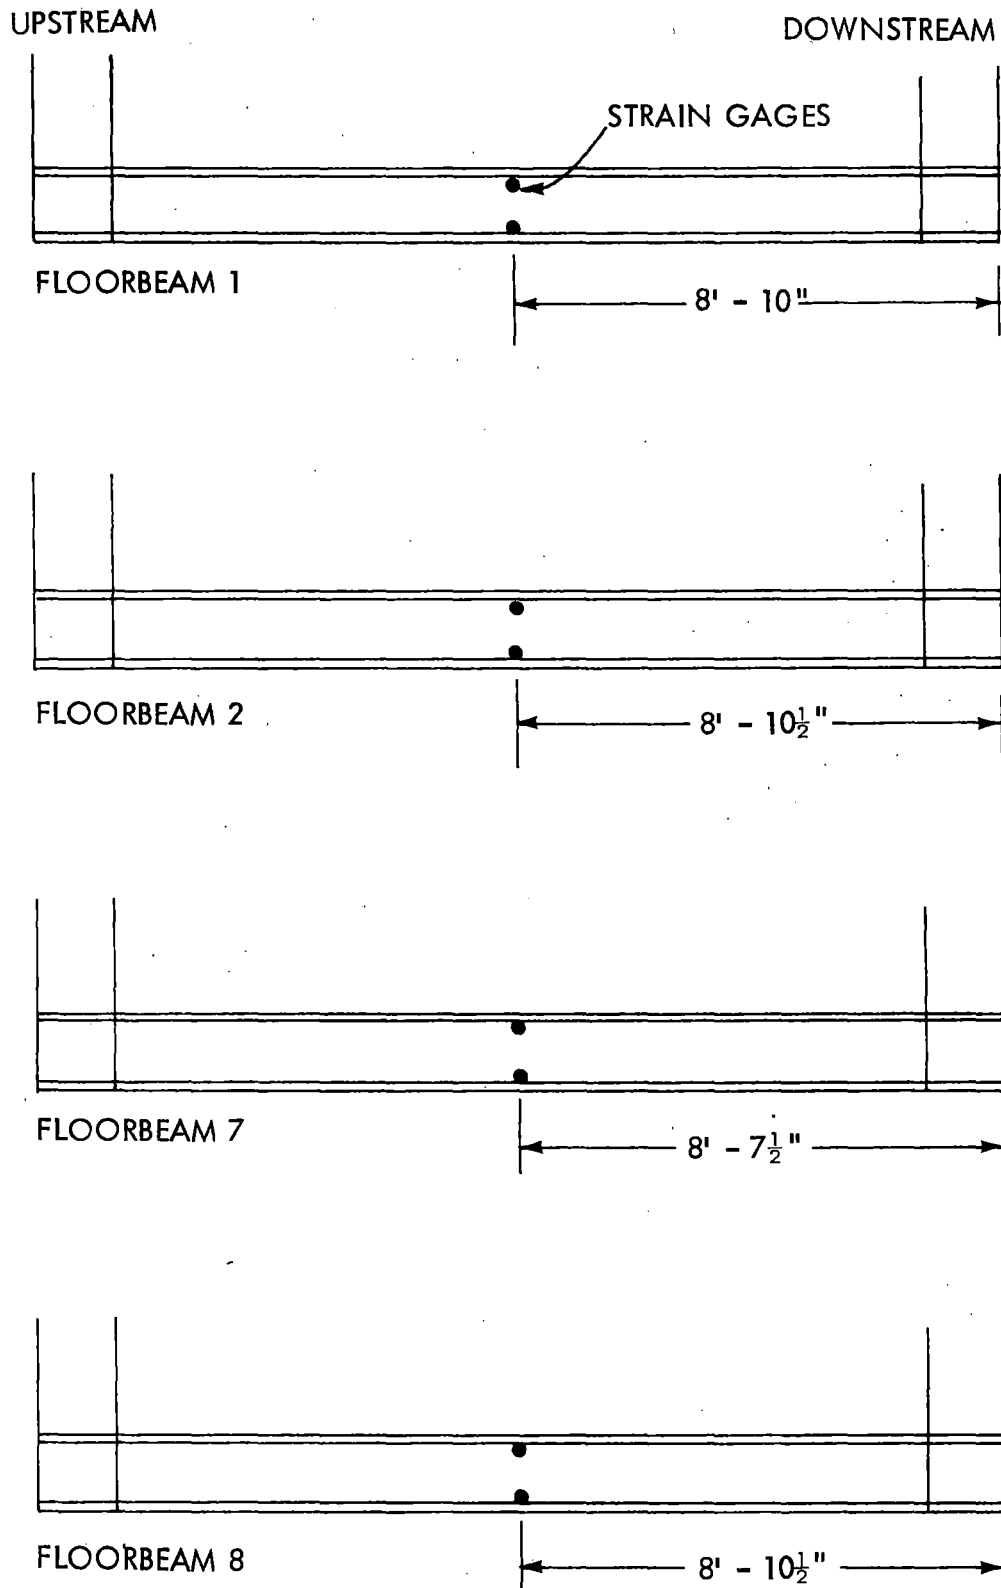
Fig. 15. Location of strain gages on floorbeams in Span 2 - Hubby Bridge.

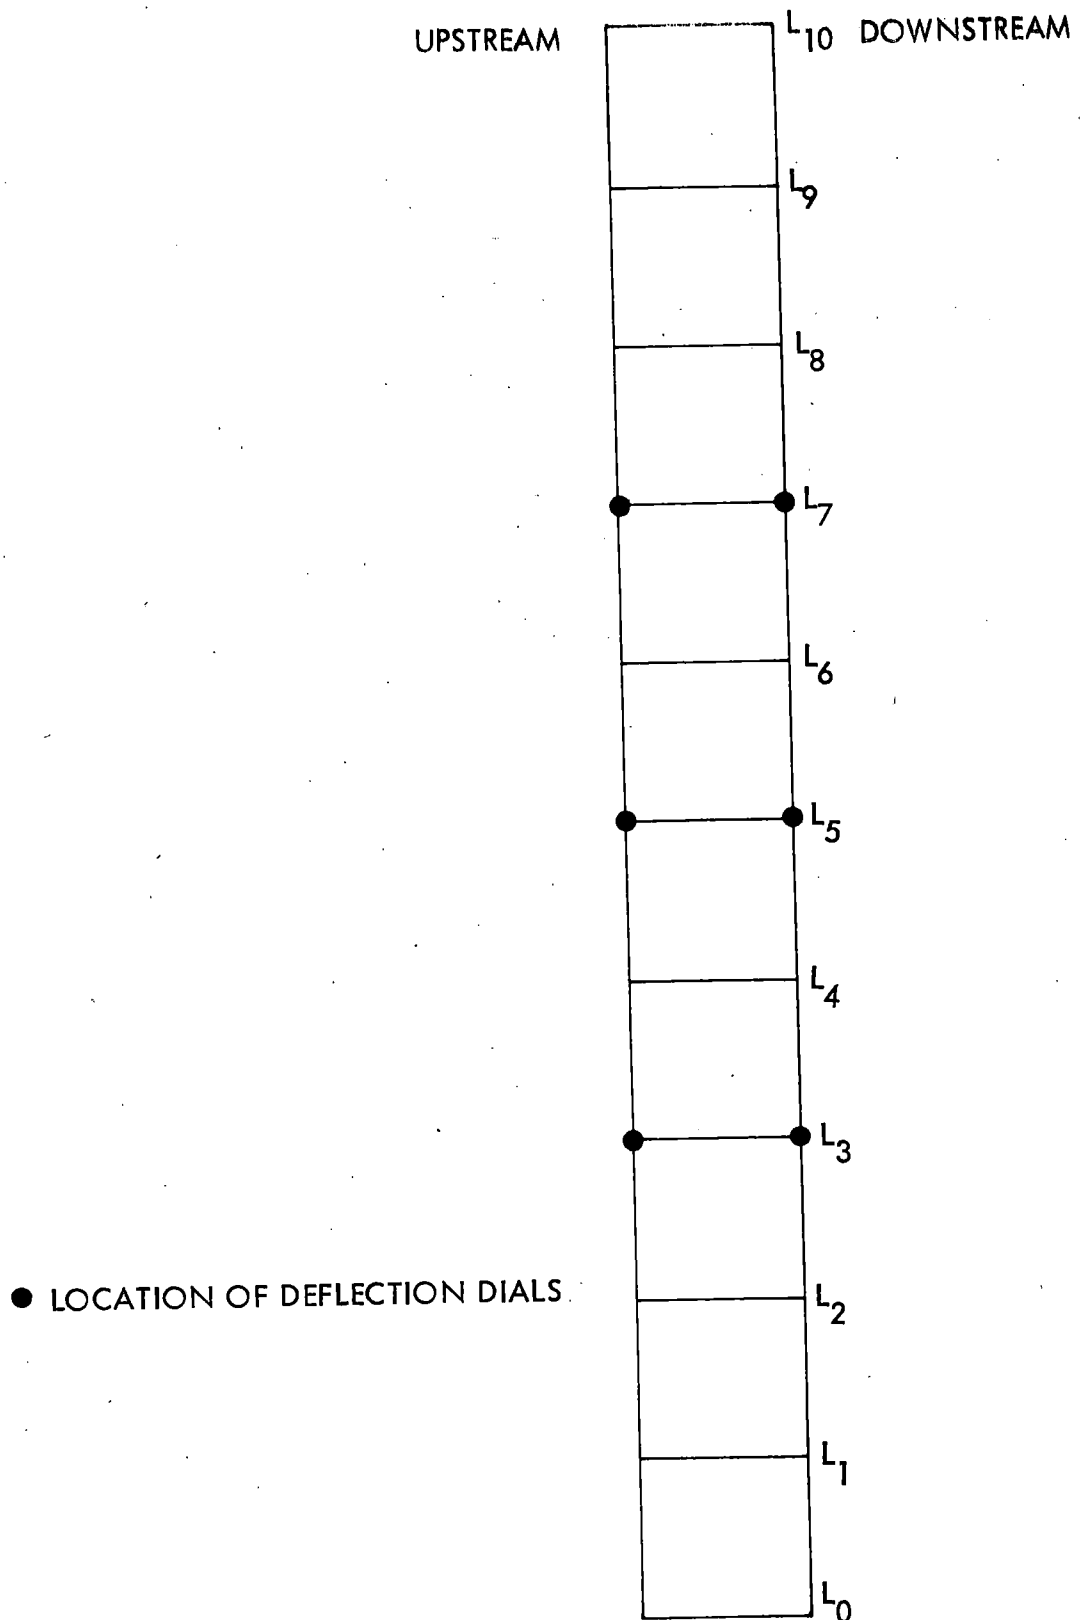
Fig. 17. Location of deflection dials for Span 2 - Hubby Bridge.

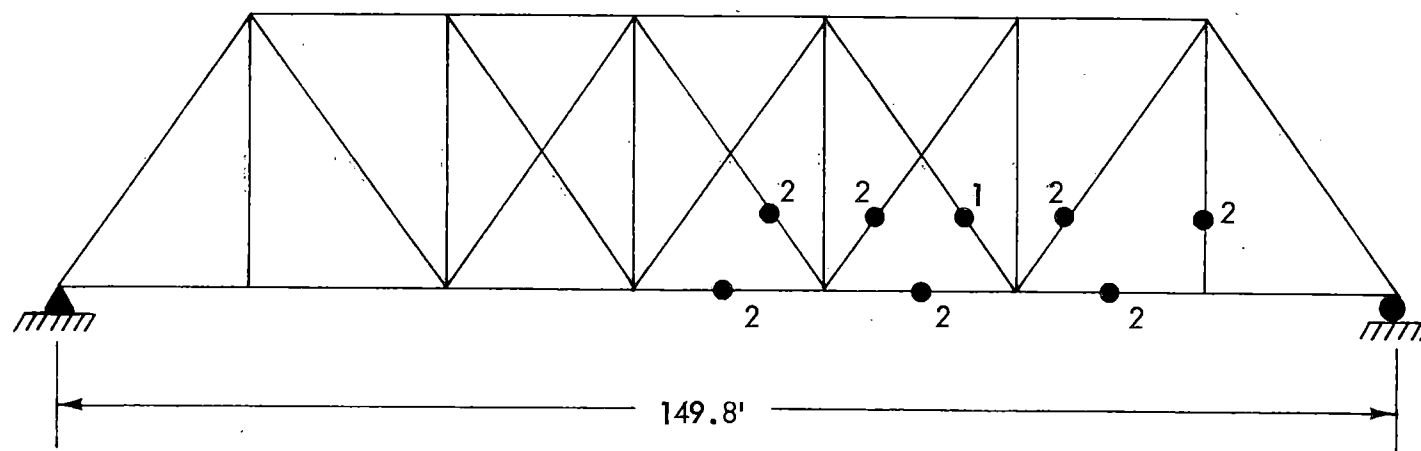
Fig. 18. Location of strain gages on Chestnut Ford Bridge.

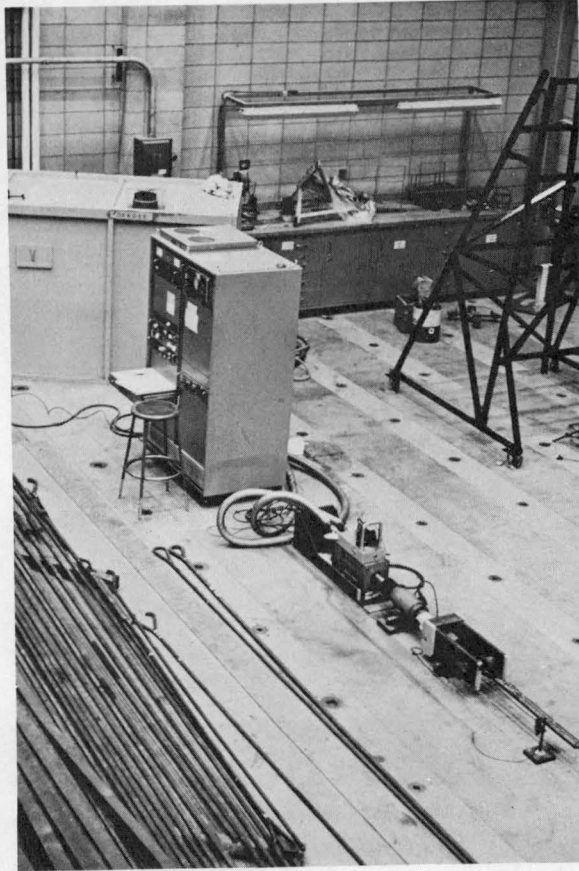
Fig. 19. Photograph of fatigue apparatus.

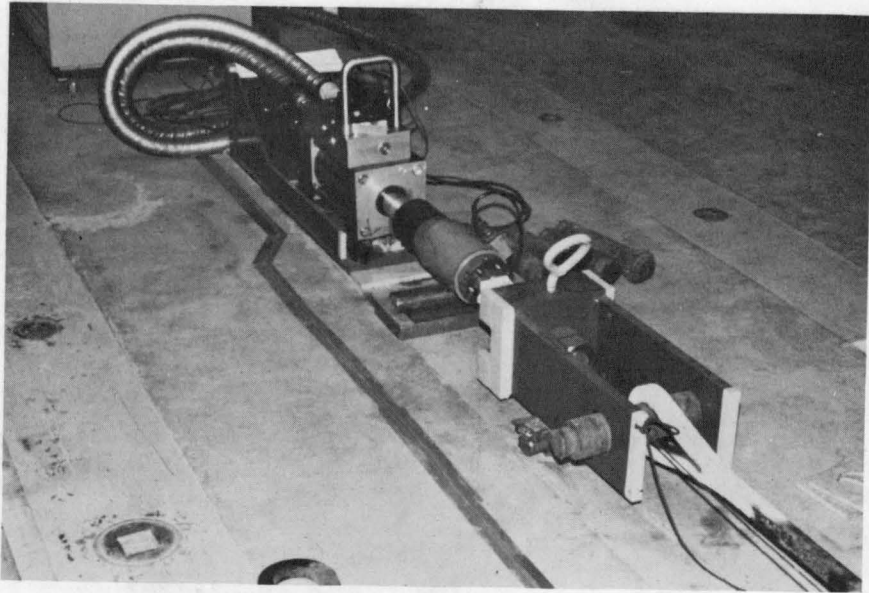
Fig. 20. Photograph of pin in fatigue test apparatus.

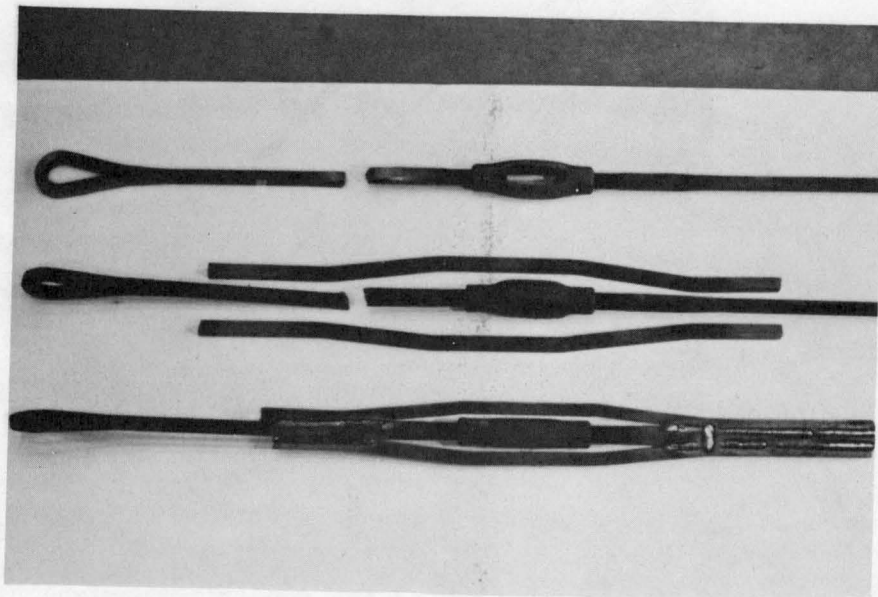
Fig. 21. Photograph showing the repair for a fracture in the forging at a turnbuckle.

1. The first type of damage simulated a fracture in the forging area near a turnbuckle. Two eyebars were cut at a forging near a turnbuckle (Fig. 21) and were then welded back together. Two pieces of cold-rolled bar stock of the same dimensions as the eyebar were spliced onto the eyebar over the fracture (Fig. 21). The splices extended for at least one foot in each direction from the fracture. All of the welds were made in the flat position using E7024 welding rod at 200 amps.

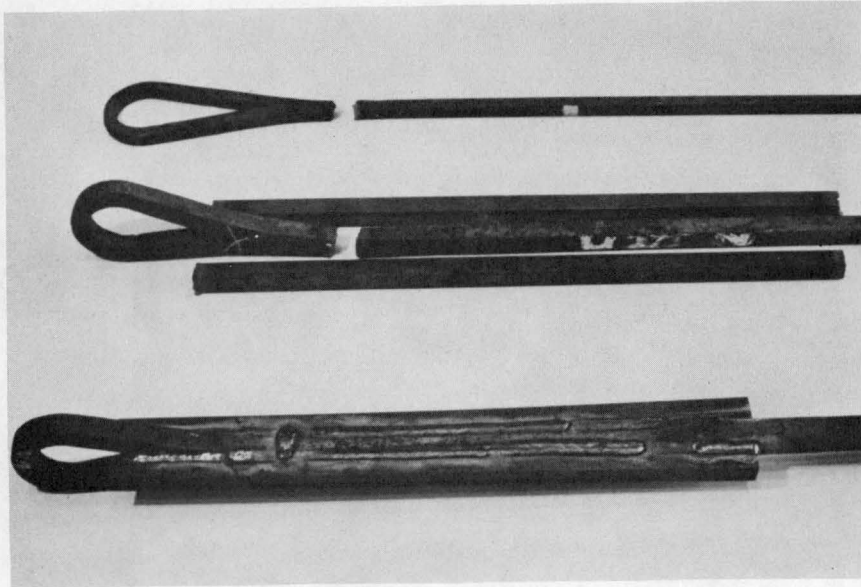
Fig. 22. Photograph showing the repair for a fracture in the forging at the neck of an eye.

2. The second type of damage simulated a fracture in the neck of an eye. Four eyebars were cut in the neck of an eye and were then welded back together (Fig. 22). Pieces of cold-rolled bar stock were spliced over the fracture. The splices extended as far into the eye as possible and at least two ft. along the bar past the fracture (Fig. 22).

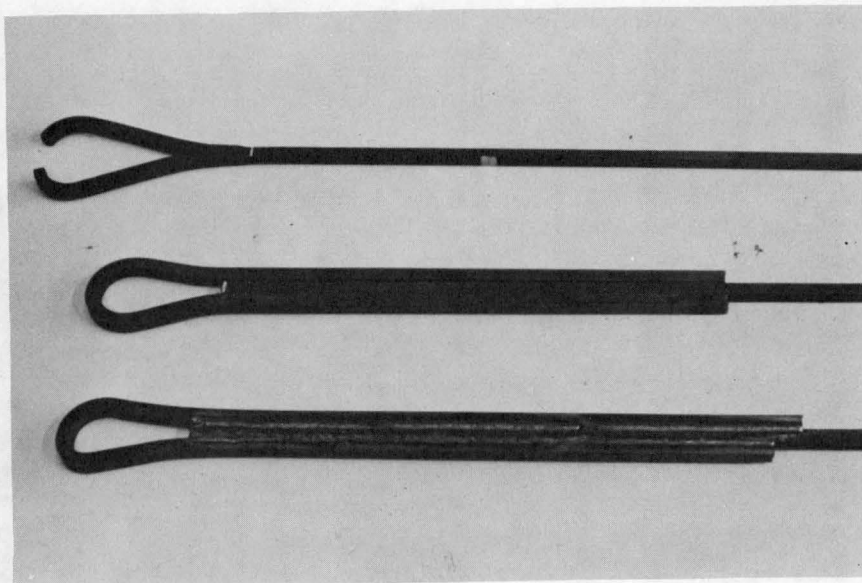
Fig. 23. Photograph showing the repair for a fracture in the eye of an eyebar.

3. The third type of damage simulated a fracture in the eye (Fig. 23). In this case the eye was cut off completely and a new eye was formed out of cold-rolled bar stock. The eye was formed by heating the bar stock cherry red and bending it into a tear-shape. This new eye was then welded onto the original eyebar (Fig. 23).

Two eyebars (Table 5; H24, H25) that were used for simulated damage and repair were eyebars that had already been tested as undamaged eyebars and had fractured in the eyes. The fractured eye was cut off each eyebar and a new eye was formed from cold-rolled bar-stock and welded on (Fig. 23). Upon reloading, each of the eyebars fractured in

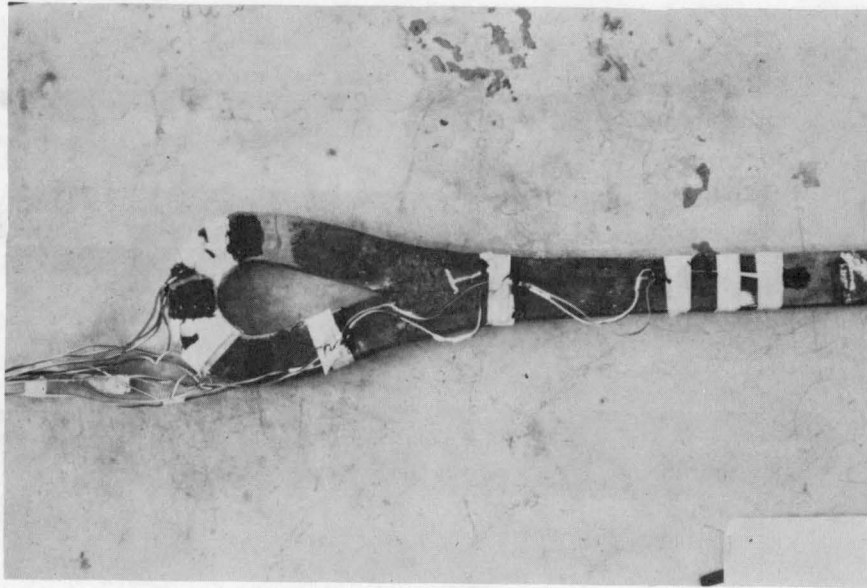
Fig. 24. Photograph showing typical static test specimen with strain gages.

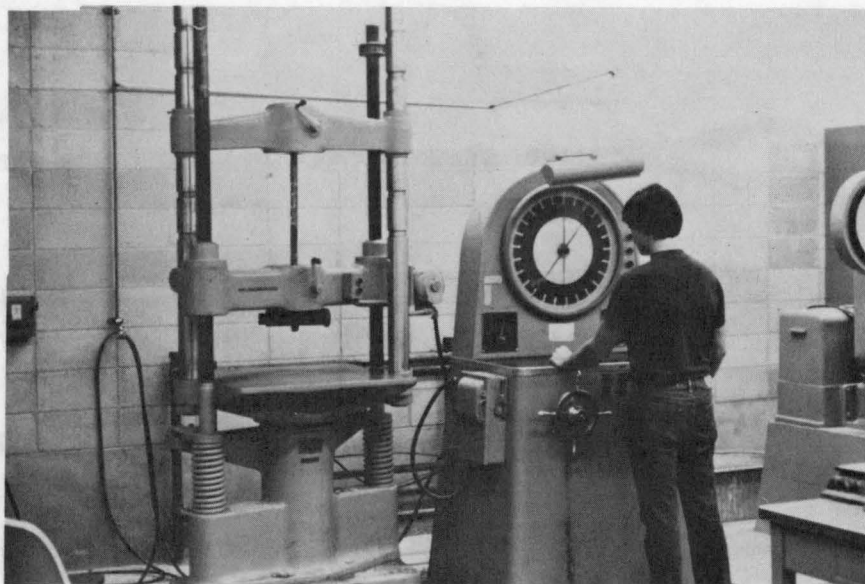
Fig. 25. Photograph showing static test apparatus.

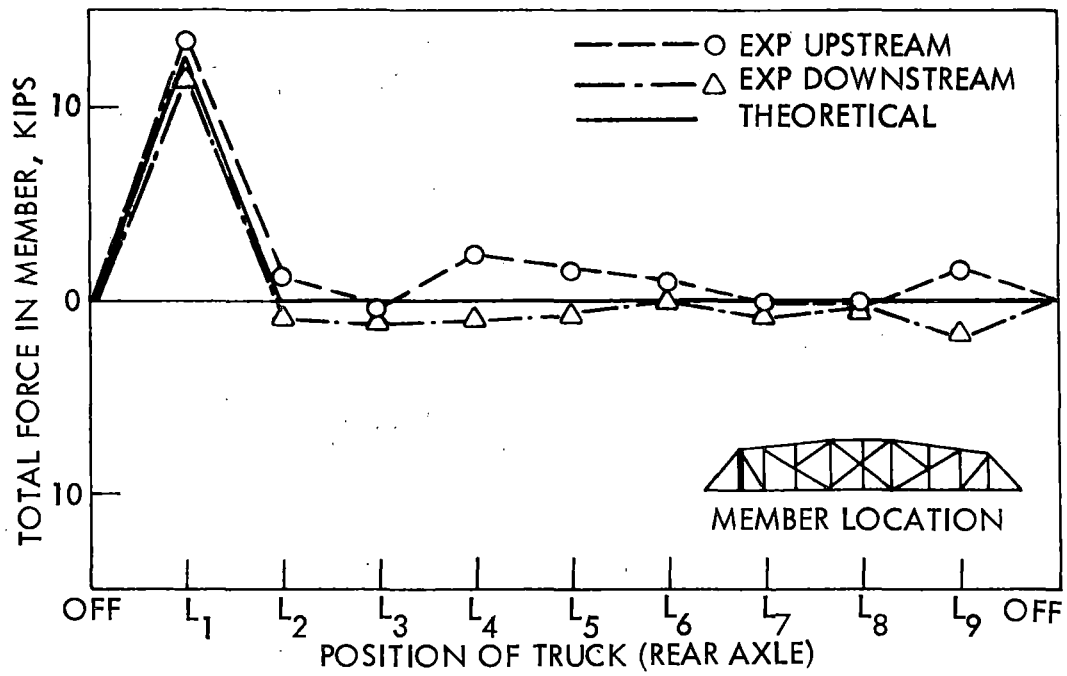
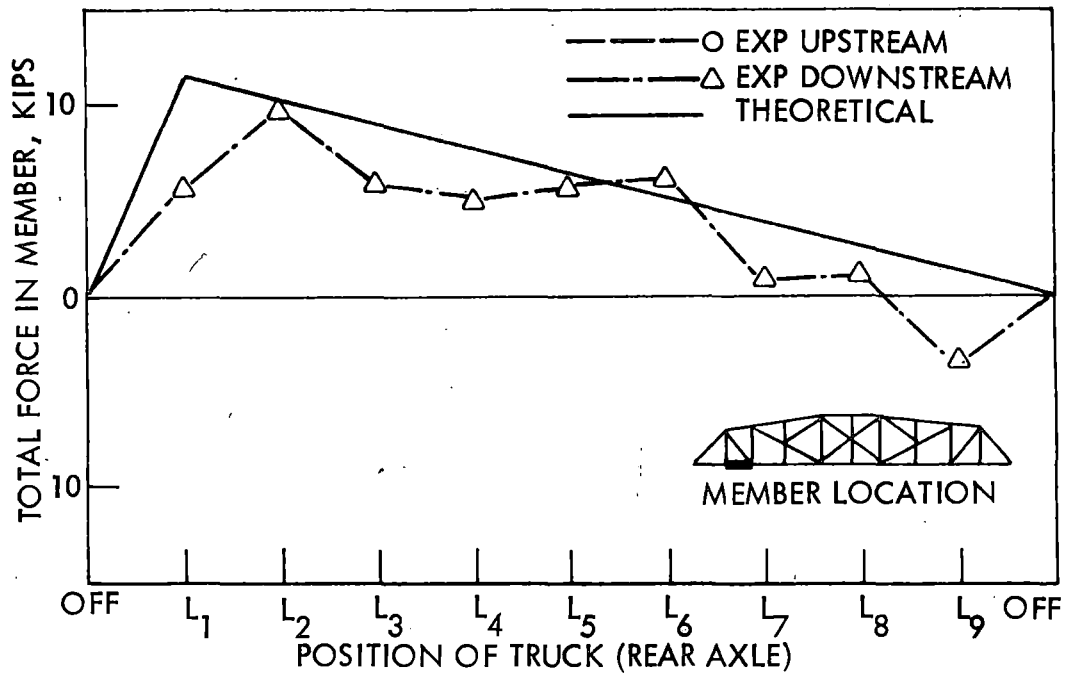
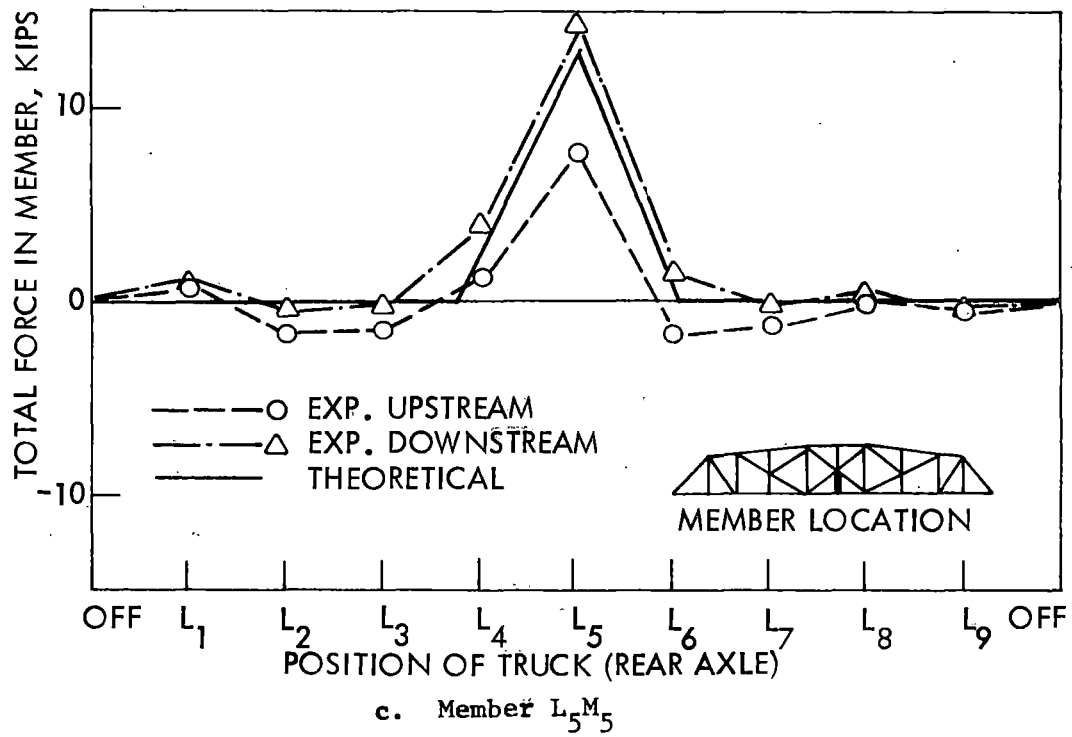
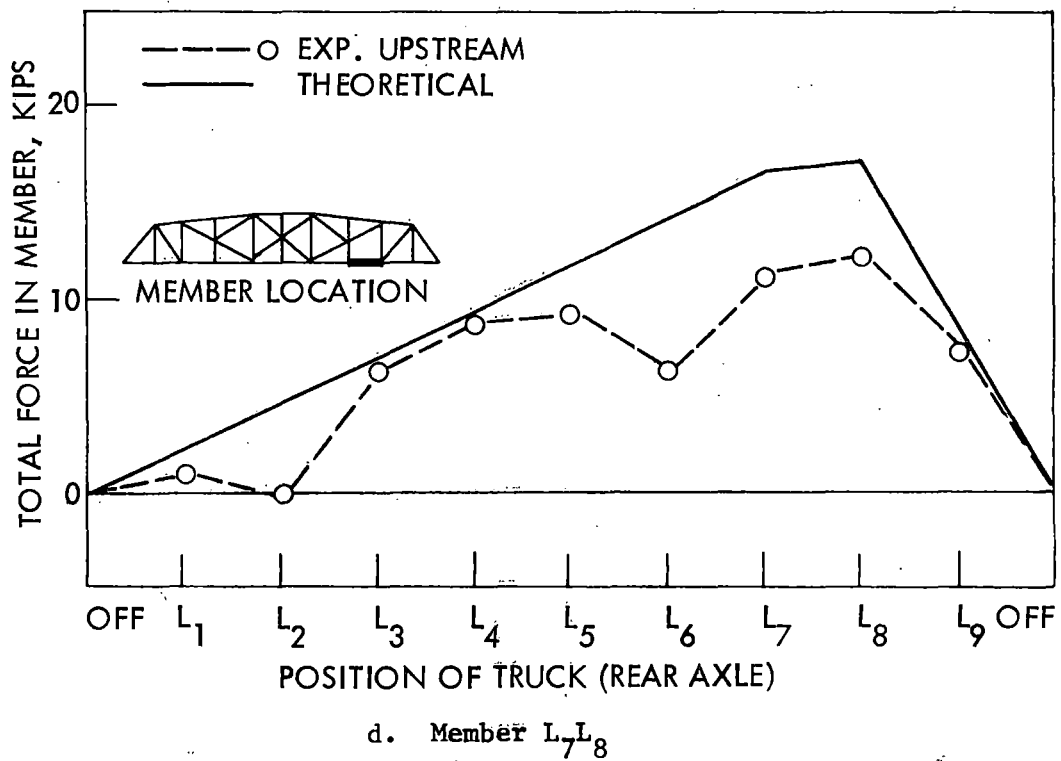
Fig. 26. Influence lines for Span 1 - Hubby Bridge.

It can be seen in Figs. 26 through 29 that in most cases for the Hubby Bridge and in all cases for the Chestnut Ford Bridge, the experimental results agree closely with the theoretical values. Figure 27h is typical of this relationship. The general shape of the experimental influence line is the same as the shape of the theoretical influence line, although the magnitude of the experimental values is less than the magnitude of the theoretical values. This difference is due in part to the partial continuity of the deck which was not taken into account in the theoretical analysis, the condition of the joints, as well as problems in the instrumentation.
