**Interim Report
ISU-ERI-Ames-76036**

ULTIMATE LOAD BEHAVIOR OF FULL-SCALE HIGHWAY TRUSS BRIDGES: PHASE II— SERVICE LOAD AND SUPPLEMENTARY TESTS

Highway Division—Iowa Department of Transportation

ERI Project 1118S

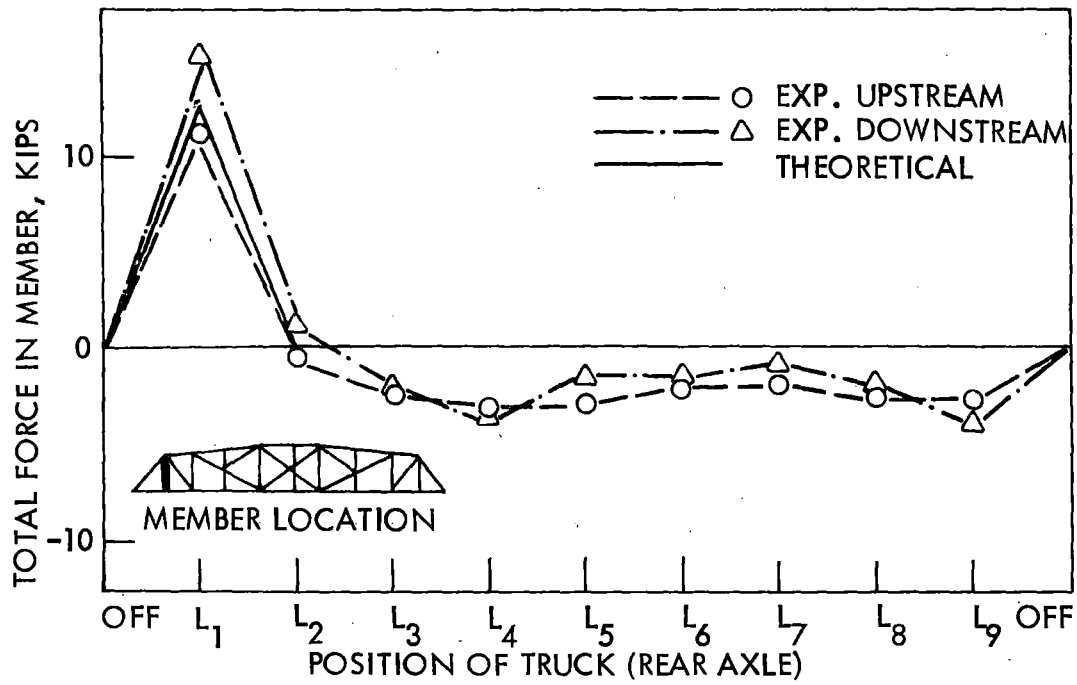
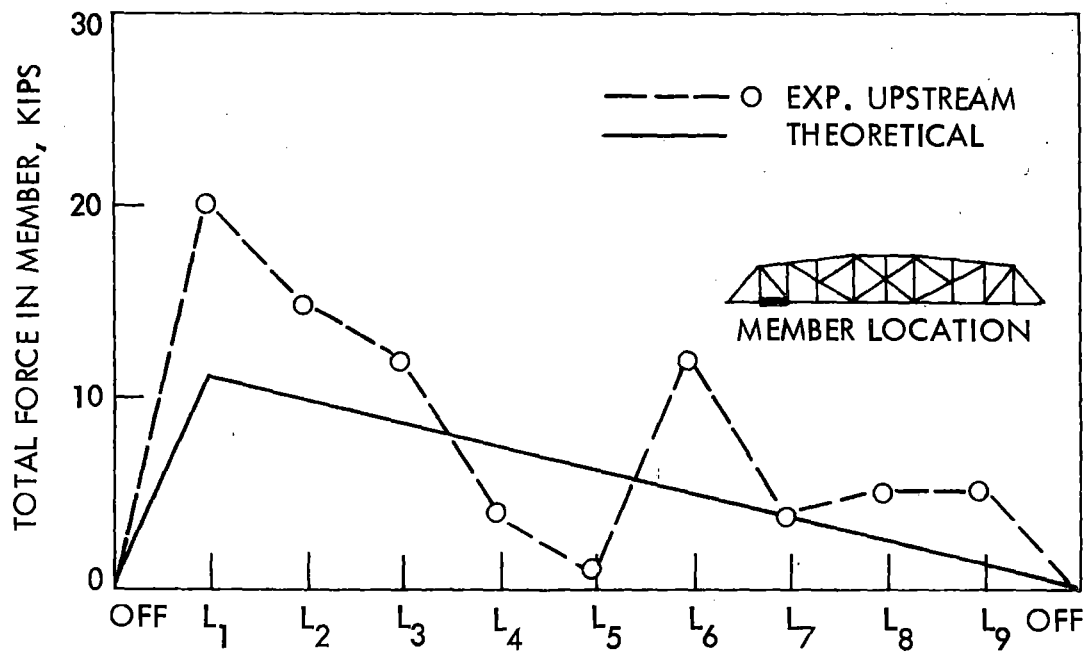
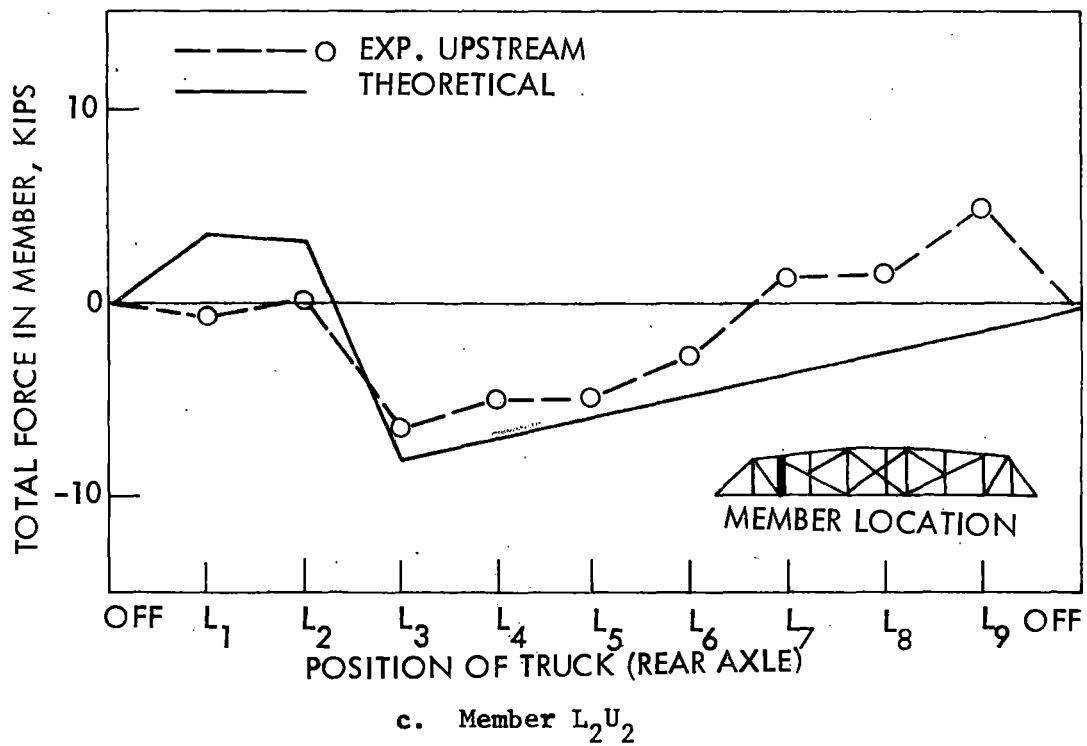
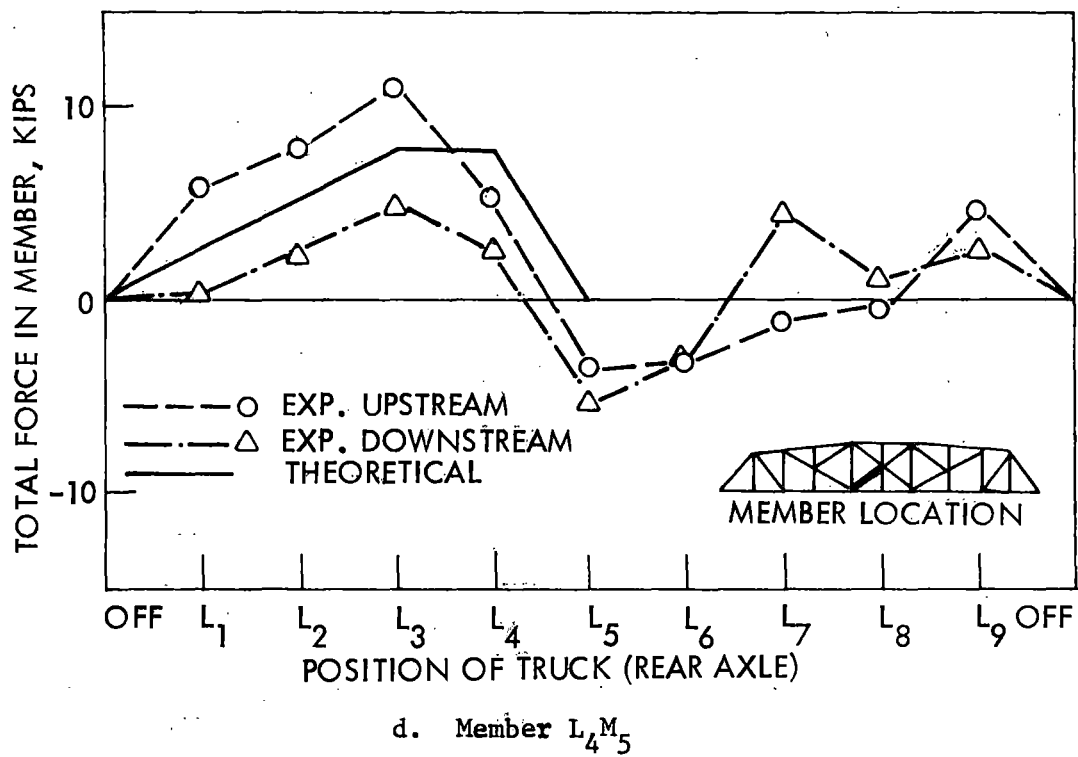
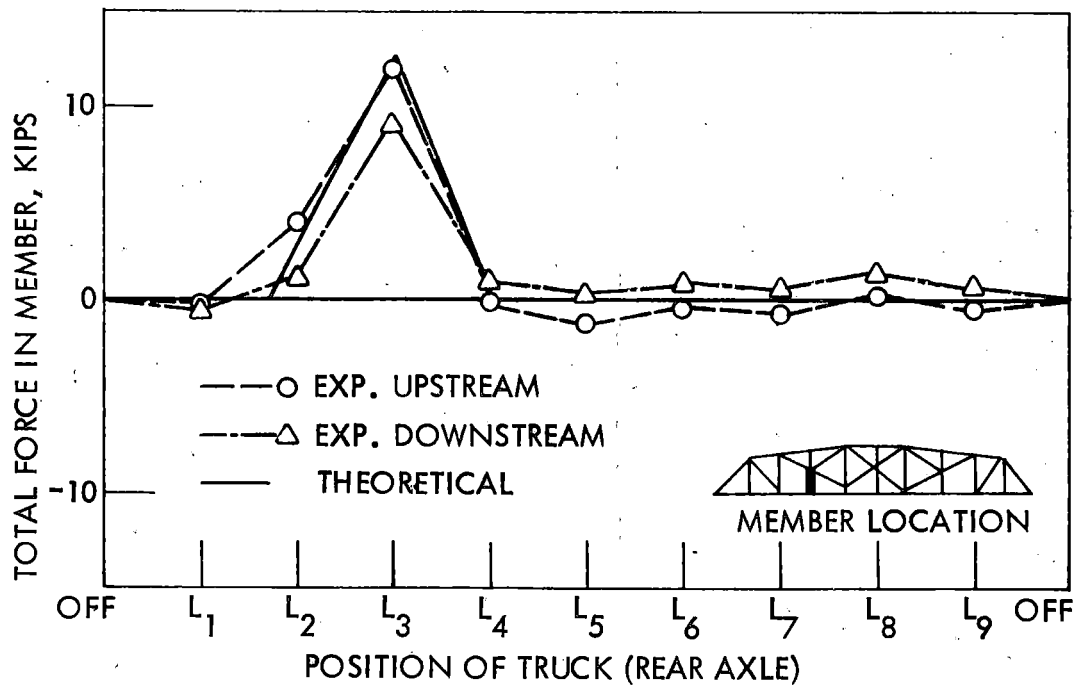
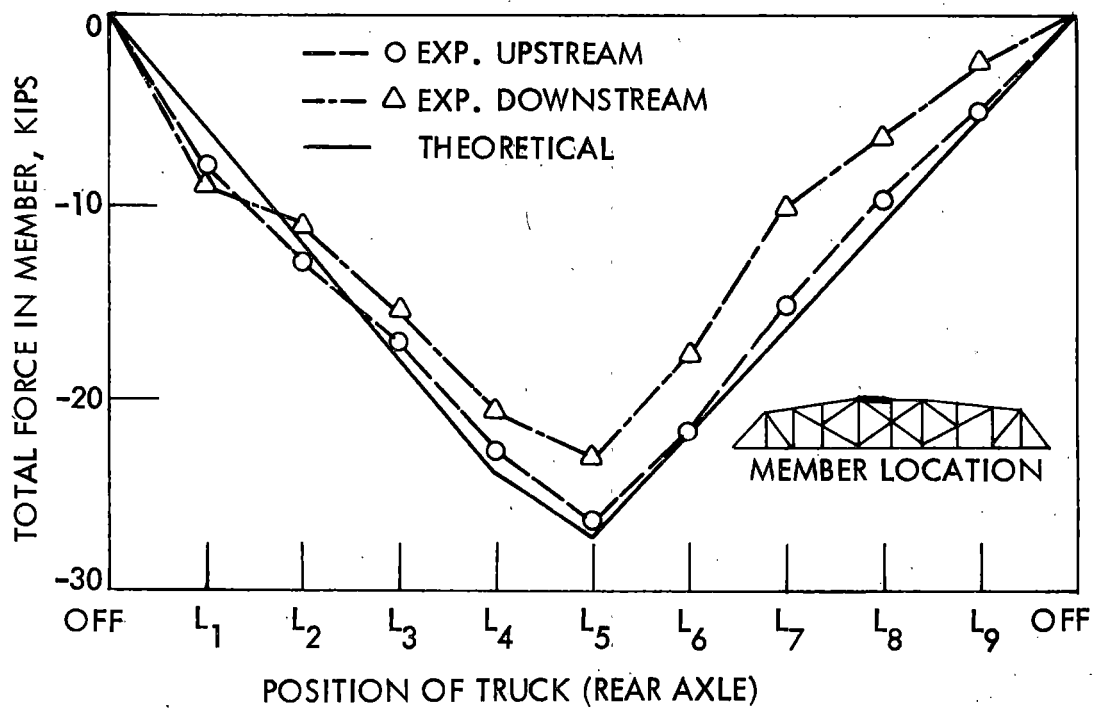
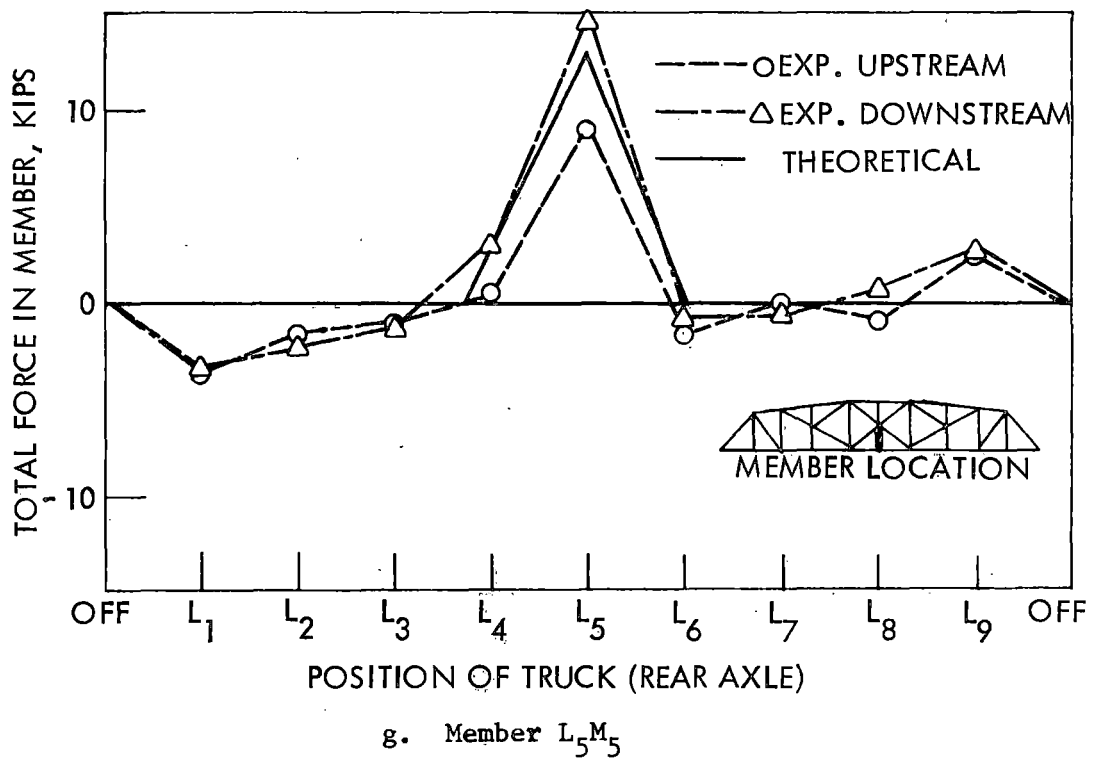
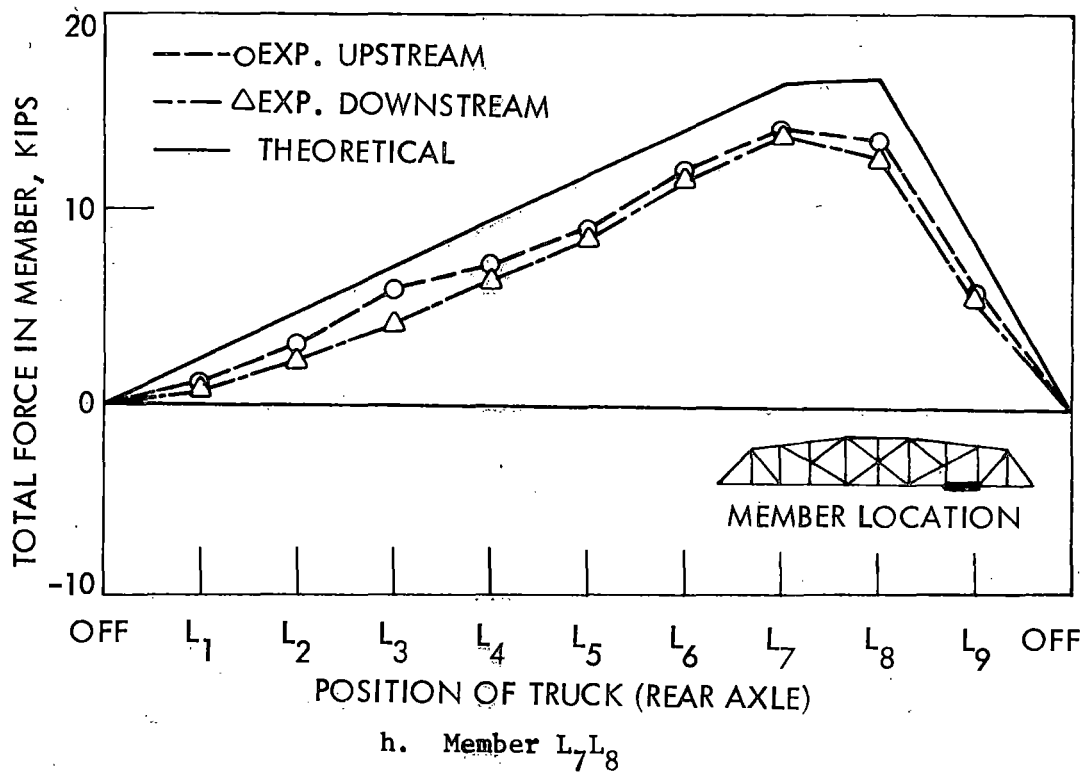
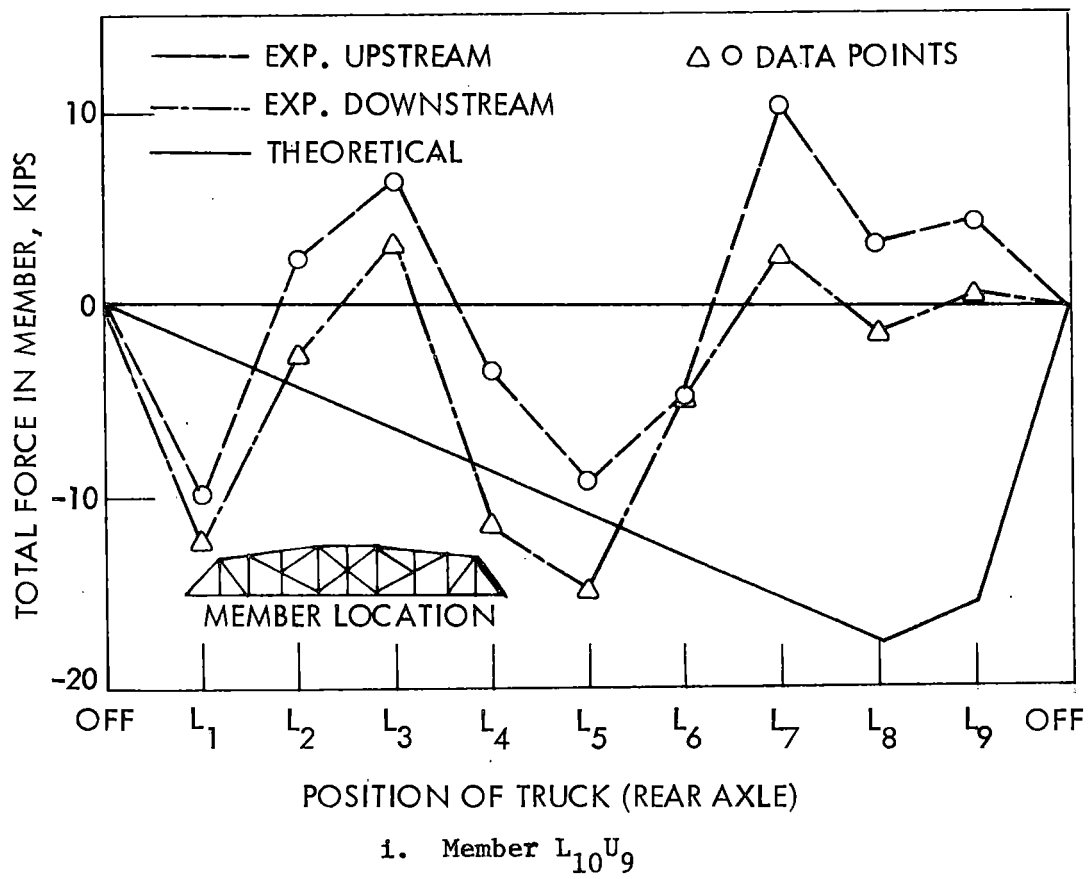
Fig. 27. Influence lines for Span 2 - Hubby Bridge.

It can be seen in Figs. 26 through 29 that in most cases for the Hubby Bridge and in all cases for the Chestnut Ford Bridge, the experimental results agree closely with the theoretical values. Figure 27h is typical of this relationship. The general shape of the experimental influence line is the same as the shape of the theoretical influence line, although the magnitude of the experimental values is less than the magnitude of the theoretical values. This difference is due in part to the partial continuity of the deck which was not taken into account in the theoretical analysis, the condition of the joints, as well as problems in the instrumentation.

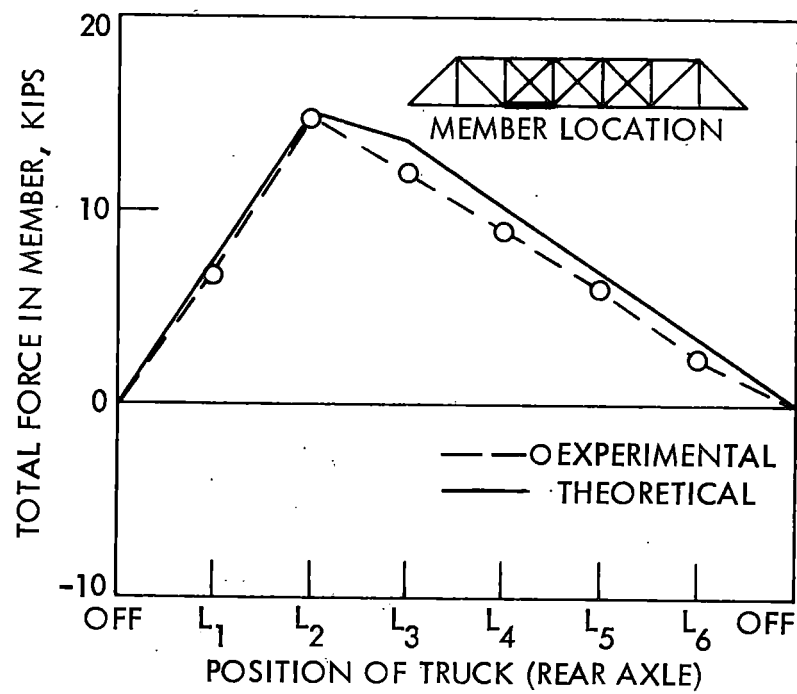
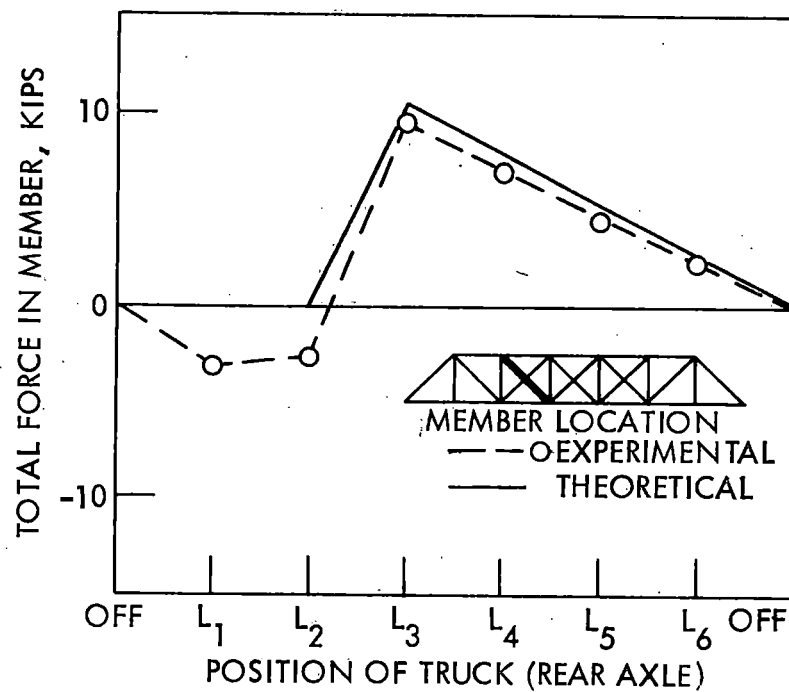
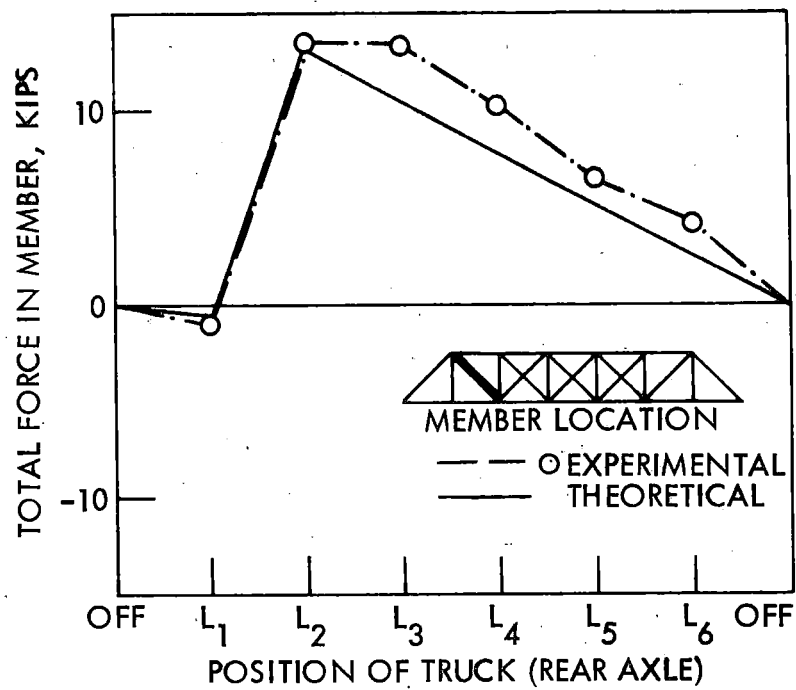
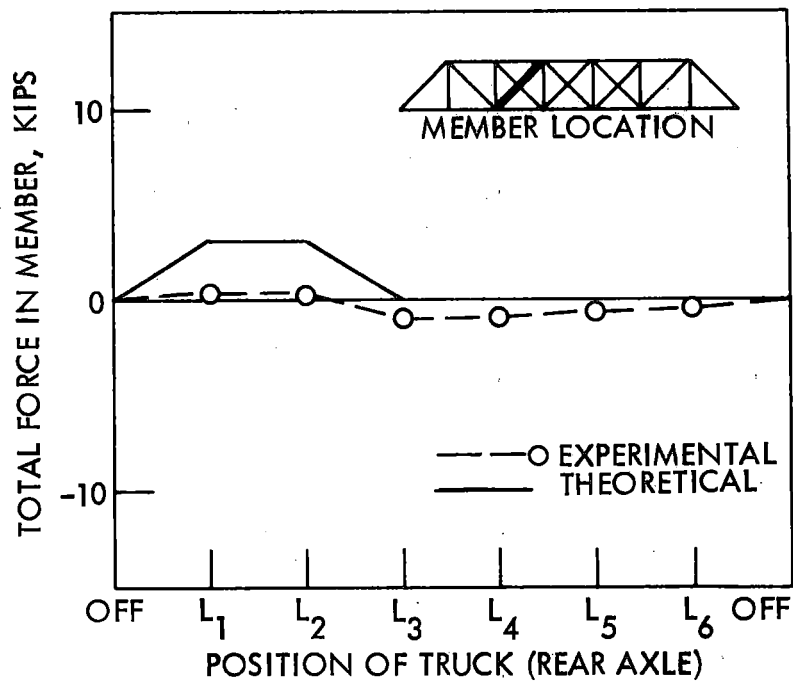
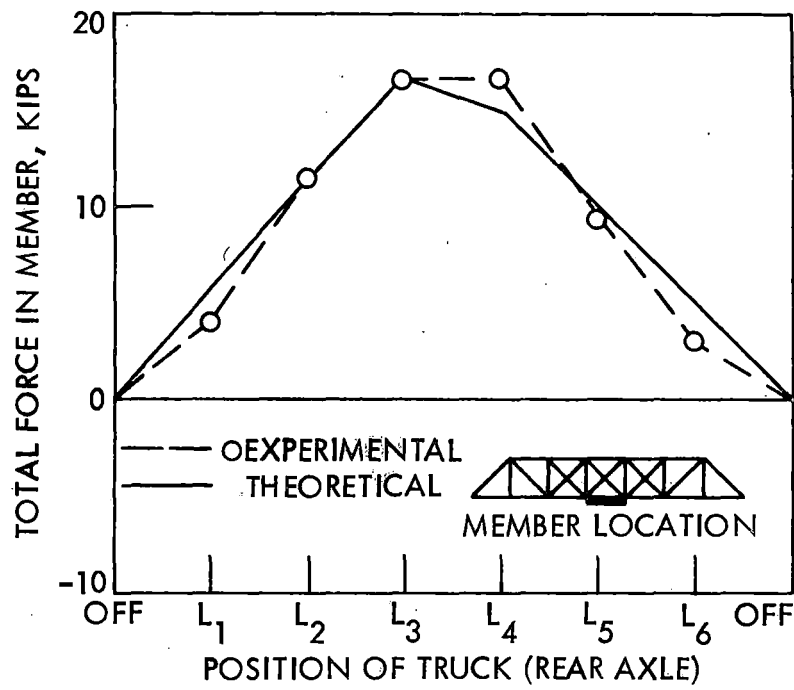
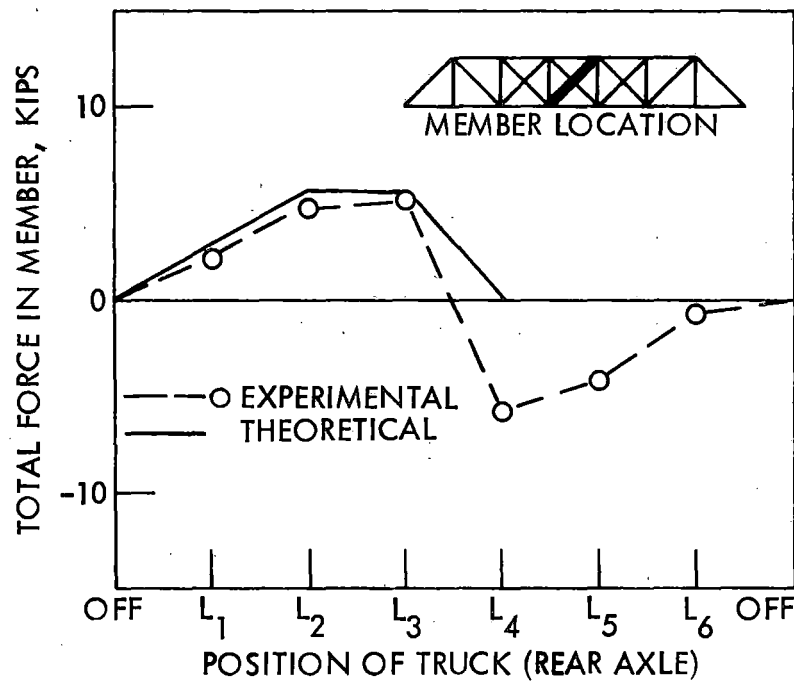
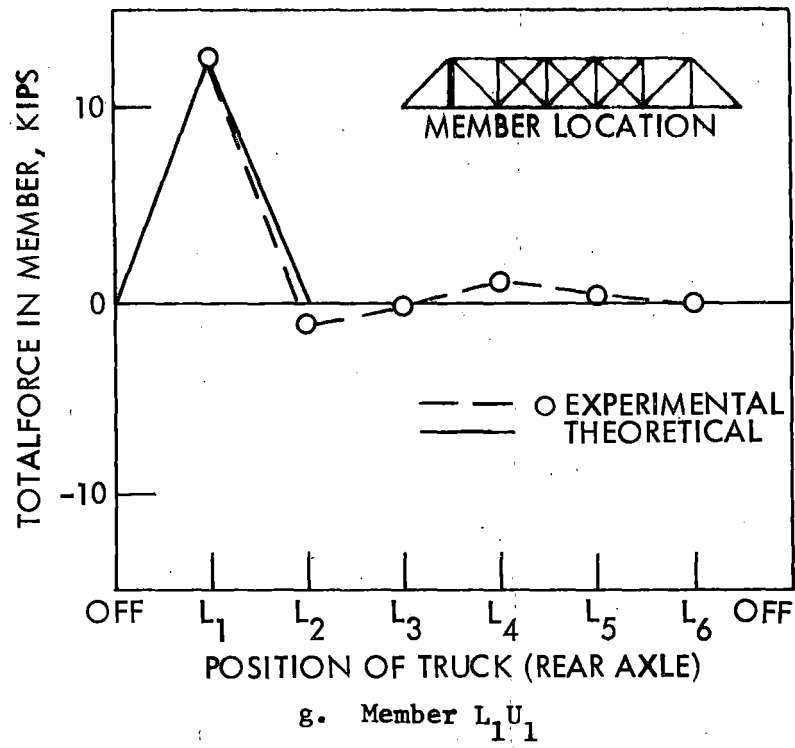
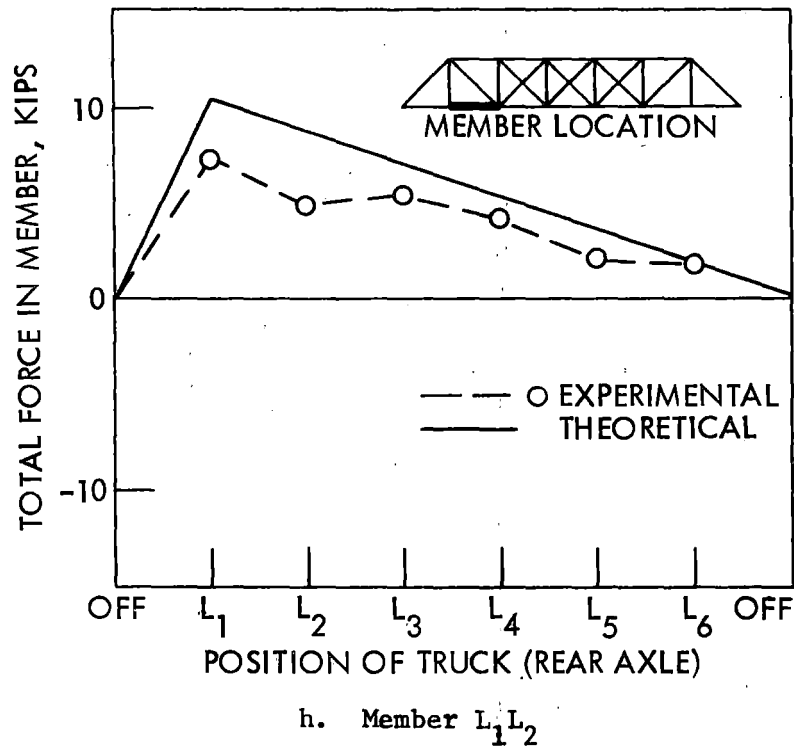
Fig. 28. Influence lines - Chestnut Ford Bridge: truck on centerline.

In the testing of the one span of the Chestnut Ford Bridge only the north truss was instrumented. The experimental influence lines are shown as broken lines. For the Chestnut Ford Bridge influence lines are shown for a truck on the centerline of the bridge (Fig. 28) and for a truck two ft. from the left edge of the deck (Fig. 29).

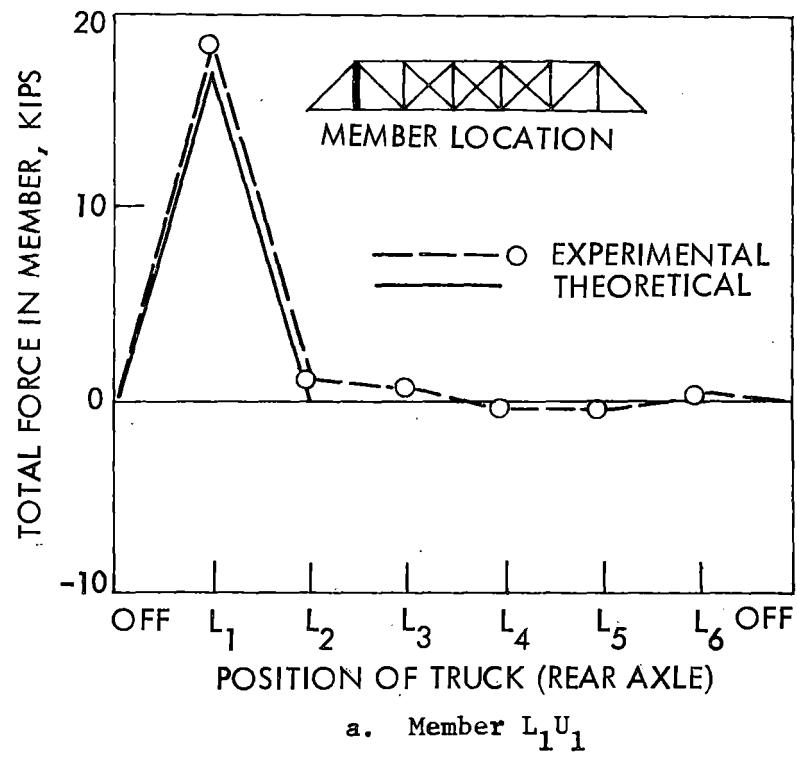
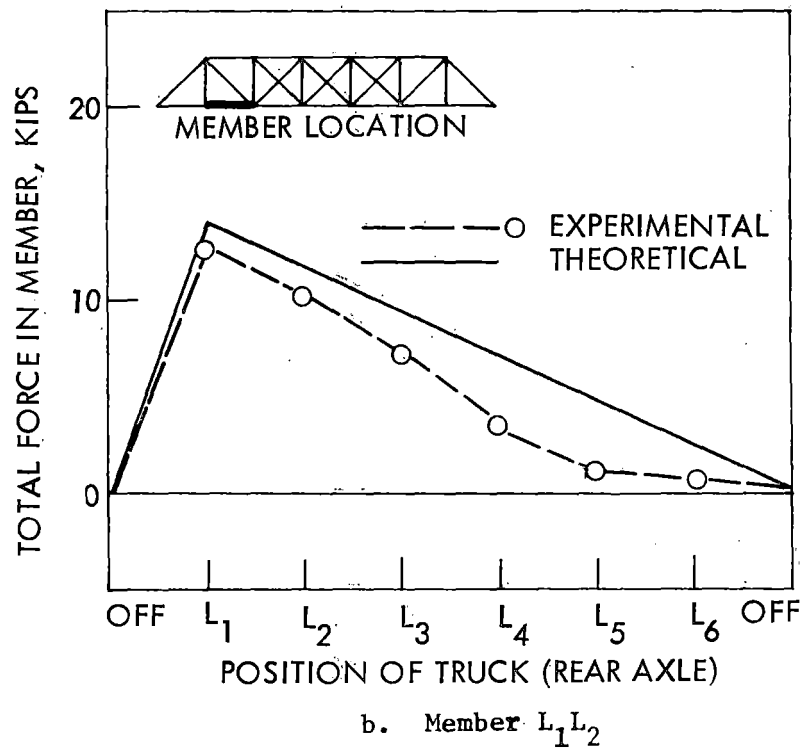
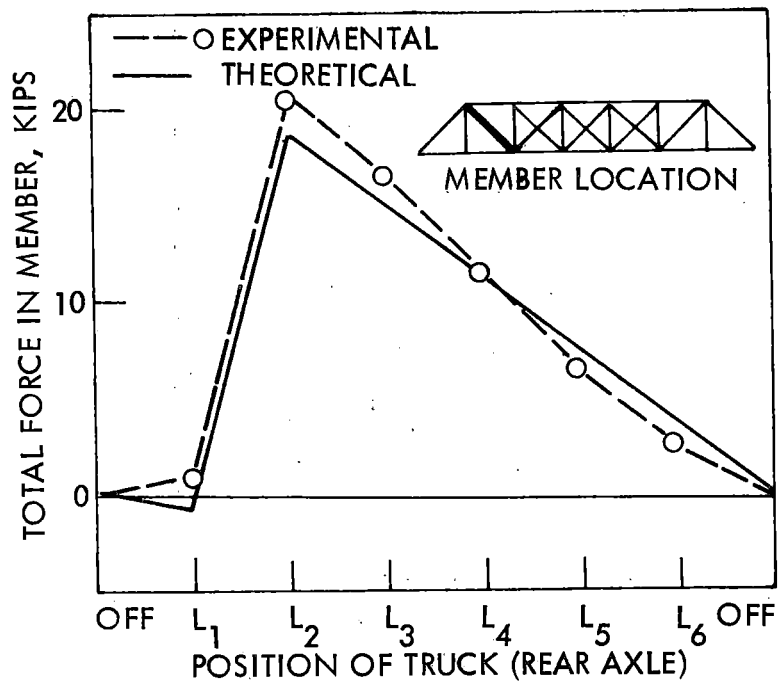
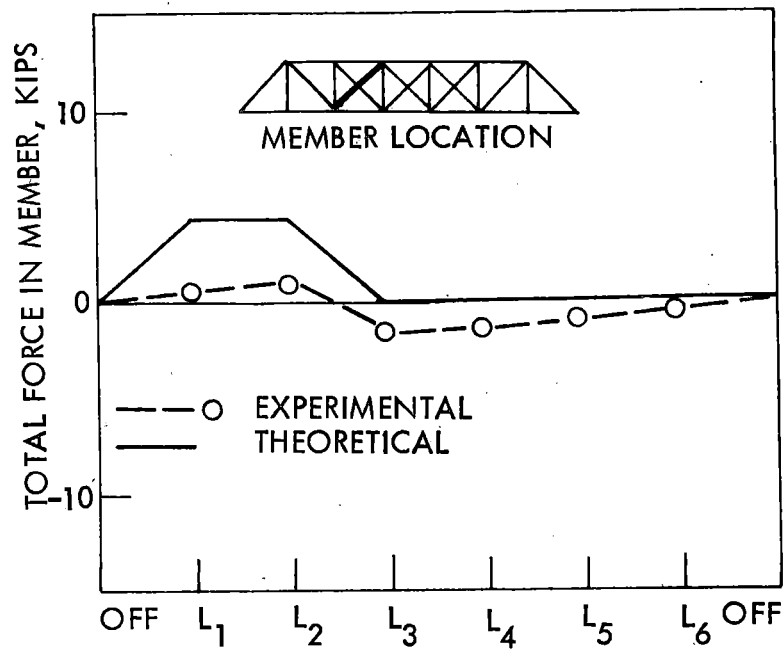
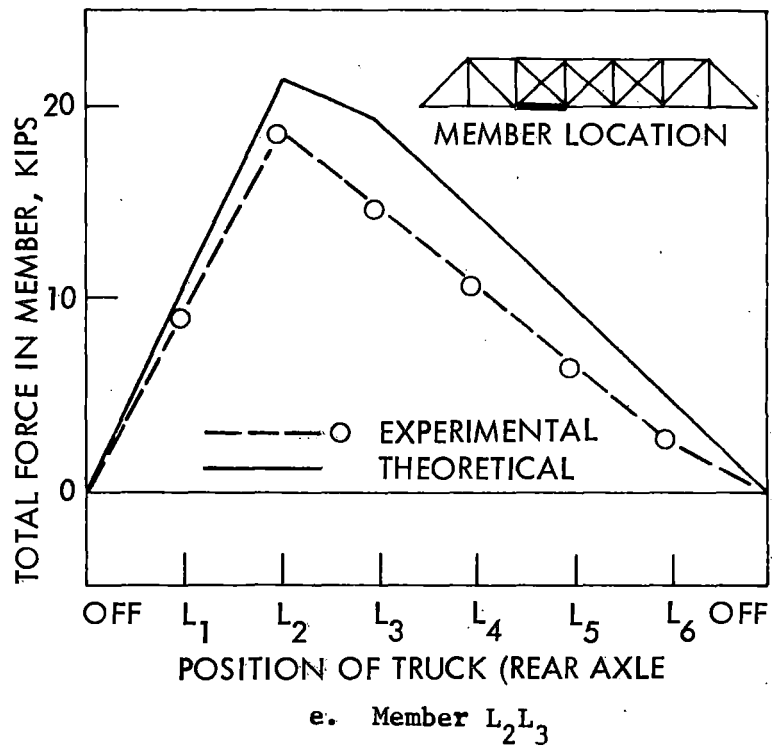
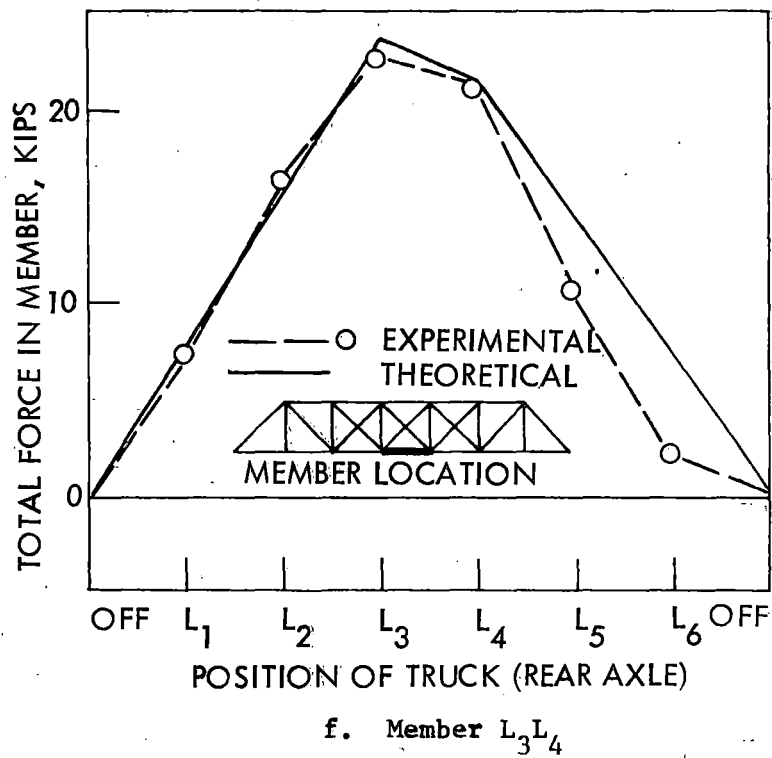
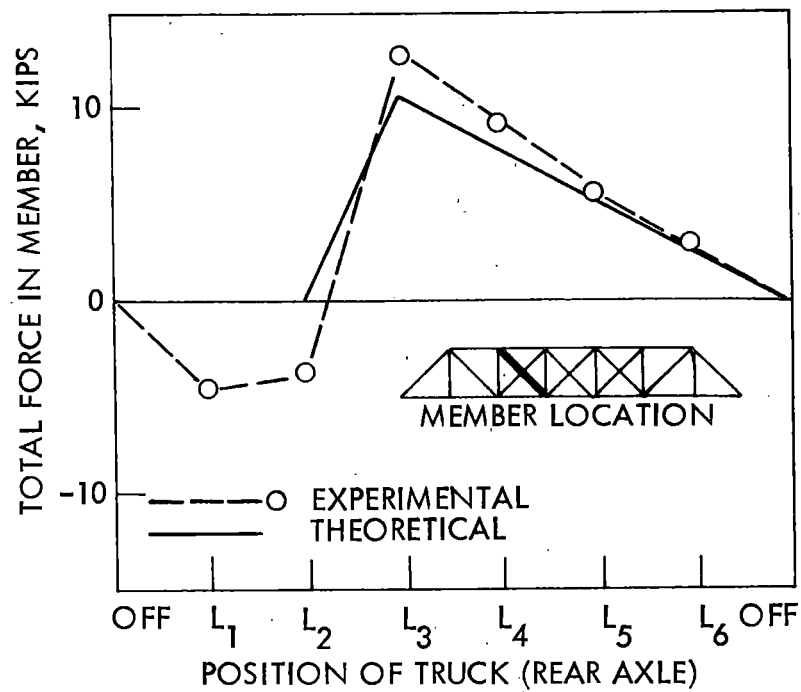
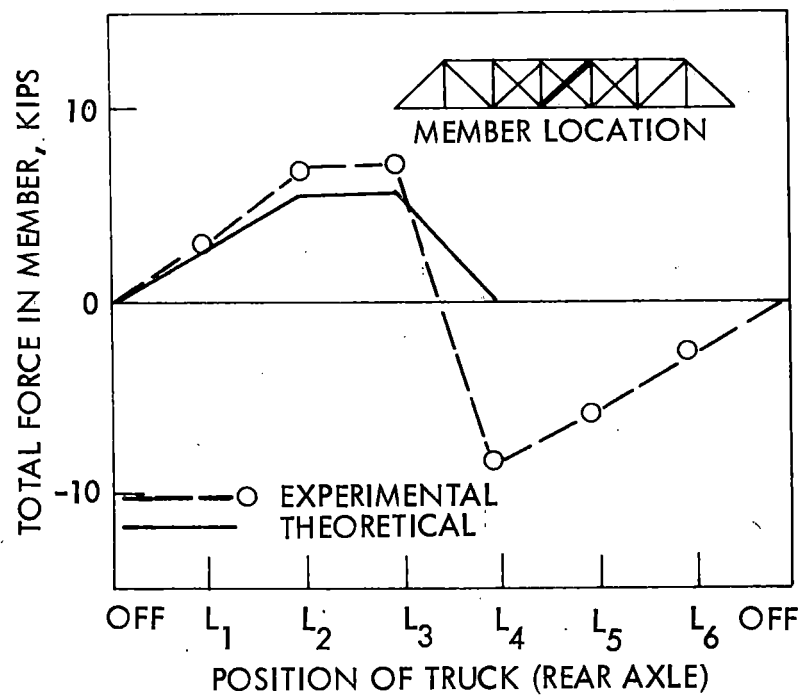
Fig. 29. Influence lines - Chestnut Ford Bridge: truck 2' from left edge.

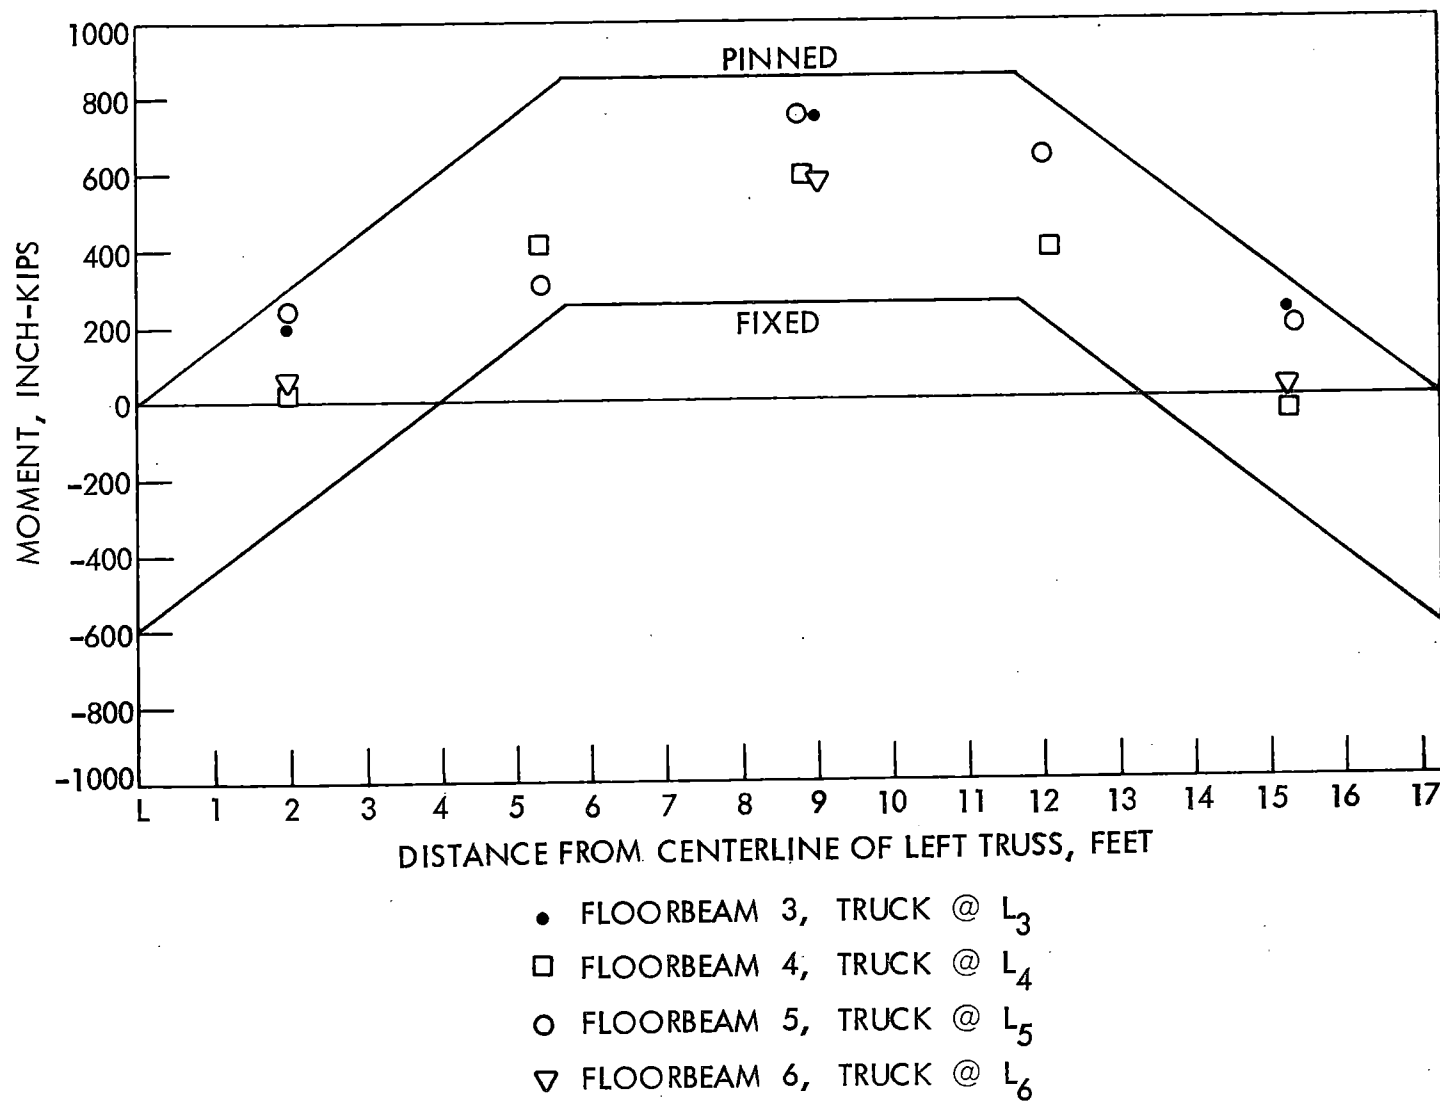
Fig. 31a. Moment for floorbeams at L_3 , L_4 , L_5 , L_6 : truck on L .

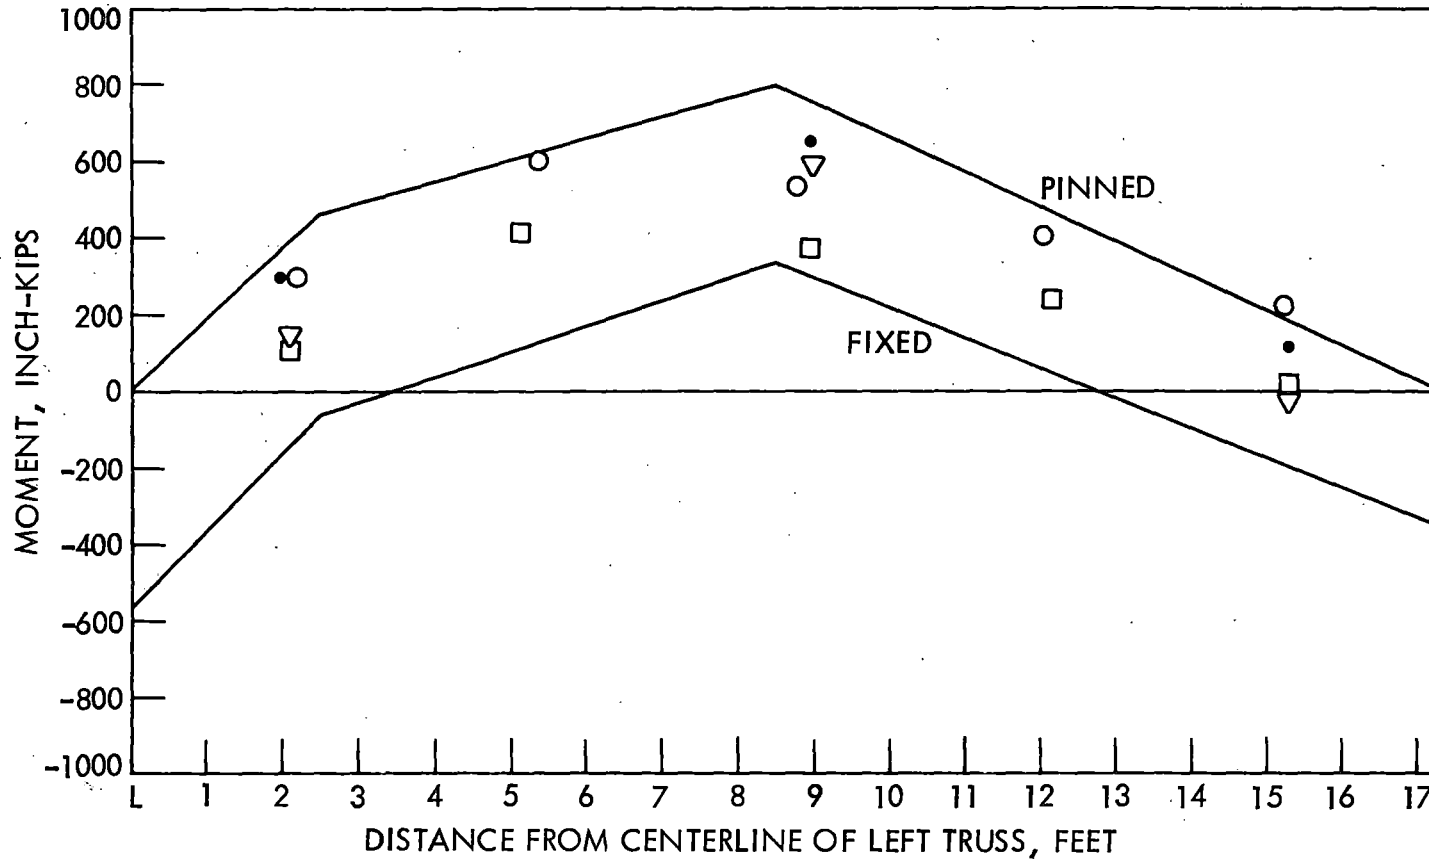
Fig. 31b. Moment for floorbeams at L_3 , L_4 , L_5 , L_6 : truck on left edge.

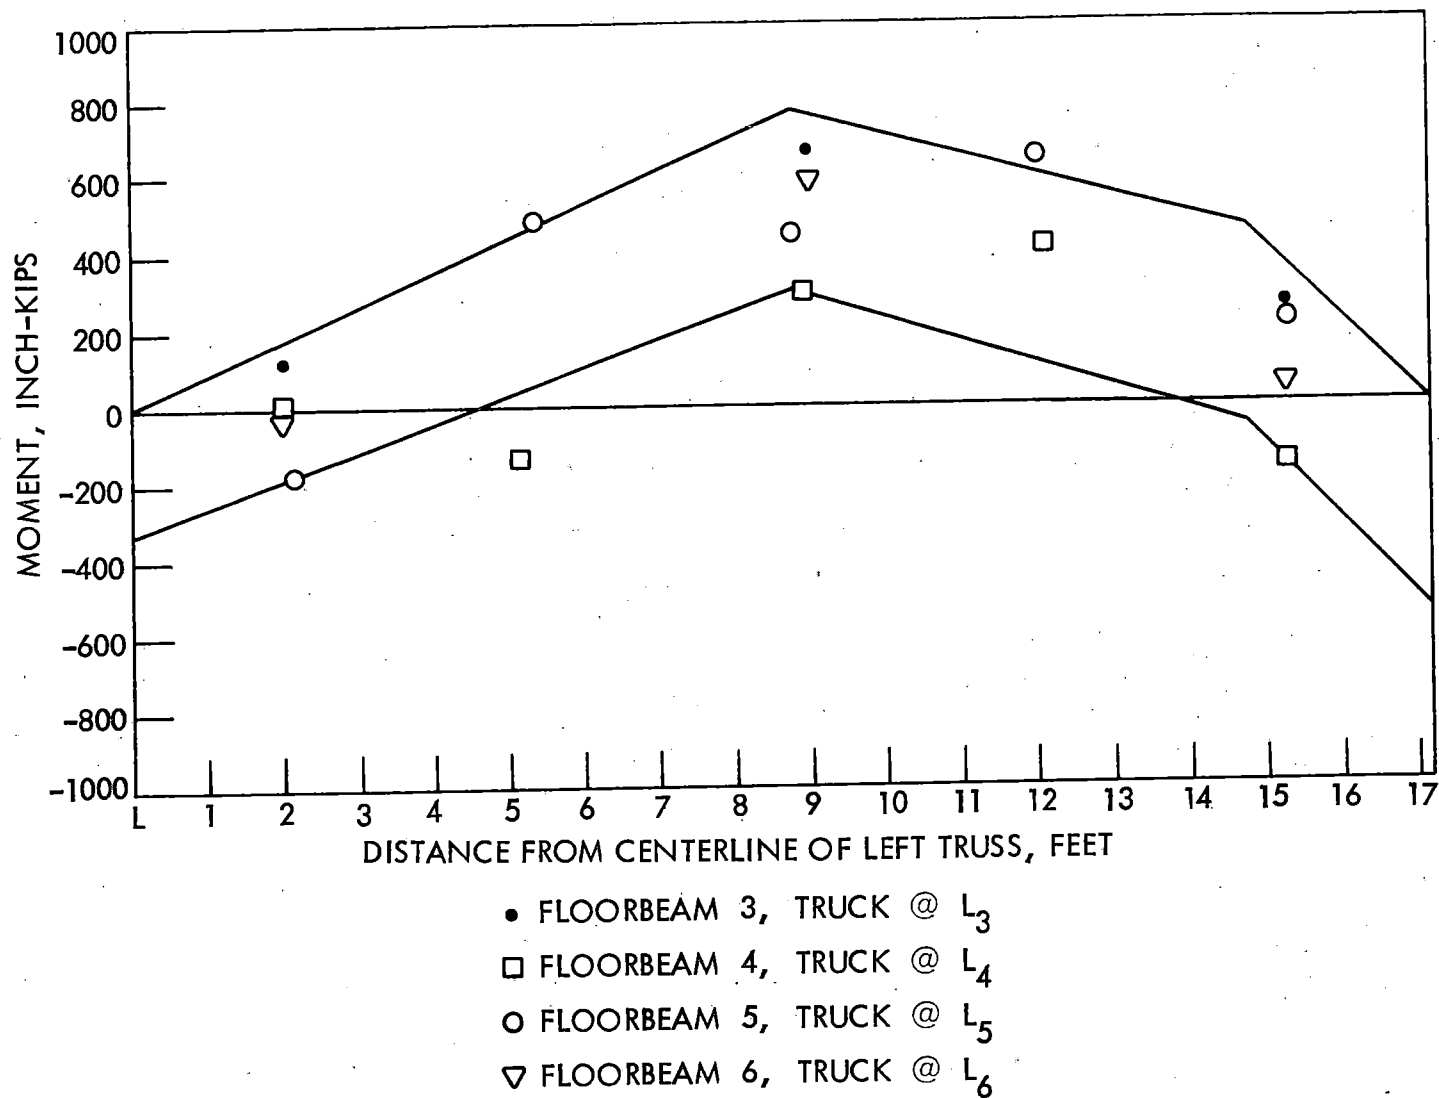
Fig. 31c. Moment for floorbeams at L_3 , L_4 , L_5 , L_6 : truck on right edge.

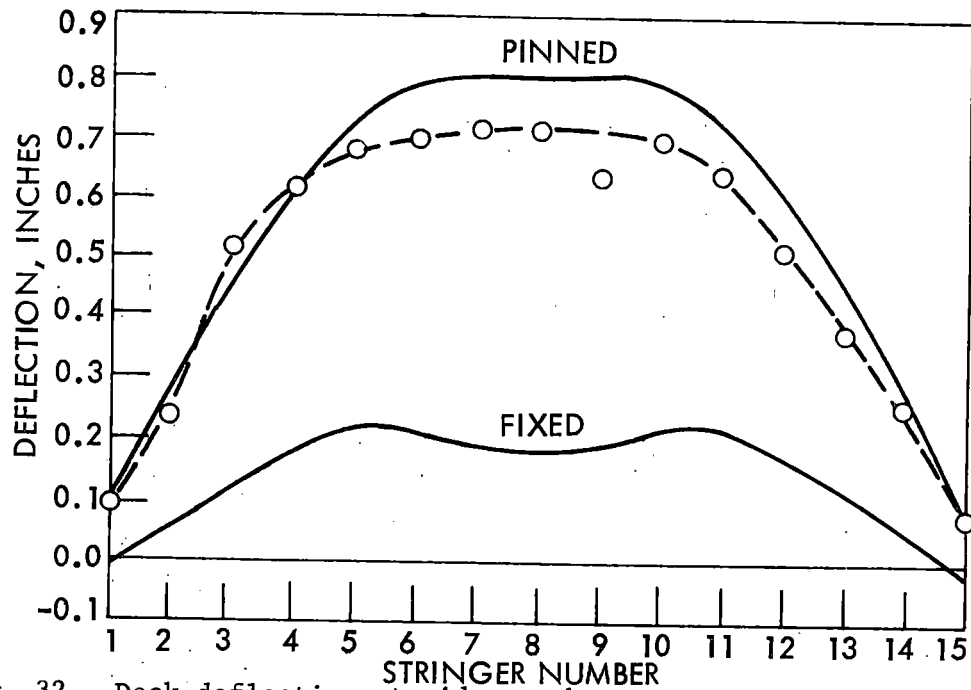
Fig. 32. Deck deflection at mid-span between L_2 and L_3 , Span 2 - Hubby Bridge, truck on centerline of deck.

In all of the cases the experimental deflections are close to the theoretical values for stringers with pinned ends, however, when the gross deflections are large, as in the case with the truck on the edge, the experimental values move away from the values for the theoretical pinned-end condition and toward the theoretical values for the fixed end assumption. This shows that when the deflections of the deck become large, the load distribution characteristics improve due to the improved effects of the layered deck.

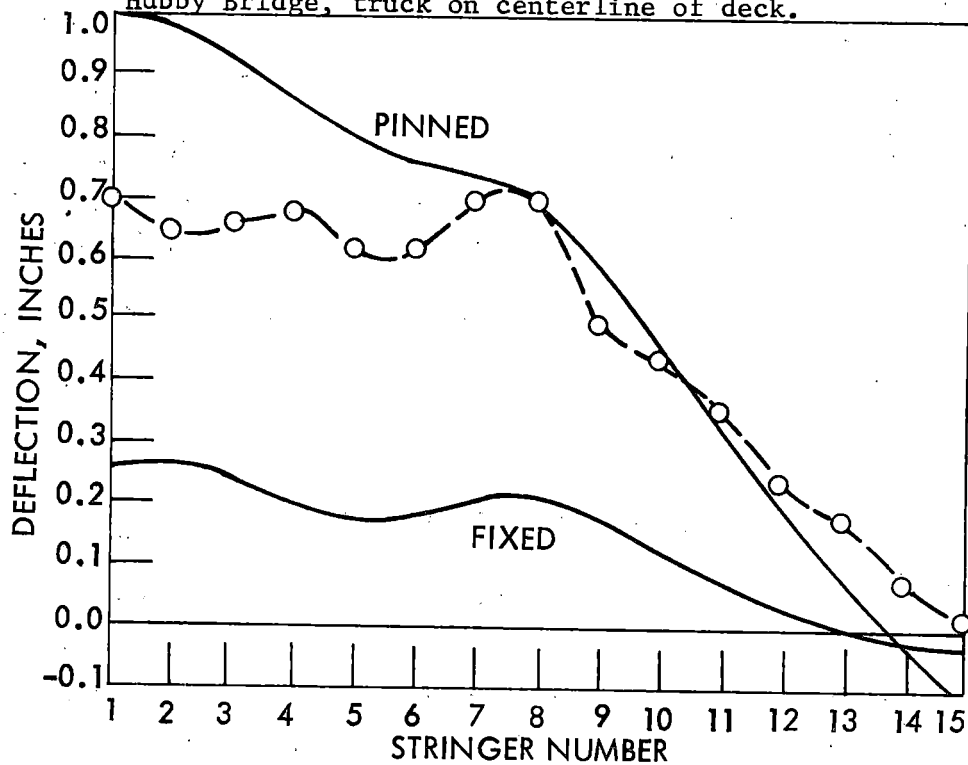
Fig. 33. Deck deflection at mid-span between L_2 and L_3 , Span 2 - Hubby Bridge, truck 2' from left edge of deck.
