**Interim Report
ISU-ERI-Ames-76036**

ULTIMATE LOAD BEHAVIOR OF FULL-SCALE HIGHWAY TRUSS BRIDGES: PHASE II— SERVICE LOAD AND SUPPLEMENTARY TESTS

Highway Division—Iowa Department of Transportation

ERI Project 1118S

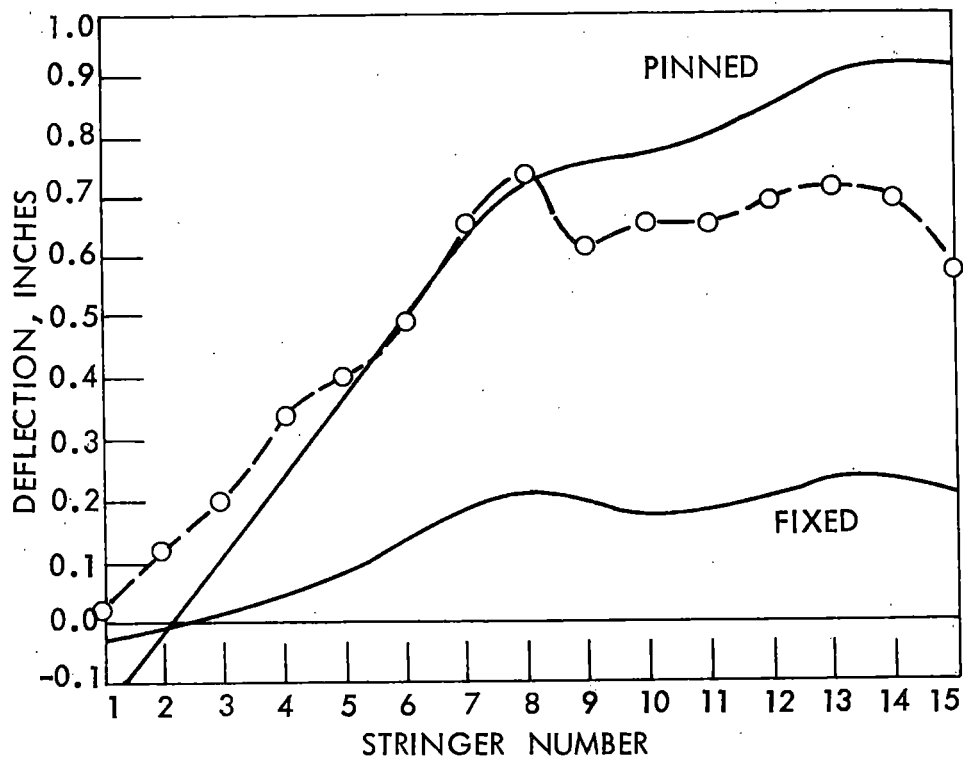
Fig. 34. Deck deflection at mid-span between L_2 and L_3 , Span 2 - Hubby Bridge, truck 2' from right edge of deck.

In all of the cases the experimental deflections are close to the theoretical values for stringers with pinned ends, however, when the gross deflections are large, as in the case with the truck on the edge, the experimental values move away from the values for the theoretical pinned-end condition and toward the theoretical values for the fixed end assumption. This shows that when the deflections of the deck become large, the load distribution characteristics improve due to the improved effects of the layered deck.

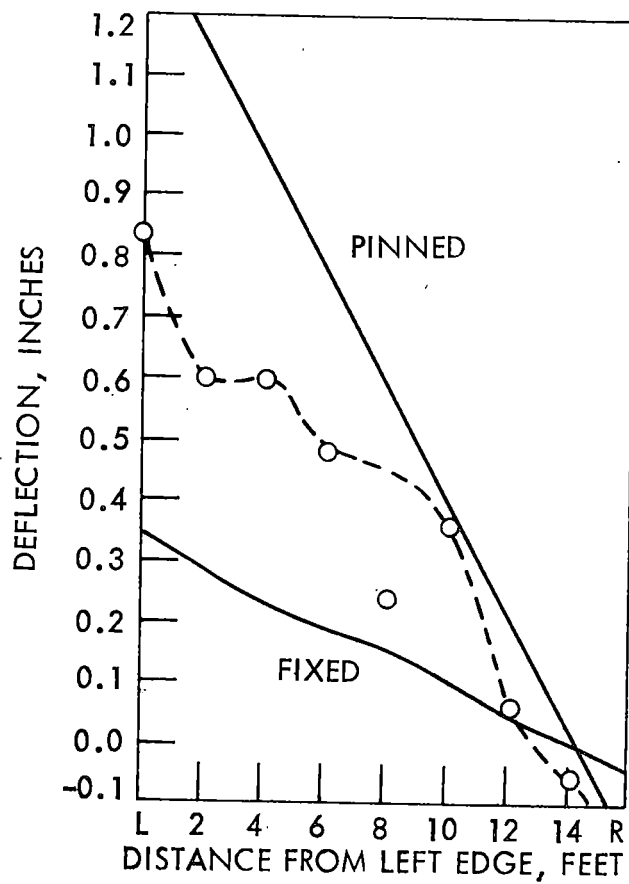
Fig. 36. Deck deflection at mid-span of panel, Chestnut Ford Bridge: truck 2' from left edge.

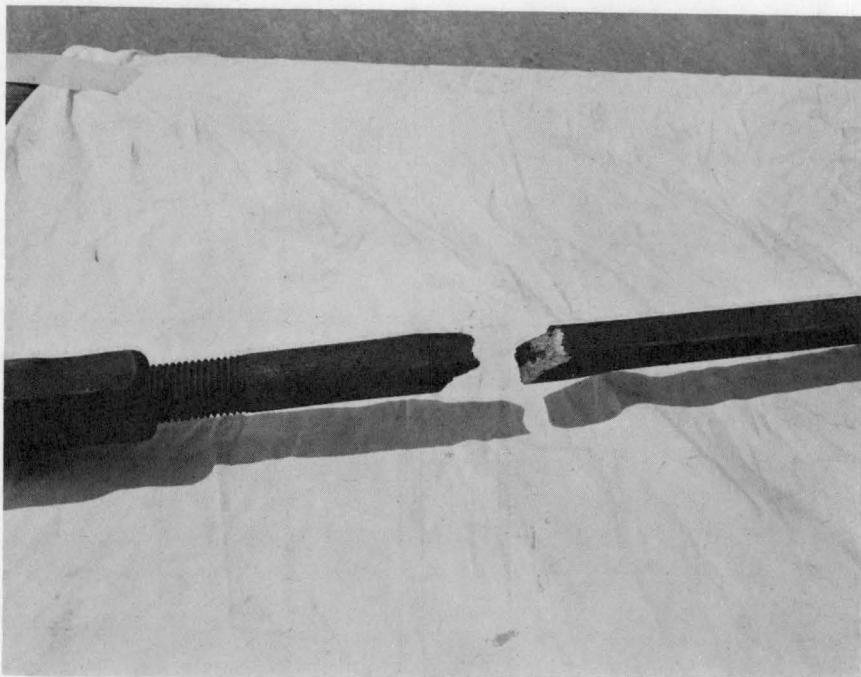
Fig. 38. Photograph showing fatigue fracture in forging near a turnbuckle.

Two of the 23 undamaged eyebars fractured in one of the forgings joining the turnbuckle to the eyobar, as illustrated in Fig. 38. These two eyebars initially had large cracks at the point of fracture prior

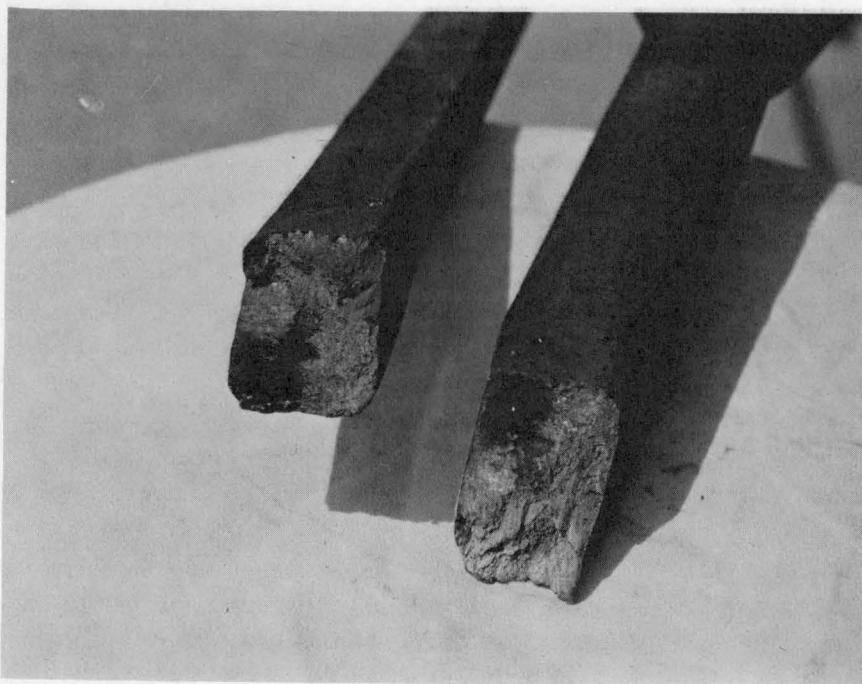
Fig. 39. Photograph showing extent of an initial crack in a forging.

to the beginning of the fatigue tests. The extent of one of these cracks can be seen in Fig. 39. This photograph was taken after the completion of the fatigue test and indicates that only 75 percent of the metal cross-section was effective.

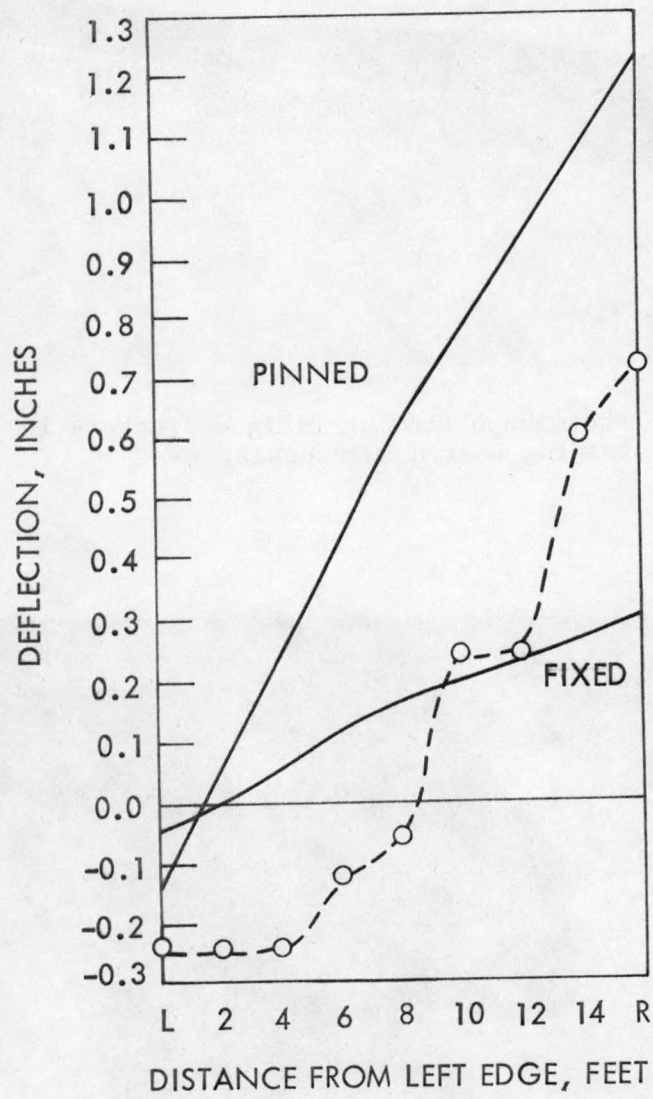
Fig. 37. Deck deflection at mid-span of panel, Chestnut Ford Bridge: truck 2' from right edge.

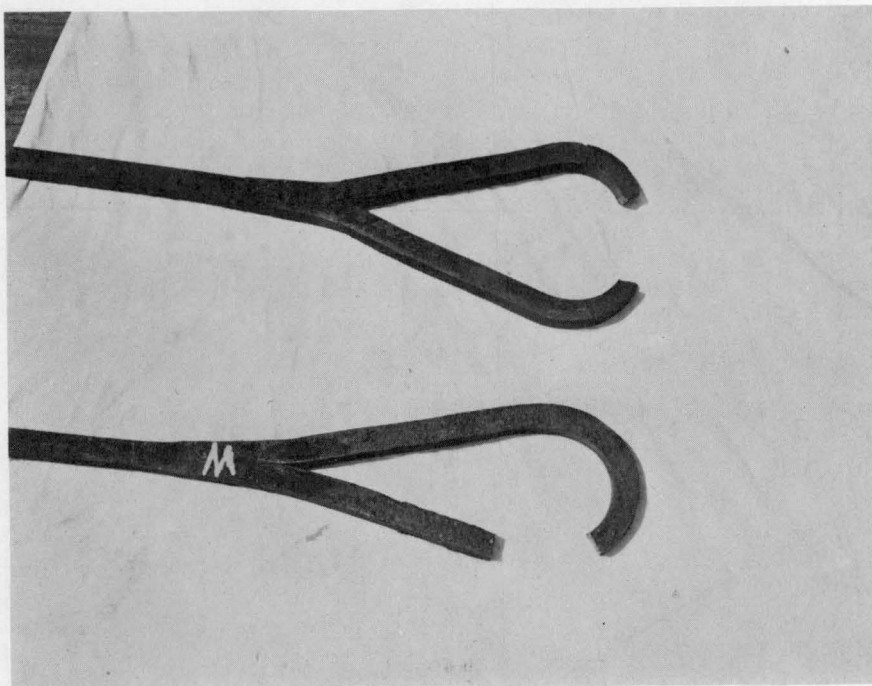
Fig. 40. Photograph showing two typical locations of fracture in an eye.

The remaining 21 eyebars each fractured in one of the eyes of the eyobar. The fractures in the eyes occurred in two different places: 1) at the tip, and 2) at the side of the eye. These two types of fractures are illustrated in Fig. 40. As the load is applied to the eyobar, the eye distorts slightly to conform to the shape of the pin. This is due to the fact that the pin is usually slightly smaller than the hole in the eye. Thus, the sides of the eye are pulled inwardly toward the pin. This induces a stress concentration on the inside of the eye and is therefore a place where fatigue cracks will most likely form. These cracks will then propagate outwardly leading to a fracture at this point. Nine out of the 21 fractures that occurred in the eye were located on the side of the eye. Figure 41 shows a fracture that occurred when cracks formed in both sides of the eye.

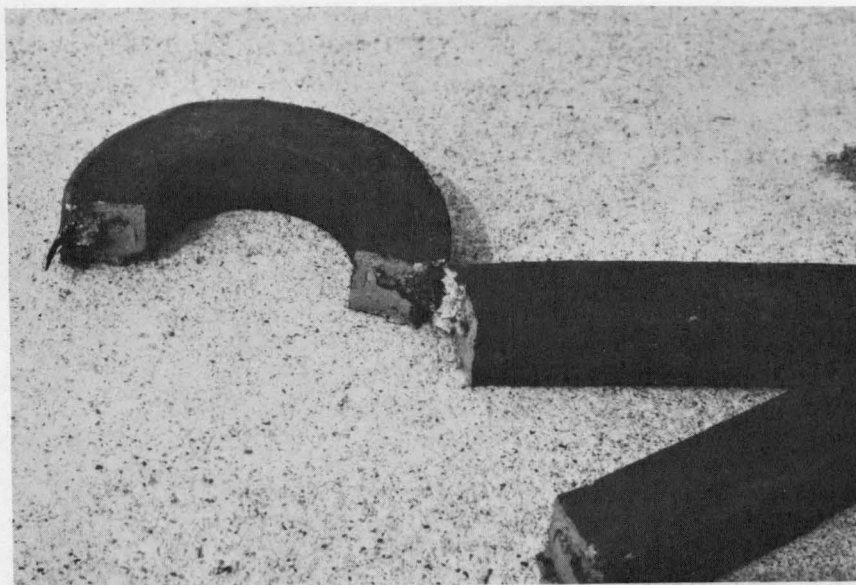
Fig. 41. Photograph showing a fracture on both sides of an eye.

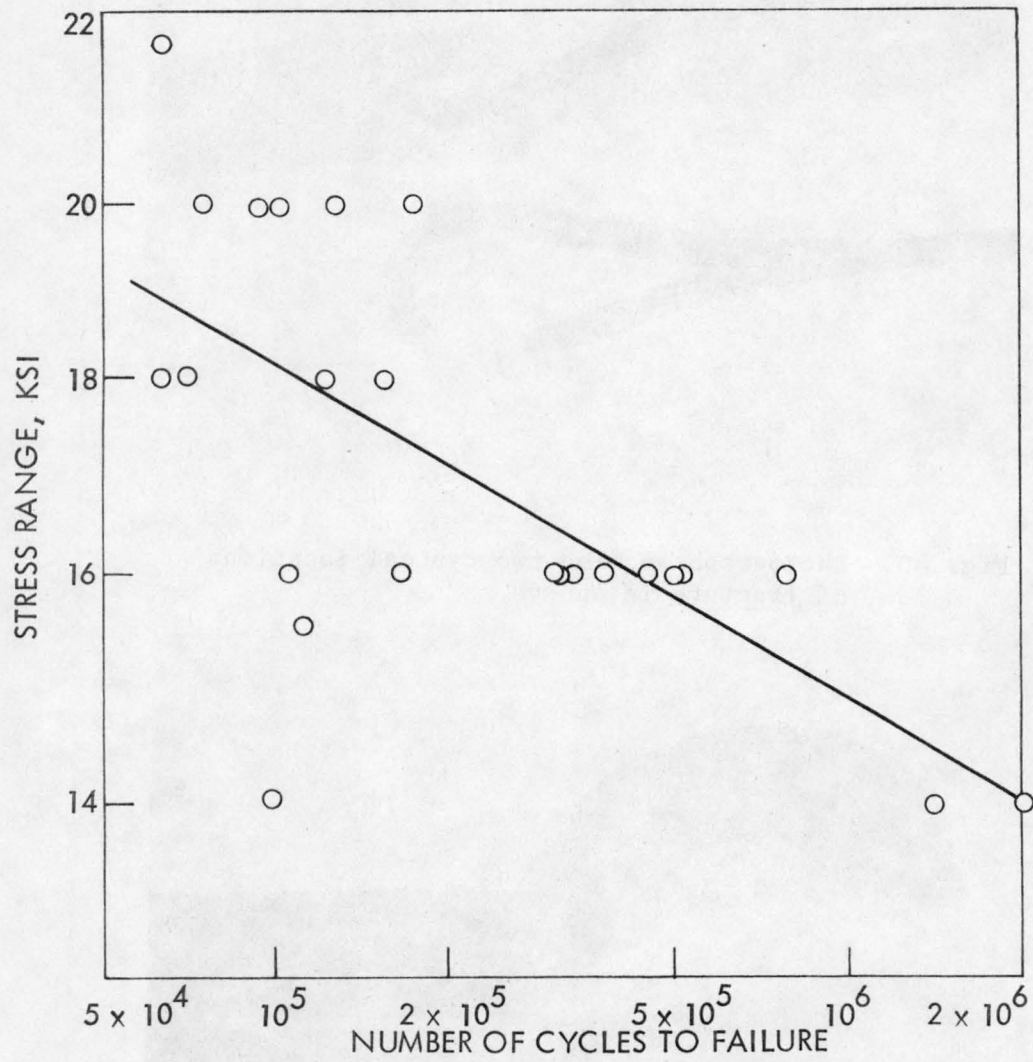
Fig. 42. S-N curve for undamaged eyebars.

Figure 42 shows the range over which the undamaged eyebars failed in fatigue. The vertical scale gives the stress range and the horizontal scale gives the number of cycles. A regression analysis was performed to find the best fit line through the points. This line approximates the S-N curve (stress range vs. number of cycles to failure) for the eyebars. From this figure it is possible to see the wide variance in fatigue strength of the eyebars taken from the bridges. This variation could be expected due to the non-homogeneity of wrought iron and the various degrees of deterioration of the eyebars.

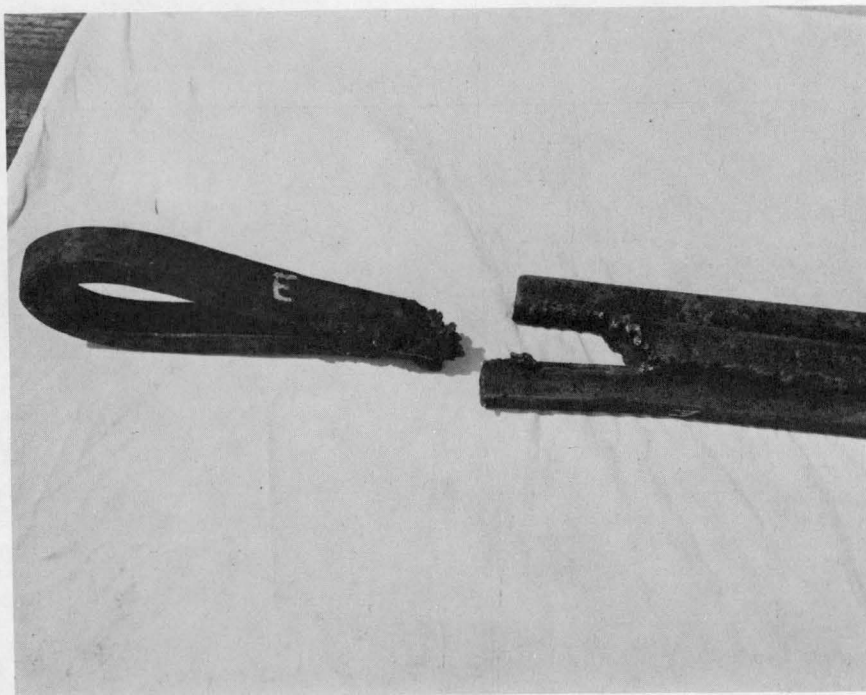
Fig. 43. Photograph showing repair and fracture of an eyebar that was repaired in the field.

One of the nine damaged and repaired eyebars tested was an eyebar that was damaged and repaired at the bridge site an estimated 40 years ago (Table 5; H4). The eyebar had fractured at the forging connecting the eye to the bar and the repair consisted of welding the pieces back together with two additional splice bars (one on each side). The design of the repair was inadequate since the splice did not extend very far onto the eye. In addition, the weld was of very poor quality with very little penetration into the base metal. The fatigue failure occurred at the point of repair. Figure 43 shows the repair and the fracture after the completion of the fatigue test.

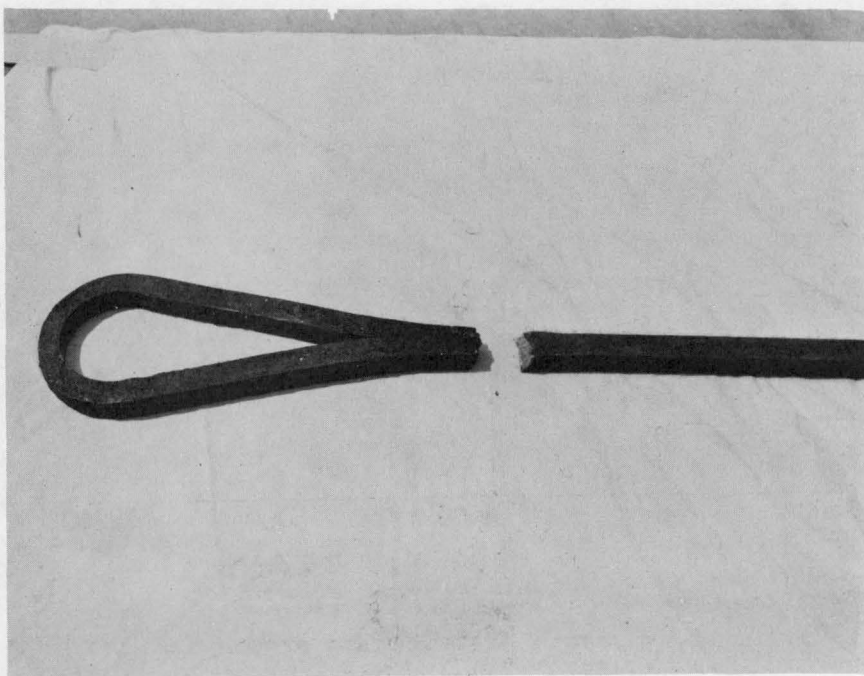
Fig. 44. Photograph showing the fatigue fracture in the forging near an eye.

Six of the eyebars were damaged and repaired in the laboratory. Four of these simulated fractures near an eye and two simulated fractures near a turnbuckle. The methods of repair for these fractures were given in Chapter 4. These repairs proved to be at least as strong as the bars since no failures occurred near the repairs. Upon testing, five of the eyebars fractured in the eyes as shown in Fig. 40, and one of the eyebars fractured in the forging near the eye at the end opposite from the repaired end (Fig. 44).

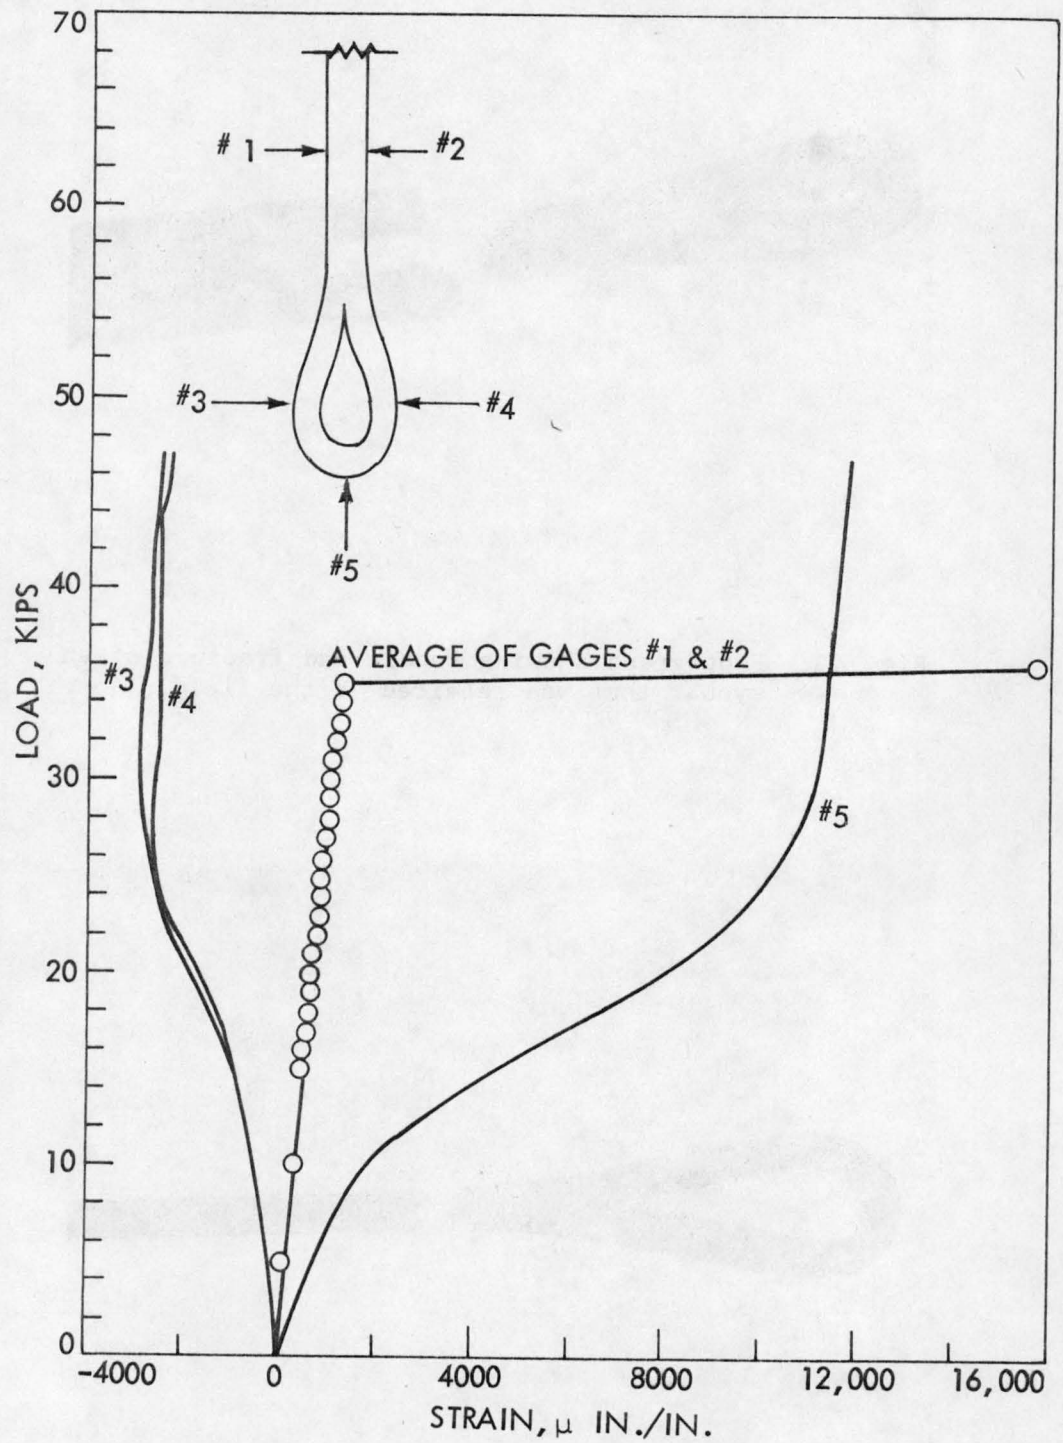
Fig. 45. Load vs strain distribution around an eye made from a square bar.

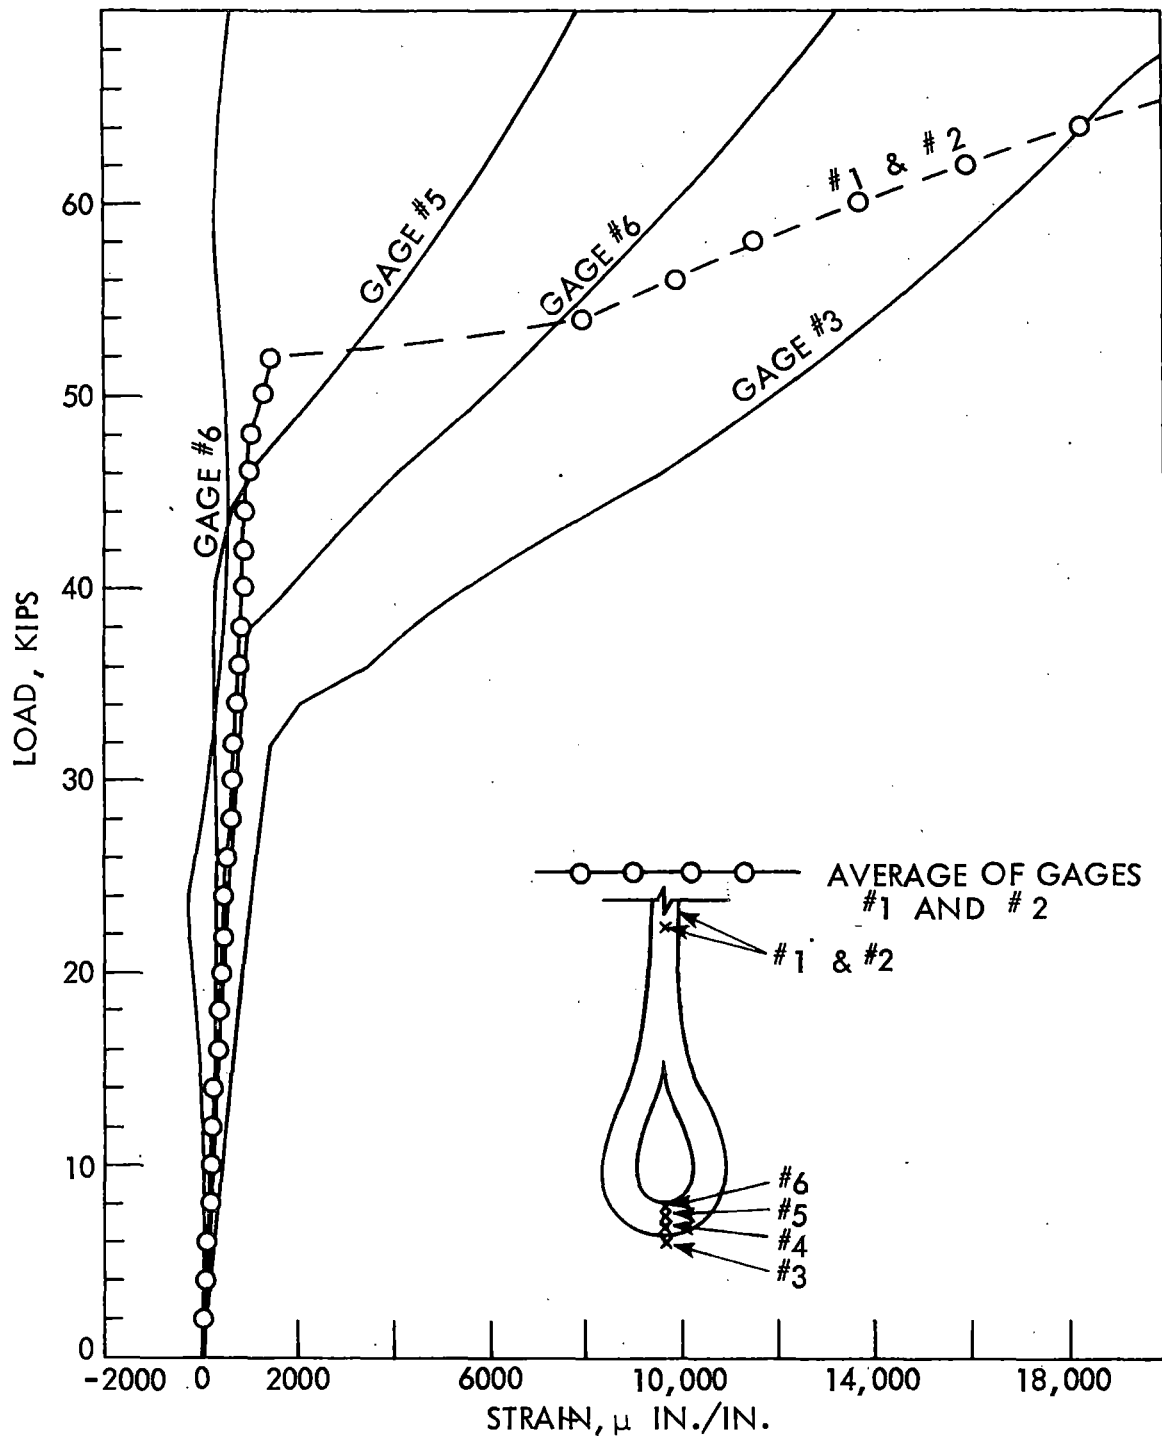
Fig. 46a. Load vs. strain distribution in tip of eye (total range).

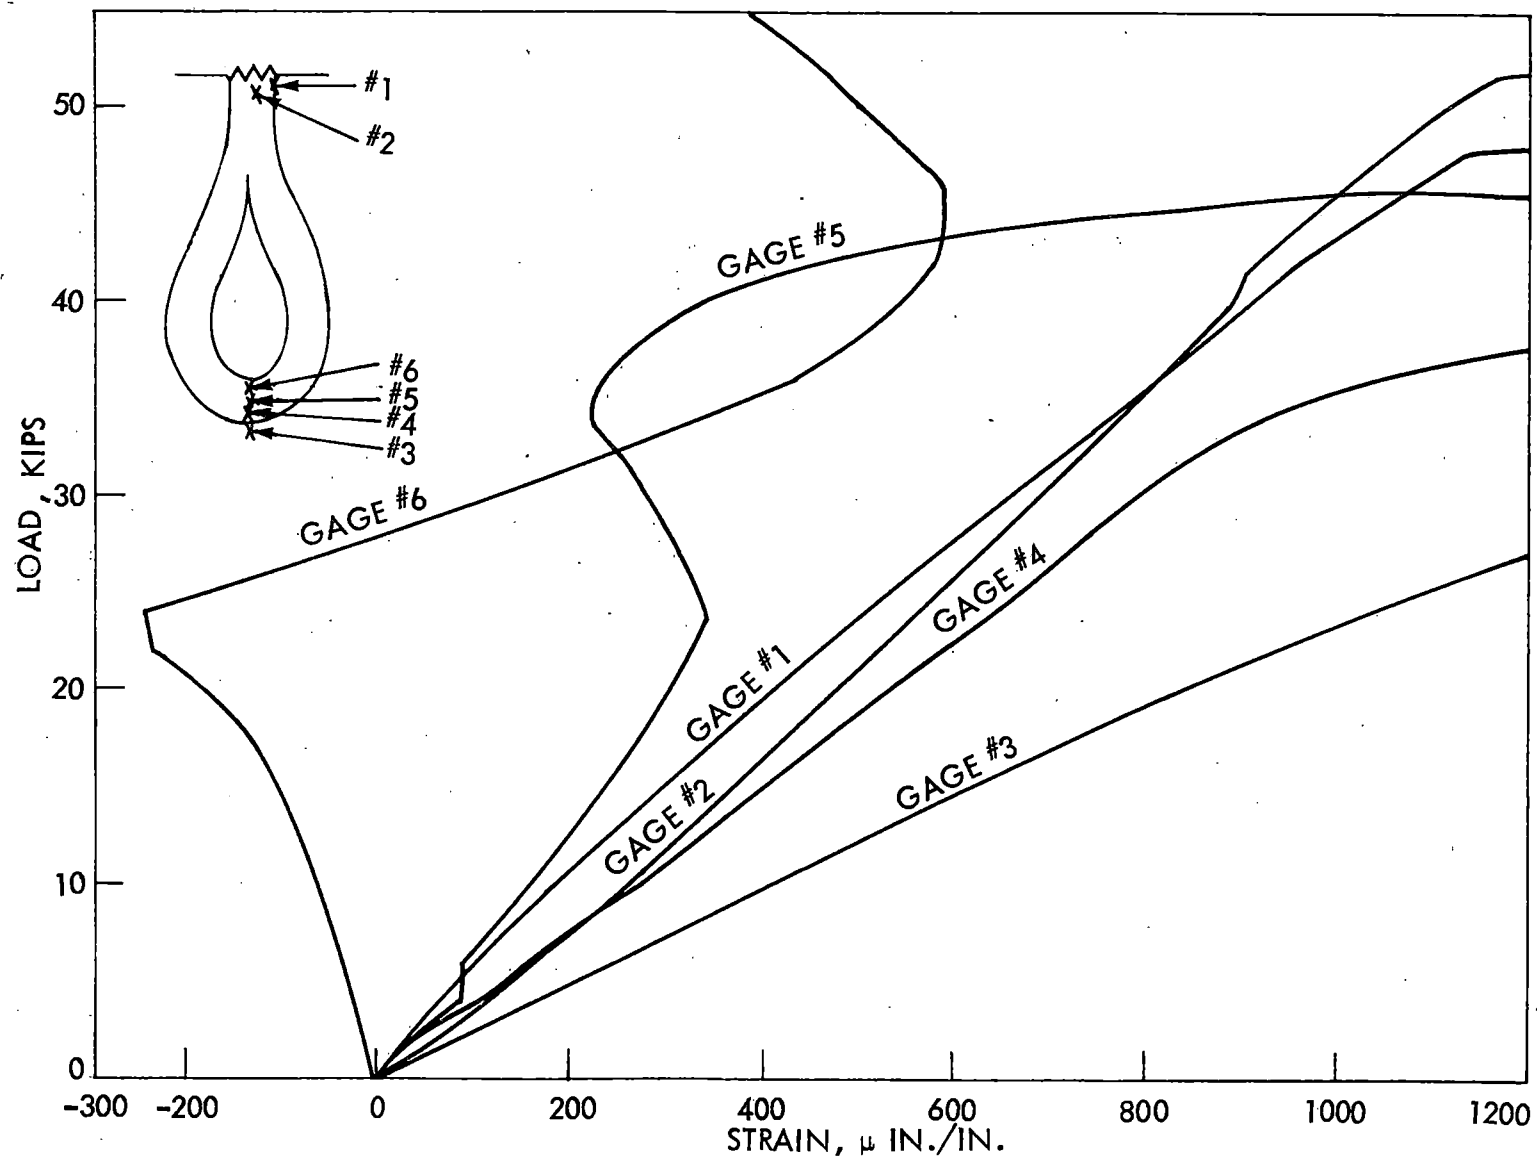
Fig. 46b. Load vs strain distribution in tip of eye (elastic range).

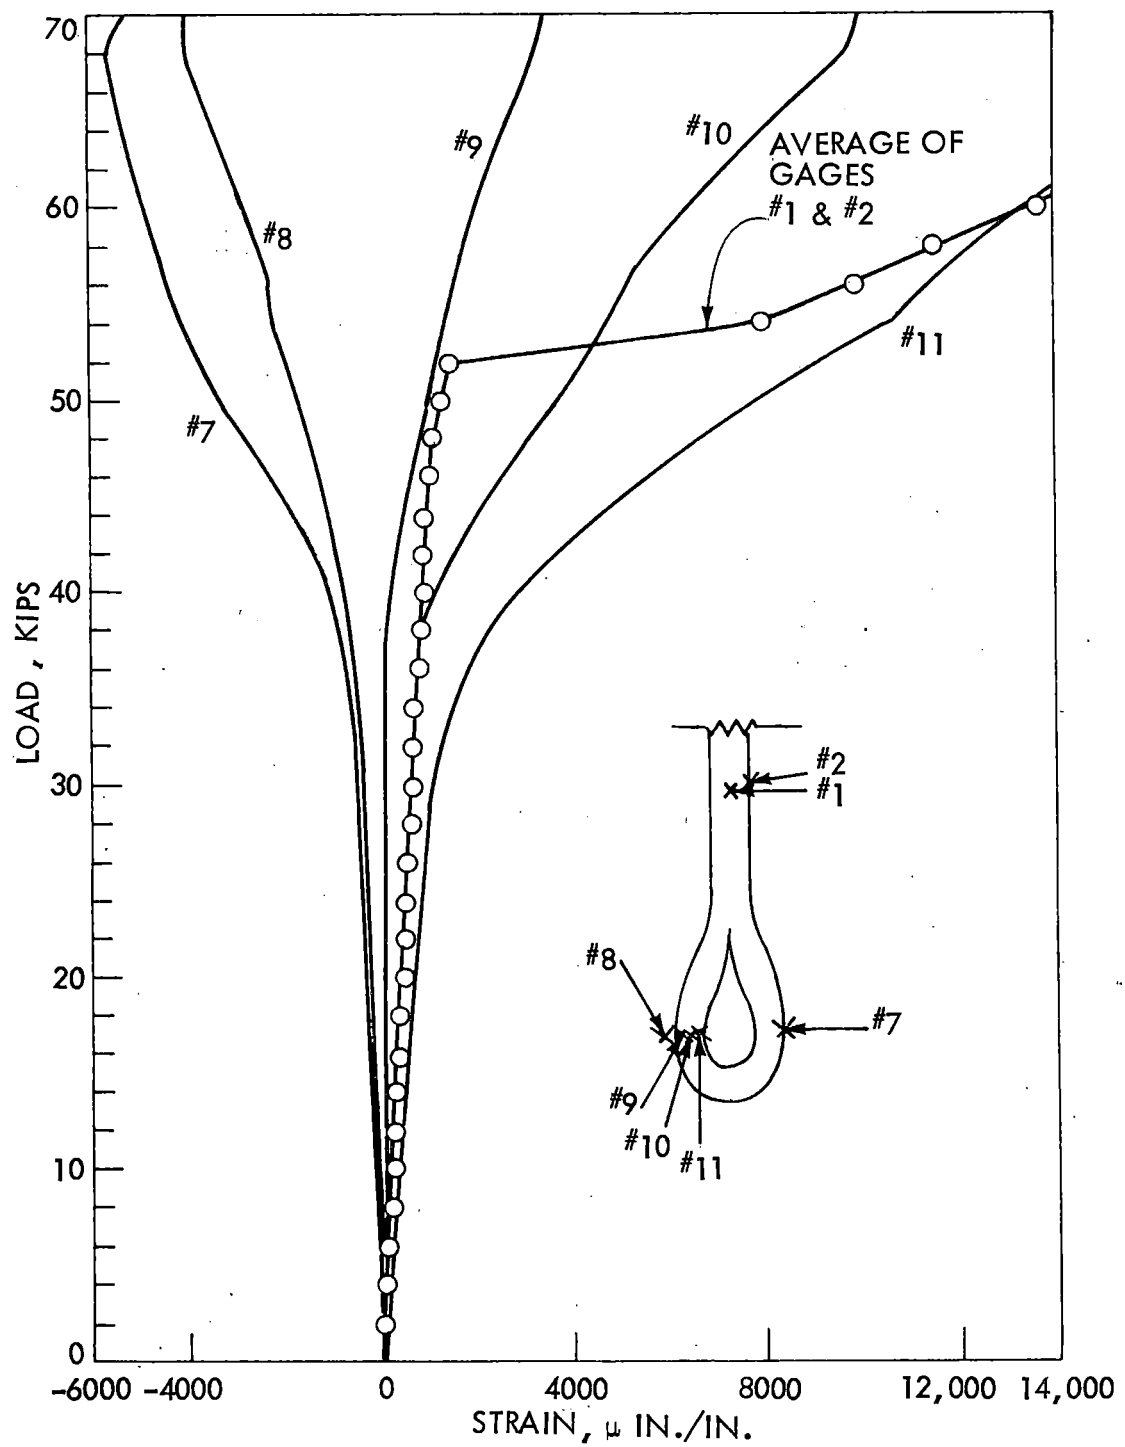
Fig. 47a. Load vs strain distribution in side of eye (total range).

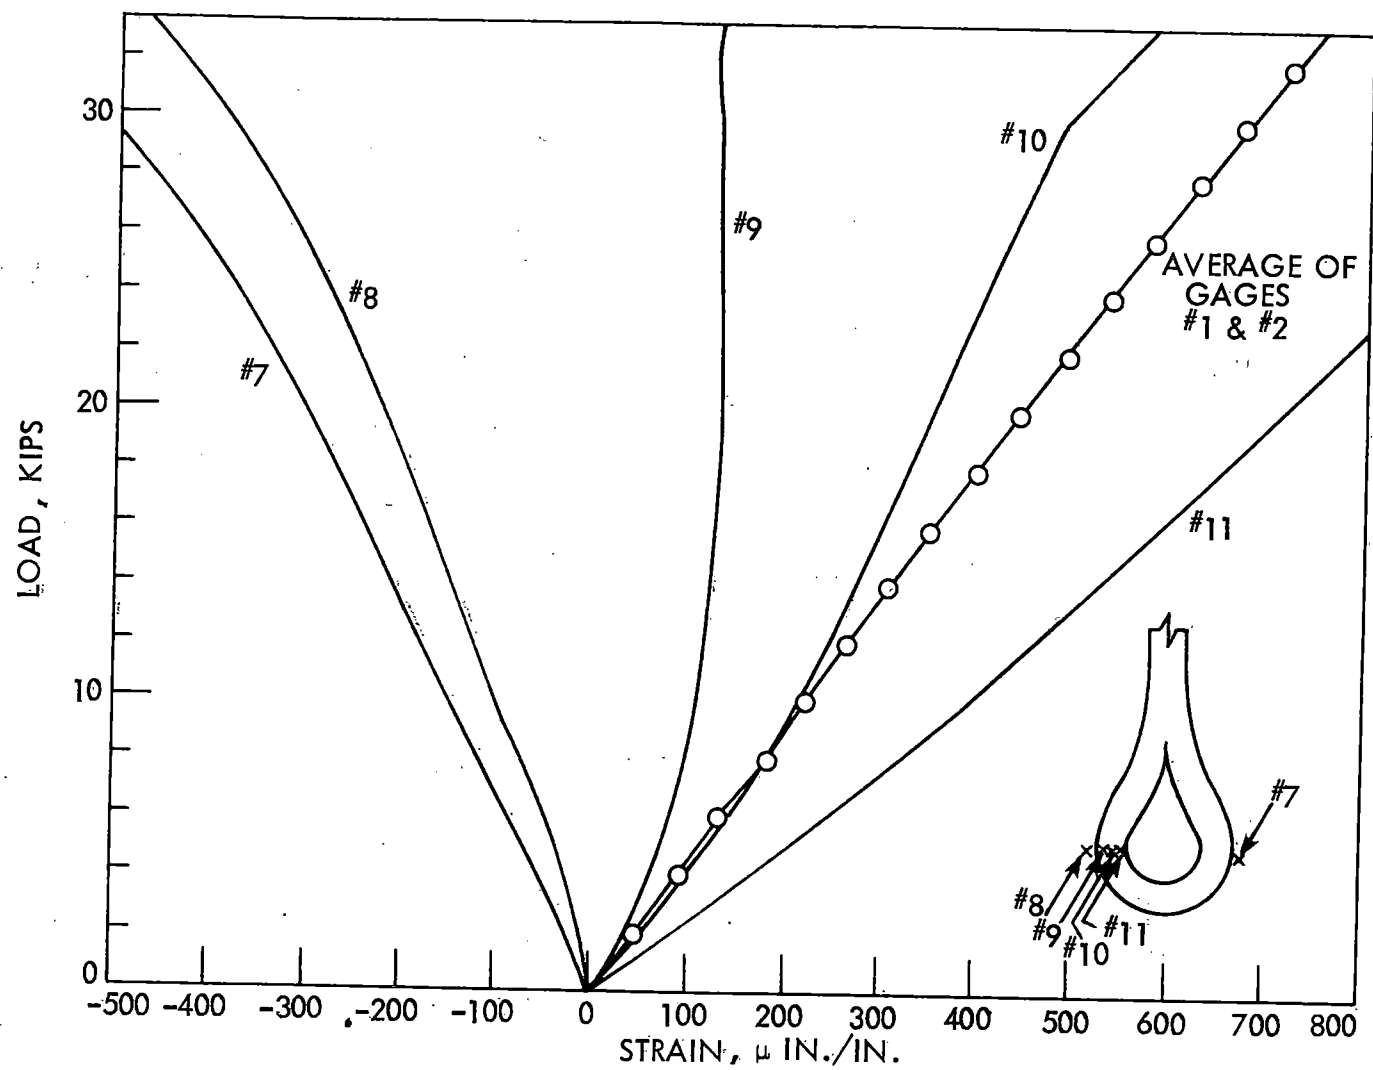
Fig. 47b. Load vs strain distribution in side of eye (elastic range).
