DEVELOPMENT OF A MANUAL CRACK QUANTIFICATION AND AUTOMATED CRACK MEASUREMENT SYSTEM

**Project TR- 457
Final Report**

**Iowa Department of Transportation and
Iowa Highway Research Board**

**PUBLIC POLICY CENTER
CIVIL AND ENVIRONMENTAL ENGINEERING
UNIVERSITY OF IOWA
January 2005**

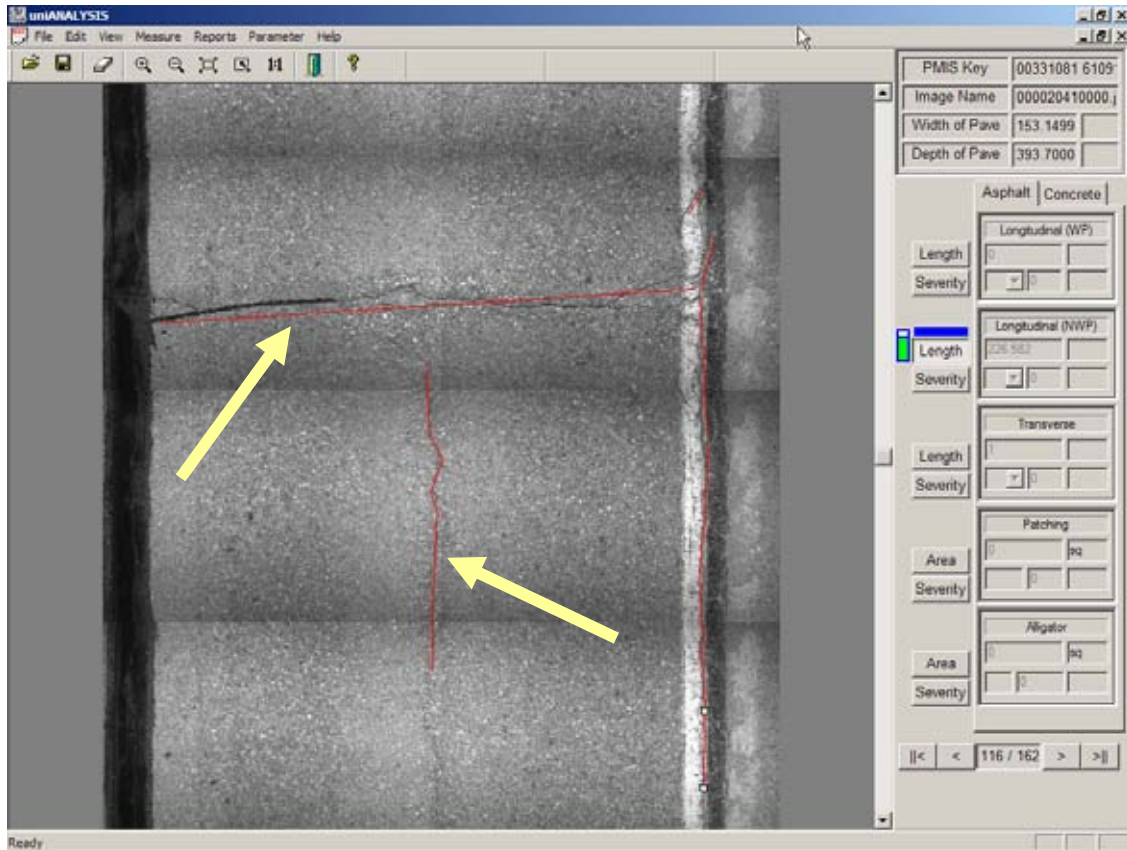
Figure 1 Analysis of Longitudinal and Transverse Crack by Line

To illustrate the manual processing concept, the following examples are provided. Figure 1 shows a sample image containing cracks, which would cover a pavement area of 153 inches (3.89 m) by 394 inches (10 m). By clicking on the button at the right dialogue panel, a crack type is selected. The user traces a selected crack using a mouse. Once the

tracing is completed, the system automatically computes actual length (226.58 inches) of a crack.

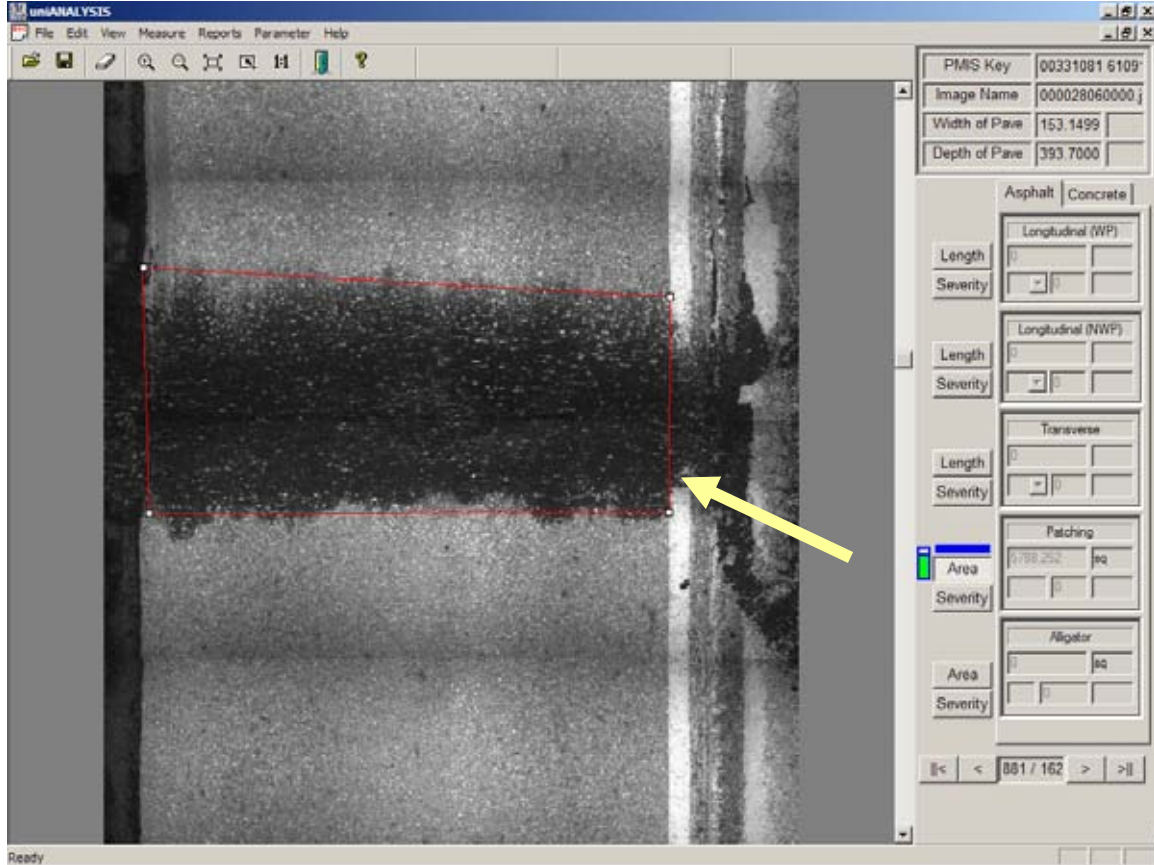
Figure 2 Analysis of Patching by Polygon

Figure 2 illustrates how to measure the area of patching. The user clicks on patching button on the right dialogue panel, patching option is selected. The user traces a boundary of the patching using a mouse. Once the boundary is closed as a polygon, the system automatically computes actual area of patching.

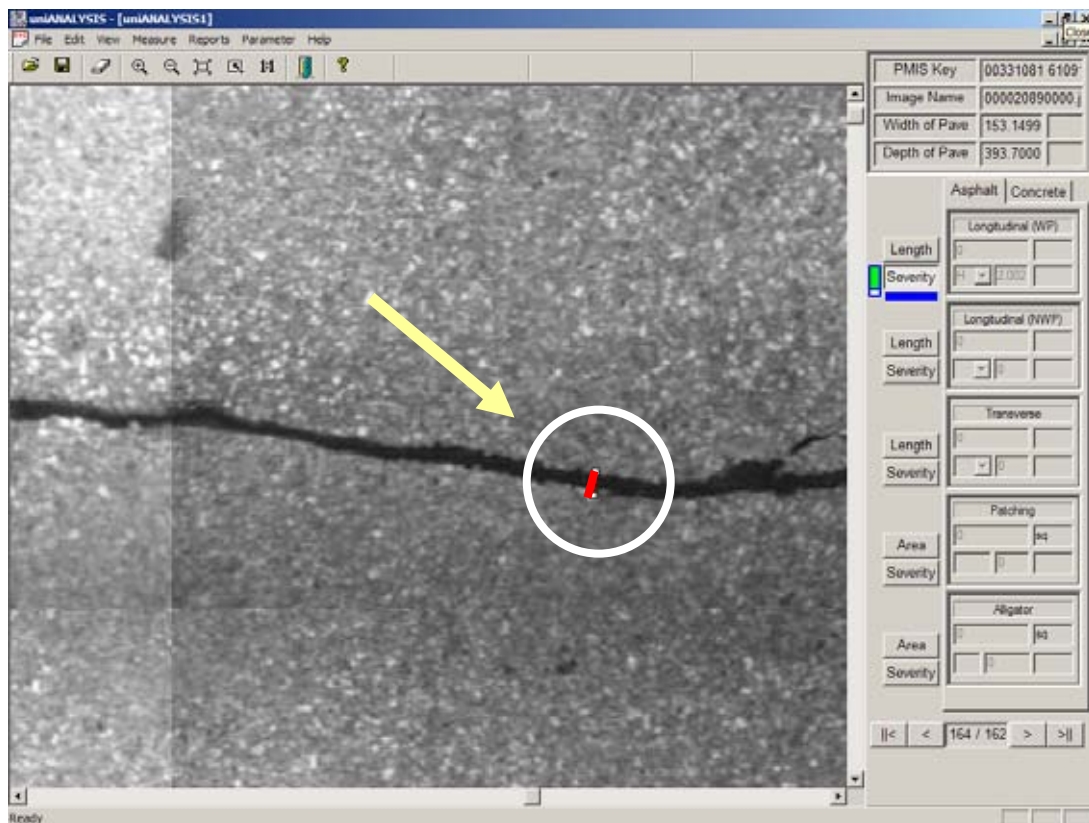
Figure 3 Measurement of Crack Width with Zooming Function

Figure 3 illustrates how to measure the crack severity. By clicking on the Zoom Rect icon from the tool bar, the function to measure severity becomes activated. The user then moves his/her mouse on the crack and click the mouse button to zoom the crack to the fixed level. The user then drags the cursor from one side of crack to the other side to measure the width of the crack. The system automatically computes the crack width, displays it on a dialogue box, and selects the appropriate severity level based on the measured crack width.

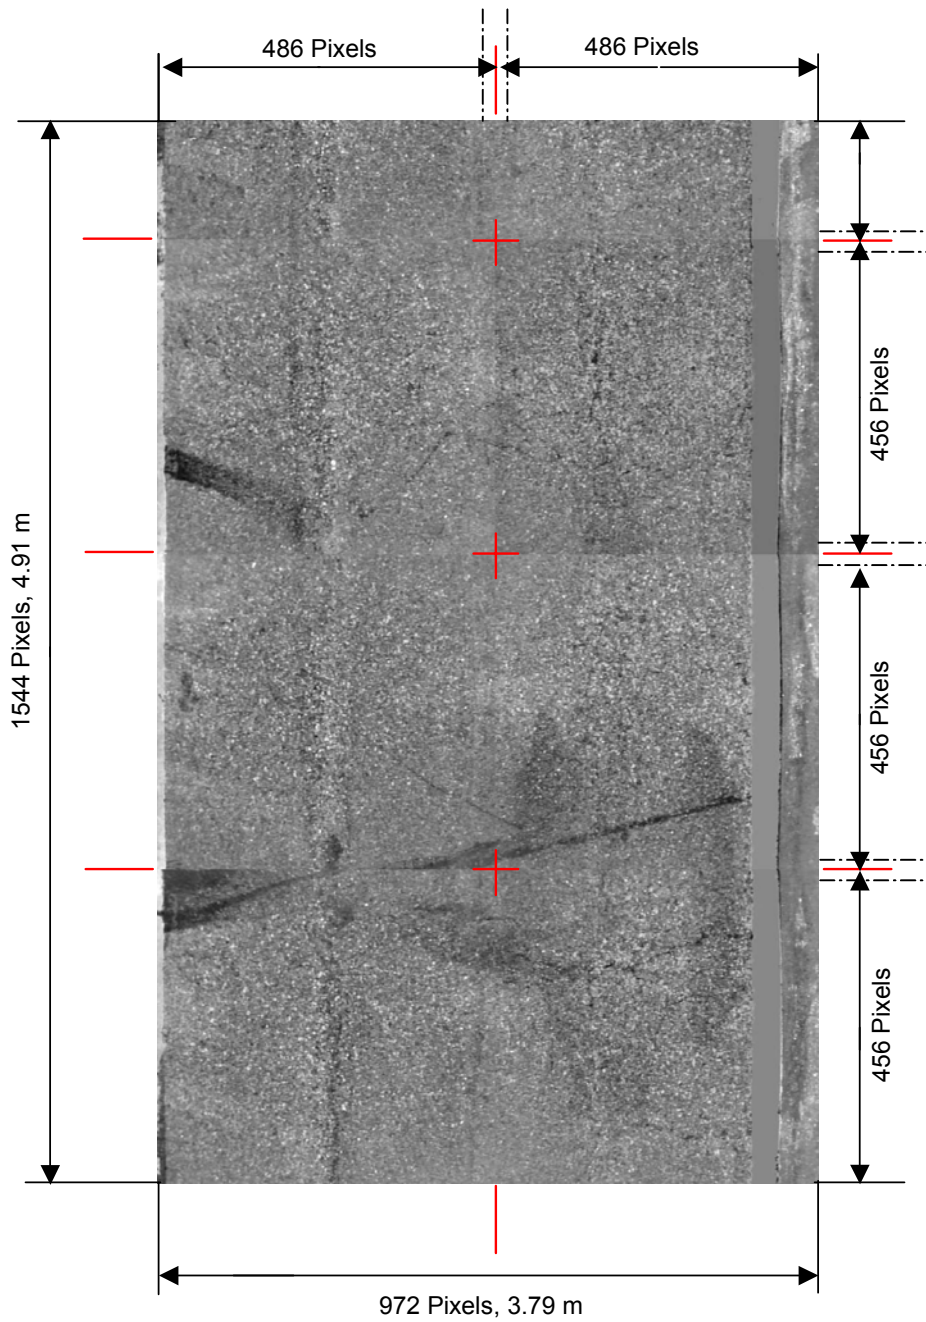
Figure 4 Image Collected by the Consultant.

Iowa DOT provided a set of digital images collected by the consultant. The size of the digital image is 154 inches (3.89m) by 394 inches (10m) as shown in Figure 4. Total 1585 images were analyzed using the manual quantification software package described above. A sample printout of the manual analysis result is reproduced in Table 1 and the printout of the manual analysis of 1,585 images is included in the Appendix.

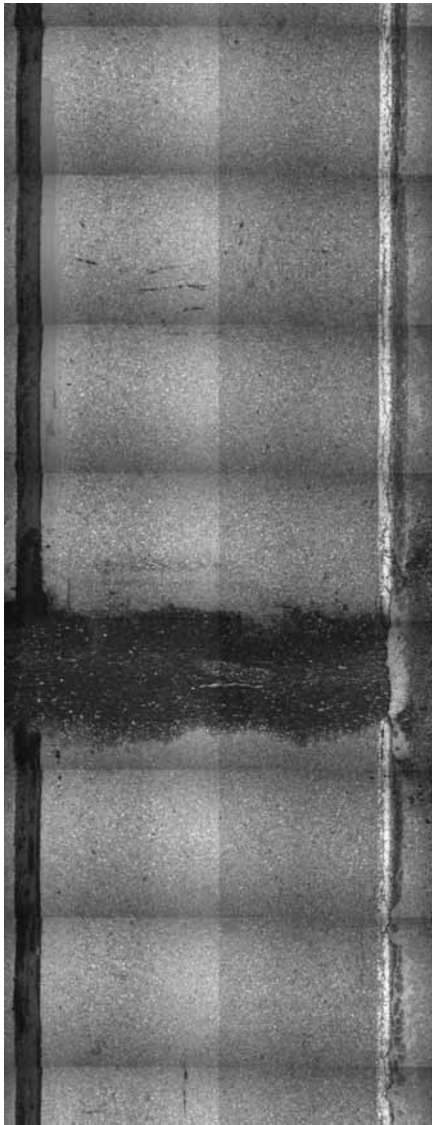
(a) No. 2156 Image

Figure 5 shows sample images used for the manual image analysis. No. 2156 image contains longitudinal crack and patching, whose measurement values are 348.526 inches and 6023.223 in², respectively. No. 2159 image shows two transverse cracks and a longitudinal crack with a total length of 212.976 in.

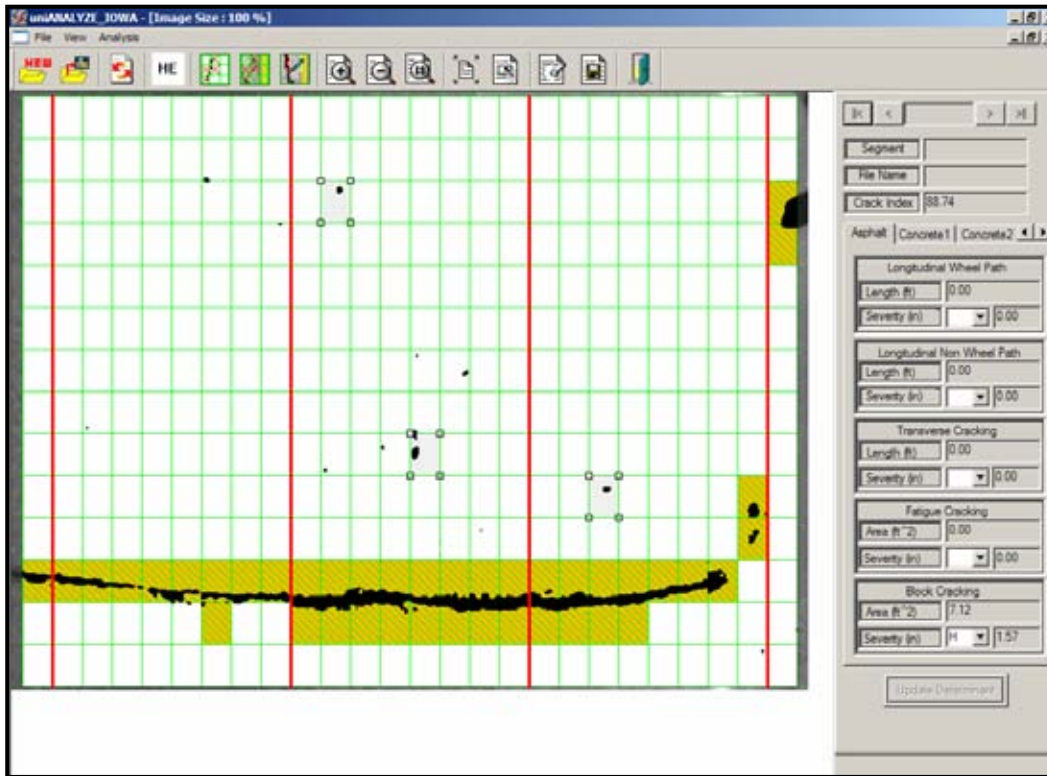
Figure 6 Crack Index Example based on Tile-based Crack Quantification Procedure

To calculate crack index, first, the value of the central pixel is compared with its neighbors at 5 x 5 pixels, and its value is adjusted to the median of these neighbors. Median filters are the most effective noise reducers due to their tendency to preserve rather than blur edges (Hansen et al. 1999). The developed automated crack imaging procedure applies a regression equation based on the average gray scale of each tile to obtain the optimum threshold value. This technique first determines an optimum threshold value for each tile as a function of its average gray-scale value. For each tile, the gray value of each pixel is compared against the optimum threshold value. The pixel is classified as a crack pixel if its gray value is less than the optimum threshold value. The decision to classify each tile as cracked or not is based on the percentage of crack pixels present in a tile. The number of cracked tiles is then divided by the total number of tiles to compute a unified crack index for each pavement image. Figure 6 shows a sample image projected on a computer screen, which displays a computed crack index of 11.26% (41 cracked tiles out of a total of 364 tiles).

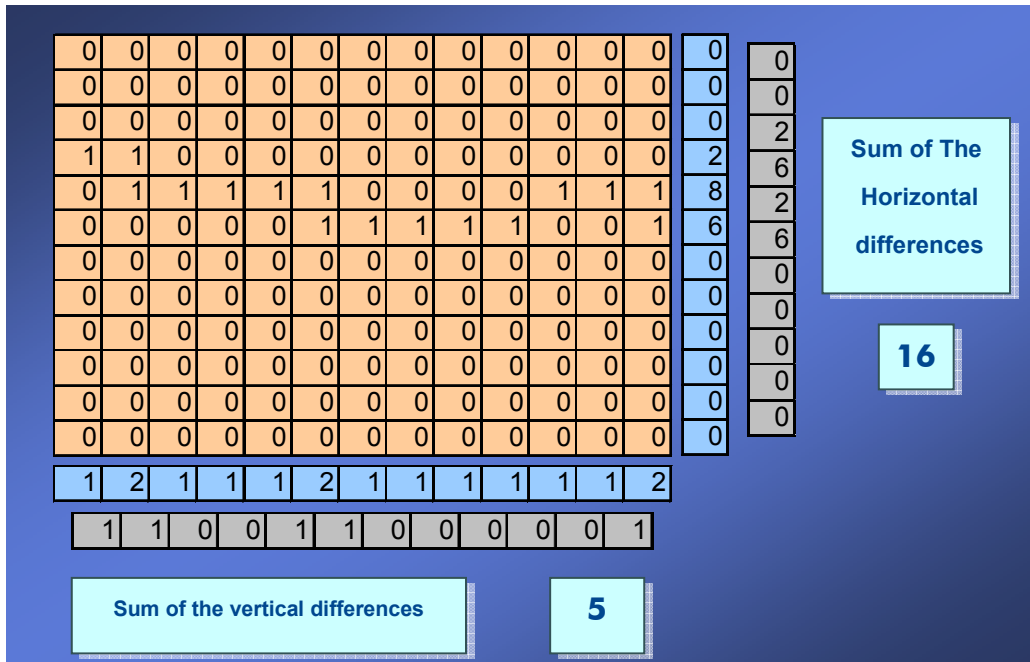
Figure 7 Calculation of Crack Type Index

The crack type of actual pavement images is determined using horizontal and vertical histograms of a binary image. First, the actual pavement image is converted into a binary image and horizontal and vertical histograms of the binary image are computed. The difference between two adjacent histogram peaks are computed and summed as illustrated in Figure 7. Crack type index is then calculated by subtracting sum of the horizontal differences from that of the vertical differences. The crack type is determined based on the value of crack type index.

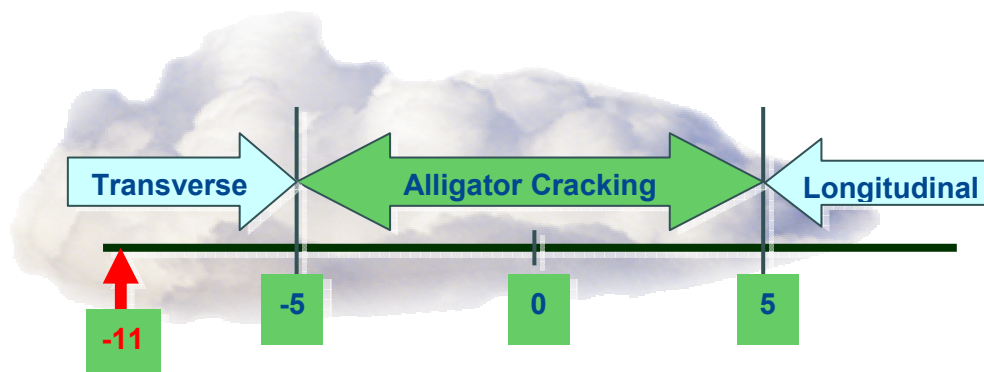
Figure 8 Range of Crack Type Index

Figure 8 illustrates the range of crack type index. For example, as shown in Figure 8, an image can be classified as transverse cracking if its crack type index is less than -5. If the crack type index ranges from -5 to 5, it can be classified as alligator cracking or block cracking. The unified crack index can be used to distinguish block cracking from alligator cracking because block cracking produces a smaller unified crack index than alligator cracking. If the crack type index is greater than 5, it can be classified as longitudinal cracking.

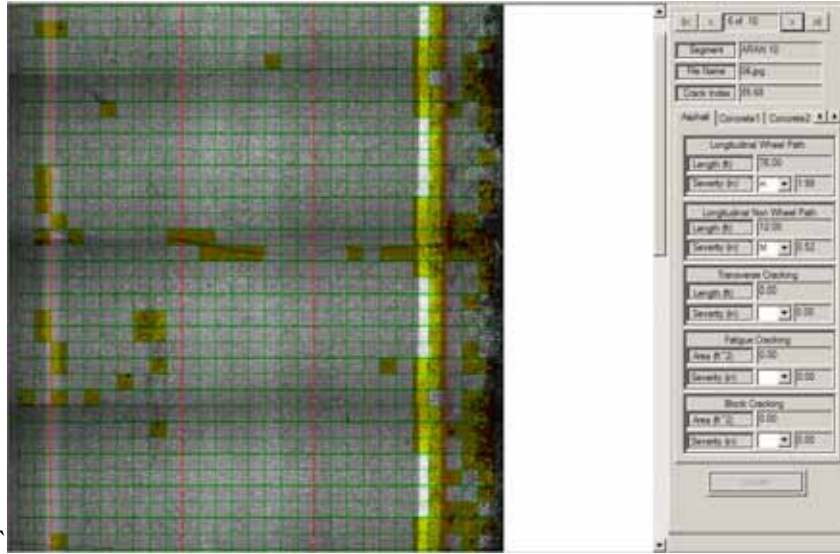
Figure 9 No. 6 Longitudinal Cracking Image analyzed by AIAS

Crack type was also analyzed using the same images shown in Table 2. AIAS can determine only one crack type for each image. Figure 9, 10, 11, and 12 show examples of crack types: 1) longitudinal, 2) transverse, 3) alligator, and 4) block cracking.
