Prevention of Longitudinal Cracking in Iowa Widened Concrete Pavement

# Prevention of Longitudinal Cracking in Iowa Widened Concrete Pavement

tech transfer summary

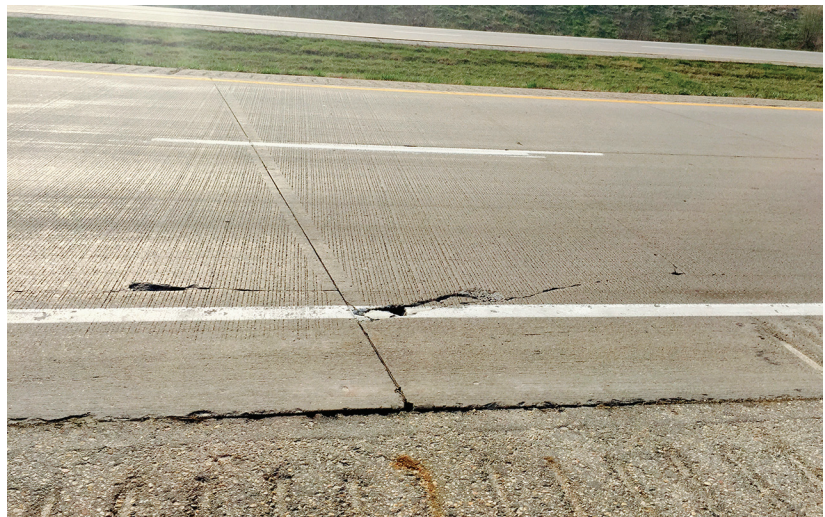
*Longitudinal cracking observed in widened concrete pavement with a skewed transverse joint on US-65 in Polk County, Iowa*

- Use of rectangular joint design instead of a skewed joint design is recommended.
- A tied PCC shoulder can perform better than other shoulder alternatives. Additionally, a regular slab (12 ft wide) with a full-depth tied PCC shoulder rather than a widened slab (14 ft wide) with a full-depth tied PCC shoulder is recommended.

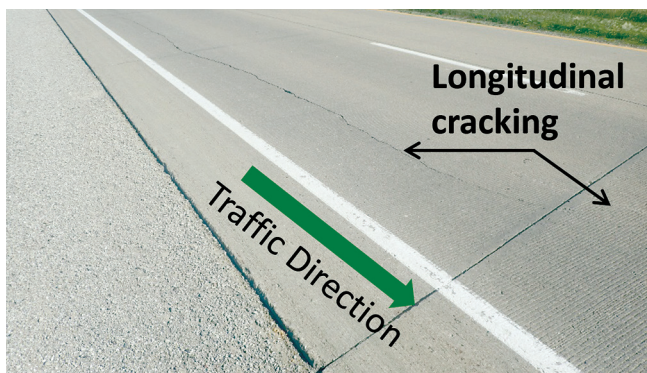
*Longitudinal cracking observed on IA-163 with widened slabs in Mahaska County, Iowa*

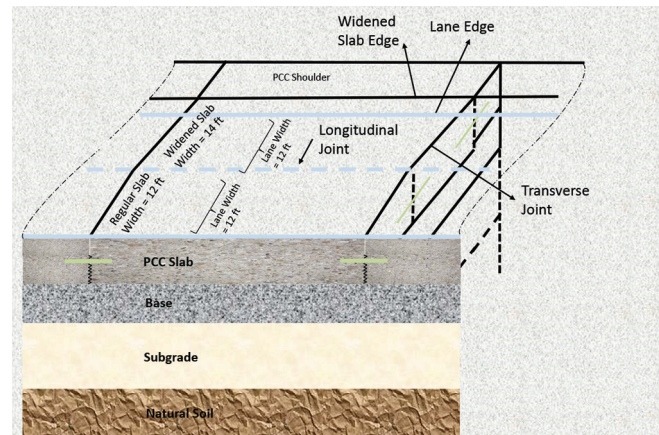
Numerical analysis using ISLAB2005 and EverFE 2.25 FEA software was conducted to understand the underlying mechanisms of longitudinal cracking failures in JPCP. A typical Iowa widened JPCP slab was modeled using a six-slab setup (three widened slabs in the traffic direction and three regular slabs adjacent to the widened slabs).

*Finite element model definitions*
