**Material and Construction Optimization for  
Prevention of Premature Pavement Distress  
in PCC Pavements**

**Annual Report (Phase I)  
September 2004**

**Study TPF-5(066)  
Transportation Pooled Fund Program  
Federal Highway Administration  
U.S. Department of Transportation**

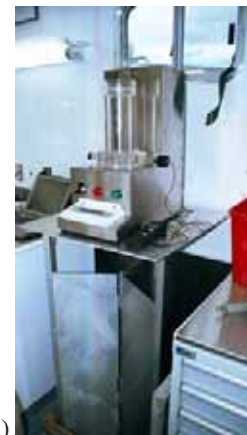
See Figure 2.

Weather data will be recorded using the lab's weather station and GPS capabilities from the beginning of testing at a project site until the testing is complete.

The AVA is a very sensitive machine that has been considered only usable in permanent buildings, thus limiting its use in field control. Because any vibration, such as that caused by wind, can dramatically skew the AVA's results, the trailer was designed with a trapdoor in the floor to accommodate the AVA. When the lab is parked, the base of the AVA will rest on the ground through the hole so that it is protected by the trailer but not touching the trailer. This will allow accurate use in the field.
