# Partially Grouted Revetment for Low-Volume Road Bridges

**Interim Report  
April 2019**

**Sponsored by**  
Iowa Highway Research Board  
(IHRB Project TR-710)  
Iowa Department of Transportation  
(InTrans Project 16-579)

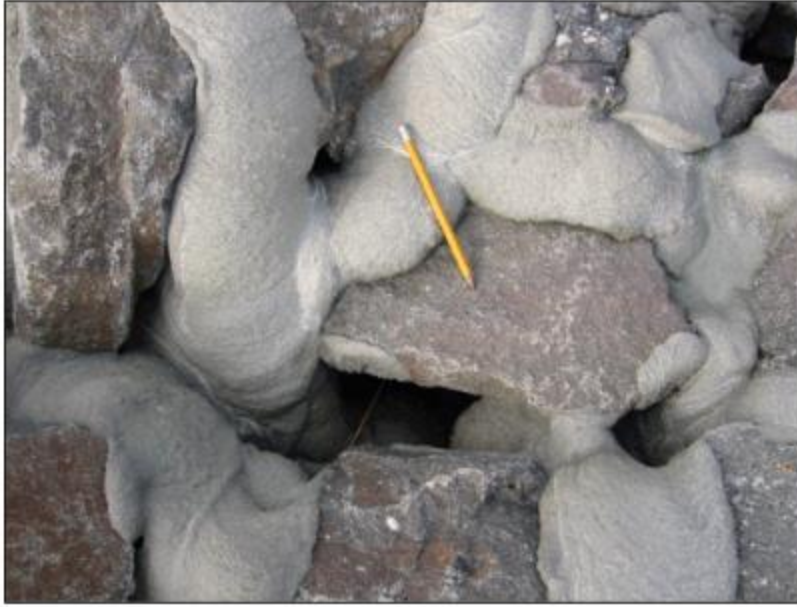
Partially grouted riprap is a system consisting of specifically size rocks, grouted together with 50 percent or less of the voids filled by the grout, as shown in Figure 7.

**Figure 7. Partially grouted riprap**

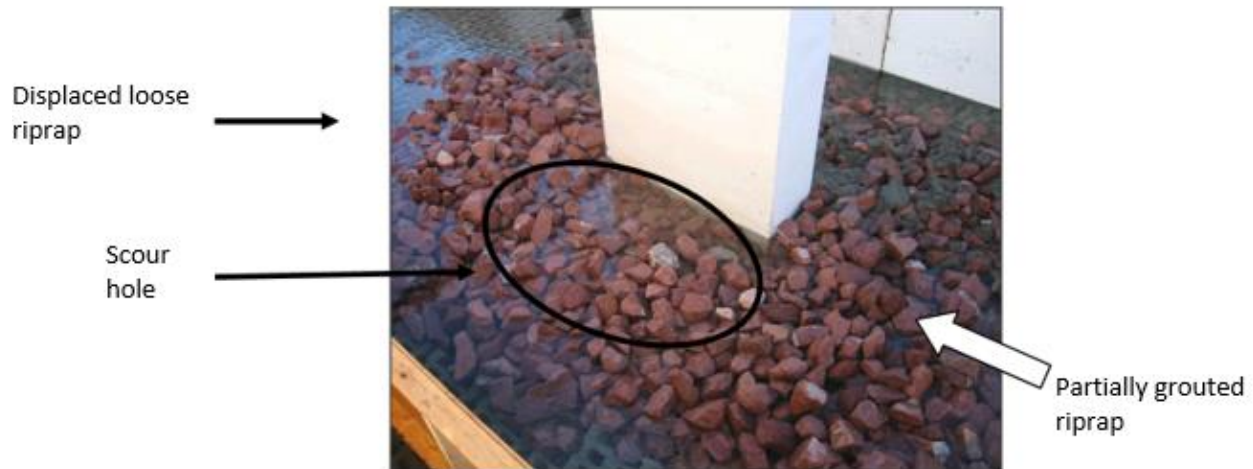
Laboratory studies have been conducted in the past to test the performance of conventional and partially grouted riprap. One such study involved prototype-scale tests of both partially grouted and loose riprap simultaneously (Lagasse et al. 2008). The results showed that the partially grouted riprap was undamaged; whereas, the loose riprap experienced failure via particle erosion or displacement, as shown in Figure 8.

**Figure 8. Laboratory test results on loose and partially grouted riprap**

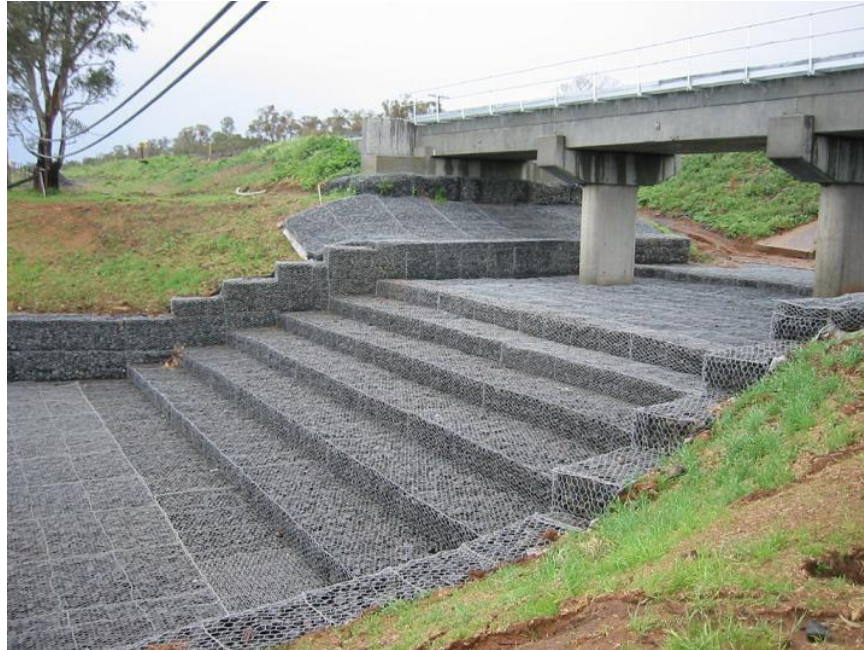
Gabion mattresses are containers constructed of wire mesh that are then filled with rocks. An example of this system is shown in Figure 11.

**Figure 11. Gabion mattress after installation**

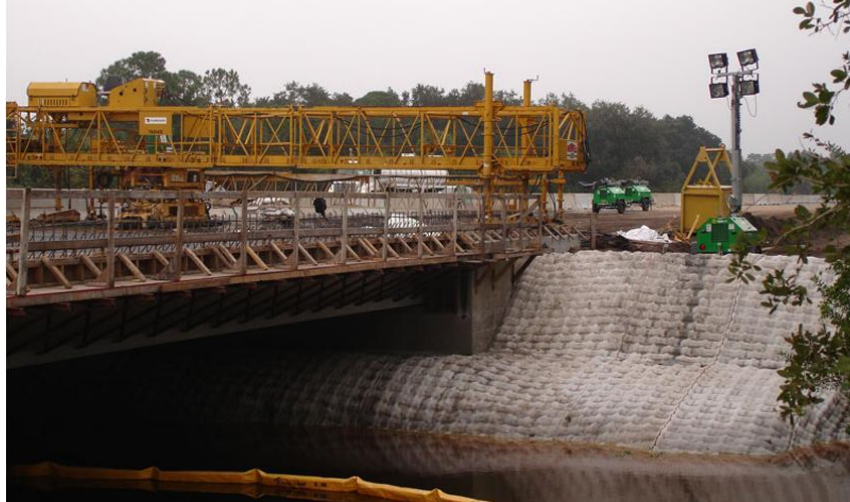
Grout-filled mattresses are composed of a double layer of synthetic fabric, often nylon or polyester material, sewn into a series of compartments. Adjacent mattresses are sewn together, as shown in Figure 12, and individual compartments are then filled with grout, which flows between compartments via ducts.

**Figure 12. Grout-filled mattresses after installation**

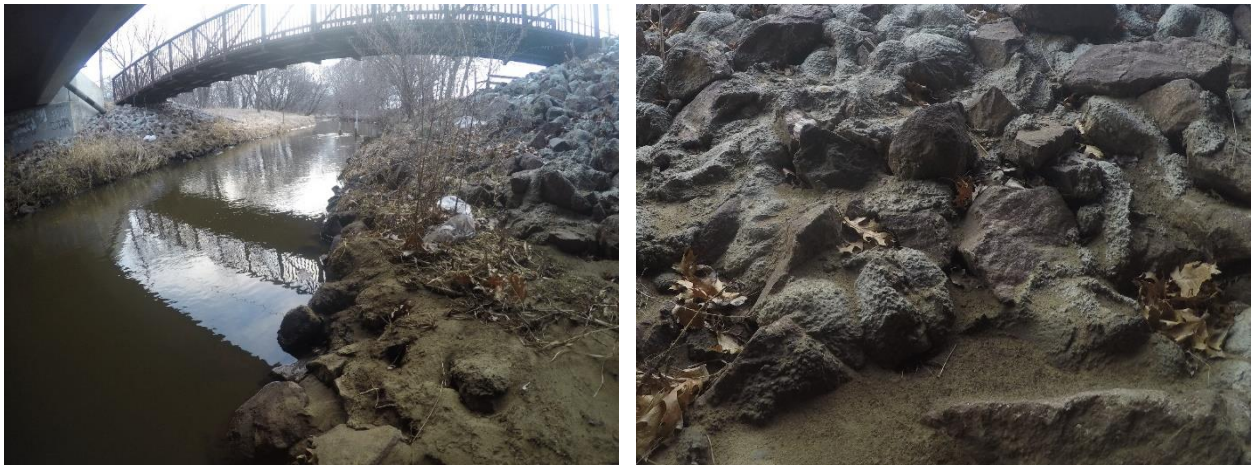
**Figure 16. Minnesota Site 1: Partially grouted riprap**

Overall, partially grouted riprap was seen to perform well when it is grouted correctly. This same finding was conveyed via conversations with the Minnesota Department of Transportation (MnDOT). All of the systems were approximately 5 years old at the time of the field visits.

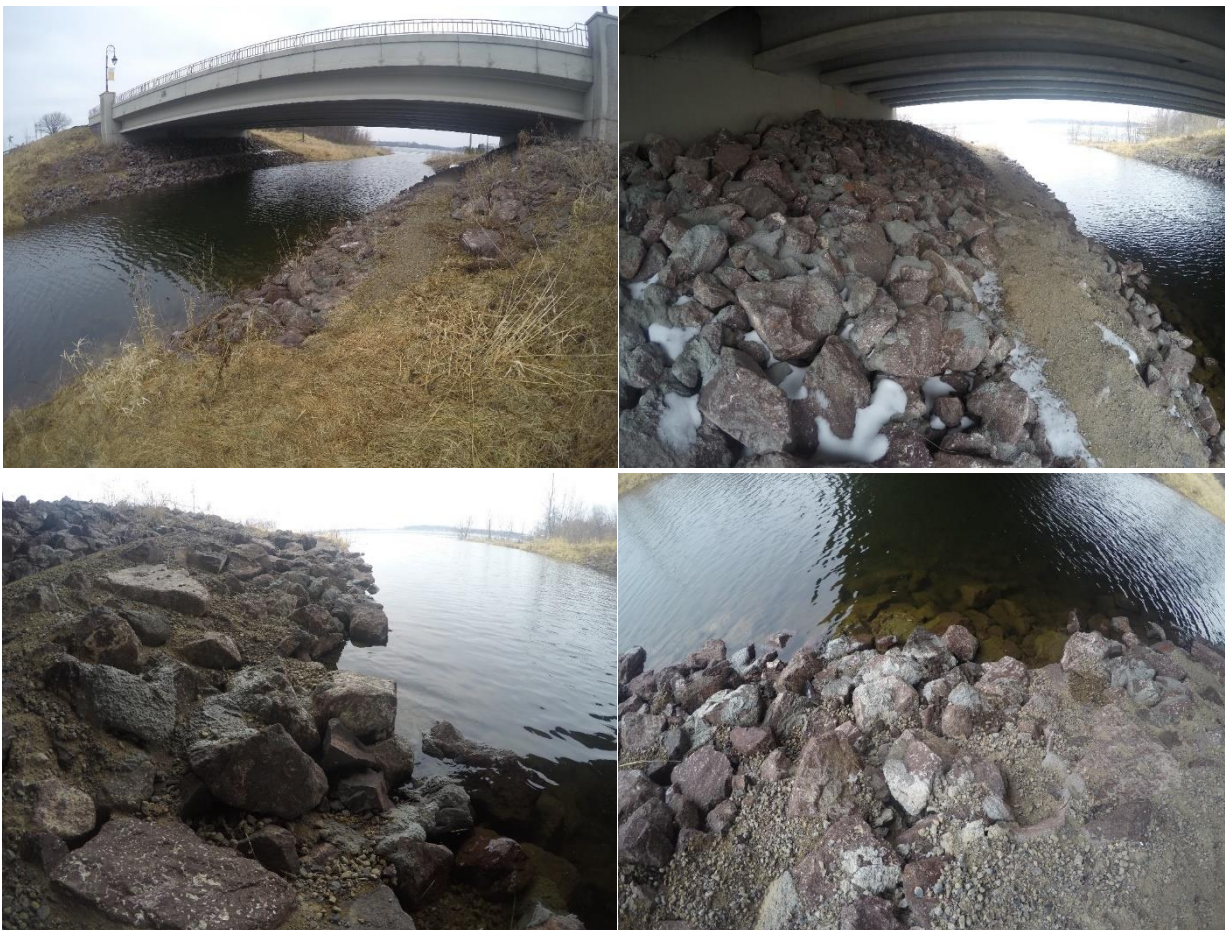
**Figure 17. Minnesota Site 2: Partially grouted riprap**

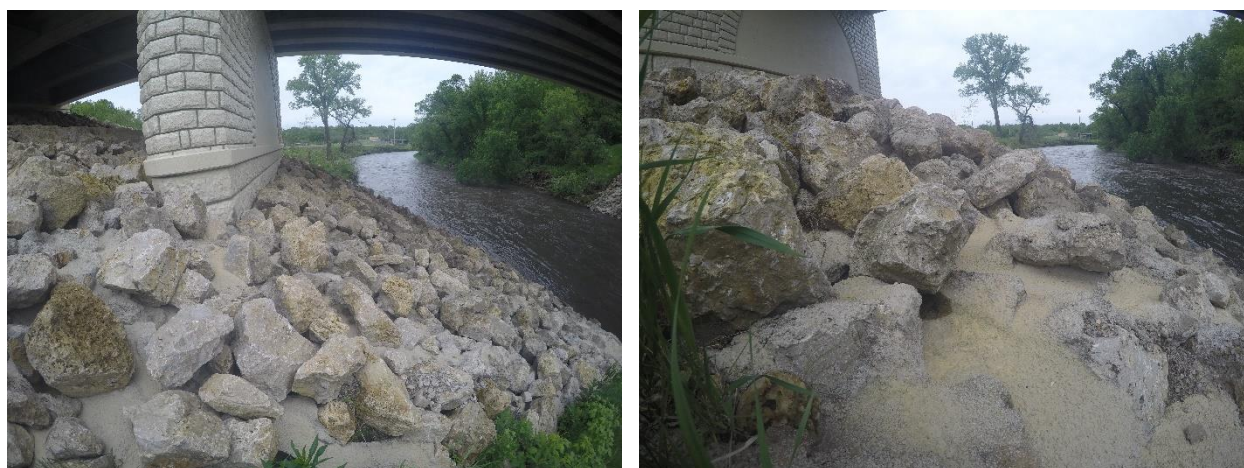
**Figure 18. Minnesota Site 3: Partially grouted riprap-thin grout**

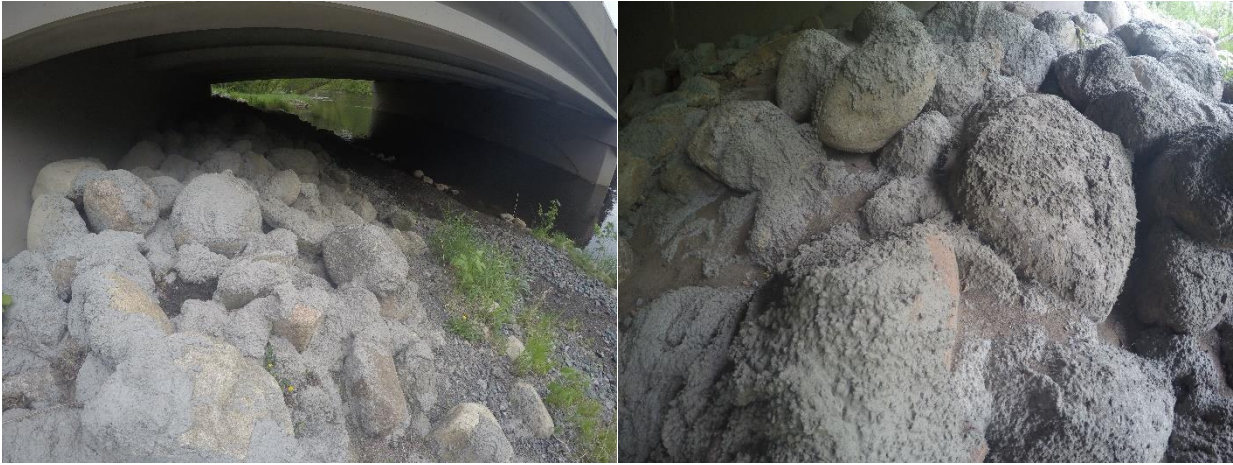
**Figure 19. Minnesota Site 4: Partially grouted riprap-splash of grout**

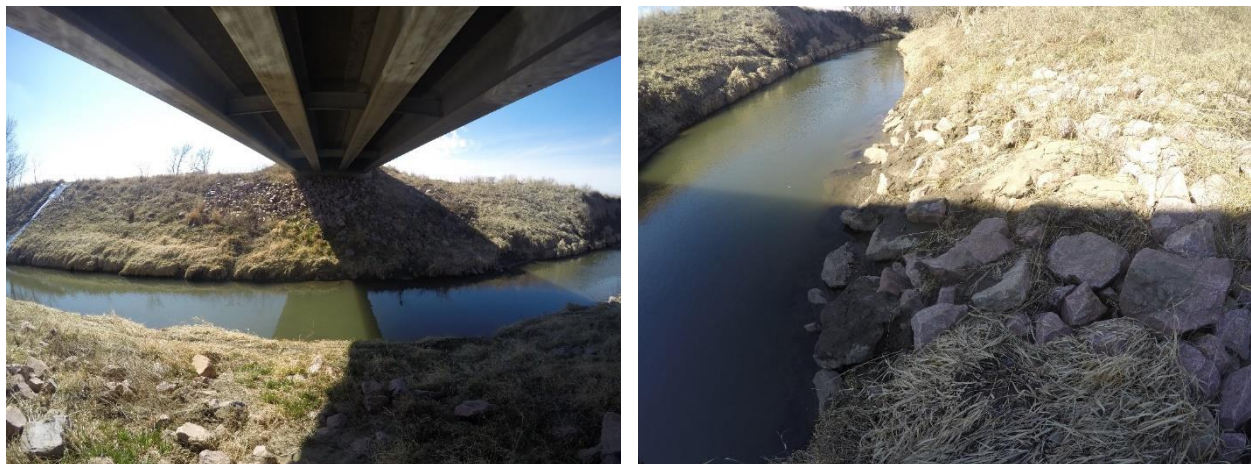
**Figure 20. Undersized loose riprap in Woodbury County, Iowa**

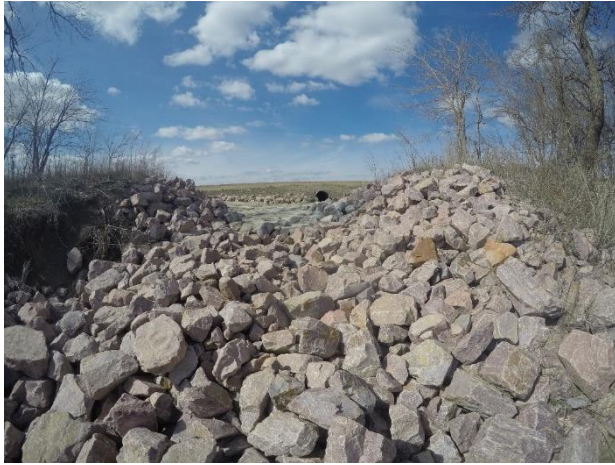
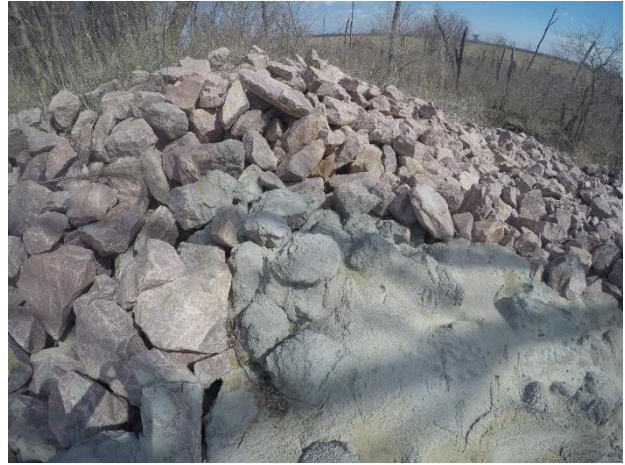
**Figure 21. Loose riprap with some grouting in Woodbury County, Iowa**

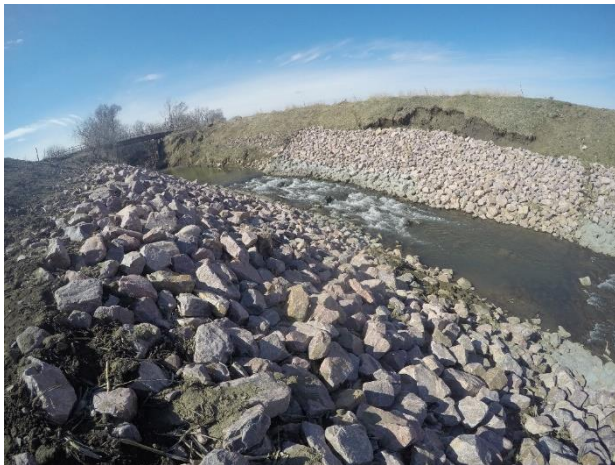
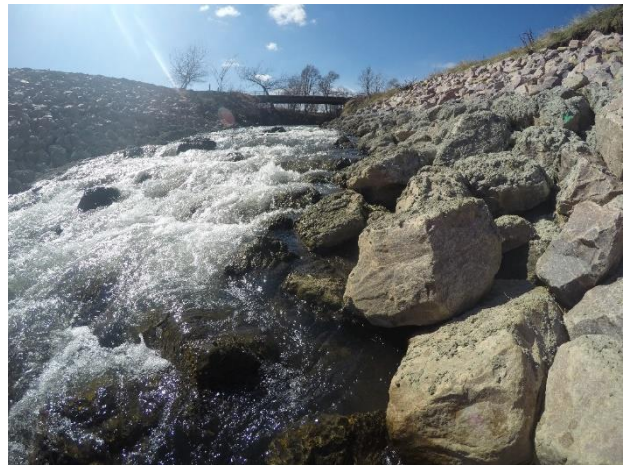
**Figure 22. Grouted and loose riprap in Woodbury County, Iowa**

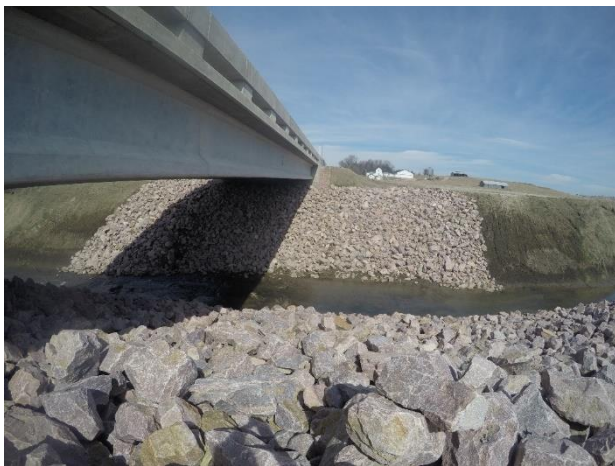
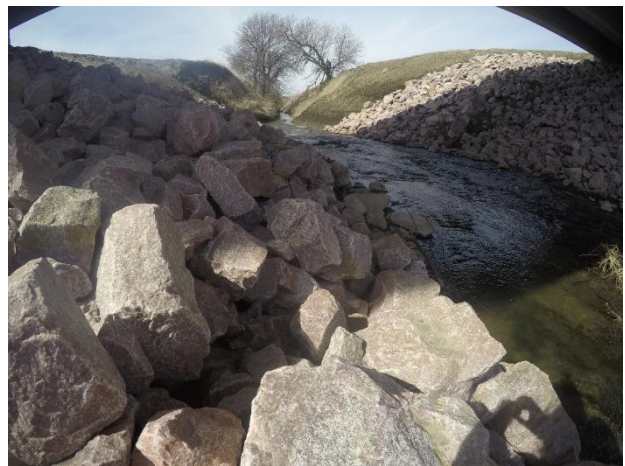
**Figure 23. Recently completed, loose riprap in good condition in Woodbury County, Iowa**

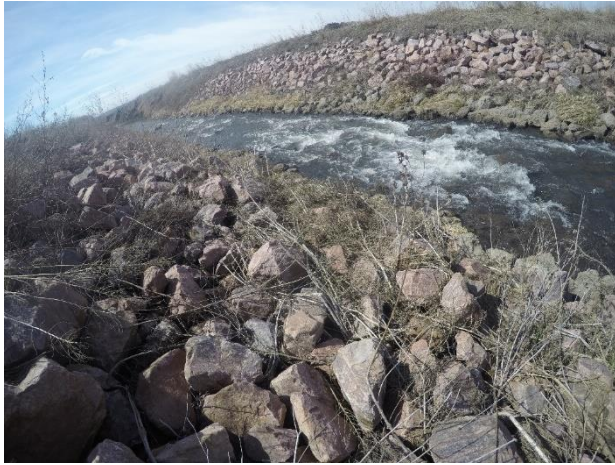
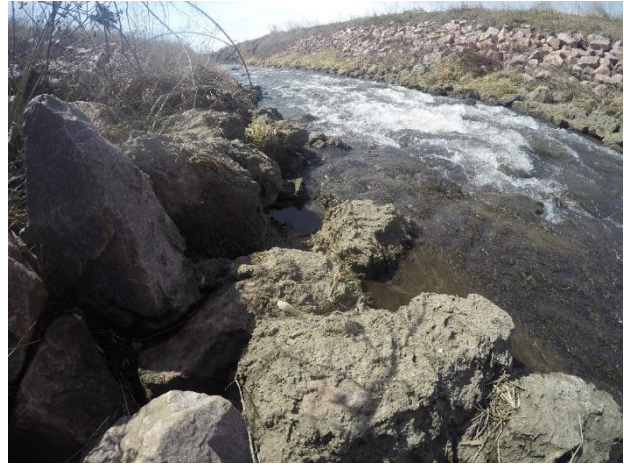
**Figure 24. Partially grouted riprap in Woodbury County, Iowa**

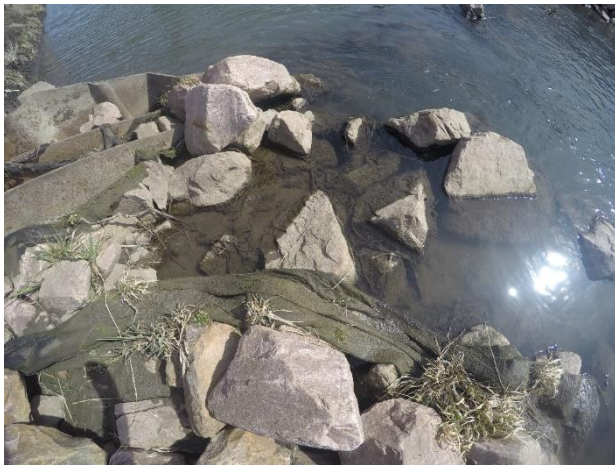
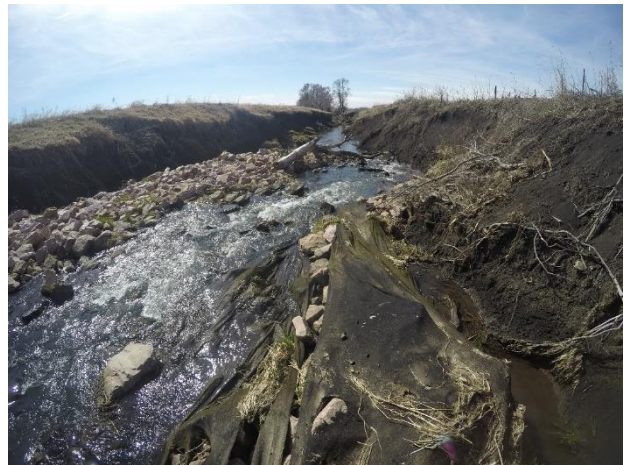
**Figure 25. Failing stream grade control in Woodbury County, Iowa**

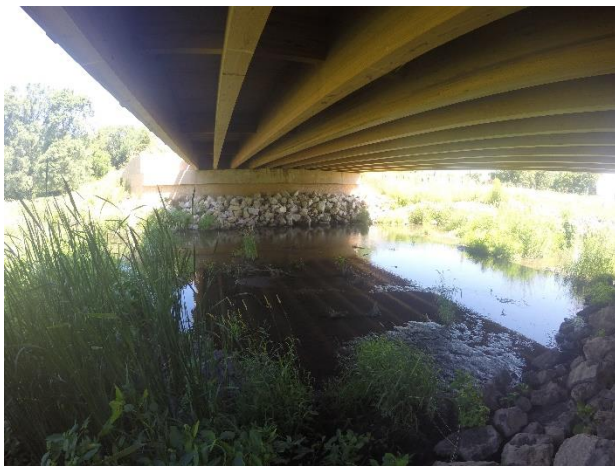
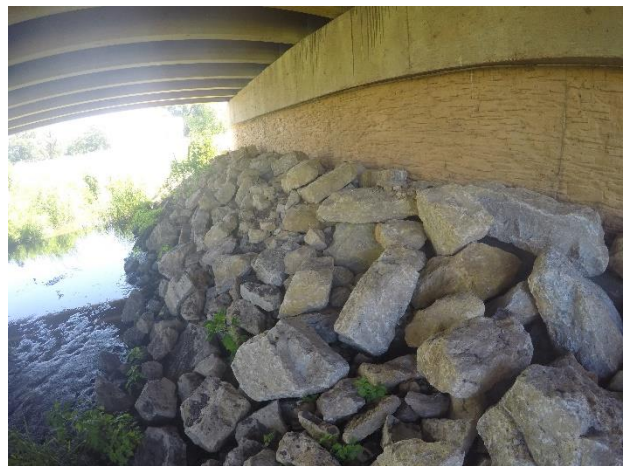
**Figure 26. Loose riprap in Buchanan County, Iowa**

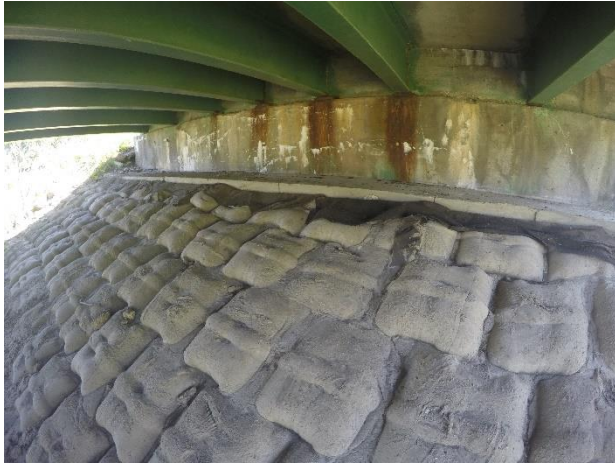
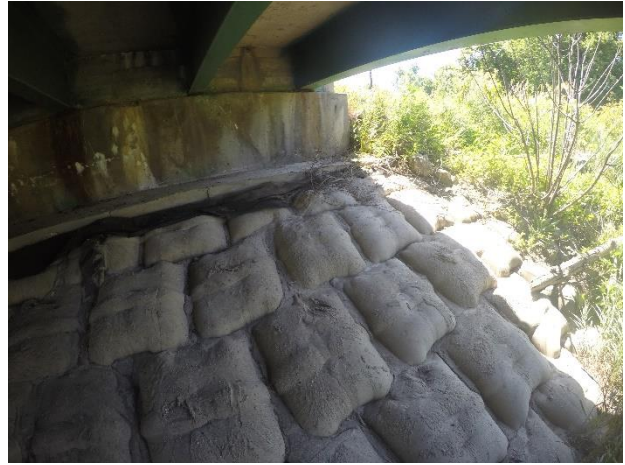
**Figure 27. Grout-filled blankets in Buchanan County, Iowa**

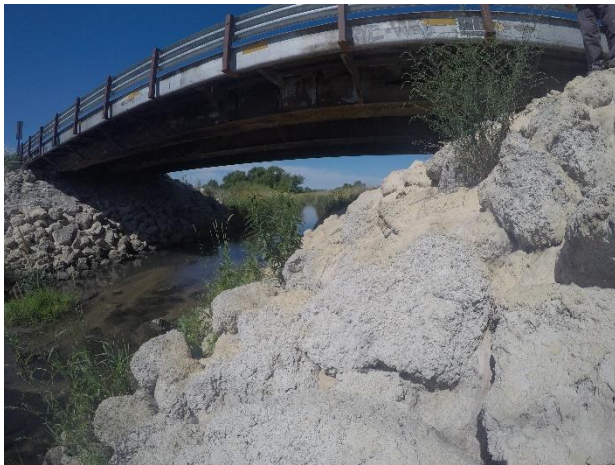
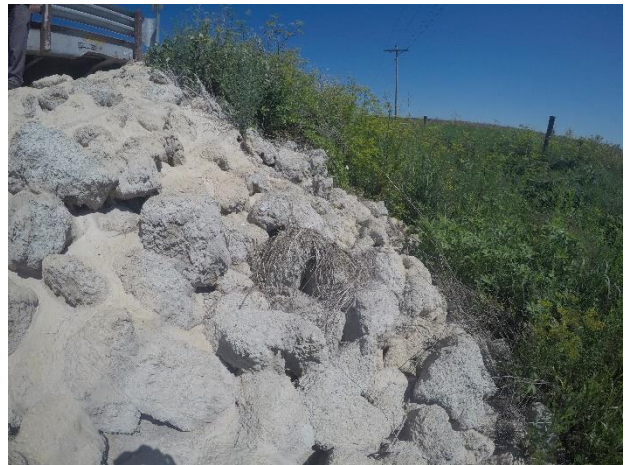
**Figure 28. Grouted riprap in Buchanan County, Iowa**

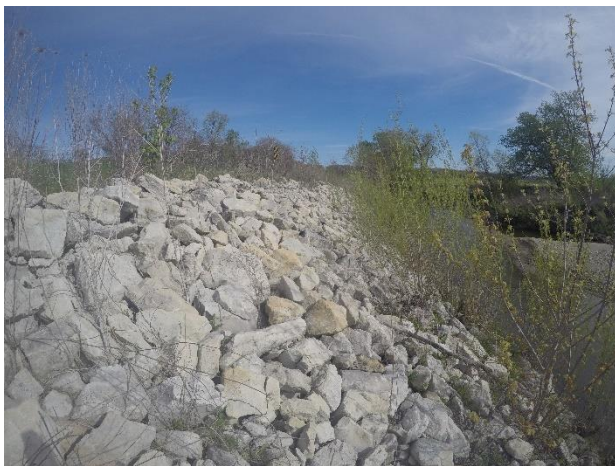
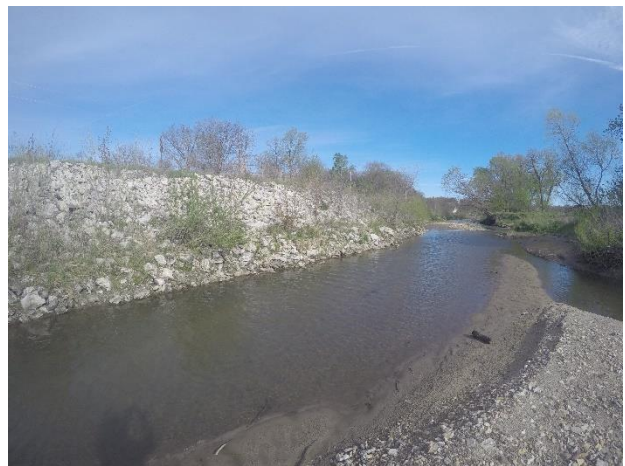
**Figure 29. Loose riprap during low water levels in Madison County, Iowa**

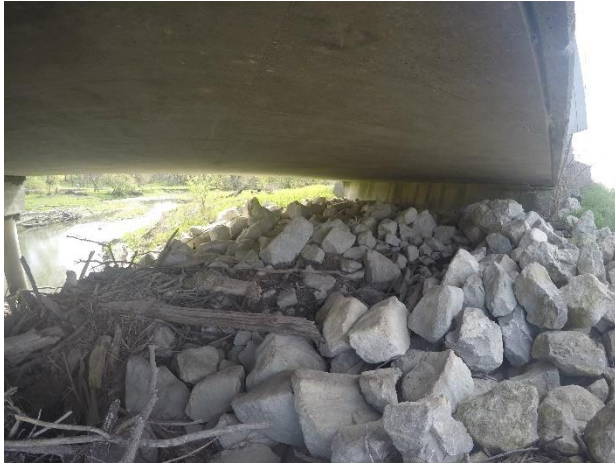
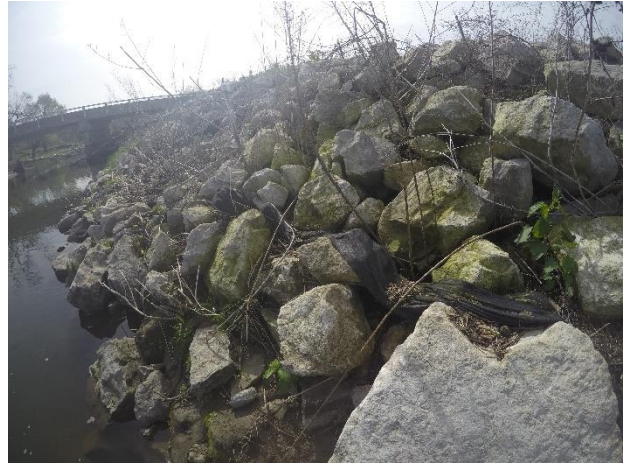
**Figure 30. Loose riprap and failing fabric in poor condition in Madison County, Iowa**

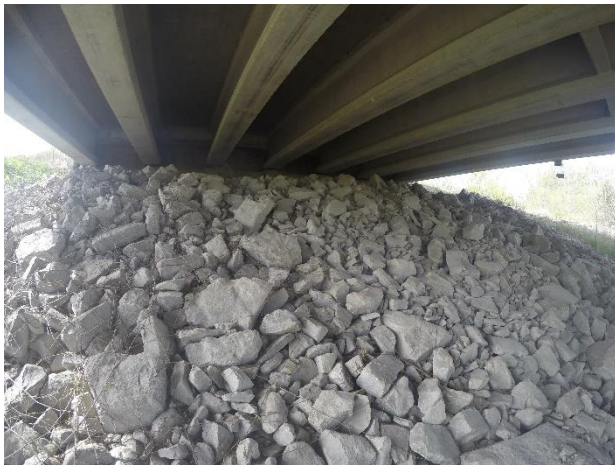
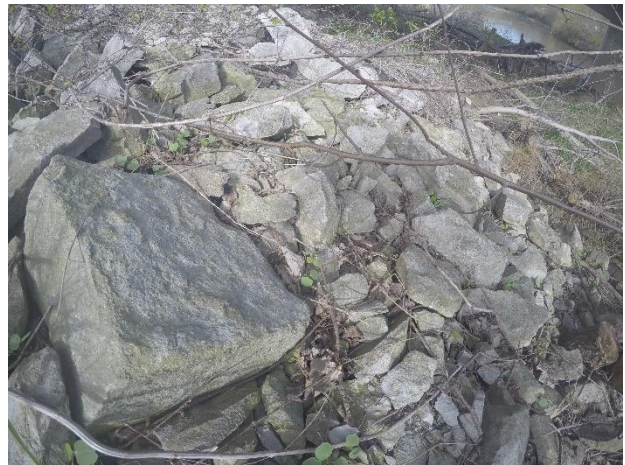
**Figure 31. Loose riprap, undersized in Madison County, Iowa**

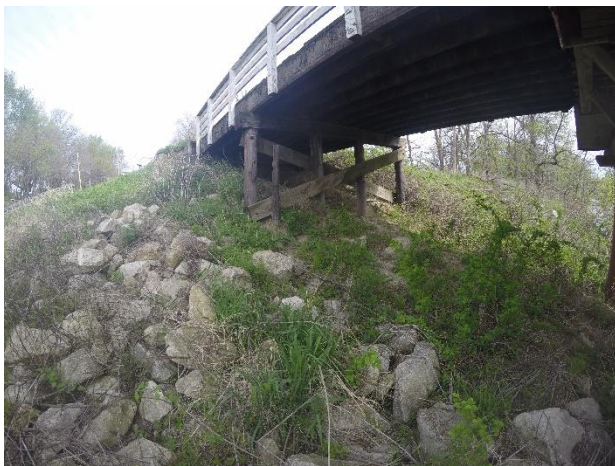
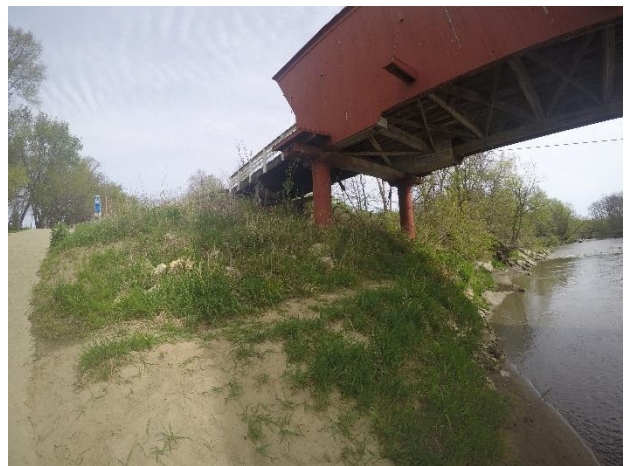
**Figure 32. Loose riprap, many washed away stones in Madison County, Iowa**

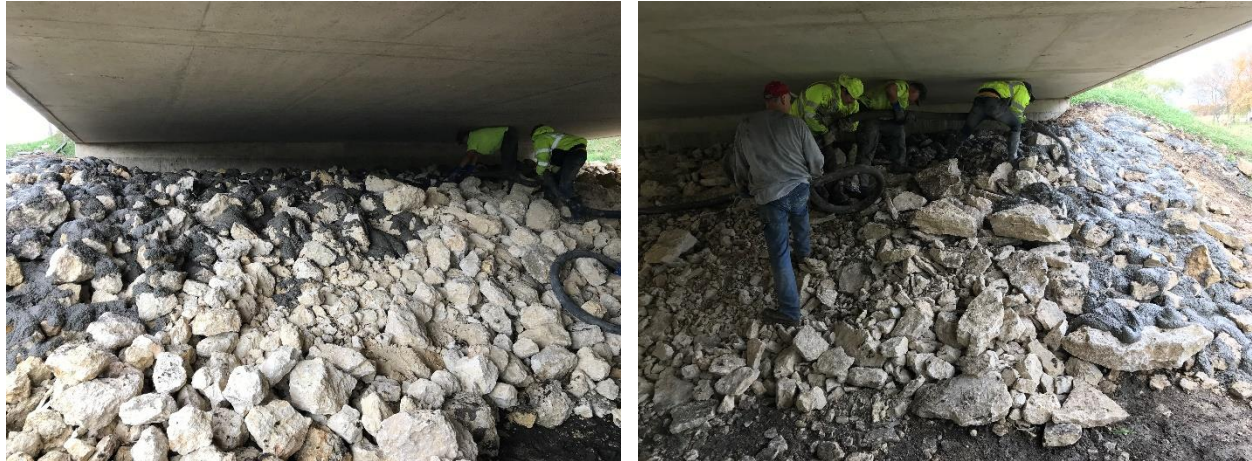
size/quality of the revetment stone to be compared when using the FHWA mix specifications. One bank used Class E revetment, while the other used recycled shotrock. Shotrock is considerably cheaper, but includes a greater variety of stone sizes, including small gravel. Figure 33 shows the difference in stone properties associated with Bridge 1.

**Figure 33. Grouting of Class E revetment (left) and shotrock (right) used for Bridge 1 in Buchanan County**

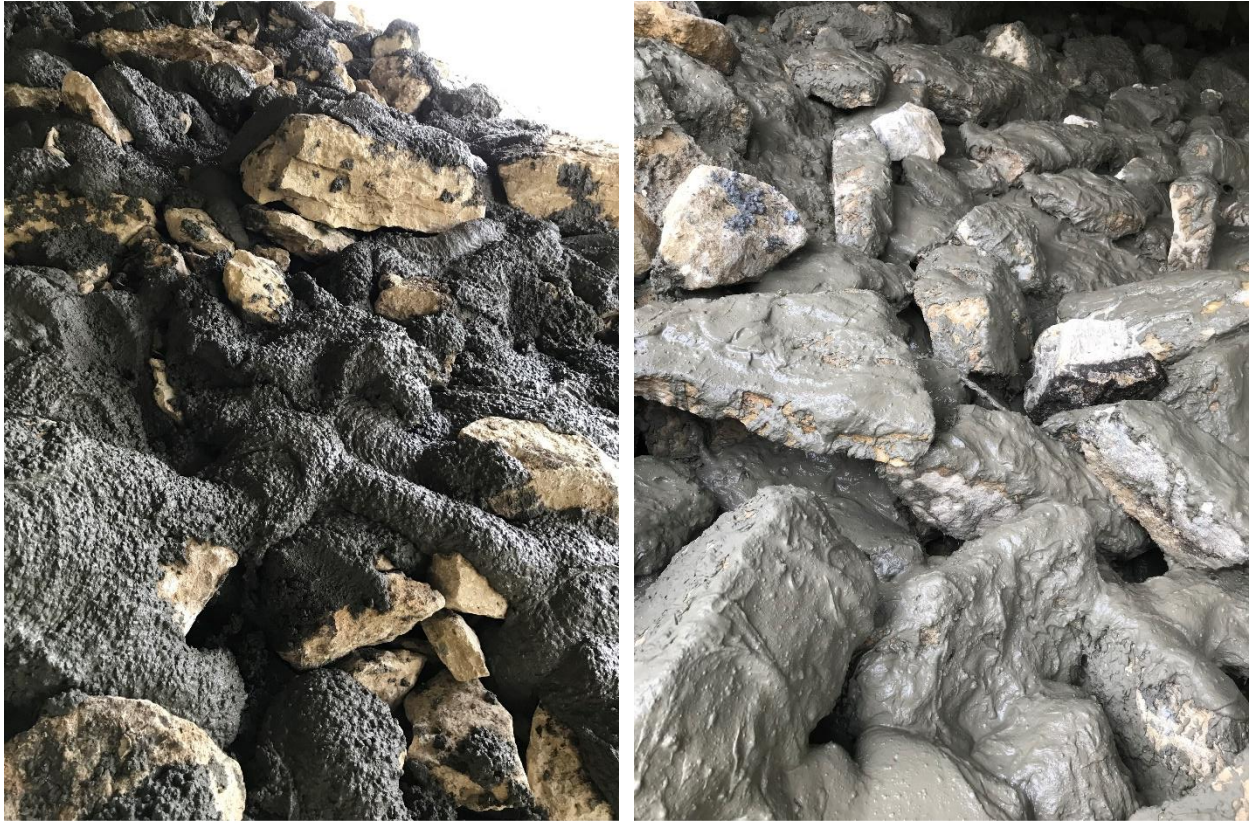
**Figure 34. Grout consistency of FHWA mix (left) and Buchanan County grout (right)**

As evident from the photos, the grout used on Bridge 2 was significantly more flowable than that used for Bridge 1 due to the crusher chips found in the mix for Bridge 1. Because of this difference in consistency, different placement methods were used based on the pump capabilities. The two hose sizes used for placement are shown in Figure 35.

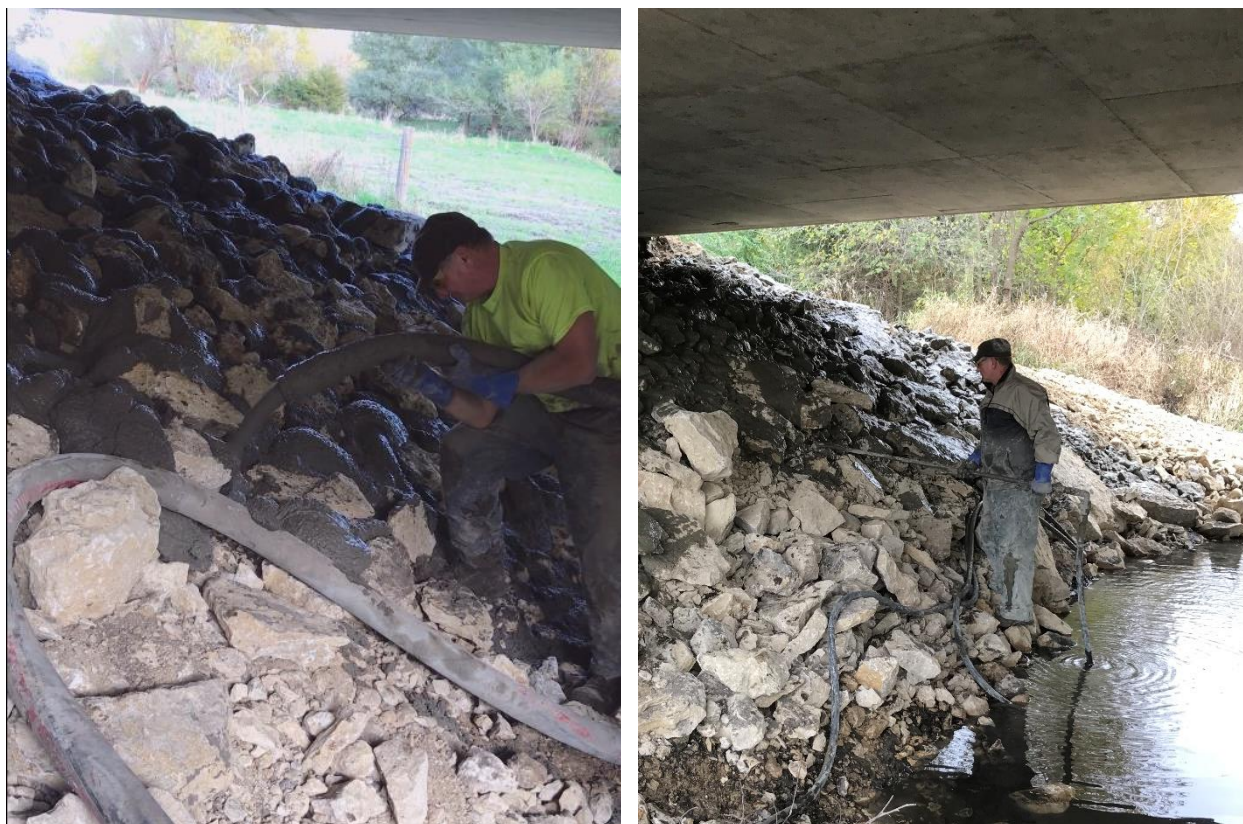
**Figure 35. Grout placement of FHWA mix (left) and Buchanan County grout (right)**

As expected, placement was more labor intensive when the large hose size was used due to the weight of the hose, often requiring multiple workers to help move it along. While the long-term performance of the two bridges is not yet known, the current condition of the two countermeasures is shown in Figure 36.

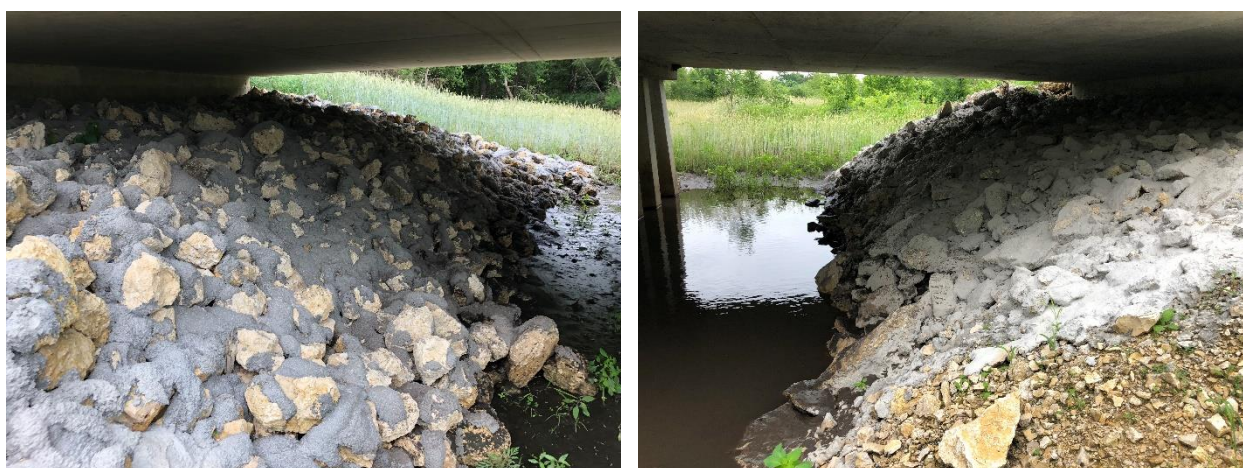
**Figure 36. Condition shortly after placement for Bridge 1 (left) and Bridge 2 (right) in Buchanan County**

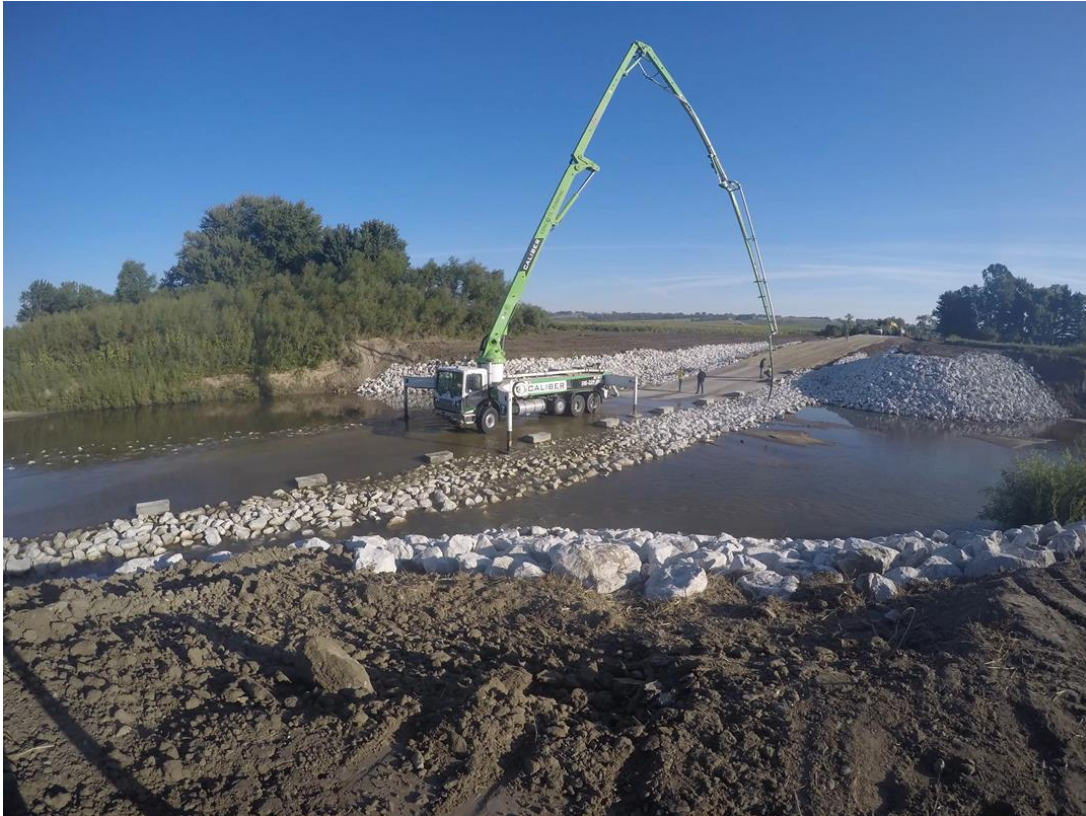
The pilot installation in Madison County, Iowa was a new construction project involving a low water crossing that utilized the specified FHWA mix with Class E revetment. Due to the size of the project site (shown in Figure 37), a 4 in. hose size was used to get adequate reach with minimal pump setup locations given the costs associated with each move of the pump. Since placement did not involve maneuvering under a bridge deck, grouting was less labor intensive than under deck placement scenarios.

**Figure 37. Low water crossing installation site in Madison County with pump shown**

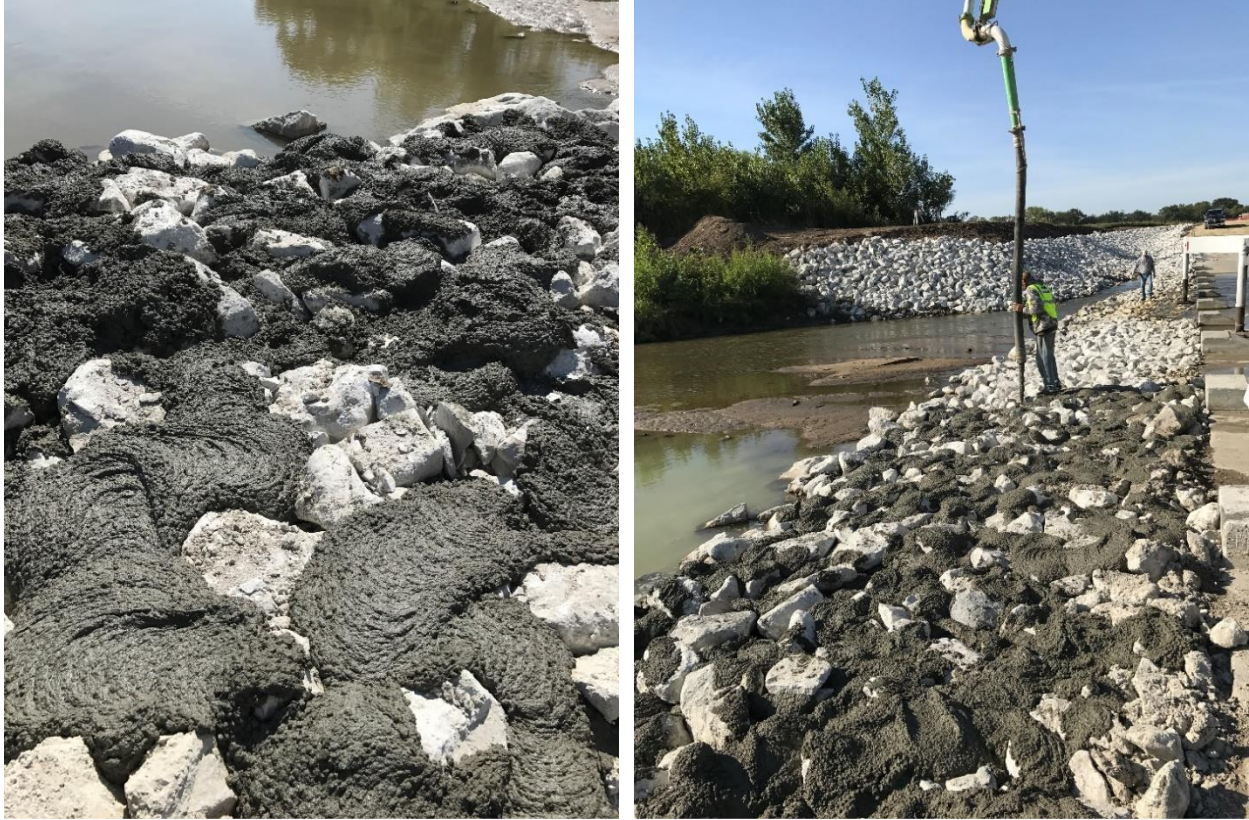
**Figure 38. Madison County pilot installation grouting**

There was initially some splash on the stones, and it took a few trucks before the mix consistency was right where desired. While the 4 in. hose size was needed due to other project constraints, it was observed that the hose size was too large for controlled placement and would not be advised for future projects whenever possible.

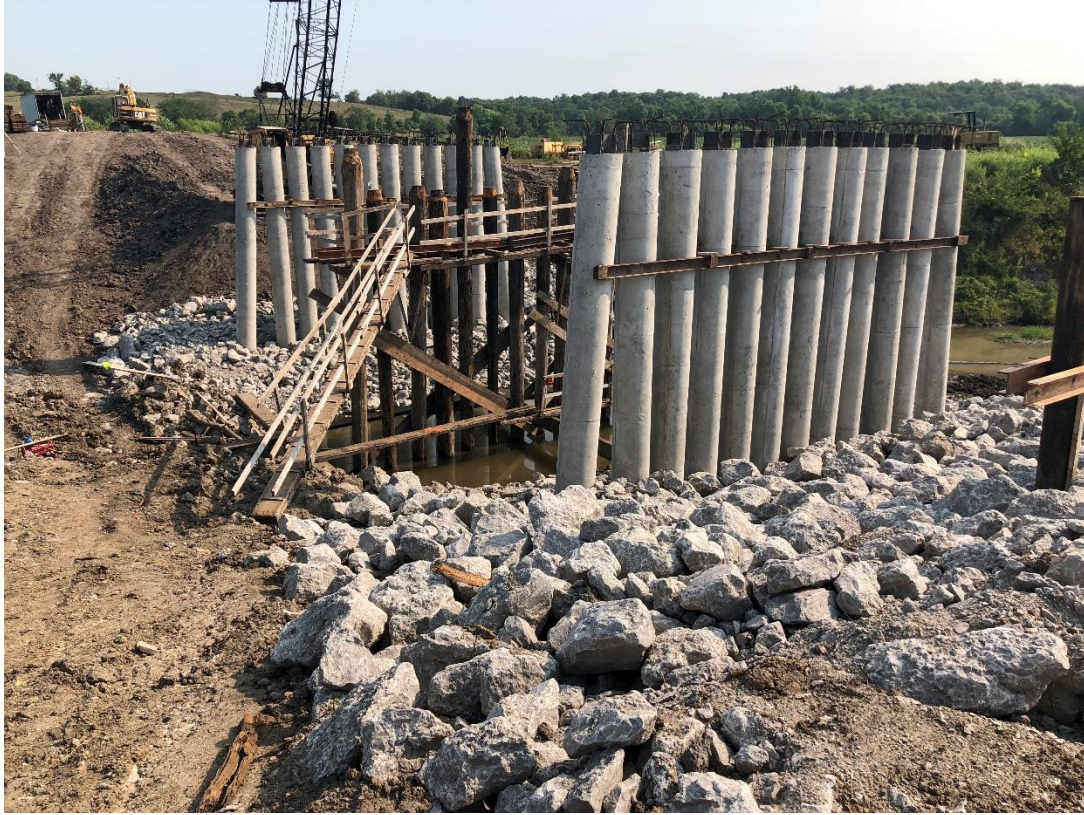
**Figure 40. Wayne County pilot installation site**

The pilot installation in Wayne County, Iowa was part of a bridge reconstruction project and used the FHWA guidelines for the grout mix. Due to temporary supports and other constraints, the grouting for this project was done in several phases. The project site is shown in Figure 40.

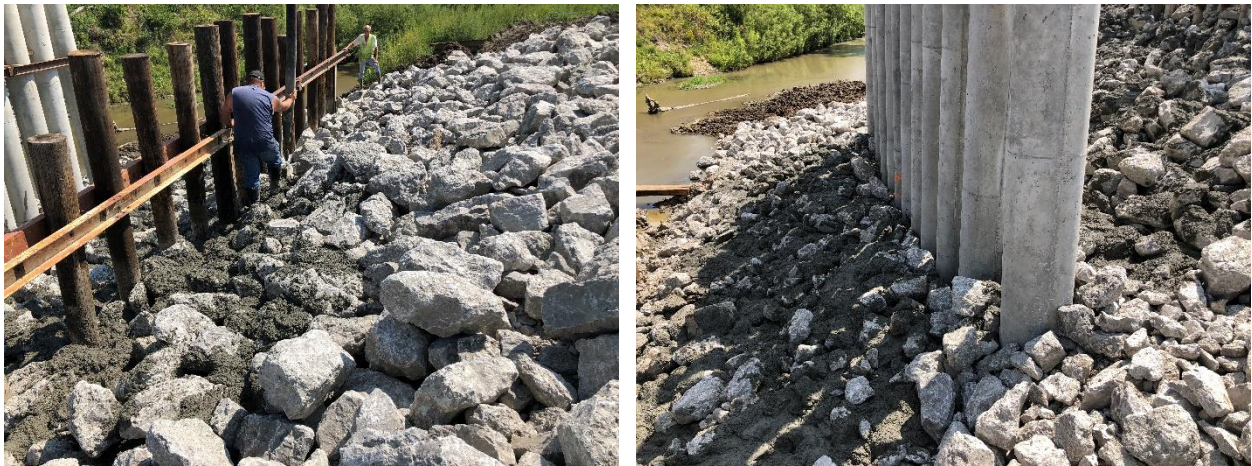
Photos of the placement procedure are shown in Figures 41 and 42.

**Figure 41. Wayne County pilot installation grouting**

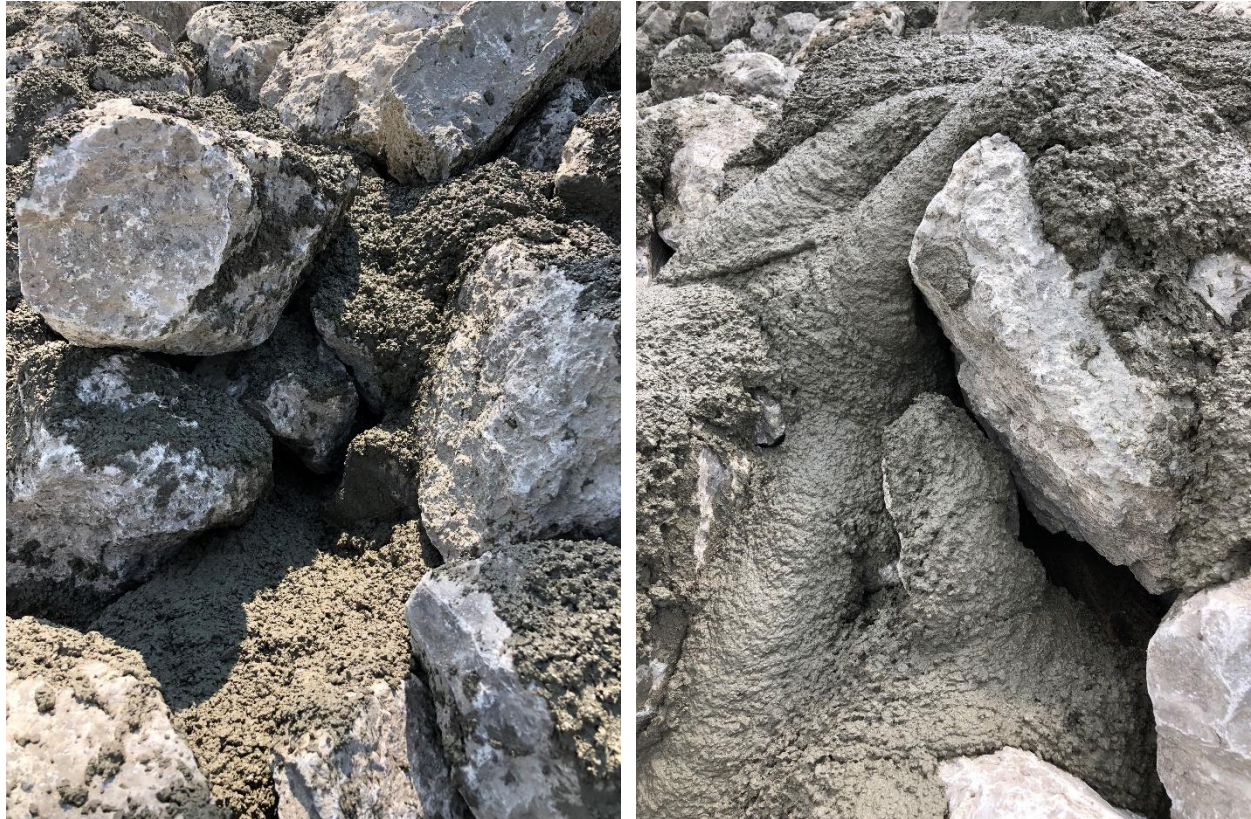
**Figure 42. Initial grout consistency (left) and desired grout consistency (right) in Wayne County**

As with the Madison County install, it took a few trucks before the grout consistency was as desired (Figure 42). Placement was again significantly easier at this site than in Buchanan County since grouting took place prior to pouring of the deck. It would be preferred if the hose size were smaller, but, again, there were project constraints associated with pump availability.

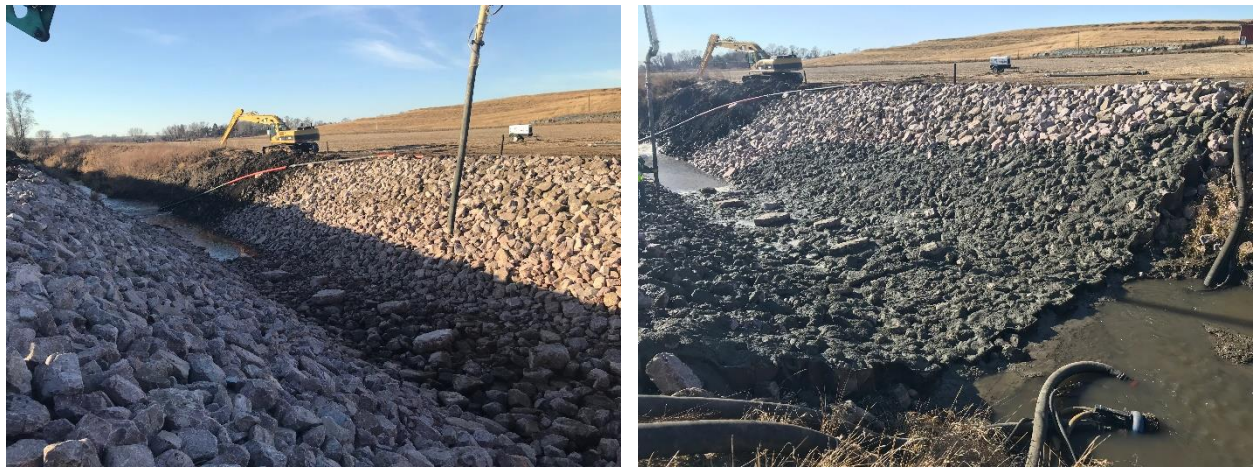
The site both before and after grout placement is shown in Figure 43.

**Figure 43. Woodbury County site before (left) and after grouting (right)**
