# Partially Grouted Revetment for Low-Volume Road Bridges

**Interim Report  
April 2019**

**Sponsored by**  
Iowa Highway Research Board  
(IHRB Project TR-710)  
Iowa Department of Transportation  
(InTrans Project 16-579)

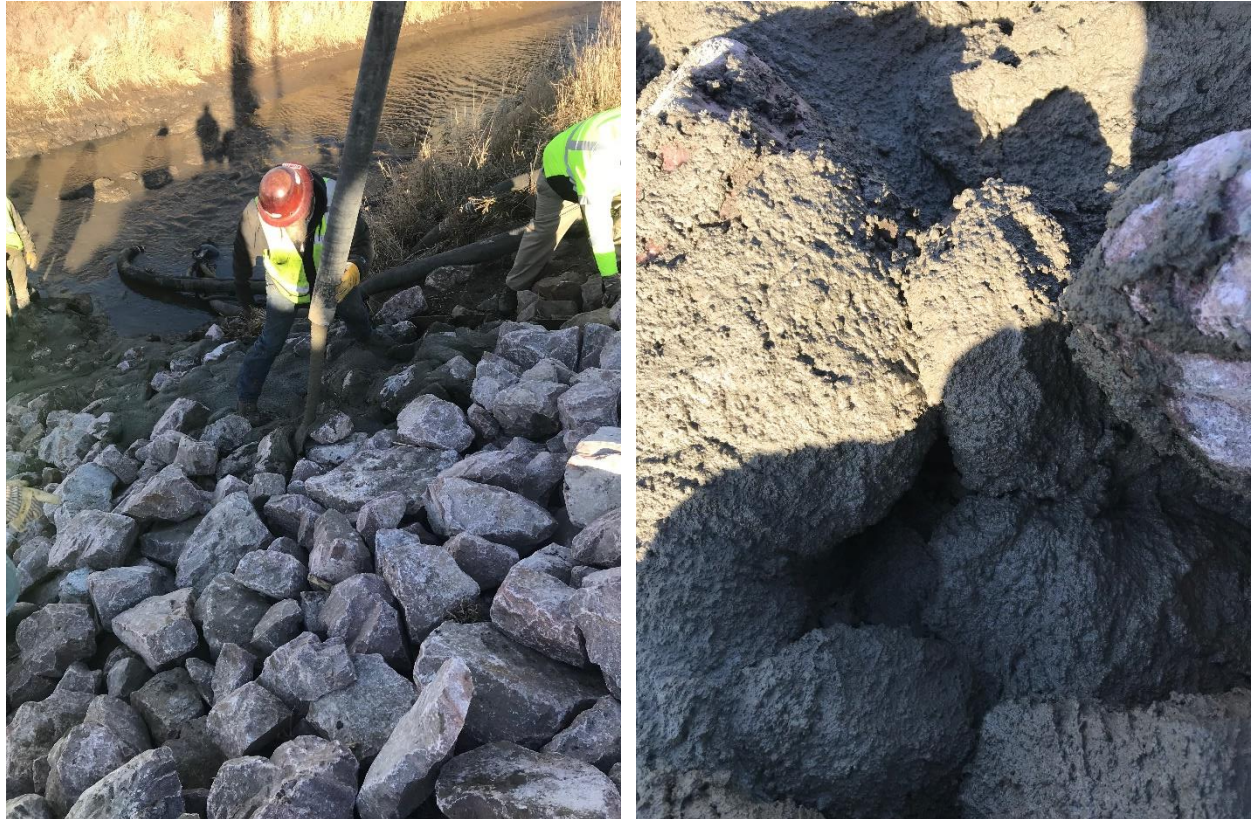
**Figure 44. Woodbury County grouting (left) and grout consistency (right)**

While this grout mix was not according to the FHWA suggested guidelines, it was closer in consistency and placement type than that used in Buchanan County.
