# IN SITU MODULUS MEASUREMENT USING AUTOMATED PLATE LOAD TESTING FOR STATEWIDE MECHANISTIC-EMPIRICAL DESIGN CALIBRATION

Final Report  
May 2019

Sponsored by  
Iowa Highway Research Board and  
Iowa Department of Transportation

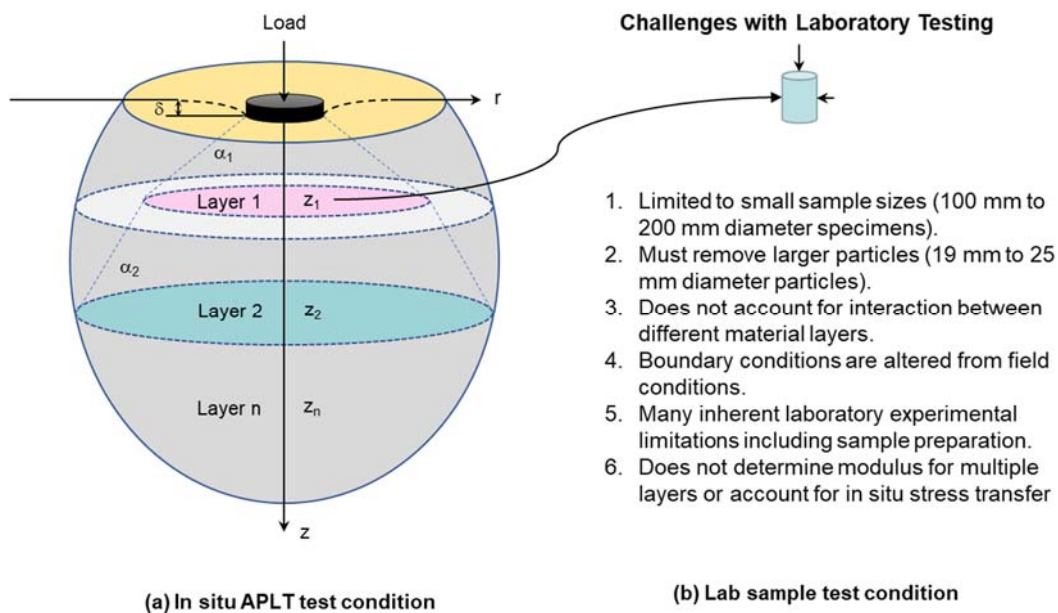
**Figure 1. Automated plate load testing (APLT) in comparison to limitations of laboratory testing.**

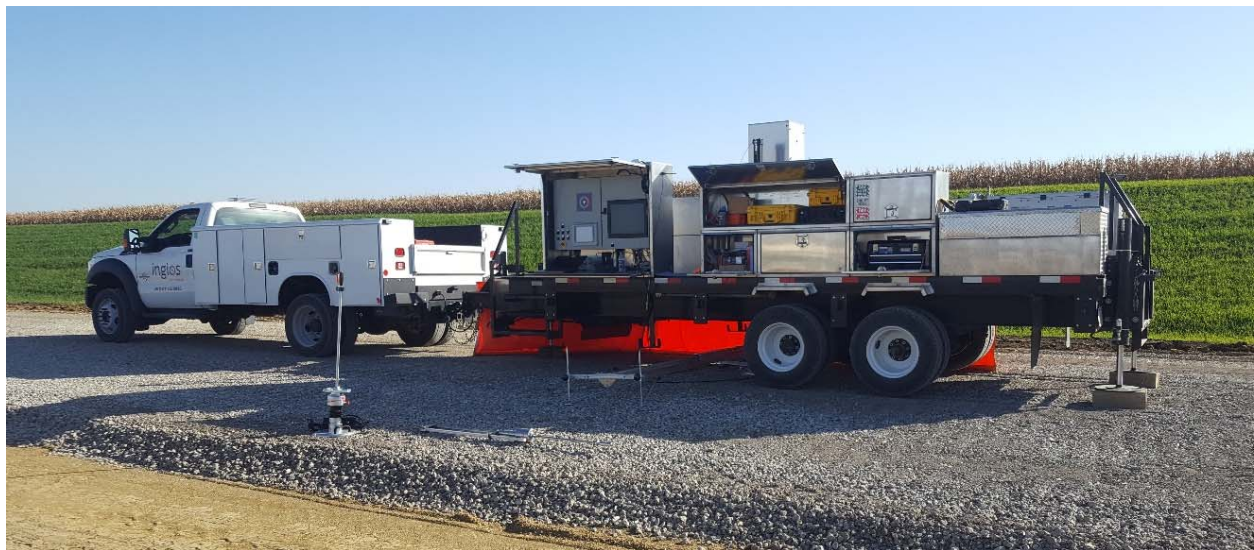
**Figure 2. Automated plate load testing setup from Project 2 – US 20 (picture taken on 10/19/2017)**

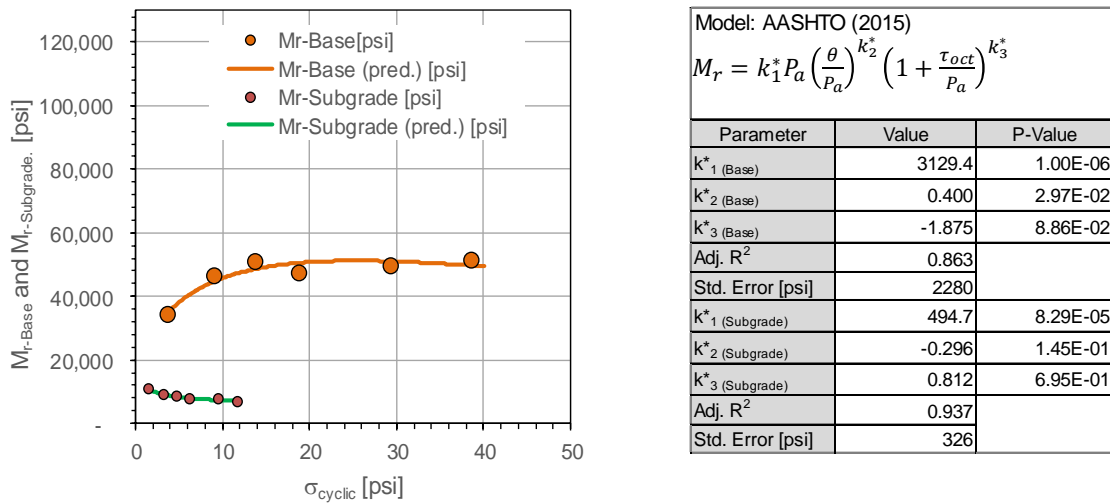
**Figure 8. Cyclic stress versus in situ  $M_r$  of base and subgrade layers, and universal model parameters separately for each layer.**

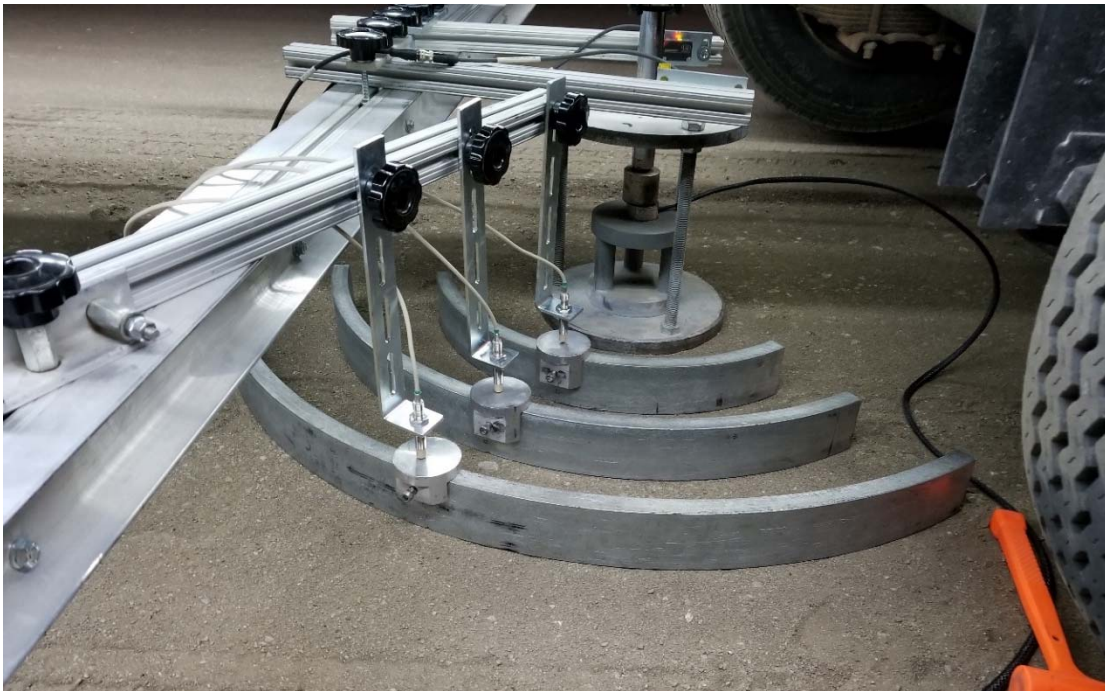
**Figure 9. 12 in. diameter loading plate setup for cyclic APLT on Project 3 – I-35/US30E Ramp (picture taken on 10/28/2017).**

The APLT testing plan summarizing the loading sequences for cyclic and static testing provided in Table 1. Cyclic APLTs involved performing a total of 1,500 loading cycles, which involved a 500 cycle conditioning sequence at 15 psi maximum stress followed by 100 to 250 cycles at 5 to 40 psi maximum stresses. Plate deformations and deflection basin measurements at 2x, 3x, and 4x, the plate radius were obtained for backcalculation of the two-layered  $M_r$  properties for each stress sequence. The average of the last 5 cycles was used for representation of  $M_r$  for each loading sequence. A 0.2 sec load time and a 0.8 sec dwell time was used. Static APLTs were performed following AASHTO T222 (2012), using two loading cycles.

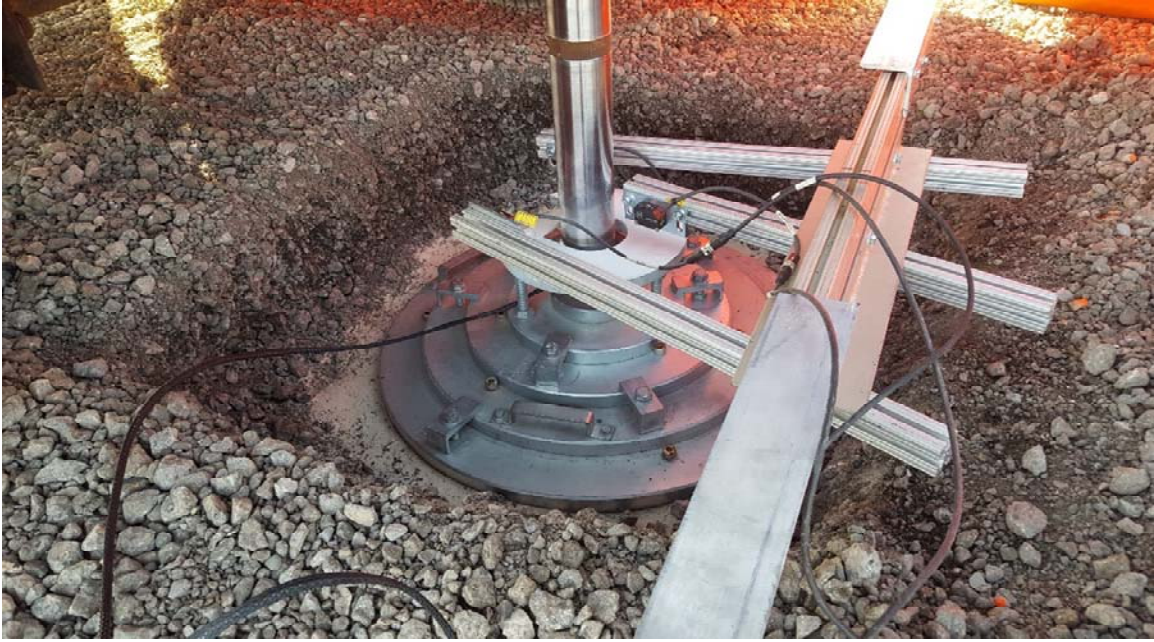
**Figure 10. 30 in. diameter loading plate setup for static APLT on Project 2 - US 20 (picture taken on 10/19/2017).**

An experimental plan was developed in collaboration with the Iowa DOT pavement design and construction engineering team to perform field testing to determine mechanistic properties on pavement foundation layers in situ at selected project sites across the State of Iowa. The goal at each site was to perform cyclic APLTs to determine composite and layered  $M_r$  properties (when subbase over subgrade conditions were present) at 4 to 8 test locations using a 12 in. diameter loading plate (Figure 9) and perform static APLTs to determine  $k$  value at 1 to 2 test locations with 30 in. diameter loading plate (Figure 10). A dynamic cone penetrometer (DCP) test was conducted at each test location (Figure 11a). Light weight deflectometer testing was also conducted on selected projects (Figure 11b).

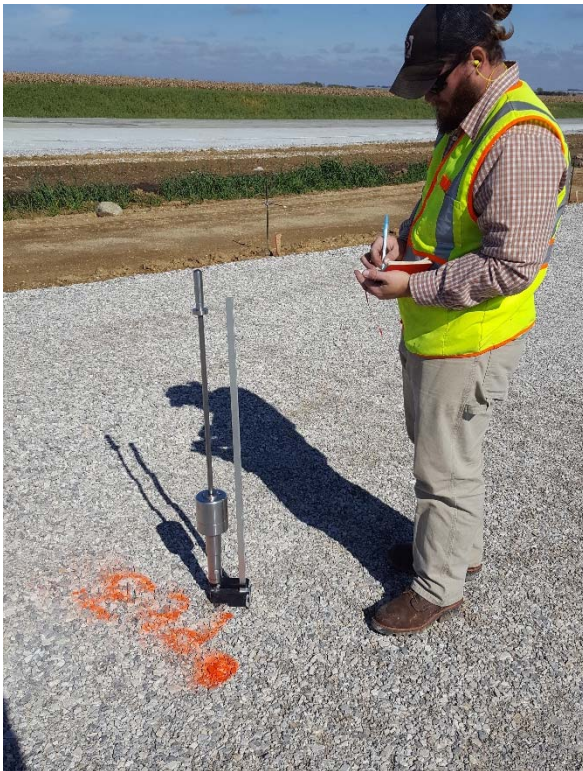
**Figure 11. (a) Dynamic cone penetrometer testing on Project 2 - US 20 (picture taken on 10/19/2017), and (b) Light weight deflectometer testing on Project 4 – Hwy 330 near Hwy 65 (picture taken on 11/2/2017).**

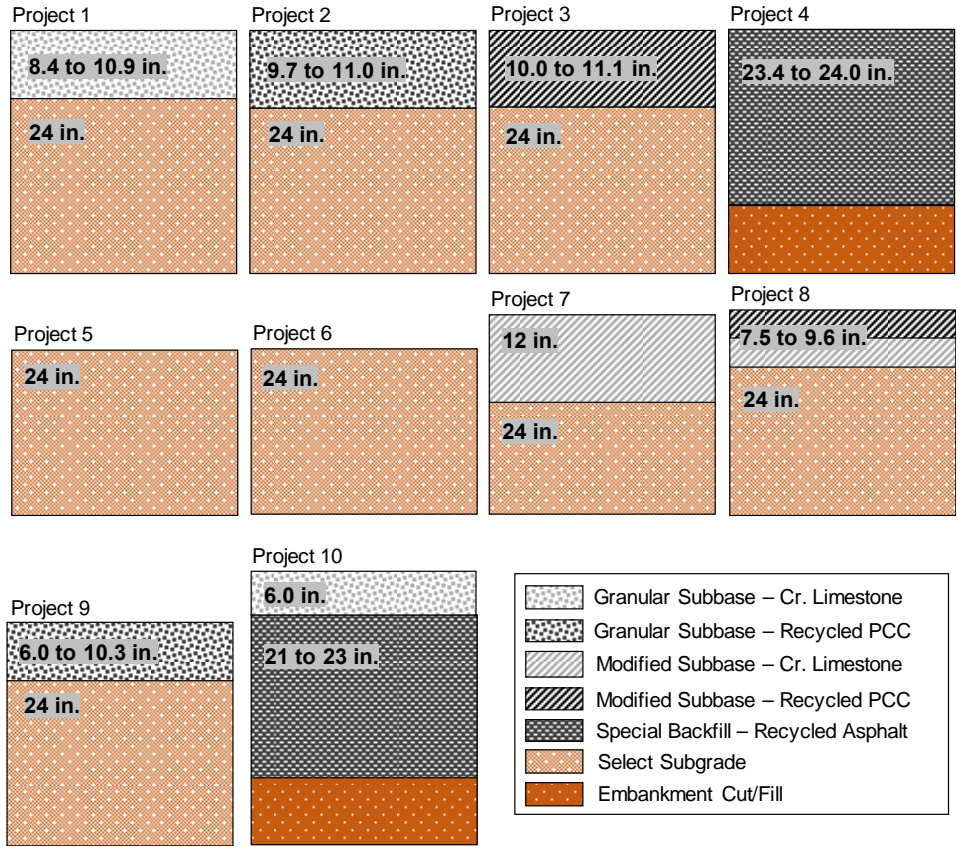
**Figure 12. Idealized cross-sections of foundation layers at different projects.**

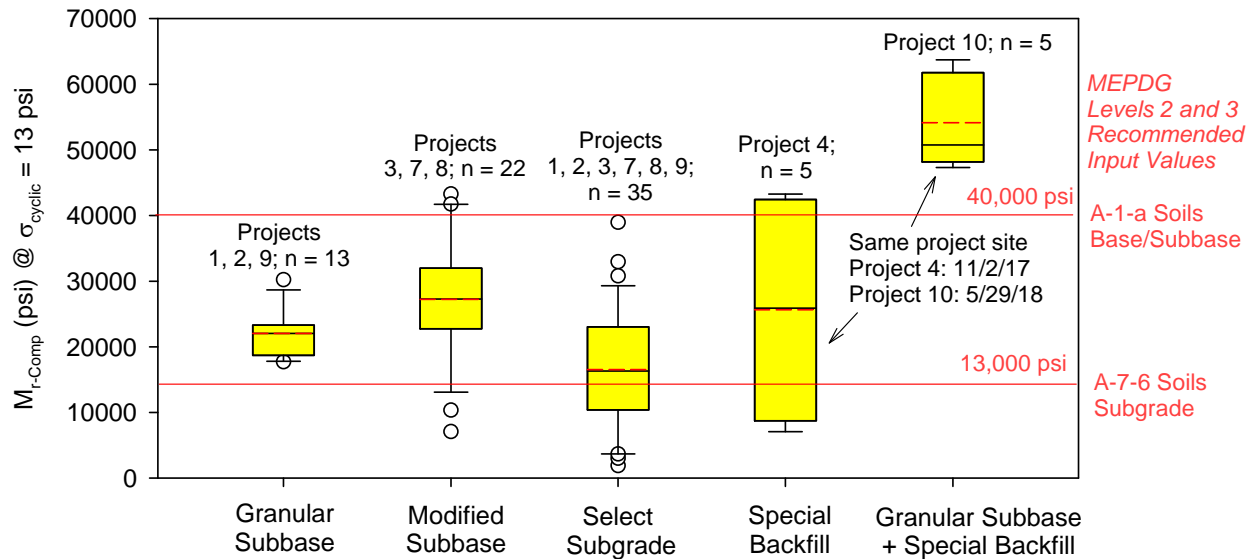
**Figure 17. Box plots of  $M_{r-Comp}$  for different material types.**

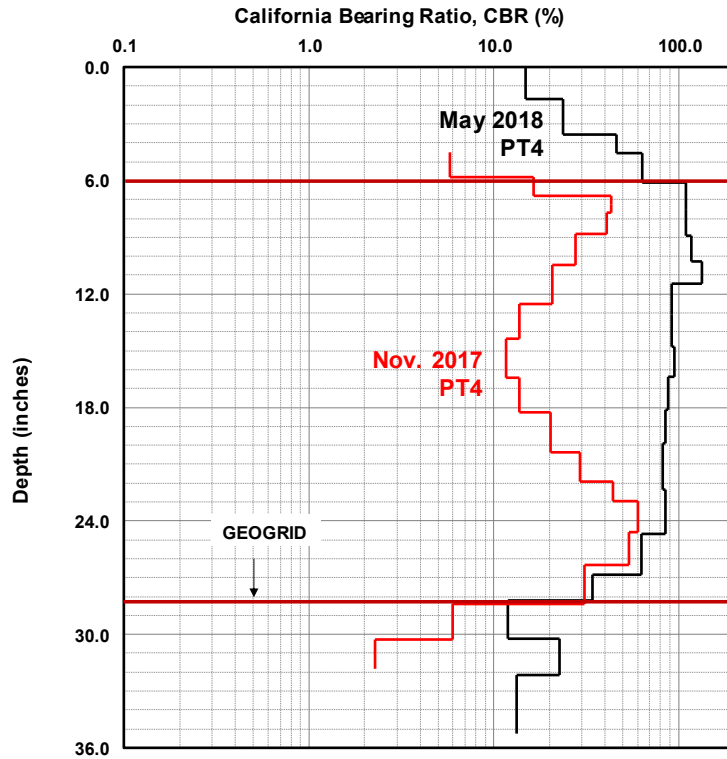
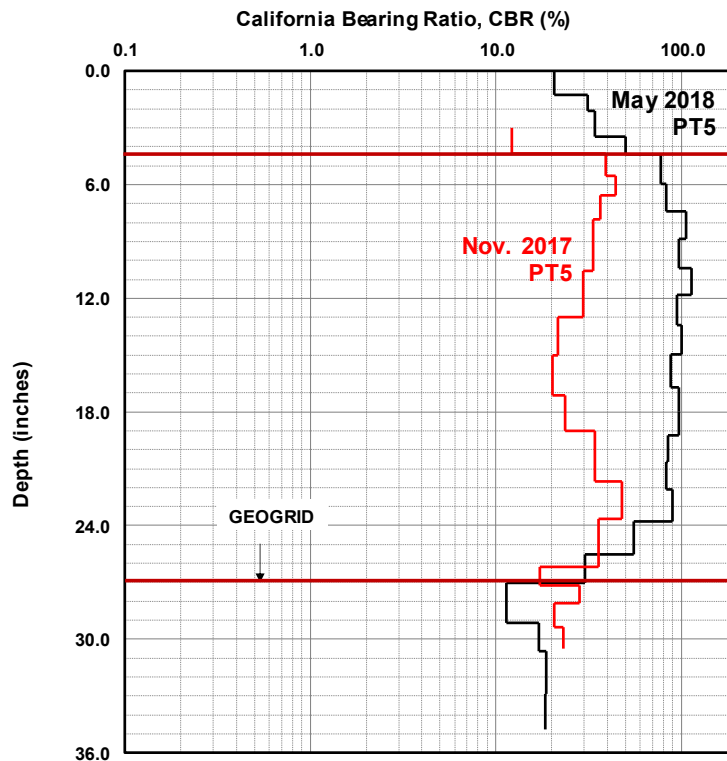
Figure 18. DCP-CBR plots at two selected locations (Points 4 and 5) from November 2017 (Project 4) and May 2018 (Project 10).

Field testing on Projects 4 and 10 were performed at similar test locations (matched using GPS measurements). However, as explained earlier for Project 10 conducted in May 2018, a nominal 6 in. of granular subbase was placed over the 2 ft of special backfill originally tested in Project 4 (November 2017). Results indicated a two-fold increase in  $M_{r-Comp}$  values on average. DCP test results from November 2017 and May 2018 tests (at two selected locations) are compared in Figure 18, which show that the special backfill layer increased in stiffness from 6 in. to 24 in. depths. The special backfill material consisted of reclaimed asphalt pavement (RAP) material. The increase in the  $M_{r-Comp}$  from November 2017 to May 2018 is attributed to strength-gain from curing of RAP material and construction trafficking after November 2017 testing.

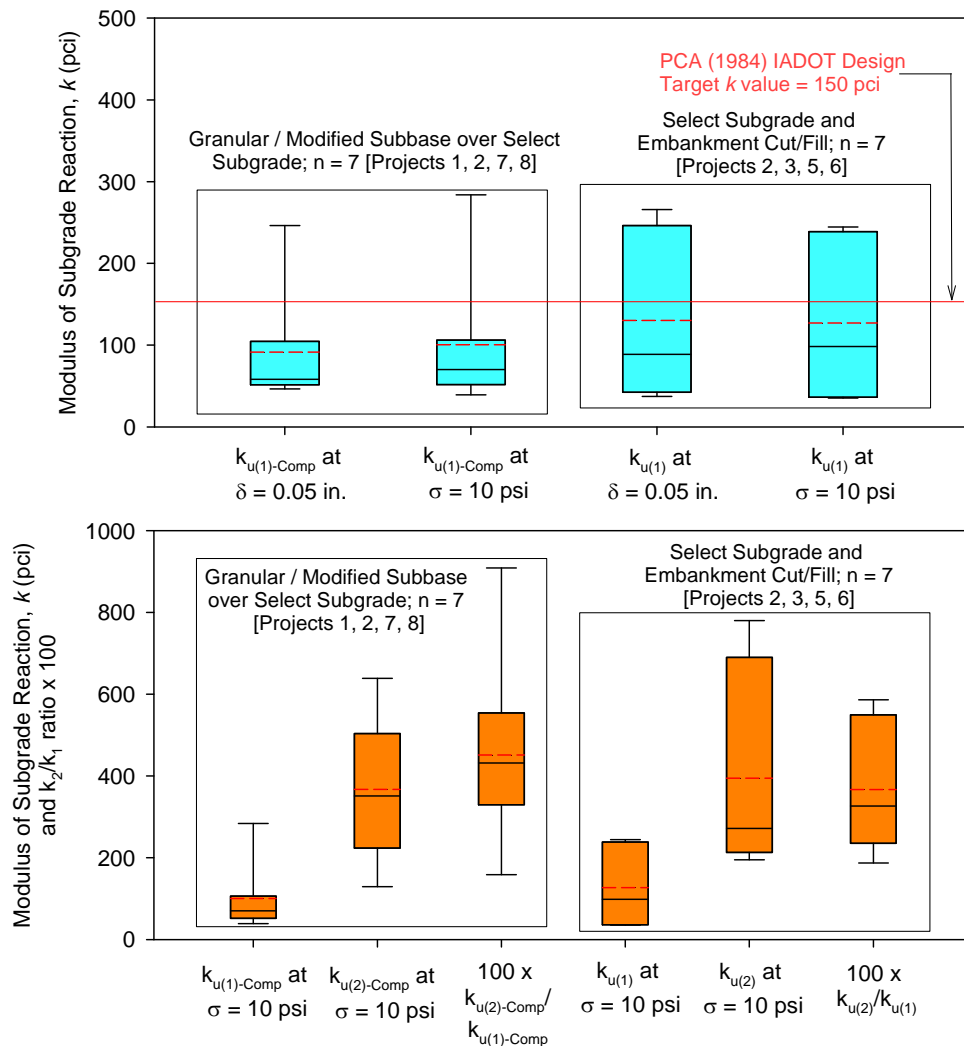
**Figure 20. Box plots of  $k$ -values for different material types.**

Box plots of  $k$ -values obtained from static APLTs from all the project sites are provided in Figure 20. The results are grouped for tests performed on granular/modified subbase layers over subgrade and for tests performed directly on subgrade. The results showed significant variability across the state, with  $k$  values varying between 35 pci to 300 pci. 11 out of the 14 tests performed across the state showed  $k$  values < the typically assumed 150 pci design input target value by the Iowa DOT for PCA (1984) design. At one site (Project 7), two tests performed on the compacted modified subbase layer about 420 feet apart, showed  $k_{u(1)}$  of 39 and 284 pci.

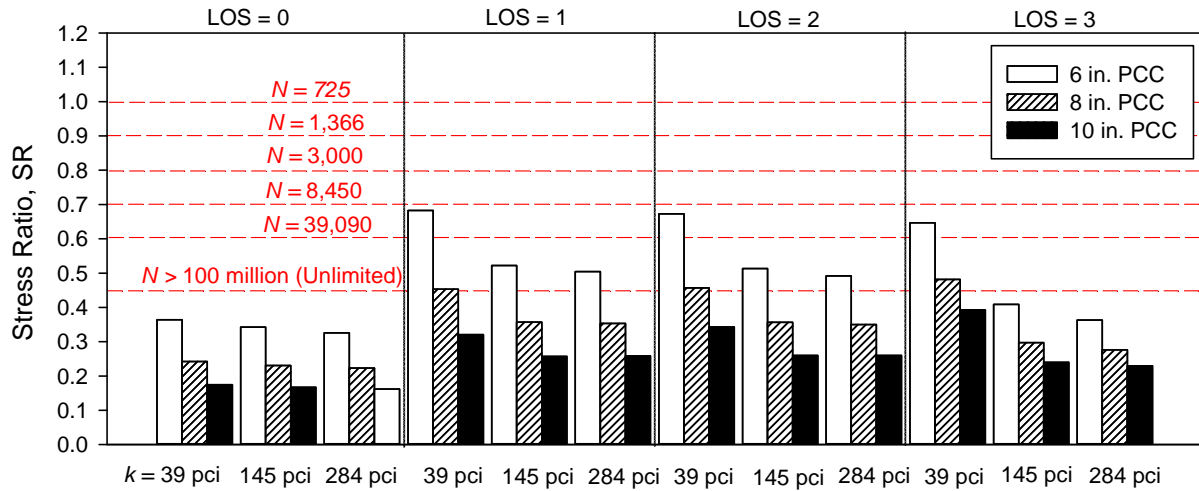
**Figure 24. Bar charts of stress ratios for different support conditions ( $k$  and LOS) at three different pavement layer thicknesses.**

The SR values calculated from the peak stresses for of the cases evaluated are presented as bar charts Figure 24. For LOS = 0 condition, the SR values are  $< 0.45$  for all three thicknesses

evaluated and  $k$ -values evaluated. For LOS = 1 and 2 conditions, the SR values increased and the associated number of load repetitions decreased, with no significant differences between LOS 1 versus 2 conditions. The SR's were either similar or lower for LOS 3 compared to LOS 2 condition.

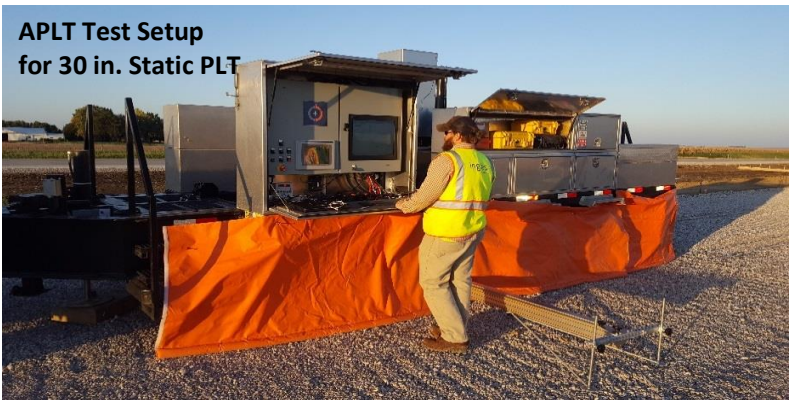
30 in. Static Plate  
Load Testing

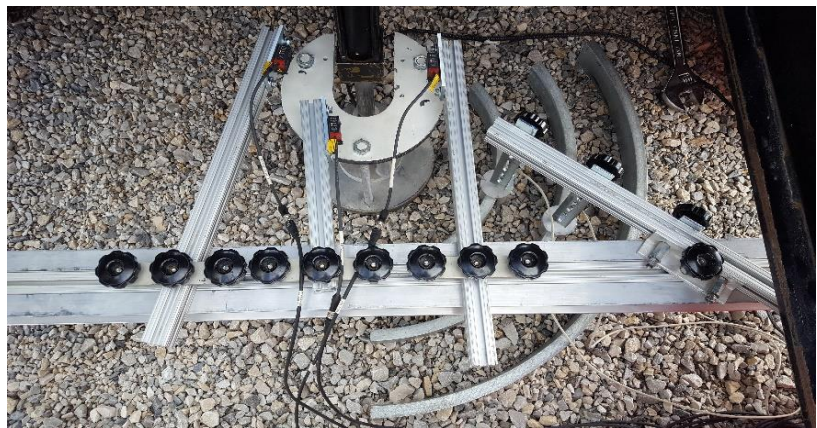
Parameter	Value	P-Value
$k_1^*$	1,371.5	1.04E-07
$k_2^*$	0.133	6.96E-02
$k_3^*$	-0.722	1.26E-01
Adj. $R^2$	0.730	
Std. Error [psi]	368

$M_{r-comp}$ (pred.)-BP [psi]	20,434
$\sigma_{cyclic-BP}$ [psi]	21.0

In-situ Resilient Modulus [Mr]: Cyclic Loading, Composite, Stress-Dependent

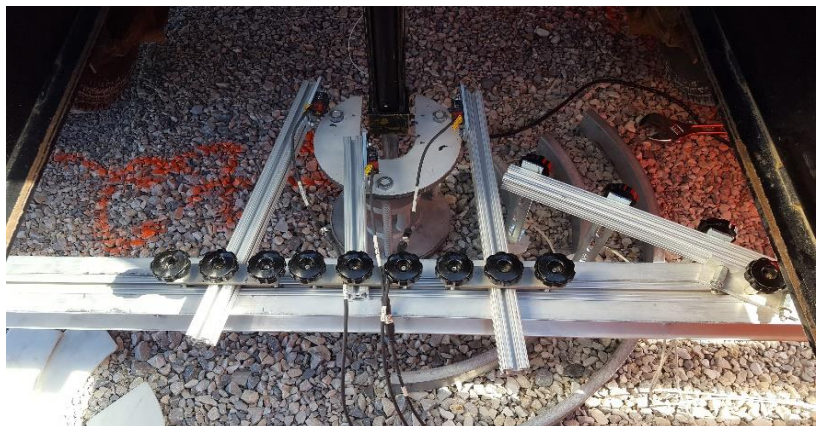
Parameter	Value	P-Value
$k_1^*$	1,148.1	2.23E-08
$k_2^*$	0.263	2.51E-03
$k_3^*$	-1.395	6.01E-03
Adj. $R^2$	0.972	
Std. Error [psi]	199

$M_{r-comp}$ (pred.)-BP [psi]	17,460
$\sigma_{cyclic-BP}$ [psi]	21.7

## In-situ Resilient Modulus [Mr]: Cyclic Loading, Composite, Stress-Dependent

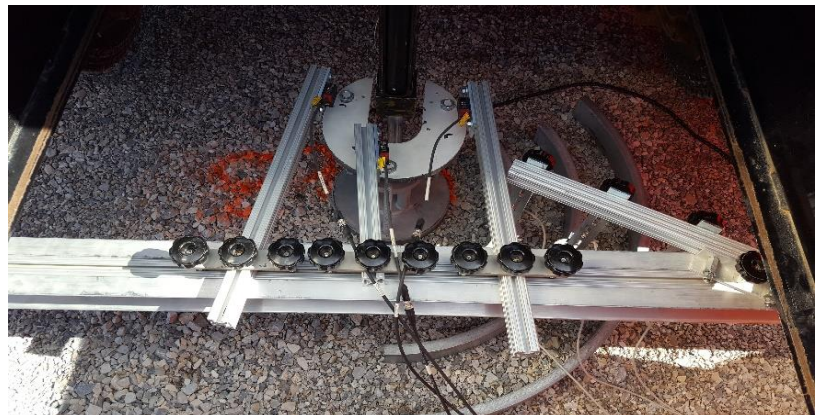
Parameter	Value	P-Value
$k_1^*$	1,433.2	9.50E-08
$k_2^*$	0.234	1.59E-02
$k_3^*$	-1.104	4.63E-02
Adj. $R^2$	0.923	
Std. Error [psi]	430

$M_{r-comp}$ (pred.)-BP [psi]	22,397
$\sigma_{cyclic-BP}$ [psi]	25.2

## In-situ Resilient Modulus [Mr]: Cyclic Loading, Composite, Stress-Dependent

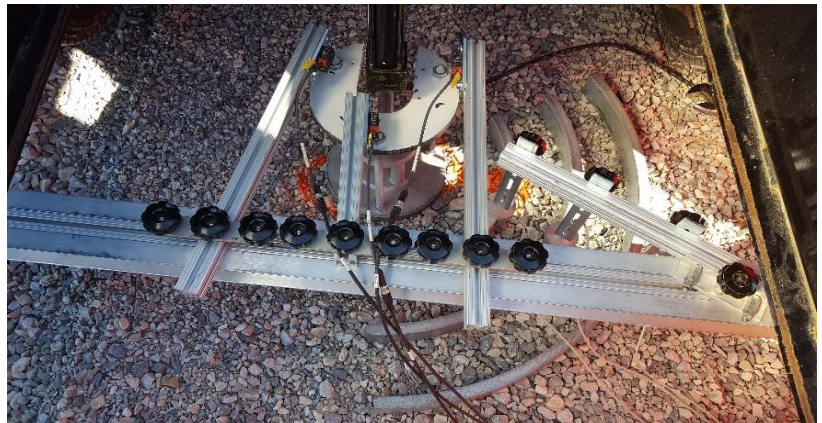
Parameter	Value	P-Value
$k_1^*$	1,255.0	5.54E-07
$k_2^*$	0.239	6.25E-02
$k_3^*$	-1.290	1.16E-01
Adj. $R^2$	0.735	
Std. Error [psi]	590

$M_{r-comp}$ (pred.)-BP [psi]	18,940
$\sigma_{cyclic-BP}$ [psi]	21.3

In-situ Resilient Modulus [Mr]: Cyclic Loading, Composite, Stress-Dependent

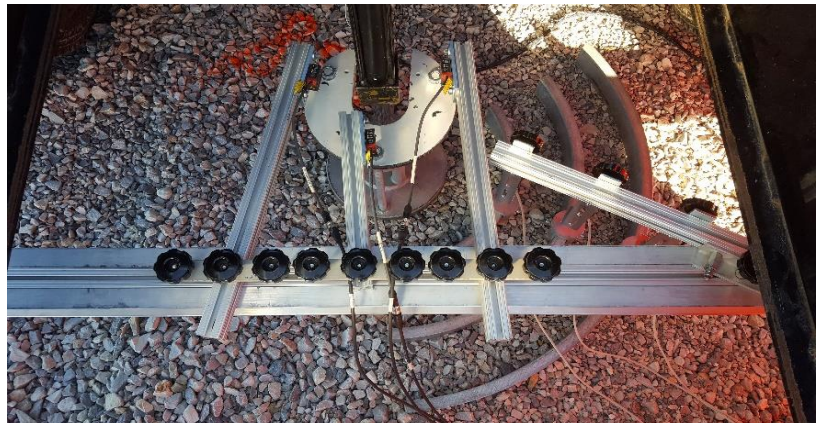
Parameter	Value	P-Value
$k_1^*$	1,433.8	2.50E-07
$k_2^*$	0.315	1.62E-02
$k_3^*$	-1.256	7.12E-02
Adj. $R^2$	0.939	
Std. Error [psi]	641

$M_{r-comp}$ (pred.)-BP [psi]	24,302
$\sigma_{cyclic-BP}$ [psi]	31.3

In-situ Resilient Modulus [Mr]: Cyclic Loading, Composite, Stress-Dependent

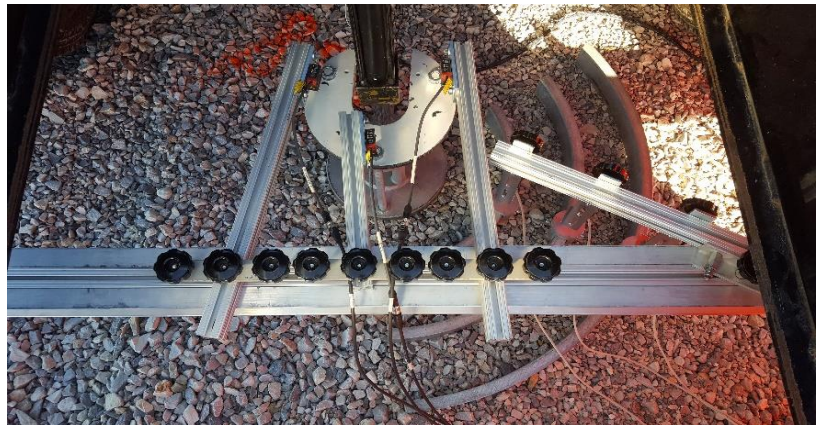
Parameter	Value	P-Value
$k_1^*$	1,655.8	5.84E-08
$k_2^*$	0.167	2.65E-02
$k_3^*$	-1.315	2.02E-02
Adj. $R^2$	0.845	
Std. Error [psi]	359

$M_{r-comp}$ (pred.)-BP [psi]	23,148
$\sigma_{cyclic-BP}$ [psi]	13.6

In-situ Resilient Modulus [Mr]: Cyclic Loading, Composite, Stress-Dependent

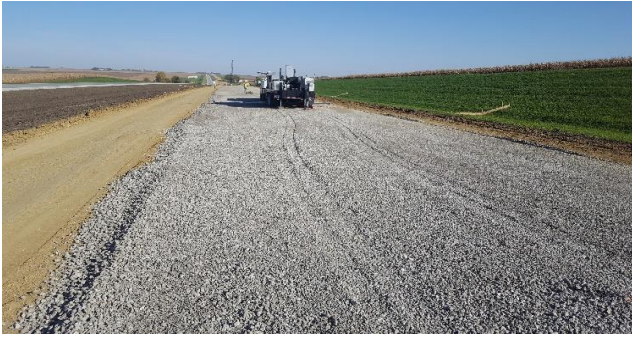
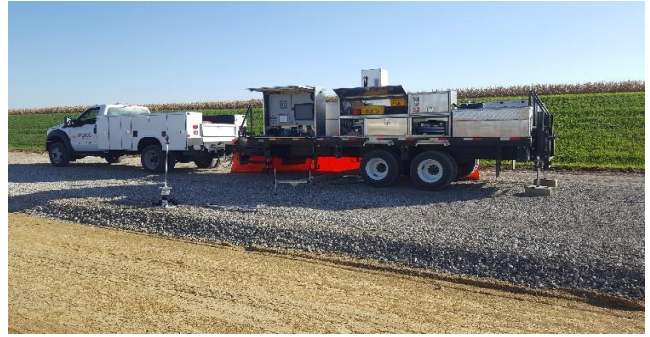
APLT Test Setup for 12 in. Cyclic PLT

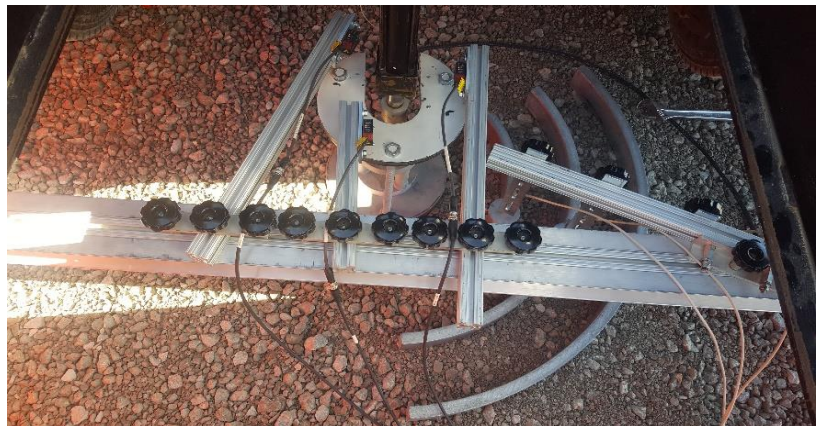
Parameter	Value	P-Value
$k_1^*$	1,509.8	6.07E-07
$k_2^*$	0.058	5.54E-01
$k_3^*$	-0.396	5.73E-01
Adj. $R^2$	-0.080	
Std. Error [psi]	287

$M_{r-comp}$ (pred.)-BP [psi]	22,012
$\sigma_{cyclic}$ -BP [psi]	16.1

In-situ Resilient Modulus [Mr]: Cyclic Loading, Composite, Stress-Dependent

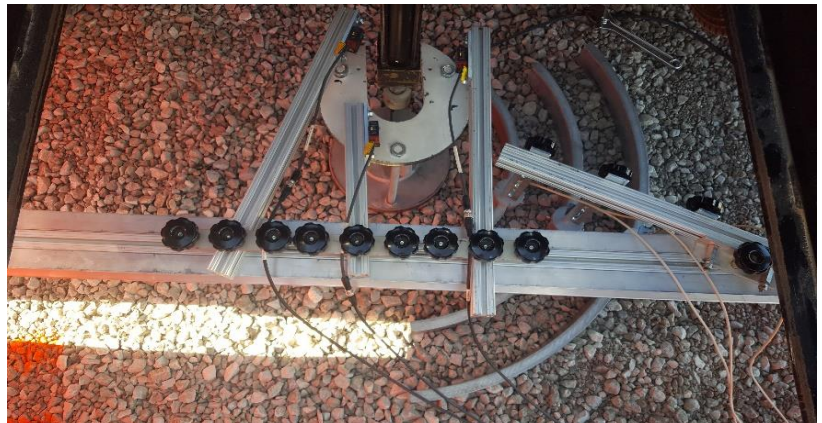
Parameter	Value	P-Value
$k_1^*$	1,386.3	2.35E-07
$k_2^*$	0.253	2.69E-02
$k_3^*$	-1.388	5.32E-02
Adj. $R^2$	0.855	
Std. Error [psi]	500

$M_{r-comp}$ (pred.)-BP [psi]	20,855
$\sigma_{cyclic-BP}$ [psi]	20.8

In-situ Resilient Modulus [Mr]: Cyclic Loading, Composite, Stress-Dependent

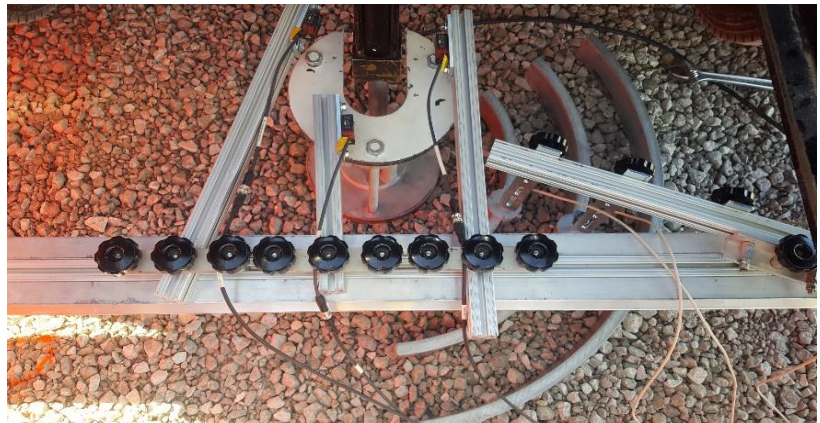
Parameter	Value	P-Value
$k_1^*$	1,767.1	4.88E-07
$k_2^*$	-0.005	9.52E-01
$k_3^*$	0.245	7.07E-01
Adj. R <sup>2</sup>	0.205	
Std. Error [psi]	575

$M_{r-comp}$ (pred.)-BP [psi]	28,013
$\sigma_{cyclic}$ -BP [psi]	39.0

In-situ Resilient Modulus [Mr]: Cyclic Loading, Composite, Stress-Dependent

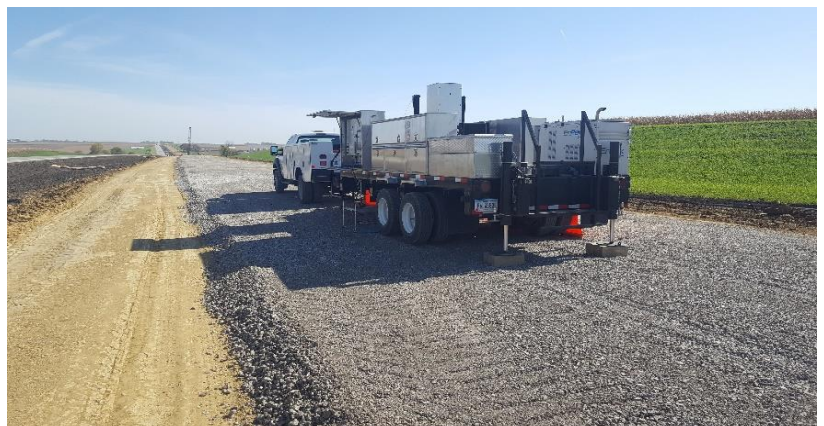
Parameter	Value	P-Value
$k_1^*$	1,454.3	1.66E-07
$k_2^*$	0.230	2.63E-02
$k_3^*$	-0.808	1.37E-01
Adj. $R^2$	0.938	
Std. Error [psi]	548

$M_{r-comp}$ (pred.)-BP [psi]	24,531
$\sigma_{cyclic-BP}$ [psi]	37.2

In-situ Resilient Modulus [Mr]: Cyclic Loading, Composite, Stress-Dependent

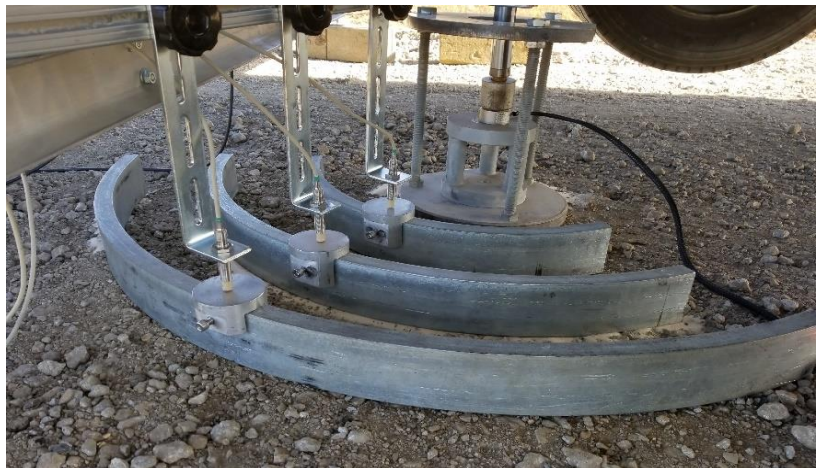
Parameter	Value	P-Value
$k_1^*$	1,790.6	6.41E-07
$k_2^*$	0.017	8.60E-01
$k_3^*$	0.622	4.09E-01
Adj. $R^2$	0.822	
Std. Error [psi]	1,075

$M_{r-comp}$ (pred.)-BP [psi]	33,750
$\sigma_{cyclic-BP}$ [psi]	39.0

In-situ Resilient Modulus [Mr]: Cyclic Loading, Composite, Stress-Dependent

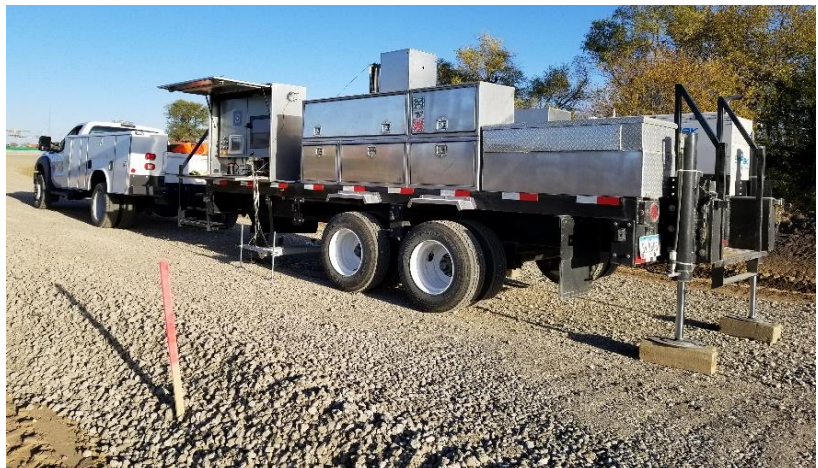
Parameter	Value	P-Value
$k_1^*$	1,477.6	2.04E-06
$k_2^*$	-0.335	1.11E-01
$k_3^*$	2.071	1.35E-01
Adj. $R^2$	0.598	
Std. Error [psi]	1,033

$M_{r-comp}$ (pred.)-BP [psi]	33,331
$\sigma_{cyclic-BP}$ [psi]	2.0

In-situ Resilient Modulus [Mr]: Cyclic Loading, Composite, Stress-Dependent

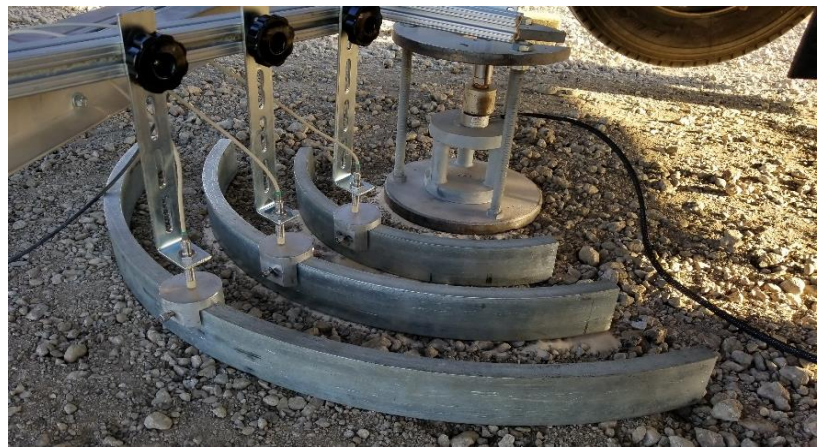
Parameter	Value	P-Value
$k_1^*$	759.4	3.34E-07
$k_2^*$	0.011	8.93E-01
$k_3^*$	-2.082	2.67E-02
Adj. $R^2$	0.982	
Std. Error [psi]	222

$M_{r-comp}$ (pred.)-BP [psi]	10,550
$\sigma_{cyclic-BP}$ [psi]	2.0

In-situ Resilient Modulus [Mr]: Cyclic Loading, Composite, Stress-Dependent

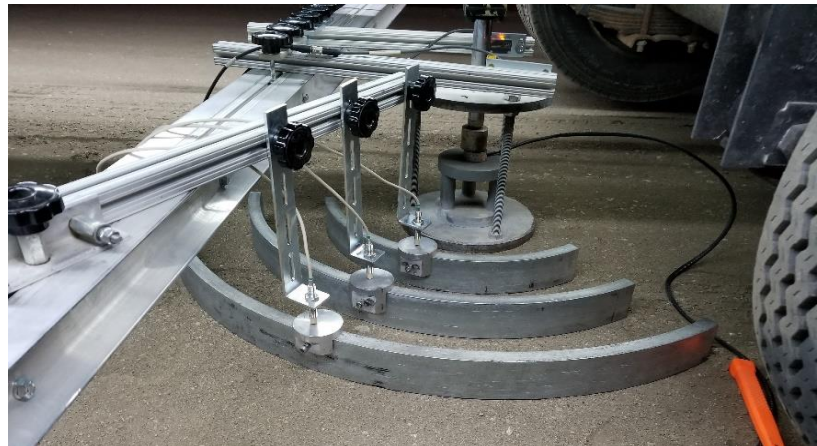
Parameter	Value	P-Value
$k_1^*$	1,759.7	2.29E-07
$k_2^*$	-0.008	9.21E-01
$k_3^*$	-0.551	3.66E-01
Adj. $R^2$	0.835	
Std. Error [psi]	626

$M_{r-comp}$ (pred.)-BP [psi]	25,812
$\sigma_{cyclic-BP}$ [psi]	2.0

In-situ Resilient Modulus [Mr]: Cyclic Loading, Composite, Stress-Dependent

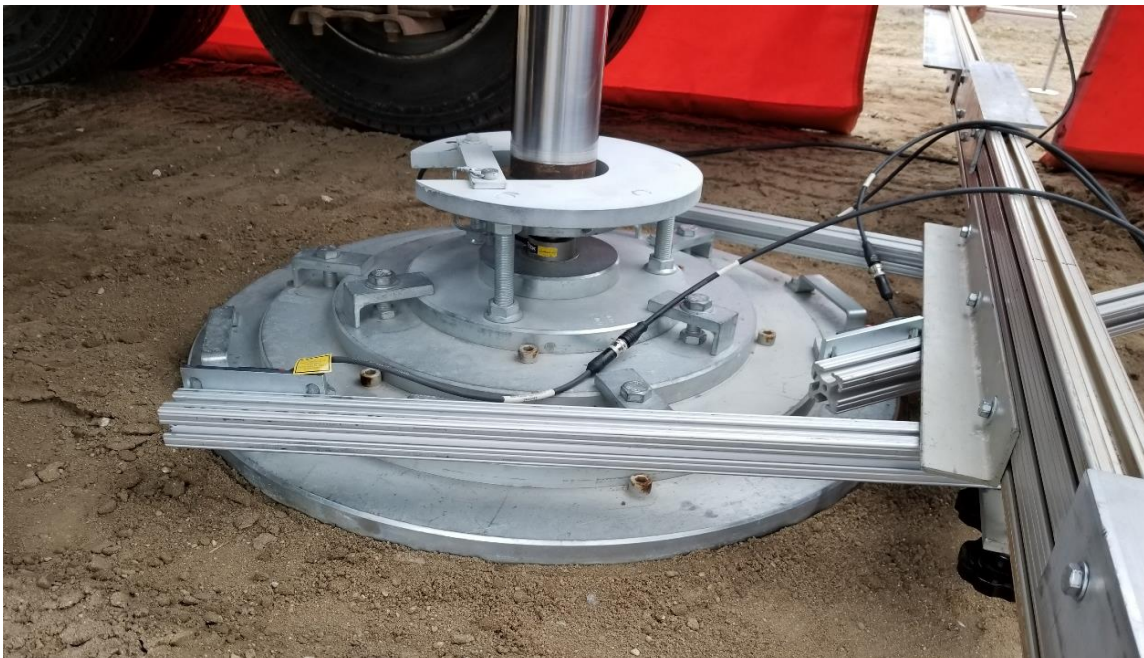
Date of Test	10/28/2017	Test ID	Subgrade_1	Operator	PV	ASTM	D6951
Latitude	42.0041633	Longitude		93.5700433		Elevation (ft)	926
Location	I35NB R./Hwy 30 EB	Station		NA			
Comments	Test conducted on subgrade.

Parameter	DPI (mm/blow)	CBR (%)	E <sub>CBR</sub> , Elastic Modulus (ksi) (non stress-dependent)	S <sub>u-CBR</sub> , Bearing Capacity (psf)
Avg. Top 12 in. of Subgrade	17.5	11.8	12.4	2,815
Avg. Bottom 12 in. of Subgrade	11.7	18.5	16.5	3,795
Ratio of Avg. Top/Bottom Layer	1.5	0.6	0.7	0.7
Std. Dev. Top 12 in. of Subgrade.	9.7	4.8	7.0	1,556
Std. Dev. Bottom 12 in. of Subgrade	7.7	8.7	10.2	2,305

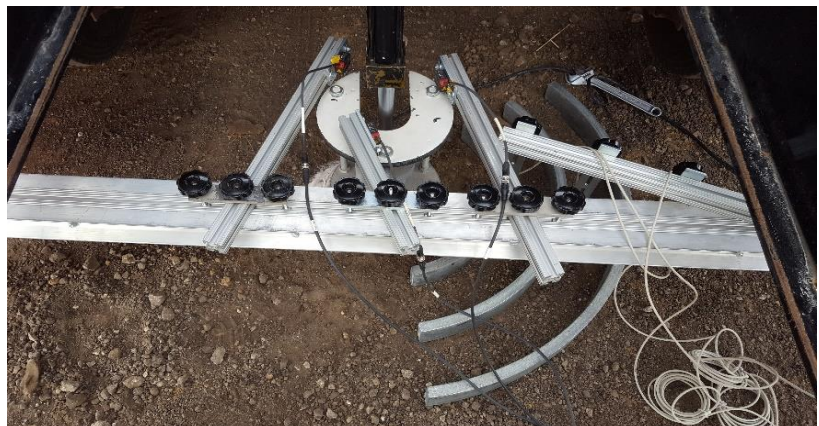
Parameter	Value	P-Value
$k_1^*$	2,649.8	7.87E-08
$k_2^*$	0.067	2.67E-01
$k_3^*$	0.011	9.76E-01
Adj. $R^2$	0.877	
Std. Error [psi]	804

$M_{r-comp}$ (pred.)-BP [psi]	44,156
$\sigma_{cyclic-BP}$ [psi]	39.0

In-situ Resilient Modulus [Mr]: Cyclic Loading, Composite, Stress-Dependent

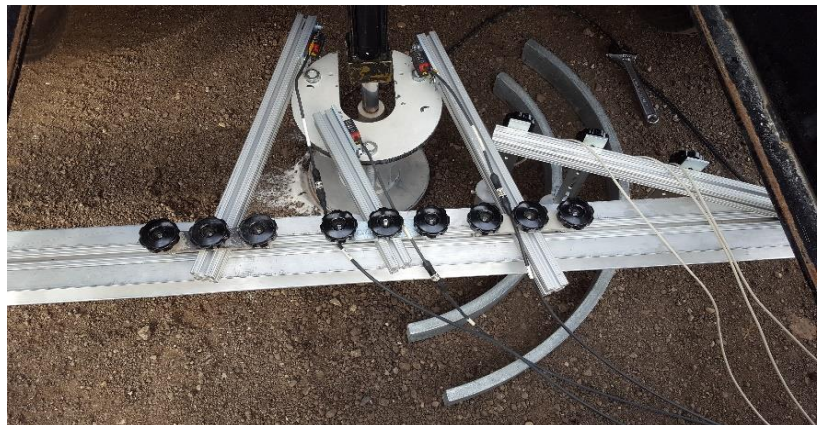
Parameter	Value	P-Value
$k_1^*$	2,557.0	3.81E-07
$k_2^*$	-0.231	9.40E-02
$k_3^*$	0.809	2.96E-01
Adj. $R^2$	0.871	
Std. Error [psi]	1,189

$M_{r-comp}$ (pred.)-BP [psi]	49,851
$\sigma_{cyclic-BP}$ [psi]	2.0

In-situ Resilient Modulus [Mr]: Cyclic Loading, Composite, Stress-Dependent

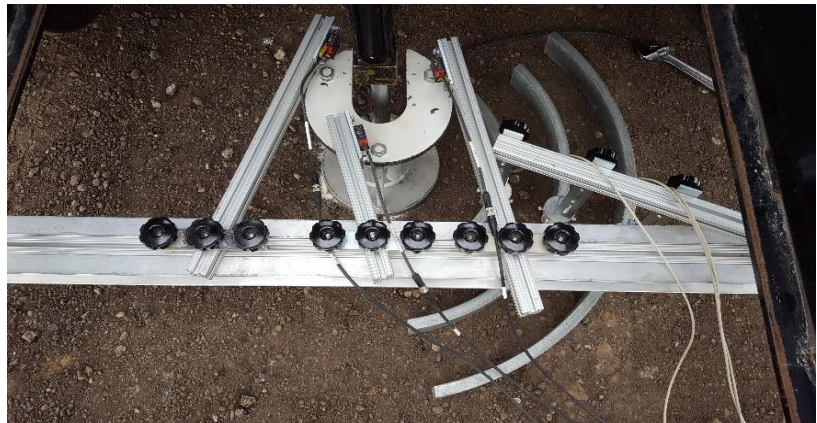
Parameter	Value	P-Value
$k_1^*$	1,536.8	2.01E-07
$k_2^*$	-0.186	8.23E-02
$k_3^*$	1.217	8.68E-02
Adj. $R^2$	0.628	
Std. Error [psi]	525

$M_{r-comp}$ (pred.)-BP [psi]	28,692
$\sigma_{cyclic-BP}$ [psi]	2.0

In-situ Resilient Modulus [Mr]: Cyclic Loading, Composite, Stress-Dependent

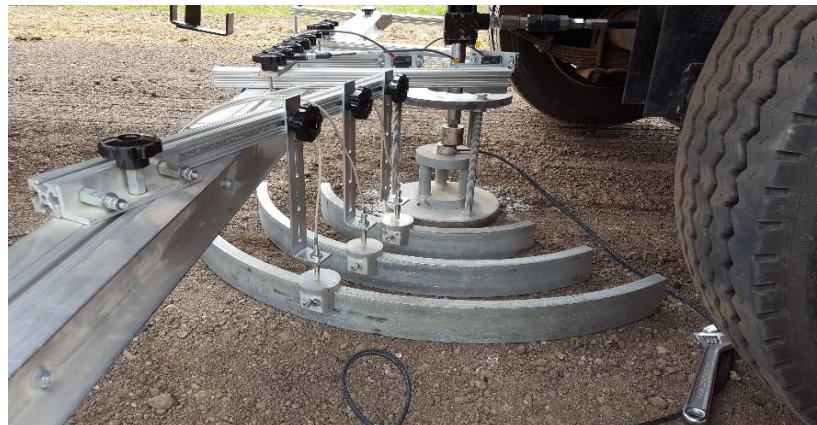
Parameter	Value	P-Value
$k_1^*$	410.5	1.69E-08
$k_2^*$	-0.166	7.13E-03
$k_3^*$	-0.120	5.39E-01
Adj. $R^2$	0.996	
Std. Error [psi]	44

$M_{r-comp}$ (pred.)-BP [psi]	7,279
$\sigma_{cyclic-BP}$ [psi]	2.0

In-situ Resilient Modulus [Mr]: Cyclic Loading, Composite, Stress-Dependent

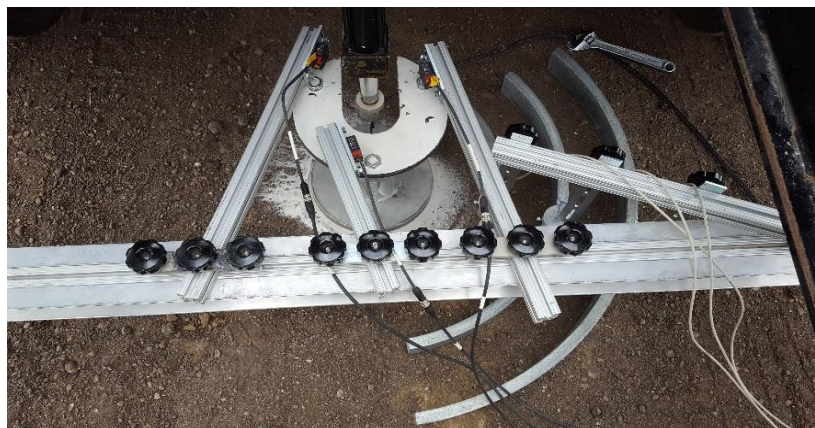
Parameter	Value	P-Value
$k_1^*$	506.5	7.40E-08
$k_2^*$	-0.107	8.06E-02
$k_3^*$	1.265	2.11E-02
Adj. $R^2$	0.945	
Std. Error [psi]	134

$M_{r-comp}$ (pred.)-BP [psi]	9,518
$\sigma_{cyclic-BP}$ [psi]	39.0

In-situ Resilient Modulus [Mr]: Cyclic Loading, Composite, Stress-Dependent

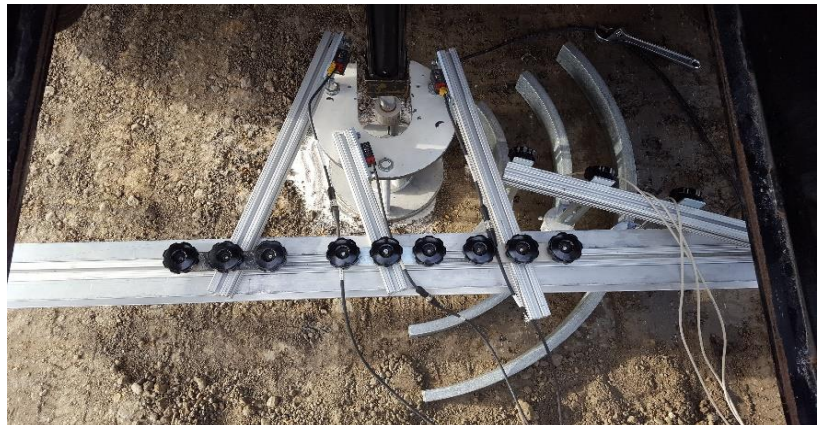
Parameter	Value	P-Value
$k_1^*$	949.6	7.18E-07
$k_2^*$	-0.040	7.13E-01
$k_3^*$	-1.713	8.62E-02
Adj. $R^2$	0.963	
Std. Error [psi]	410

$M_{r-comp}$ (pred.)-BP [psi]	14,093
$\sigma_{cyclic-BP}$ [psi]	2.0

In-situ Resilient Modulus [Mr]: Cyclic Loading, Composite, Stress-Dependent

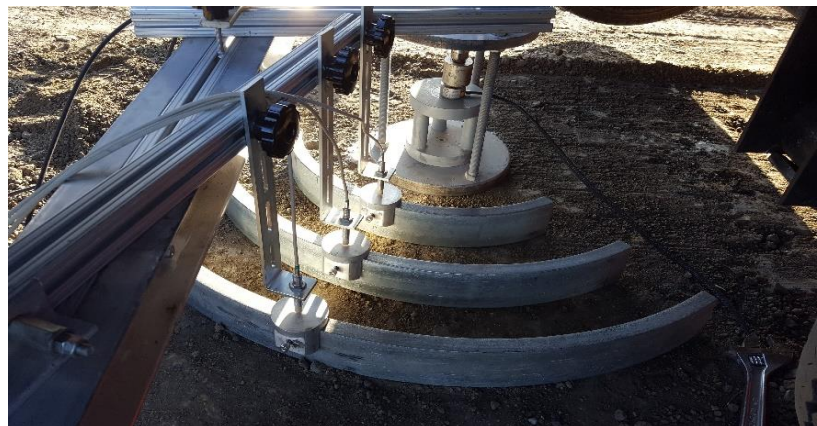
Parameter	Value	P-Value
$k_1^*$	790.4	5.86E-08
$k_2^*$	-0.328	4.70E-03
$k_3^*$	0.203	5.39E-01
Adj. $R^2$	0.996	
Std. Error [psi]	140

$M_{r-comp}$ (pred.)-BP [psi]	17,004
$\sigma_{cyclic-BP}$ [psi]	2.0

In-situ Resilient Modulus [Mr]: Cyclic Loading, Composite, Stress-Dependent

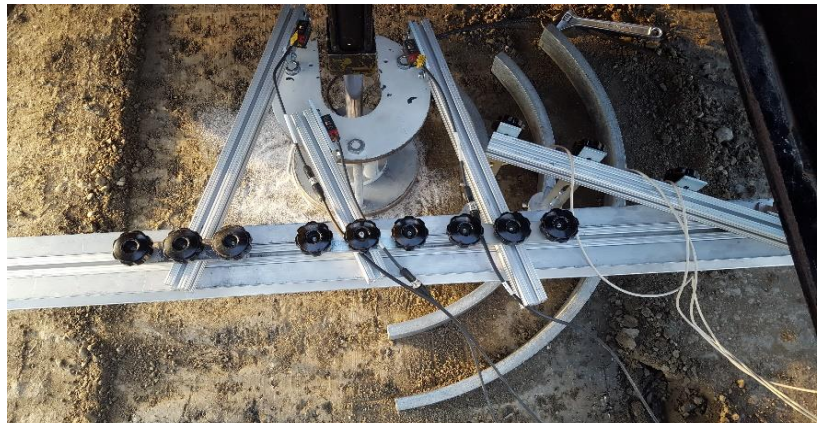
Parameter	Value	P-Value
$k_1^*$	1,431.0	3.17E-08
$k_2^*$	-0.023	5.97E-01
$k_3^*$	-2.194	3.54E-03
Adj. $R^2$	0.997	
Std. Error [psi]	192

$M_{r-comp}$ (pred.)-BP [psi]	20,613
$\sigma_{cyclic-BP}$ [psi]	2.0

In-situ Resilient Modulus [Mr]: Cyclic Loading, Composite, Stress-Dependent

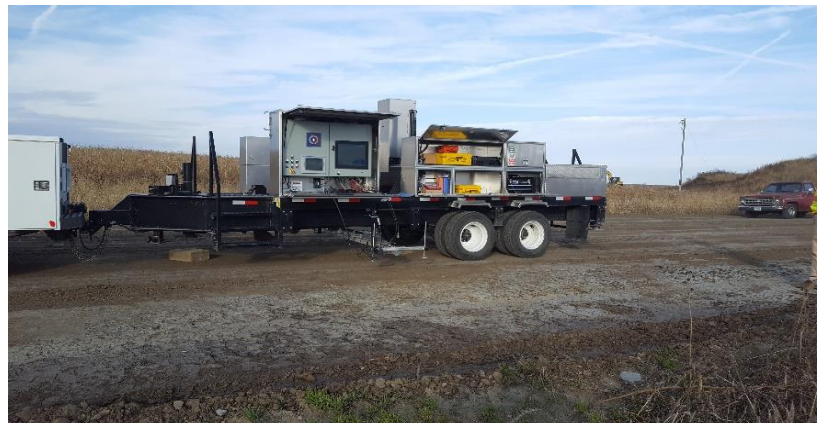
Parameter	Value	P-Value
$k_1^*$	904.2	5.20E-08
$k_2^*$	0.259	5.54E-03
$k_3^*$	-1.715	6.91E-03
Adj. $R^2$	0.929	
Std. Error [psi]	182

$M_{r-comp}$ (pred.)-BP [psi]	12,903
$\sigma_{cyclic-BP}$ [psi]	16.6

In-situ Resilient Modulus [Mr]: Cyclic Loading, Composite, Stress-Dependent

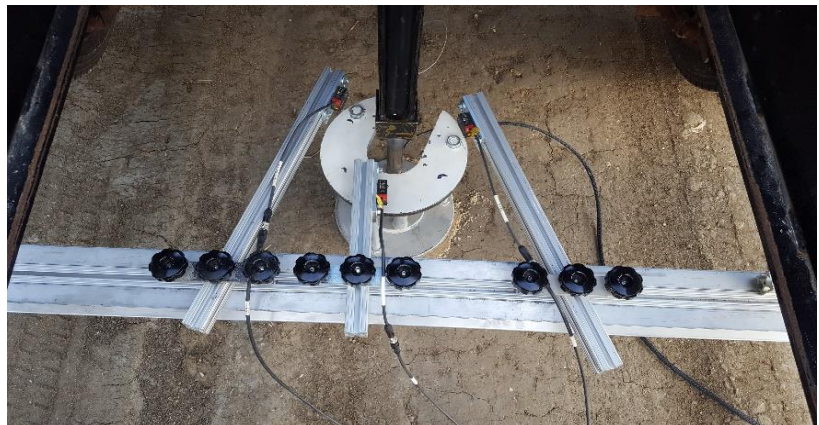
Parameter	Value	P-Value
$k_1^*$	1,154.3	6.04E-07
$k_2^*$	-0.181	1.62E-01
$k_3^*$	0.637	4.09E-01
Adj. $R^2$	0.795	
Std. Error [psi]	540

$M_{r-comp}$ (pred.)-BP [psi]	21,178
$\sigma_{cyclic-BP}$ [psi]	2.0

In-situ Resilient Modulus [Mr]: Cyclic Loading, Composite, Stress-Dependent

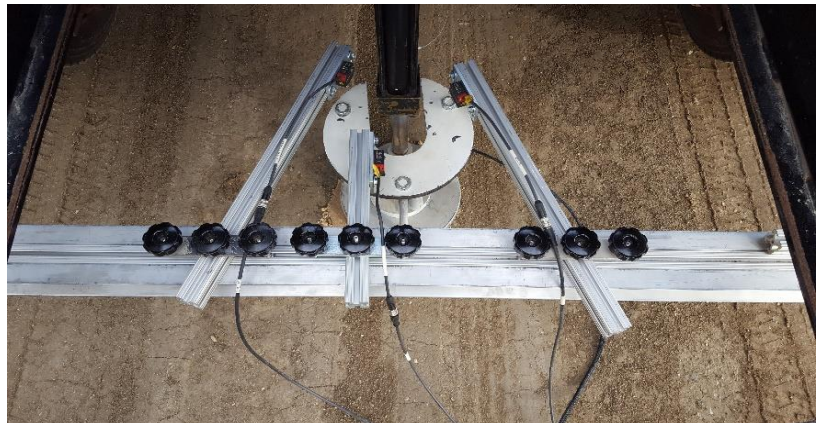
Parameter	Value	P-Value
$k_1^*$	1,764.6	1.66E-07
$k_2^*$	-0.075	3.60E-01
$k_3^*$	-0.187	7.16E-01
Adj. $R^2$	0.895	
Std. Error [psi]	586

$M_{r-comp}$ (pred.)-BP [psi]	28,164
$\sigma_{cyclic-BP}$ [psi]	2.0

In-situ Resilient Modulus [Mr]: Cyclic Loading, Composite, Stress-Dependent

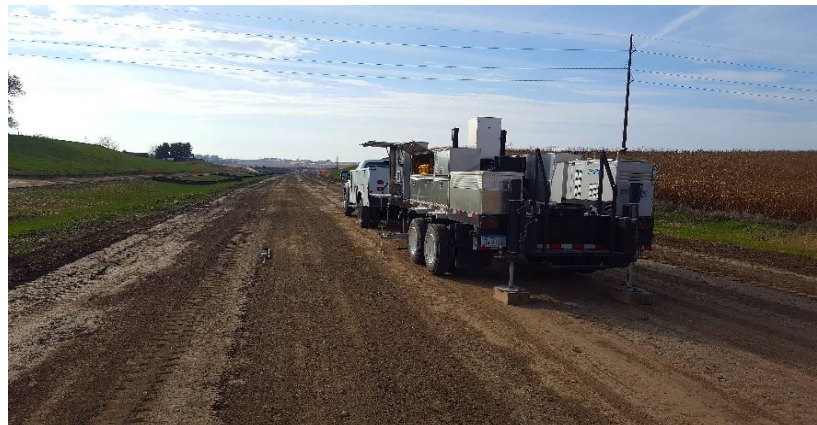
Parameter	Value	P-Value
$k_1^*$	1,211.5	7.89E-07
$k_2^*$	0.473	2.35E-02
$k_3^*$	-2.613	3.90E-02
Adj. $R^2$	0.831	
Std. Error [psi]	690

$M_{r-comp}$ (pred.)-BP [psi]	18,551
$\sigma_{cyclic-BP}$ [psi]	20.7

In-situ Resilient Modulus [Mr]: Cyclic Loading, Composite, Stress-Dependent
