# IN SITU MODULUS MEASUREMENT USING AUTOMATED PLATE LOAD TESTING FOR STATEWIDE MECHANISTIC-EMPIRICAL DESIGN CALIBRATION

Final Report  
May 2019

Sponsored by  
Iowa Highway Research Board and  
Iowa Department of Transportation

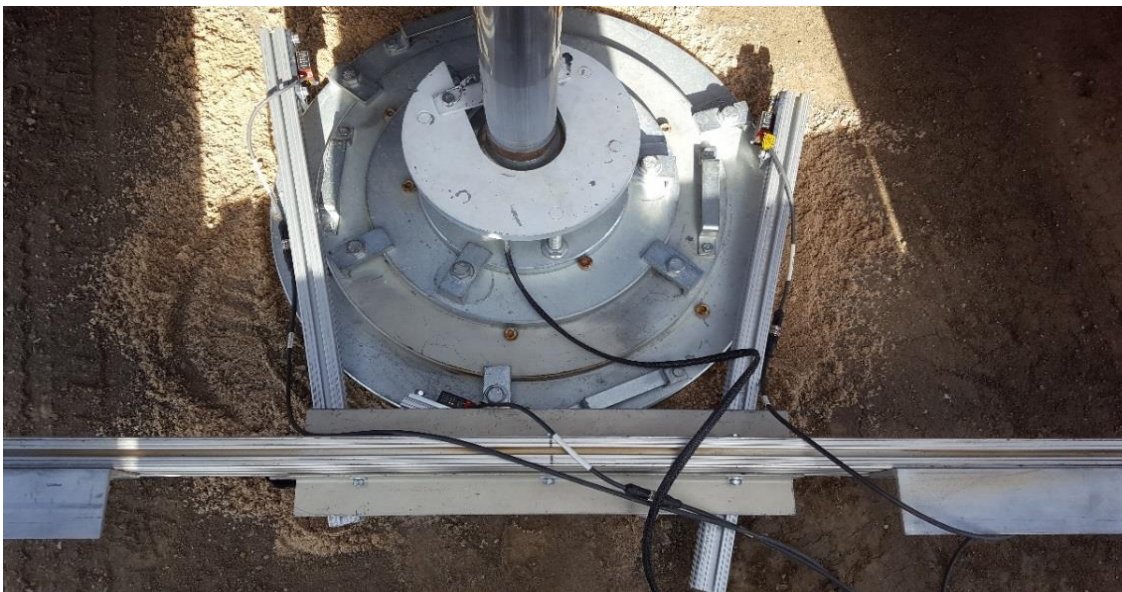
- Test performed per AASHTO T222/ASTM D1196.
- k-value determined using:
  - calculated stress at 0.05 in. plate deformation (δ) for first loading cycle, per PCA design guidelines, and
  - for a defined target stress and calculating corresponding plate deformations using polynomial fit parameters.

## Automated Plate Load Test [APLT]

Test:	In-Situ Static Plate Load Test: Two Loading Cycles.				
Date:	11/3/2017	Time:	12:18:33 PM	Test ID:	Hwy100_30Static_5_Subgrade
Tested By:	DW, JV	Location:	Hwy 100	Sta.:	NA
Latitude:	41.98567	Longitude:	91.77604	Elev. (ft):	786
Comments:	Select Subgrade, Cut Area.

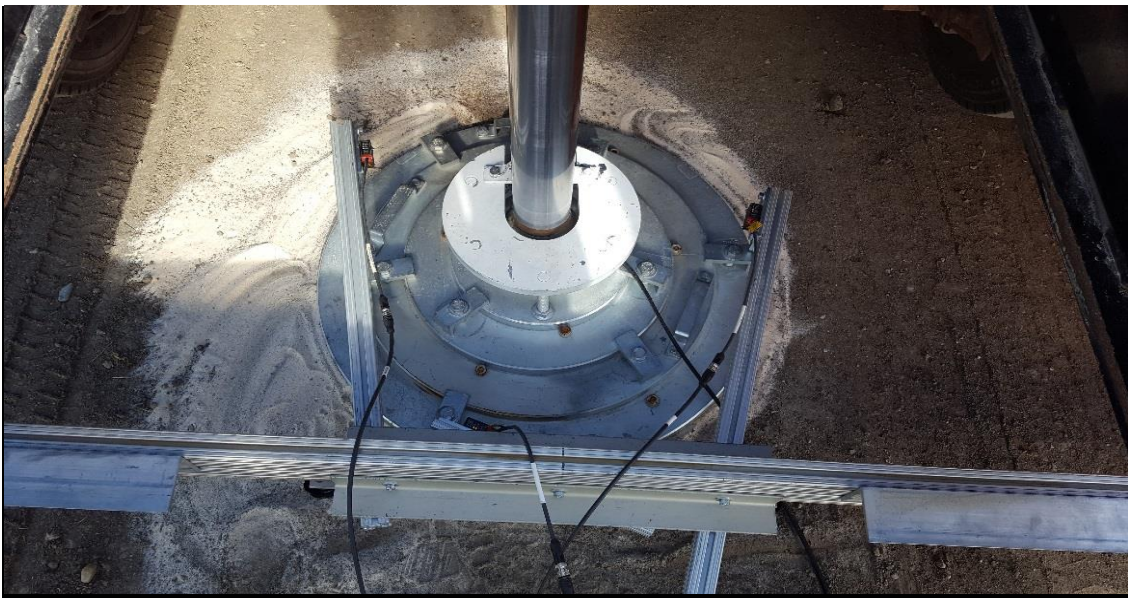
Date of Test	11/3/2017	Test ID	PT 1	Operator	DW/JV	ASTM	D6951
Latitude	41.9890860		Longitude	-91.7757030		Elevation (ft)	815
Location	Hwy 100 N. of E Ave		Station	NA			
Comments	Select Subgrade, Fill Area.

Parameter	DPI (mm/blow)	CBR (%)	$E_{CBR}$ , Elastic Modulus (ksi) (non stress-dependent)	$S_{u-CBR}$ , Bearing Capacity (psf)
Avg. Top 12 in. of Subgrade	11.4	19.0	16.8	3,865
Avg. Bottom 12 in. of Subgrade	14.2	14.9	14.4	3,286
Ratio of Avg. Top/Bottom Layer	0.8	1.3	1.2	1.2
Std.Dev. Top 12 in. of Subgrade.	1.5	3.0	5.2	1,141
Std. Dev. Bottom 12 in. of Subgrade	4.9	7.4	9.2	2,059

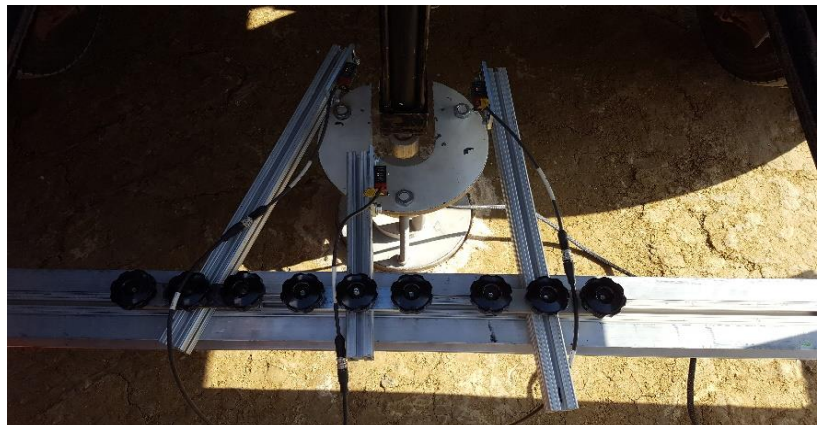
Parameter	Value	P-Value
$k_1^*$	633.6	8.54E-08
$k_2^*$	0.106	7.64E-02
$k_3^*$	-1.205	2.46E-02
Adj. $R^2$	0.911	
Std. Error [psi]	138

$M_{r-comp}$ (pred.)-BP [psi]	8,658
$\sigma_{cyclic-BP}$ [psi]	9.0

In-situ Resilient Modulus [Mr]: Cyclic Loading, Composite, Stress-Dependent

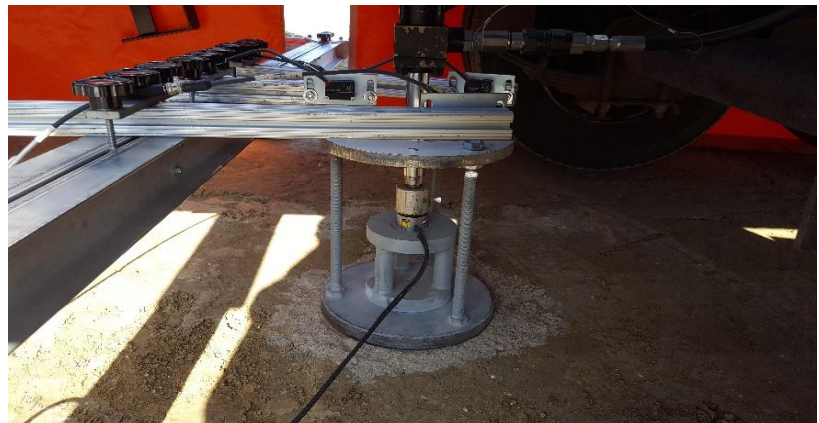
Parameter	Value	P-Value
$k_1^*$	648.8	2.57E-07
$k_2^*$	0.078	2.69E-01
$k_3^*$	-1.619	2.99E-02
Adj. $R^2$	0.957	
Std. Error [psi]	189

$M_{r-comp}$ (pred.)-BP [psi]	8,611
$\sigma_{cyclic-BP}$ [psi]	4.7

In-situ Resilient Modulus [Mr]: Cyclic Loading, Composite, Stress-Dependent

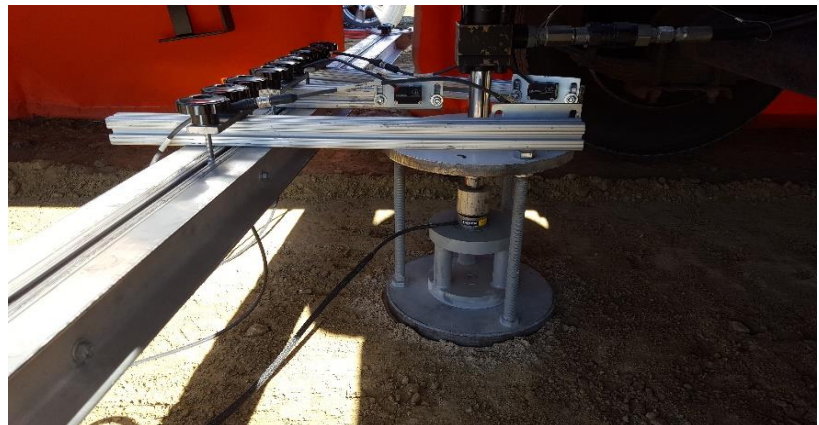
Parameter	Value	P-Value
$k_1^*$	737.7	7.13E-09
$k_2^*$	-0.146	6.42E-03
$k_3^*$	-0.801	1.18E-02
Adj. R <sup>2</sup>	0.998	
Std. Error [psi]	64

$M_{r-comp}$ (pred.)-BP [psi]	12,613
$\sigma_{cyclic-BP}$ [psi]	2.0

In-situ Resilient Modulus [Mr]: Cyclic Loading, Composite, Stress-Dependent

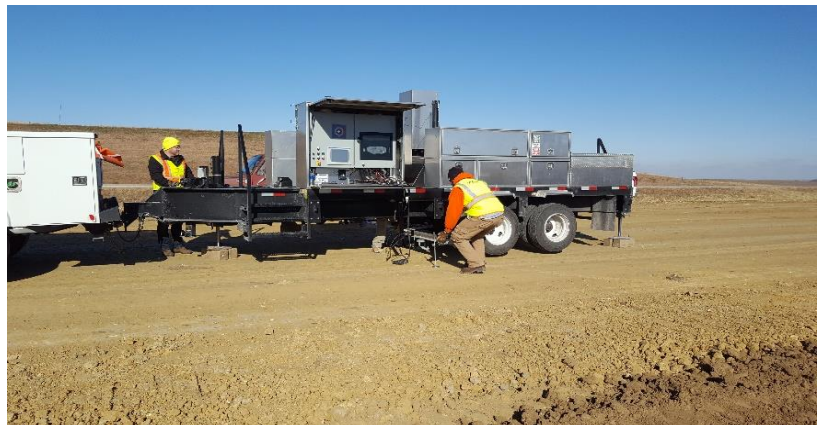
Parameter	Value	P-Value
$k_1^*$	549.6	4.45E-08
$k_2^*$	-0.082	1.18E-01
$k_3^*$	0.104	7.12E-01
Adj. $R^2$	0.931	
Std. Error [psi]	102

$M_{r-comp}$ (pred.)-BP [psi]	8,893
$\sigma_{cyclic-BP}$ [psi]	2.0

In-situ Resilient Modulus [Mr]: Cyclic Loading, Composite, Stress-Dependent

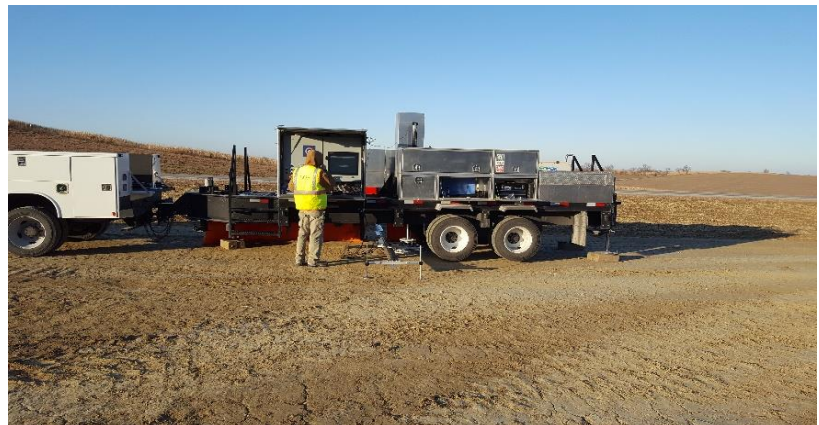
Parameter	Value	P-Value
$k_1^*$	579.1	2.19E-07
$k_2^*$	-0.083	2.92E-01
$k_3^*$	-0.327	5.09E-01
Adj. $R^2$	0.945	
Std. Error [psi]	172

$M_{r-comp}$ (pred.)-BP [psi]	9,295
$\sigma_{cyclic}$ -BP [psi]	2.0

In-situ Resilient Modulus [Mr]: Cyclic Loading, Composite, Stress-Dependent

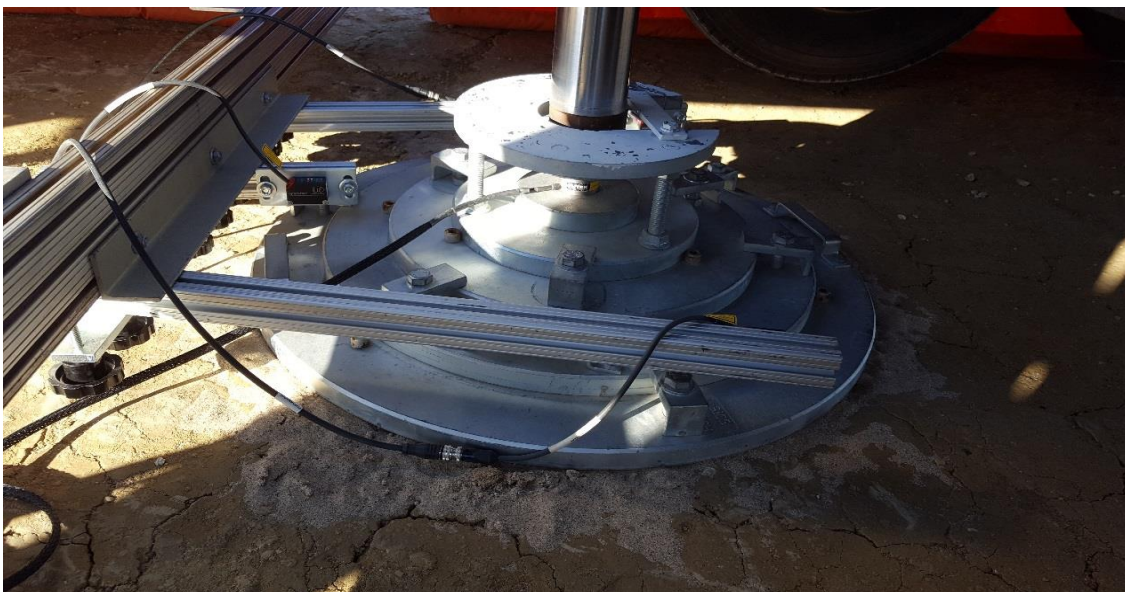
1. Test performed per AASHTO T222/ASTM D1196.
2. k-value determined using:
  - (a) calculated stress at 0.05 in. plate deformation (δ) for first loading cycle, per PCA design guidelines, and
  - (b) for a defined target stress and calculating corresponding plate deformations using polynomial fit parameters.

## Automated Plate Load Test [APLT]

Test:	In-Situ Static Plate Load Test: Two Loading Cycles.				
Date:	11/15/2017	Time:	2:41:24 PM	Test ID:	Hwy20_30Static_6_5Fill
Tested By:	DW, JV	Location:	Hwy 20 (E. of Merville)	Sta.:	NA
Latitude:	42.482430	Longitude:	95.9953450	Elev. (ft):	1371
Comments:	Select subgrade. Fill Area.

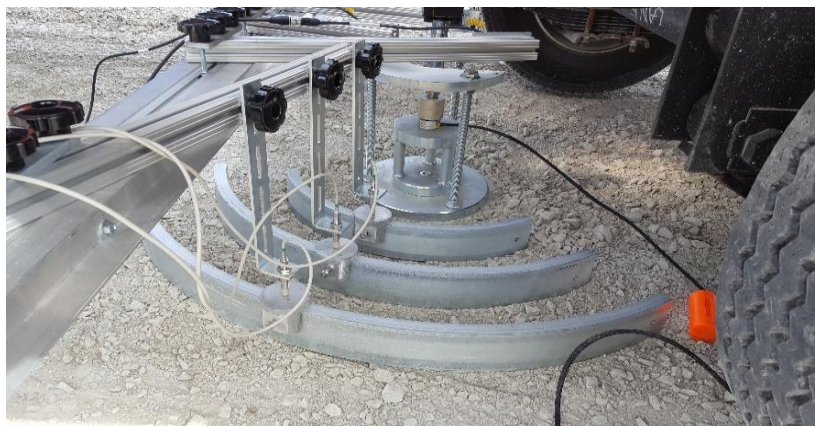
Parameter	Value	P-Value
$k_1^*$	1,644.0	4.35E-07
$k_2^*$	0.352	2.05E-02
$k_3^*$	-3.501	8.58E-03
Adj. $R^2$	0.940	
Std. Error [psi]	572

$M_{r-comp}$ (pred.)-BP [psi]	19,938
$\sigma_{cyclic-BP}$ [psi]	10.5

In-situ Resilient Modulus [Mr]: Cyclic Loading, Composite, Stress-Dependent

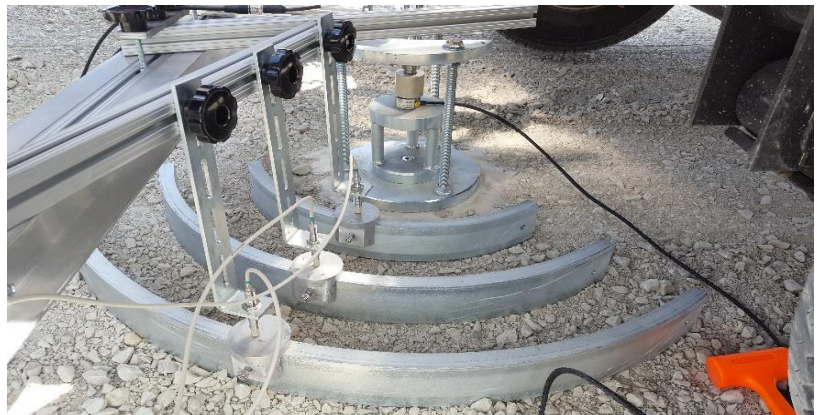
In-situ Resilient Modulus [Mr]: Cyclic Loading, Composite, Stress-Dependent

Parameter	Value	P-Value
$k_1^*$	1,118.5	1.08E-07
$k_2^*$	0.308	7.03E-03
$k_3^*$	-2.883	3.37E-03
Adj. $R^2$	0.963	
Std. Error [psi]	253

$M_{r-comp}$ (pred.)-BP [psi]	14,171
$\sigma_{cyclic-BP}$ [psi]	11.2

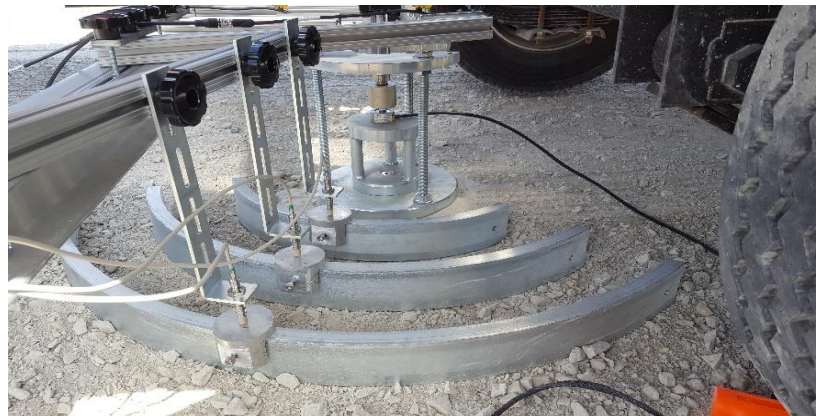
In-situ Resilient Modulus [Mr]: Cyclic Loading, Composite, Stress-Dependent

Parameter	Value	P-Value
$k_1^*$	866.4	8.67E-07
$k_2^*$	0.167	1.58E-01
$k_3^*$	-3.273	1.50E-02
Adj. $R^2$	0.967	
Std. Error [psi]	340

$M_{r-comp}$ (pred.)-BP [psi]	10,334
$\sigma_{cyclic-BP}$ [psi]	5.0

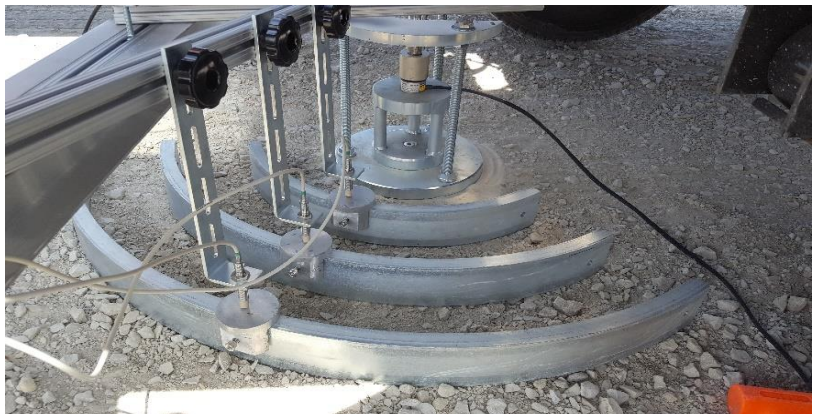
In-situ Resilient Modulus [Mr]: Cyclic Loading, Composite, Stress-Dependent

Parameter	Value	P-Value
$k_1^*$	1,221.8	2.65E-07
$k_2^*$	0.221	3.88E-02
$k_3^*$	-2.245	1.60E-02
Adj. $R^2$	0.906	
Std. Error [psi]	400

$M_{r-comp}$ (pred.)-BP [psi]	15,836
$\sigma_{cyclic-BP}$ [psi]	10.2

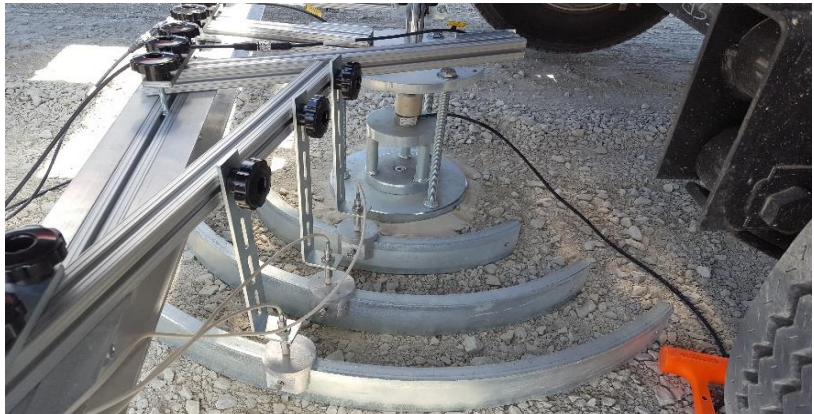
In-situ Resilient Modulus [Mr]: Cyclic Loading, Composite, Stress-Dependent

Parameter	Value	P-Value
$k_1^*$	1,802.9	1.89E-07
$k_2^*$	0.126	1.30E-01
$k_3^*$	-1.242	6.54E-02
Adj. $R^2$	0.768	
Std. Error [psi]	558

$M_{r-comp}$ (pred.)-BP [psi]	24,767
$\sigma_{cyclic-BP}$ [psi]	10.6

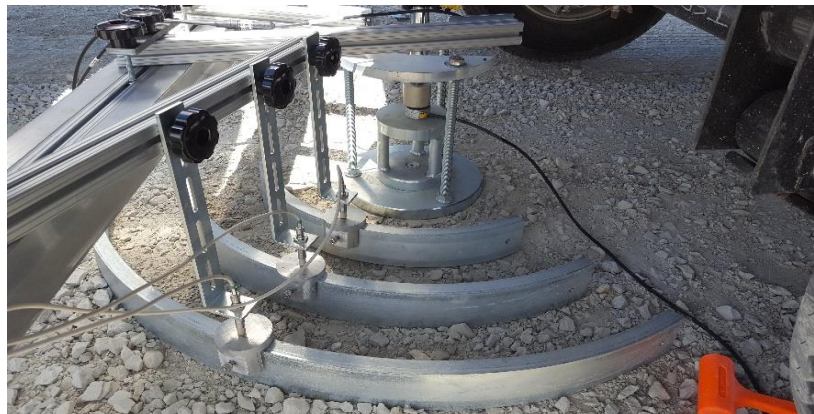
## In-situ Resilient Modulus [Mr]: Cyclic Loading, Composite, Stress-Dependent

Parameter	Value	P-Value
$k_1^*$	1,611.8	3.93E-07
$k_2^*$	0.305	2.74E-02
$k_3^*$	-3.377	8.61E-03
Adj. $R^2$	0.963	
Std. Error [psi]	475

$M_{r-comp}$ (pred.)-BP [psi]	19,375
$\sigma_{cyclic-BP}$ [psi]	9.3

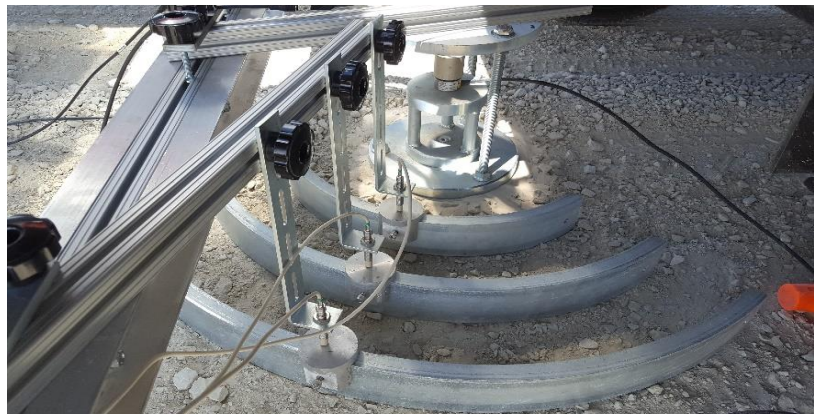
### In-situ Resilient Modulus [Mr]: Cyclic Loading, Composite, Stress-Dependent

Parameter	Value	P-Value
$k_1^*$	1,612.4	6.67E-07
$k_2^*$	0.337	3.44E-02
$k_3^*$	-2.371	3.63E-02
Adj. $R^2$	0.762	
Std. Error [psi]	731

$M_{r-comp}$ (pred.)-BP [psi]	22,311
$\sigma_{cyclic}$ -BP [psi]	15.5

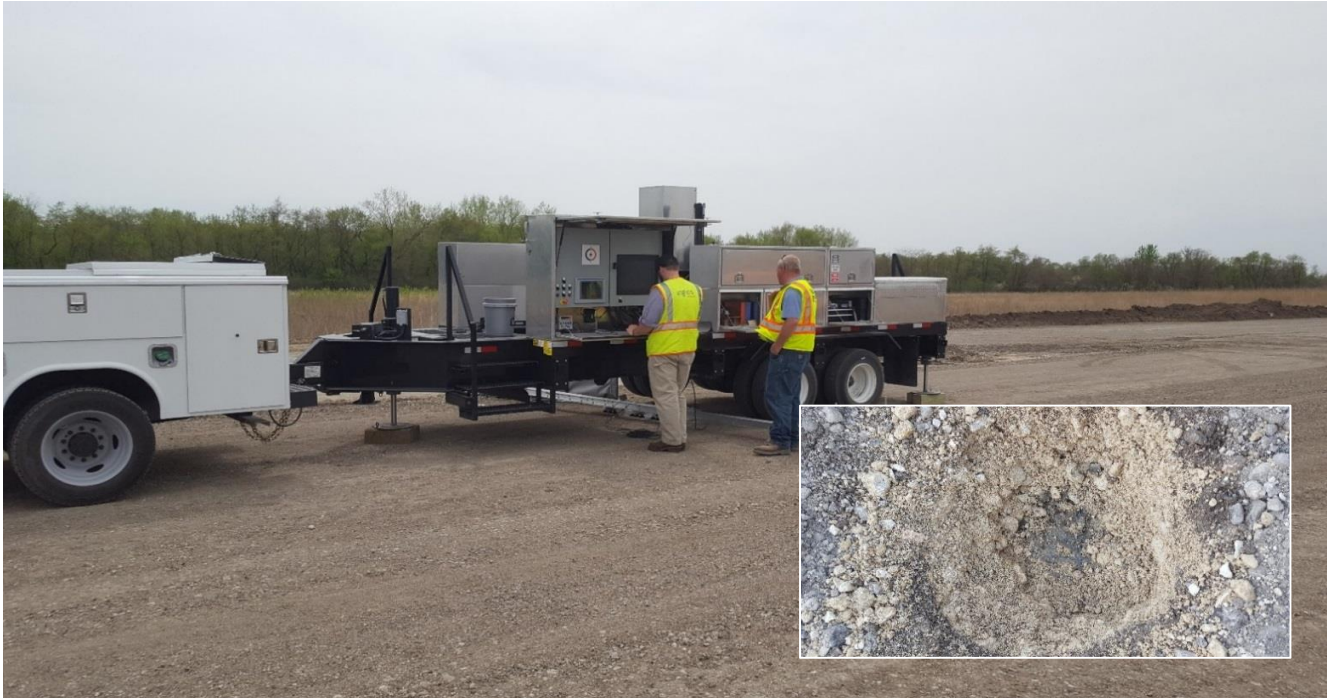
APLT Test Setup  
for 12 in. Cyclic PLT

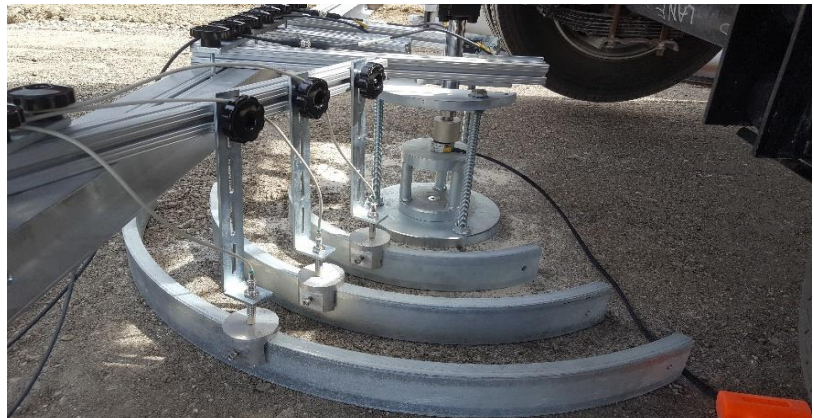
In-situ Resilient Modulus [Mr]: Cyclic Loading, Composite, Stress-Dependent

Parameter	Value	P-Value
$k_1^*$	1,002.3	9.71E-07
$k_2^*$	-0.024	8.15E-01
$k_3^*$	-2.211	4.77E-02
Adj. $R^2$	0.975	
Std. Error [psi]	412

$M_{r-comp}$ (pred.)-BP [psi]	14,453
$\sigma_{cyclic-BP}$ [psi]	2.0

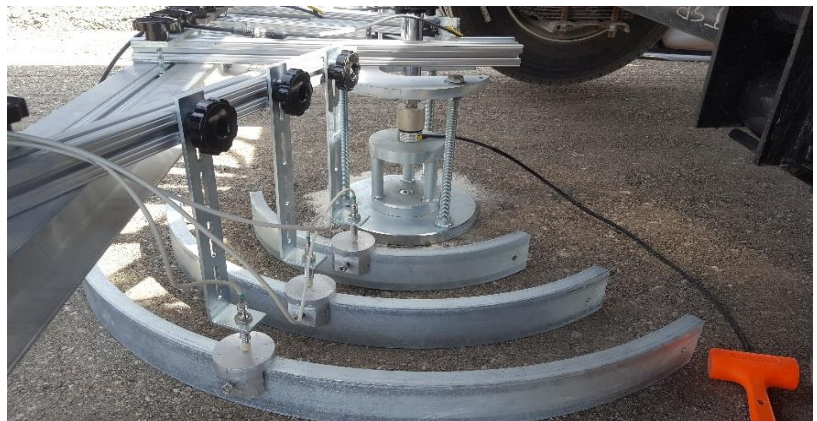
## In-situ Resilient Modulus [Mr]: Cyclic Loading, Composite, Stress-Dependent

Parameter	Value	P-Value
$k_1^*$	1,612.3	2.92E-07
$k_2^*$	0.035	6.46E-01
$k_3^*$	-2.435	1.66E-02
Adj. $R^2$	0.983	
Std. Error [psi]	499

$M_{r-comp}$ (pred.)-BP [psi]	21,617
$\sigma_{cyclic}$ -BP [psi]	2.0

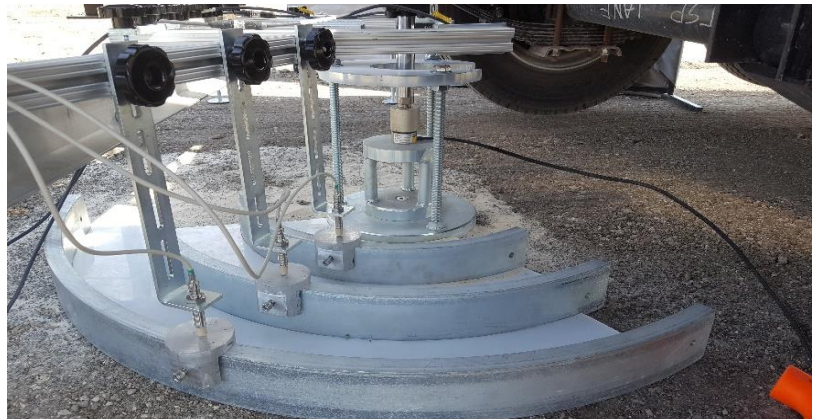
### In-situ Resilient Modulus [Mr]: Cyclic Loading, Composite, Stress-Dependent

Parameter	Value	P-Value
$k_1^*$	1,085.4	4.12E-07
$k_2^*$	0.001	9.85E-01
$k_3^*$	-1.997	3.20E-02
Adj. $R^2$	0.981	
Std. Error [psi]	338

$M_{r-comp}$ (pred.)-BP [psi]	15,269
$\sigma_{cyclic-BP}$ [psi]	2.0

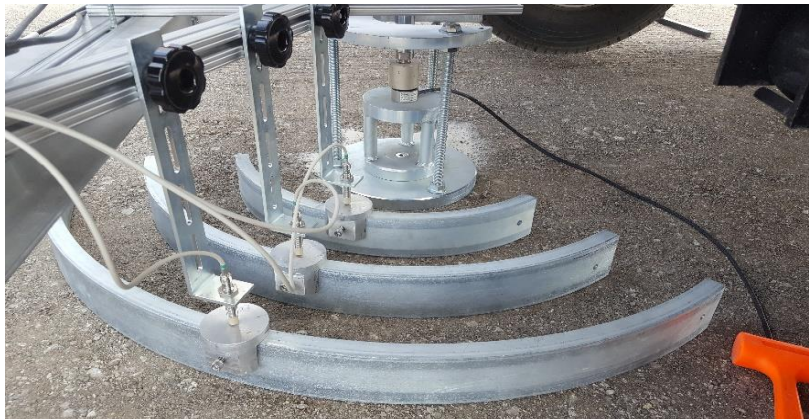
## In-situ Resilient Modulus [Mr]: Cyclic Loading, Composite, Stress-Dependent

$$M_{r-comp} = k_1^* P_a \left(\frac{\theta}{P_a}\right)^{k_2^*} \left(1 + \frac{\tau_{oct}}{P_a}\right)^{k_3^*}$$

Parameter	Value	P-Value
$k_1^*$	1,616.1	1.54E-07
$k_2^*$	0.055	4.02E-01
$k_3^*$	-1.905	1.82E-02
Adj. $R^2$	0.979	
Std. Error [psi]	426

$M_{r-comp}$ (pred.)-BP [psi]	21,477
$\sigma_{cyclic-BP}$ [psi]	3.0

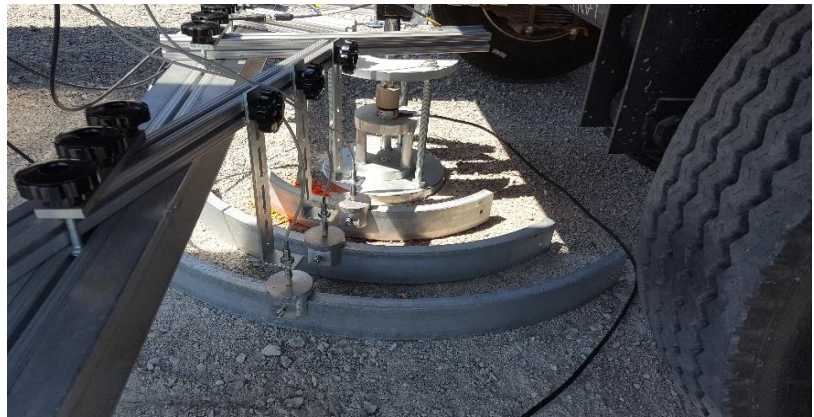
In-situ Resilient Modulus [Mr]: Cyclic Loading, Composite, Stress-Dependent

Parameter	Value	P-Value
$k_1^*$	3,513.4	6.65E-07
$k_2^*$	0.230	1.02E-01
$k_3^*$	-1.416	1.44E-01
Adj. $R^2$	0.586	
Std. Error [psi]	1,655

$M_{r-comp}$ (pred.)-BP [psi]	51,255
$\sigma_{cyclic-BP}$ [psi]	18.2

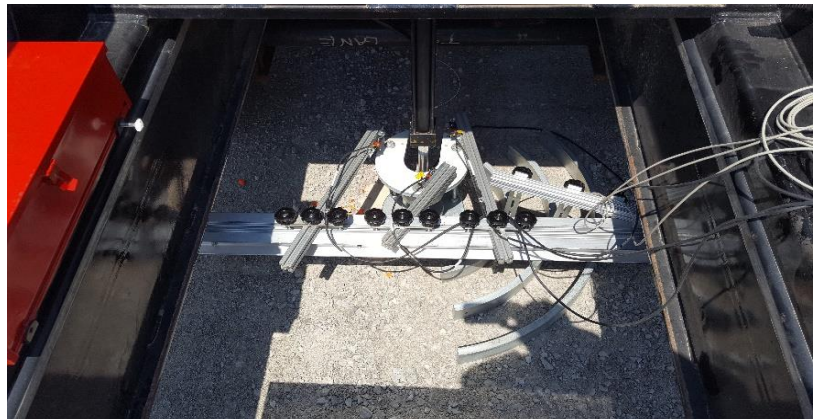
In-situ Resilient Modulus [Mr]: Cyclic Loading, Composite, Stress-Dependent

Parameter	Value	P-Value
$k_1^*$	2,982.1	2.26E-07
$k_2^*$	0.465	6.09E-03
$k_3^*$	-1.896	3.02E-02
Adj. $R^2$	0.982	
Std. Error [psi]	1,108

$M_{r-comp}$ (pred.)-BP [psi]	53,486
$\sigma_{cyclic-BP}$ [psi]	30.4

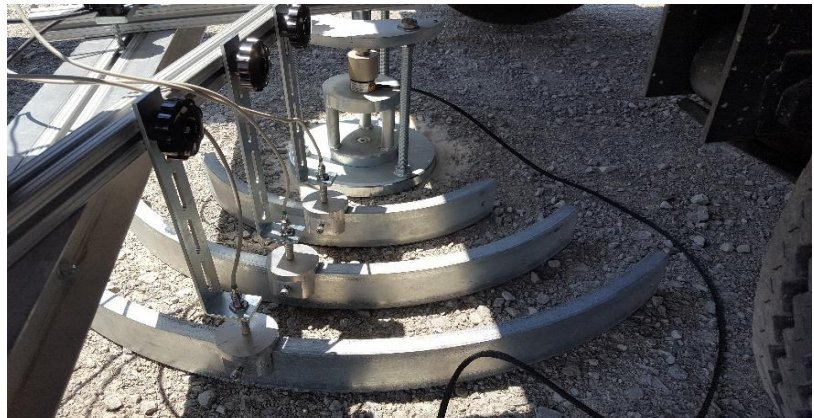
In-situ Resilient Modulus [Mr]: Cyclic Loading, Composite, Stress-Dependent

Parameter	Value	P-Value
$k_1^*$	2,996.2	2.01E-07
$k_2^*$	0.189	6.18E-02
$k_3^*$	-0.476	3.86E-01
Adj. $R^2$	0.941	
Std. Error [psi]	1,199

$M_{r-comp}$ (pred.)-BP [psi]	52,650
$\sigma_{cyclic-BP}$ [psi]	39.0

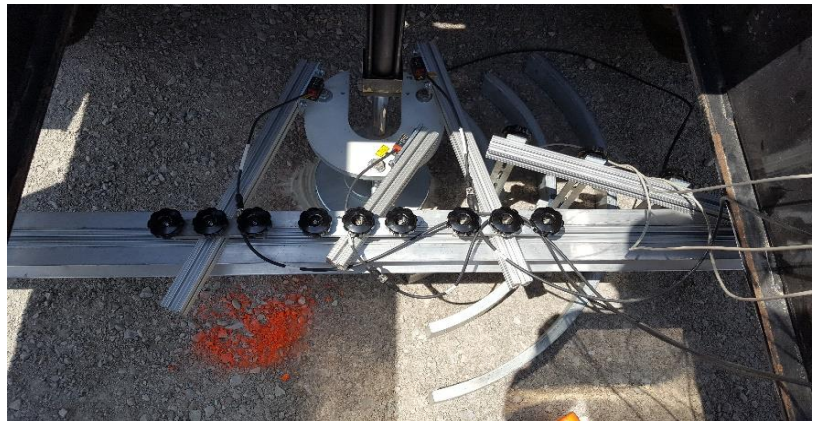
In-situ Resilient Modulus [Mr]: Cyclic Loading, Composite, Stress-Dependent

Parameter	Value	P-Value
$k_1^*$	2,993.5	8.74E-07
$k_2^*$	0.181	1.85E-01
$k_3^*$	-0.680	4.41E-01
Adj. $R^2$	0.782	
Std. Error [psi]	1,622

$M_{r-comp}$ (pred.)-BP [psi]	48,327
$\sigma_{cyclic-BP}$ [psi]	33.8

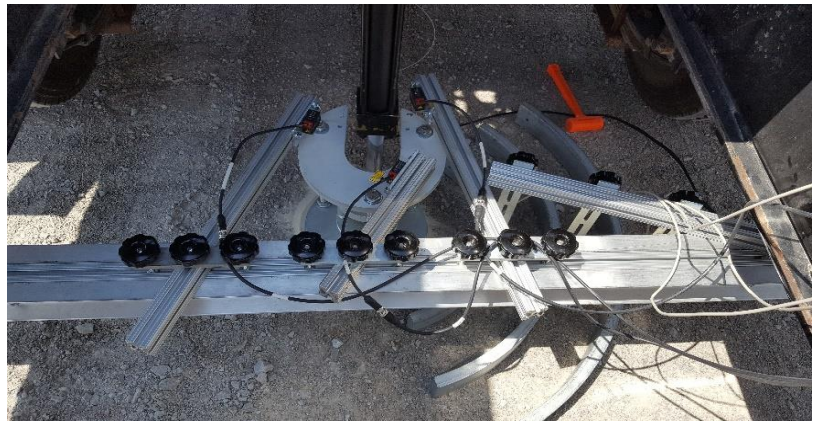
In-situ Resilient Modulus [Mr]: Cyclic Loading, Composite, Stress-Dependent

Parameter	Value	P-Value
$k_1^*$	3,446.5	3.60E-07
$k_2^*$	0.346	2.22E-02
$k_3^*$	-1.925	4.47E-02
Adj. $R^2$	0.882	
Std. Error [psi]	1,506

$M_{r-comp}$ (pred.)-BP [psi]	52,046
$\sigma_{cyclic-BP}$ [psi]	20.5
