# Evaluation of the Performance of A1010 Bridge Steel

tech transfer summary

Evaluation of the Performance of A1010 Bridge Steel

Iowa Department of Transportation  
(InTrans Project 16-562)

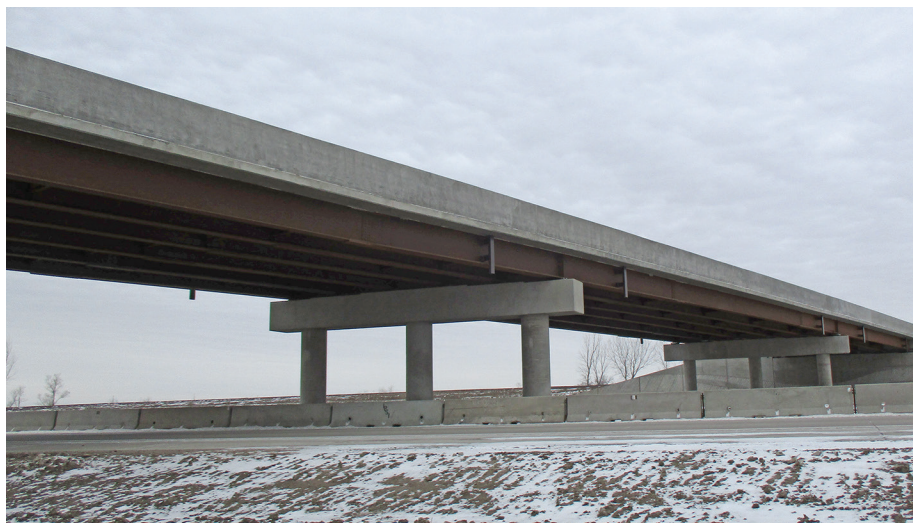
Salix Interchange Bridge on County Road K25 over I-29 in Woodbury County, Iowa

In 2016, the Iowa Department of Transportation (DOT) replaced a bridge in Woodbury County (on County Road K25 over I-29 at the Salix interchange) with a two-lane, four-span, continuous, steel-girder bridge partially constructed using ASTM A1010 bridge steel, i.e., for the two southernmost girders.

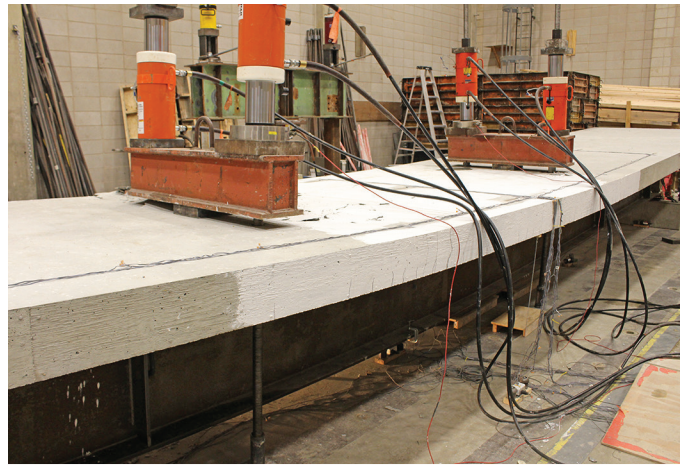
*Ultimate flexural performance testing for the A1010 specimen*

A comprehensive experimental program was carried out to investigate the performance of A1010 steel under a four-point bending scenario to determine the plate girder and composite flexural behavior.

A 52 ft 9 in. long A1010 steel girder like the two used in the bridge was designed, fabricated, and laboratory tested, with the results also compared to the current American Association of State Highway and Transportation Officials (AASHTO) Load and Resistance Factor Design (LRFD) Bridge Design Specifications. Additionally, tensile and fatigue tests were conducted to obtain the mechanical and fatigue behavior for the A1010 steel.

- The predictions obtained utilizing actual material properties were reasonable compared to the results obtained from the laboratory test, indicating the A1010 girder's ability to meet the AASHTO design requirements. When the designed material properties were utilized for hand calculations, the flexural capacity measured from the laboratory test was 15.4% higher. This may be due to the difference between the material properties of A1010 steel obtained from tensile tests and the recommendations in design.

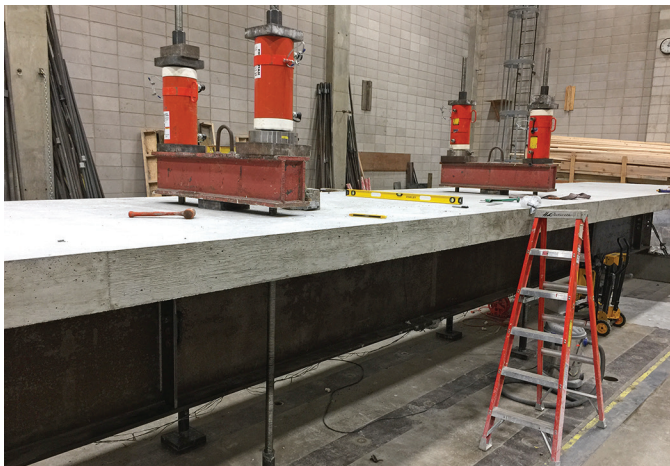
*Loading setup for composite beam under 50% yield moment*

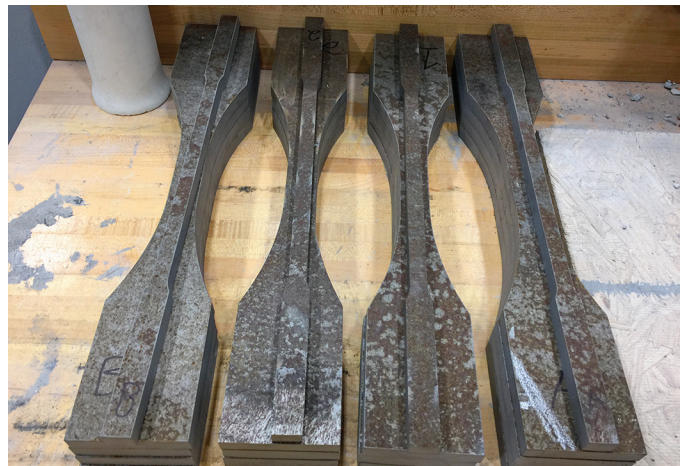
*Coupon sample specimens for fatigue testing*

Cyclic material tests were carried out on coupon samples to investigate the high-cycle fatigue properties for A1010 steel. The stress-life method was adopted to predict the fatigue life for A1010 steel, and the predicted S-N curve (a log-log plot of stress range versus the number of cycles to failure) for A1010 steel was compared to other steel, including A709 weathering steel and A7 steel.

- In the fatigue tests of coupon samples, A709 steel showed a slightly higher fatigue resistance in the high-cycle fatigue region compared to A1010 steel. Both A1010 and A709 steel exhibited higher fatigue resistance than A7 steel, which may be caused by the difference in their strength. However, the fatigue limit for A1010 steel was found to be between 37.4 ksi and 40.8 ksi in the laboratory testing, indicating A1010 steel can provide adequate fatigue resistance according to current fatigue design provisions.

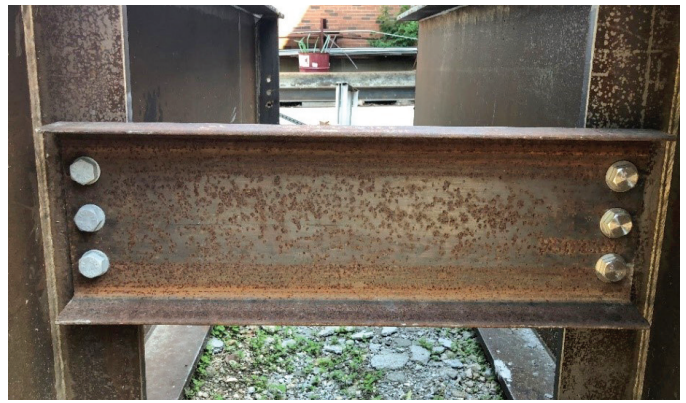
*Girder cross frame specimen for galvanized corrosion monitoring with galvanized steel bolts on the left and stainless steel bolts on the right*

To characterize the behavior of galvanic corrosion of the A1010 steel in contact with other metal, this study implemented galvanic corrosion evaluation testing on a full-scale girder cross frame and also on an exposed A1010 steel plate at the bridge site.

Both of these test specimens were constructed using different types of steel bolts and welds for comparison purposes, and corrosion testing on them will be ongoing.

- Long-term observational monitoring of galvanic corrosion on the full-scale cross frame will collect data for two types of bolted connections: stainless and galvanized steel.
- Likewise, long-term monitoring of the A1010 steel plate placed at the bridge site will be conducted and periodically documented for the development of corrosion.

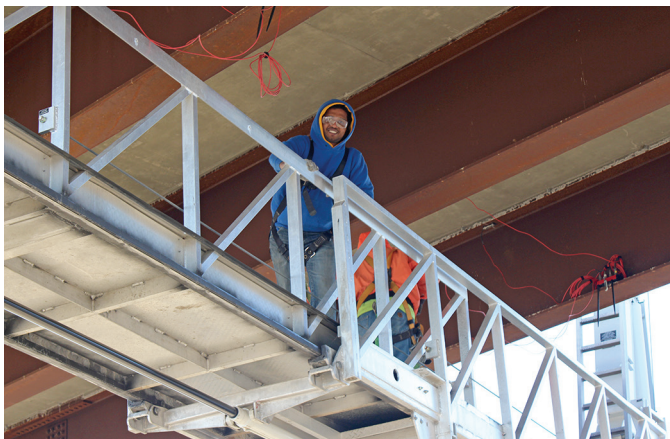
*Instrumenting the girders for the live load tests*

Instrumented live-load tests on the bridge were conducted to identify any changes in behavior that occurred with time. The data were also analyzed for differences in response between the A1010 and A709 steel girders.

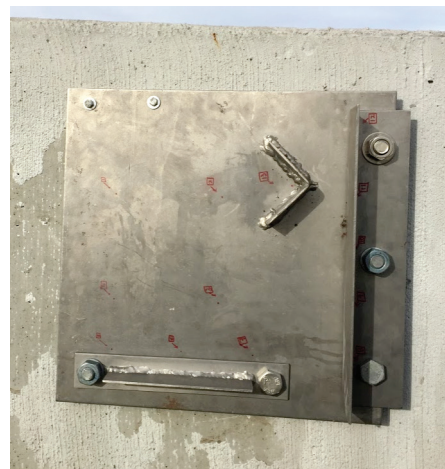
*A1010 steel plate with stainless steel and galvanized steel bolts and welded connection*

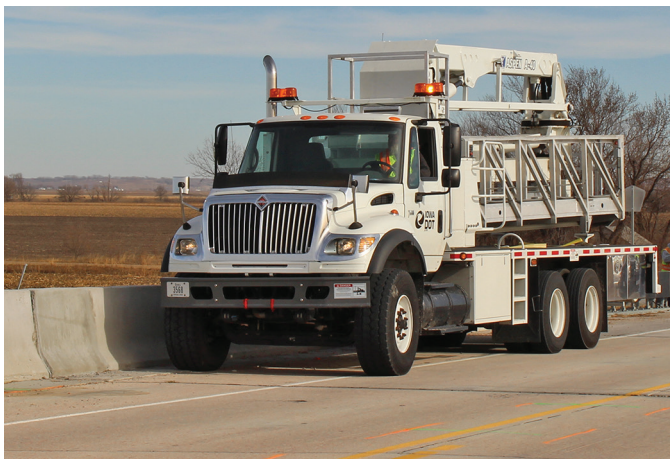
*Live-load testing on the bridge*

Two field tests for the Woodbury County (Salix Interchange) Bridge, which was designed utilizing A1010 steel and A709 weathering steel girders, were conducted with the goal of characterizing the difference in responses between the two types of steel.

- The calculated distribution factors from the measured field strains and the AASHTO-recommended equations were investigated for comparison, and, for all cases, the maximum measured distribution factors were less than those calculated using the equations.

- In general, the results showed that the changes of structural performance for the girders when subjected to static live load tests over the two years were minimal.
